DGGS November 2011 Bering Sea Storm Rapid Response fieldwork

Nicole Kinsman

Coastal Geologist, Alaska Division of Geological & Geophysical Surveys

March 13, 2013

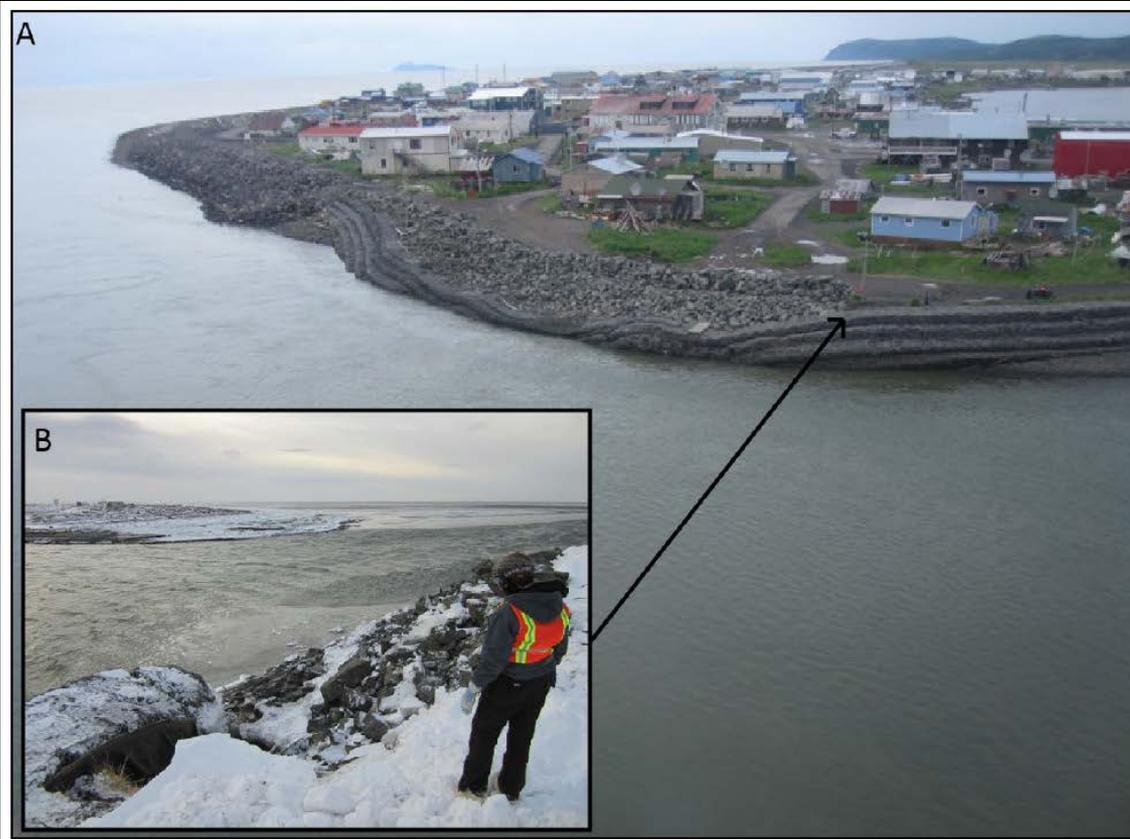
Blow-out occurred of gabion revetment at inlet mouth.

Blow-out of UNK Revetment

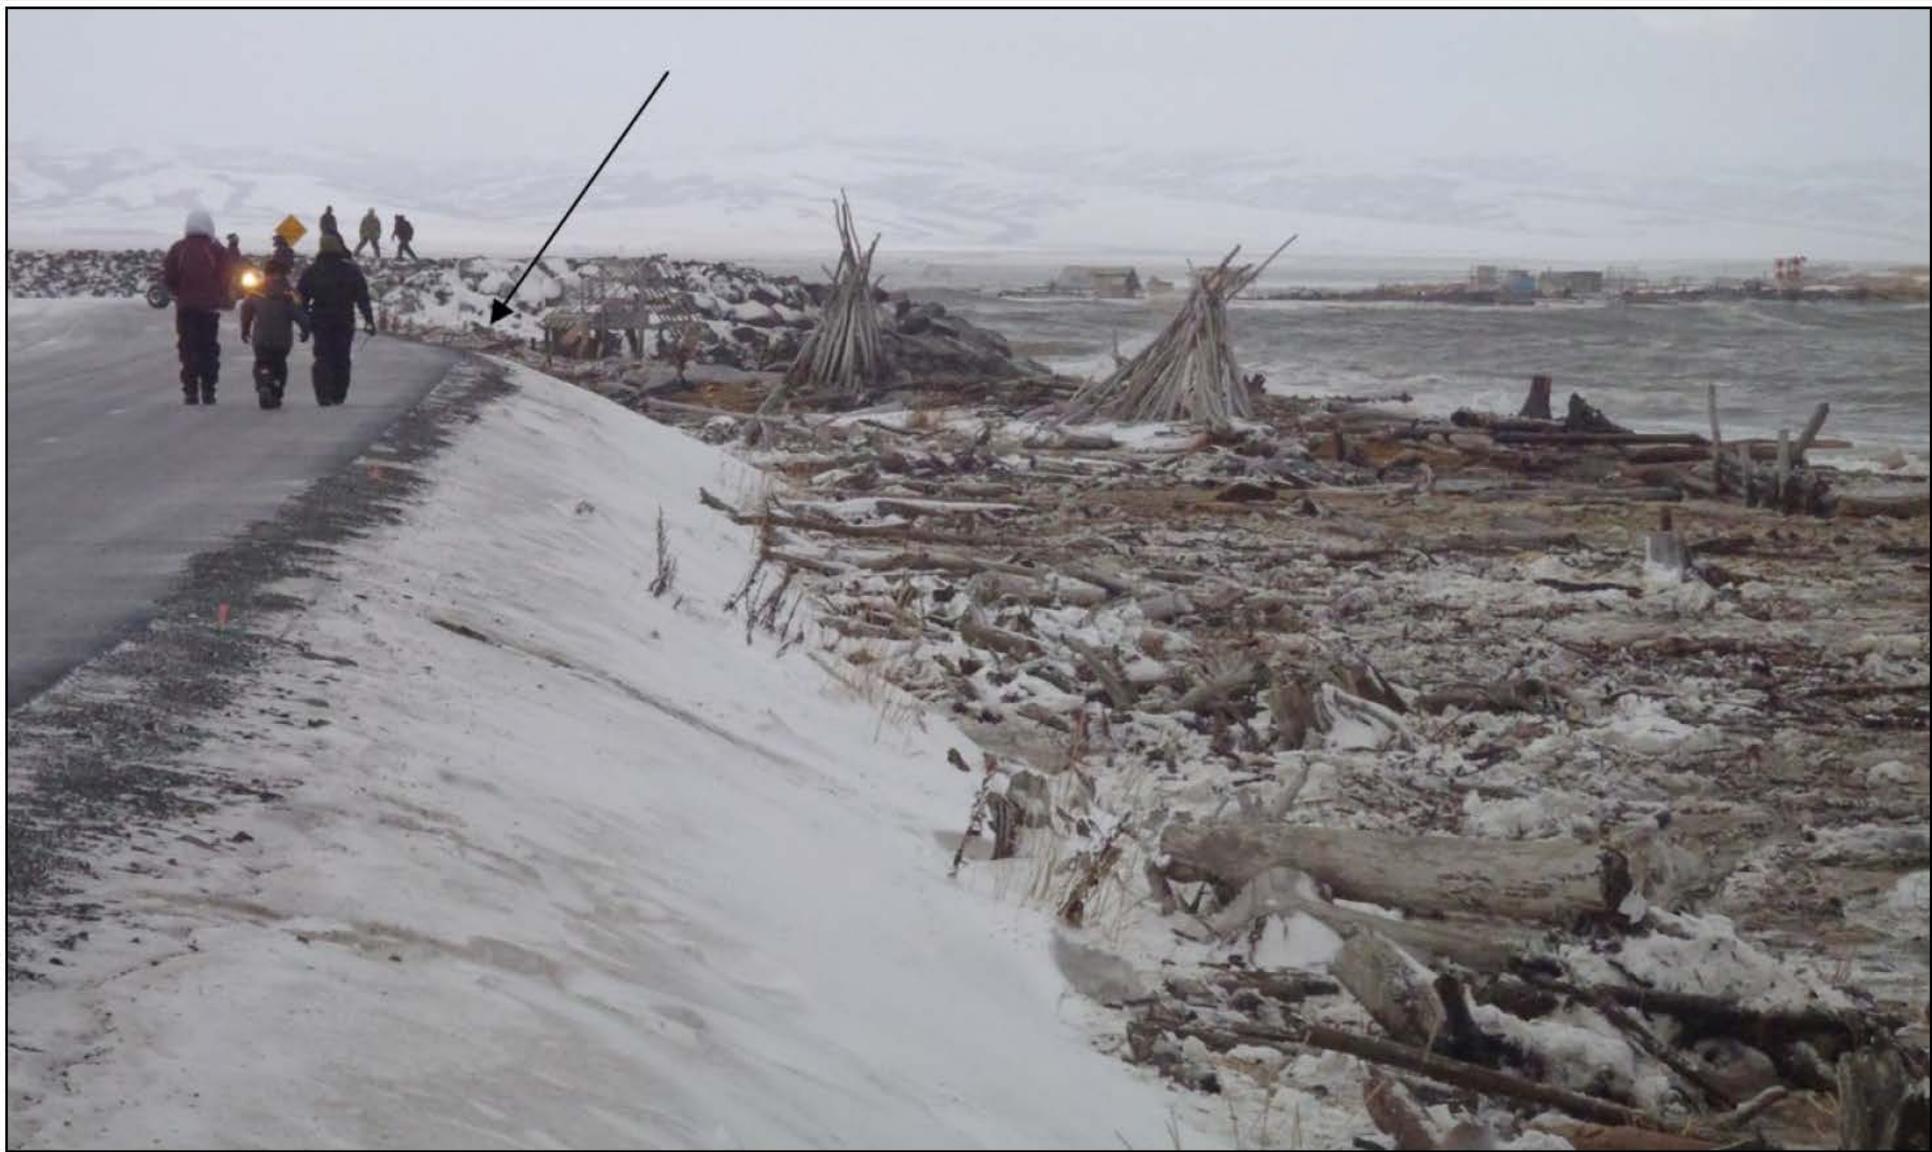
Unalakleet raised road

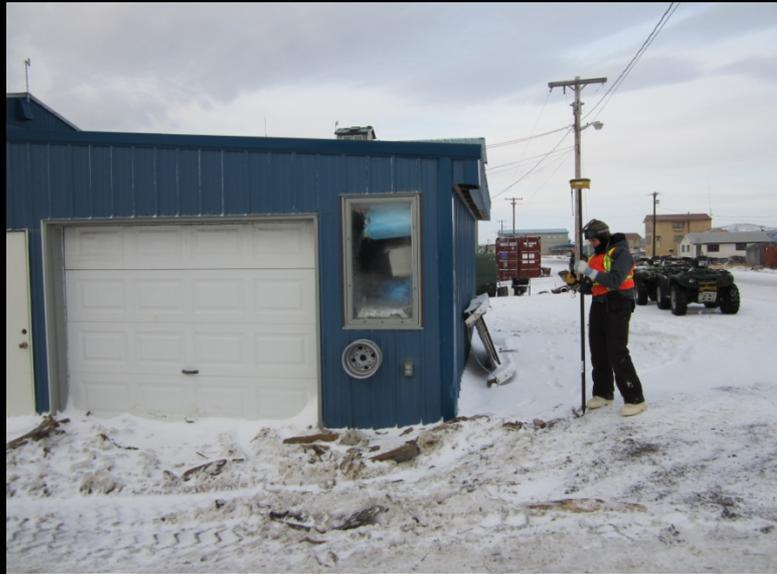
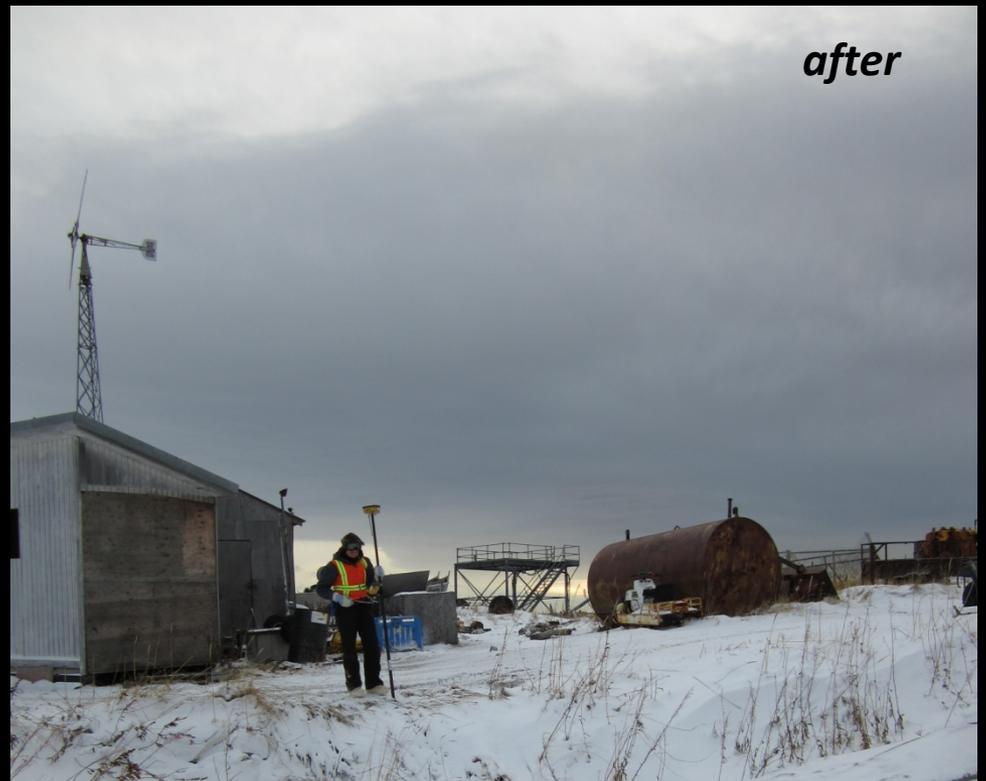
Flooding in UNK

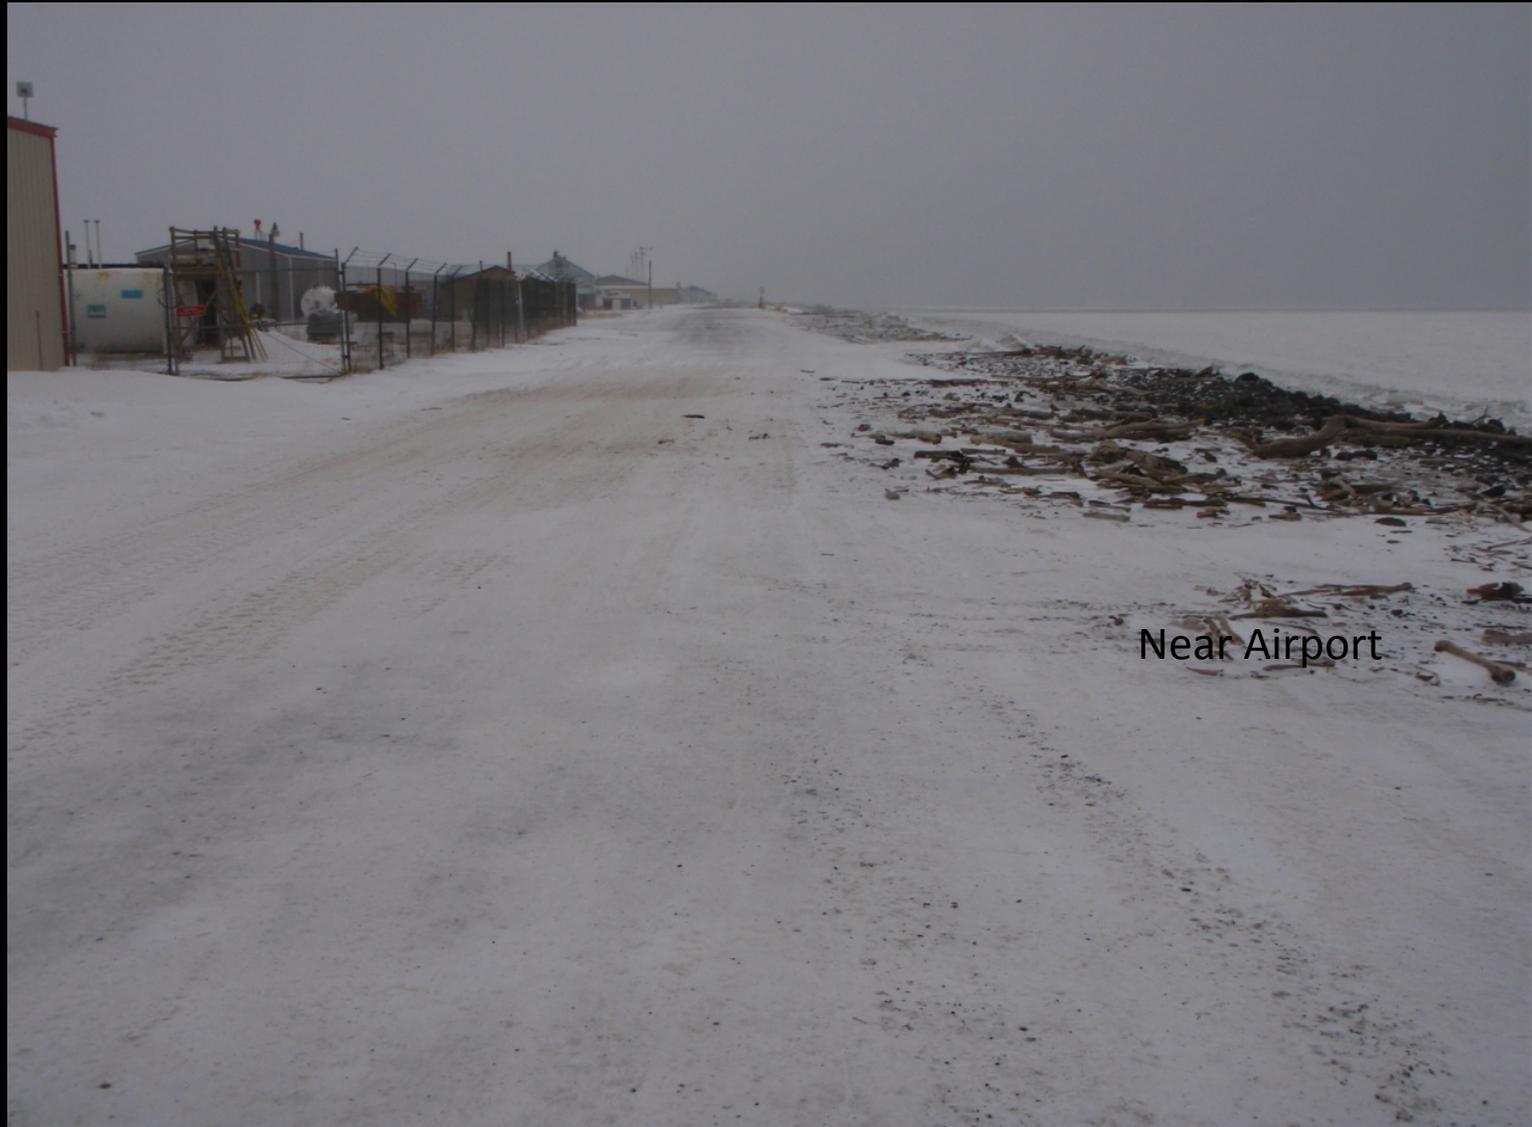
Overtopping of airport road in UNK

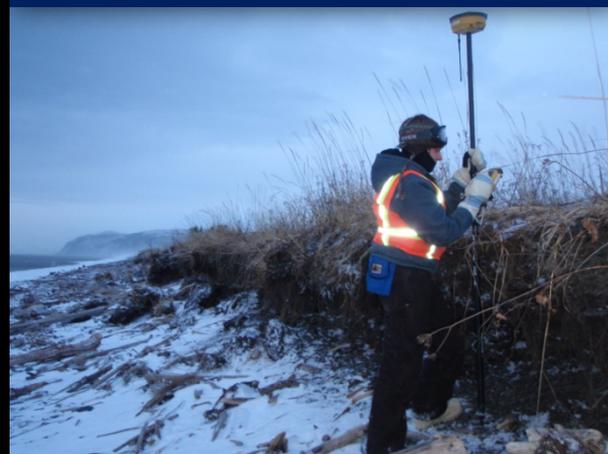
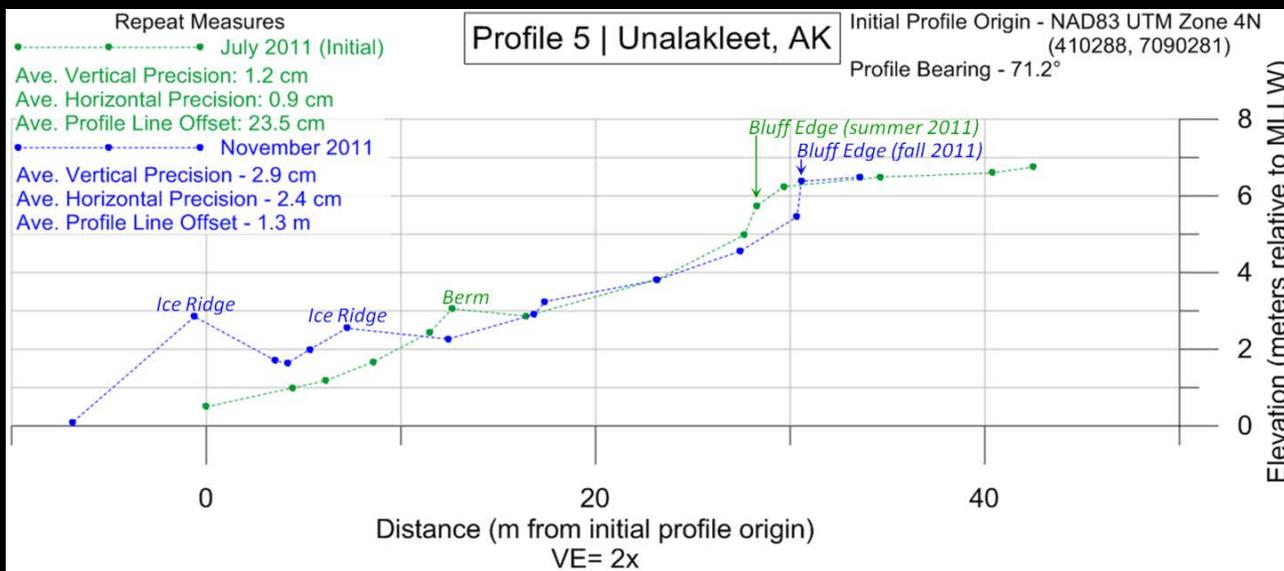
← 2.3 meters
of bluff retreat

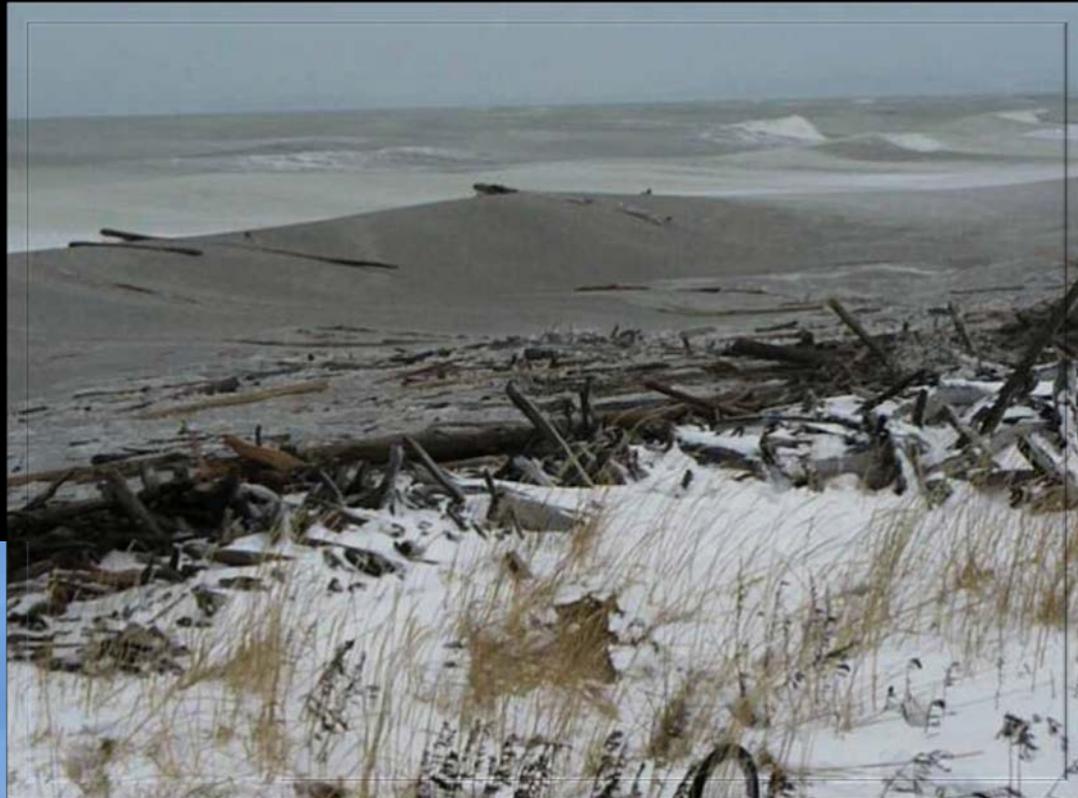
Wave attack in front of Shaktoolik

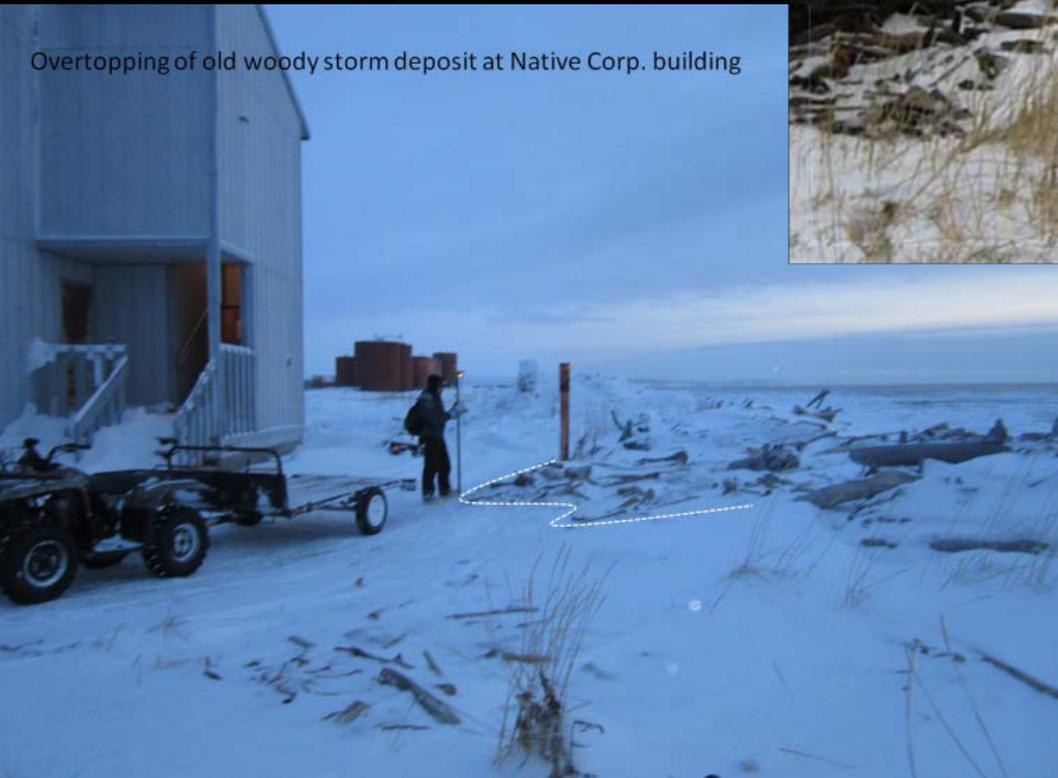
Overtopping of old woody storm deposit at Native Corp. building

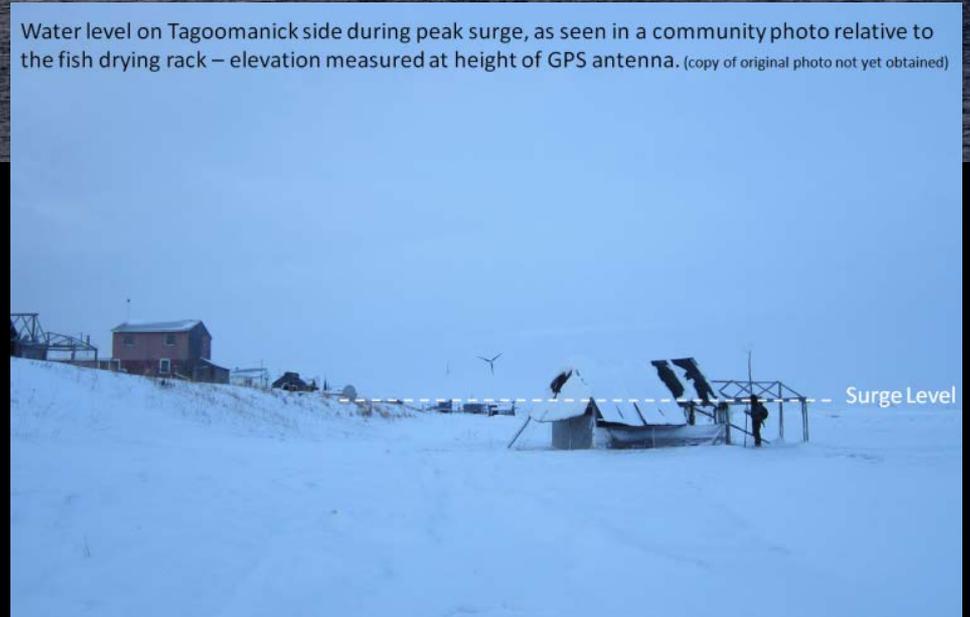
Water level on Tagoomanick side during peak surge, as seen in a community photo relative to the fish drying rack – elevation measured at height of GPS antenna. (copy of original photo not yet obtained)

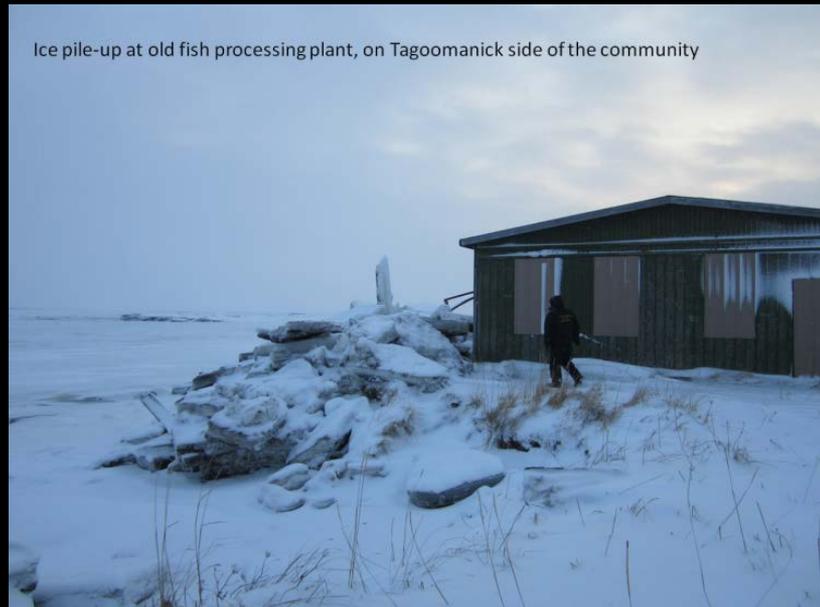
Ice pile-up at old fish processing plant, on Tagoomanick side of the community

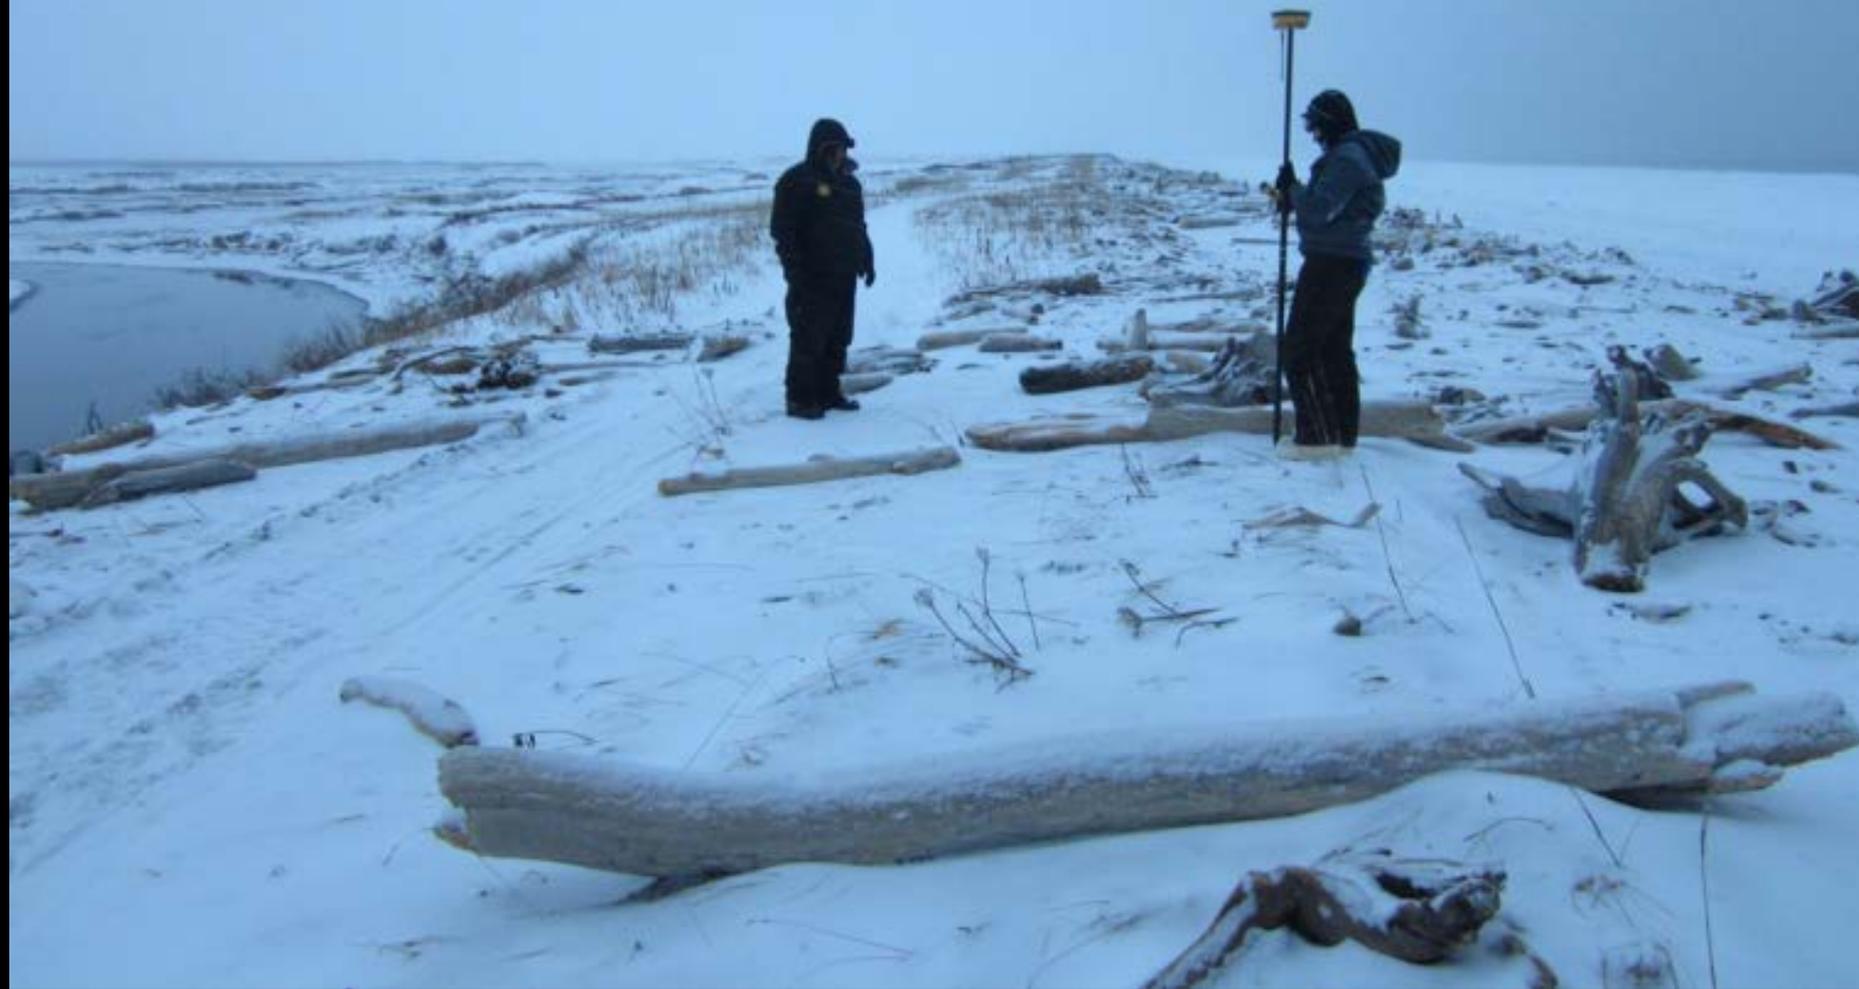
Overwash into Tagoomanick River bend S. of old community site

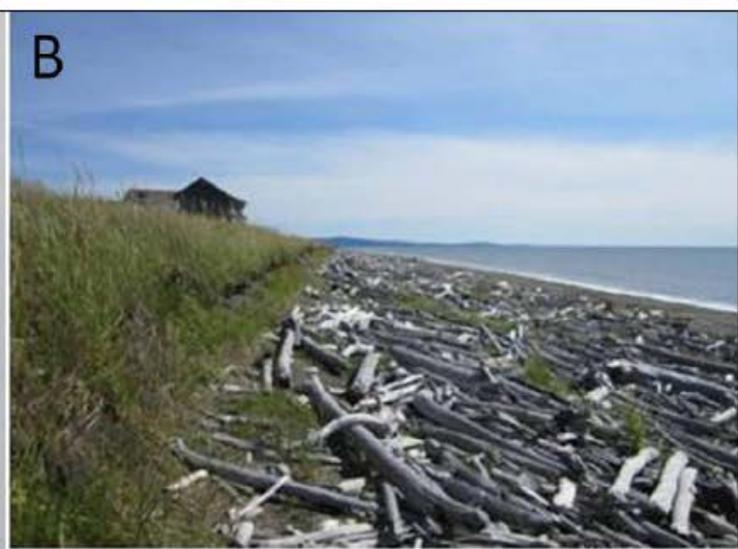
Notching at base of coastal bluff, old community site

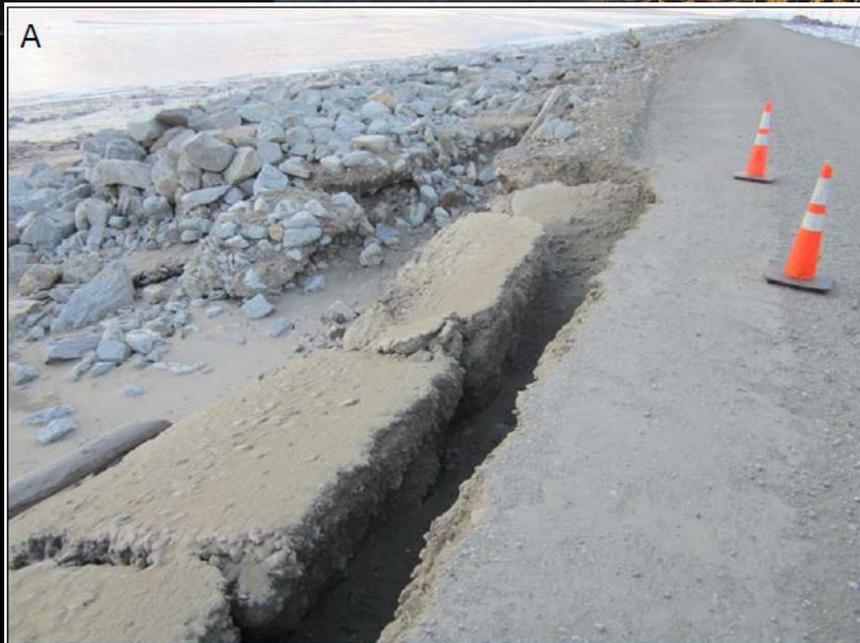
Armor rock ~2' in diameter

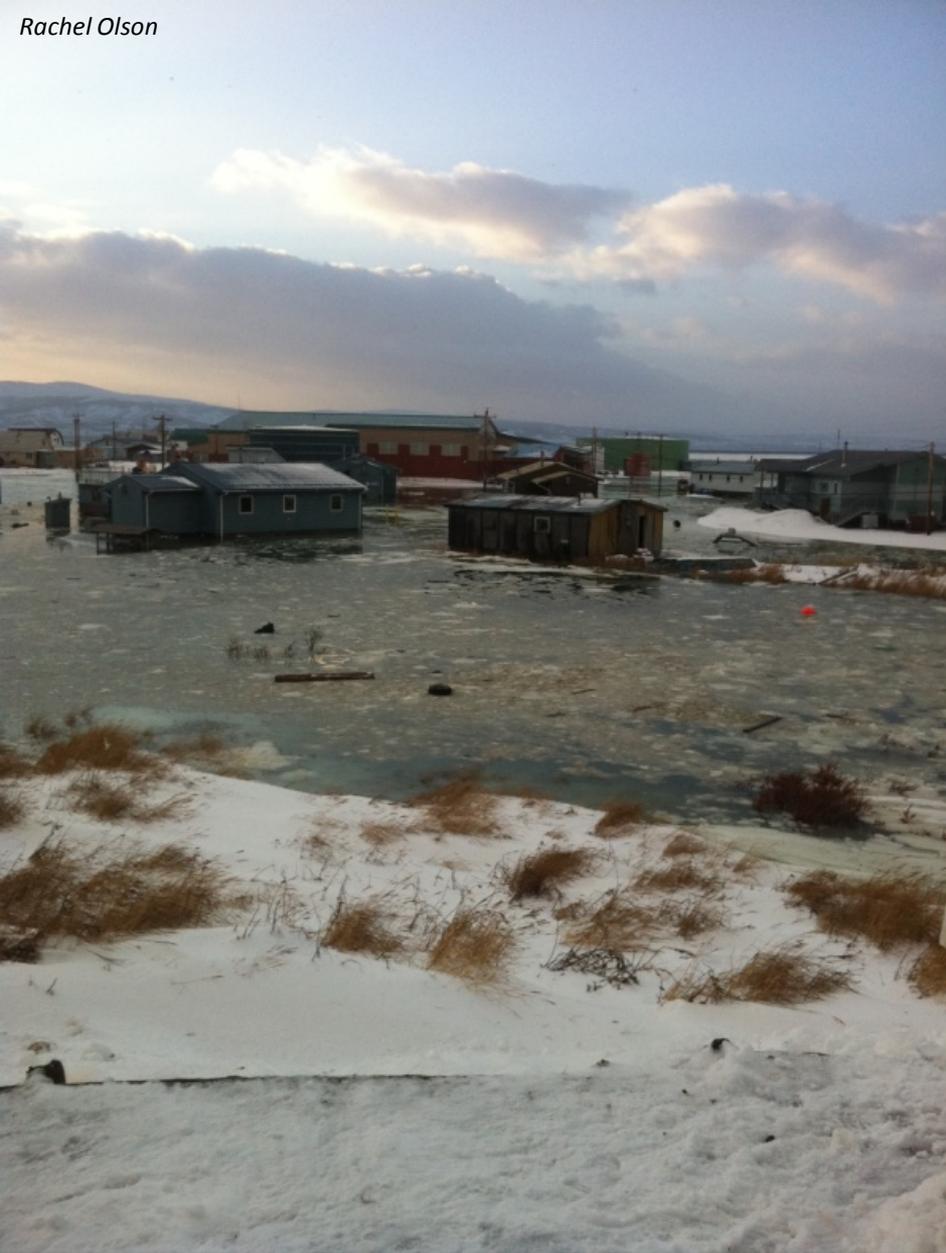
Extensive flooding throughout the lower community and a large ivu (ice push) that carried some cabins ~1 km and piled others up/reduced them to rubble at a fish camp further up in the bay.

Flooding in Golovin

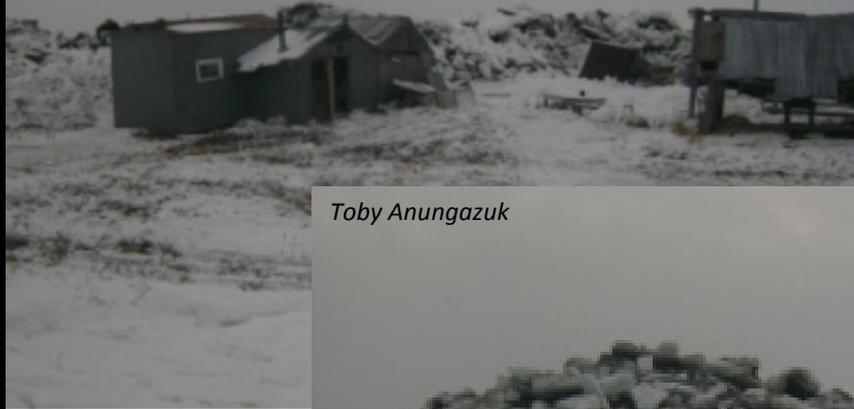
Ivu at Golovin Fish Camp

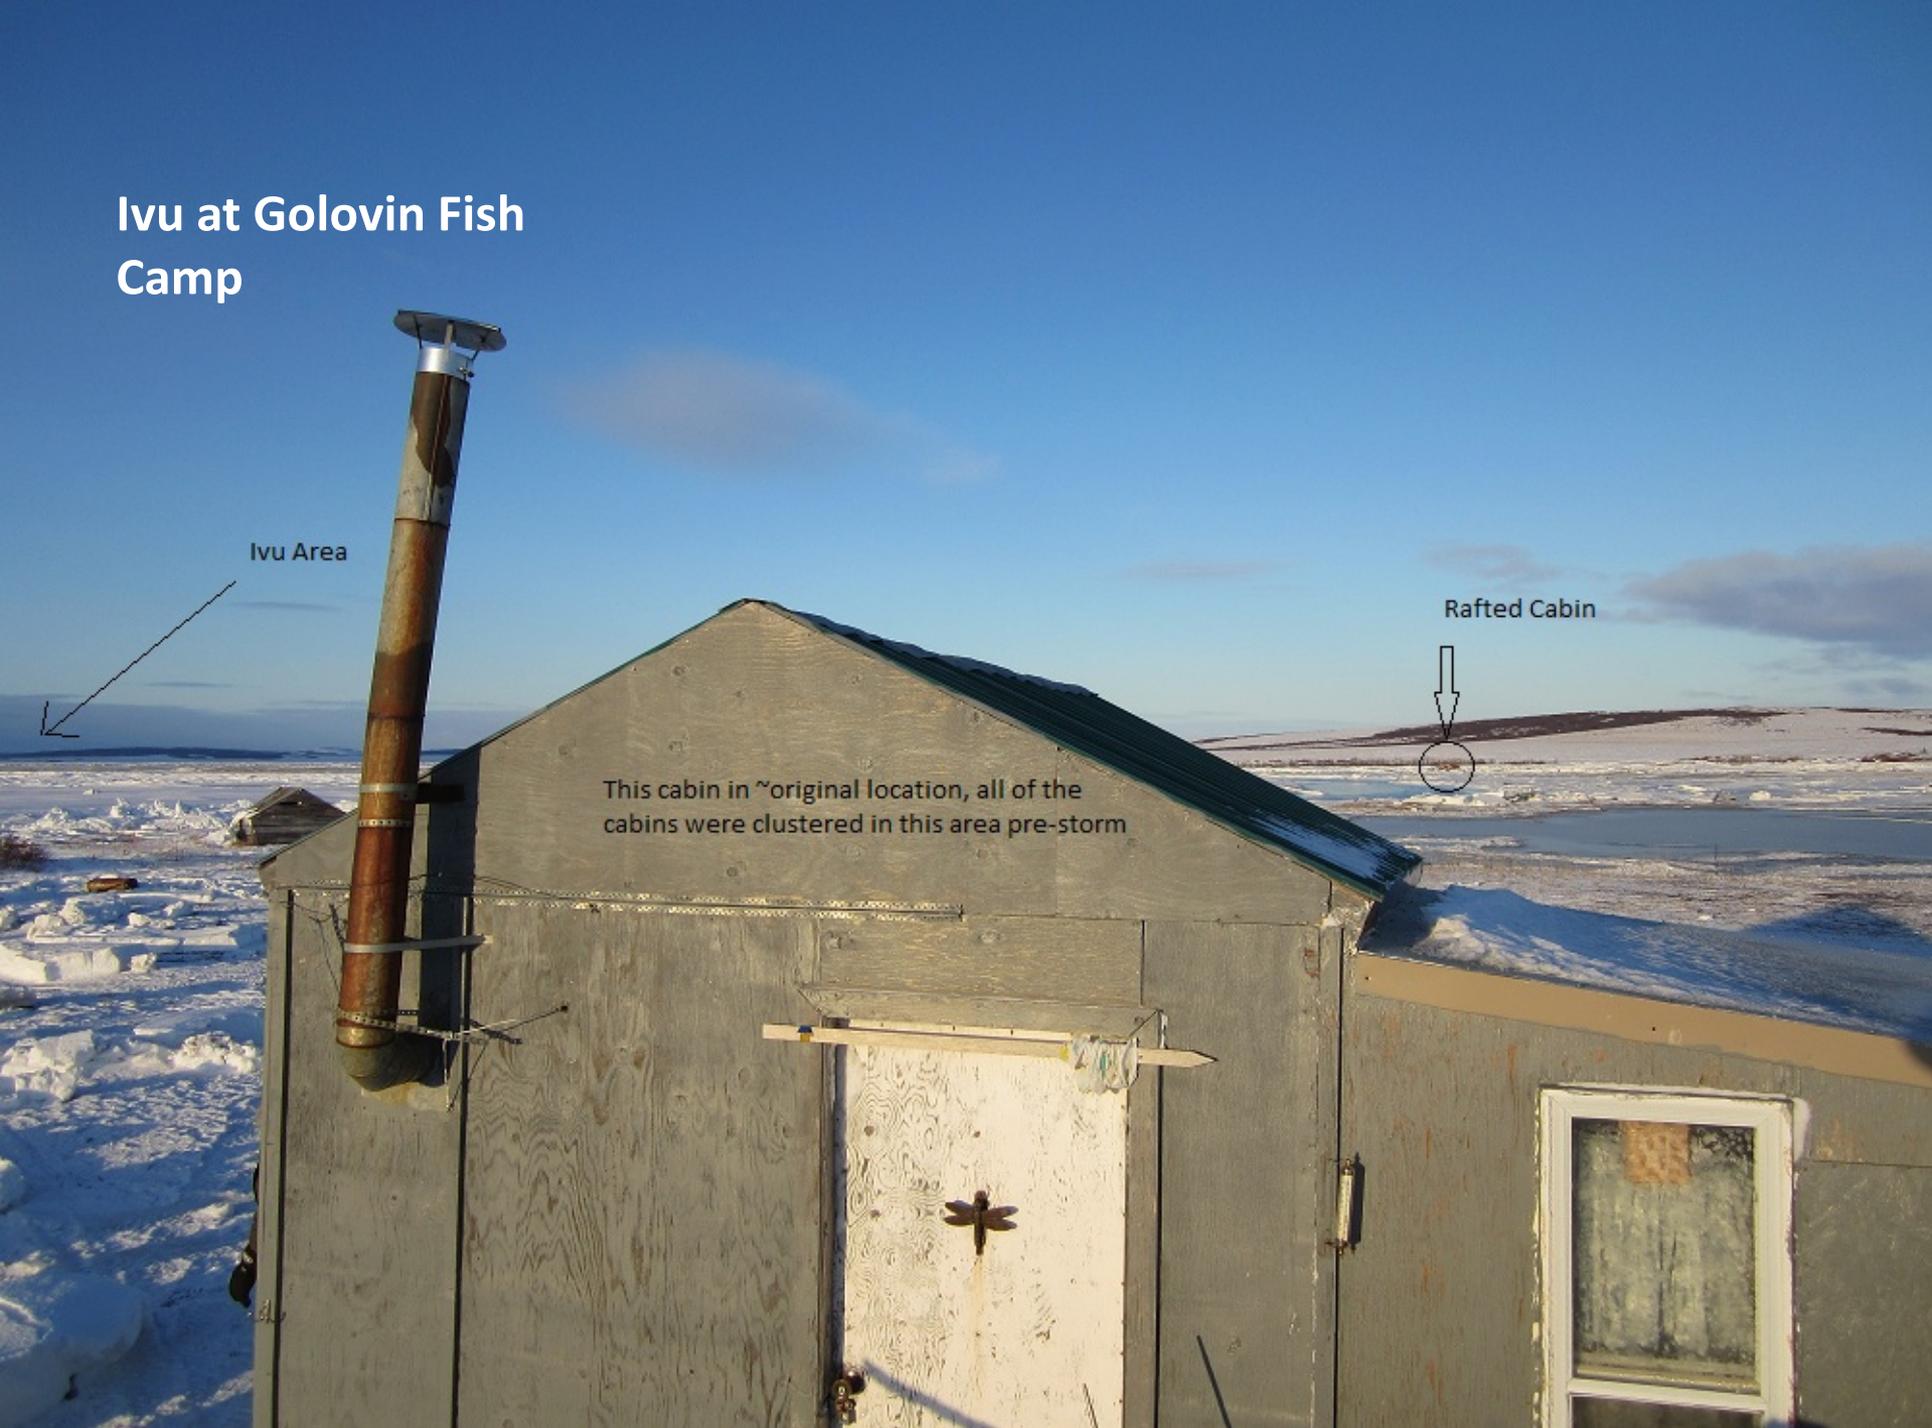
This cabin in ~original location, all of the cabins were clustered in this area pre-storm

Rafted Cabin
