ASSESSMENT OF GEOMORPHOLOGY AND GEOLOGIC HAZARDS IN THE PARKS HIGHWAY–MINTO FLATS–DALTON HIGHWAY INFRASTRUCTURE CORRIDOR: COOK INLET TO PRUDHOE BAY, ALASKA

Rich D. Koehler, Richard D. Reger, Eleanor R. Spangler, and Trent D. Hubbard

Report of Investigation 2016-

State of Alaska
Department of Natural Resources
Division of Geological & Geophysical Surveys

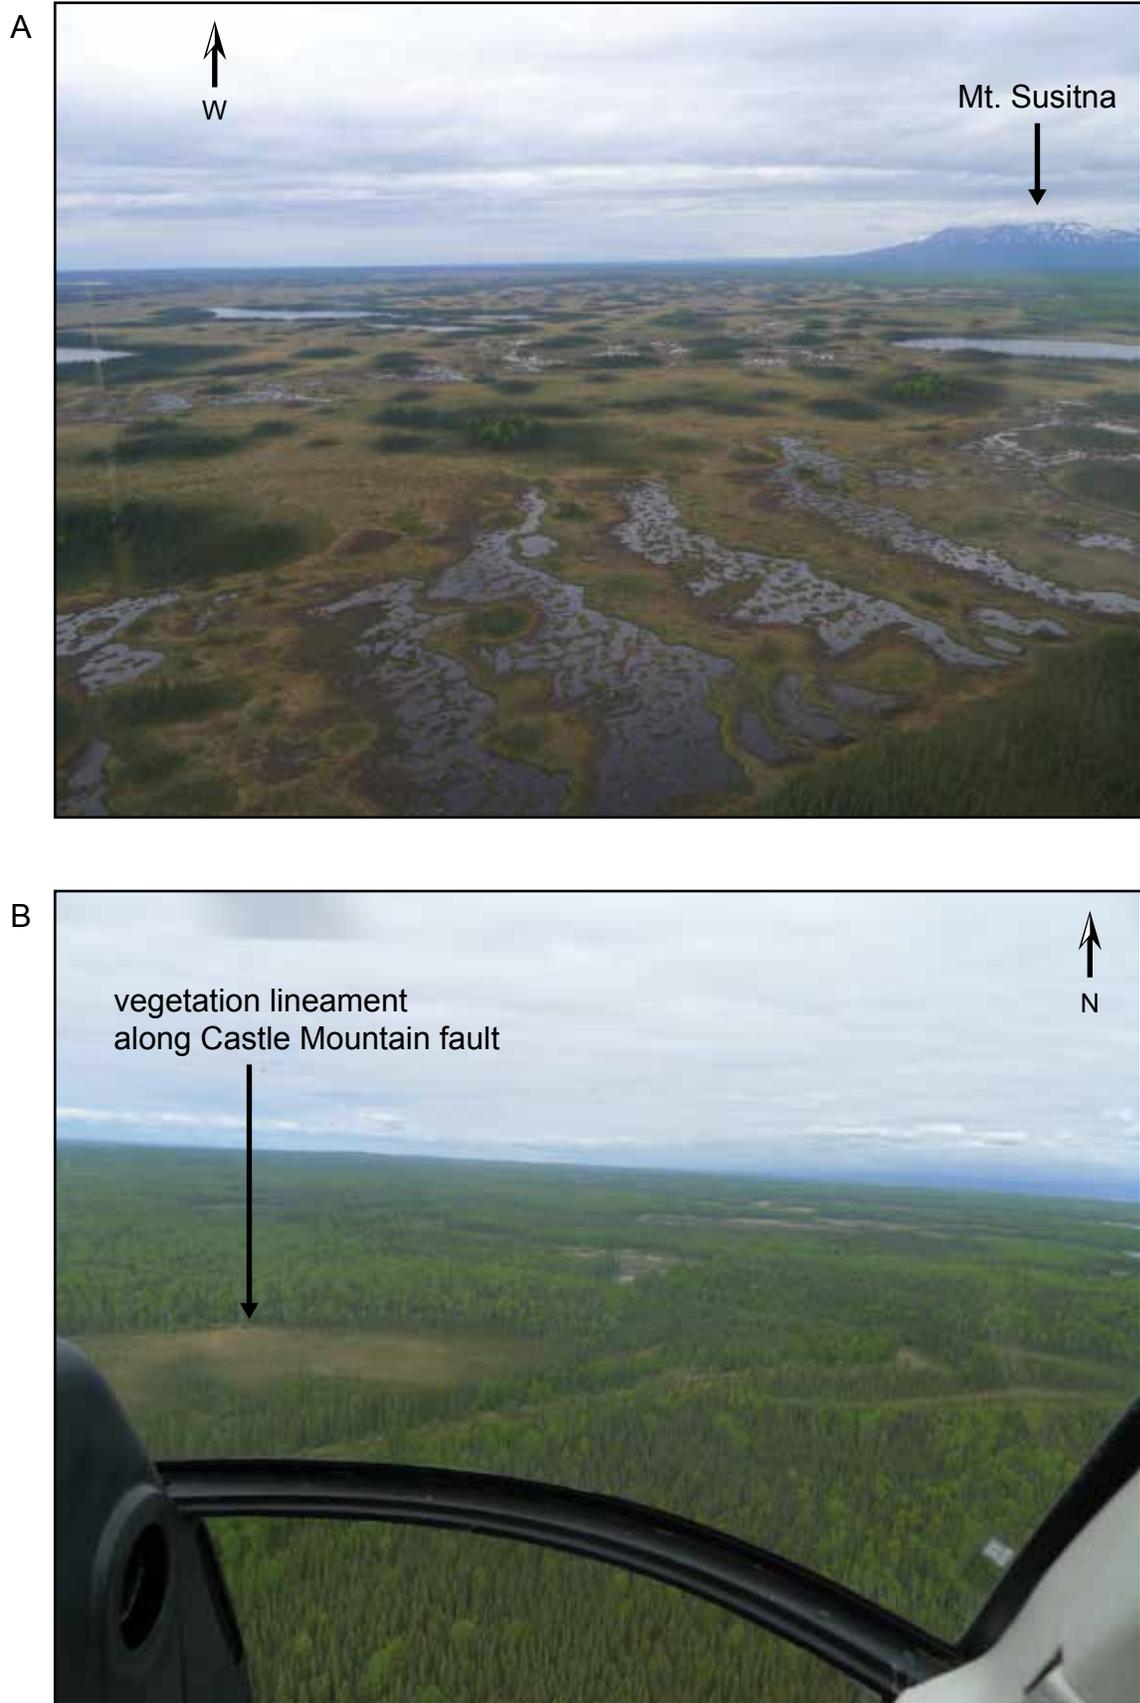
FIGURE 3. A. Westward view of small lake and sand dune complexes near the southern end of the corridor. B. View to the north, showing subtle vegetation lineament along the Castle Mountain fault.

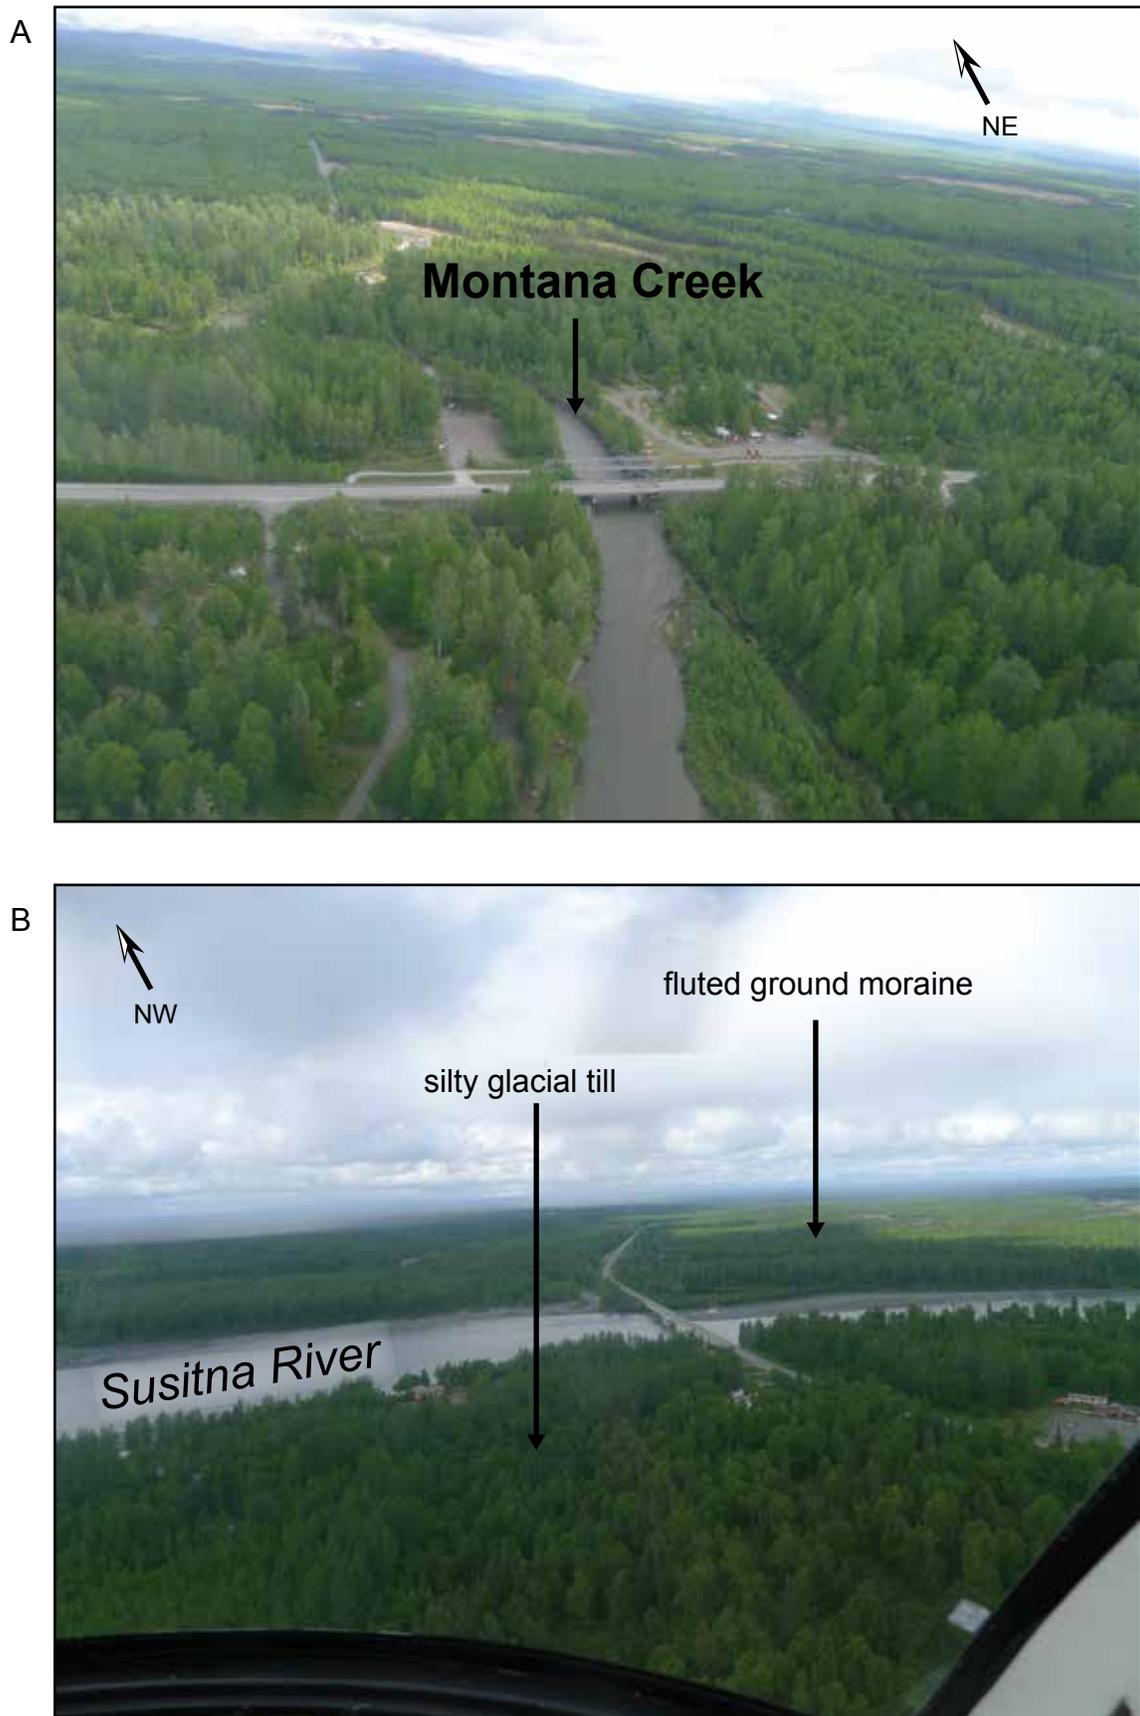
FIGURE 5. A. View to northeast across the Parks Highway bridge, showing channel of Montana Creek incised into hummocky till and outwash alluvium. B. View to northwest of the Parks Highway bridge over the Susitna River. The southeast bank of the river consists of silty till.

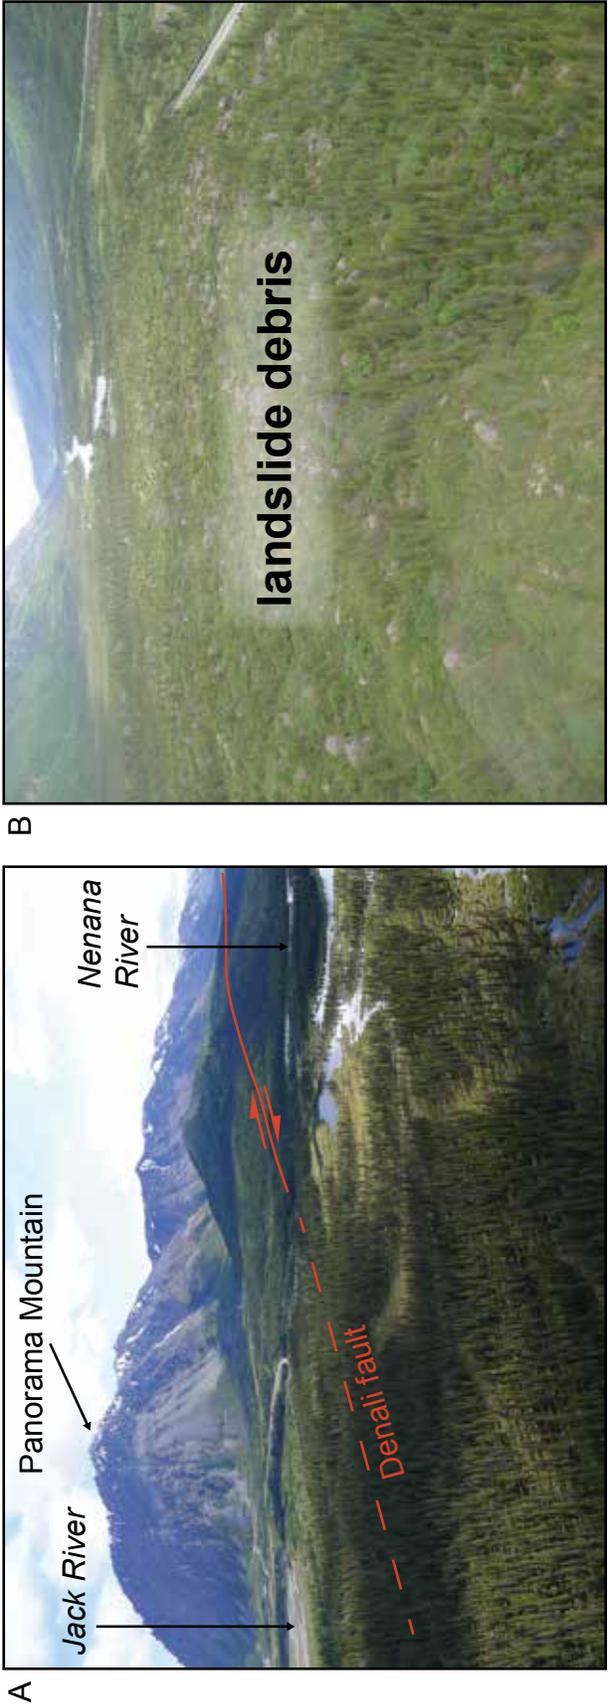
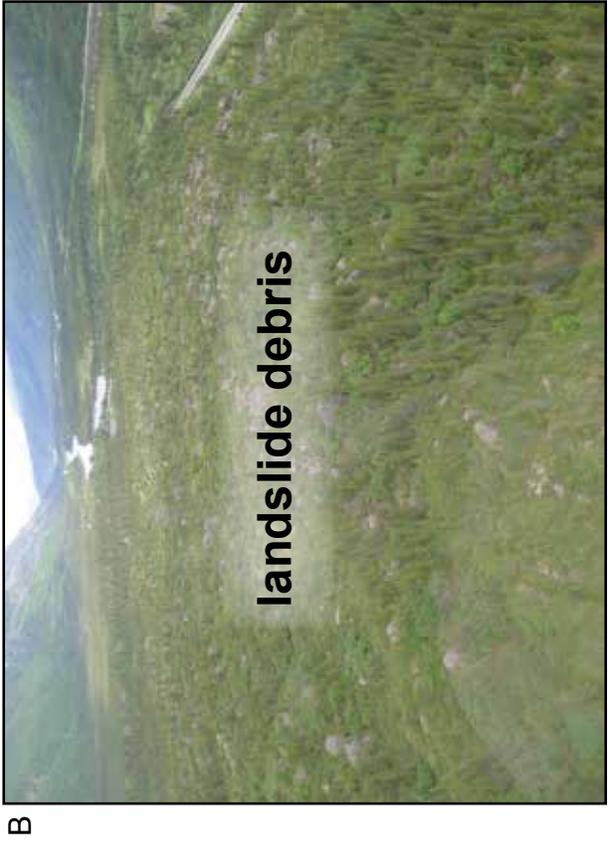
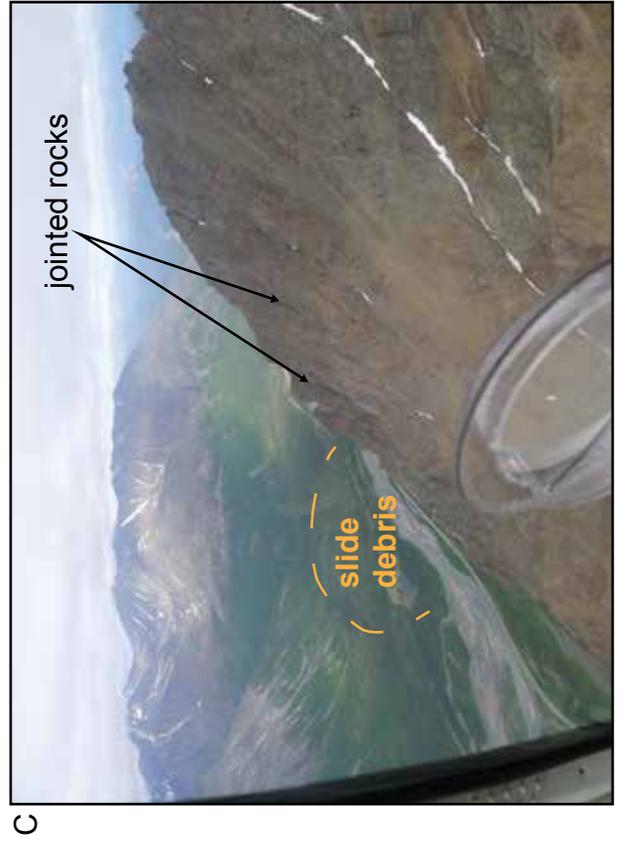
FIGURE 8. A. View of Panorama Mountain in the vicinity of the Jack/Nenana rivers confluence. The location of the Denali fault is shown in red. B. Close-up view of massive Panorama Mountain rock avalanche deposit with blocks of rock up to 20 ft (6 m) in diameter. C. View of side of Panorama Mountain, which exhibits intensely jointed and fractured volcanic rocks. The slide debris in B along the Nenana River is outlined by dashed black line. Views in all photographs are to the north.

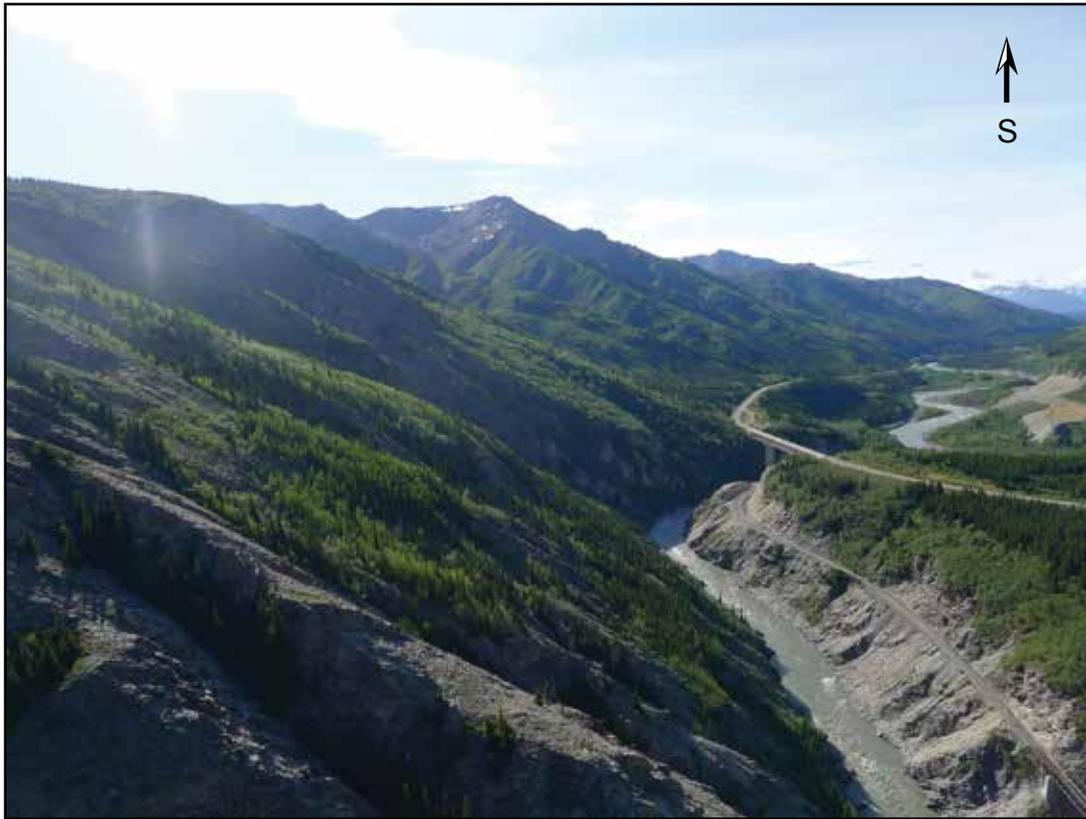
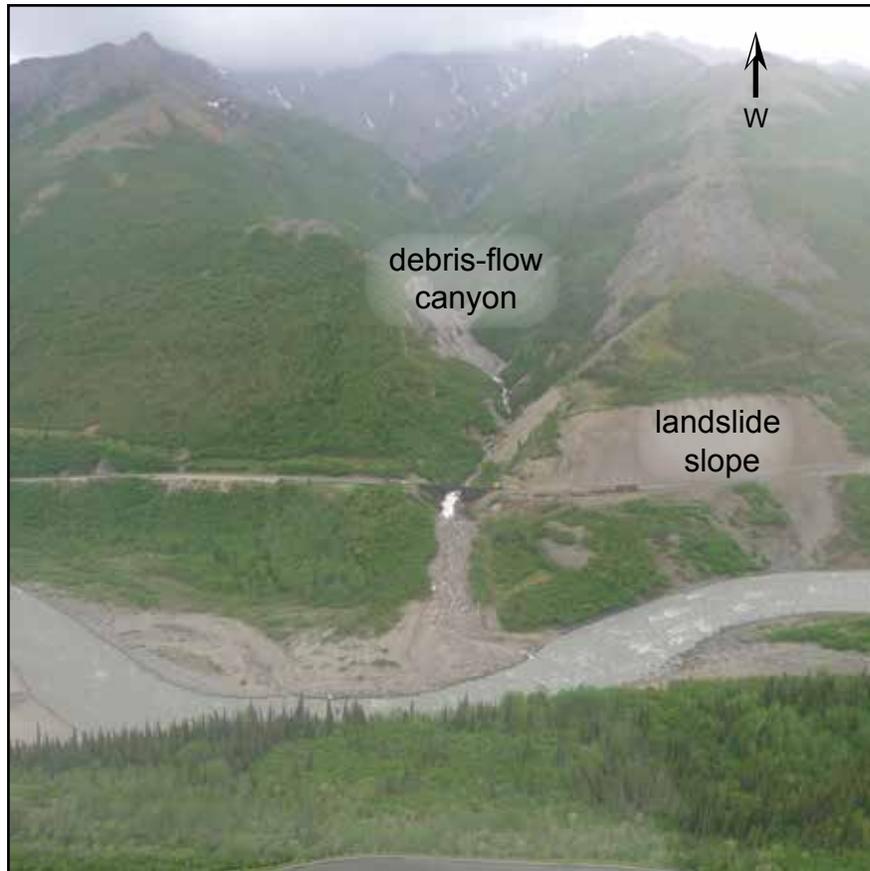
In the Healy D-4 Quadrangle the corridor continues north–northwest along the Nenana River gorge to the vicinity of the town of Healy (fig. 10). Between Junco Creek and Iceworm Gulch, the corridor crosses the crown of a chronic landslide zone in shattered and decomposed schist bedrock associated with basalt dikes in the steep eastern wall of the Nenana Gorge. Just north of Hornet Creek the corridor traverses fine-grained lake sediments (Wahrhaftig, 1958, pl. 2). These wet, clayey sediments have caused numerous landslides along the Alaska Railroad in the Nenana River gorge (Wahrhaftig and Black, 1958). Except for short stretches crossing granular alluvial fans and granular outwash terraces, most of the next 1.8 mi to the crossing of the Nenana River traverses steep sideslopes of schistose bedrock. Rock avalanches and rock fall have continuously impacted the Parks Highway in this area.

FIGURE 10. Photographs of the Nenana River gorge. A. Steep eastern wall of the gorge near the Parks Highway bridge. B. Western wall of the gorge along the Alaska Railroad tracks, showing active debris-flow canyons and landsliding.

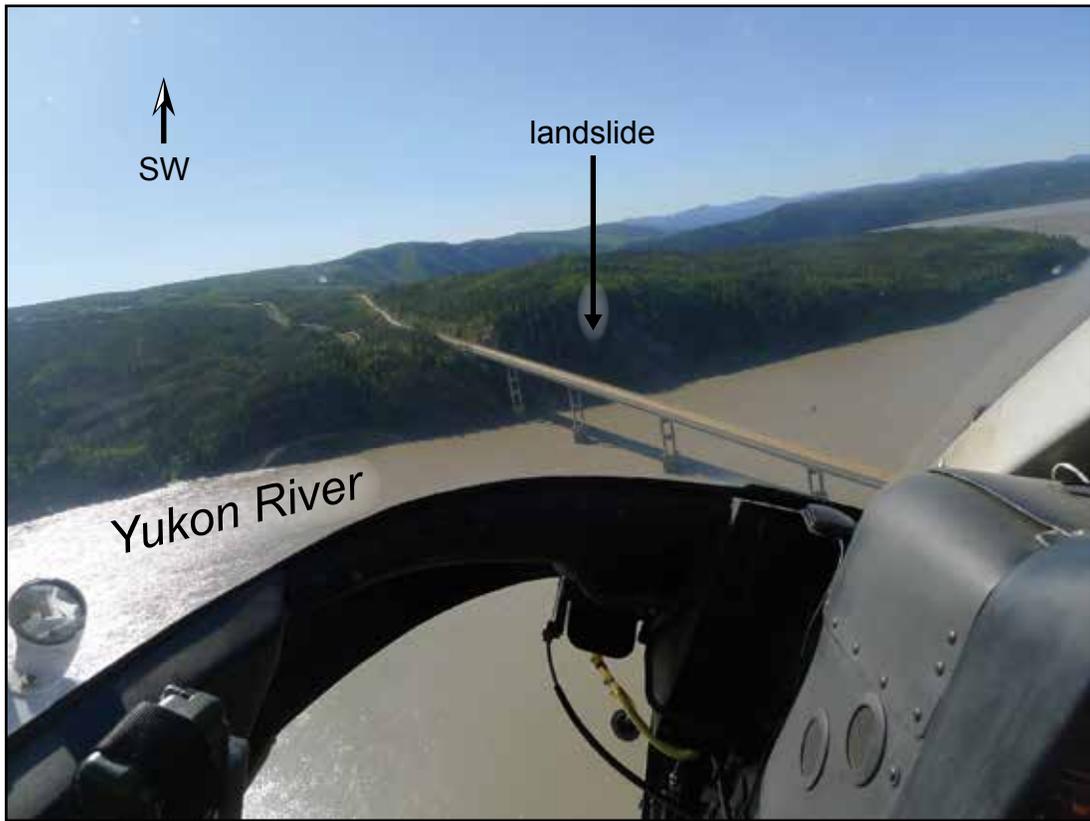
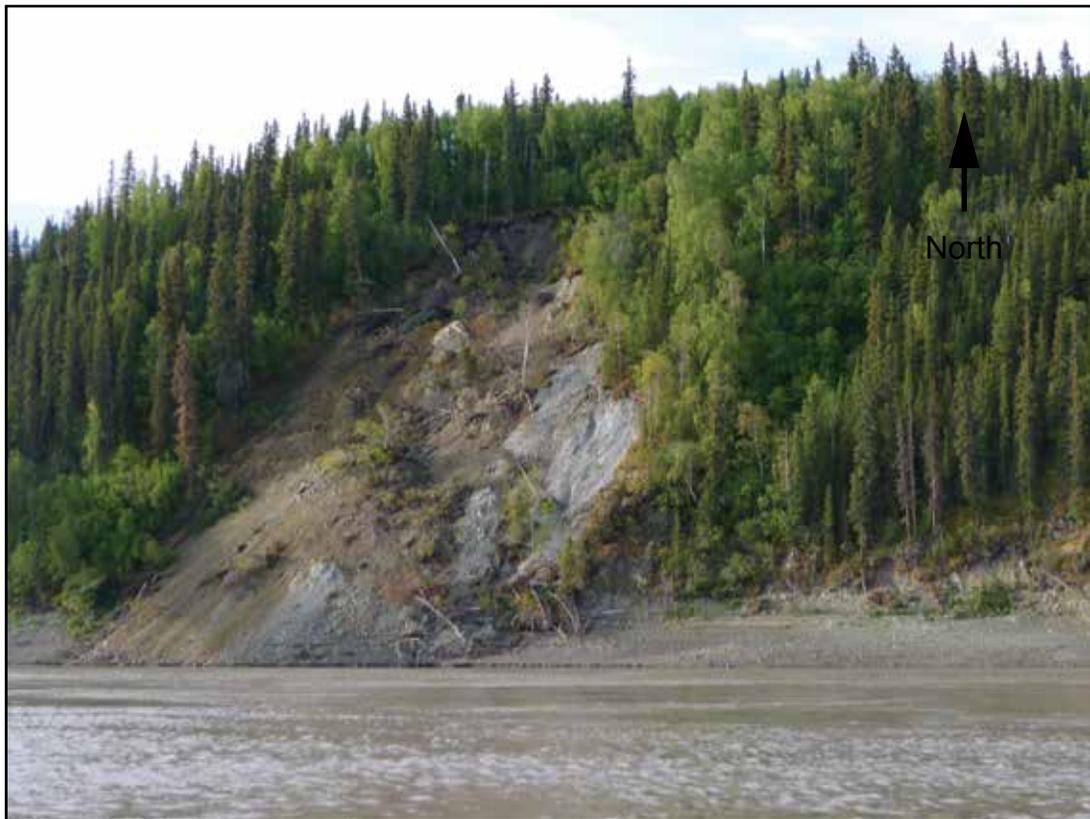
FIGURE 17. A. View toward southwest of southern bluff of the Yukon River. Hills slope gently to the north to the crest of the bluff and exhibit yedoma, gullies, and landslide headscarps. B. View of the 2012 landslide directly west of the Yukon River bridge. Location of slide is shown in A.

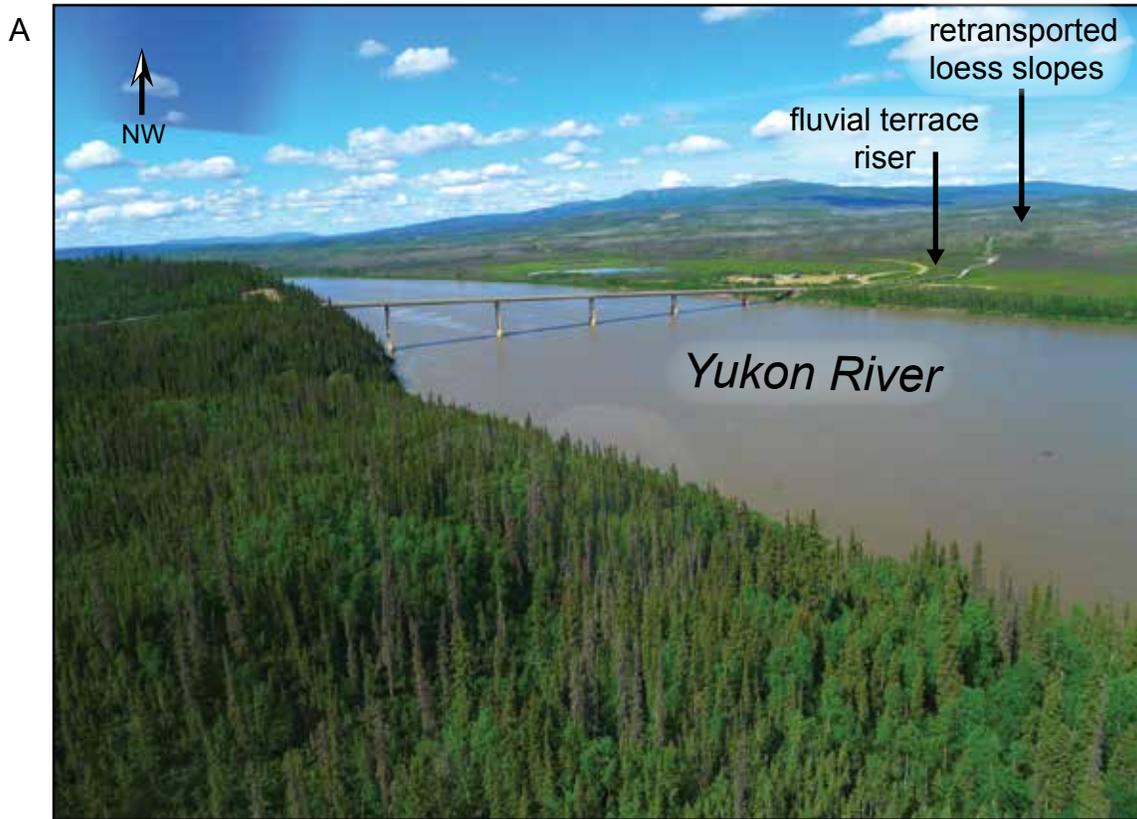
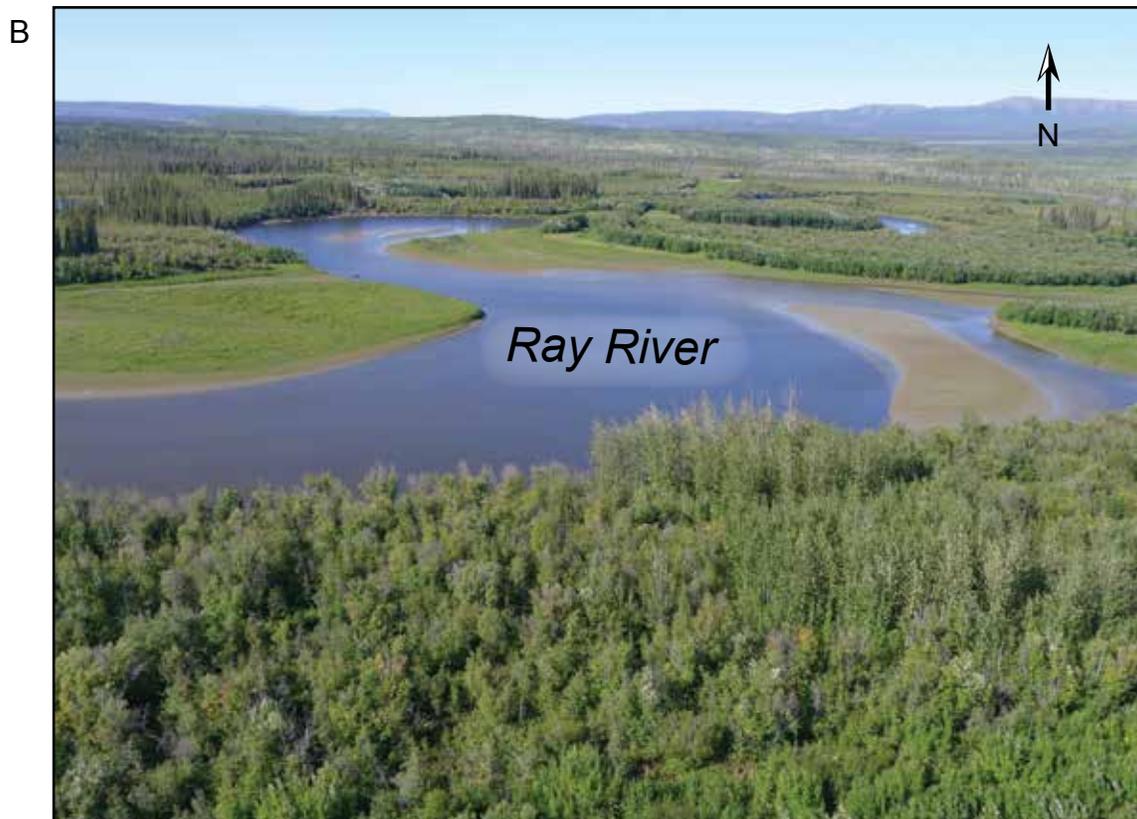
FIGURE 18. A. View showing low slopes of ice-rich, retransported loess directly north of the Yukon River bridge. B. Ray River lowland in the vicinity of its confluence with the Yukon River.

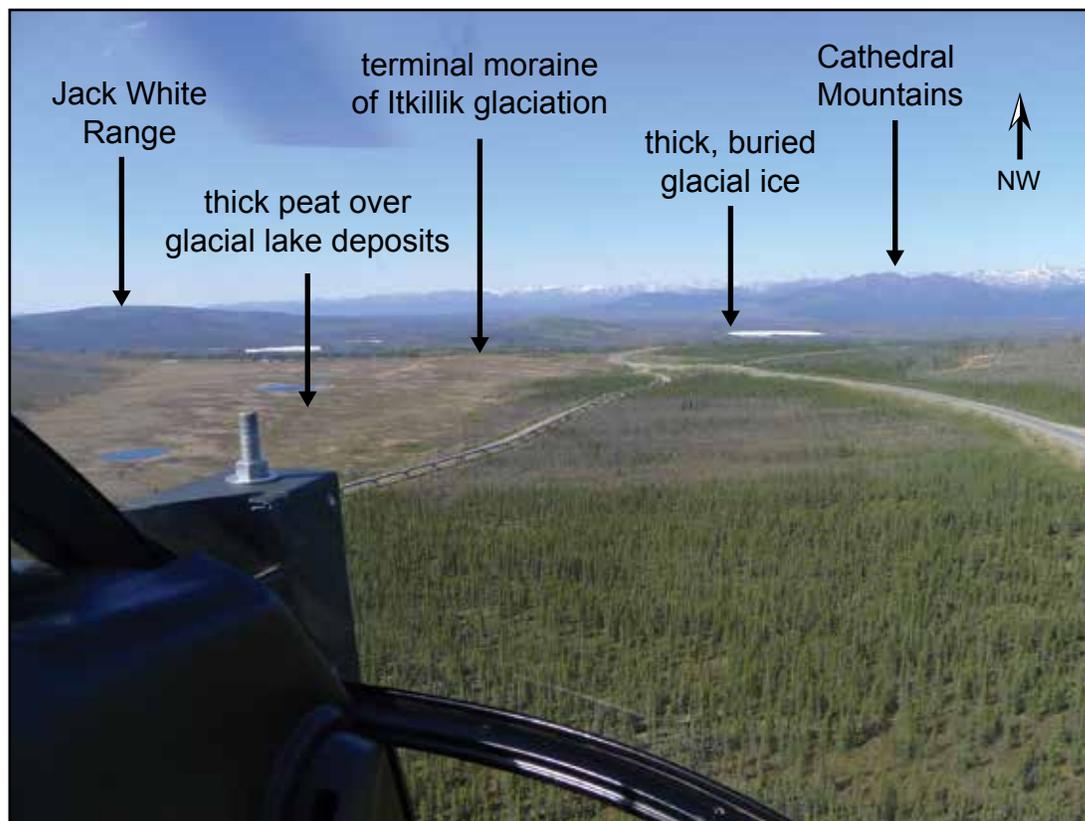
FIGURE 24. View toward northwest of terminal moraine of Itkillik glaciation north of the South Fork Koyukuk River. Thick, buried glacial ice is present in the topographic trough between the eastern Jack White Range and the Cathedral Mountains, resulting in the thermokarst modification of kettle lakes.

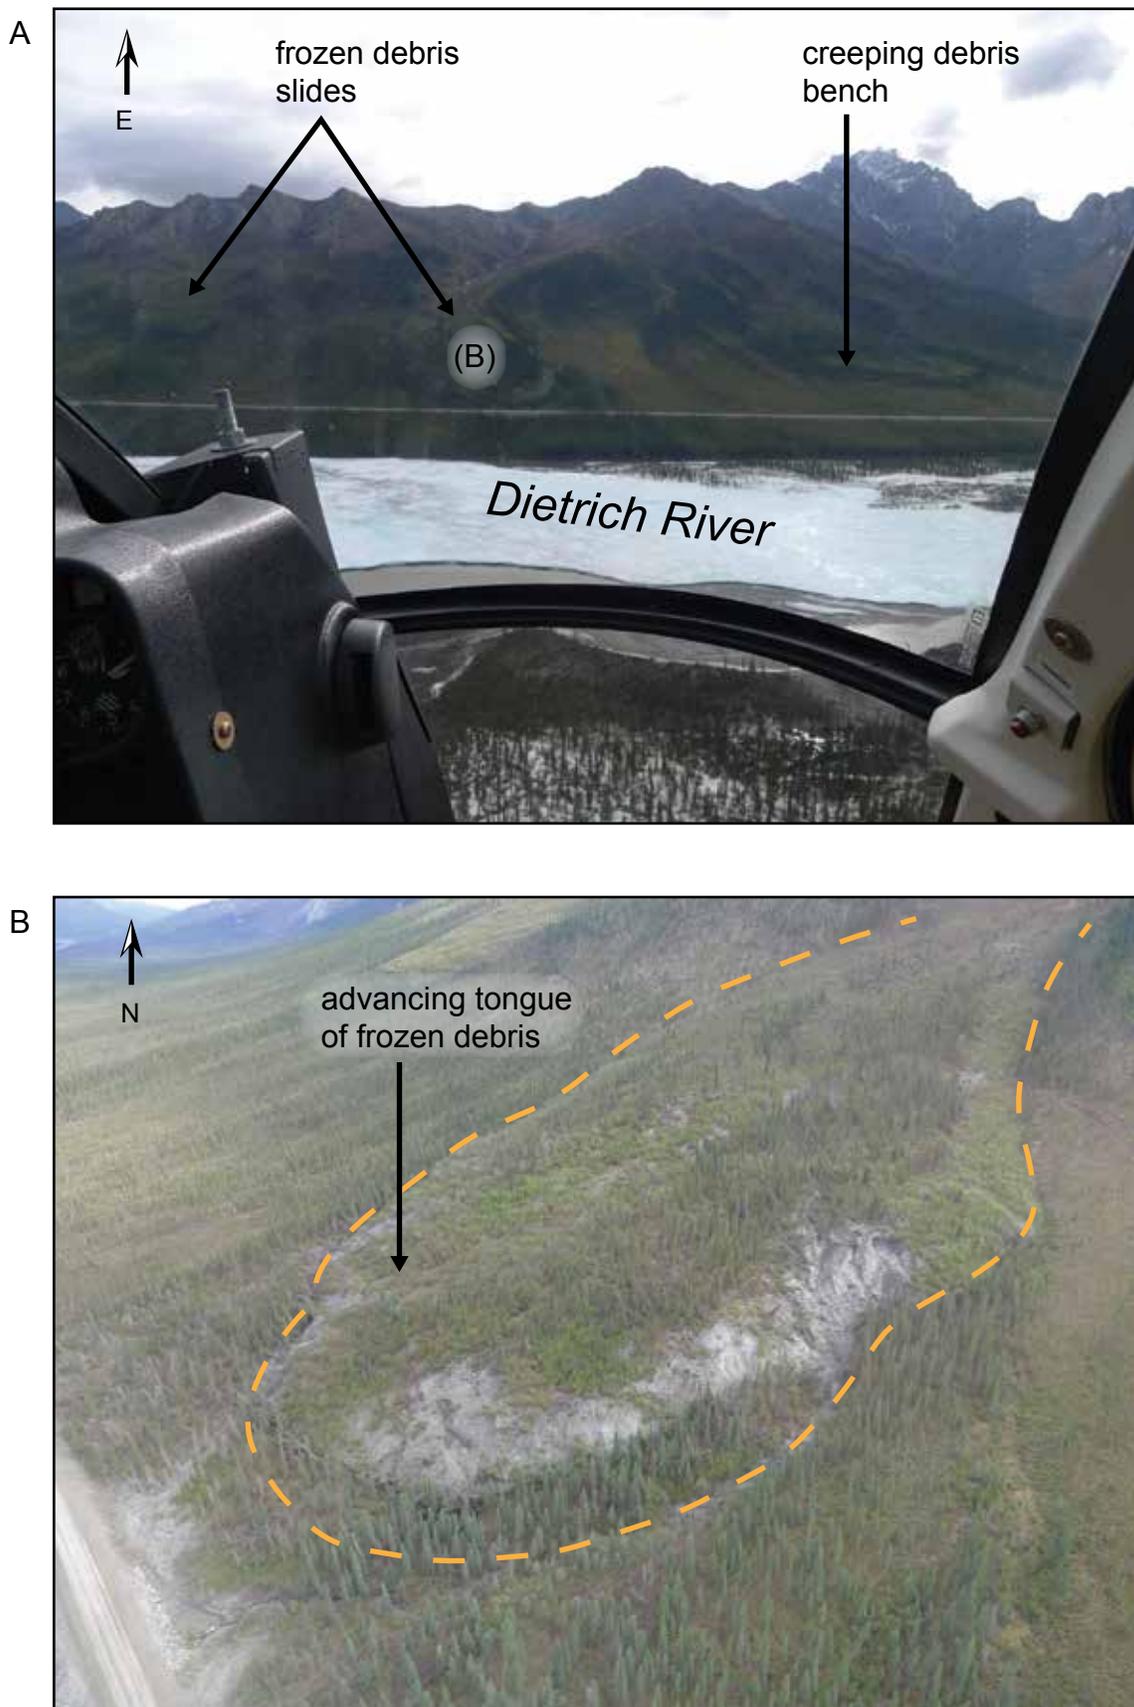
FIGURE 28. A. Aerial view, toward the east, of massive creeping, frozen colluvial lobes along both sides of the Dietrich River valley. These lobes typically have bench or tongue morphology. B. View, facing north, of actively advancing tongue of frozen debris near MP 219 of the Dalton Highway, approximately 131 ft (40 m) from the highway. Feature is outlined by dashed orange line.

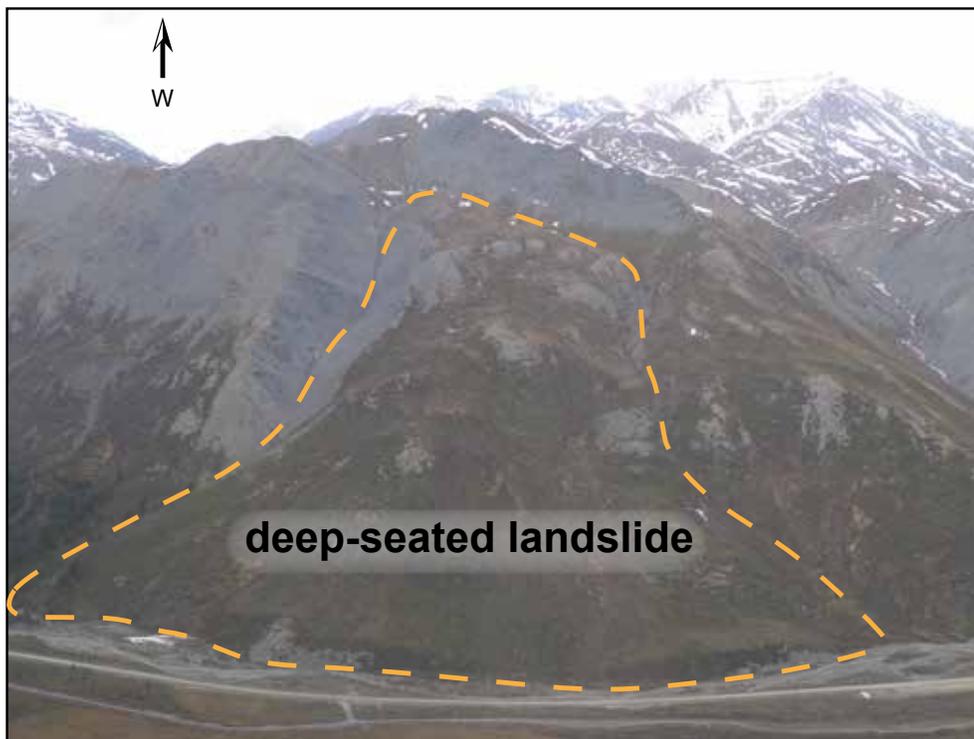
FIGURE 30. Aerial view toward the west of massive, deep-seated landslides in bedrock north of Nutirwik Creek along the western margin of the upper Dietrich River. Margins of slide are indicated by dashed orange line.

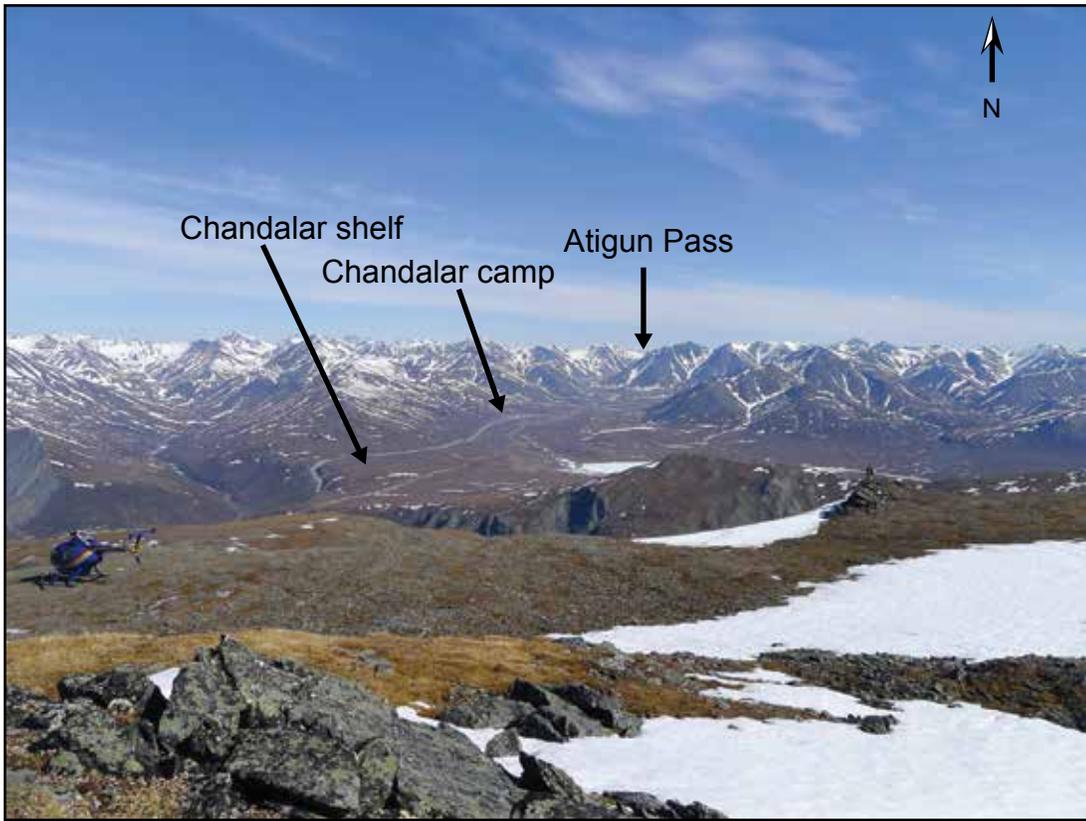
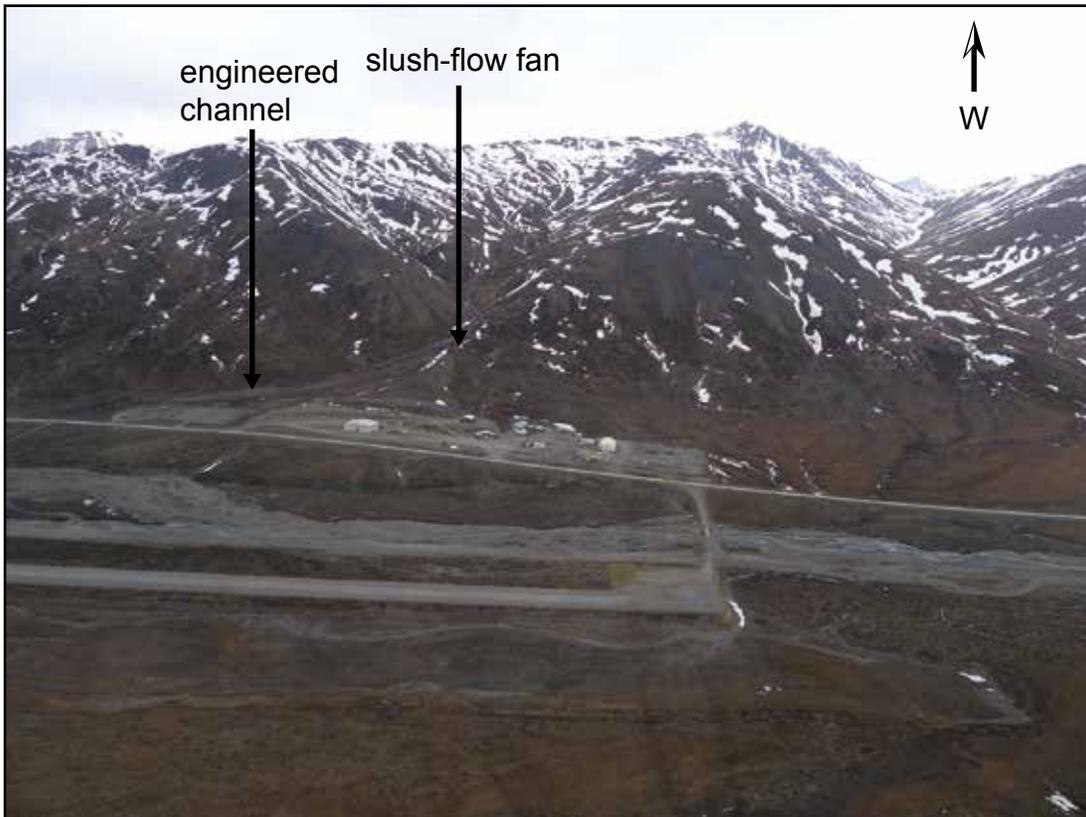
FIGURE 31. A. Looking north down U-shaped valley extending from the Chandalar shelf to Atigun Pass. B. View toward the west of active slush-flow fan at Chandalar Camp. Note engineered channel along south margin of fan installed to divert slush flows away from camp installments.

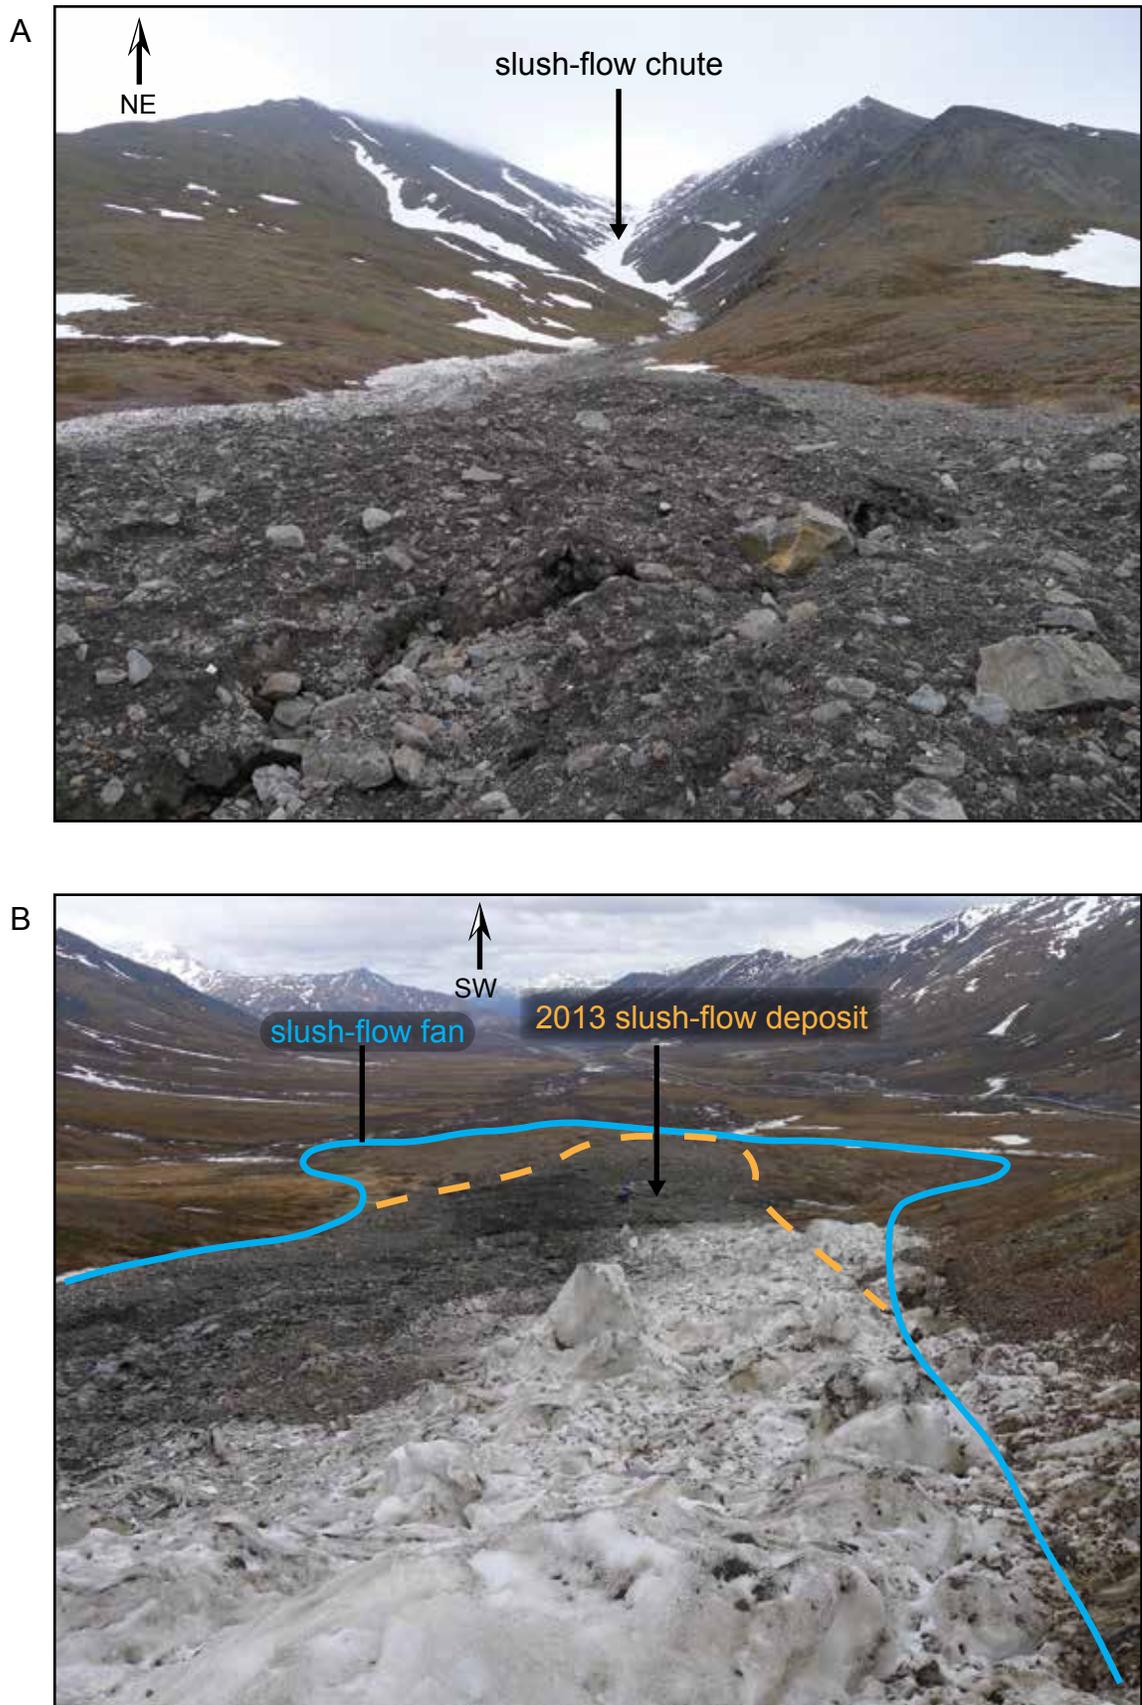
FIGURE 32. A. View to the northeast of slush-flow chute that released snow, blocks of ice, and large boulders in spring 2013. B. View to the southwest of slush-flow fan (outlined by solid blue line) and 2013 deposit (dashed orange line). Helicopter in upper center of photograph for scale.

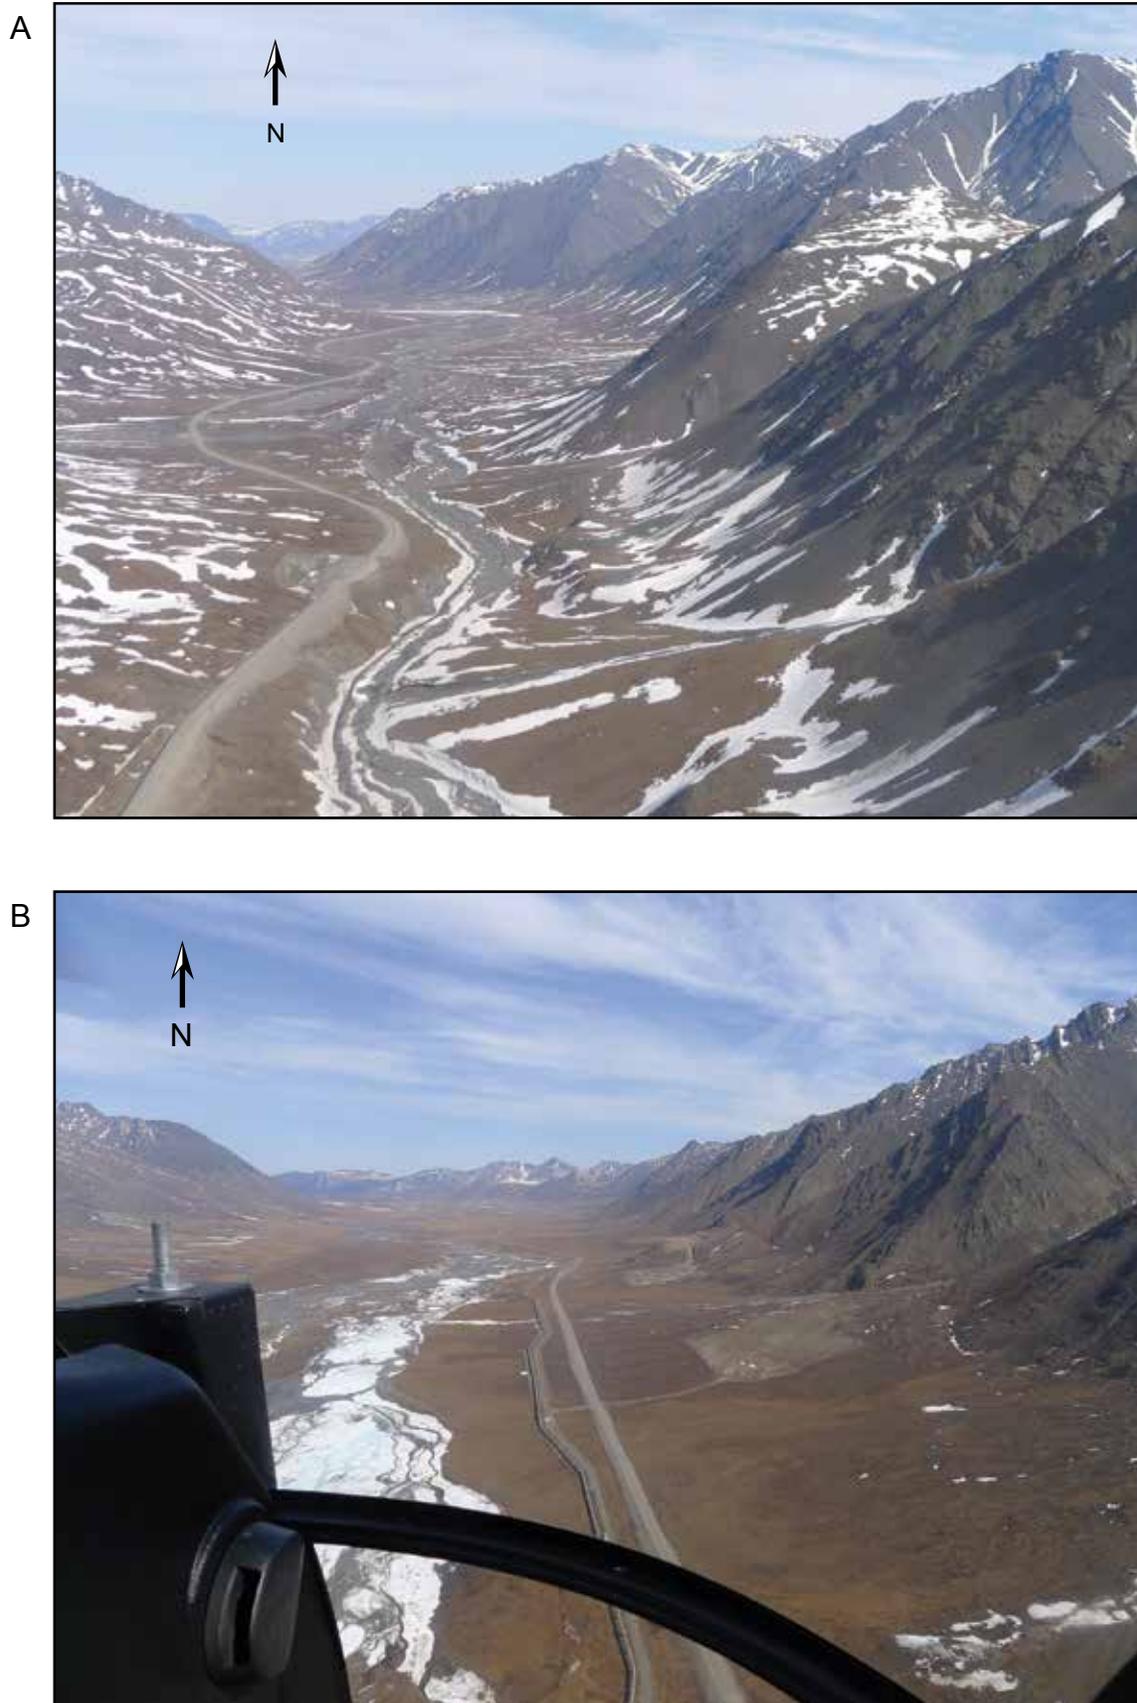
FIGURE 33. A. Looking north toward the upper Atigun River south of the Atigun River bridge on the Dalton Highway. Coalescing coarse-grained debris flows and avalanche cones characterize the eastern valley wall, and colluvial and alluvial fans characterize the western valley wall. B. Looking north toward the Atigun River valley north of the Atigun River bridge, showing coalescing colluvial and alluvial fans and low fluvial terraces of the Atigun River.

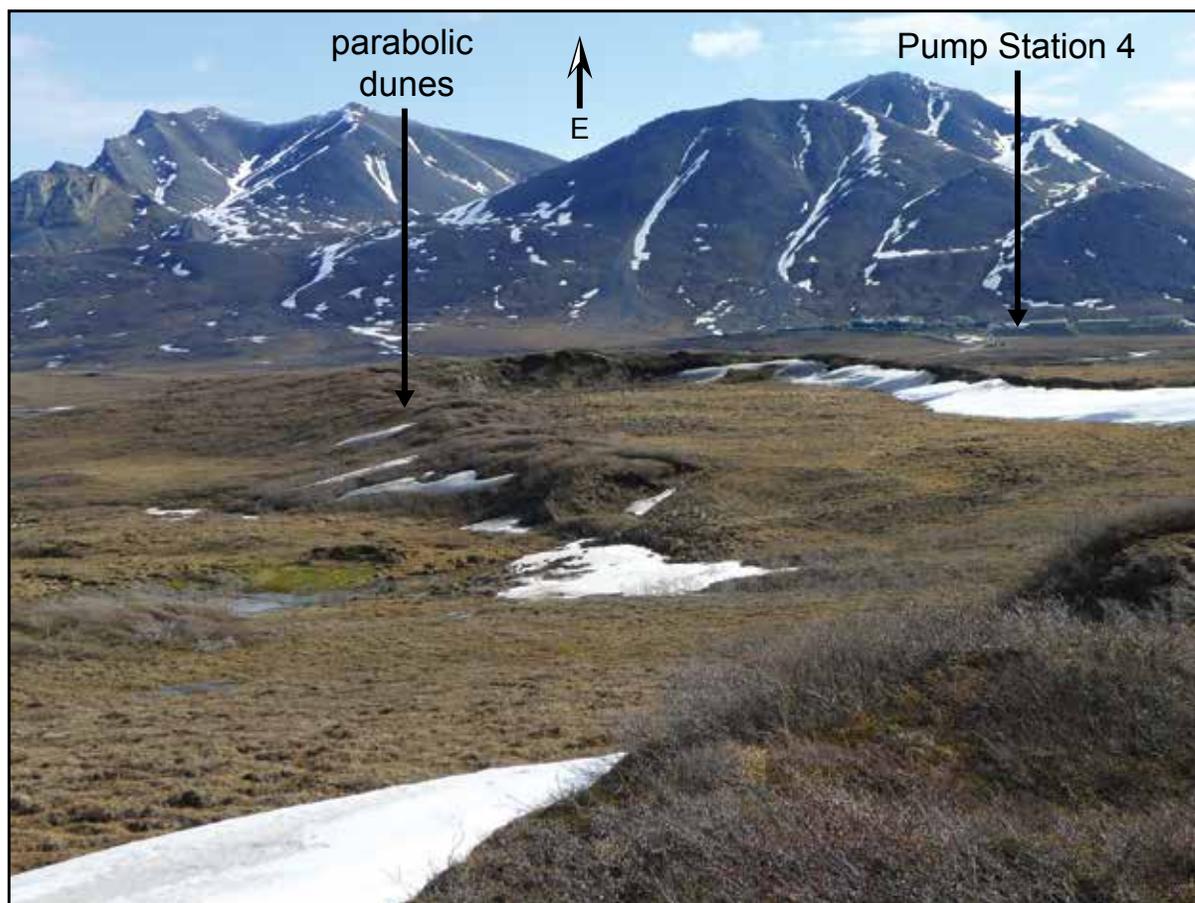
FIGURE 34. View, looking east, of bimodal failures in parabolic dunes west of Pump Station 4 south of Galbraith Lake.
