ASSESSMENT OF GEOMORPHOLOGY AND GEOLOGIC HAZARDS IN THE PARKS HIGHWAY–MINTO FLATS–DALTON HIGHWAY INFRASTRUCTURE CORRIDOR: COOK INLET TO PRUDHOE BAY, ALASKA

Rich D. Koehler, Richard D. Reger, Eleanor R. Spangler, and Trent D. Hubbard

Report of Investigation 2016-

State of Alaska
Department of Natural Resources
Division of Geological & Geophysical Surveys

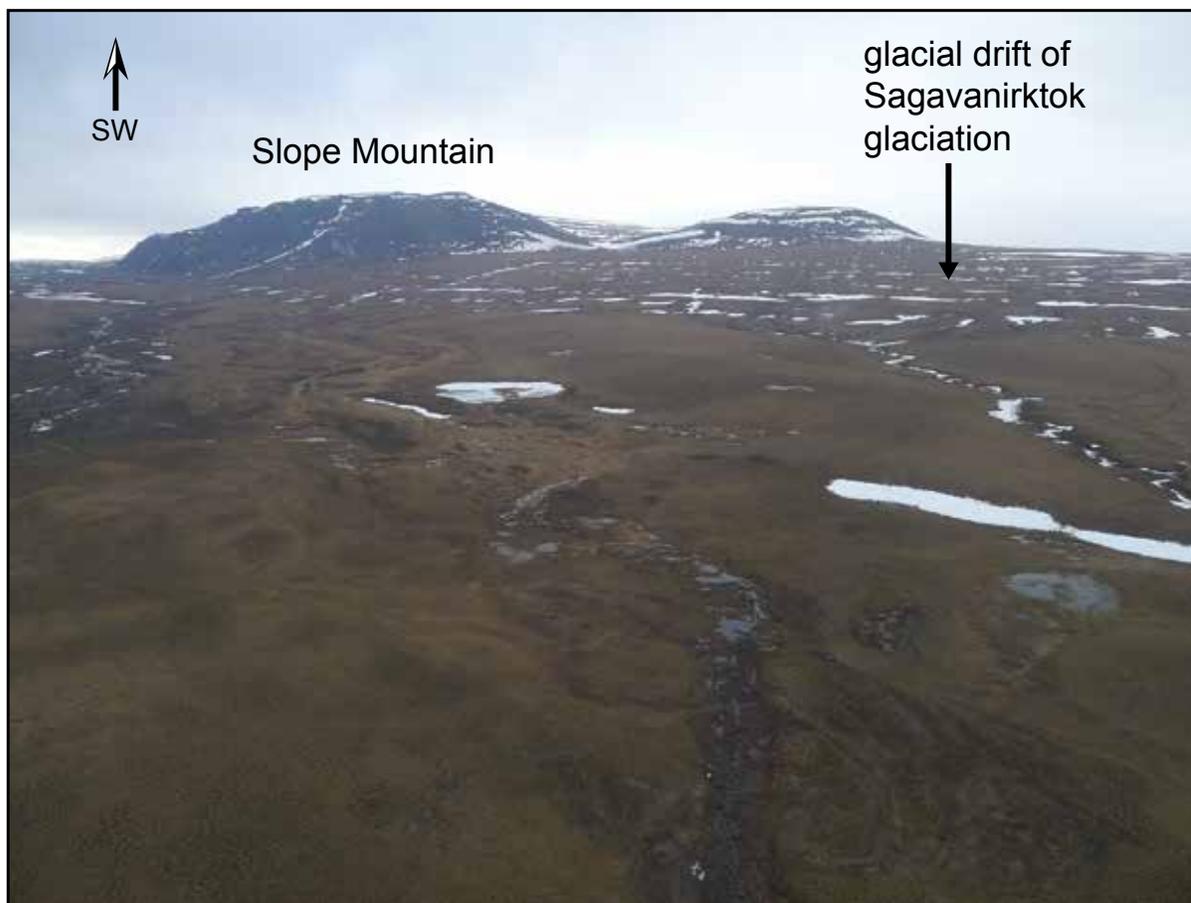
FIGURE 35. Aerial photograph, looking southwest, of glacial drift of the Sagavanirktok glaciation extending north of Slope Mountain. Margins of lateral moraines are highlighted by snow.

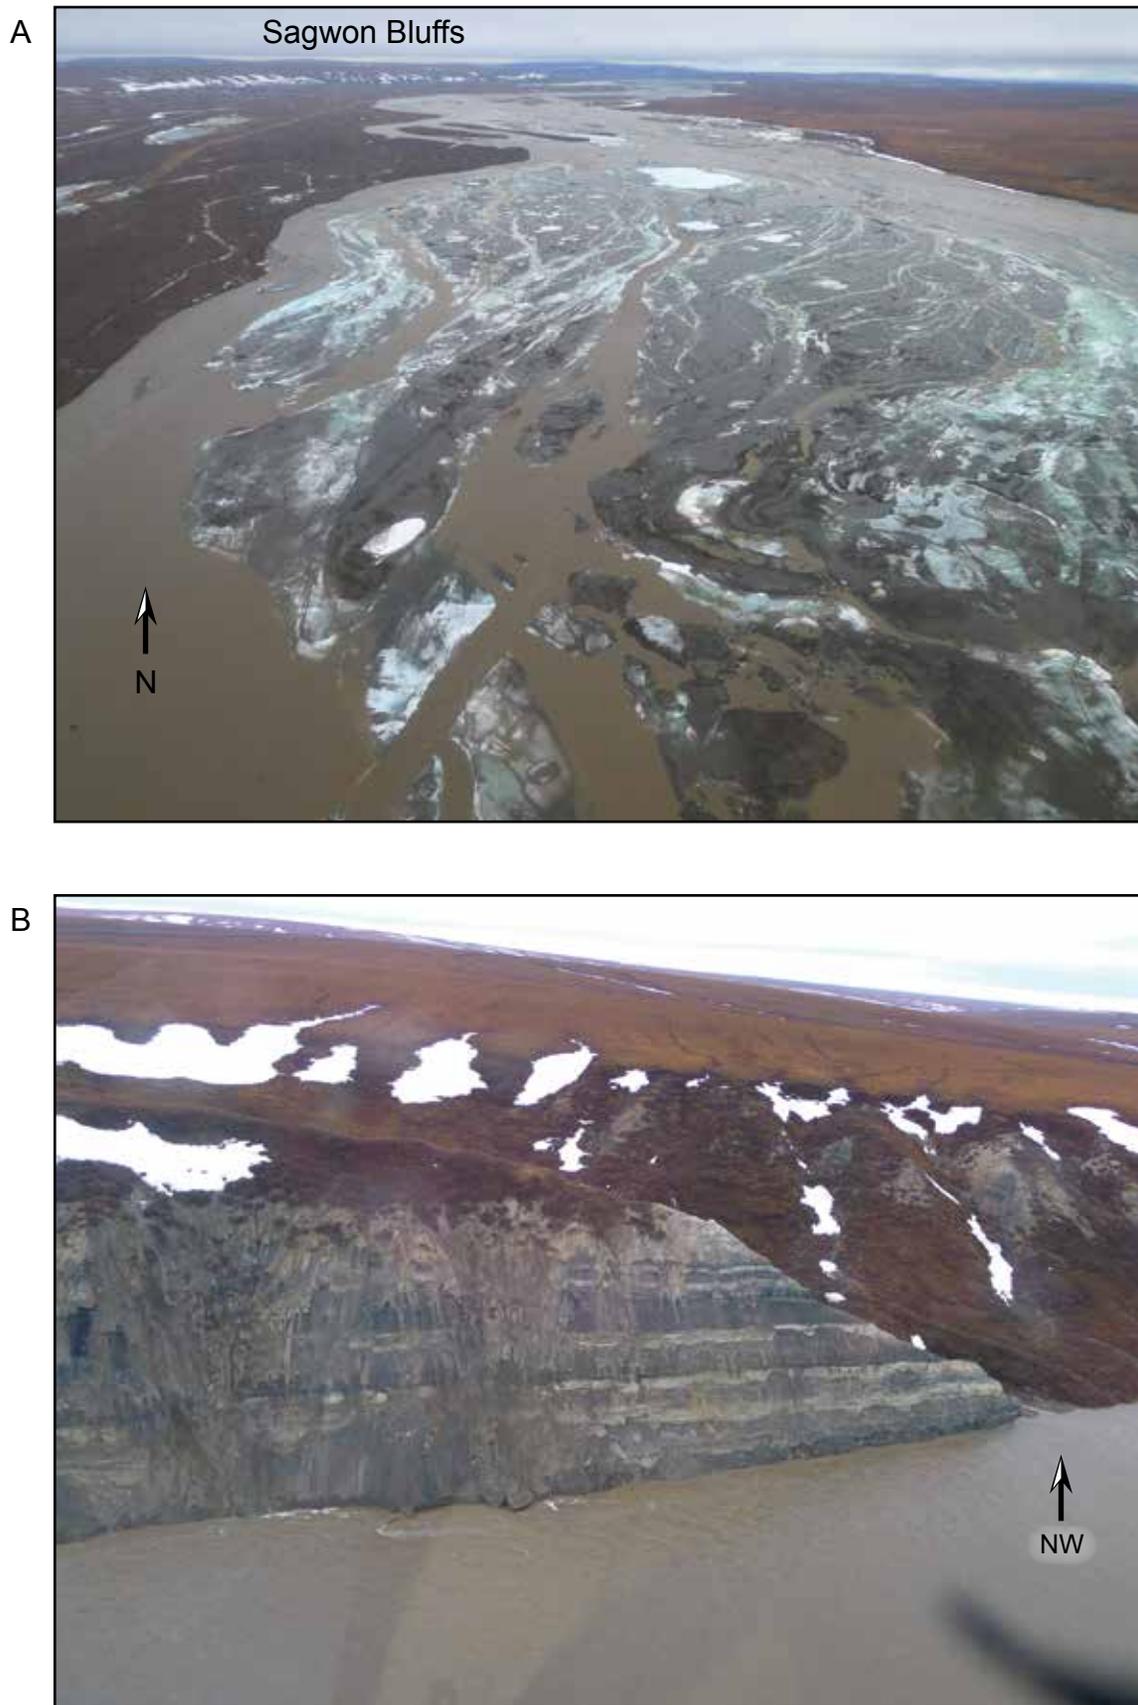
FIGURE 36. A. View, looking north, of braided channels of the Sagavanirktok River floodplain south of its confluence with the Ivishak River, showing extensive stream icing. Sagwon Bluffs are in the background on the upper left. B. Aerial view, looking northwest, of Cretaceous bedrock exposed in the Sagwon Bluffs. The rounded upland ridges and slopes that cap the bluffs are underlain by thin colluvium and possibly discontinuous deposits of the Anaktuvuk River glaciation.
