IR-078-01

TERRITORY OF ALASKA  
DEPARTMENT OF MINES  
JUNEAU, ALASKA

Report of Observations and Mining Investigations during  
Trip from Fairbanks to Anchorage

By  
J. C. Roehm  
Associate Mining Engineer  
September 3-7, inclusive - 1946

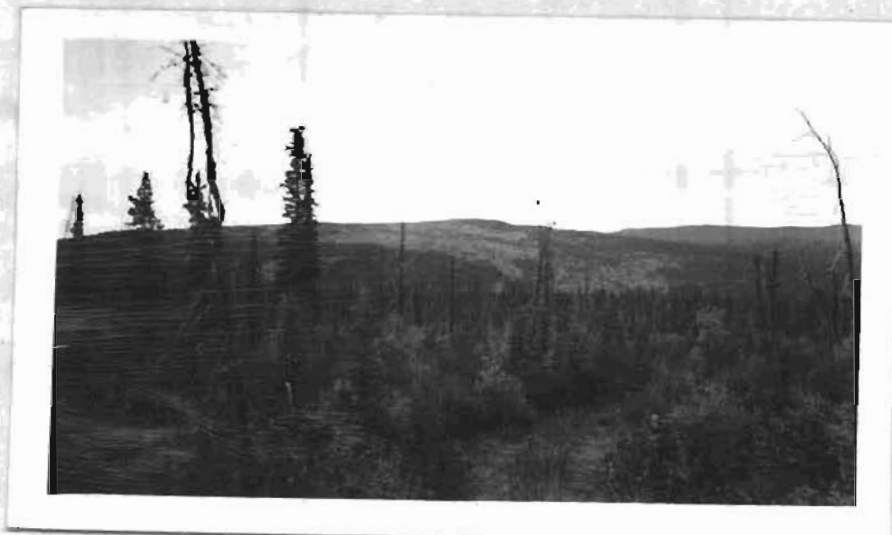
Photo No. 1 - View of slide area from Glenn Highway, Mile 141.

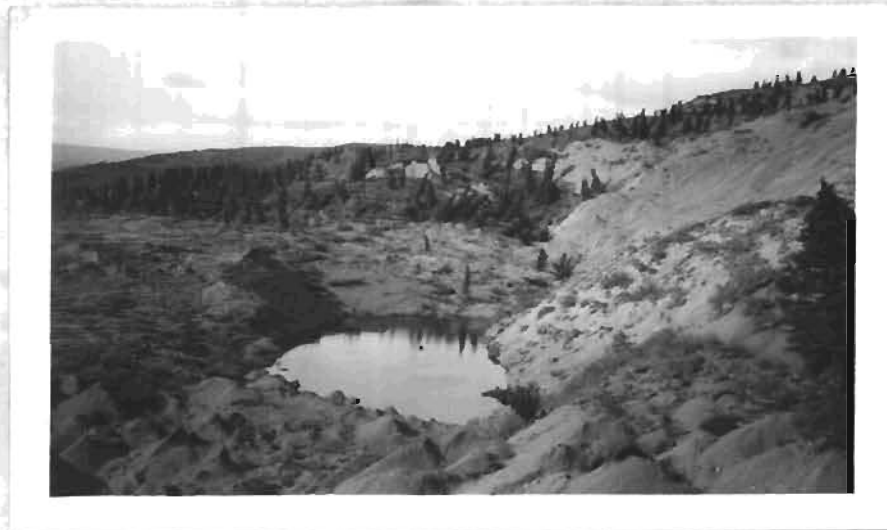
The major structural feature is the central fault displacement area near the center and striking parallel to the elongated portion of the area. This fault trend is easily traced by the steep footwall in relation to the lower hanging wall which indicates normal faulting. (Note Photos Nos. 2 and 3.

Photo No. 2 - Shows the depression which marks the fault trend to the northwest from a small lake situated near the center of the upper portion of the disturbance.

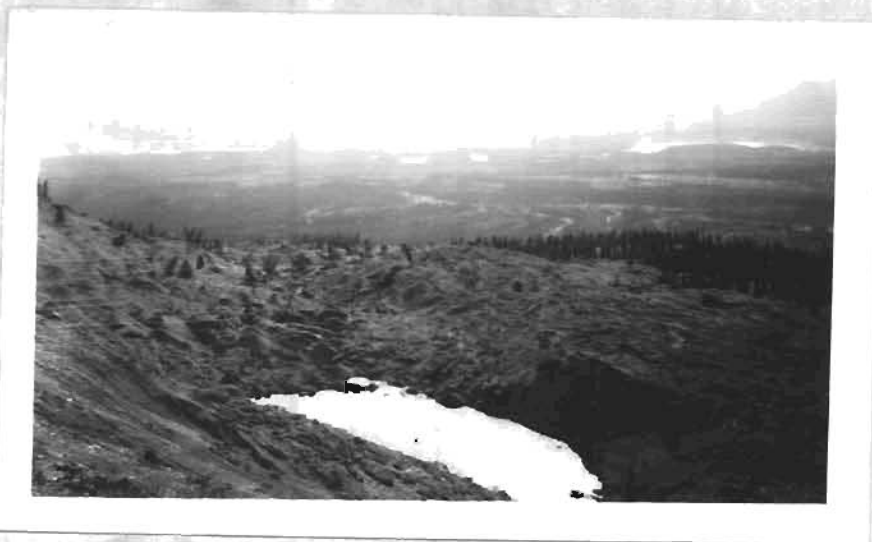
Photo No. 3 - Shows the continuation of the fault trend southeast from the same lake as shown in No. 2. Note the trees leaning each way toward the fault line.

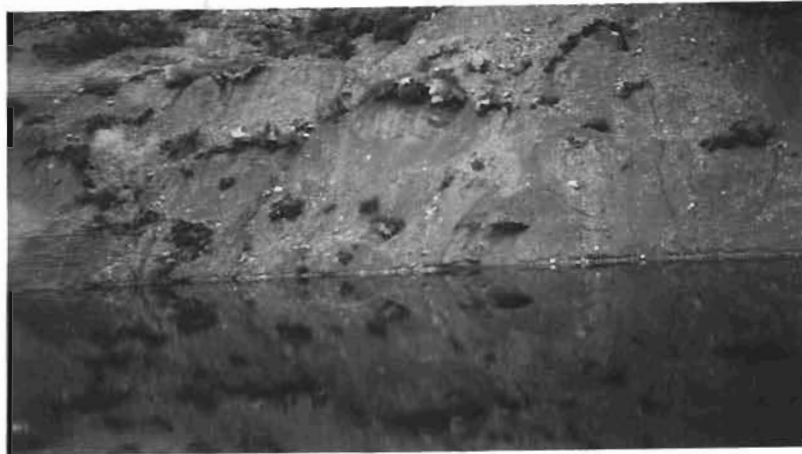
Photo No. 4 - Shows a close-up of the north shore of the lake shown on Photos Nos. 2 and 3, indicating the steepness of the footwall of the fault.

Transverse faults of a minor nature appear to intersect the major fault in the vicinity of this lake, which probably created the deep depression which later filled with water, forming the lake.

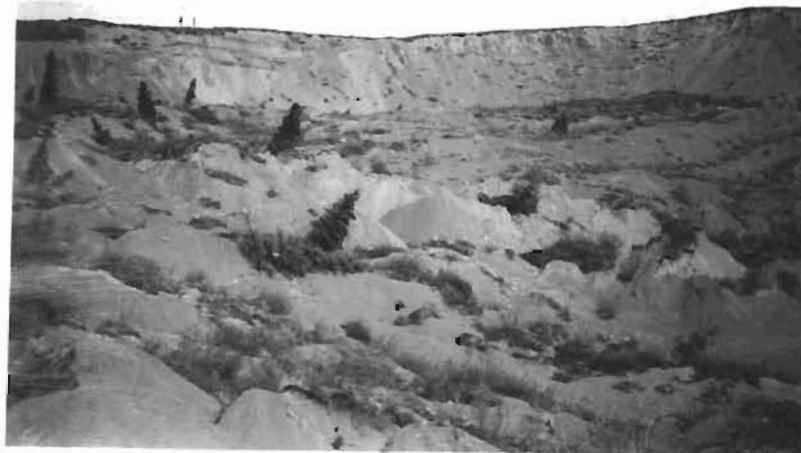
The apparent displacement along the major fault zone resulted in the lowering of the hanging wall and the vibrations or tremors which followed caused a large section of the footwall to slough, reaching nearly to the top of the mountain. This slough is represented by a large semi-circular shaped basin, surrounded on the upper side by a nearly vertical bank two to three hundred feet in height.

Photo No. 5 - Shows the upper basin and the 200-300 foot bank marking the limits of the area to the north and representing a slough which occurred after the main displacement along the fault zone. The

surface material or the upper 20 to 30 feet of this bank consists of unconsolidated sand and gravel. The remaining exposure below the sand and gravel consists of a limy to sandy Upper Cretaceous shale ranging in color from a greenish gray to nearly black. The dark colored shale contains considerable carbonaceous material. The shale formation has a northwest-southeast strike and contains a very low dip to the north-east. The shale slacks readily upon exposure, breaking into small bits and forming talus cones.

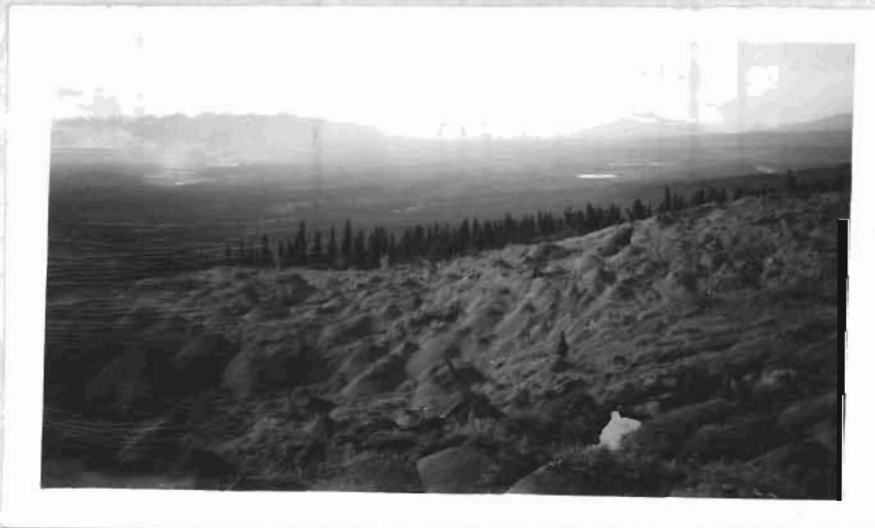
Photo No. 6 - View looking southwest across the slide area. Note the absence of trees in the disturbed area and the dense forest along the edge. Note the enumerable cone-shaped piles, which were solid blocks of shale lifted to the surface by violent earthquake tremors, and which rapidly disintegrated, forming talus cones.

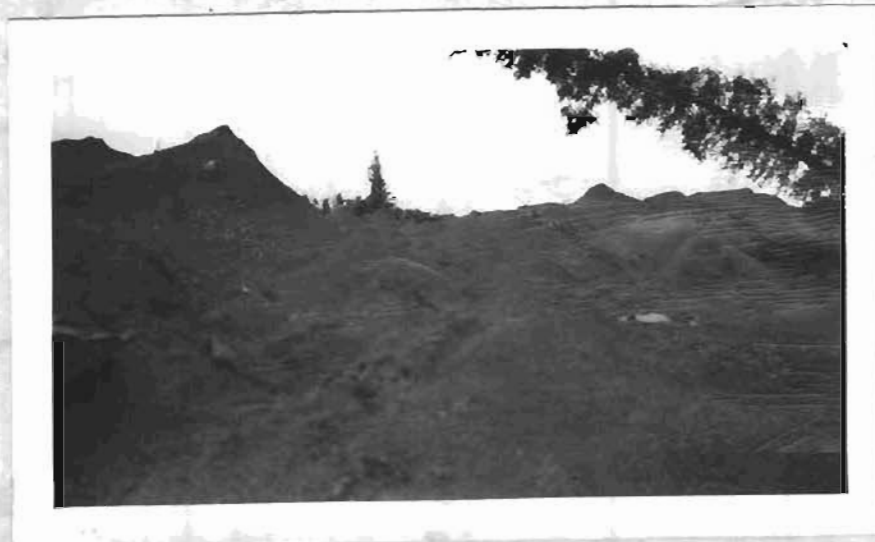
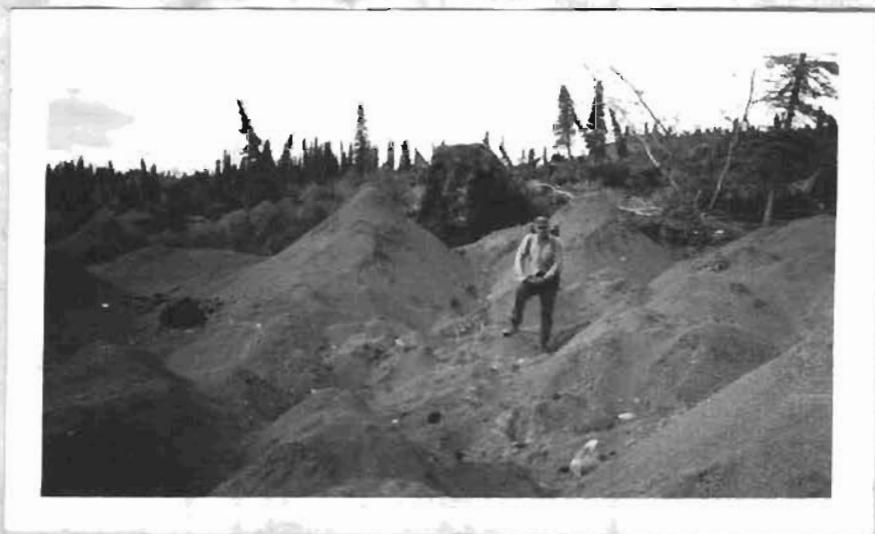
Photos Nos. 7 & 8 - These photos show the abundance of talus cones which range in size from very minute, one to two inches, up to 30 or 40 feet in height. The size and height of the cones was determined by the size of the shale blocks. The vibrational effect on the blocks was also a factor in their disintegration. The existence of these enumerable cones is one of the most striking features of the area.
