TERRITORY OF ALASKA
DEPARTMENT OF MINES

Lucky Shot Mine.

OLD PROSPECTOR MINE
 WILLOW CREEK DISTRICT
 Owned by Mrs. H.A. Drake
 Scale 1" = 30'
 G.E. Zeigler. 8-17/40

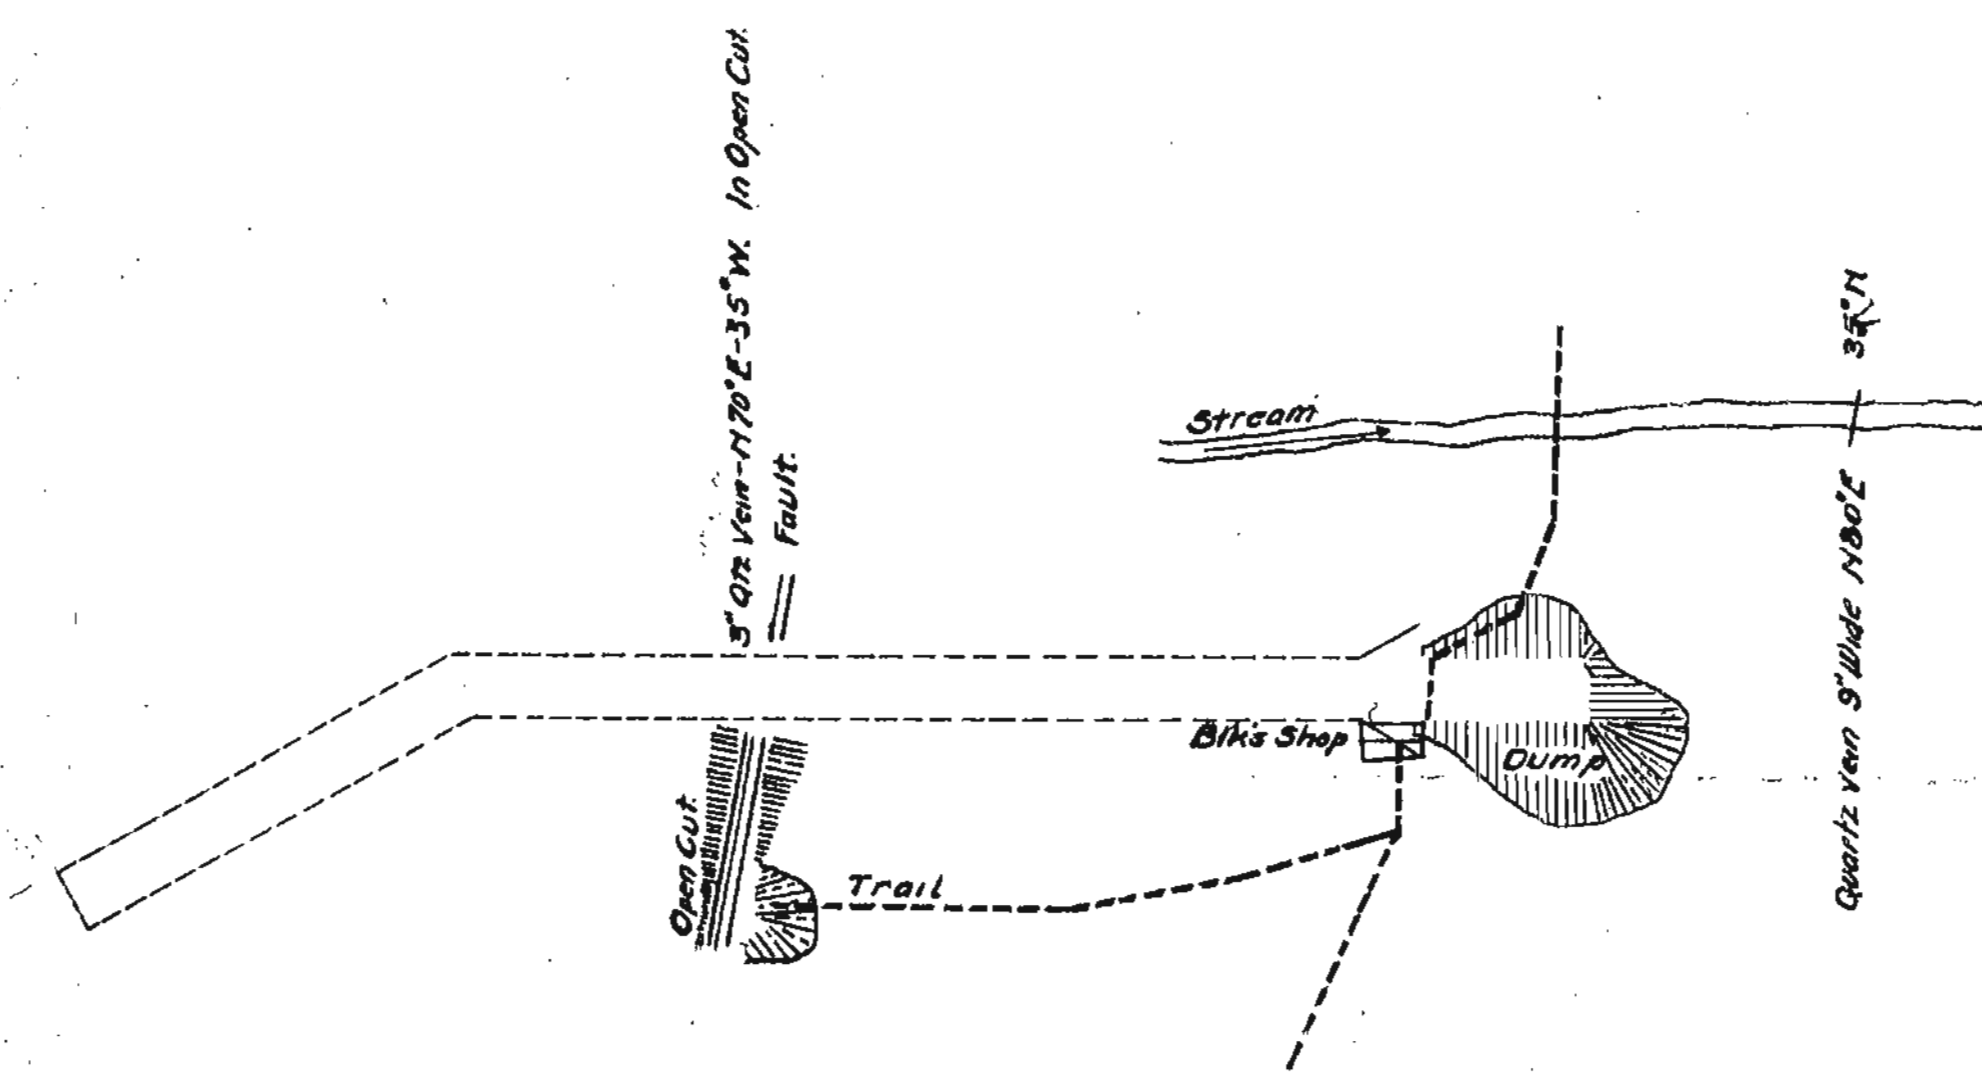
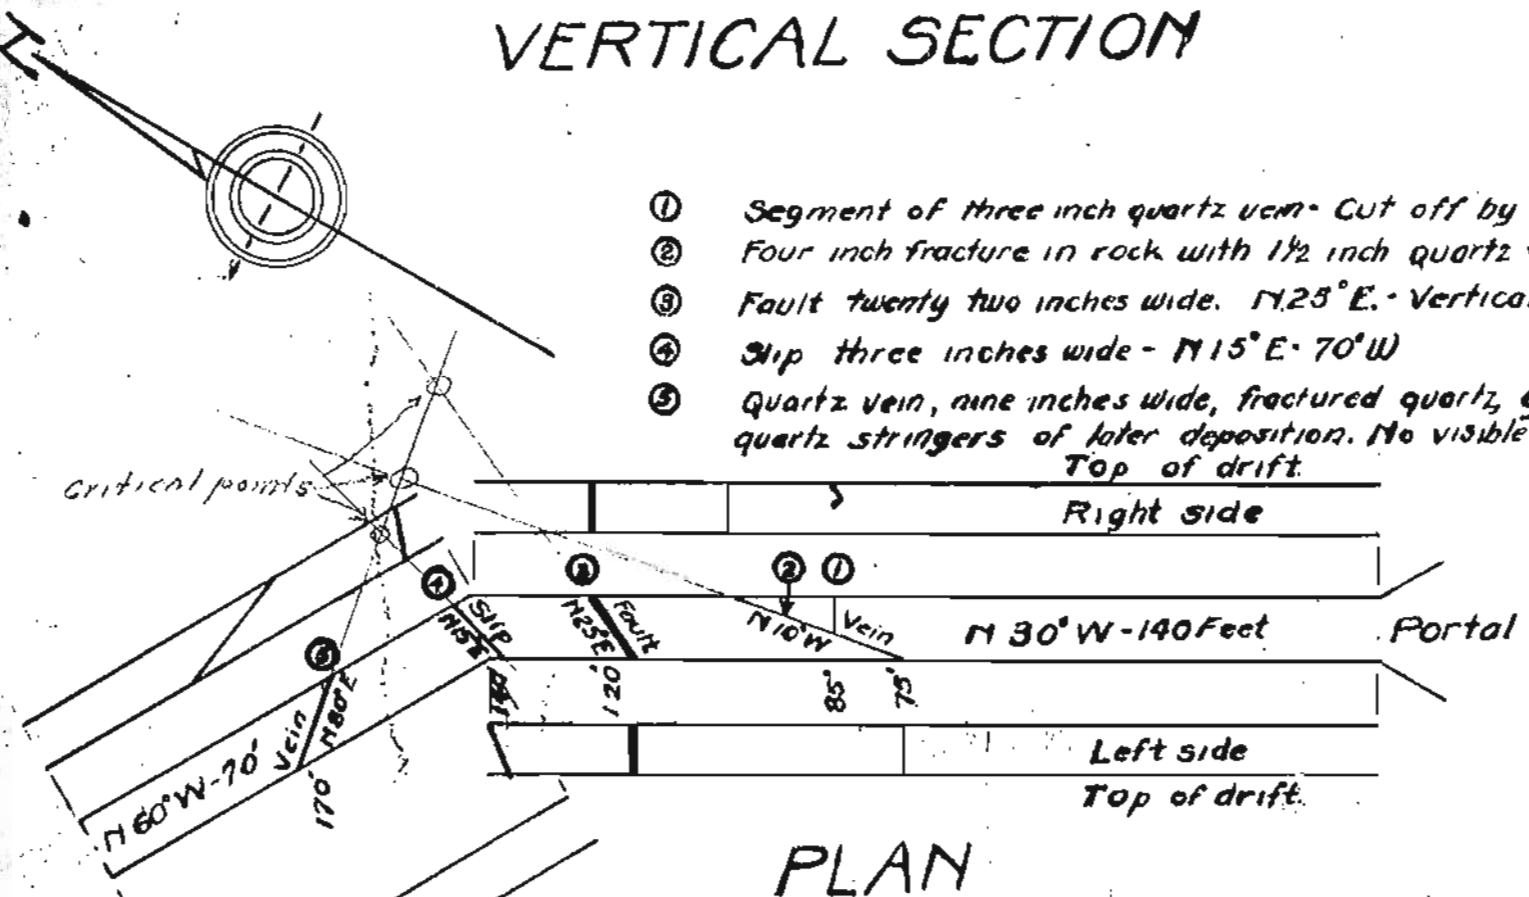
This prospect is located on Upper Craigie Creek a little above the Rapp and Till Operations. It was first leased by H. A. Drake and is now controlled by Mrs. H. A. Drake the change being occasioned by the death of Mr. Drake. Underground operations consist of one drift approximately 210 feet long. This drift cuts a nine inch vein about 170 feet from the portal. The prospect is idle at the present time. A sketch has been made of this property and is enclosed for your information. There is evidence of considerable faulting which is very apparent on the sketch. Assays of the vein were not made available to me. Below the portal of the tunnel a vein (9") occurs in the bottom of a stream which carries visible gold. Farther down the hill along the trail is a basic dike, apparently in place but may be in slide rock, which carries copper and molybdenum. The property is worthy of additional exploration, but the operator should be prepared to expend in the neighborhood of 150,000 dollars due to the spotty nature of the Willow Creek deposits and the fact that new development must be done as there is very little ore indicated above the drift. The vein in the creek bottom should not be passed by as it too looks very favorable, may be the same vein displaced by faulting.

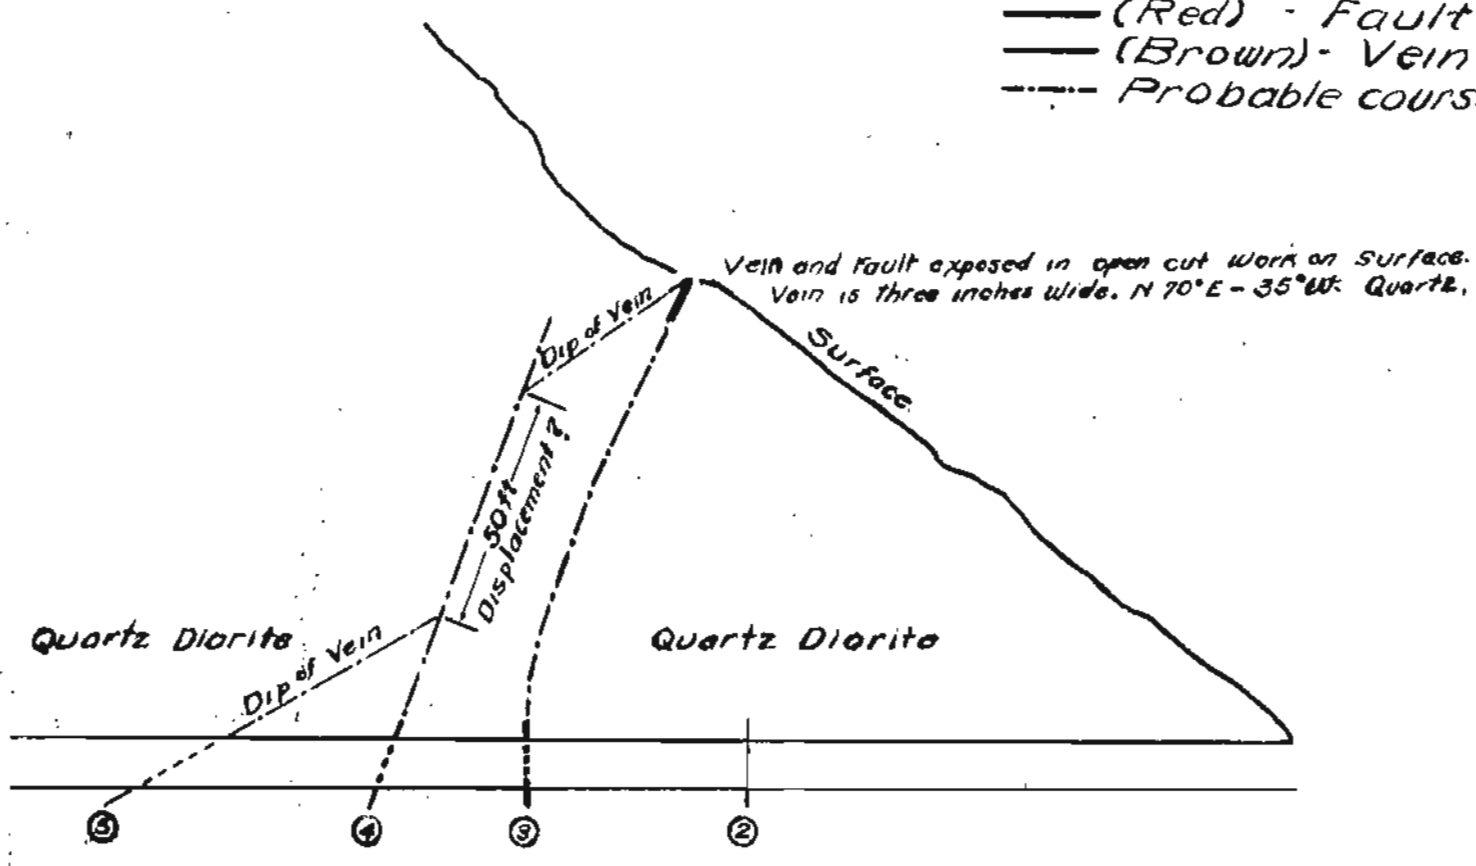
VERTICAL SECTION

- ① Segment of three inch quartz vein - Cut off by fracture ②. Exposed on Pt. Wall
- ② Four inch fracture in rock with 1/2 inch quartz vein. N10°W - Vertical.
- ③ Fault twenty two inches wide. N25°E - Vertical.
- ④ Slip three inches wide - N15°E - 70°W
- ⑤ Quartz vein, nine inches wide, fractured quartz, gouge material and solid quartz stringers of later deposition. No visible mineralization. N80°E - 30°N Top of drift.
