TERRITORY OF ALASKA

DEPARTMENT OF MINES

MOHAWK MINE TAILING TREATMENT, 1956 4-58-69

Robert H. Saunders
Associate Mining Engineer

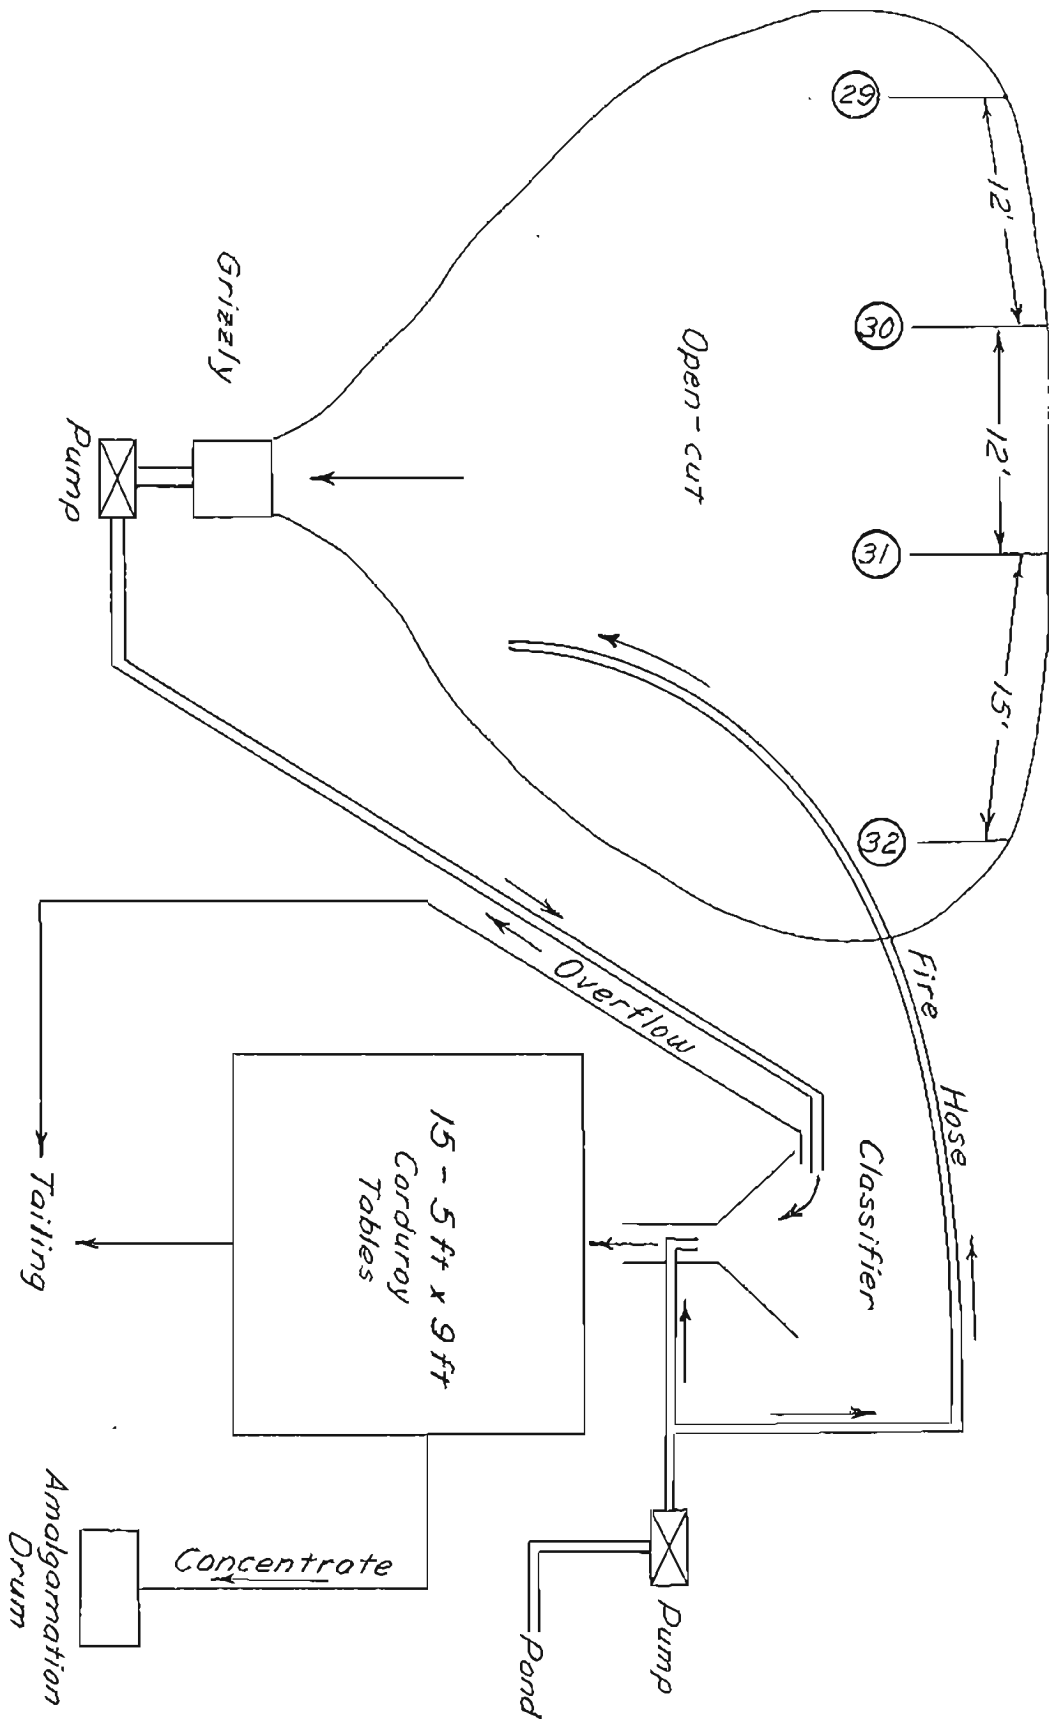
TERRITORY OF ALASKA
DEPARTMENT OF MINES
Diagram of Plant for
Washing Mohawk Tailing

Plate I is a diagram of the treatment plant. A fire hose was being used to wash the tailing to a grizzly. The material that did not go through the grizzly (mostly bits of brush and moss) was removed with a rake from time to time. The material that went through the grizzly went into a box that led to the suction

of a gasoline-powered WEMCO pump. The pump discharged into the top of a home-made classifier; overflow from the classifier was discarded, and the discharge from the bottom of the classifier went over the corduroy tables. The concentrate from the corduroy tables was put through an amalgamation drum. A second gasoline-powered pump was being used to provide water for the fire hose and the classifier.

During the examination several pans of material were caught from the lower end of the tables; neither gold nor sulfides could be found in any of the pans. A sample of the concentrate after it had been treated in the amalgamation drum assayed 25 ounces of gold per ton. It might have been feasible to ship to the smelter the concentrate from the tables, but the low value of the tailing being fed to the treatment plant discouraged the operators, and they dismantled the plant shortly after the examination.
