REPORT ON THE EXAMINATION OF THE BUSTY BELLE MINING CLAIMS

Theodore Vance and Rod Asher, Mining Engineers

March 27, 1968

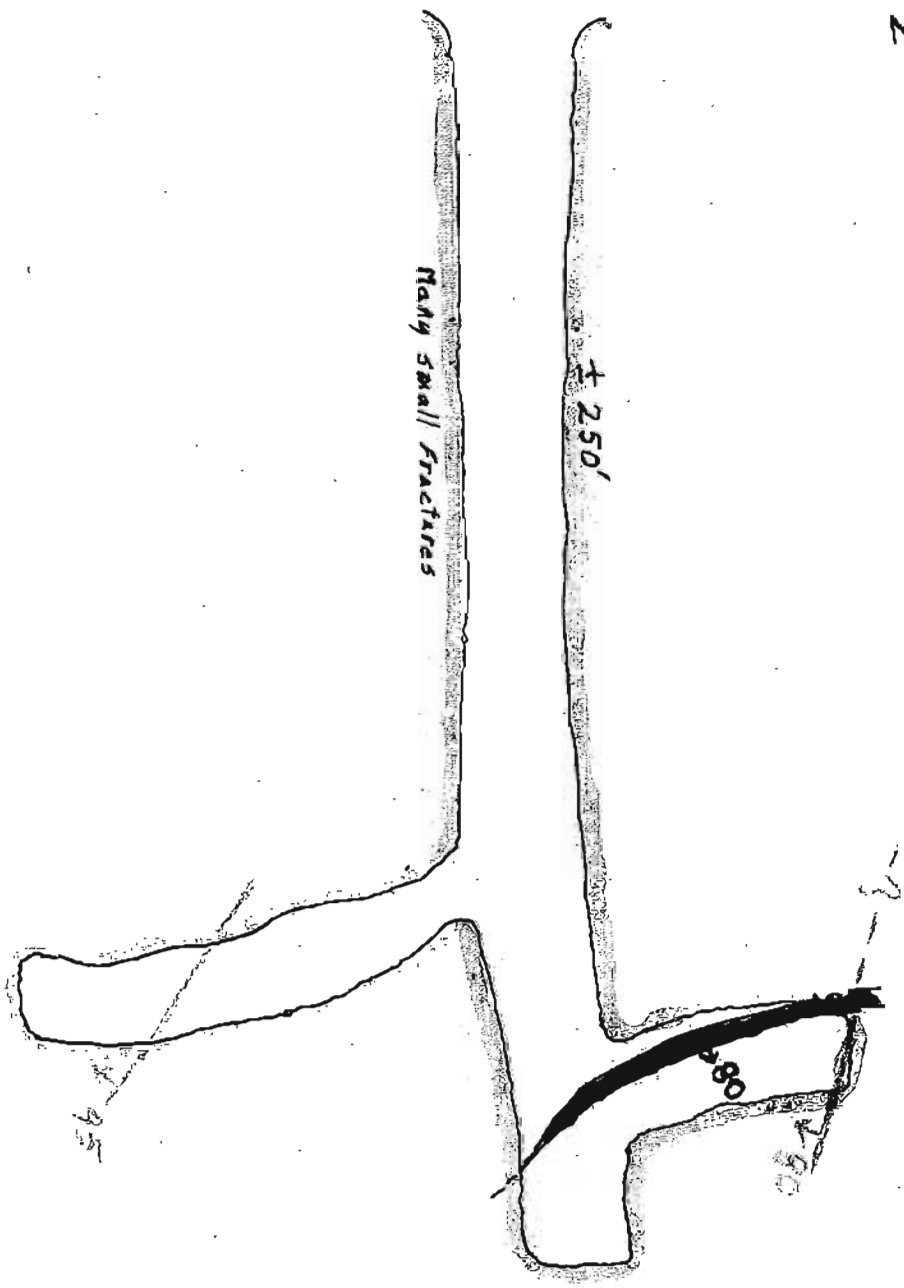
Figure 1 is a sketch map of the only adit on the property. The country rock exposed in the crosscuts is a dark fine-to-medium grained diorite that has been extensively fractured with subsequent deposition of numerous calcite and quartz veinlets. These small veins vary from $\frac{1}{4}$ " to $\frac{1}{2}$ " in width and appear to be barren of sulphide mineralization. No apparent alteration of the diorite was noted in any part of the crosscuts or drift.

Faulting is present but is not excessive. Gouge with abundant slickensides was observed in a fault in the face of the drift. This fault appears to cut across the vein but not enough development work has been performed, to show the amount of displacement.

The vein strikes N85W and dips steeply to the south. Vein width at the face is 18 inches and pinches to a mere crack on the west end. The minerals present are chalcopryrite, galena, marmatite, gold and silver; with abundant pyrite (approximately 60%), calcite and quartz. The vein is well defined at both the hanging wall and footwall; it appears to be of the fissure type. No alteration of the country rock was observed adjacent to the vein or in any other part of the workings.

Due to the heavy snow cover no examination of outcrops could be done, consequently, a prediction of strike length of the vein underground is impossible at the present time. The writers advised Mr. Anderson to continue drifting on the vein and to cut representative channel samples at frequent intervals.
