PE-085-12

REPORT ON THE GOLD CENTER MINES, WILLOW CREEK DISTRICT

Leo H. Saarela, Associate Engineer
Territorial Department of Mines

August 2-5, 1945

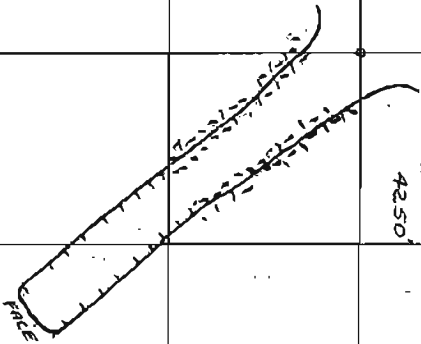
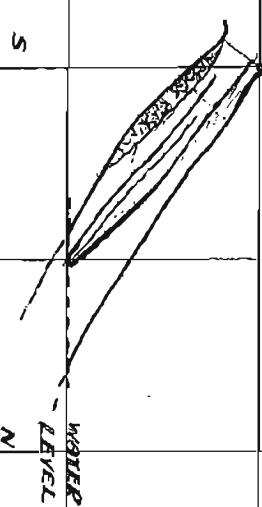
Sheet 1

There are numerous surface pits, cuts, and other workings indicating that numerous out-crops are present. No attempt was made to examine all of these, only a general picture was obtained. South of the upper level and approximately six hundred feet from it, at an elevation of 4210, a winze has been sunk on a vein dipping forty-eight degrees to the southwest and striking north 53 west. This winze was examined and found to contain a three inch vein

In rather soft and highly faulted quartz diorite. A plan and section are included herewith. There is much movement on the plane of the vein and the diorite is heavily stained with iron oxide. West of this winze, at an elevation of 4250, is a forty-five foot drift, the last twenty feet of which are in solid quartz diorite. No vein was visible here. However, some quartz was on the dump and, judging from the bearing of the drift, the strike of the vein must have been about north 40 west.

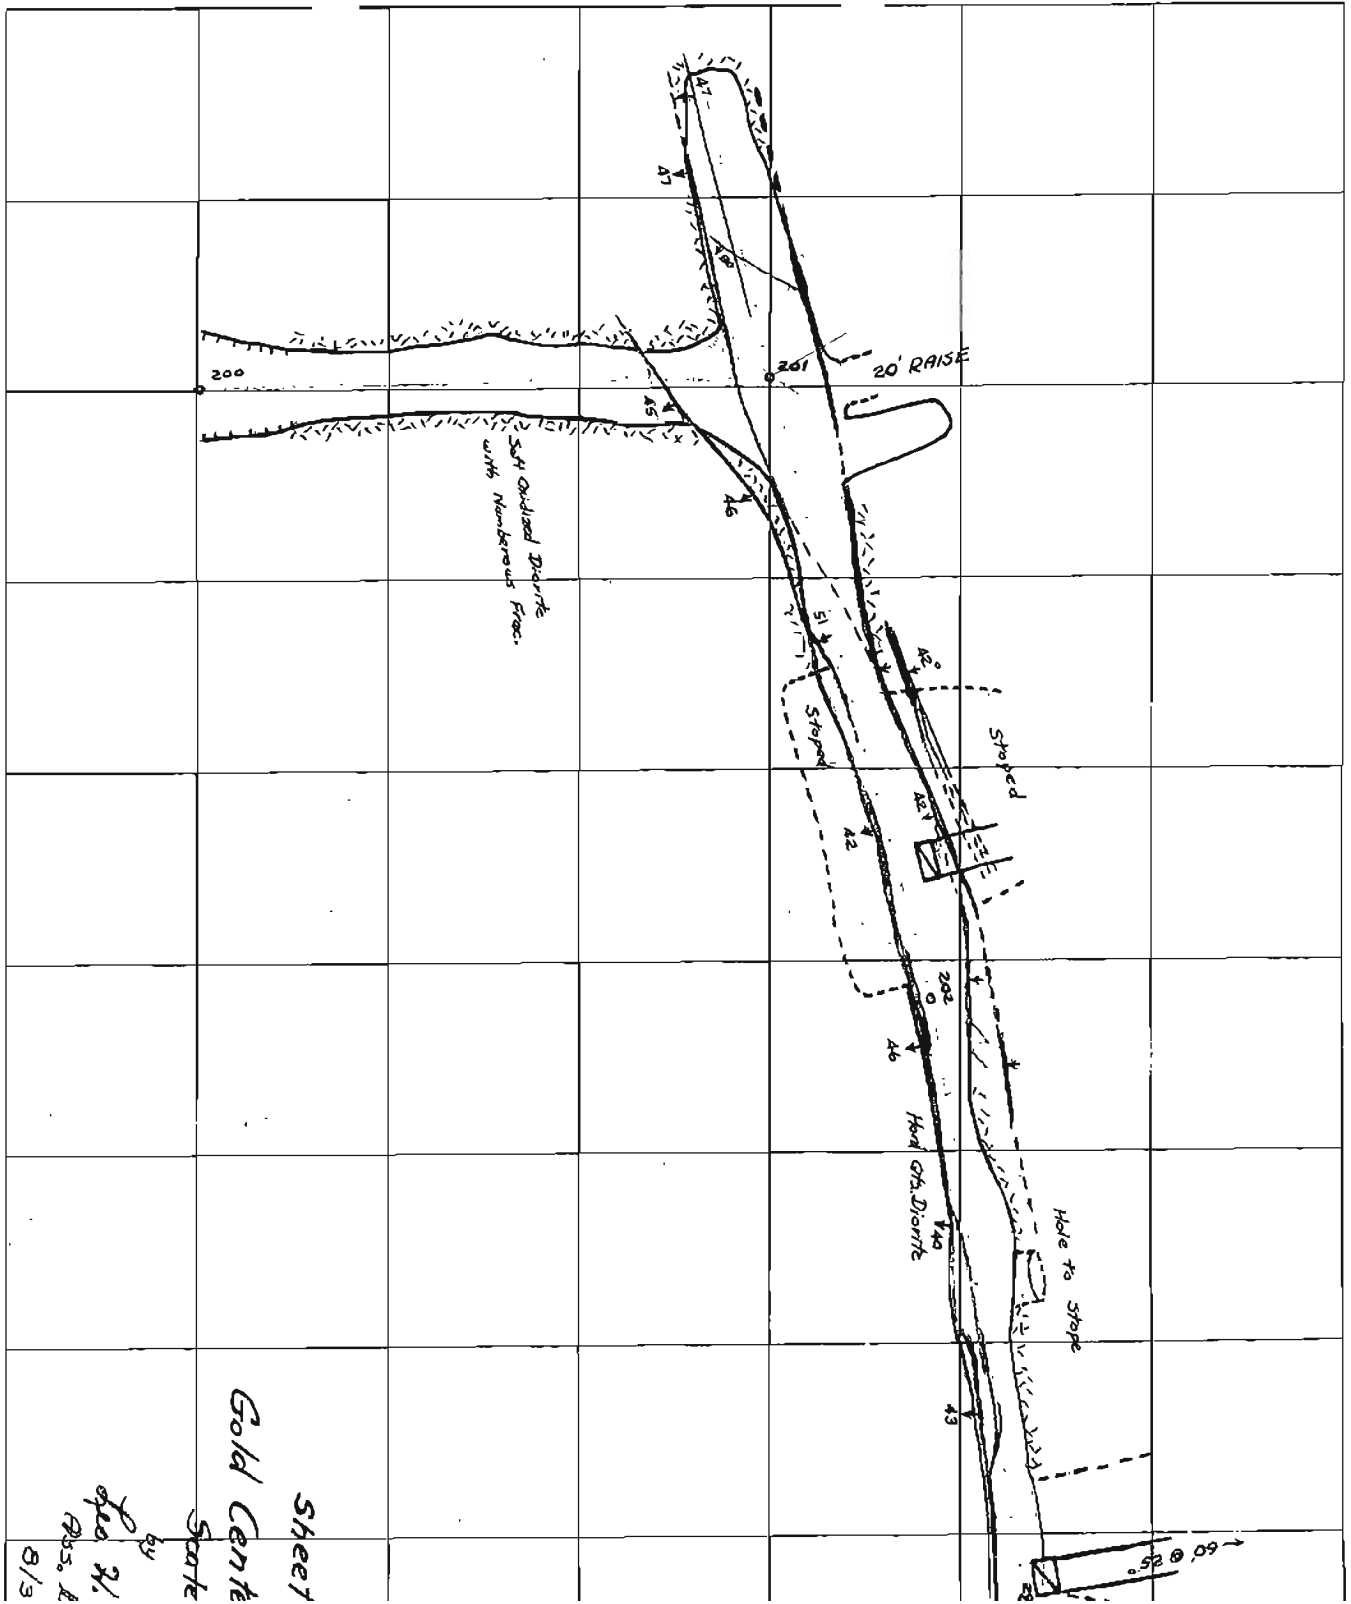
Sheet
Gold Centre

The Upper Level The upper level, at an elevation of 4140, has produced all the ore mined to date. This consists of a sixty foot crosscut bearing almost due east and intersecting a fracture zone of about fifteen feet wide. The vein throughout these workings was dispersed along movement of the hanging wall and foot wall. The ground, through this fracture zone, is generally very soft. In the drift (see map enclosed) eastward the vein strikes about south 15 east and dips at an average about 43 degrees to the west. The vein has been underhand stoped along 35 feet and 15 feet below the floor, and was reported to have excellent values. There is still some quartz remaining at the bottom of this winze. Above this a raise was driven along the ore and a stope was mined out. The vein in the stope was reported to have reached maximum thickness of about 24 inches. However, there was much lensing and doubling over of the vein, as numerous faults in the plane of the vein caused duplication. The stope is in soft ground and all vein matter in the stope was cut by a straight fault coming out of the foot wall. This fault is exposed in the drift near station 204 and has an approximate strike of the vein and dips from 76 to 56 degrees to the east. The total production from this level is estimated at about twenty thousand dollars.

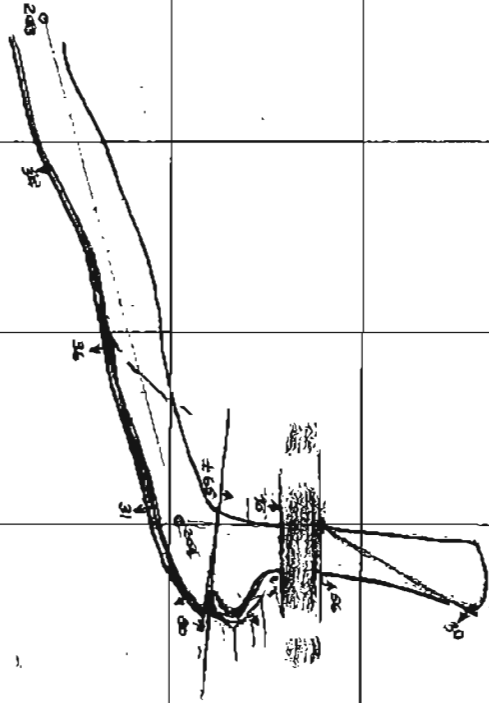
Sheet 3

The Lower Level The lower level, an elevation of 3793 feet, consists of a crosscut 345 feet long and drifts driven off this along various fracture zones. This drift bears about south 80 east and was driven in the hope of intersecting the upper veins at this level. Throughout its length the rock is very hard quartz diorite. At about 125 feet in, a small vein about an inch in thickness and striking north 35 west and dipping 37 degrees to the west, was intersected. This was reported to have good values but owing to its small width only a little work has been done on it. At 110 feet from station 101, a strong fracture zone striking about north 20 west and dipping about 46 degrees to the west was intersected. This

fracture zone is about four feet wide and has approximately 12 inches of heavy gouge along the hanging wall. Some ground-up quartz was reported to have been in this gouge and must have been the incentive for driving this tunnel. No vein was hit and work was discontinued. Later the crosscut was continued and at two hundred feet from station 101, a fault striking about north or east and dipping 66 degrees to the west, was struck. Eighty two feet from station 102 a strong fracture zone striking about north 15 west and dipping about 45 degrees west was reached. It was apparently thought that this was the downward extension of the upper workings. This fracture system is very persistent and in places has a little quartz that is reported to be of low grade. The quartz seen along this fracture system was at those places where small faults horsetailed from the main zone of movement. This is especially true around station 104 where a raise was driven for about thirty feet in the hope of finding a thicker vein.

General Suggestions It is quite apparent that the lower level is not on the same vein zone as the upper workings, as the projection of the upper vein at the level of the lower tunnel is about 315 feet to the east. It can, therefore, be assumed that a vein close to the eastern-most tram tower on the surface and prospected by numerous pits, is on the same vein zone as this main drift. A suggested method for prospecting this area would be to continue the crosscut from station 103 and at about the same bearing until the vein zone was intersected, or diamond-drill from any position eastward from the drift. The character of the ground would be the criterion of the ore to be expected, as very dense and hard rock rarely produces any ore. This has been proved on the upper level as numerous faults on the plane of the vein in relatively broken ground produced a sizeable ore body. Careful consideration should be given to both hanging wall and foot wall of vein zones and especially on the other side of slickensides or zoning on the plane of the vein. Many ore deposits have been found by accidentally blasting too hard and revealing veins along the opposite sides of these fault planes.
