PE-096-02

February 1954

PROPERTY EXAMINATION REPORT

THE FIDALGO-ALASKA COPPER PROPERTY,
PRINCE WILLIAM SOUND

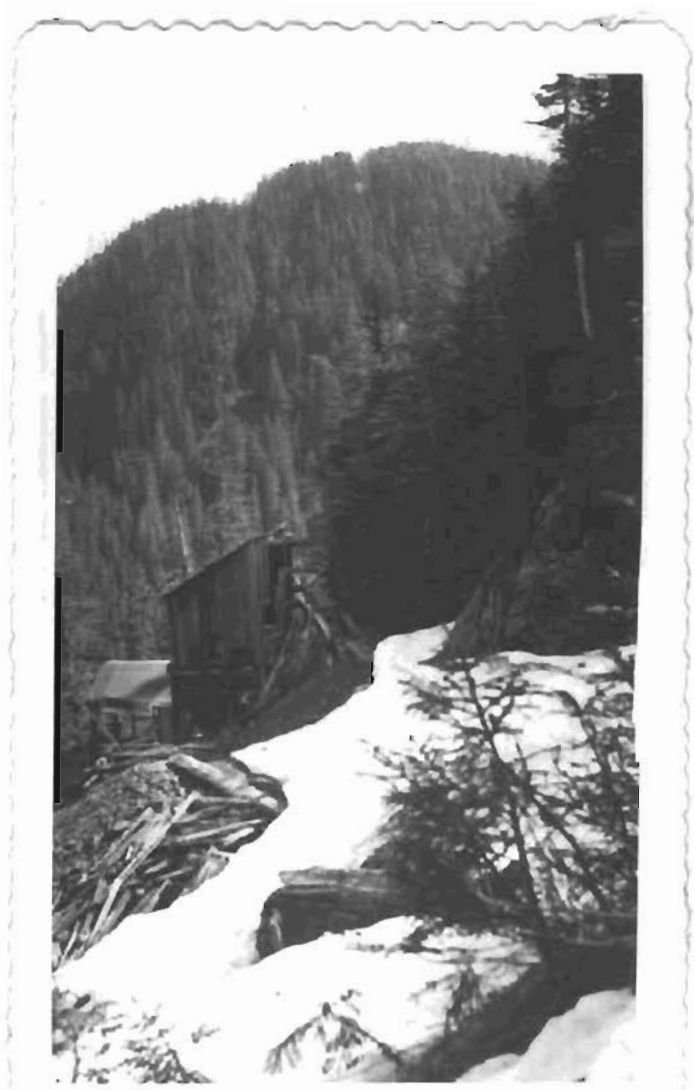
There appears to be two shear zones within the area of mineralization, either one of which, or both, might be the ore control. Geologists seem to favor the NS shear, but the possibility of the parallel EW faults which show on the hilltop, (see Figure 1) and cut across the upper portals should not be overlooked. Other prospects along these faults show mineralization in the form of covellite and bornite as well as chalcopyrite.

Buildings and structures at the property are in ruins. Figures 1 and 2 show the building at the upper end of the former tram line at one of the upper levels. Figure 3 is a closeup of the bunker at the beach, and Figure 4 is a distant shot of the same thing, also showing some of the country. Figure 5 is the cabin at the beach in which the present drilling crew lived, but this would need repairs or replacement for a permanent dwelling.

Figure 1. Aerial Tram Building at upper levels. Note parallel east-west faults in distant hill.

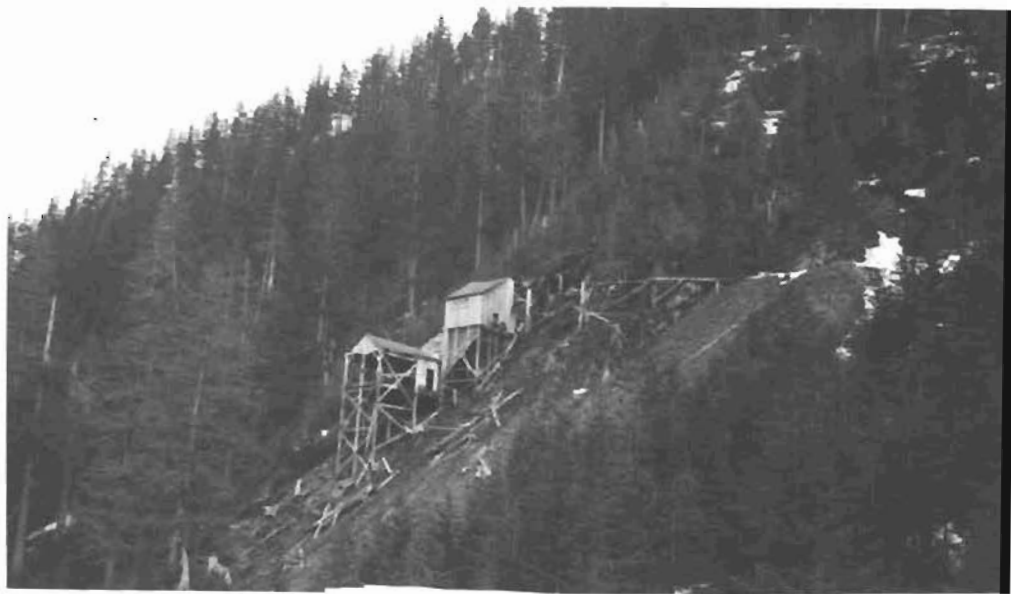
Figure 2. Another view of tram building at upper levels.

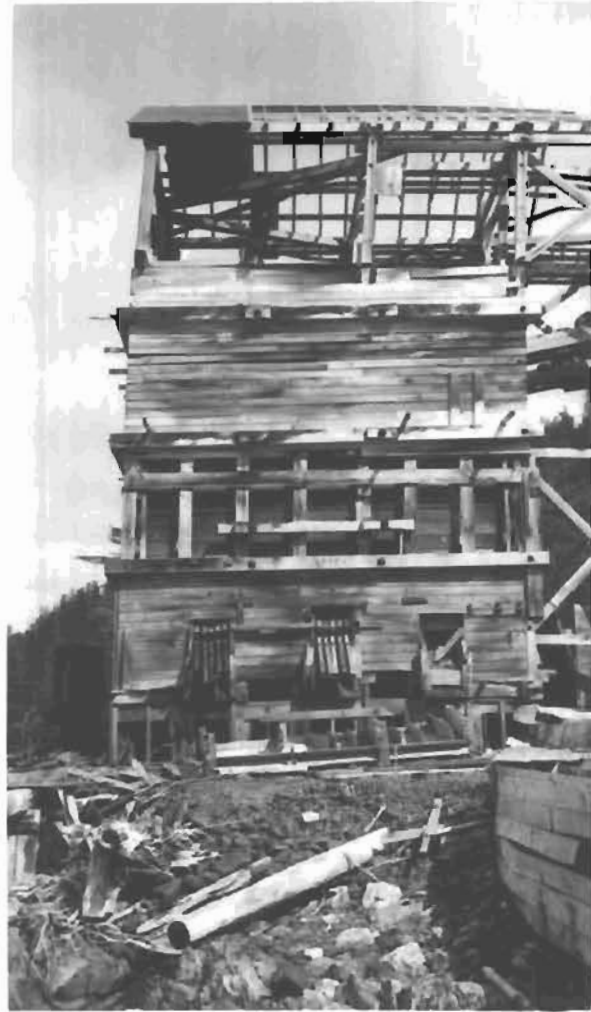
Figure 3. Remains of ore bunker at beach.

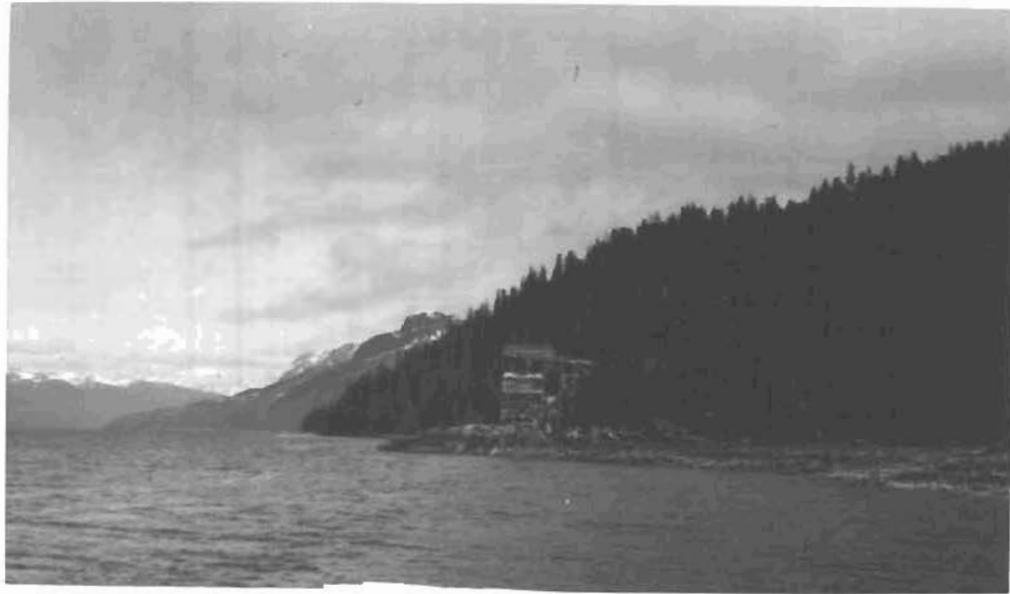
Figure 4. Distant picture of ore bunker and showing some of the country.

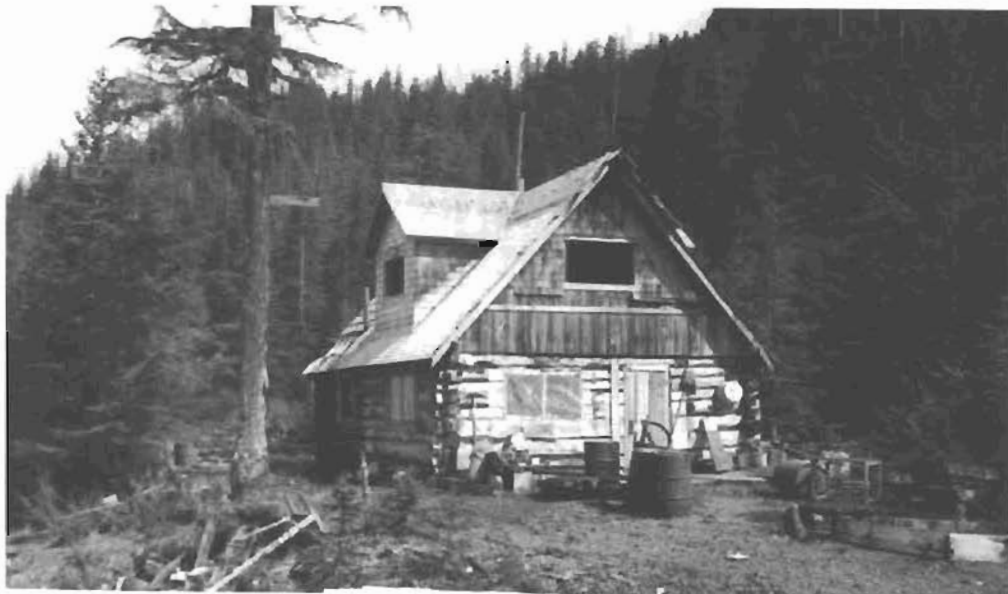
Figure 5. Only habitable (?) building at property.

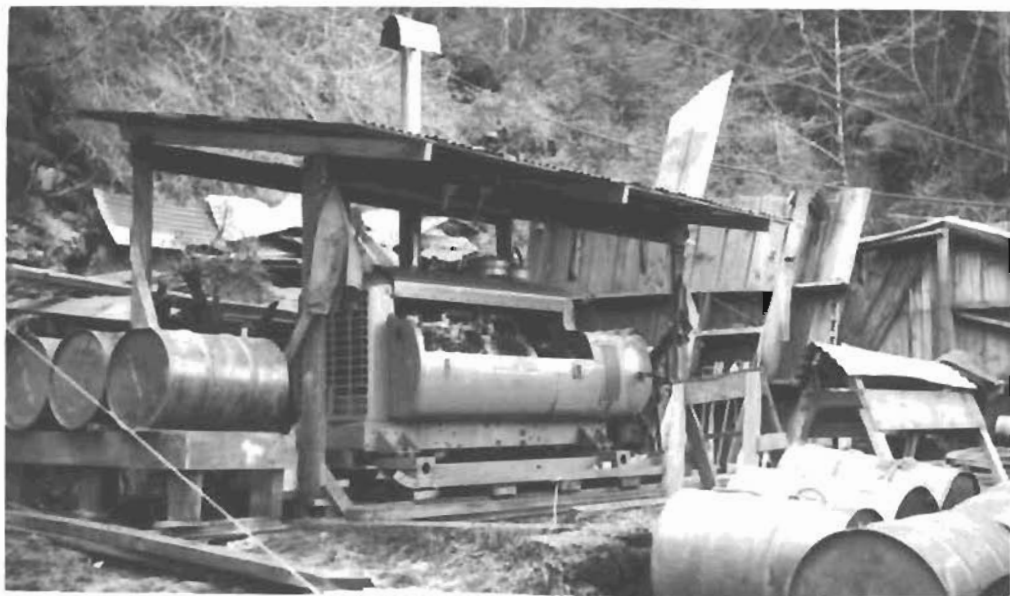
Equipment used was all new and in good condition. The compressor was a Joy 210 with a 57 HP Caterpillar Diesel engine. The drill was a Joy H 515 standard blast and core drill, 7/8" core EX rod, 500-foot capacity, with an air-driven piston rod-puller. A two-drum Skagit hoist with a Wisconsin motor was used for moving the equipment up to the portal. Figures 6 and 7 are views of the compressor and the portal of No. 9 Level, respectively.

Figure 6. Compressor used by Alaska Copper Corp. at portal of No. 9 Level.

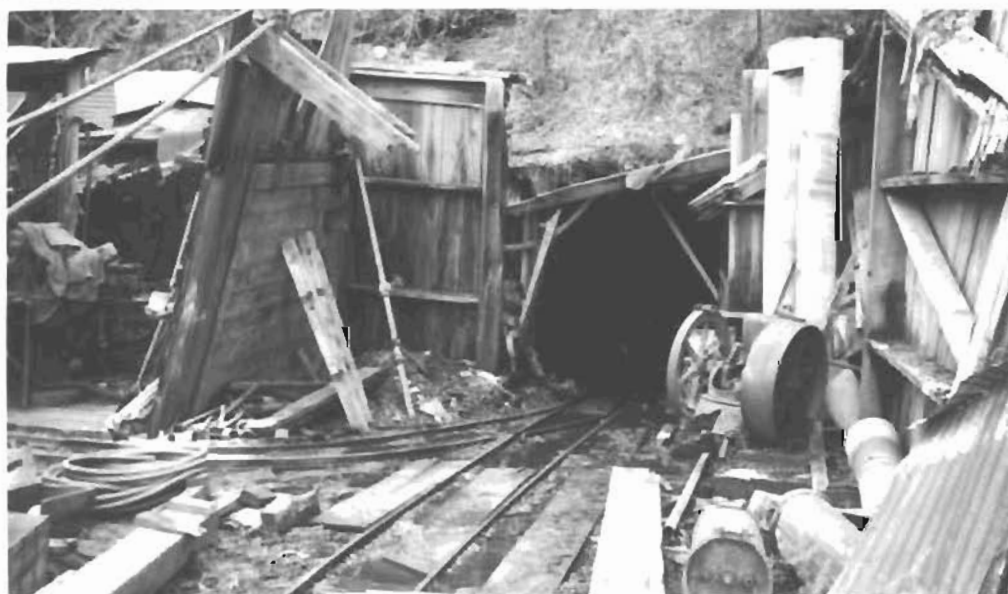
Figure 7. No. 9 Level Portal.
