PRELIMINARY INTERPRETIVE REPORT 2000-3

**TECHNICAL REVIEW OF THE SEPTEMBER 1999
GROUNDWATER DISTURBANCE NEAR ESTER, ALASKA**

Jim Vohden
Alaska Department of Natural Resources
Division of Mining, Land and Water
Alaska Hydrologic Survey

March 2000

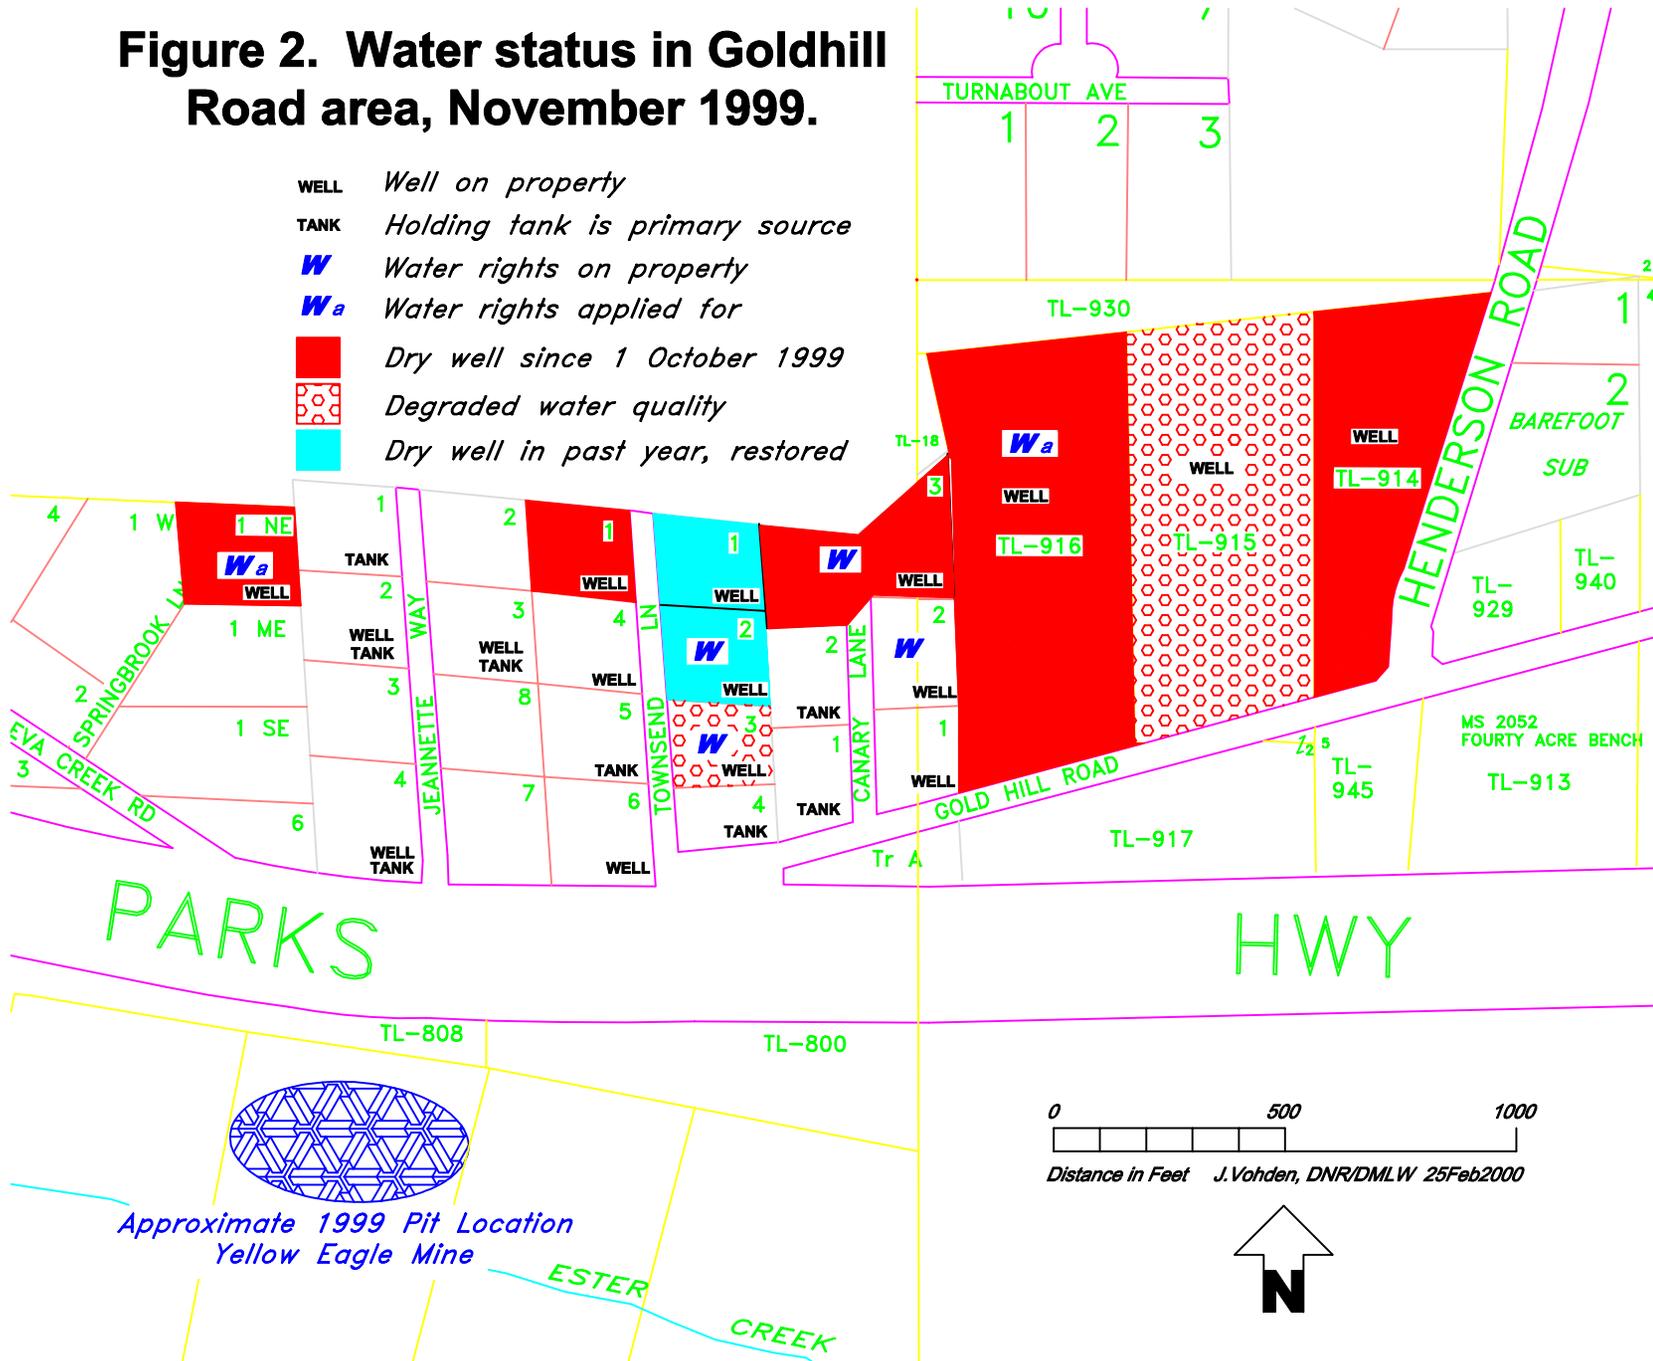
Figure 2. Water status in Goldhill Road area, November 1999.

(Figure 2). The common complaint was increased sediment in the water requiring sediment filters to be changed more frequently, sometimes as often as every other day. One additional well was reportedly dry beyond normal use but could not be confirmed as the homeowner was out of town for several months. By early November 1999, DMLW confirmed that two other wells experienced a drop in the static water levels sufficiently in prior weeks such that the wells were not usable by the residents, for a total of five residences (which includes the one in question) experiencing water shortage problems since late September 1999, and two residences experiencing water quality degradation.

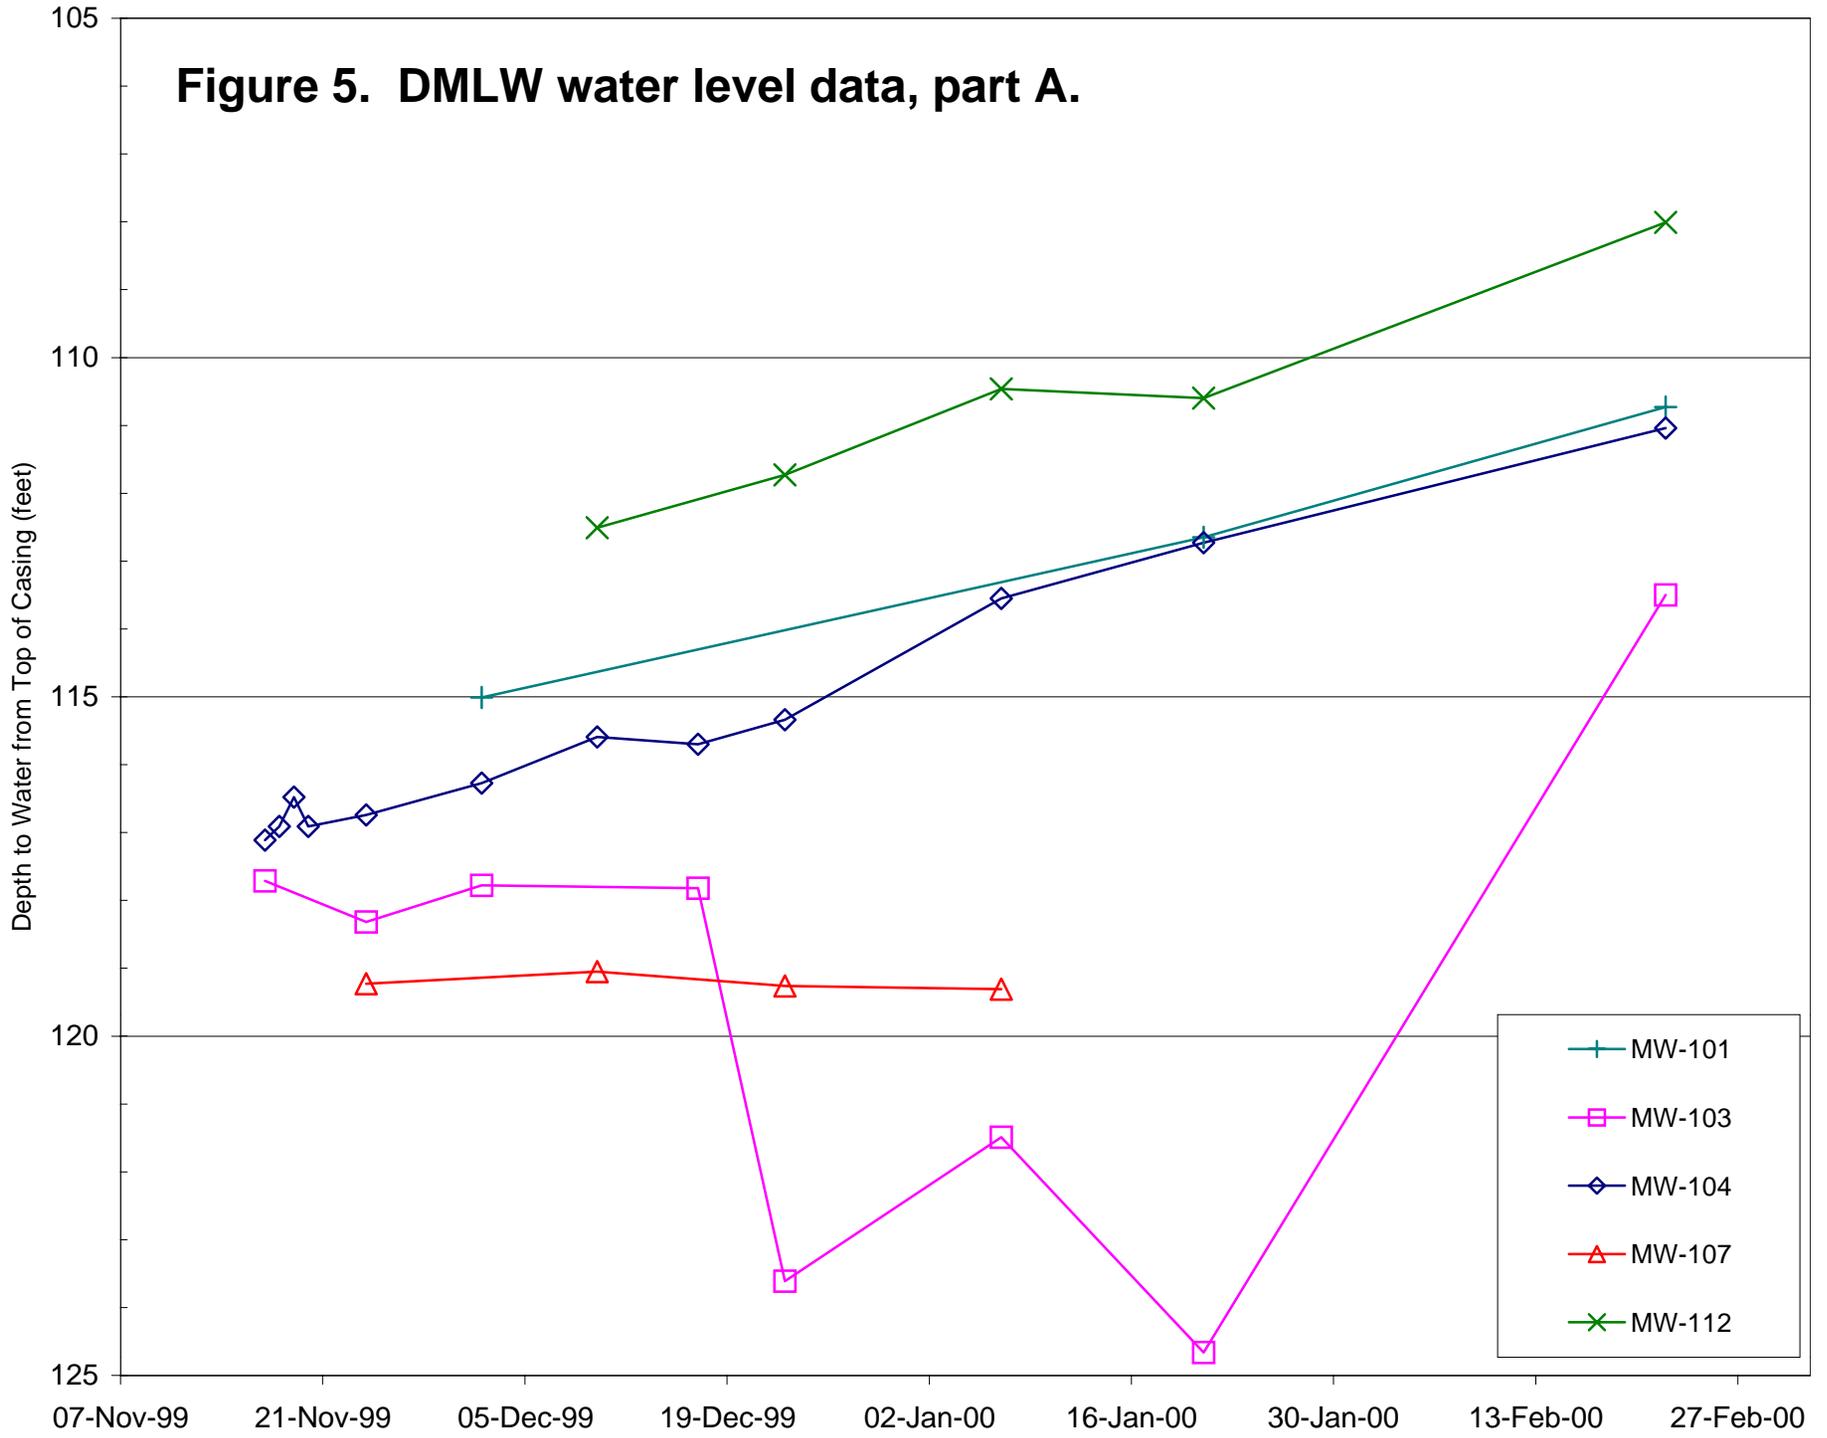
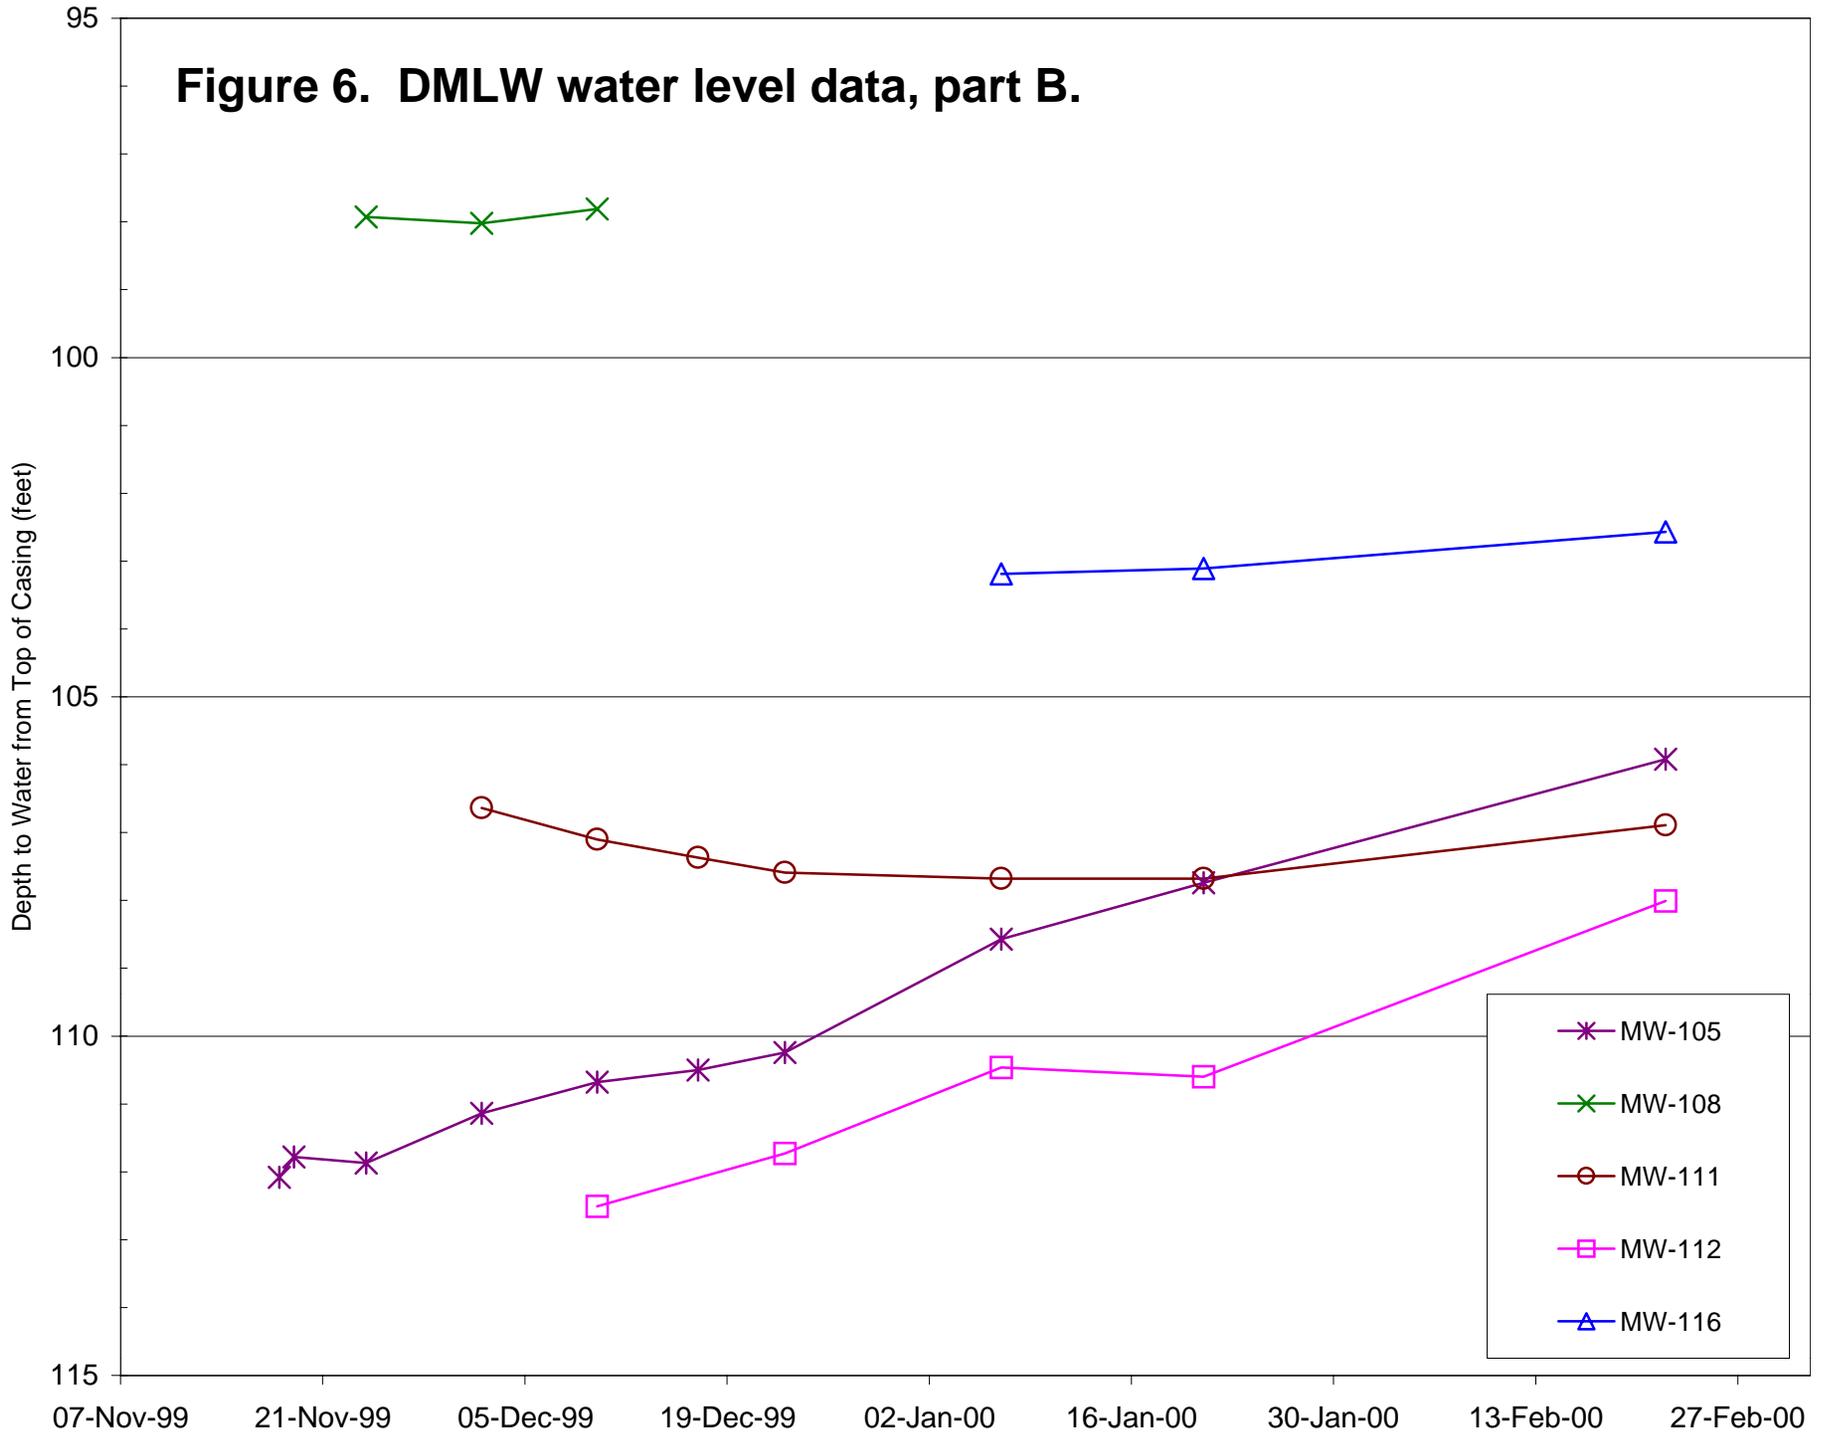
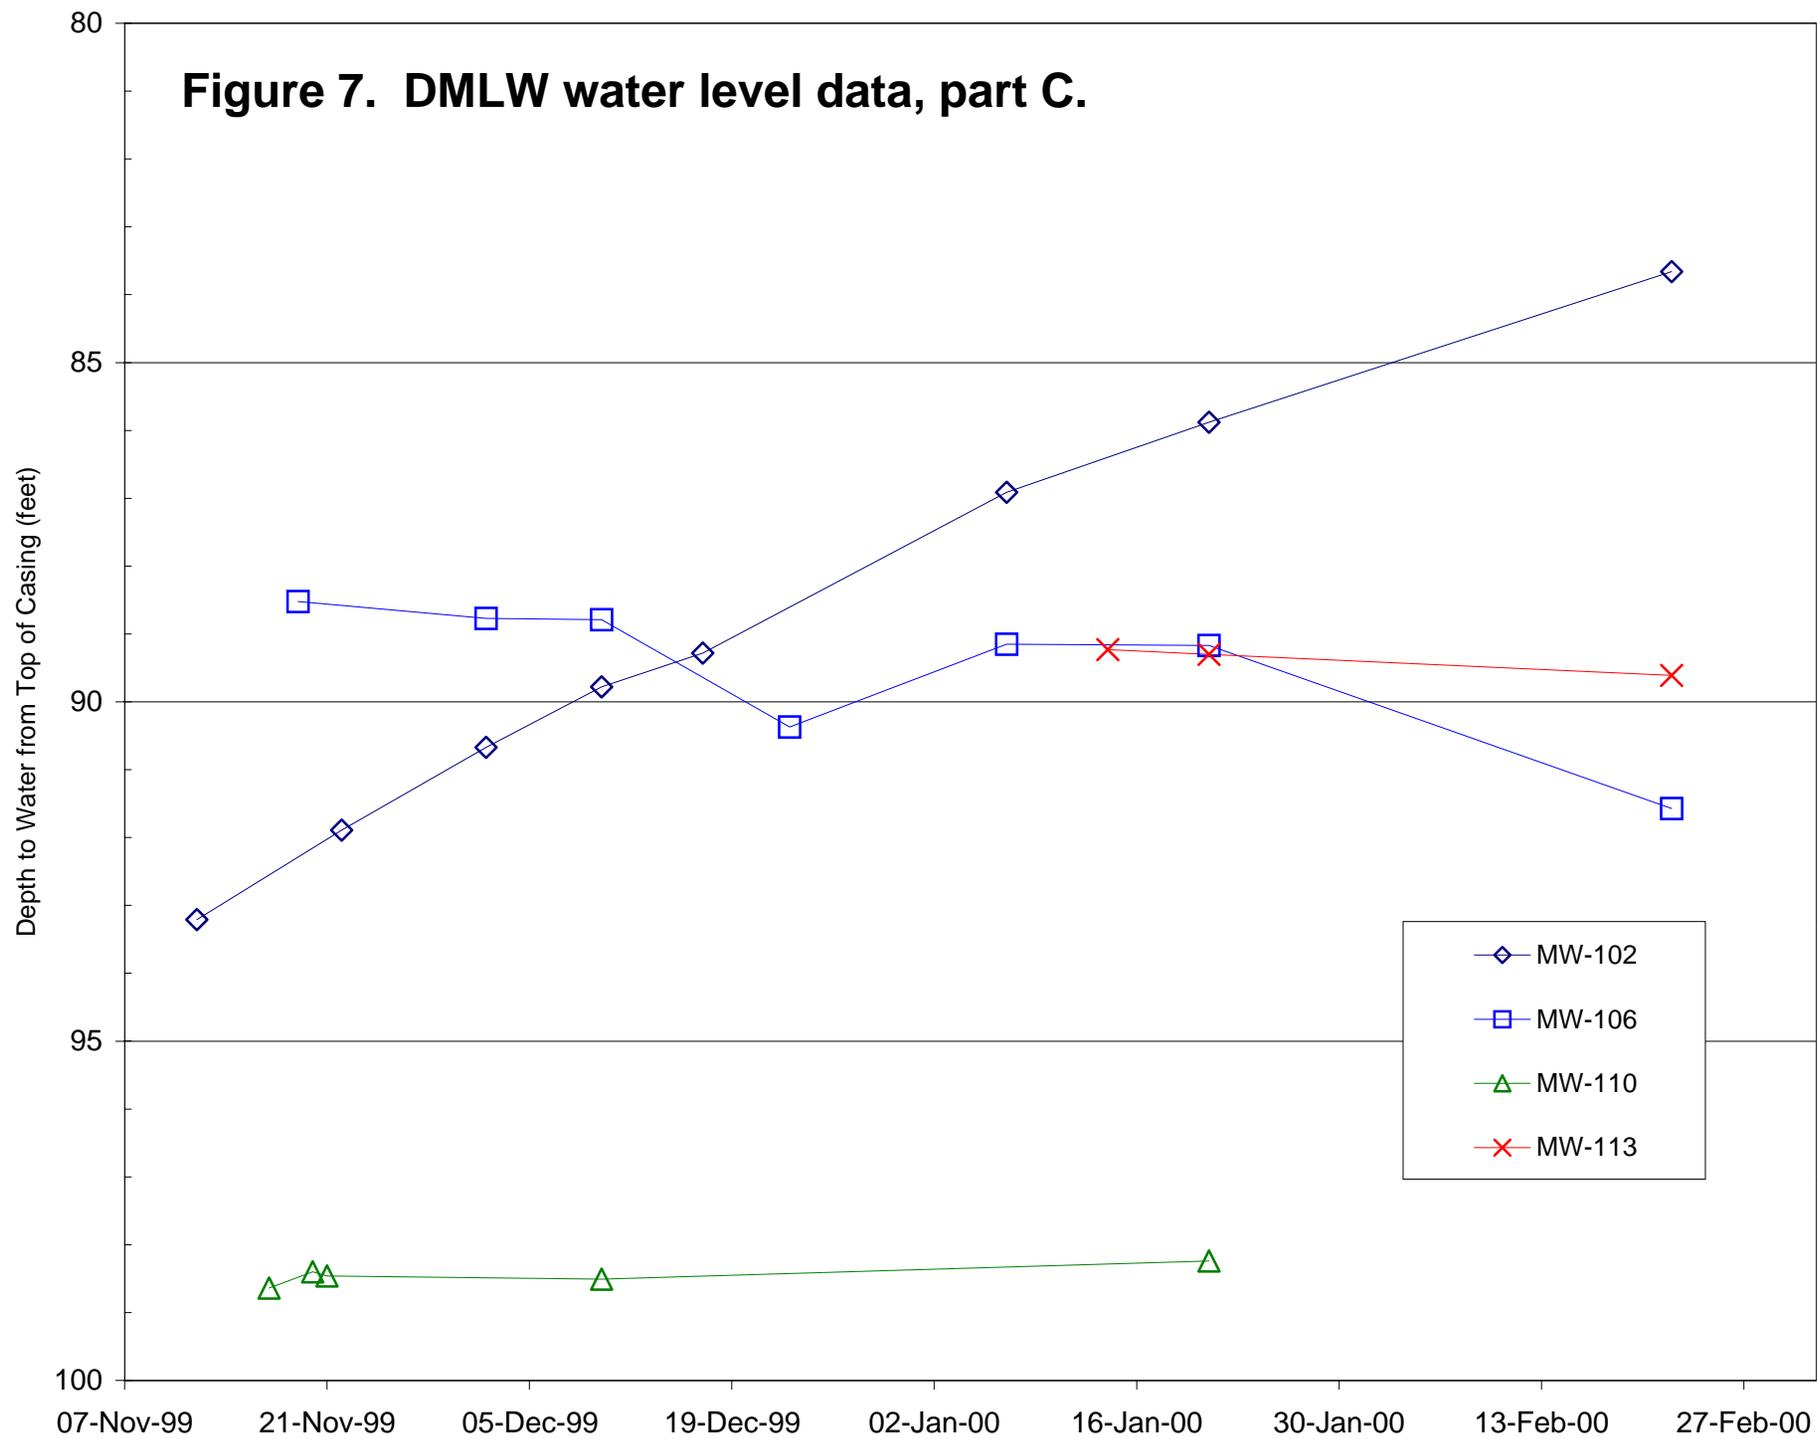
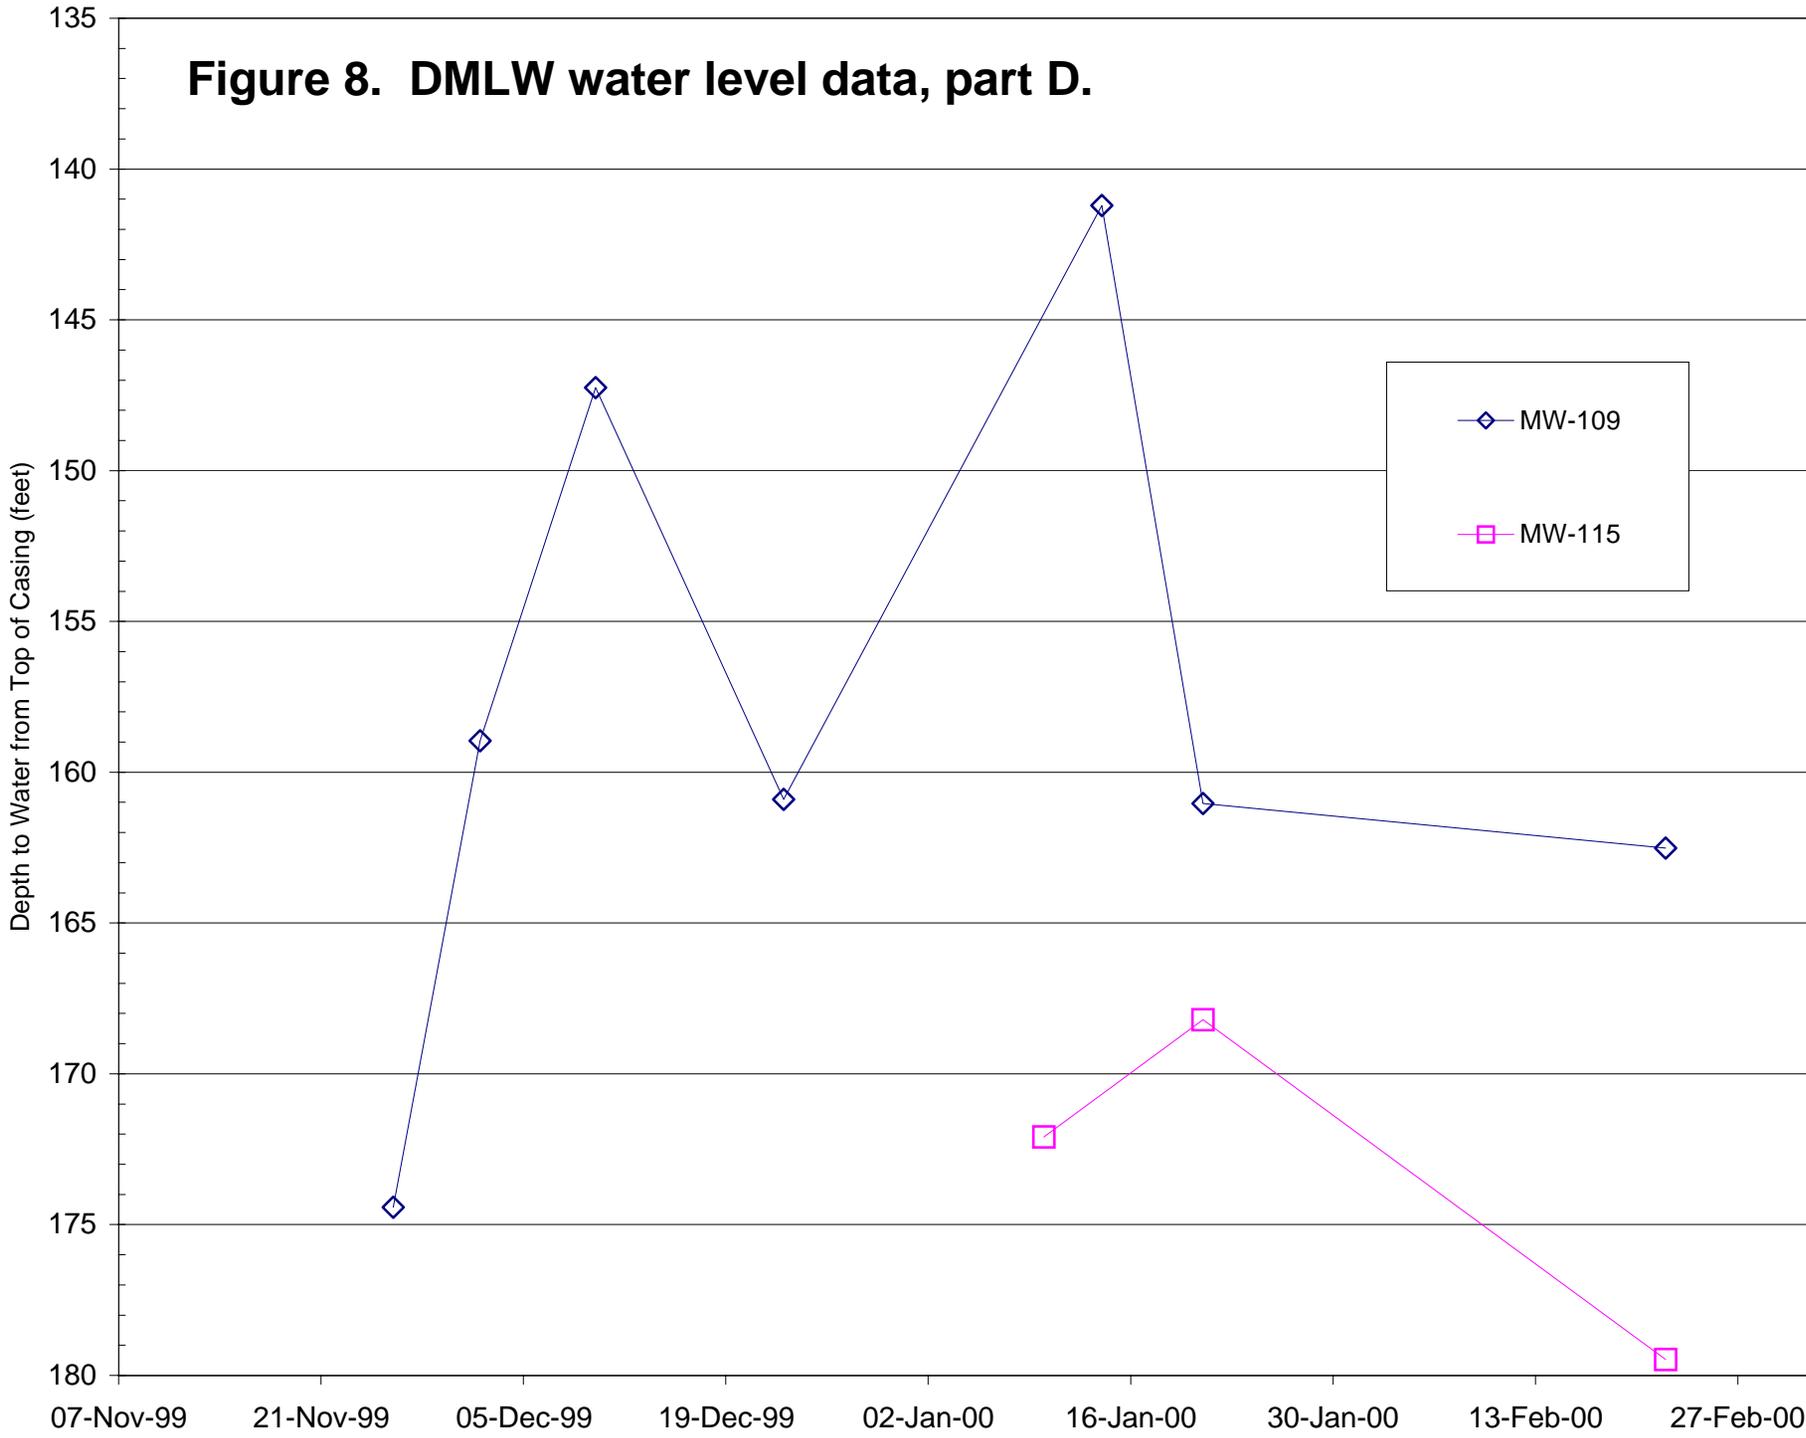
(MW-107) was added primarily in response to the concerns of the homeowner, and serves the same function as the first control site. Well hydrographs (Figures 5 through 8) indicate that the water levels had been depressed at the onset of monitoring and have been recovering for some time now to various degrees. Most recently, MW-111 and MW-116 appear to have “turned the corner” and the water levels are now increasing in elevation.

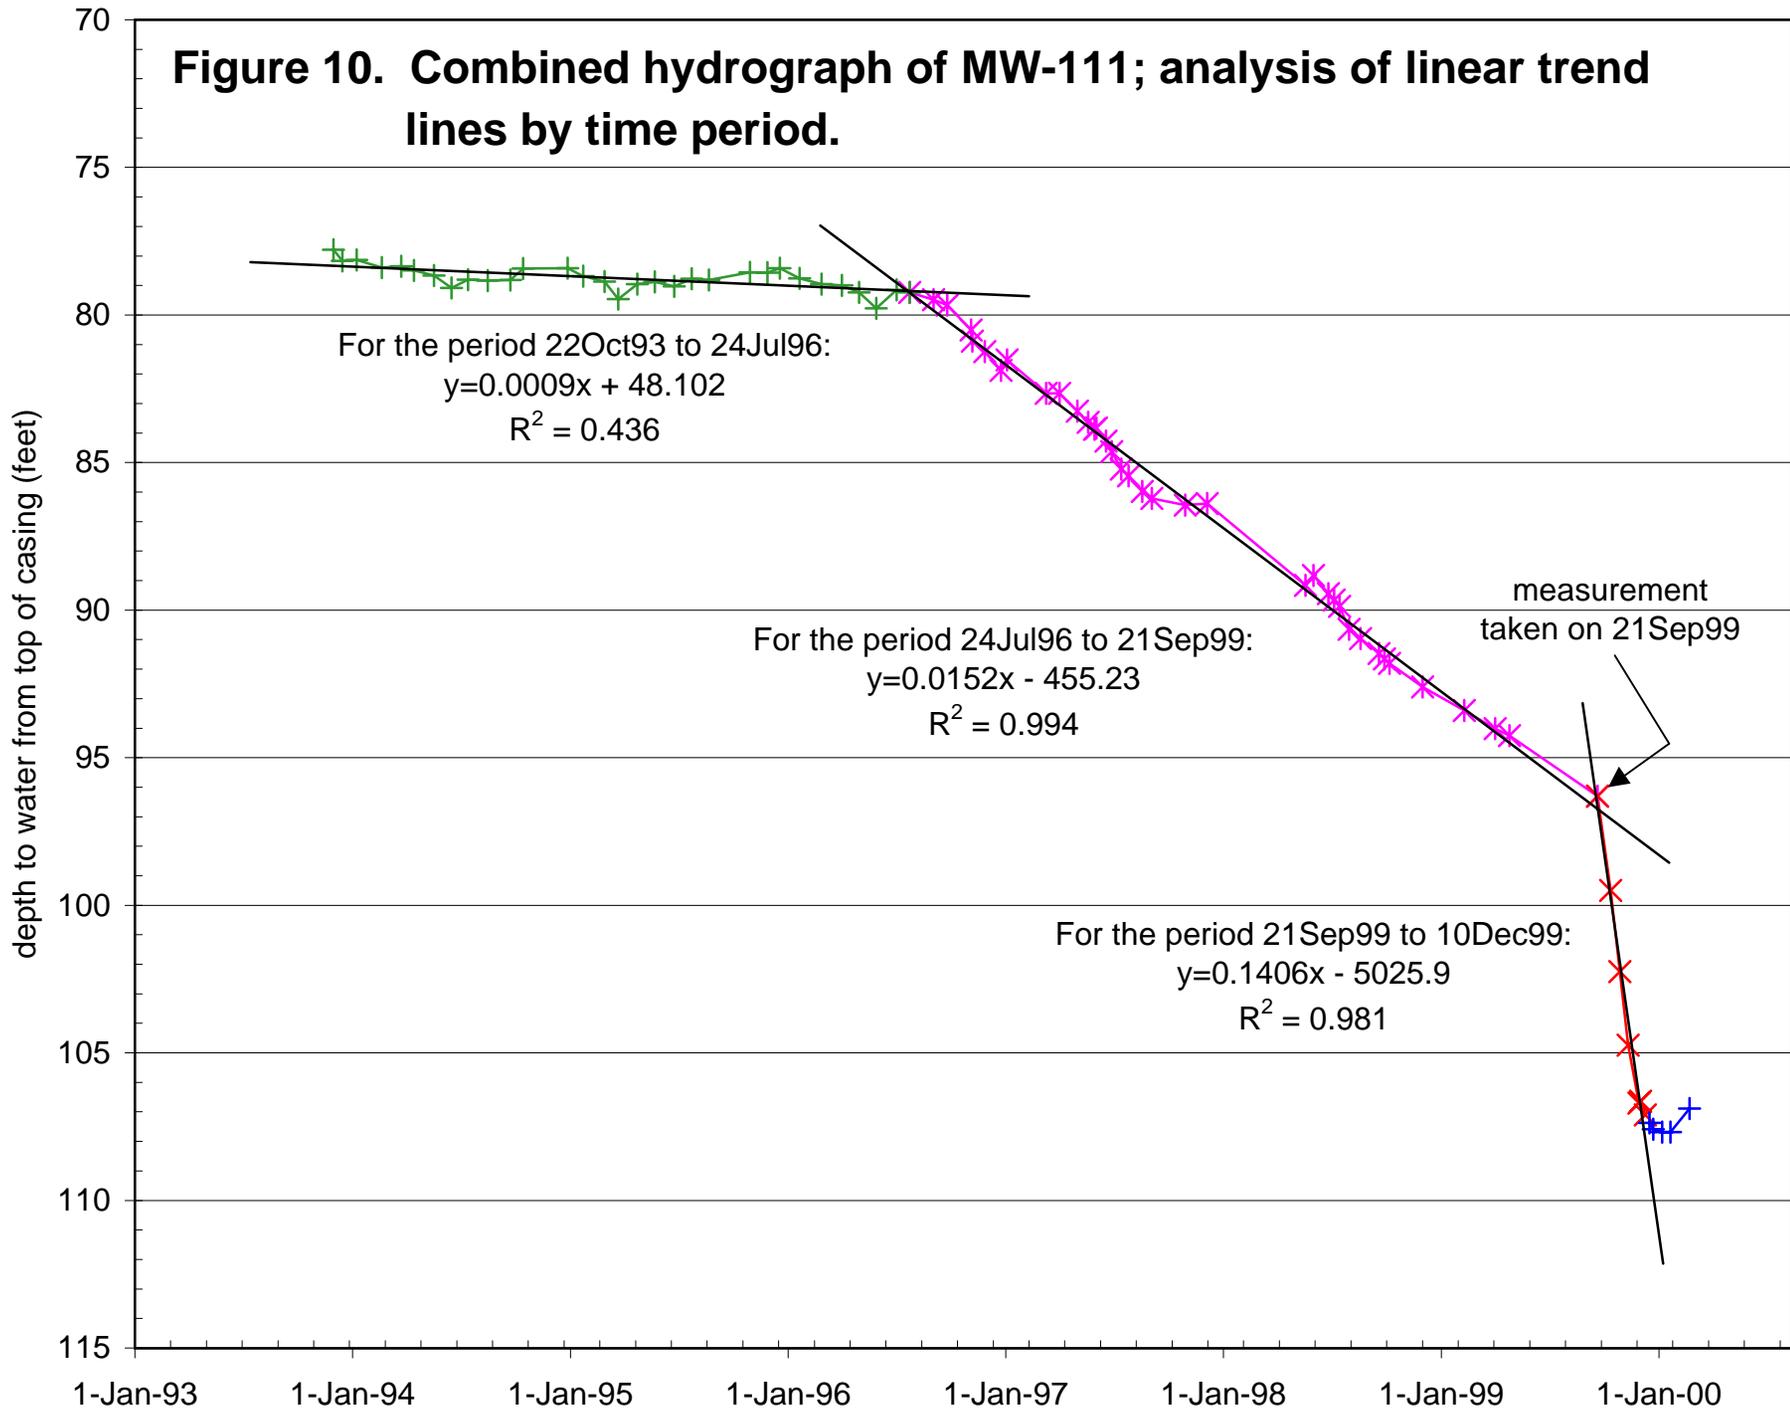
Figure 10. Combined hydrograph of MW-111; analysis of linear trend lines by time period.

Coincidentally, a fairly large body of data exists from previous efforts to monitor the groundwater table on Ester Dome, and specifically in the Goldhill Road area. This database was most recently maintained by Design Science and Engineering of Fairbanks Alaska, and was courteously shared with DMLW. One well monitored (MW-111) is located in the middle of the primarily affected area and two are located on the fringe of this area (MW-113 and MW-114). These wells have been monitored sporadically since 1993. These long term hydrographs have been serendipitously useful in describing the state of the groundwater table before, during and after the 25 September 1999 incident at Yellow Eagle (Figure 9). As seen in Figures 9 and 10, there is a marked depression in the groundwater table just following the 21 September measurement. Clearly the best-fit of the data in the individual segments of time since 1996 produce trend lines with very good correlation. Although the long term slope of the hydrograph of MW-111, for instance, prior to 25 September 1999 is declining, the significant decline beginning with the 13 October 1999 measurement indicates that there was a major change in the system, one which hadn't been observed in this long period of record. The regular monitoring of some of these historic wells is now being continued by DMLW as part of this investigation. The seasonal trends in the Fairbanks area dictate that during winter, when the ground is frozen, there is very little probability of increased groundwater recharge occurring (Table 3). However, as seen in Figures 5 through 10, there appears to be recharge in all of the primarily affected Goldhill Road area wells monitored as of 22 February 1999. Additionally, wells upgradient of the Goldhill Road area (i.e. MW-106 and MW-115) appear to be unaffected by the 1999 groundwater disturbance, in effect confirming the extent of the primarily affected area. The “control” wells demonstrate some fluctuation over the period of record, but essentially no significant trend.

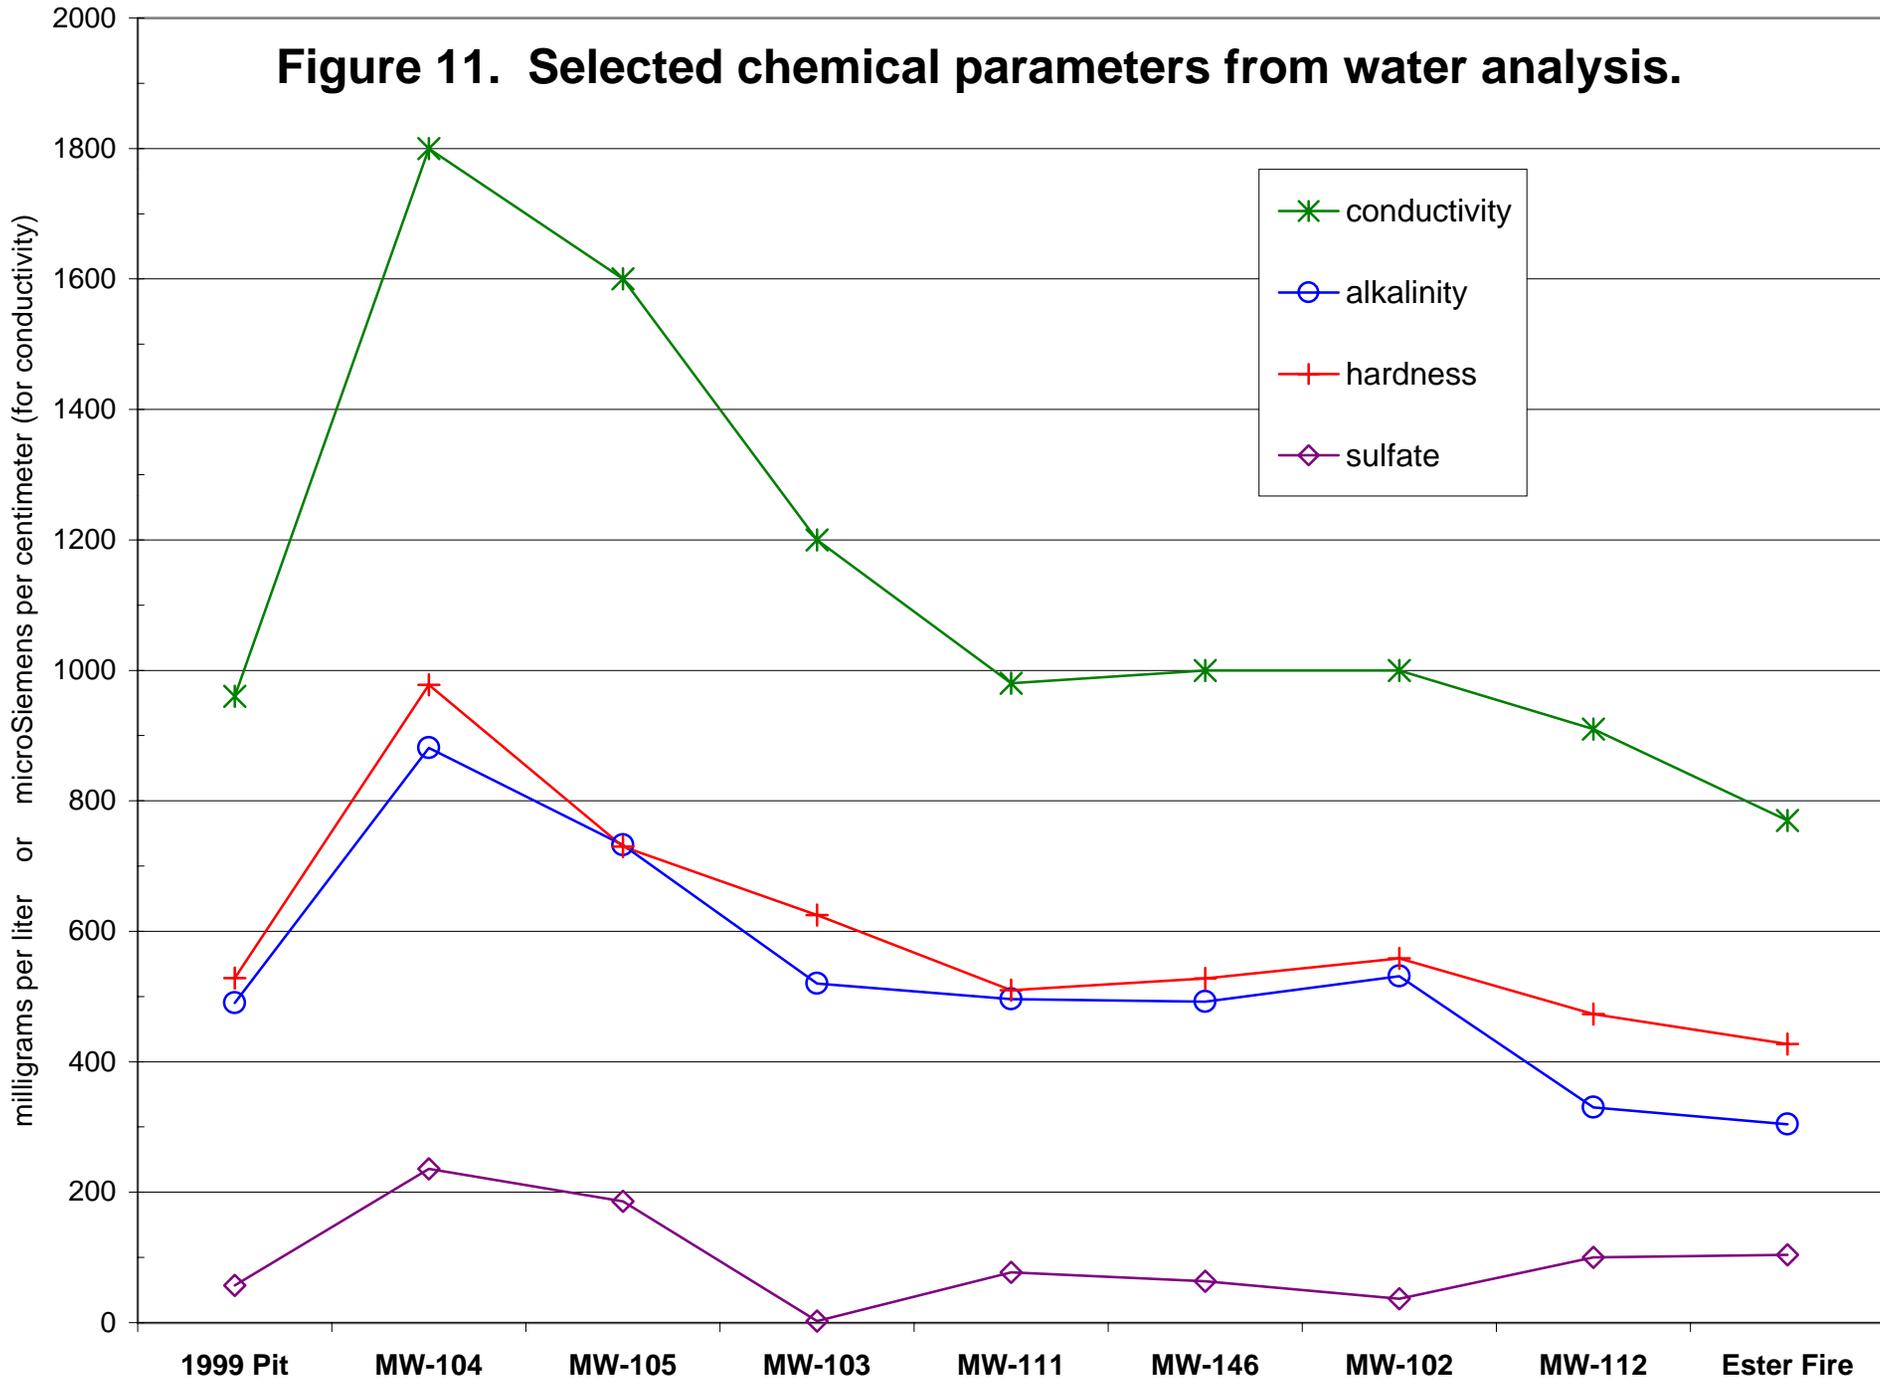
Figure 11. Selected chemical parameters from water analysis.

Analysis shows that the water of the area is principally the calcium bicarbonate type, which is typical of the Fairbanks area. Narrowing the field of view to selected analytical parameters (Figure 11), the data does not intuitively imply a relationship on its own. However, once the relative percentage of each of the major ions is plotted in a trilinear diagram (Figure 12), a relationship begins to become evident. With the exception of MW-101, all of the samples plot within the same area, indicative of similar geochemical composition. This similarity establishes two things. One, that the water flowing into the 1999 pit at Yellow Eagle is geochemically similar to water found in the domestic wells where samples were taken. Two, because the water from the well at the Ester Fire Department shows the same similarity, it can be generalized that water in the entire region will show the same similarity. Water flowing through native material in the vicinity of the Fire Department is comprised of similar ratios of major chemical constituents to that of water flowing near Goldhill Road because the native geologic material is, in a very basic sense, the same. This point is critical because it confirms that the source of water in the Yellow Eagle 1999 pit *could* be from the same source that supplies the domestic wells near Goldhill Road, and at the same time it is not conclusive evidence on its own that it is the *sole* source. One slight anomaly in the chemical analysis are the results from MW-101, which was sampled after the homeowner had the well re-drilled. The original well was finished at approximately 120' below ground surface in alluvium, the re-drilled well was completed in bedrock at 240' below ground surface. Using the trilinear diagram, it appears that water from the re-drilled well is slightly dissimilar from the other waters, indicating that it might be from a different source than the original well.

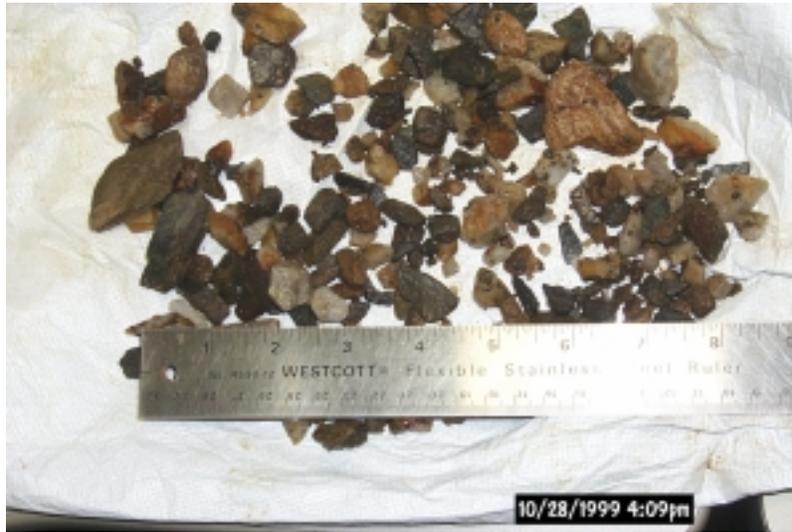
Figure 13. Material brought up during re-drilling of MW-101, from approximately 121 feet below ground surface.

drilling process was washed with clean water and contains alluvial gravels (Figure 13). Most of the wells in the Goldhill Road study area are finished at a similar depth below ground surface (although a more complete survey will confirm this); it is presumed that most of these wells are in a similar portion of the aquifer. It can be surmised that the domestic wells are completed in an ancient riverbed which is conveying water that remains perched due to the presence of a clay layer identified during the redrilling of MW-101, and described in the new well log for MW-101 (Appendix G). Similarly, the material at the bottom of the Yellow Eagle 1999 pit have been classified as “thawed and frozen gravels” by Yellow Eagle’s consulting geologist. From preliminary elevation data, it is determined that the bottom of the 1999 pit is lower in elevation than the bottom of any of the wells that experienced problems in the Goldhill Road area. The only possible exception is MW-101 after it was redrilled. Further surveying, as discussed, will confirm this.

- ◆ Material obtained during the redrilling of one of the residential wells in the Goldhill Road area appears to be alluvial gravels, consistent with those found in the 1999 pit. This supports the description of the most probable underground lithology which includes a narrow “conduit” of water bearing material both north and south of the 1999 pit, leading upgradient into the residential area and downgradient into the Dredge Pond.

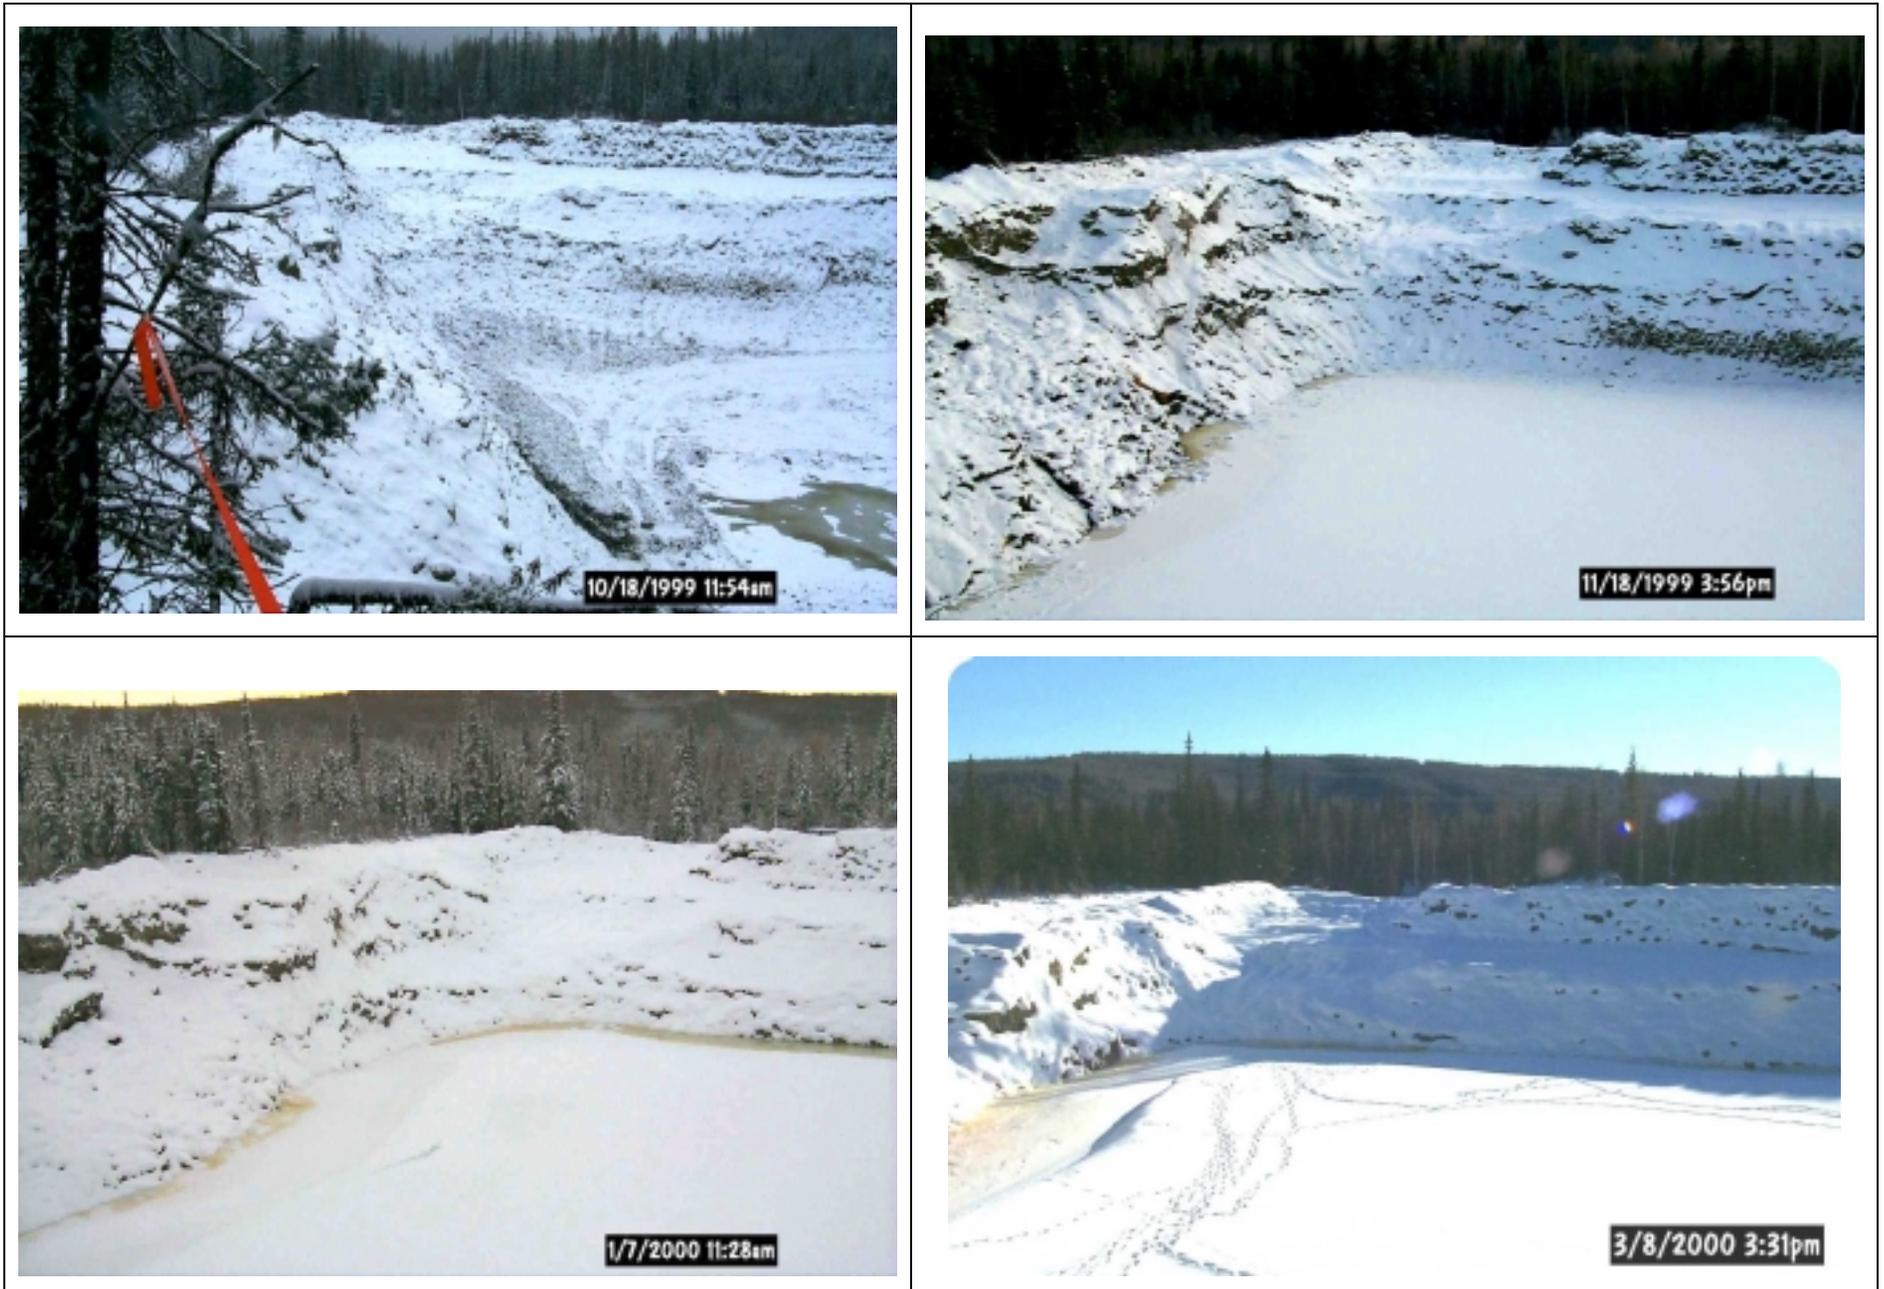
In terms of the relative height of the water in the 1999 pit, two surveys have been carried out. On 1 November 1999, the Alaska Department of Transportation surveyed the relative elevation of the water in the 1999 pit and in the Weigh Station pit. The data showed the 1999 pit was 38' lower in elevation than the Weigh Station pit. In a survey completed by DMLW on 22 February 2000, the elevation of the ice surface in the 1999 pit was approximately 19 feet below the elevation of ice in the Weigh Station pit. Given that the elevation of the water in the Weigh Station pit appears to have risen slightly since the previous survey, the difference between the two pits is diminishing. As there are no known geologic structures between the two pits to account for a difference in the water elevations, it is surmised that the water levels in the two pits will equilibrate in time. During the course of work on 22 February, DMLW staff confirmed that the apparent inflow of slightly warmer groundwater into the 1999 pit has caused slushy conditions around the entire perimeter of the body of water, preventing safe access to the ice surface.

Figure 14. Photos of 1999 pit taken from top of north face, looking towards the southeast corner of the pit; note rise in water level over time and wetness around perimeter of pit.
