ASSESSMENT OF GEOMORPHOLOGY AND GEOLOGIC HAZARDS IN THE PARKS HIGHWAY-MINTO FLATS-DALTON HIGHWAY INFRASTRUCTURE CORRIDOR: COOK INLET TO PRUDHOE BAY, ALASKA

Report of Investigation 2019-8

Published by
STATE OF ALASKA
DEPARTMENT OF NATURAL RESOURCES
DIVISION OF GEOLOGICAL & GEOPHYSICAL SURVEYS
2019

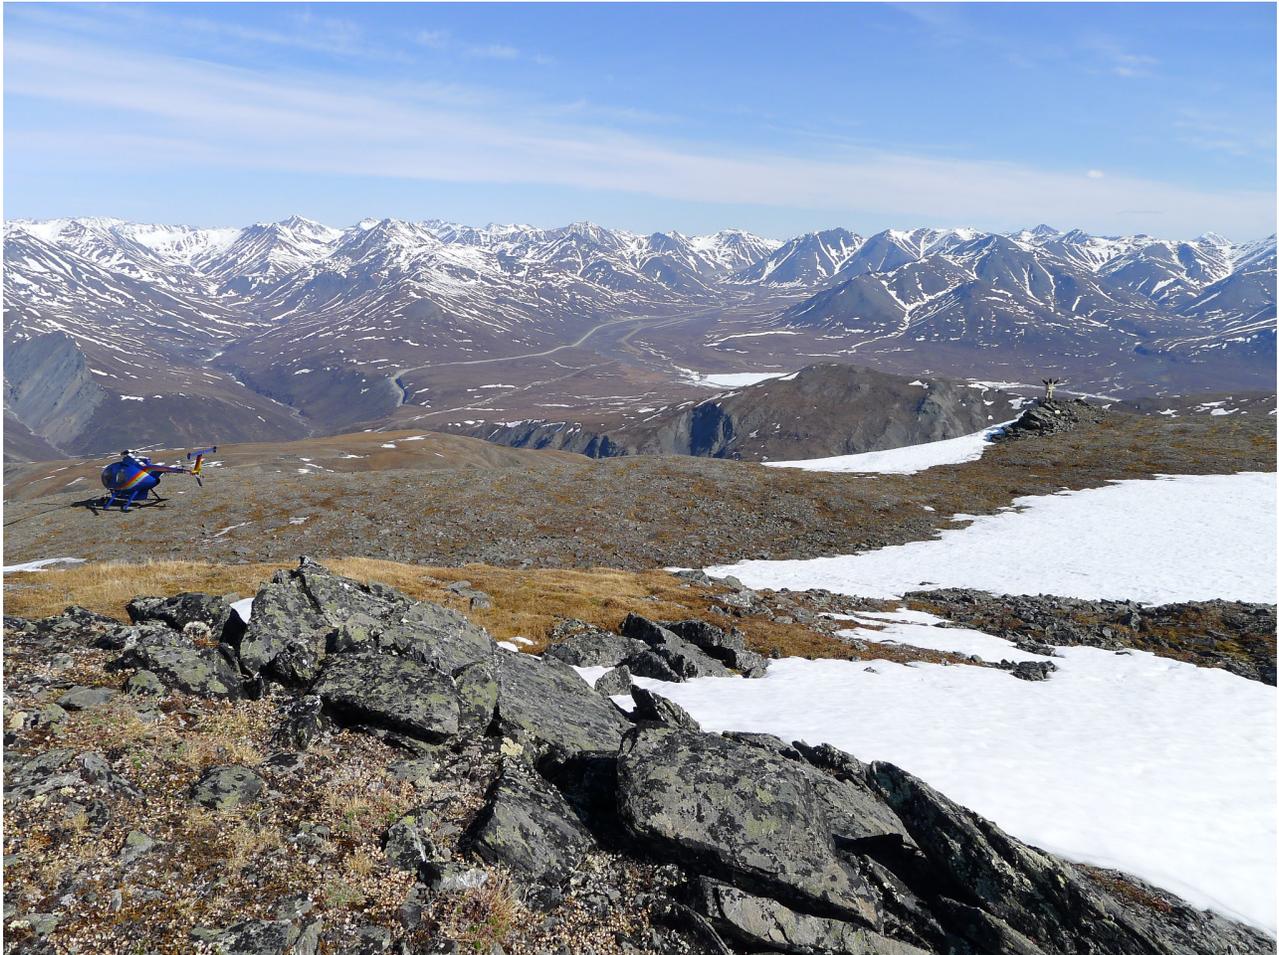
Cover. View of Chandalar Shelf and Atigun Pass from Table Mountain. Steep slopes and frost-shattered bedrock contribute to high debris-flow, slush-flow, and avalanche hazards along this section of the Dalton Highway and Trans-Alaska Pipeline System. Photo by Rich Koehler.

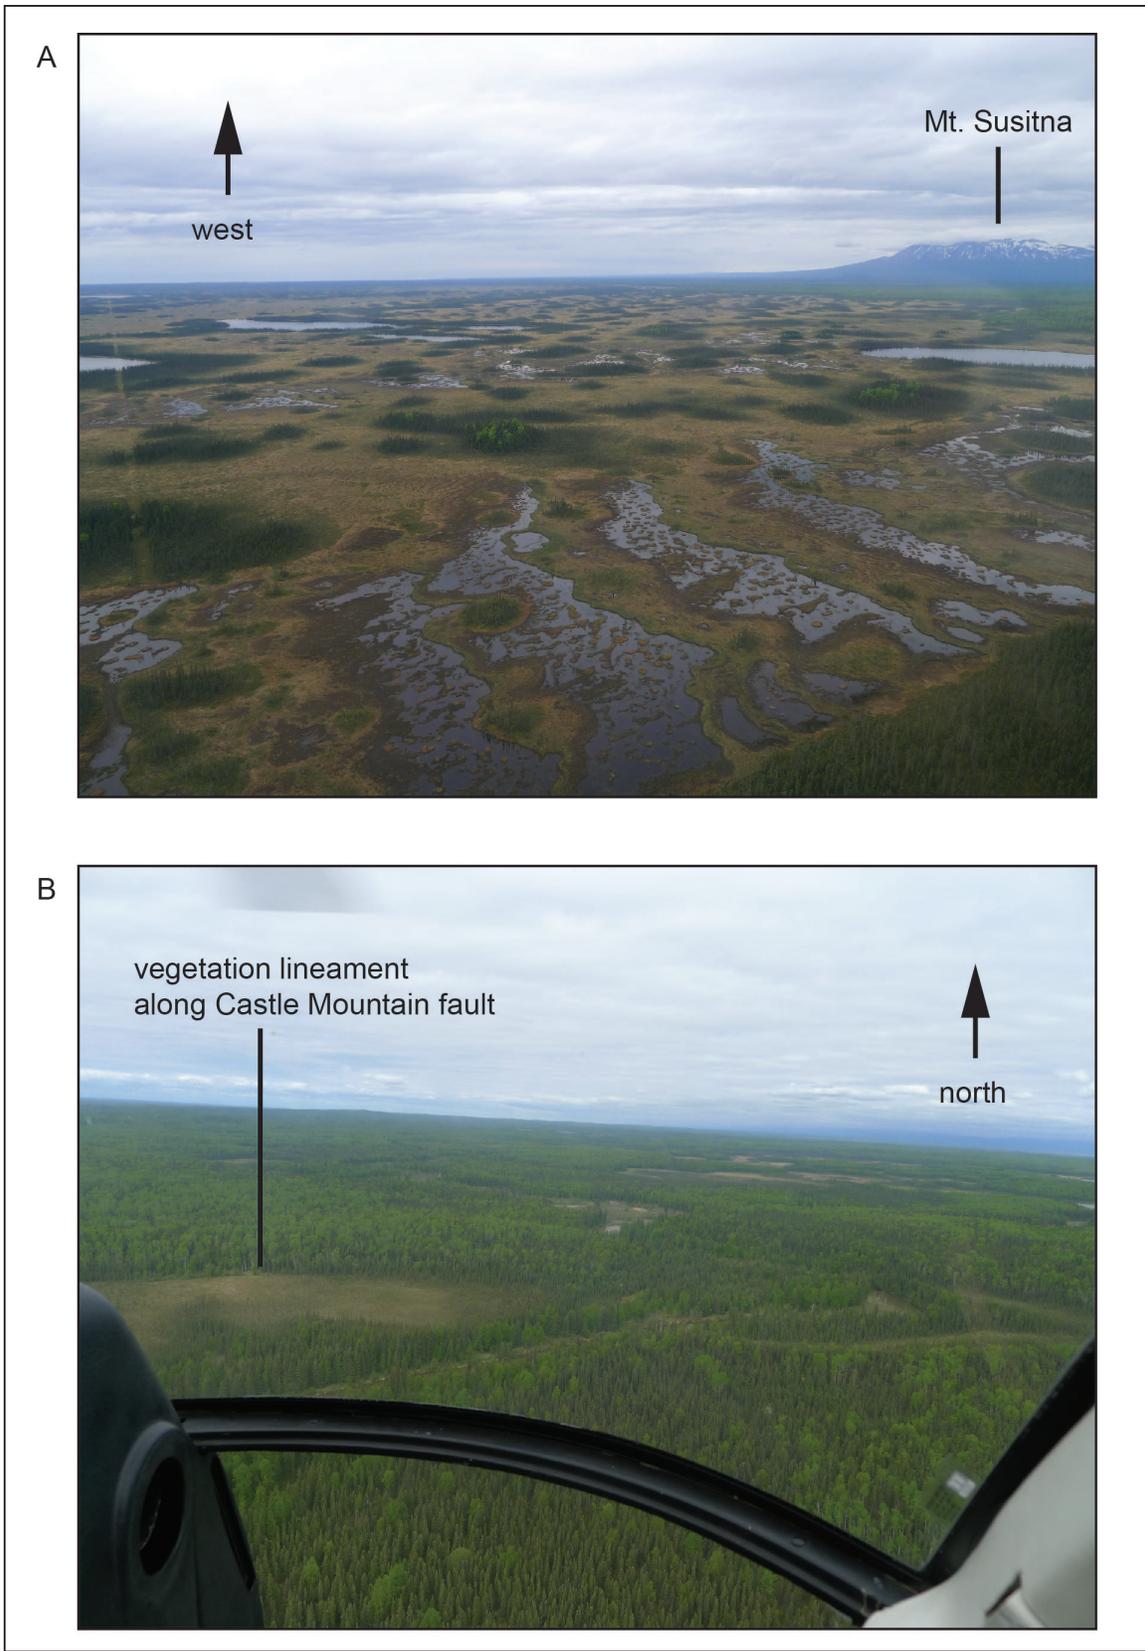
Figure 3. A. Westward view of small lake and sand dune complexes near the southern end of the corridor. **B.** View to the north, showing subtle vegetation lineament along the Castle Mountain fault.

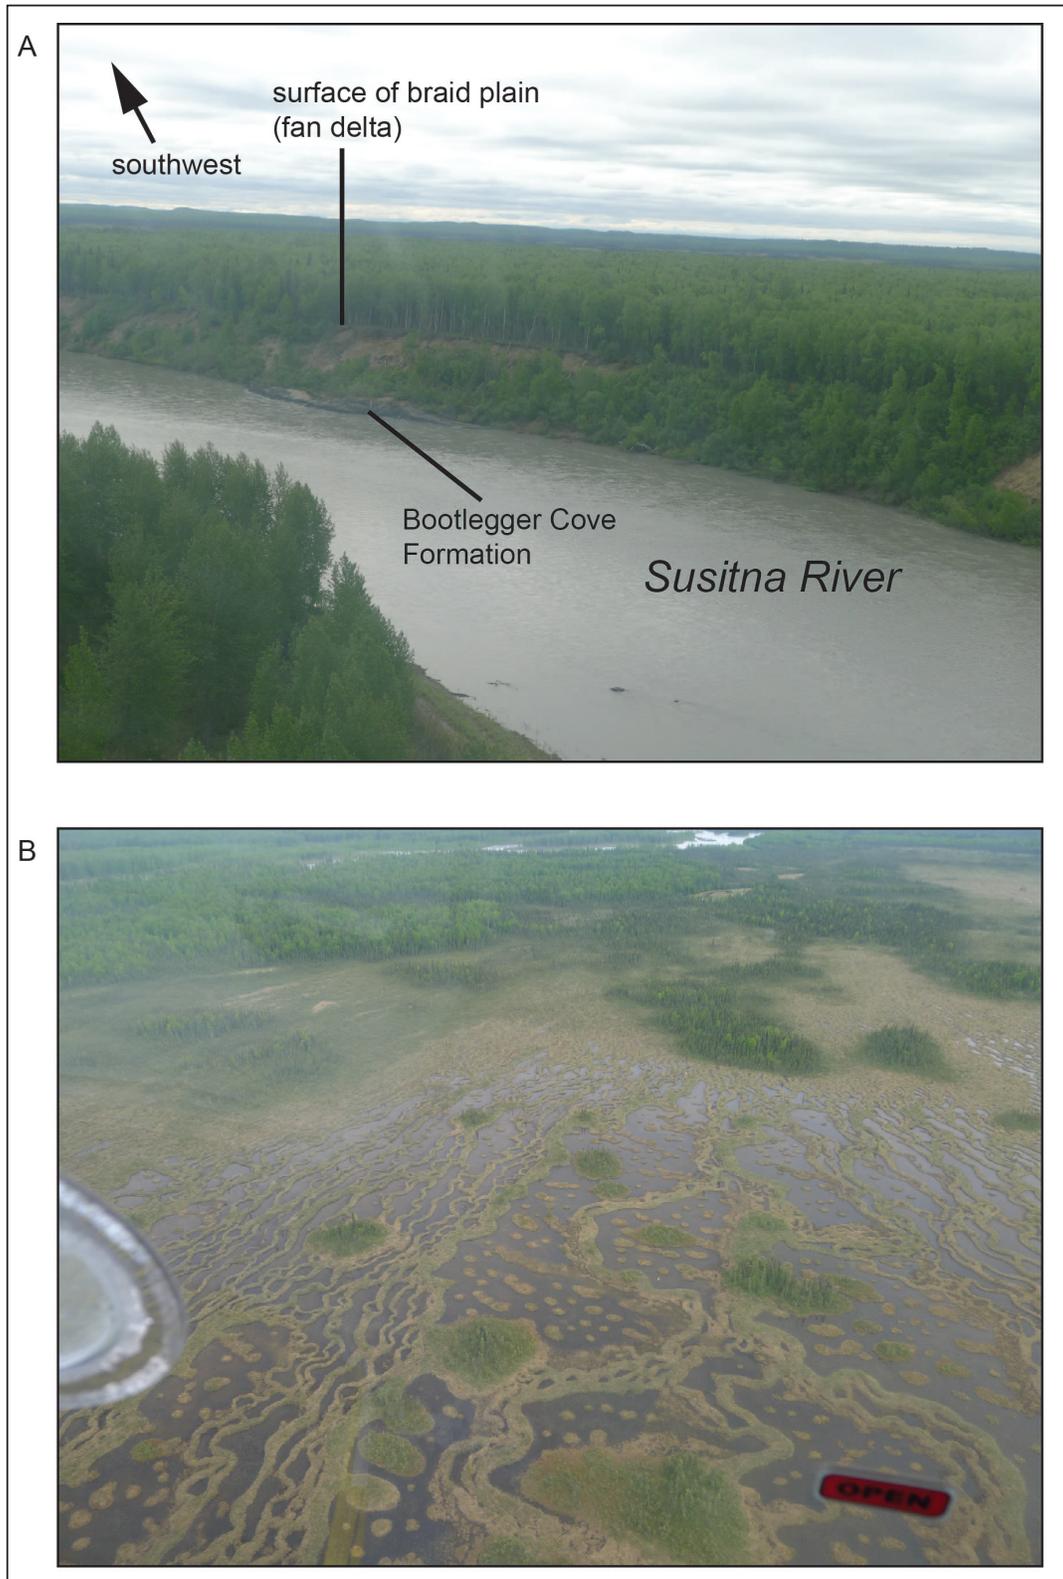
Figure 4. A. Surface of the sandy glaciomarine braid plain (fan delta) along the west bank of the Susitna River. The Bootlegger Cove Formation is exposed at the base of the bluffs (dark gray band). The sand plain extends between the Susitna River on the west and the Elmendorf terminal moraine on the east. **B.** Aerial photograph showing string bogs and vegetated sand dunes along the corridor surface between the Susitna River and the Elmendorf moraine. Red and black "OPEN" label in bottom right corner is attached to the helicopter window and is not meant to draw attention to any particular feature in the photo.

potential flooding of the Susitna River across the meander floodplain surface could possibly erode and undermine the high terrace scarp. This process could result in bank failure or large landslides, potentially undermining infrastructure elements along the top of the terrace riser. We recommend that future infrastructure developers conduct additional site-specific studies at these locations to determine the potential for erosion and/or flood damage. Except for these sites, the majority of the corridor is relatively protected from flooding and erosion hazards by either being an adequate distance (> 1 mi) from the eastern bank of the Susitna River or because of protection provided by being on top of high scarps cut into the outwash terraces (> 65 ft [> 20 m] tall).

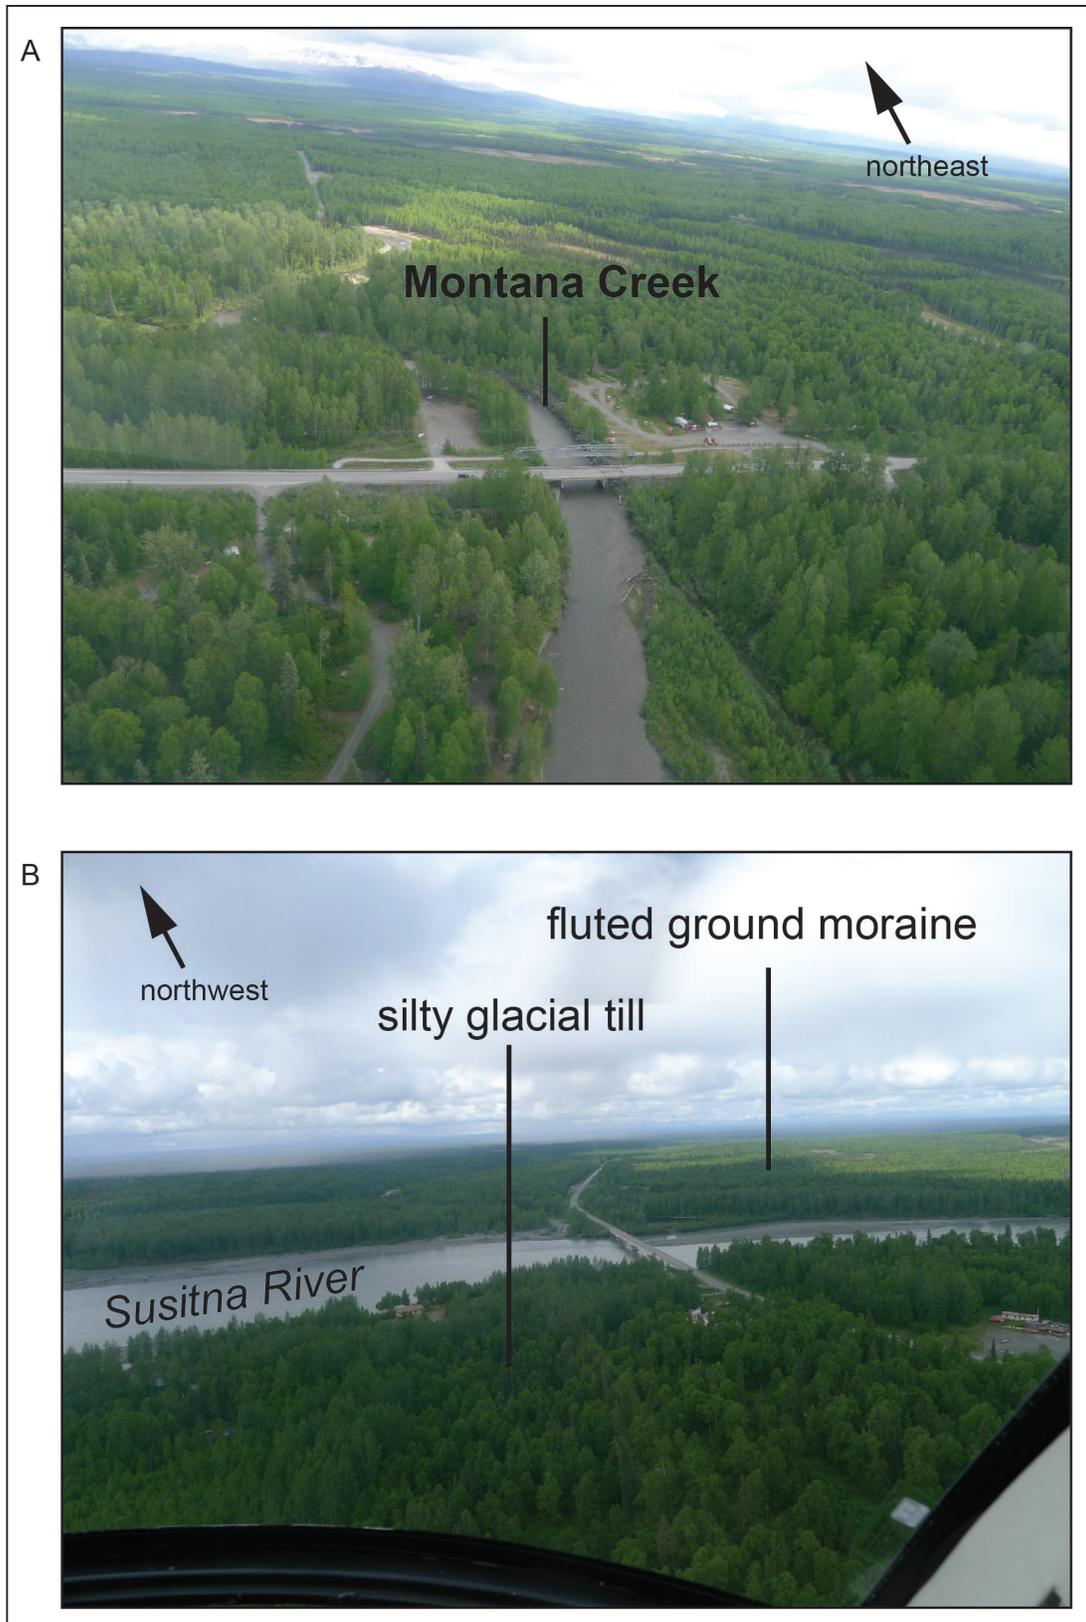
Figure 5. **A.** View to northeast across the Parks Highway bridge, showing channel of Montana Creek incised into hummocky till and outwash alluvium. **B.** View to northwest of the Parks Highway bridge over the Susitna River. The southeast bank of the river consists of silty till.

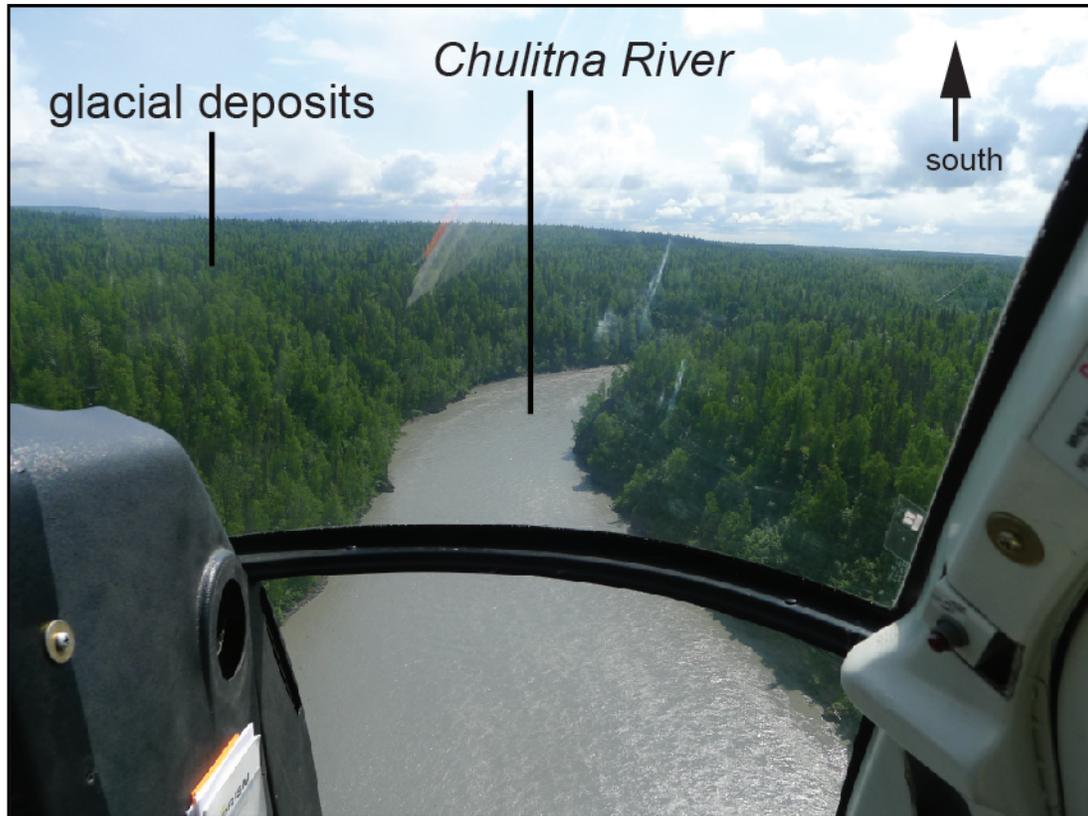
Figure 7. View to the south of the Chulitna River gorge, which is deeply incised through till, glaciolacustrine, and kame terrace deposits. Bedrock is exposed on the lower slopes of the gorge.

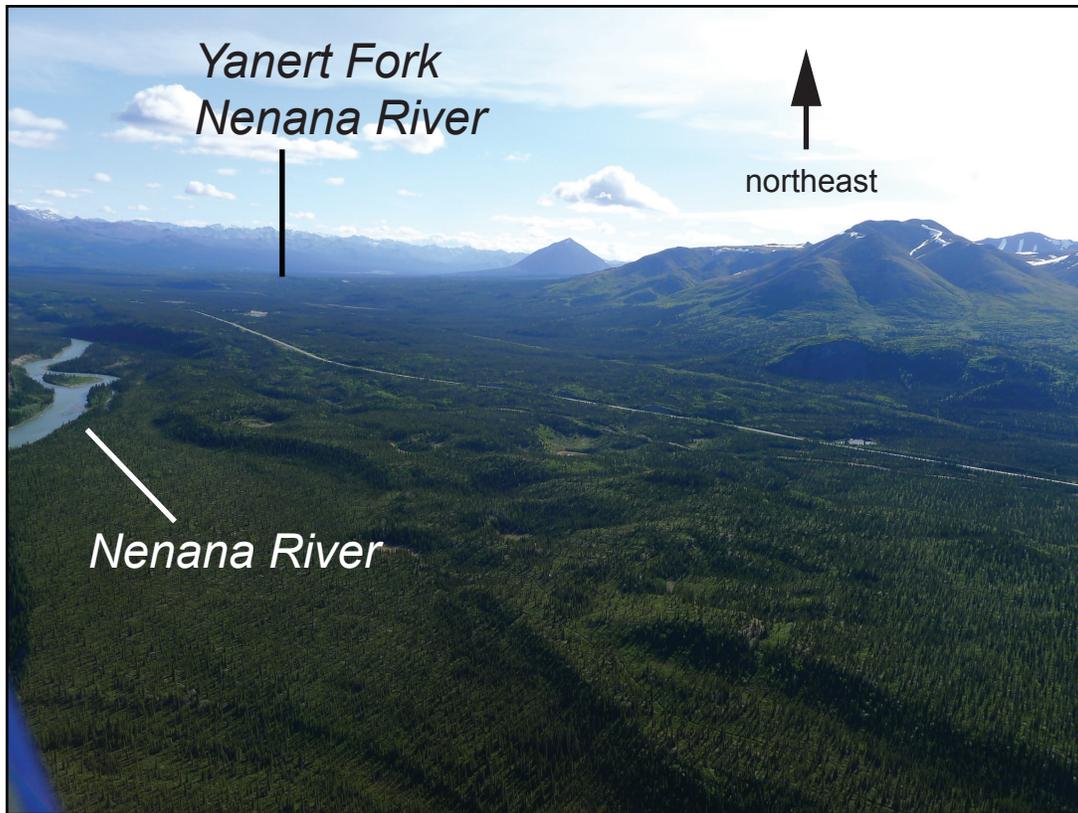
Creek glaciation (fig. 9). In places the till is thin with bedrock exposed west of the corridor along the Nenana River. Buried frozen, ice-rich deposits of a former ice-dammed meltwater lake cause chronic local subsidence problems in this till along the Parks Highway north of McKinley Village.

Figure 9. View to the northeast, showing irregular knob-and-kettle topography that has developed on sandy, granular till of the Riley Creek glaciation south of the Yanert Fork Nenana River. Fluvial terraces of the Nenana River can be seen on the east bank of the river (lower left of photograph).

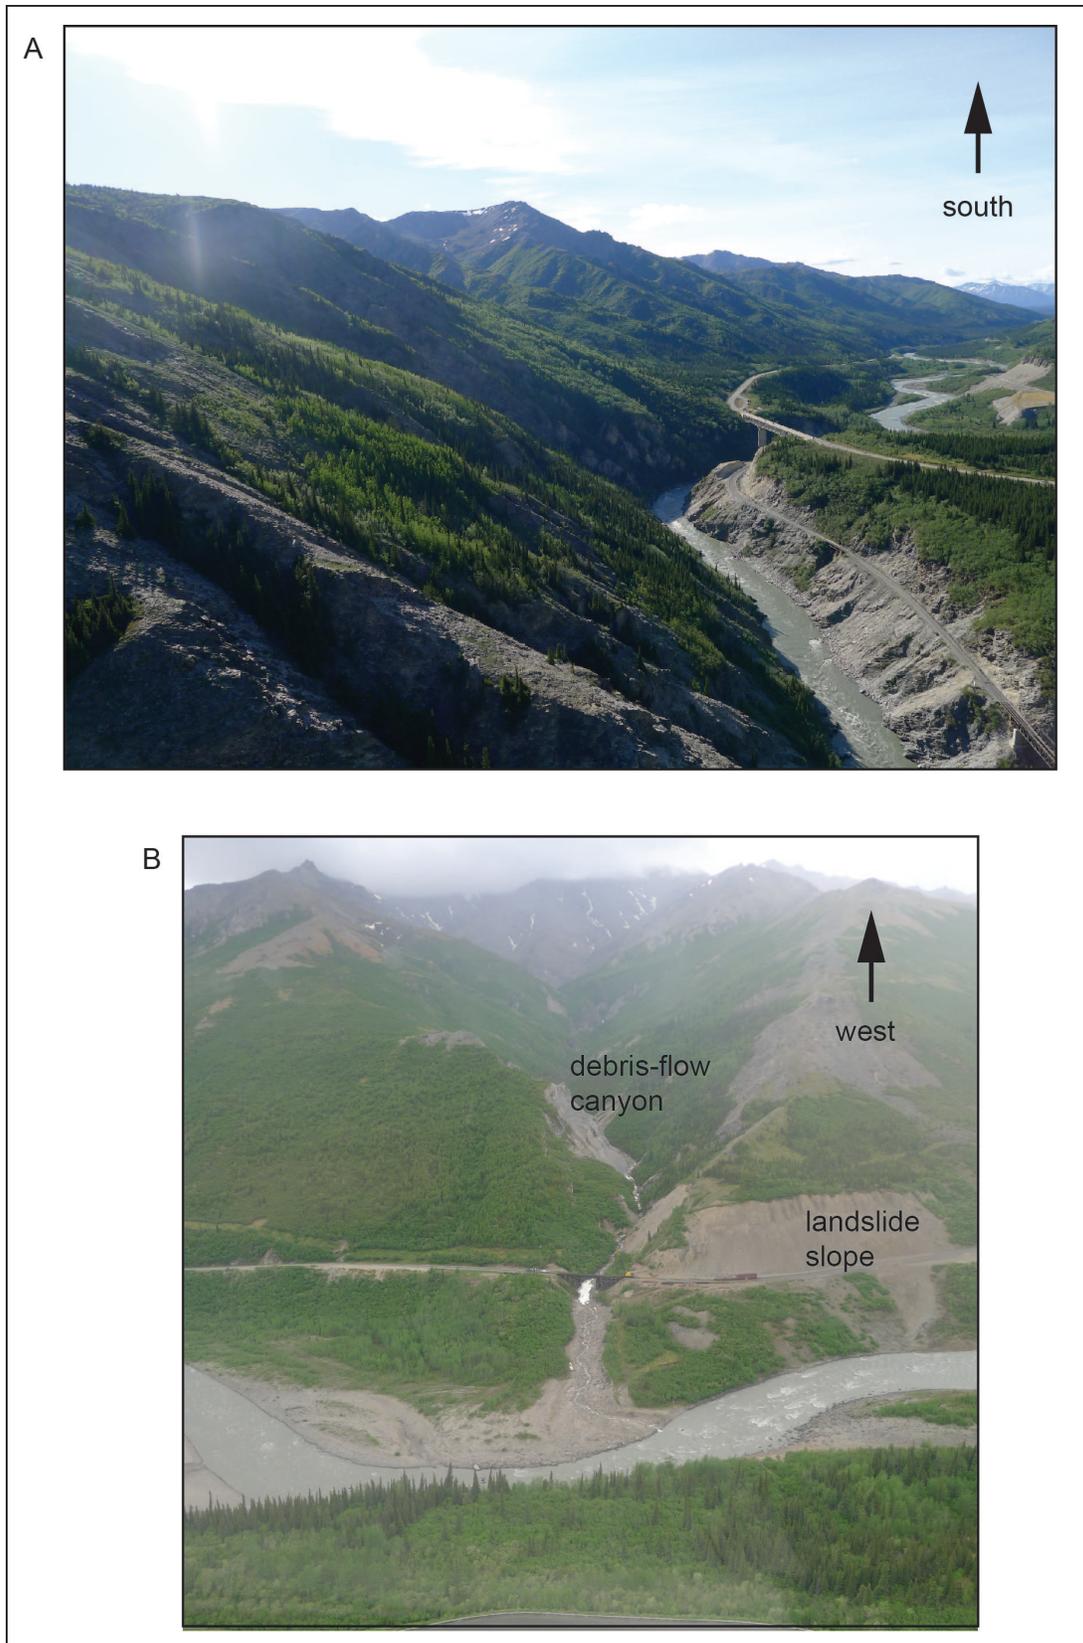
In the Healy D-4 Quadrangle the corridor continues north–northwest along the Nenana River gorge to the vicinity of the town of Healy (fig. 10). Between Junco Creek and Iceworm Gulch, the corridor crosses the crown of a chronic landslide zone in shattered and decomposed schist bedrock associated with basalt dikes in the steep eastern wall of the Nenana Gorge. Just north of Hornet Creek the corridor traverses fine-grained sediments deposited in a lake dammed behind the massive Healy-age terminal moraine at mouth of the gorge (Wahrhaftig, 1958, pl. 2). These wet, clayey sediments have caused numerous landslides along the Alaska Railroad in the Nenana River gorge (Wahrhaftig and Black, 1958). Except for short stretches crossing granular alluvial fans and granular outwash terraces, most of the next 1.8 mi to the crossing of the Nenana River traverses steep sideslopes of schistose bedrock. Rock avalanches

Figure 10. Photographs of the Nenana River gorge. **A.** Steep eastern wall of the gorge near the Parks Highway bridge. **B.** Western wall of the gorge along the Alaska Railroad, showing active debris-flow canyons and landsliding.

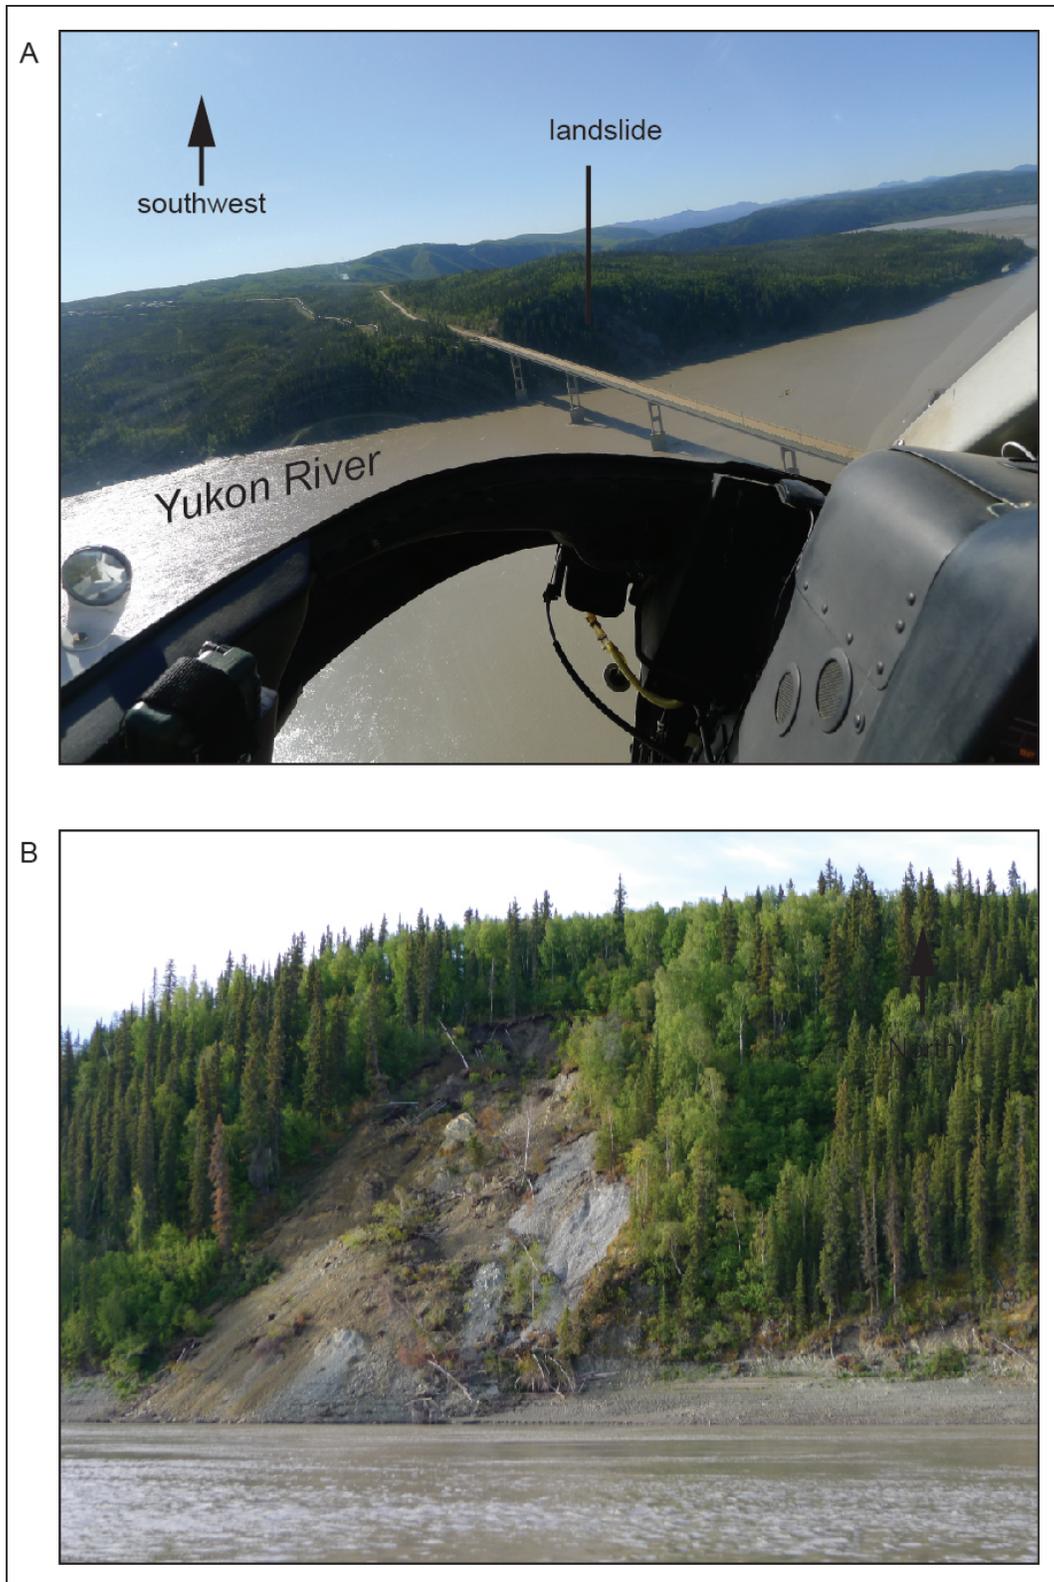
Figure 17. A. View toward southwest of southern bluff of the Yukon River. Hills slope gently to the north to the crest of the bluff and exhibit yedoma, gullies, and landslide headscarps. **B.** View of the 2012 landslide directly west of the Yukon River bridge. Location of slide is shown in A.

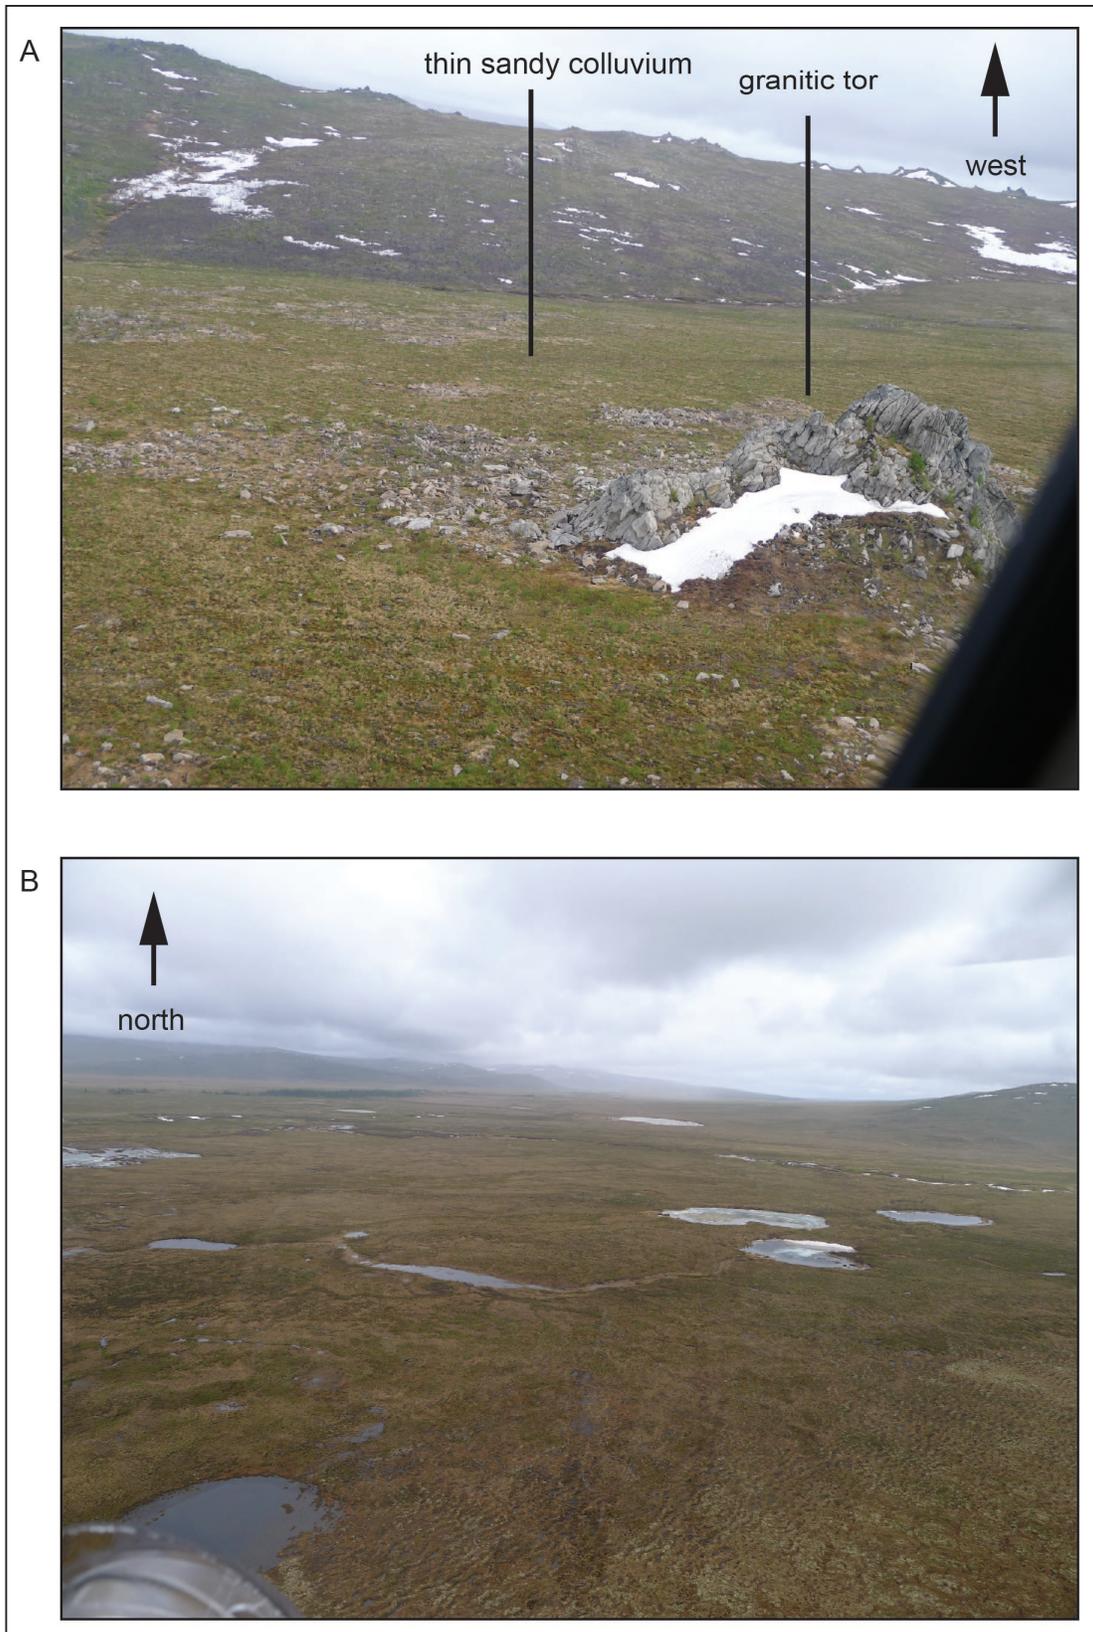
Figure 20. A. Photograph showing residual outcrops, which are common along bedrock slopes mantled by sandy colluvium directly south of Olsons Lake basin. **B.** View of Olsons Lake basin, which is characterized by thaw lakes and polygonal ground.

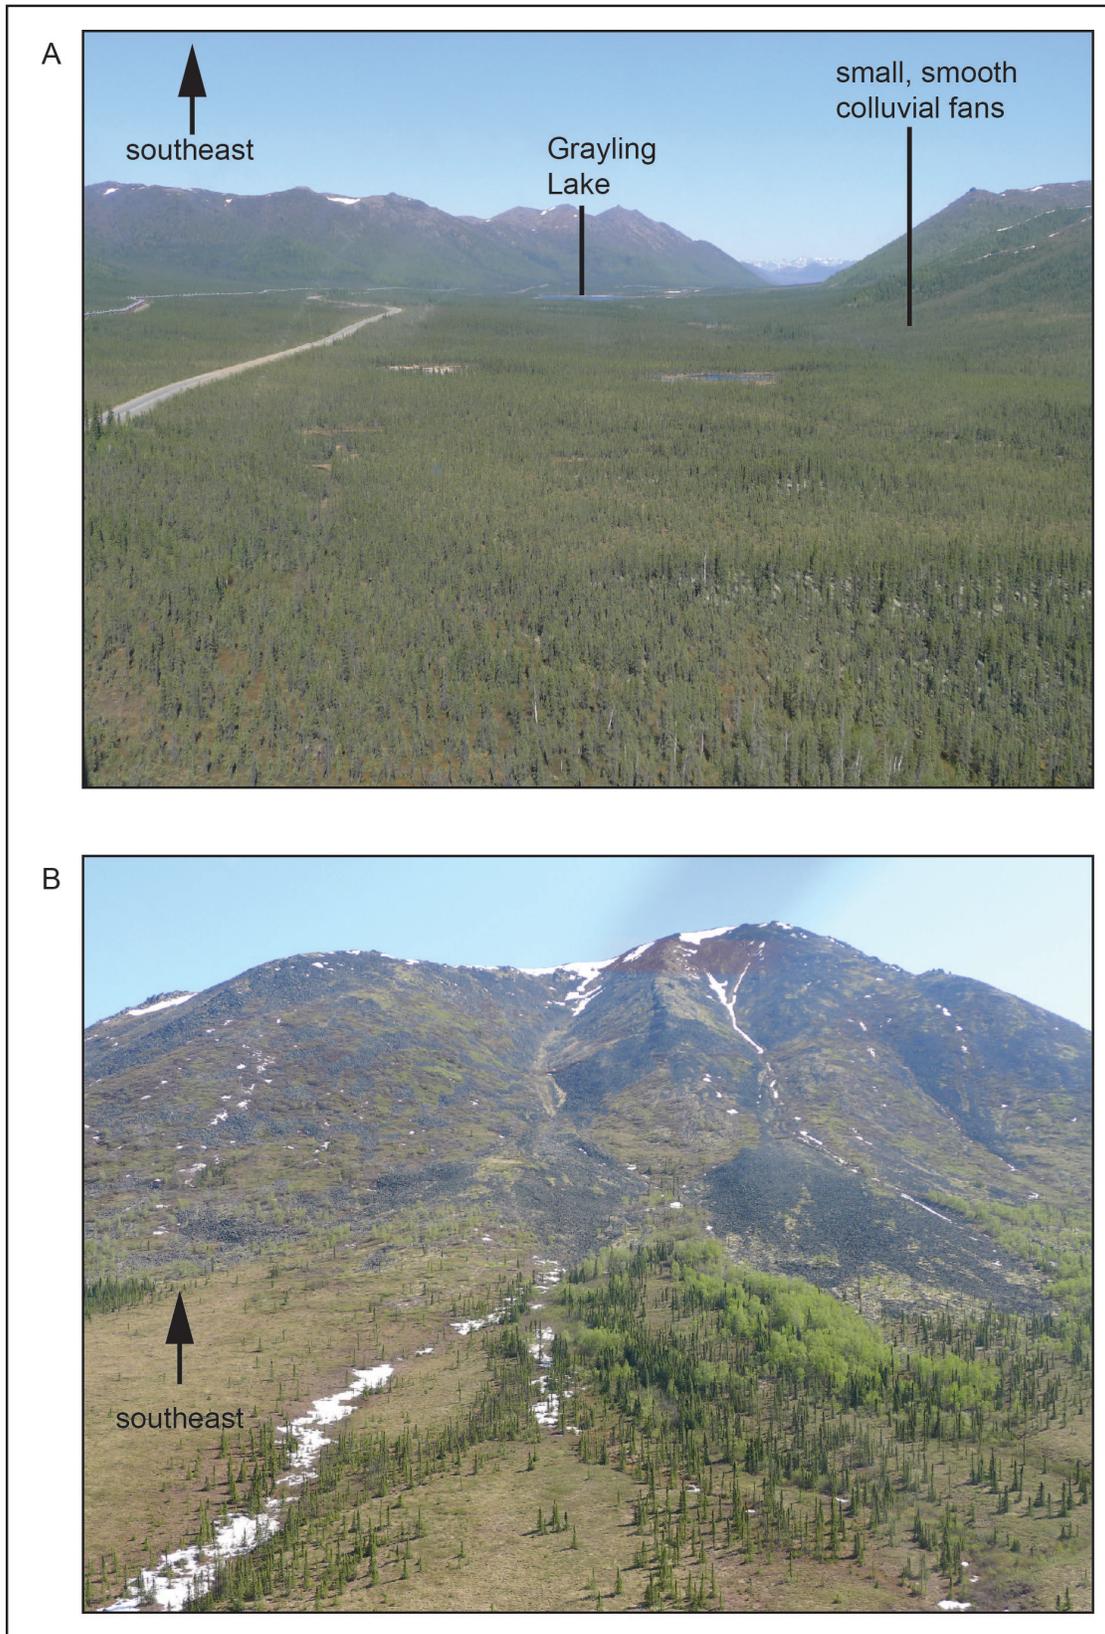
Figure 23. A. Southeast view of the corridor in the area of Grayling Lake, showing small, smooth colluvial fans along the northwestern valley wall. **B.** Coarse rock rubble fans along the southeastern valley wall of the corridor in the Grayling Lake area.

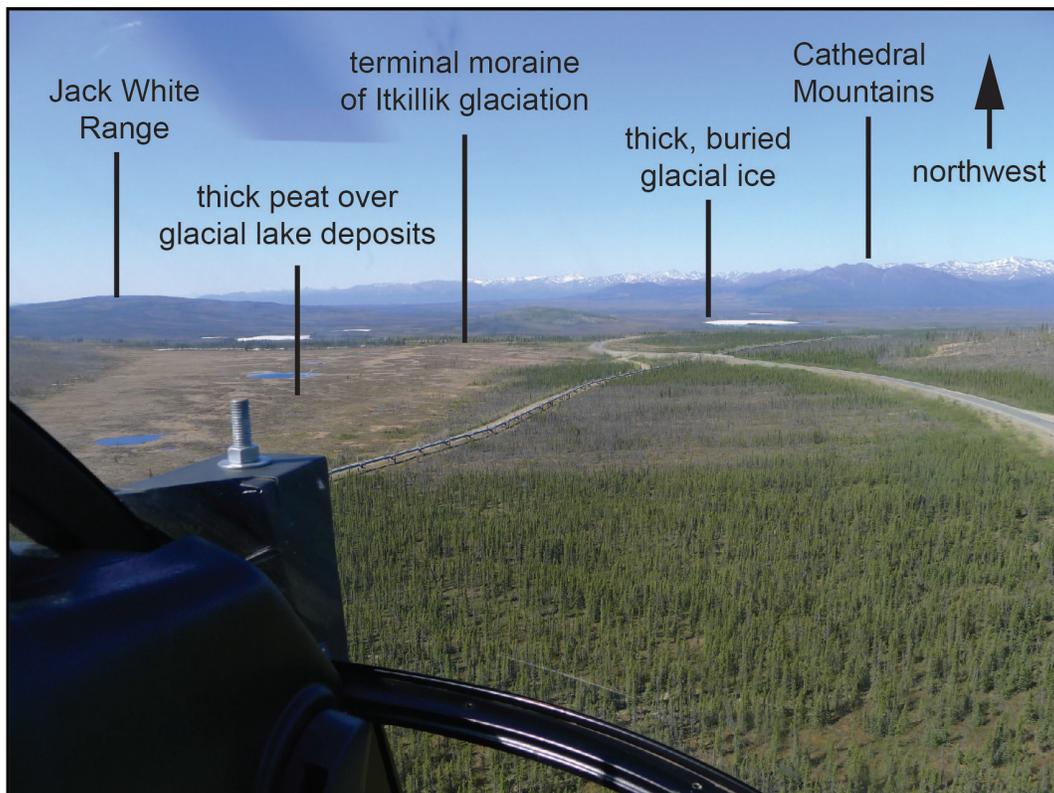
Figure 24. View toward northwest of terminal moraine of Itkillik glaciation north of the South Fork Koyukuk River. Thick, buried glacial ice is present in the topographic trough between the eastern Jack White Range and the Cathedral Mountains, resulting in the thermokarst modification of kettle lakes.

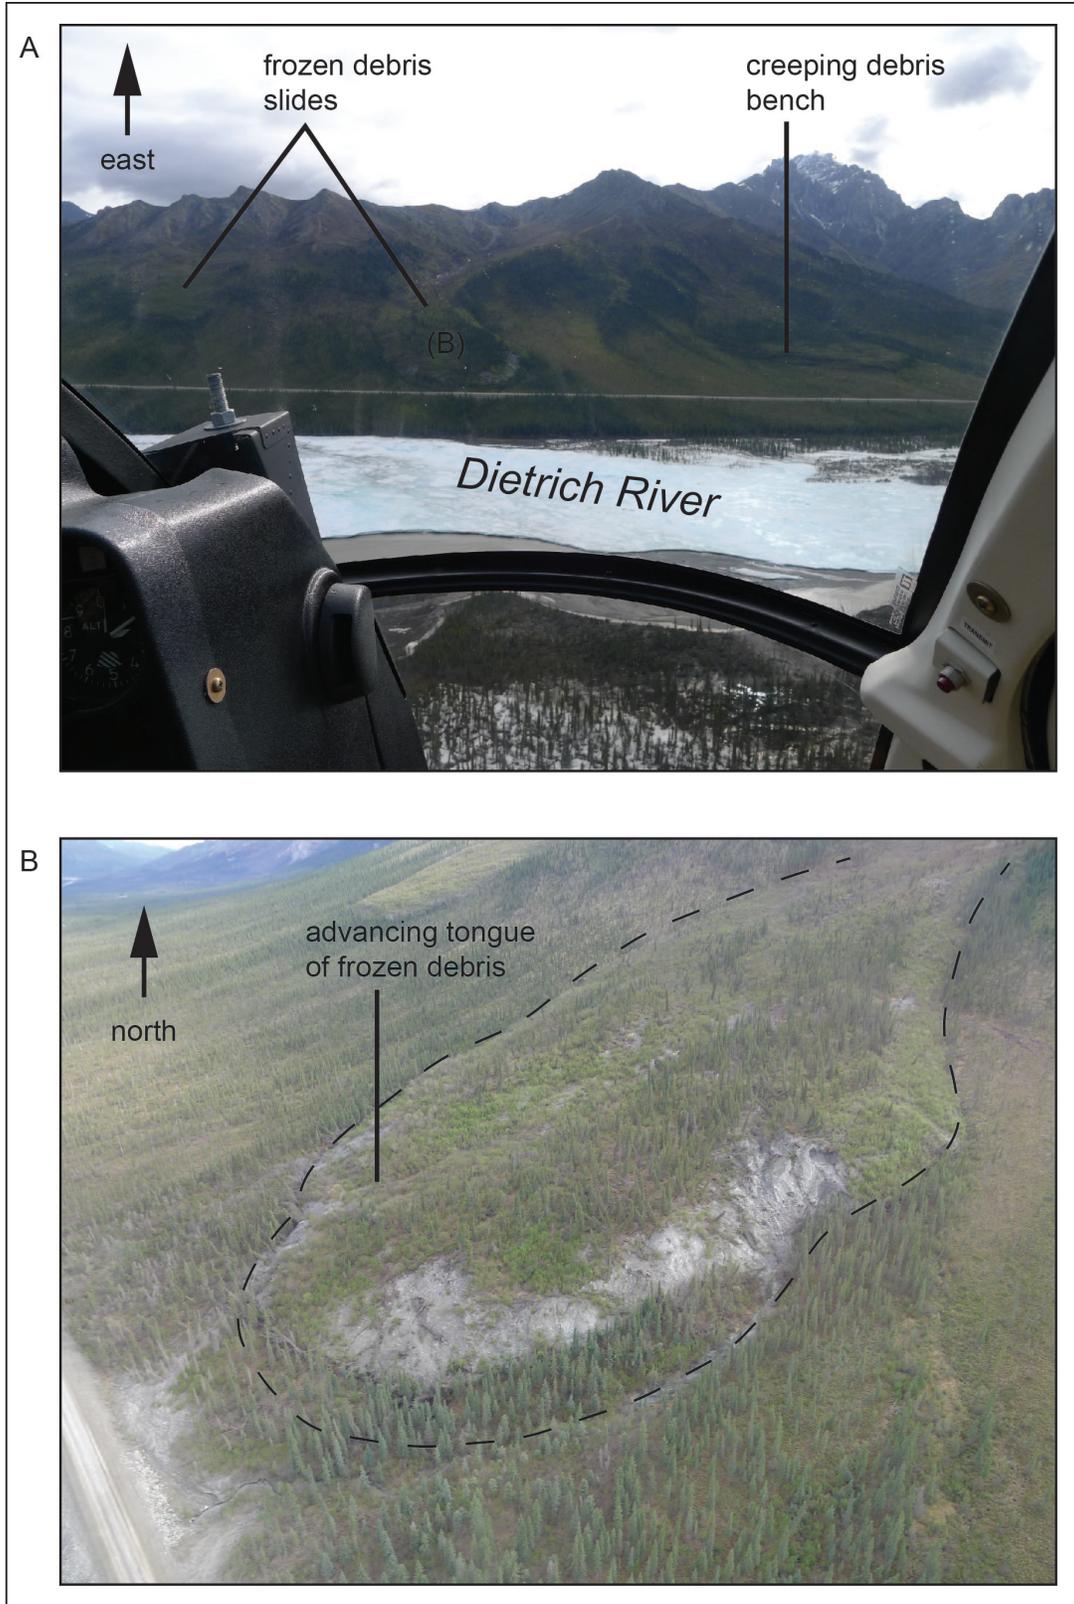
Figure 28. A. View, toward the east, of massive creeping, frozen colluvial lobes along both sides of the Dietrich River valley. These lobes typically have bench or tongue morphology. **B.** View, facing north, of actively advancing tongue of frozen debris near MP 219 of the Dalton Highway, approximately 131 ft (40 m) from the highway. Feature is outlined by dashed black line.

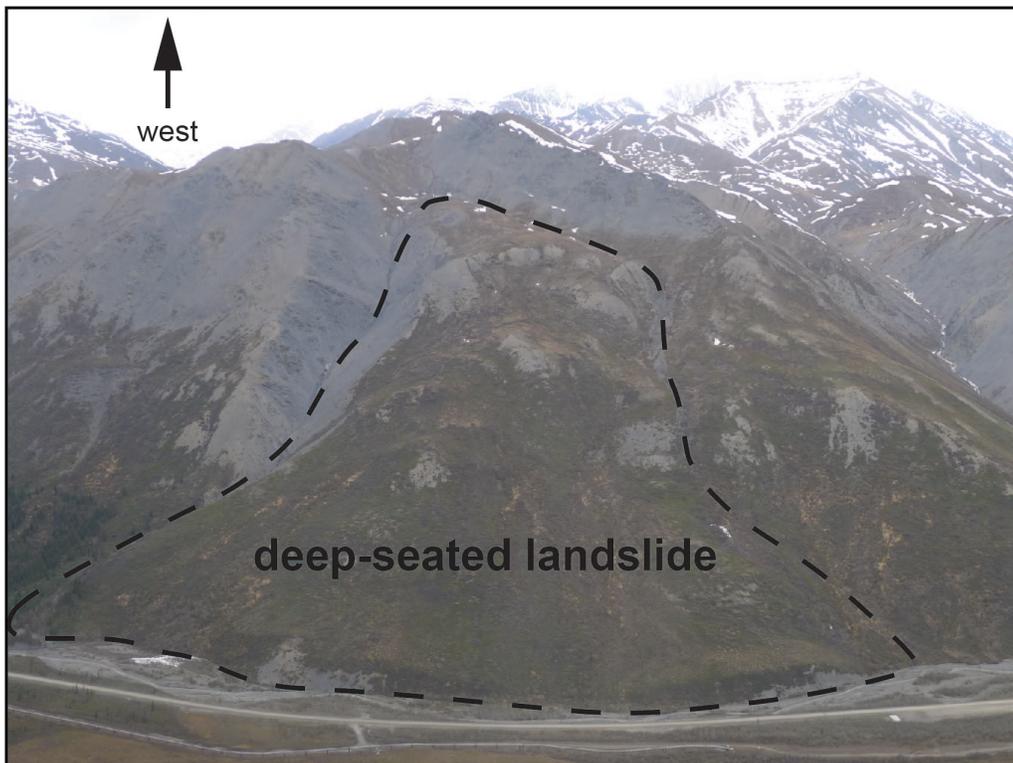
Figure 30. View toward the west of massive, deep-seated landslides in bedrock north of Nutirwik Creek along the western margin of the upper Dietrich River. Margins of slide are indicated by dashed black line.

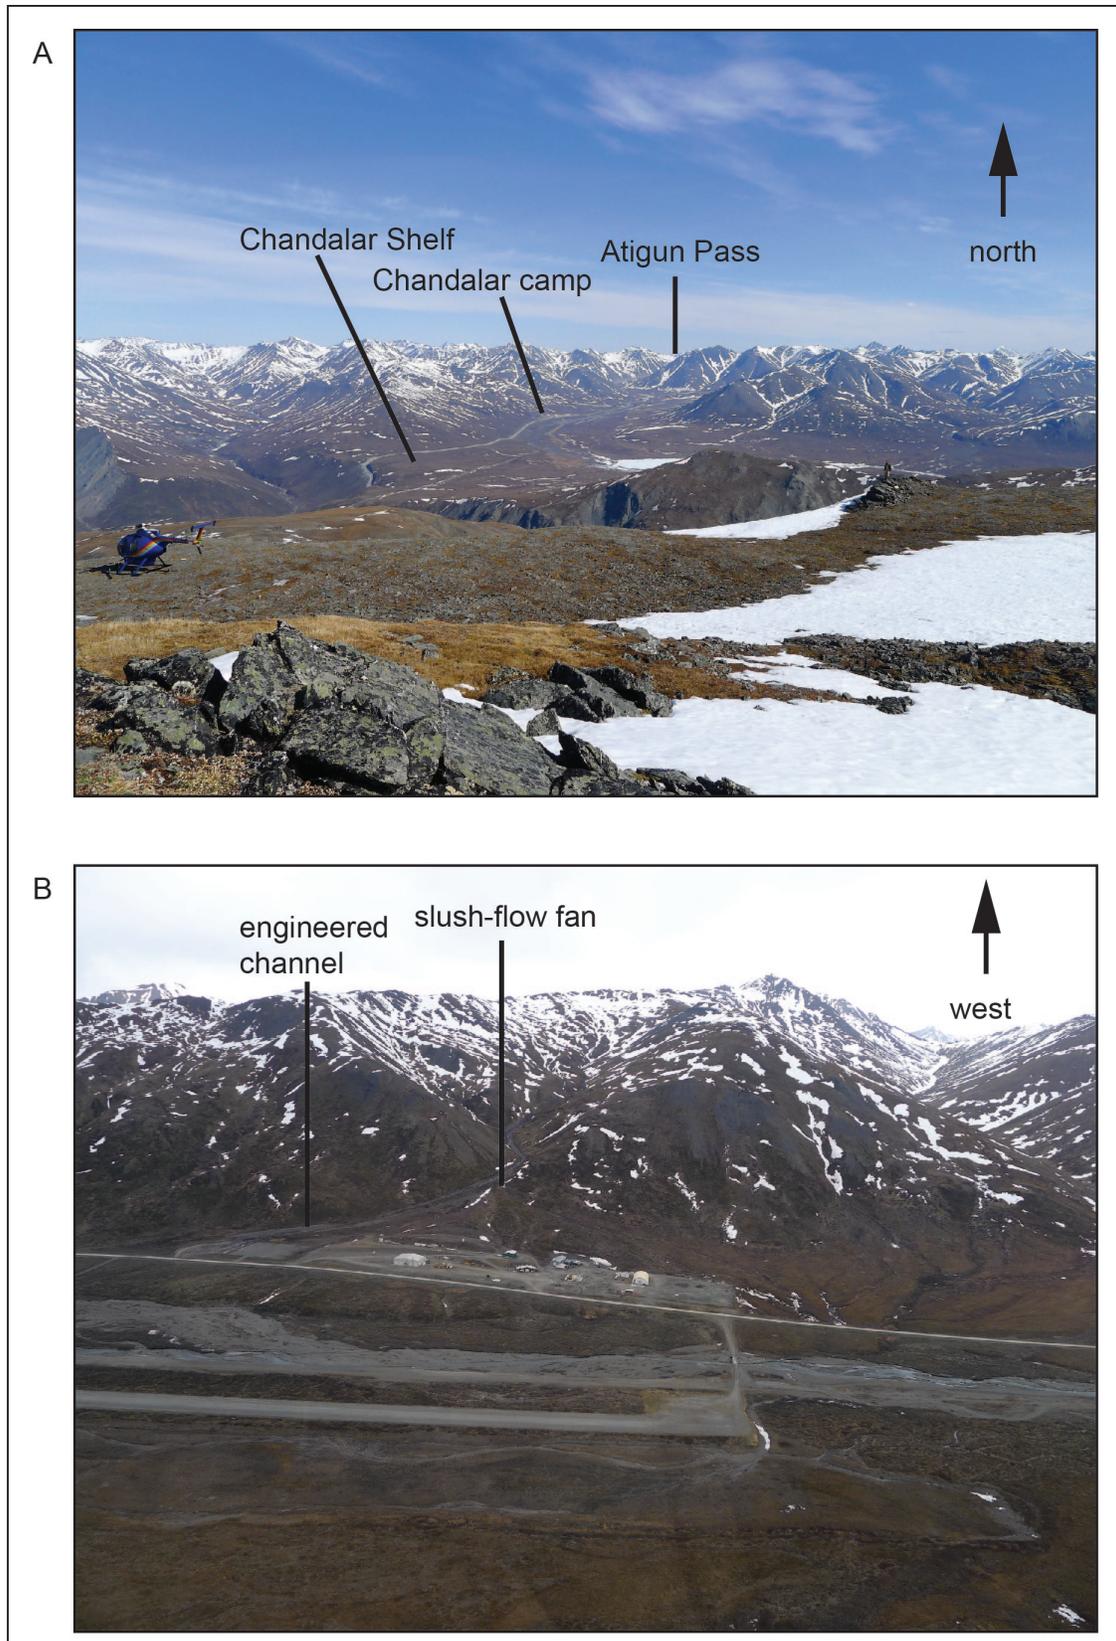
Figure 31. A. Looking north down U-shaped valley extending from the Chandalar shelf to Atigun Pass. **B.** View toward the west of active slush-flow fan at Chandalar Camp. Note engineered channel along south margin of fan installed to divert slush flows away from camp installments.
