ASSESSMENT OF GEOMORPHOLOGY AND GEOLOGIC HAZARDS IN THE PARKS HIGHWAY-MINTO FLATS-DALTON HIGHWAY INFRASTRUCTURE CORRIDOR: COOK INLET TO PRUDHOE BAY, ALASKA

Report of Investigation 2019-8

Published by
STATE OF ALASKA
DEPARTMENT OF NATURAL RESOURCES
DIVISION OF GEOLOGICAL & GEOPHYSICAL SURVEYS
2019

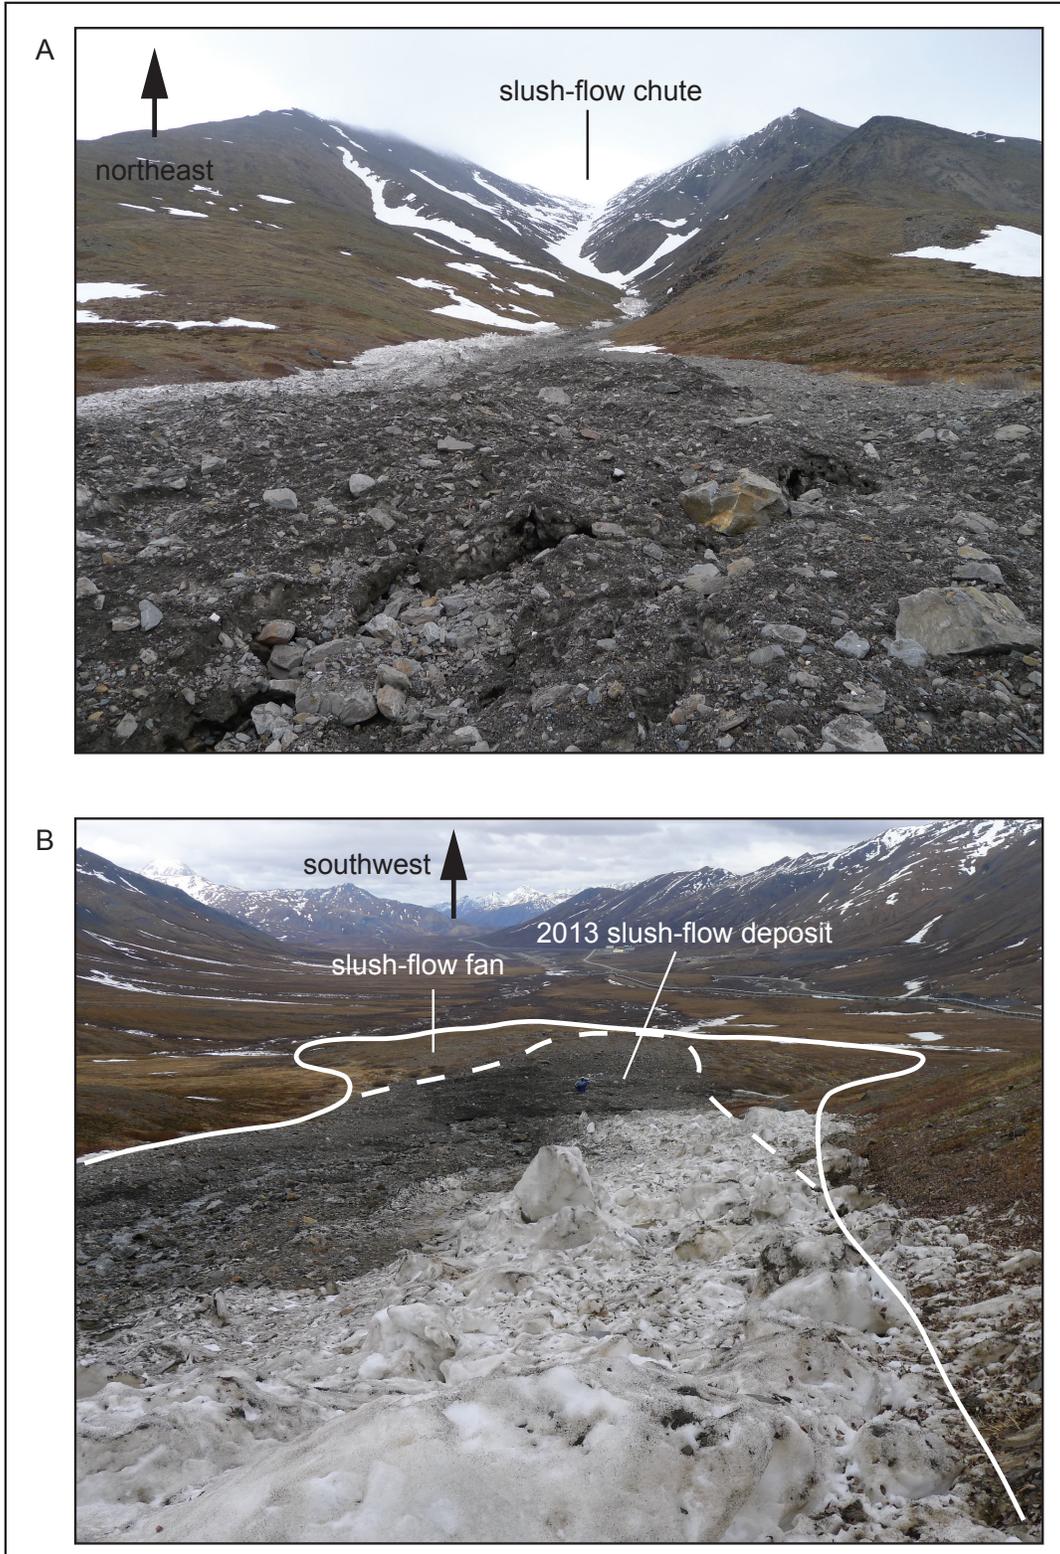
Figure 32. A. View to the northeast of slush-flow chute that released snow, blocks of ice, and large boulders in spring 2013. B. View to the southwest of slush-flow fan (outlined by solid white line) and 2013 deposit (dashed white line). Helicopter in upper center of photograph for scale.

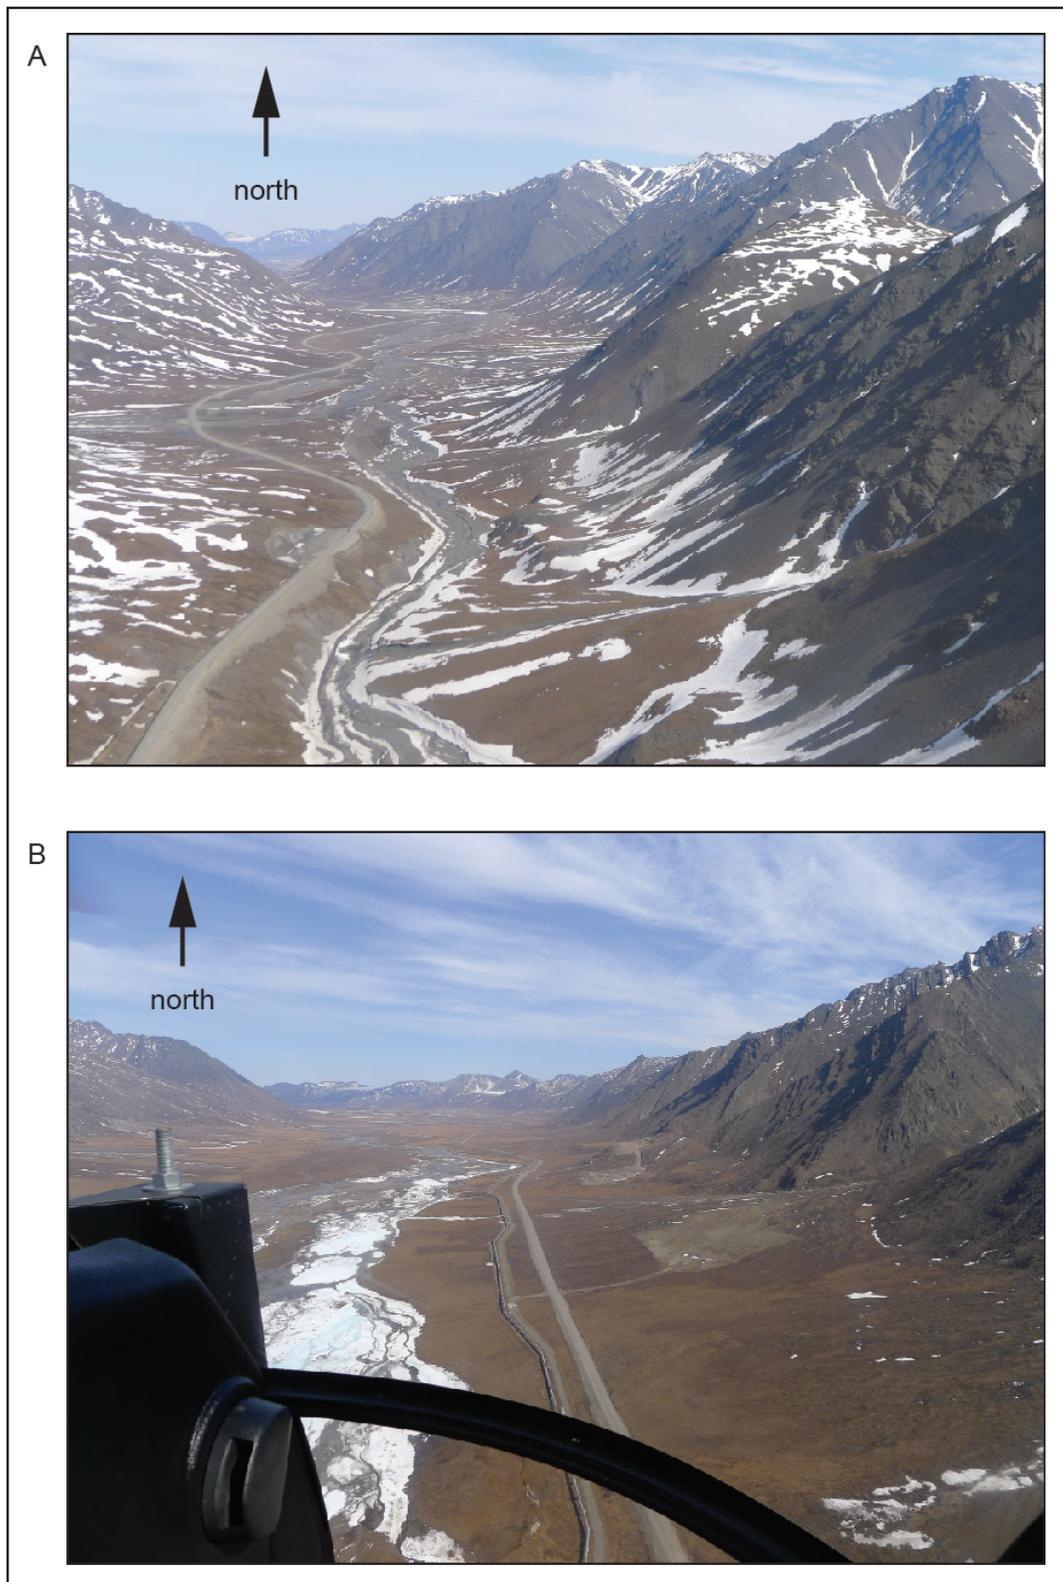
Figure 33. A. Looking north toward the upper Atigun River south of the Atigun River bridge on the Dalton Highway. Coalescing coarse-grained debris flows and avalanche cones characterize the eastern valley wall, and colluvial and alluvial fans characterize the western valley wall. **B.** Looking north toward the Atigun River valley north of the Atigun River bridge, showing coalescing colluvial and alluvial fans and low fluvial terraces of the Atigun River.

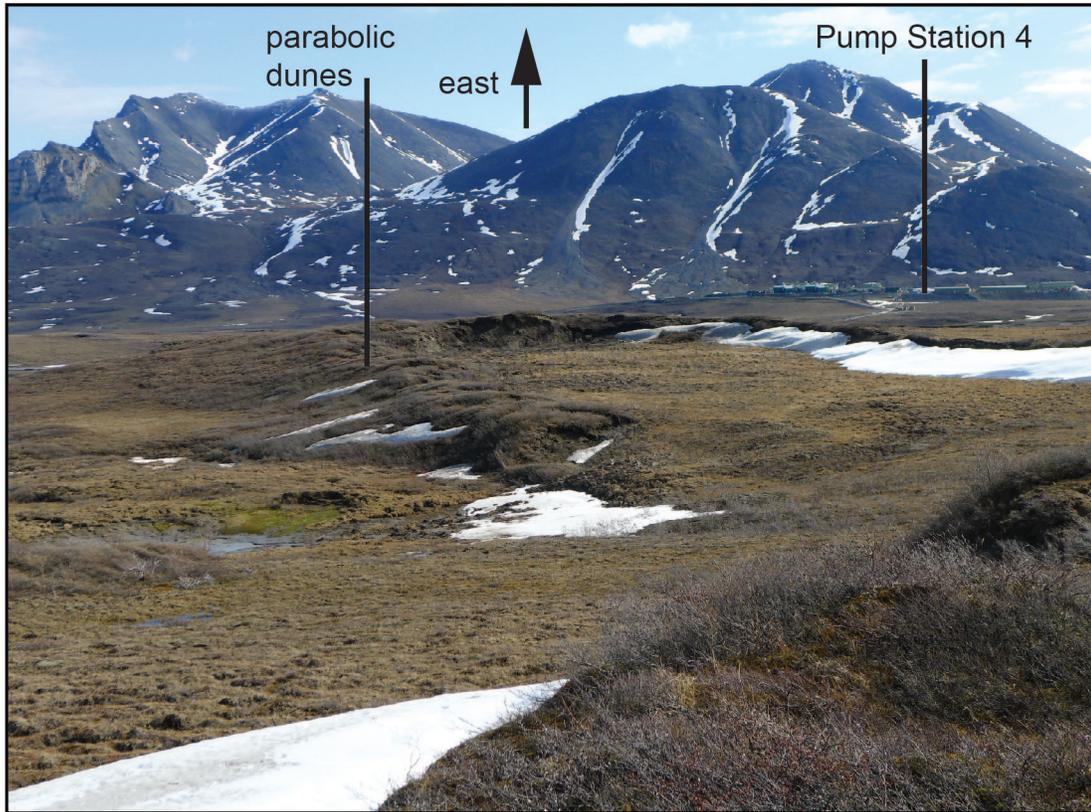
Figure 34. View, looking east, of bimodal failures in parabolic dunes west of Pump Station 4, south of Galbraith Lake.

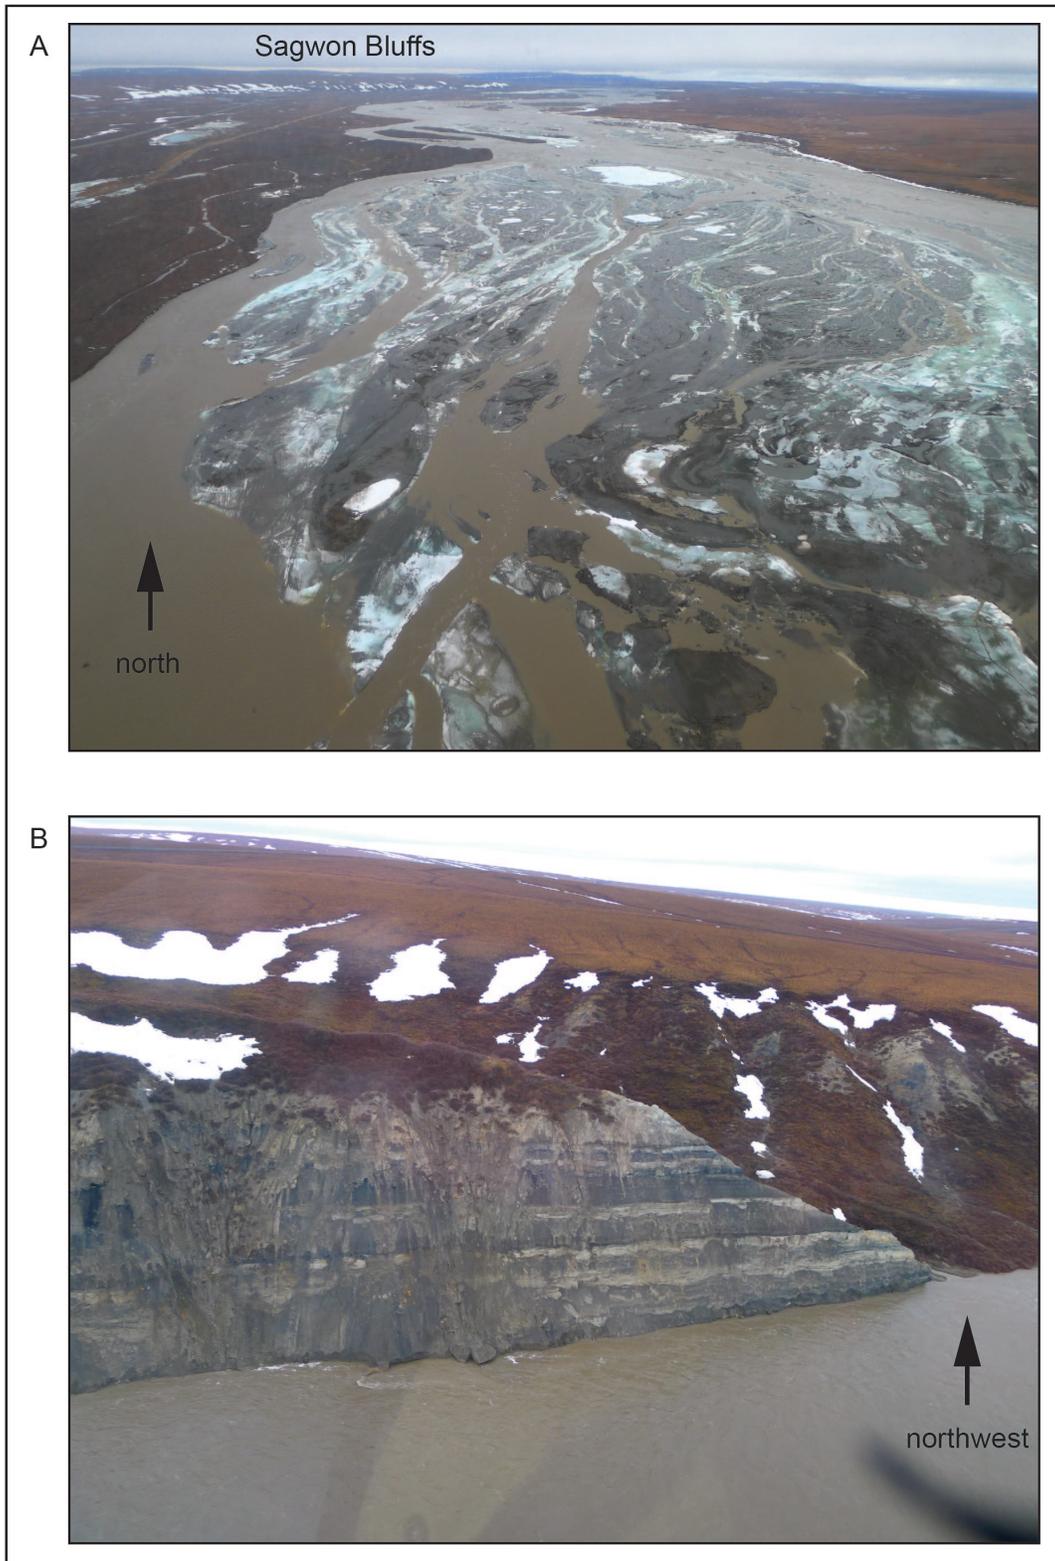
Figure 36. A. View, looking north, of braided channels of the Sagavanirktok River floodplain south of its confluence with the Ivishak River, showing extensive stream icing. Sagwon Bluffs are in the background on the upper left. **B.** View, looking northwest, of Cretaceous bedrock exposed in the Sagwon Bluffs. The rounded upland ridges and slopes that cap the bluffs are underlain by thin colluvium and possibly discontinuous deposits of the Anaktuvuk River glaciation.
