**UNITED STATES DEPARTMENT OF THE INTERIOR  
GEOLOGICAL SURVEY**

**Riverbank erosion and ground-water conditions  
at Beaver, Alaska**

Roger M. Waller

October 1957

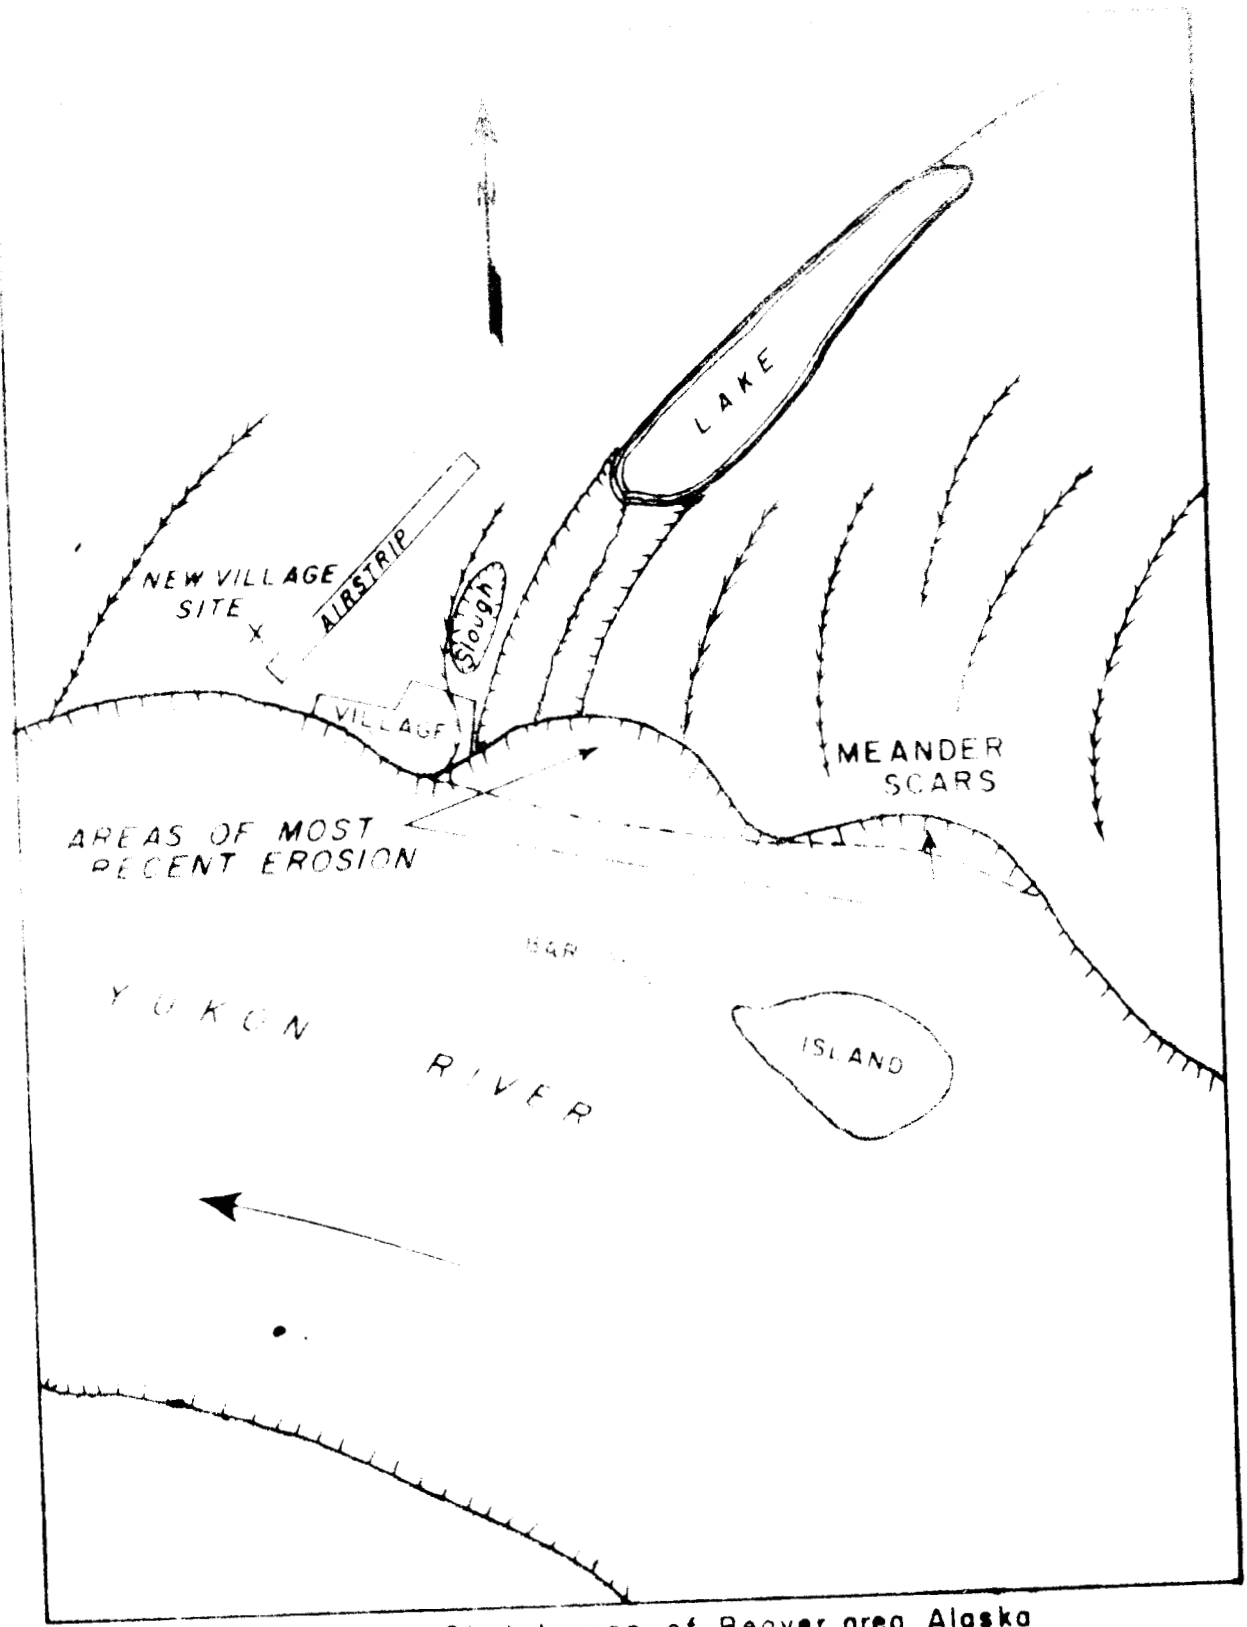
Figure 1-- Sketch map of Beaver area, Alaska

More rapid erosion because of an increase in river current appears to be a factor also. The villagers reported, and maps indicate, that a gravel bar is exposed at lower river level opposite the actively eroding bank (fig. 1). This bar is approximately a third of the way across the main channel and downstream from an island. The gravel bar undoubtedly divides and directs a portion of the current toward the north bank. Leopold and Wolman,<sup>4/</sup> in their summary of braided rivers, conclude that after deposition of a gravel bar in a river, the current is deflected against the banks of the channel causing them to be eroded. The villagers reported that the summer low flow of the river around the gravel bar and against the bank is more destructive than the flood flow when the bar is not exposed. Williams (1952, p. 520) concludes that wind-generated waves from the southwest are a very effective erosive agent on the north bank of the Yukon River during the summer. Hence, it appears that current and wave action are combined to form a more effective erosion agent.

In summarizing the causes of the increased erosion upstream from the village it appears to the writer that the predominant cause is probably the presence and enlargement of the gravel bar in the river which is directing a part of the current against the bank.

Another factor which could deter the erosion would be a change in the river channel. The abandoned meander at the upstream edge of the village (see fig. 1) extends for about 5 miles to the northeast. The upstream end of this partly filled meander is about 100 feet from the bank of the Yukon river and the bank at that point is being eroded. It is possible that if, and when, a flood cuts into this old meander the river will reoccupy the meander. The current produced from this side channel would undoubtedly remove, or retard the growth of, the present gravel bar in the main channel, thus halting the present riverbank erosion. However, the new channel would most likely create new erosion problems along its bank near the village.

The new village site (see fig. 1) picked by the villagers would appear to be the least likely area to undergo river erosion in the near future. Subsurface conditions would be similar to those in the present village area.
