UNITED STATES DEPARTMENT OF THE INTERIOR  
GEOLOGICAL SURVEY

PILLAR MOUNTAIN LANDSLIDE, KODIAK, ALASKA

Reuben Kachadoorian and Willard H. Slater

OPEN-FILE REPORT

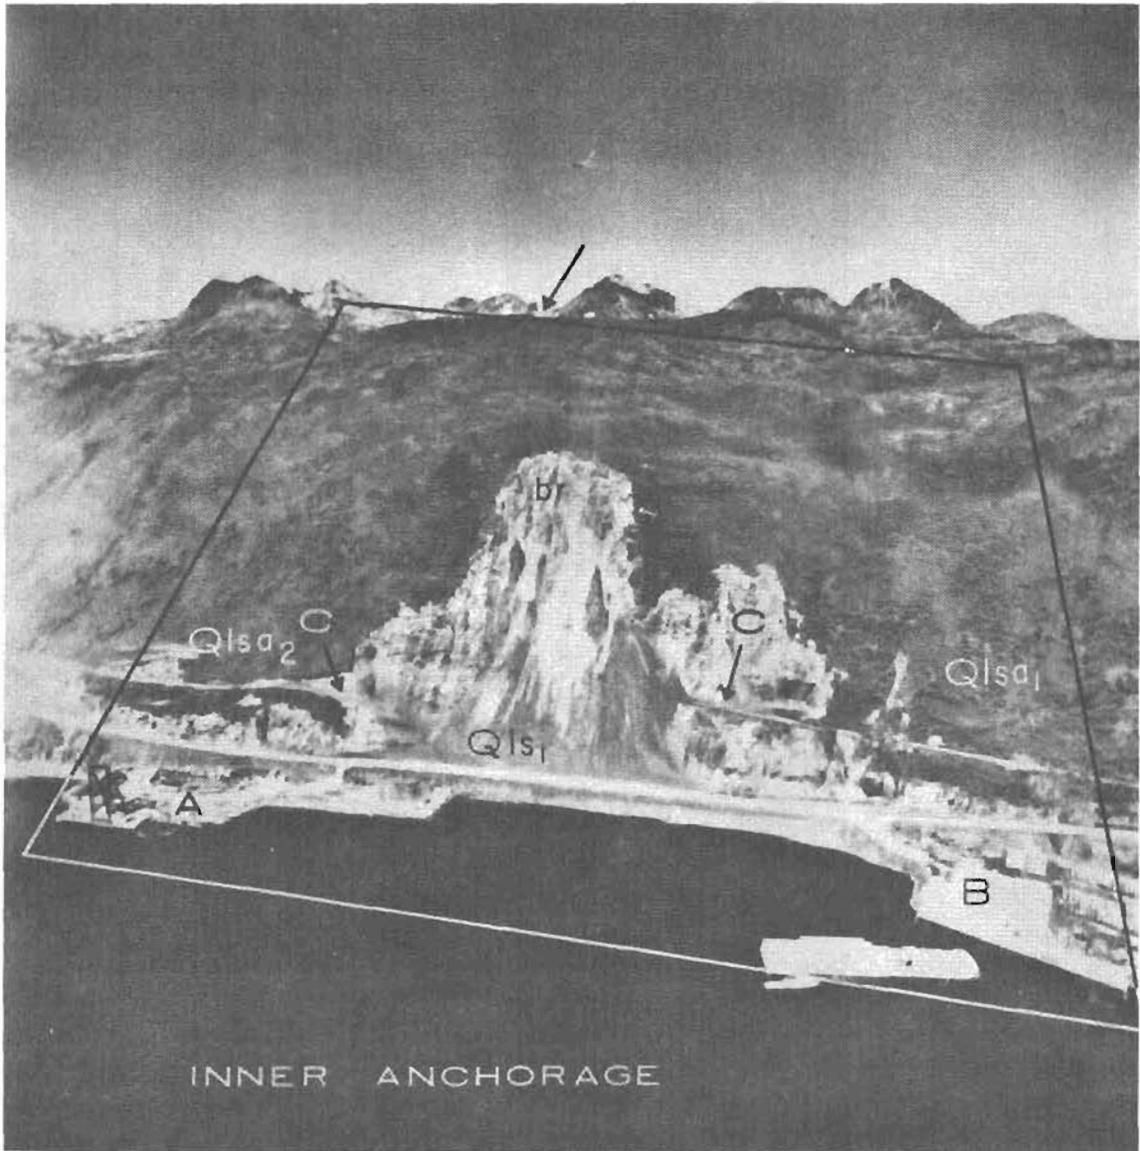
Figure 2. View northwest of Pillar Mountain landslide, Kodiak, Alaska, A, new city dock; B, dock; C, abandoned highway; arrow at skyline points to White Alice station;  $Qls_1$ , talus;  $Qlsa_1$  and  $Qlsa_2$ , ancient slide debris; br, slate, argillite, and graywacke; line indicates approximate boundaries of Plate 2.

Before 1957 or 1958, the face of the slide area was crossed by a highway at about altitude 38 to 49 m (125 to 160 ft), labeled C on figure 2 and Abandoned Highway on Plate 2. The roadway was moved to its present lower location at the base of Pillar Mountain because of rockfall and maintenance problems.

Renewed movement of the Pillar Mountain landslide began during the removal of approximately 230,000 m<sup>3</sup> (300,000 yd<sup>3</sup>) of rock from the toe of the slope of Pillar Mountain for use as fill for the new city of Kodiak dock (A on fig. 2). Material was quarried, pushed downhill from the abandoned highway (C, fig. 2) and collected at the base of the slope. It was then transported to the dock site. On Sunday, December 5, 1971, when the contractor had removed nearly 230,000 m<sup>3</sup> of material from the base of Pillar Mountain, showers of small rocks and occasionally large rocks began cascading down the rock slope above the abandoned highway. The source for the rockfall progressed upslope from its initial altitude of about 91 m (300 ft) to about an altitude of 215 m (700 ft) for the first four days (12/5 to 12/8, 1971) and was primarily confined to a single gully (D. S. Esch and W. H. Slater (Internal Memorandum), 1971)

We learned in the fall of 1977 that the new city of Kodiak dock at the base of Pillar Mountain (A, fig. 2) is undergoing displacement. Five slope-indicator borings drilled to bedrock have been placed in the dock to measure displacement. The cause of the inferred displacement is unknown. It may be because of displacement in the fill or more deep-seated. The dock is at the base of an old landslide identified as Qlsa<sub>2</sub> in figure 2.

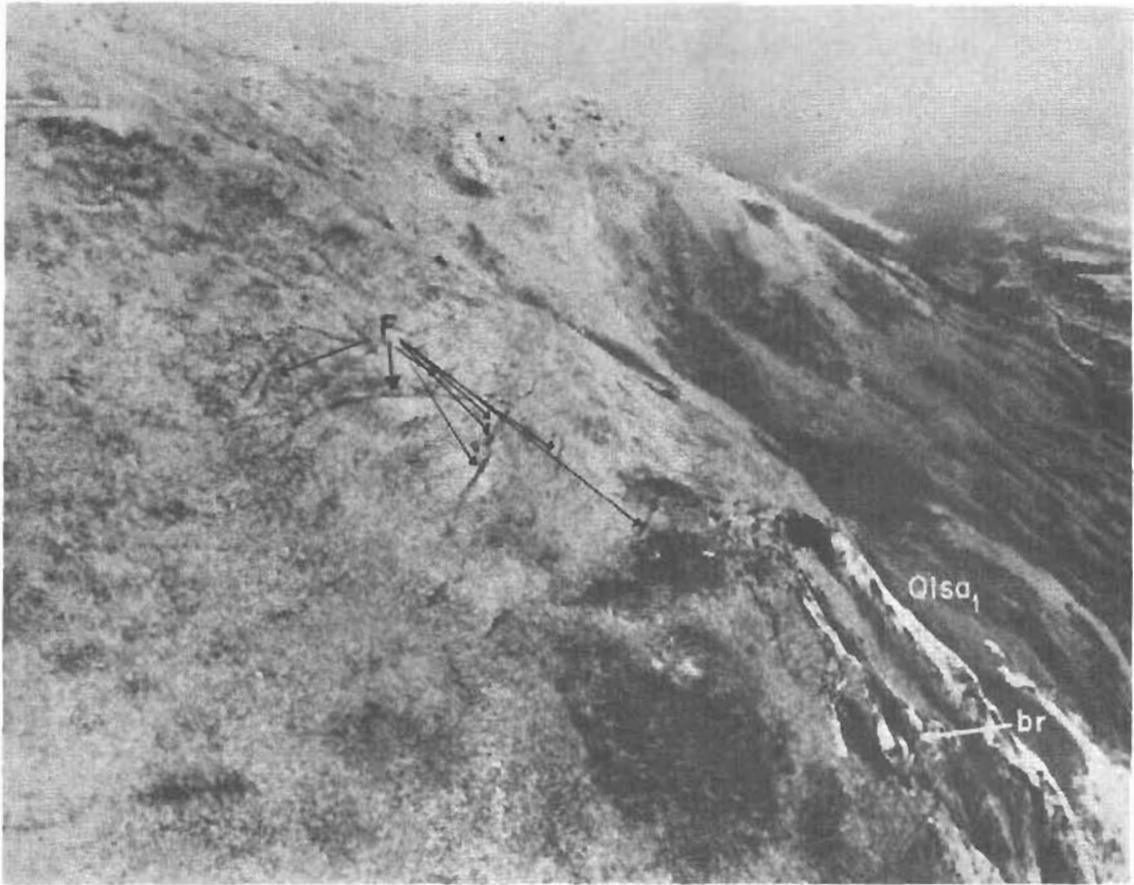
Figure 3. View northeast showing fractures on Pillar Mountain landslide, Kodiak, Alaska. F, fractures at about altitude 244 m (800 ft.); Qlsa<sub>1</sub>, ancient slide debris; br, slate, argillite, and graywacke.

fracture pattern suggested that the entire center block was moving downhill. Some of these cracks can be seen in figure 3. The uppermost crack was estimated to be approximately 122 m (400 ft) horizontally and 38 m (125 ft) vertically from the White Alice communication site (arrow, fig. 2) on the crest of Pillar Mountain at about an altitude of 381 m (1,250 ft). As snow was present on the ground and none in the cracks, the observers concluded that the cracks had developed no more than a few days prior to the December 9 aerial observations.

The December 14, 1971, aerial observation was made after a snowstorm that ended about 10:00 AM, December 13. At the time of this flight, most of the cracks observed on December 9 were obscured by the snow. However, Esch noted visually that the uphill cracks were wider, about 50 percent, than when he inspected them on December 9, 1971 (Esch and Slater, Internal Memorandum, 1971). Ground inspection by Esch of the cracks on December 9 and again on December 14, 1971, indicated that they had increased in size and appeared to mirror the shape of an ancient landslide on the upper half of Pillar Mountain. The cracks or fractures were as much as 1 m (3 ft) wide. During our field observations on August 3 and 4, 1976, some cracks were as much as 1.2 m (4 ft) wide. We also noted a crack at about altitude 343 m (1,125 ft) that is not shown on Plate 1. Plate 1 is a copy of a geologic map submitted by Dames and Moore to accompany their report to the Alaska Department of Highways (1973). The crack we noted at altitude 343 m is in the vicinity of S-1 on Plate 2.

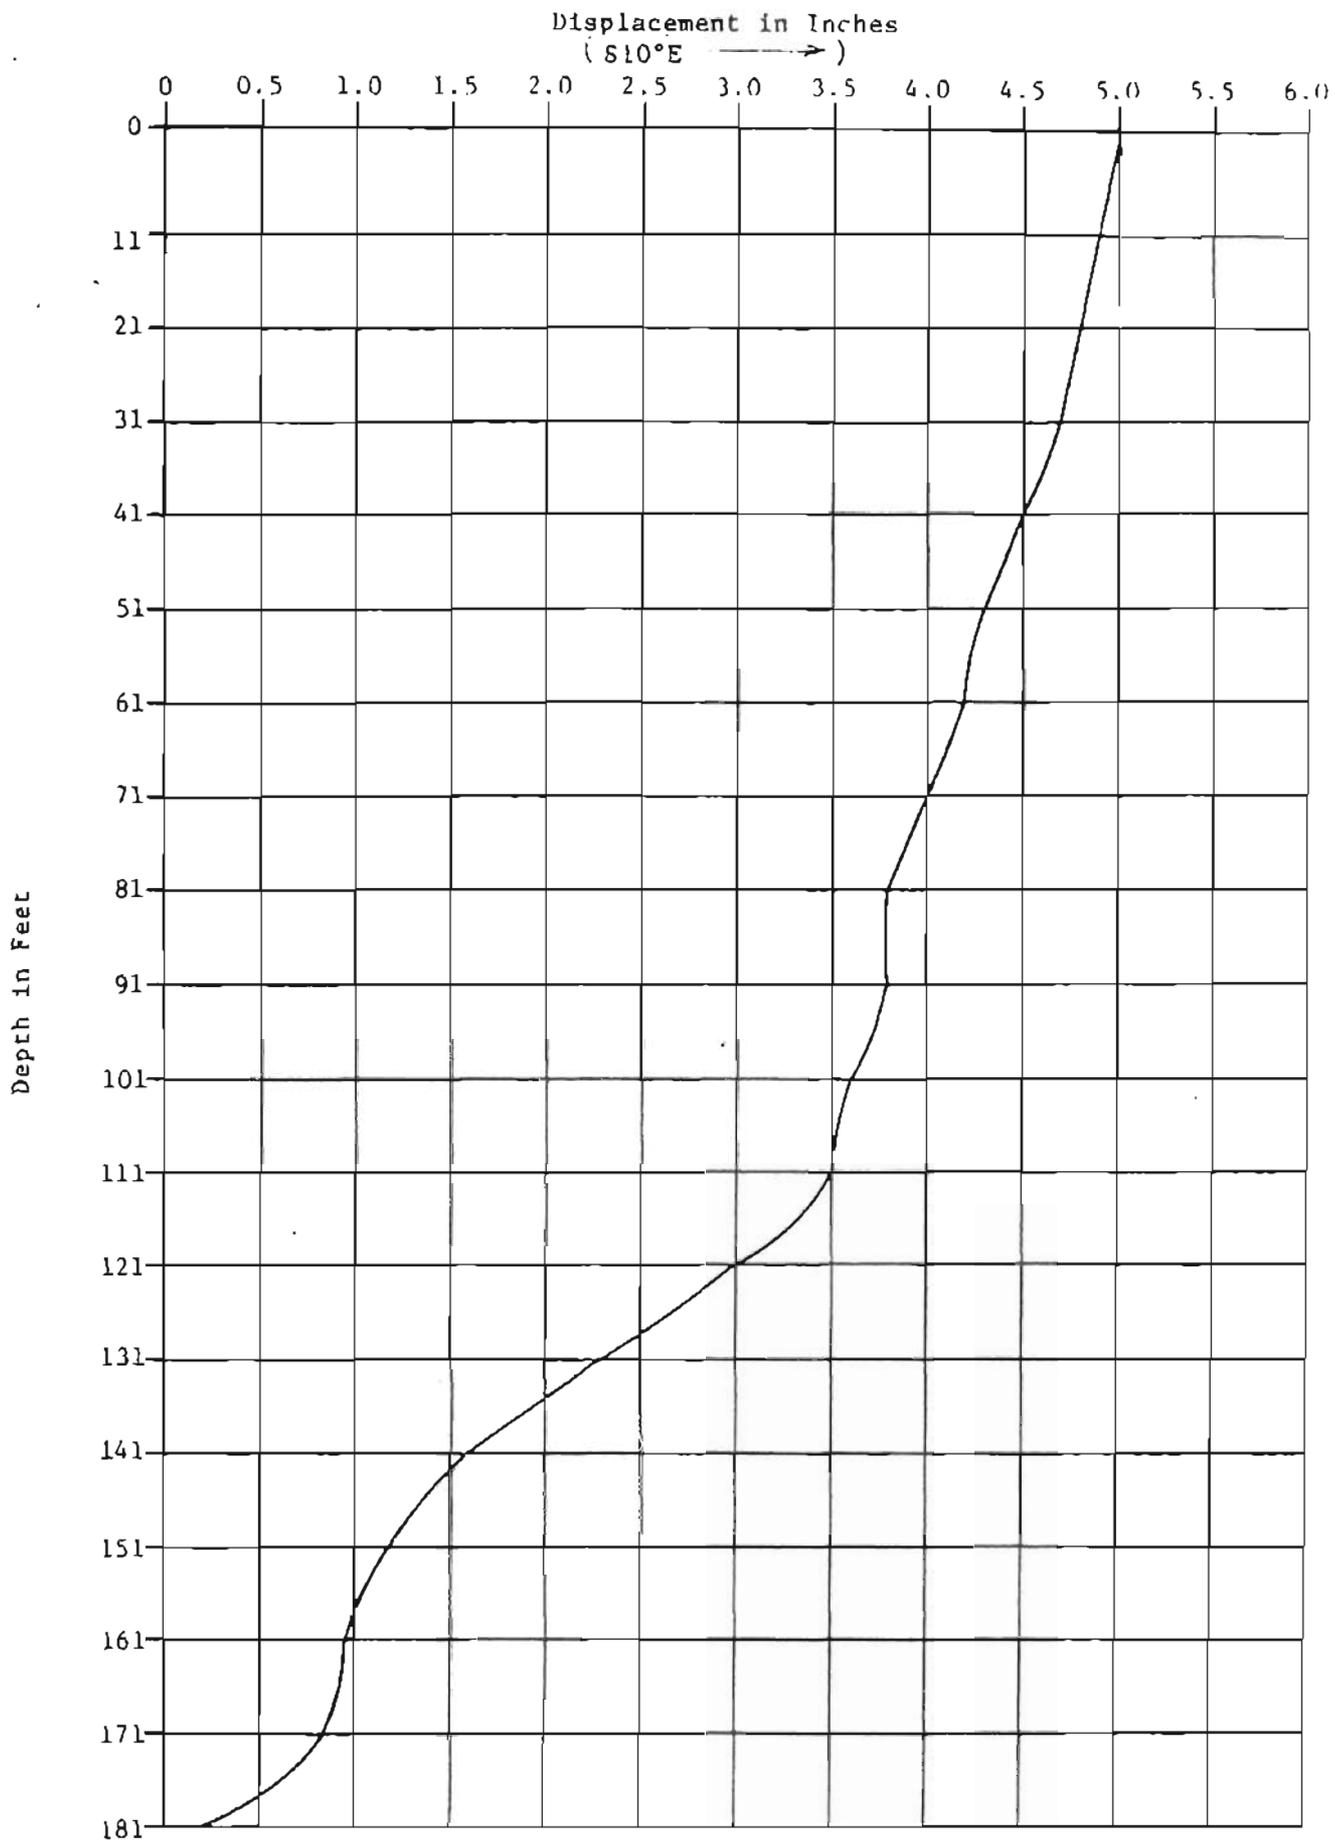
Slope-indicator readings on D.H. 1 (fig. 4) indicate a displacement of about 127 mm (5.0 in) in a S10°E direction between the initial reading on September 25, 1972, and readings on August 3, 1976 (plotted as dashed vector, Plate 2). More than one-half of the total displacement occurred between the depths of 33.8 to 49.1 (111 to 161 ft). Nearly 25 mm (1 in) of movement was recorded in the lower 6.1 m (20 ft) of the hole and the data do not conclusively prove that the casing extends entirely through the landslide.

Figure 4. Slope indicator data, D. H. 1, showing amount of displacement between September 25, 1972, and August 3, 1976 11

There is an apparent discrepancy of the data in D.H. 1. The slope-indicator data suggest 127 mm (5 in) of downslope movement between the top and bottom of the casing. The surface survey of the same point suggests 165 mm (6.5 in) of downslope displacement. The slope-indicator data suggest that movement may be occurring below the slope-indicator casing. We believe that this may be so and that the 38 mm (1.5 in) apparent discrepancy may in fact be a record of displacement below the casing between October, 1972 and October, 1976.

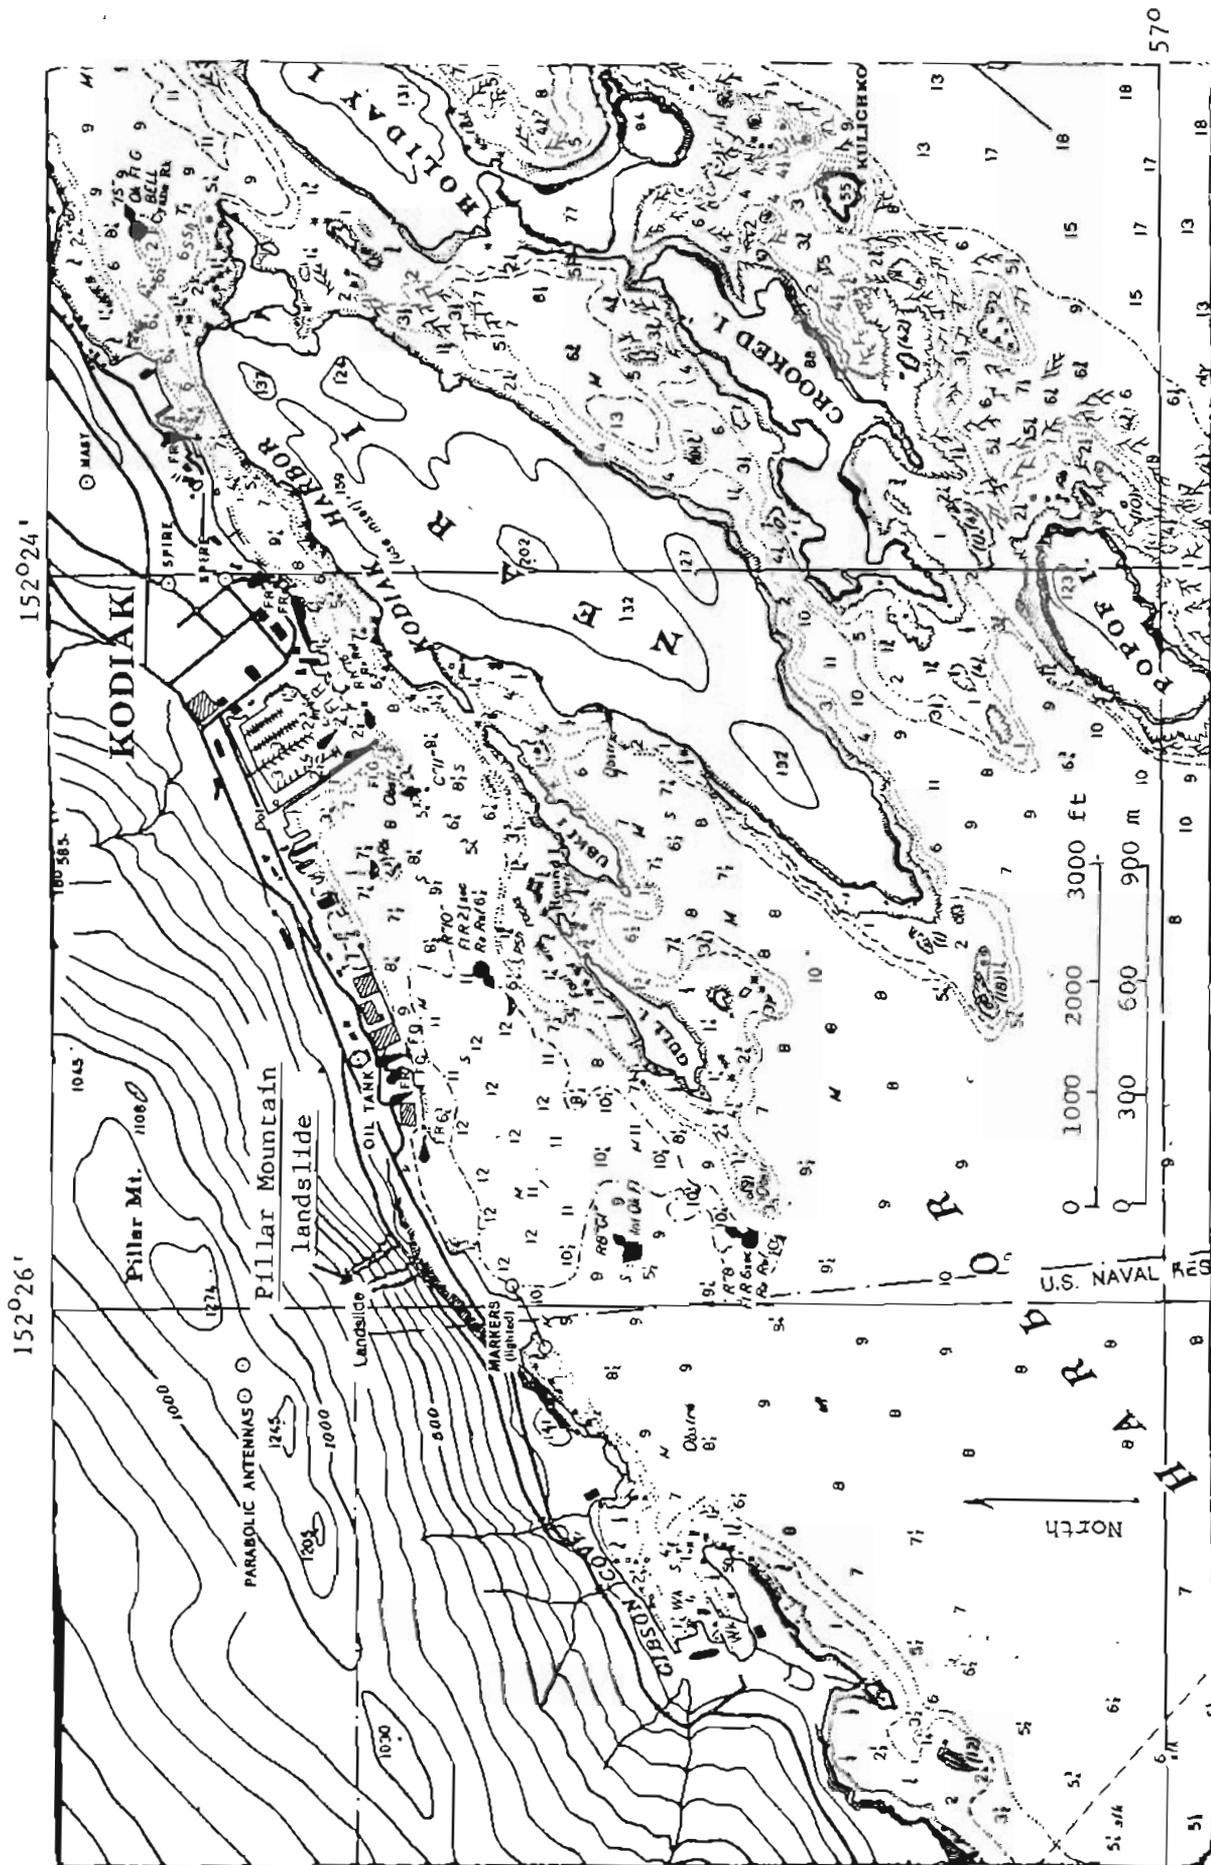
To determine whether the Pillar Mountain landslide had, in the past, slid to the bottom of the slope, we made an analysis of the offshore bathymetry at the base of the mountain. The study showed a large submarine basin with an average depth of 12 fathoms (fig. 5). On either side of the basin, the depth of the water is about 9 fathoms, or about 3 fathoms shallower than the basin. Although it is possible that the basin is a feature of marine processes, we believe it may exist because ancient slides on both sides of Pillar Mountain slid to the base of the slope or into Inner Anchorage, resulting in the relatively shallow depths below them.

Figure 5. Bathymetry of Inner Harbor, Kodiak, Alaska. Soundings in fathoms, datum MLLW; scale 1:20,000; from NOAA Chart No. 16595--Kodiak and St. Paul Harbors, May 10, 1975.

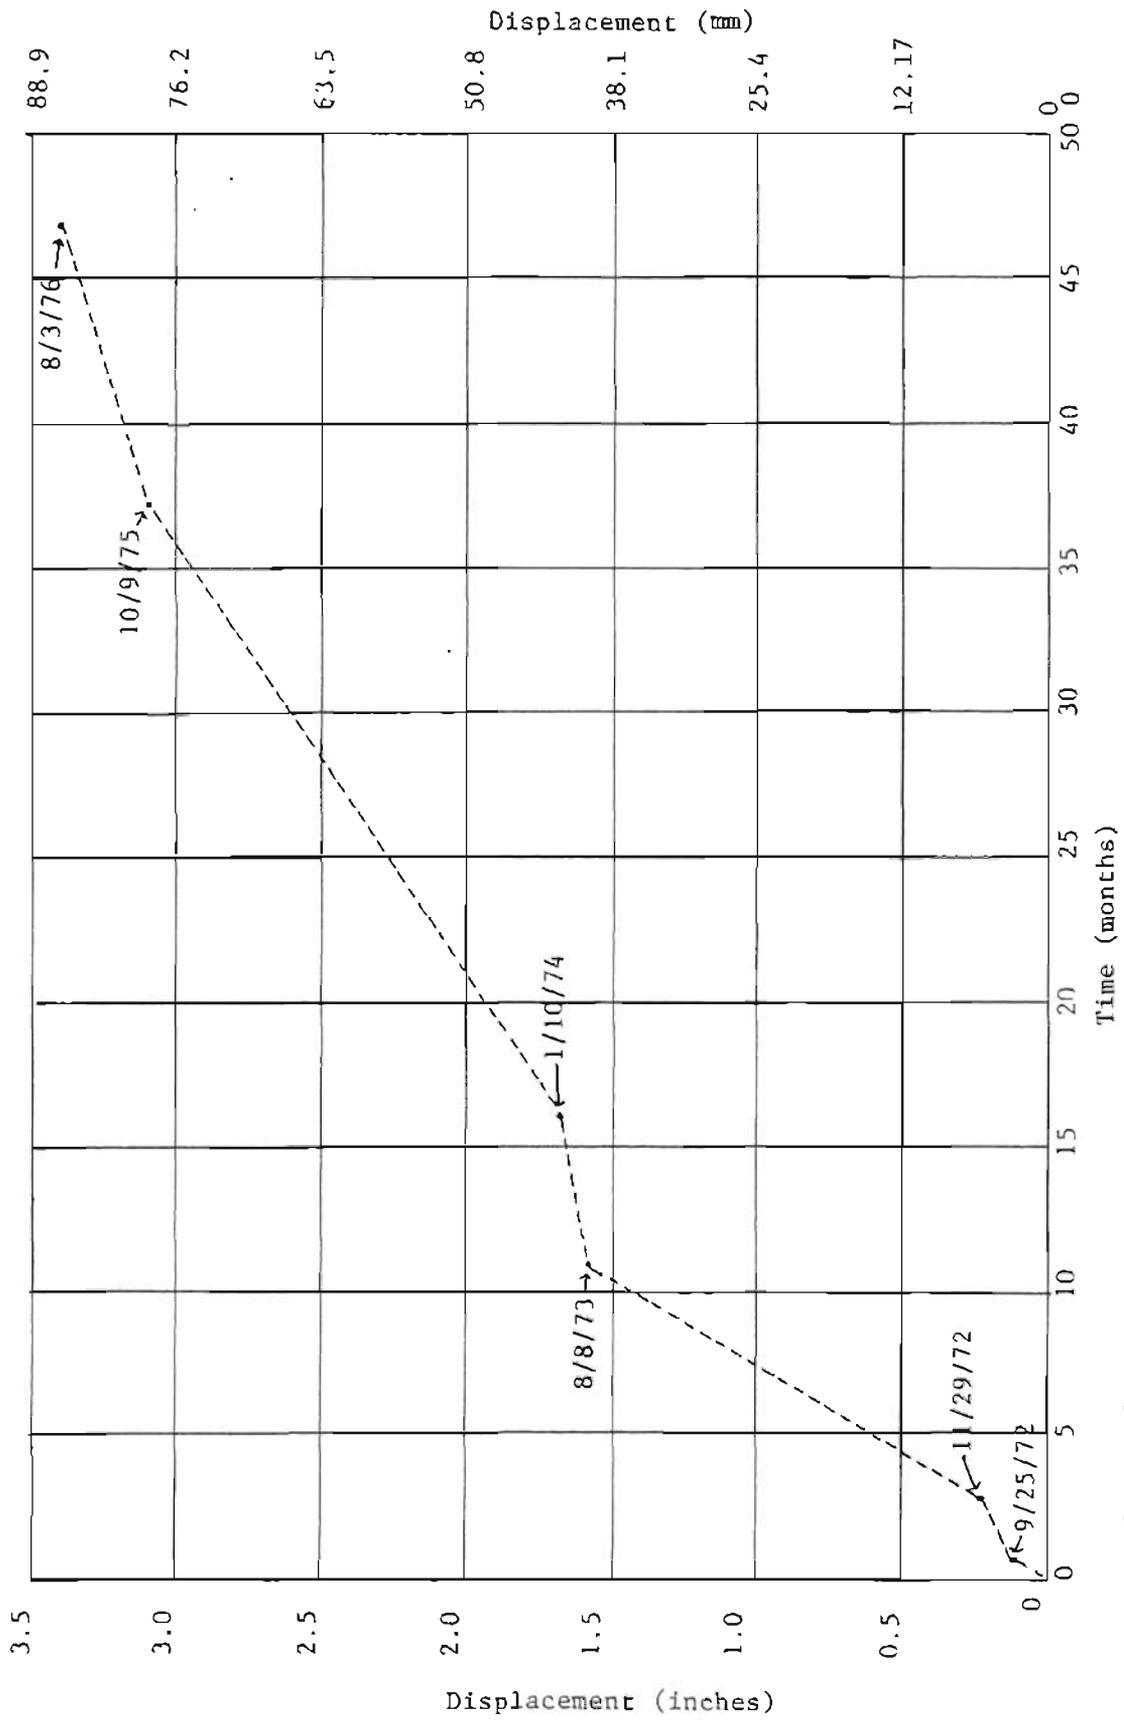
Movement of the Pillar Mountain landslide continues, although it has decelerated relative to the movement observed in December, 1971. Figure 6 shows time versus displacement between September 25, 1972, and August 3, 1976, at a depth of 33.8 m (111 ft) in D.H. 1. Because of the limited number of observations, we are unable to define the type and nature of movement.

Figure 6. Graph showing time vs. displacement at a depth of 111 feet (33.83 m) in D.H.1, Pillar Mountain Landslide, Kodiak, Alaska,
