EFFECTS OF THE EARTHQUAKE
OF MARCH 27, 1964
AT VALDEZ, ALASKA

Effects of the Earthquake Of March 27, 1964 At Valdez, Alaska

By HENRY W. COULTER and RALPH R. MIGLIACCIO

GEOLOGICAL SURVEY PROFESSIONAL PAPER 542-C

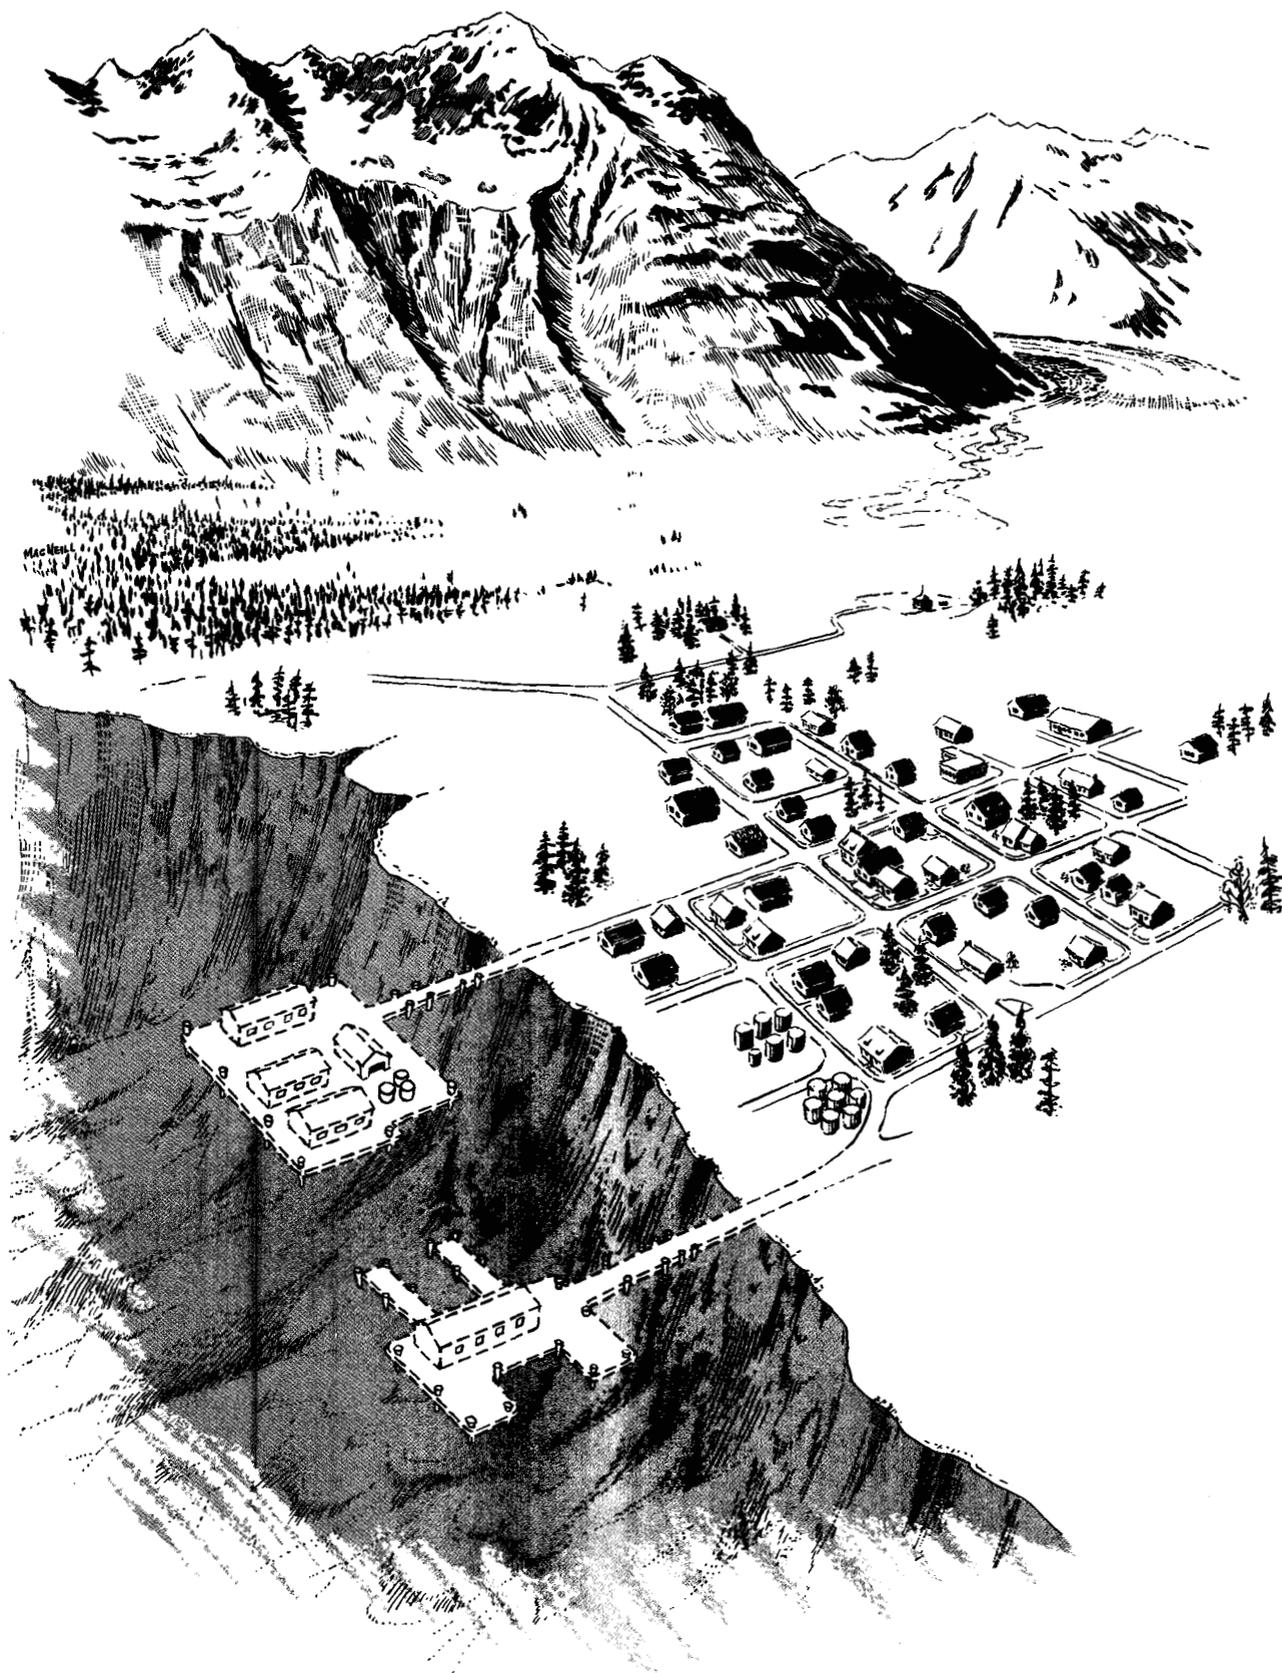
4.—Submerged slide area at Valdez. Dashed lines indicate dock area destroyed in earthquake. Sketch by David Laneville.

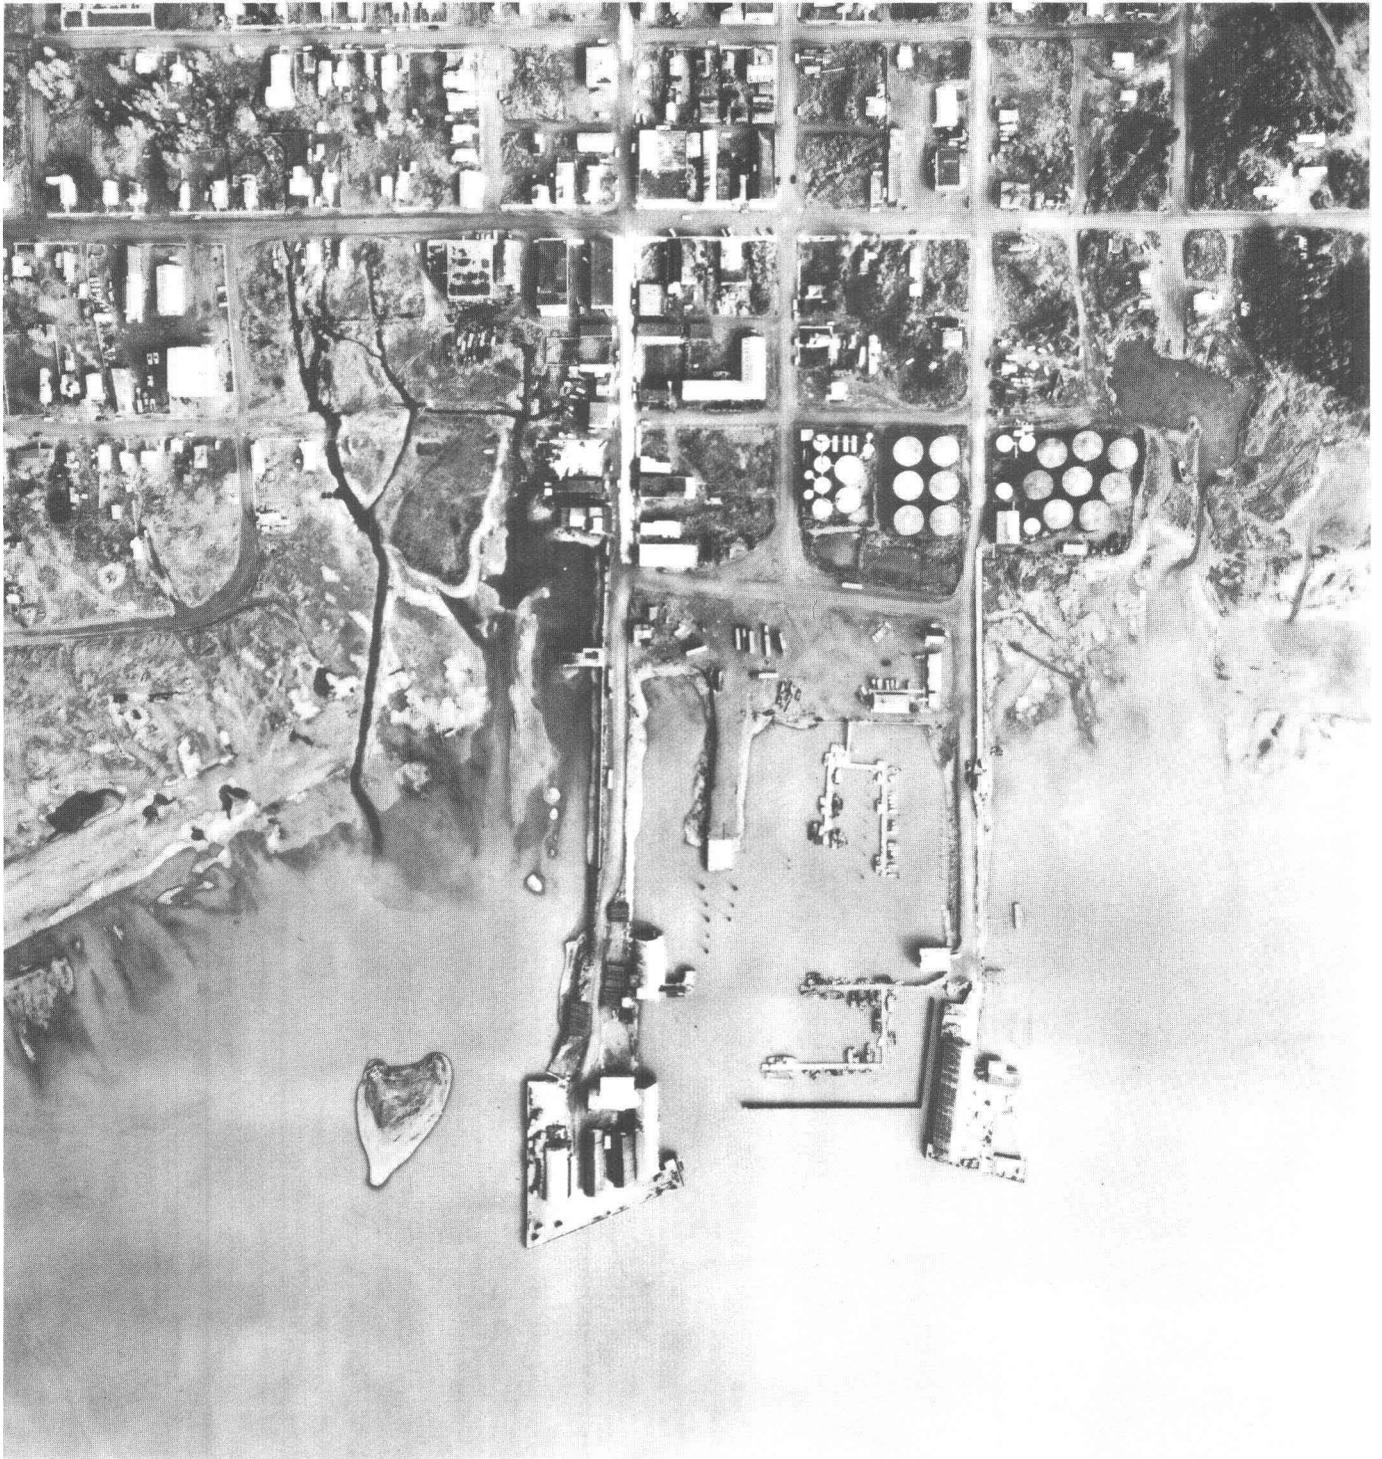
damage in the city as well as the destruction of all docks and associated facilities (figs. 5 and 6).

5.—Valdez dock area, September 23, 1965. Photographed by U.S. Bureau of Land Management.

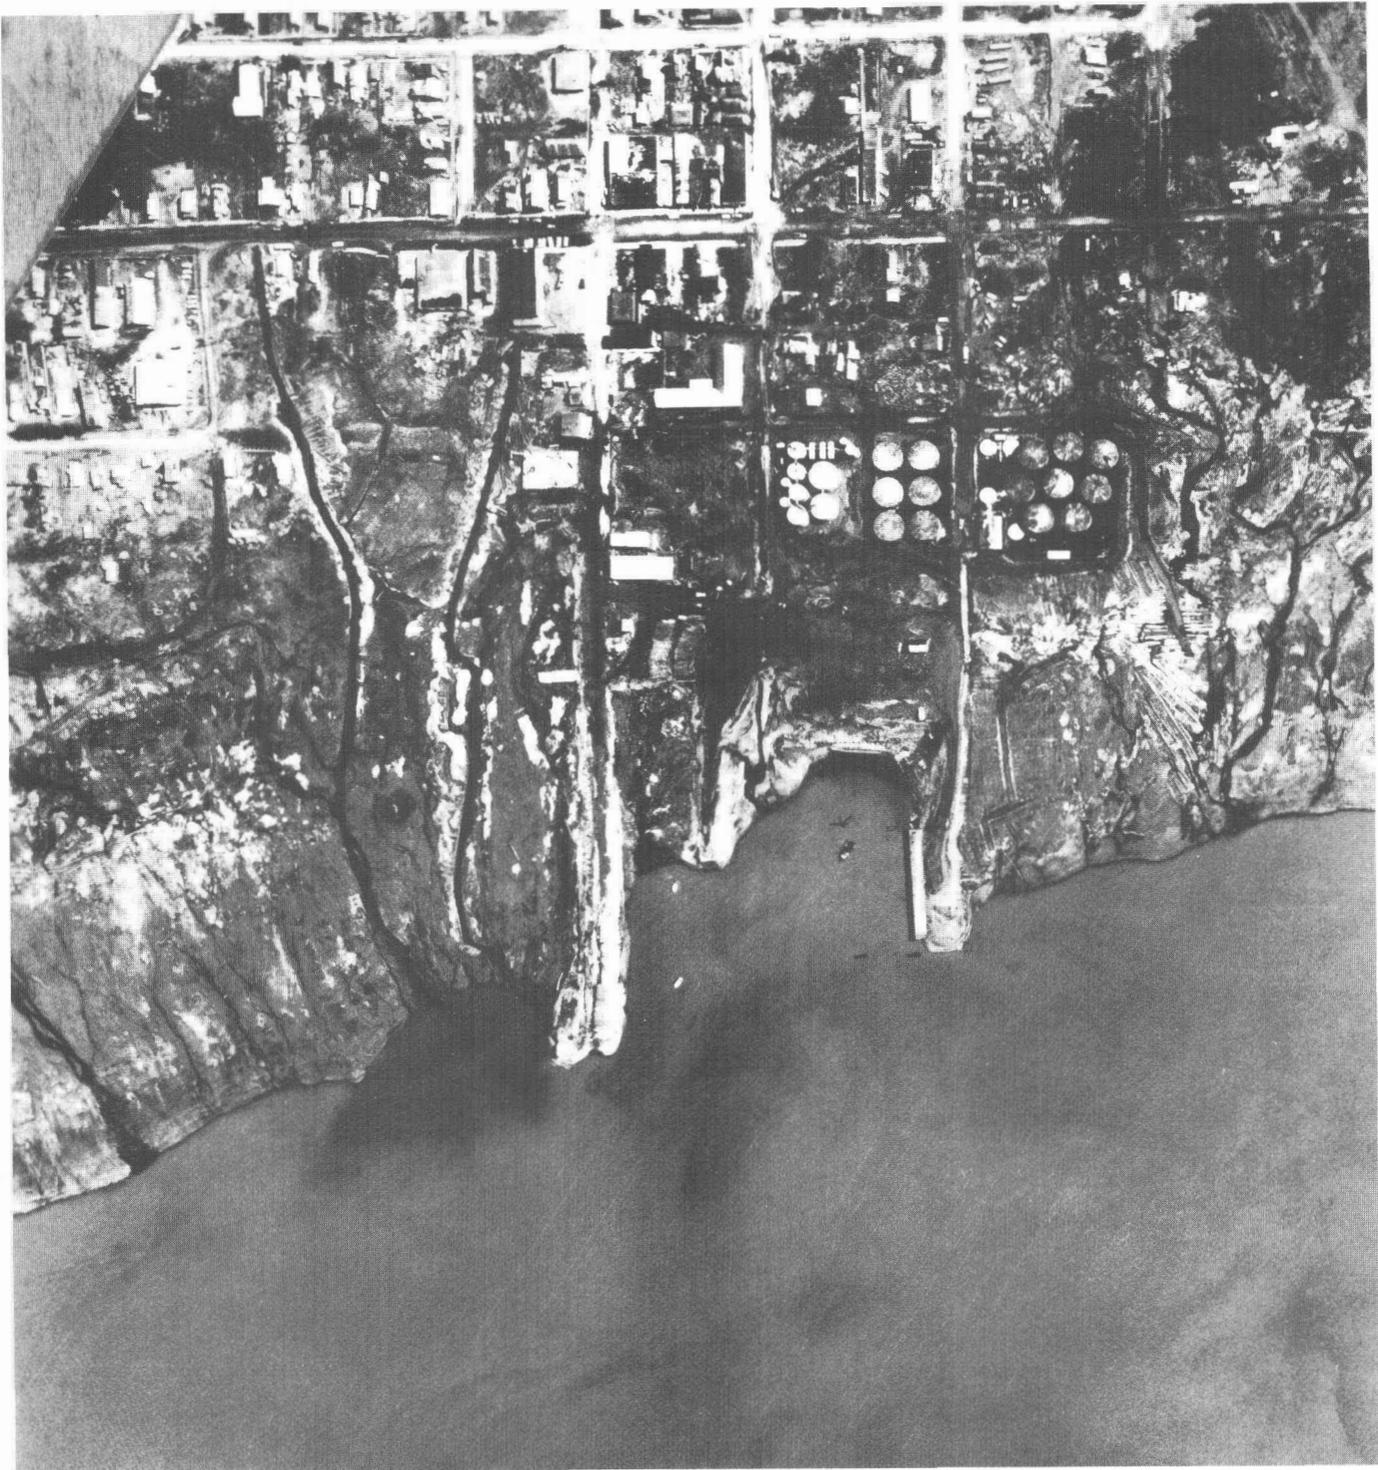
6.—Valdez dock area, June 13, 1964. Photograph by Air Photo Tech, Inc.

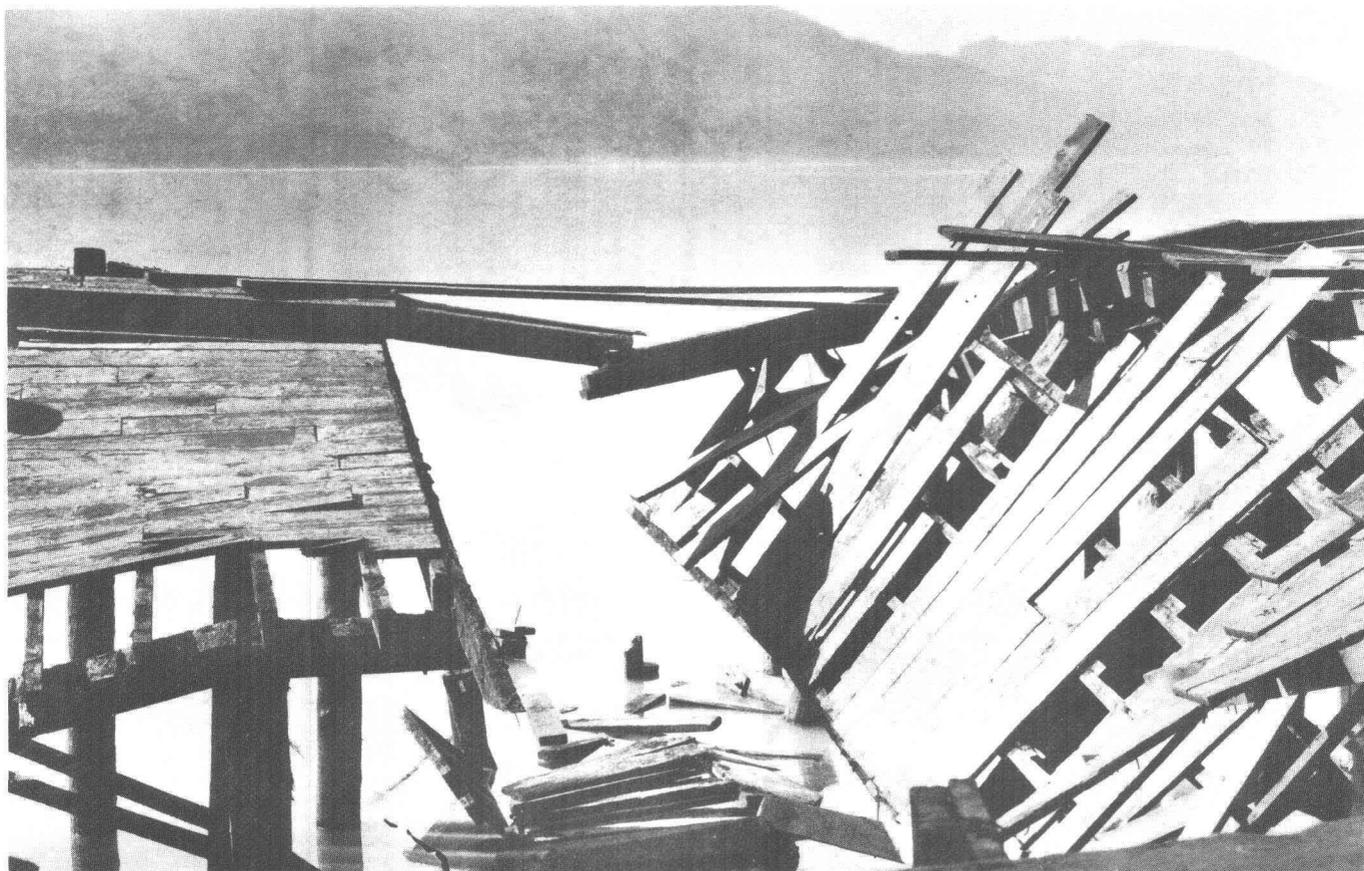
The second dock failure occurred in the late 1920's and is illustrated by figure 7. In this failure there is no record of heavy loads on the dock at the time of failure. Note that the failed section is tipped shoreward.

7.—Dock failure in late 1920's. Note that failed section has tipped shoreward. Photograph courtesy of James Derringer.

The reason for these two later slides is not as clearly understood as the first slide described. The dock was empty when the last two slides occurred, and there was no noticeable seismic action. Because both seismic action and heavy loads can be ruled out, other factors were undoubtedly responsible. It should be emphasized that these slumps were small localized features.

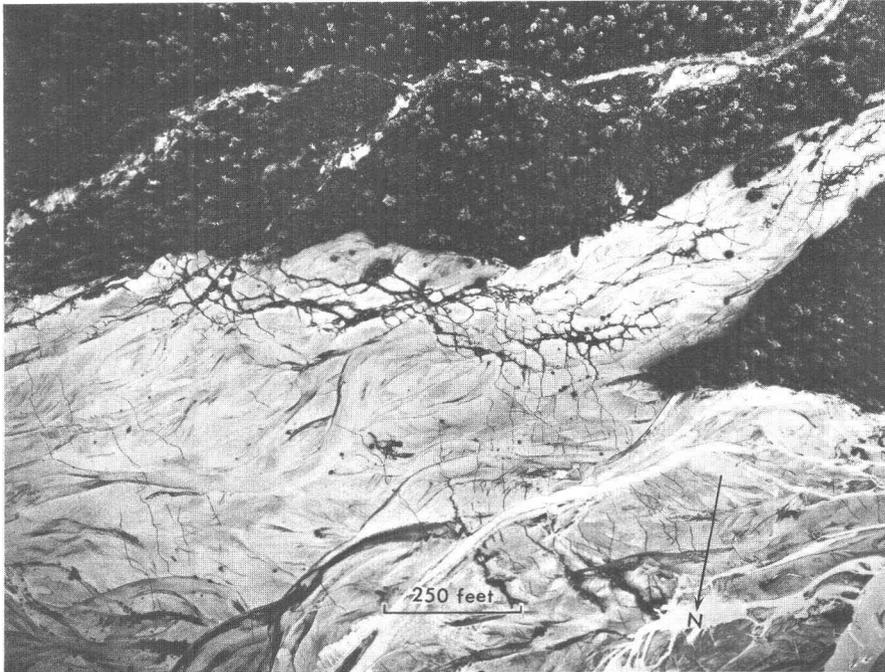
8.—Vertical aerial photograph showing fissures on the flood plain of the stream from the Valdez Glacier. Photograph by Air Photo Tech, Inc.

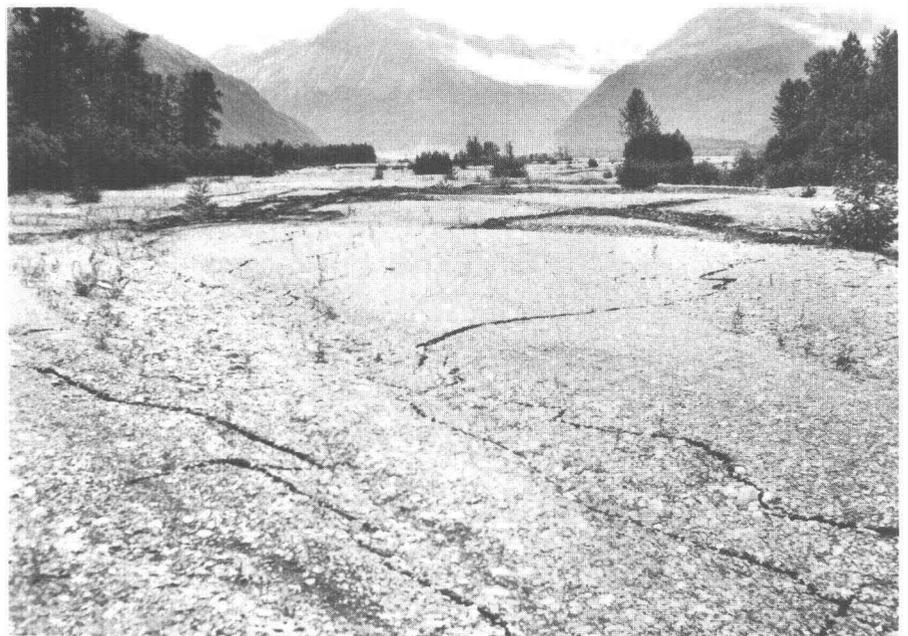
9.—Transverse fissures (foreground) and longitudinal fissures (in the middle distance). Ridges of ejected material (silt and sand) border the longitudinal fissures.

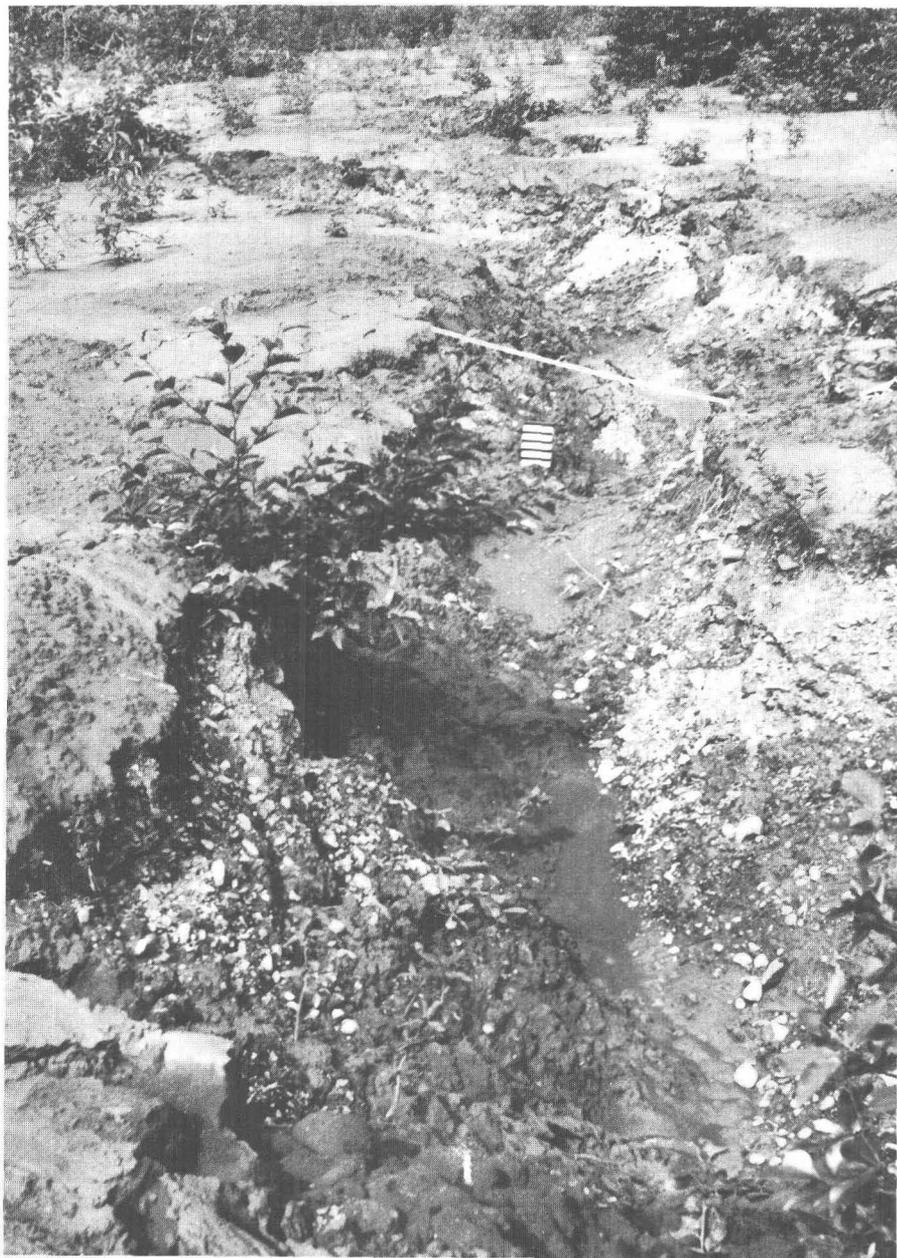
The largest individual longitudinal-fissure segment observed was located 1,500 feet east of Dike Road and 800 feet north of Richardson Highway. It was 6 feet

wide, 4 feet deep, and approximately 250 feet long (see fig. 10). Although some parts of the walls of the fissure apparently had collapsed during the spring thaw, the overall width does not appear to have been increased appreciably. A large volume of fine sand and silt was ejected from this fissure.

10.—Large longitudinal fissure. Surrounding area covered by ejected sand and silt. Carpenter's rule across fissure is 6 feet long; vertical scale below it is 1 foot high.

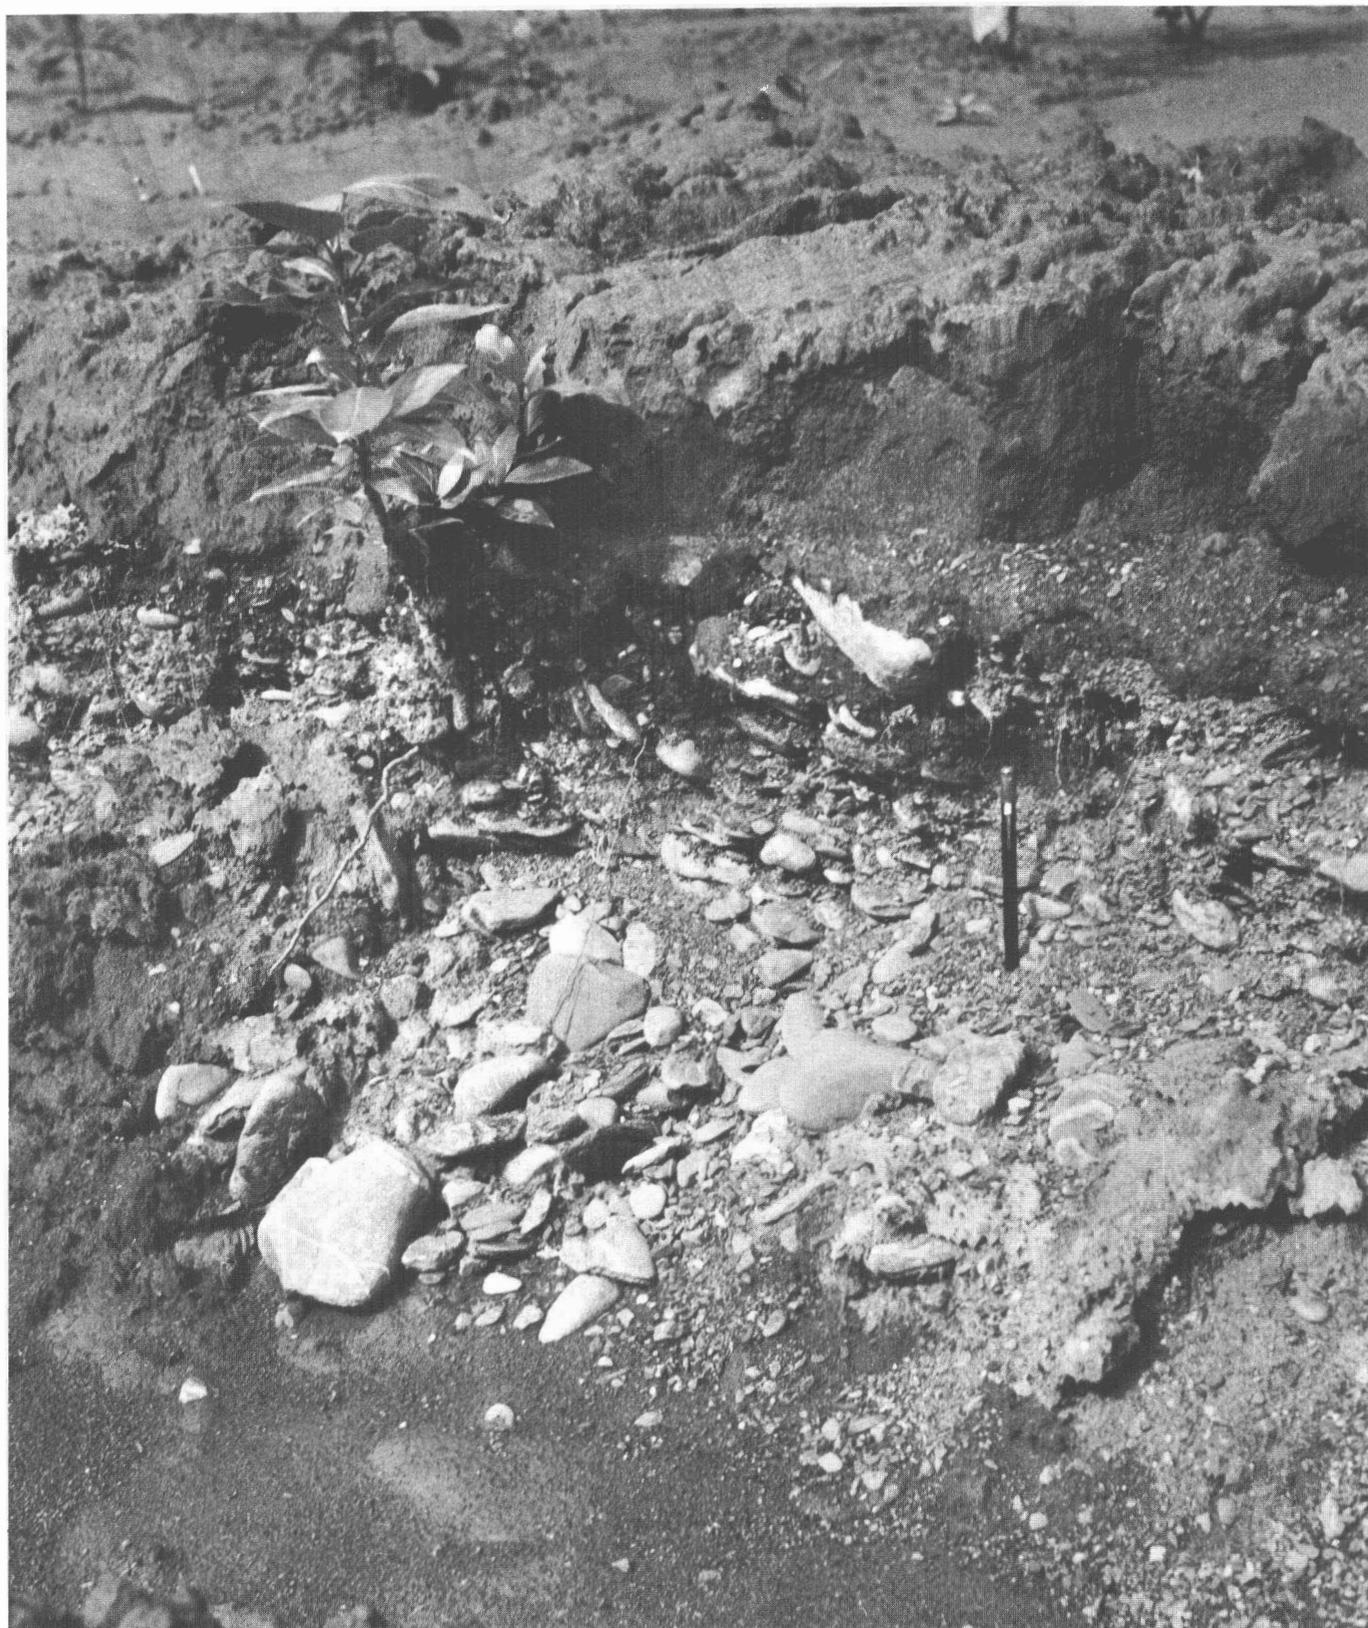
Figure 11 shows the fissure wall and approximately 2 feet of ejected material overlying the original surface. The thickness of this blanket of ejecta decreases away from the fissure on both sides to a feathered edge approximately 100 feet from the centerline of the fissure. The volume of material ejected is roughly estimated as 2,000 cubic yards.

11.—Longitudinal-fissure wall showing concentration of fines in ejected material. Original surface at pencil top.

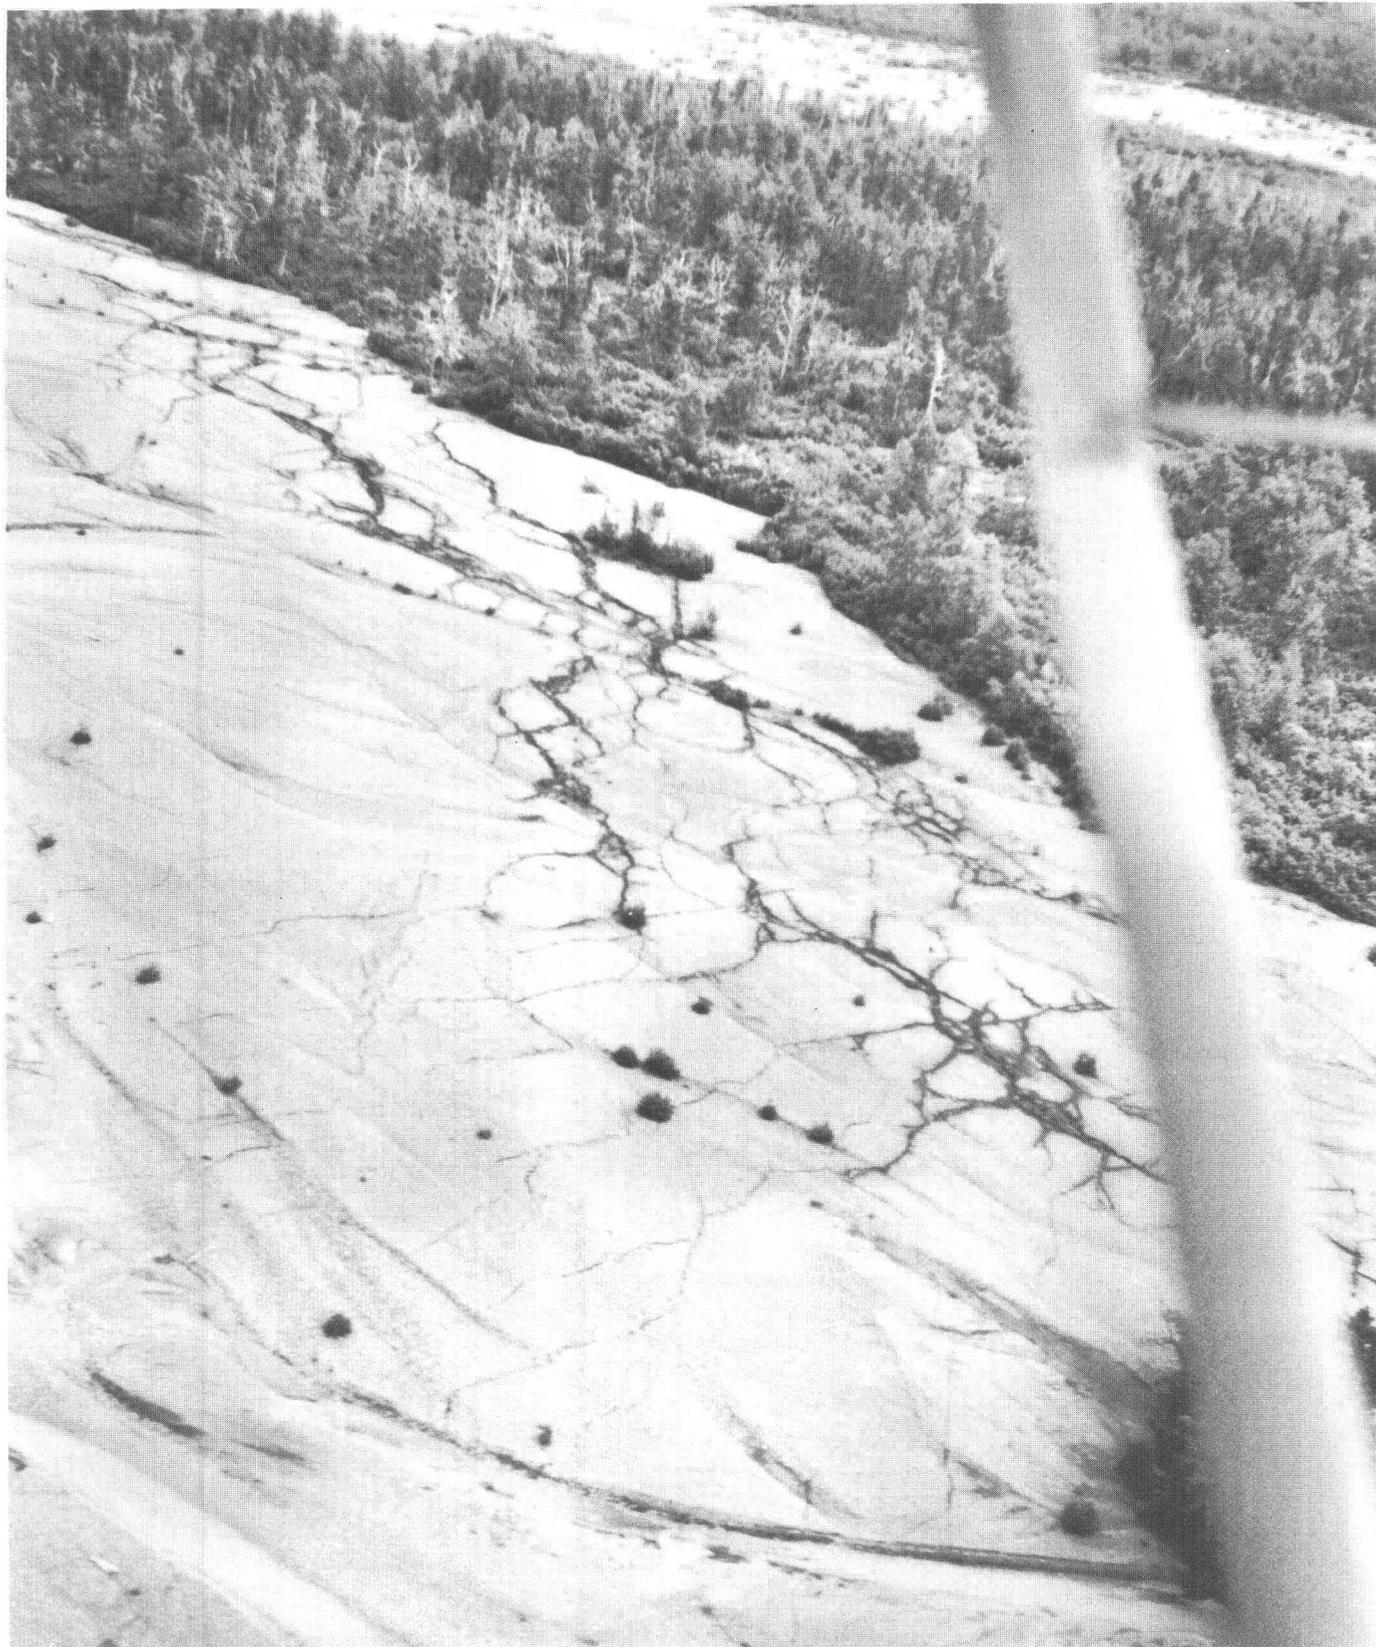
12.—Flood plain of the stream from the Valdez Glacier showing the intersection of a set of transverse fissures with a set of longitudinal fissures. The longitudinal set appears darker because of ejected silt and sand.

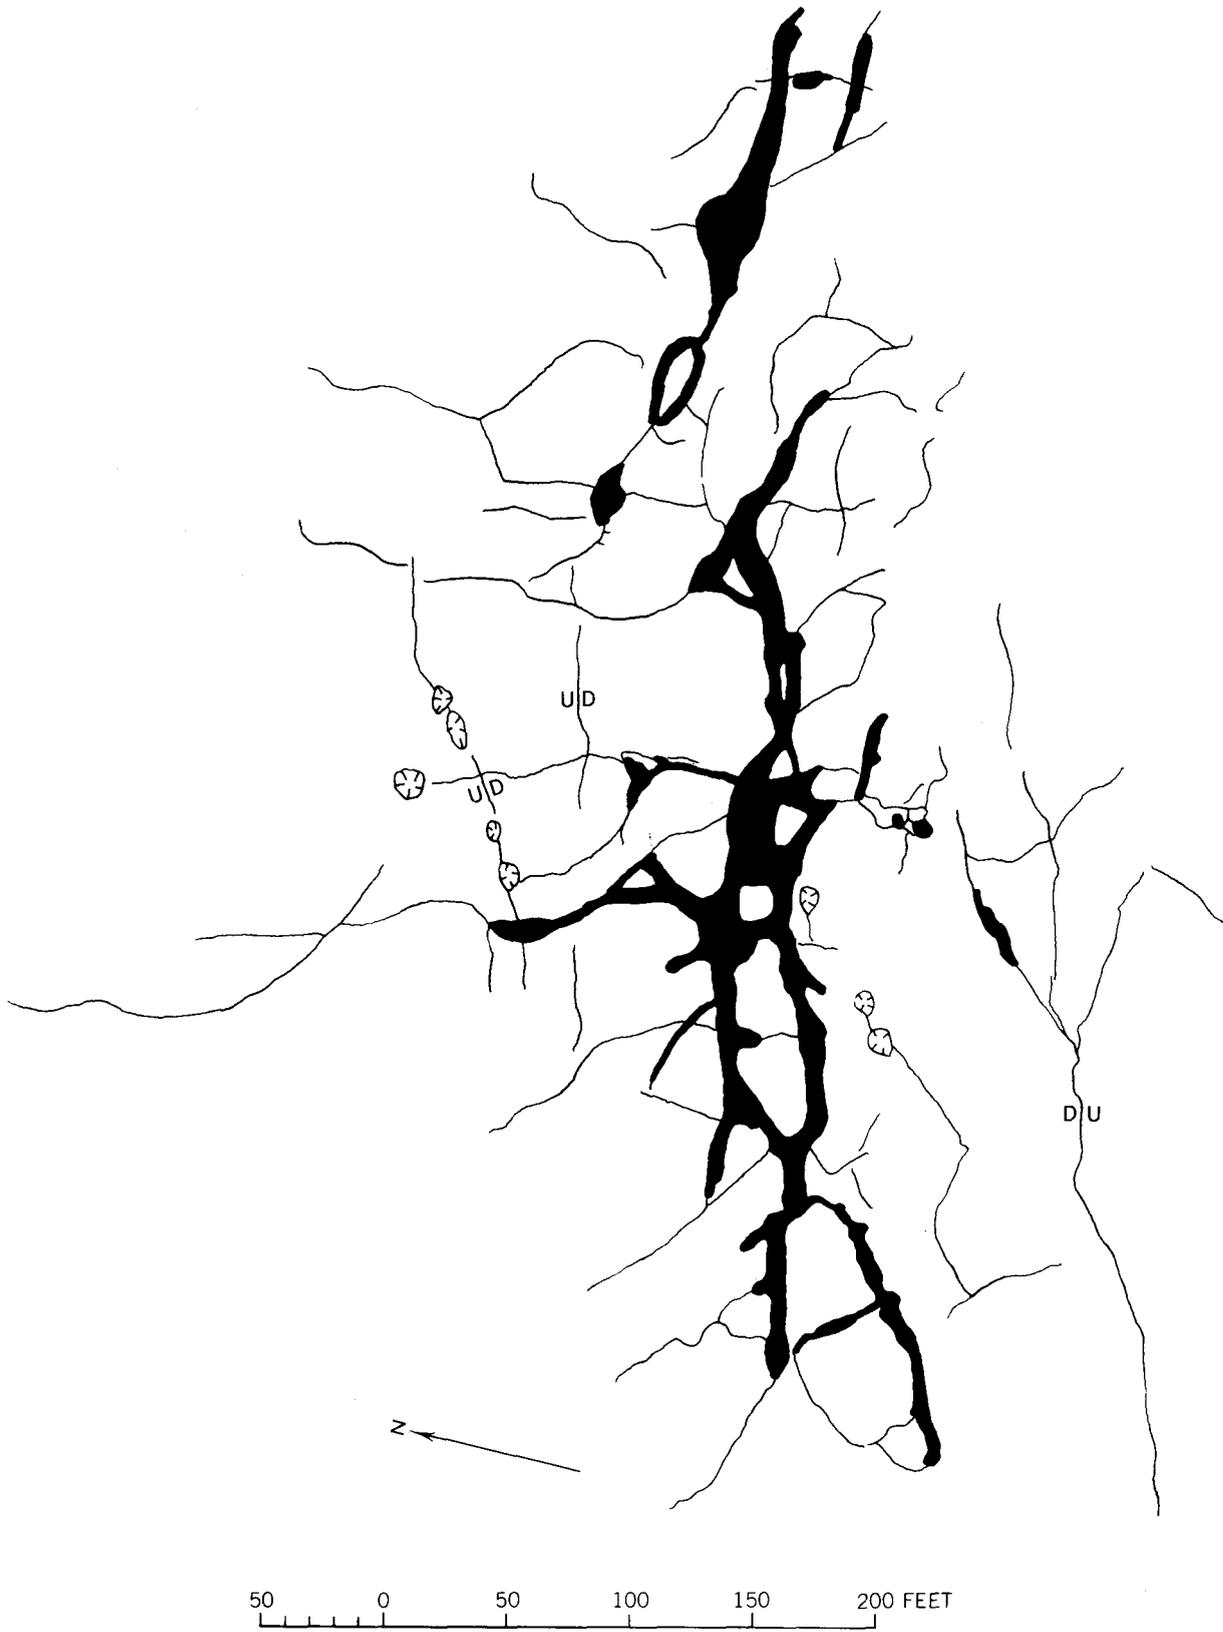
13.—Map showing details of fissures shown on figure 12.

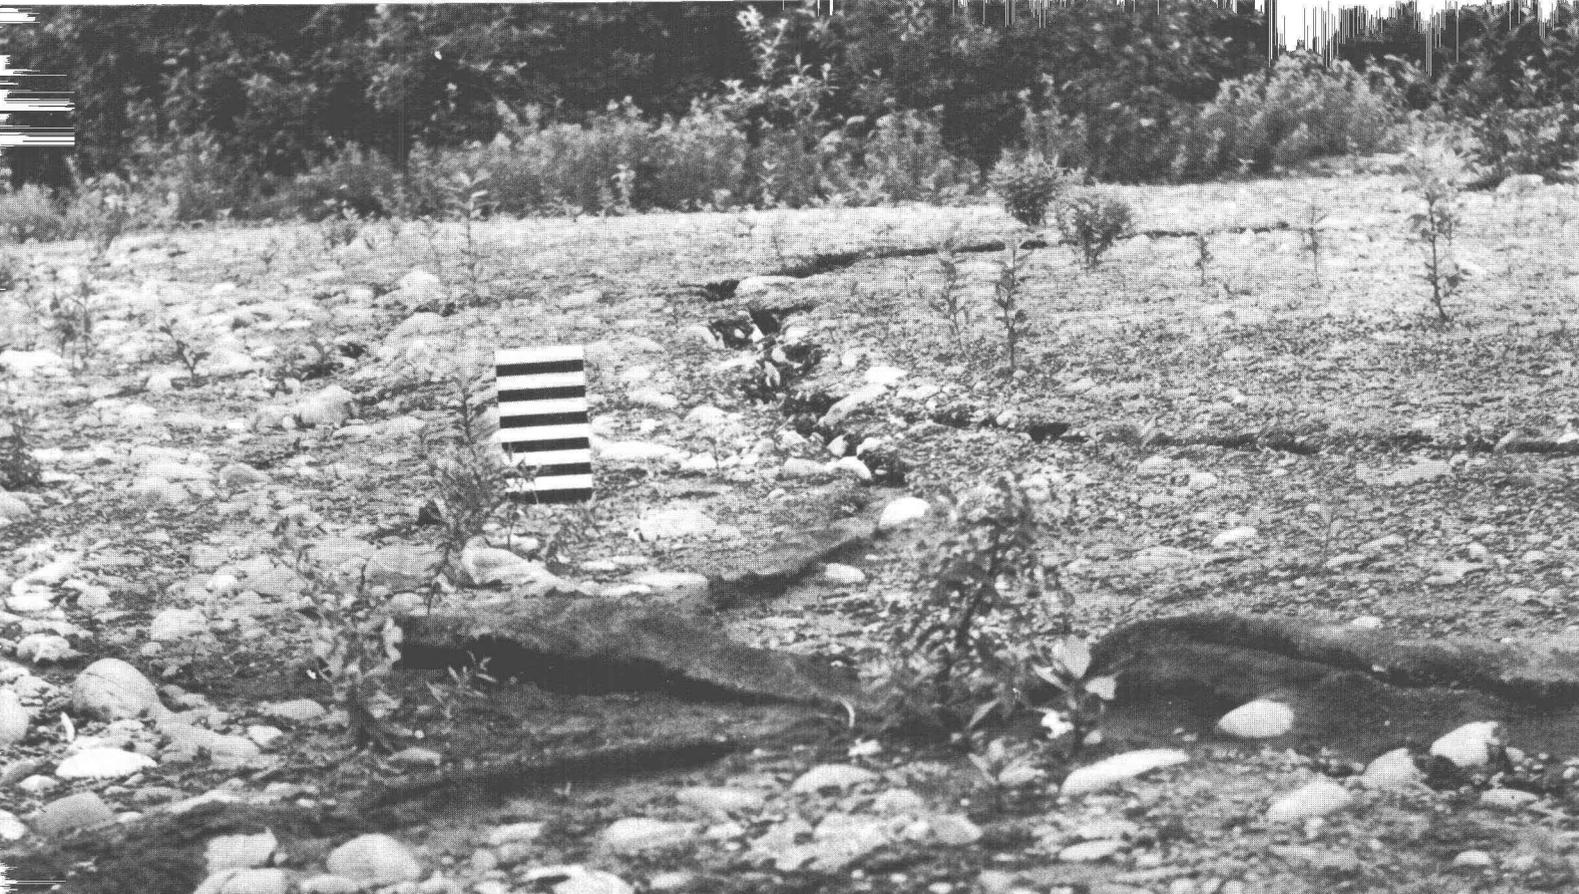
Tabular ridges of silt and sand stand in relief along some of the narrower fissures (fig. 14). These ridges were at first interpreted as extrusions indicating final compressive stress along these particular fissures. However, the fact that many of these ridges intersect almost at right angles argues against their origin by compression. The absolute lack of plasticity of the granular materials comprising these ridges also militates against this explanation; it appears that the ridges are not extrusions but are accumulations of ejected material deposited in fissures that were propagated up into the snow cover; and that the ejecta were left standing in relief after the snow melted.

14.—Zone of intersection between longitudinal fissures (foreground) and transverse fissure (background). Note increasing evidence of sand ejection along transverse fissure as it approaches longitudinal-fissure complex. Scale is 1 foot.

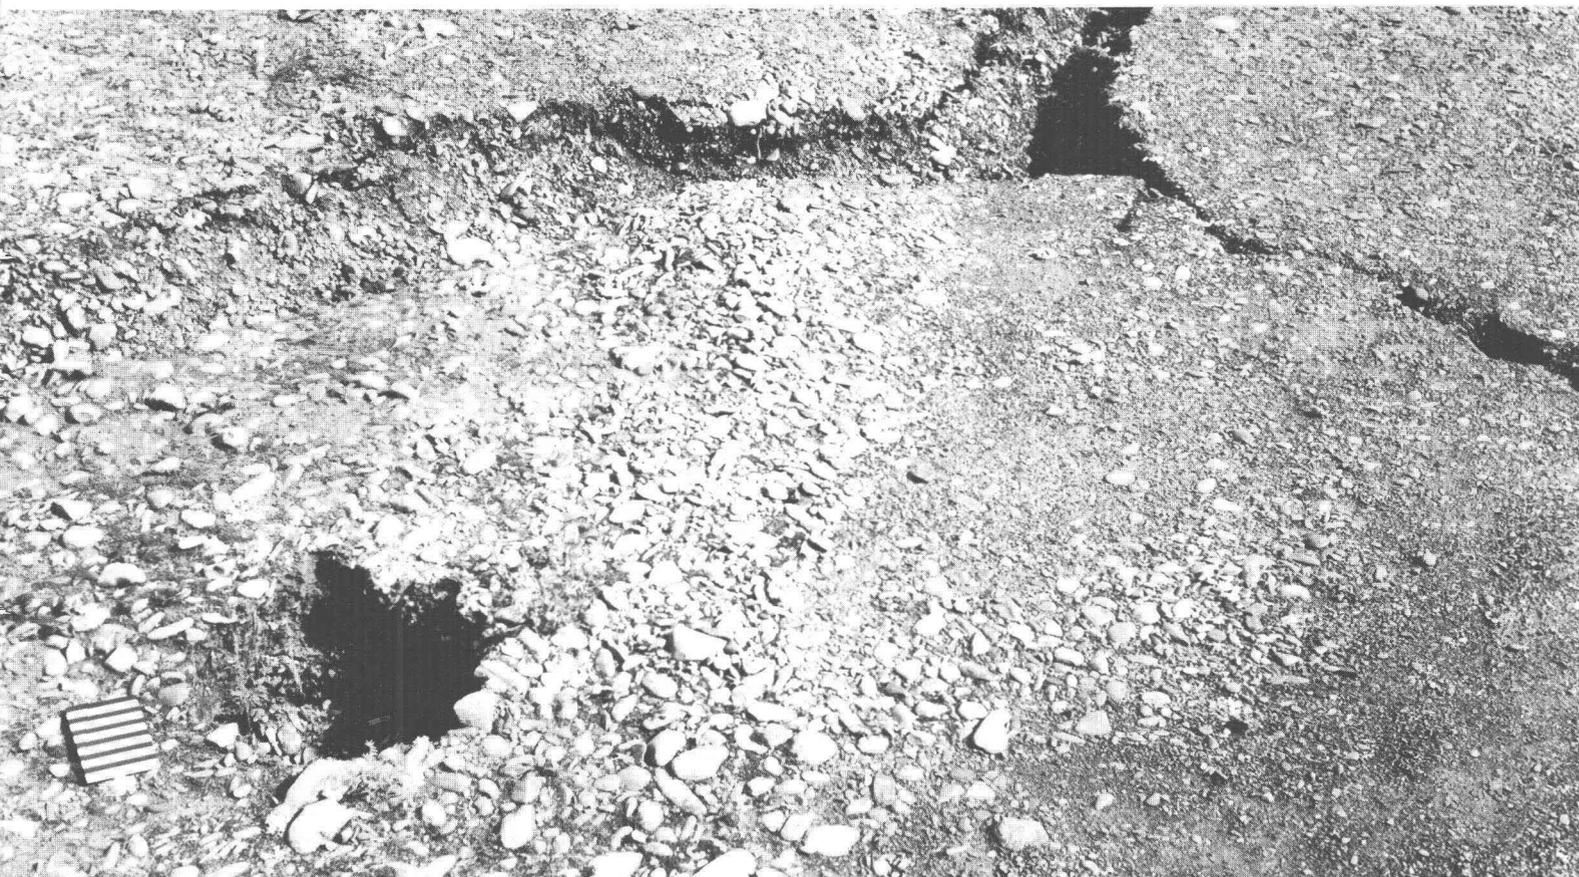
15.—Collapse pit in a graben on the flank of a set of longitudinal fissures. Scale is 1 foot.

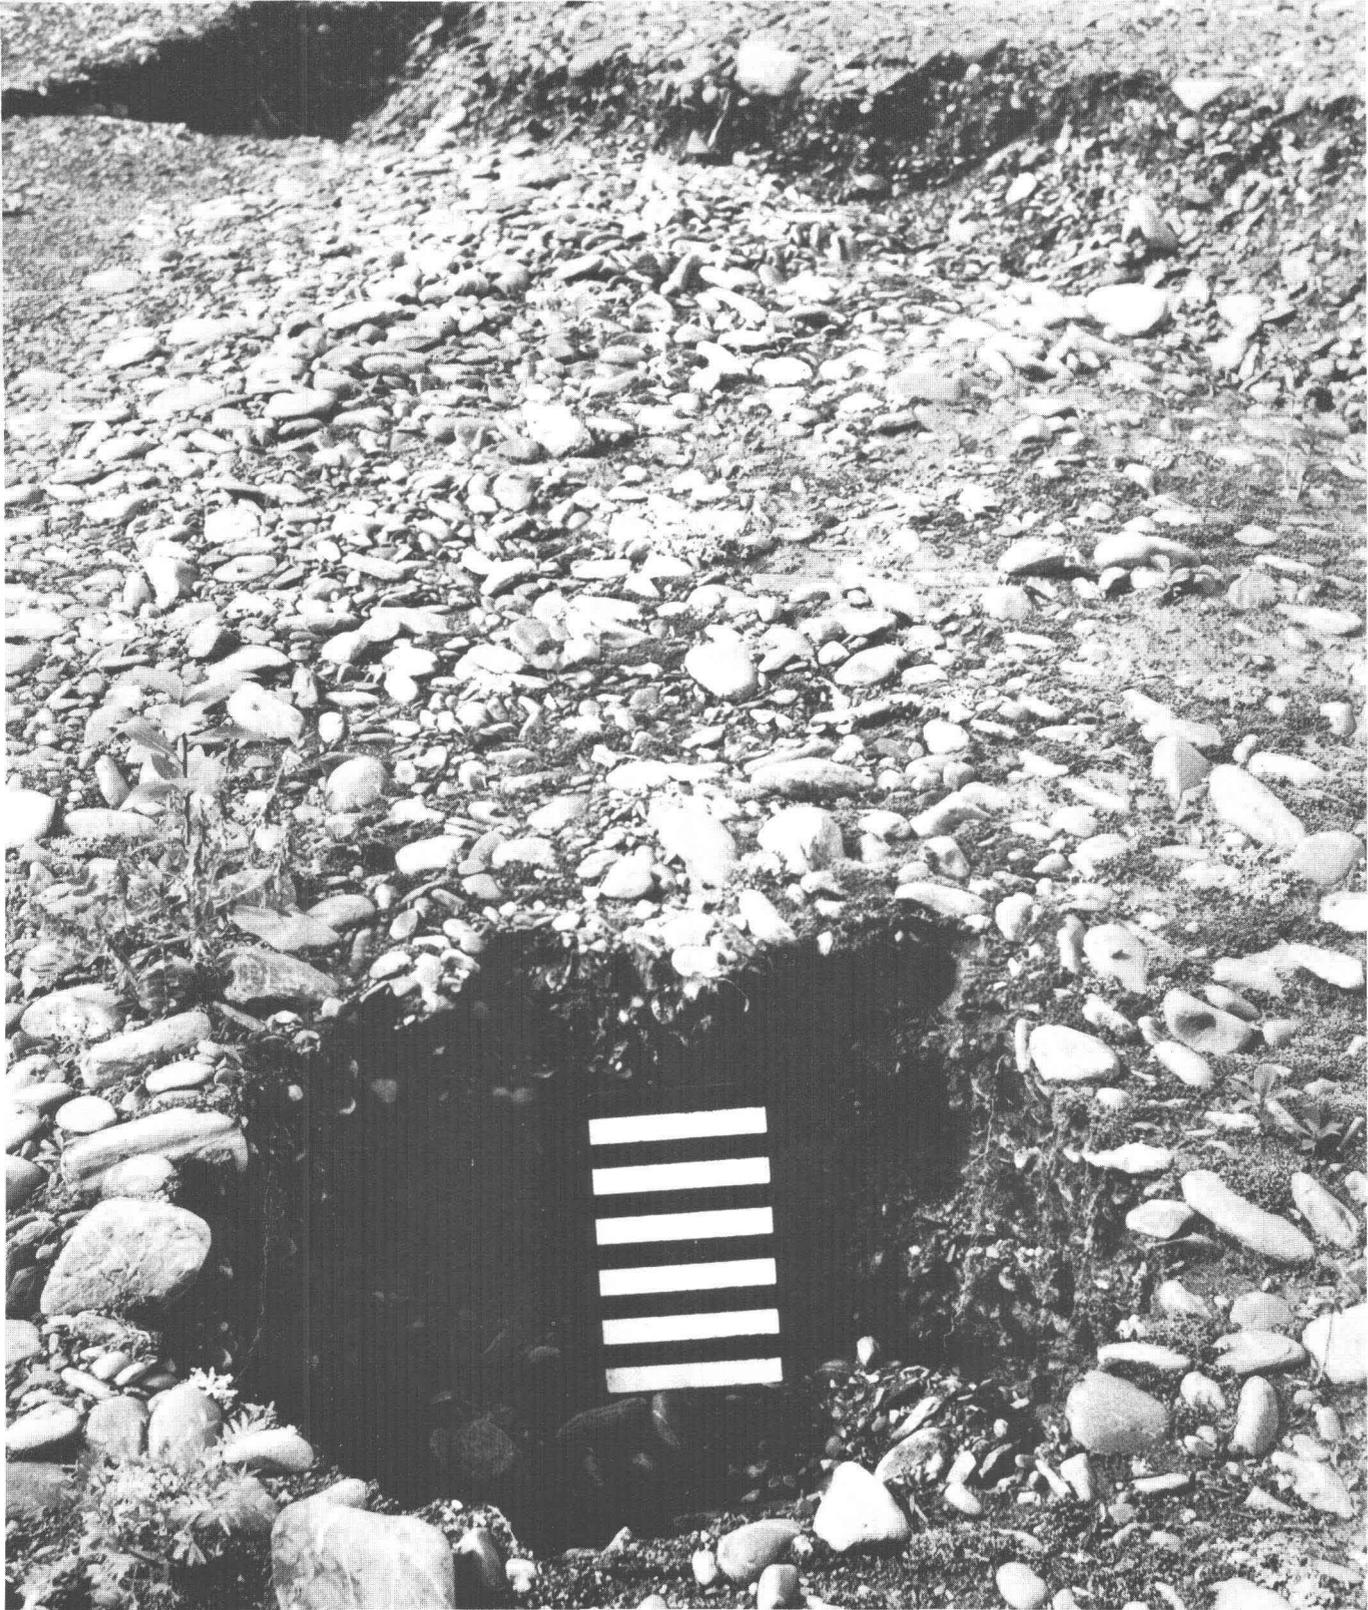
16.—Collapse pit on the flank of a set of longitudinal fissures. Scale is 1 foot.
