EFFECTS OF THE EARTHQUAKE
OF MARCH 27, 1964
AT VALDEZ, ALASKA

Effects of the Earthquake Of March 27, 1964 At Valdez, Alaska

By HENRY W. COULTER and RALPH R. MIGLIACCIO

GEOLOGICAL SURVEY PROFESSIONAL PAPER 542-C

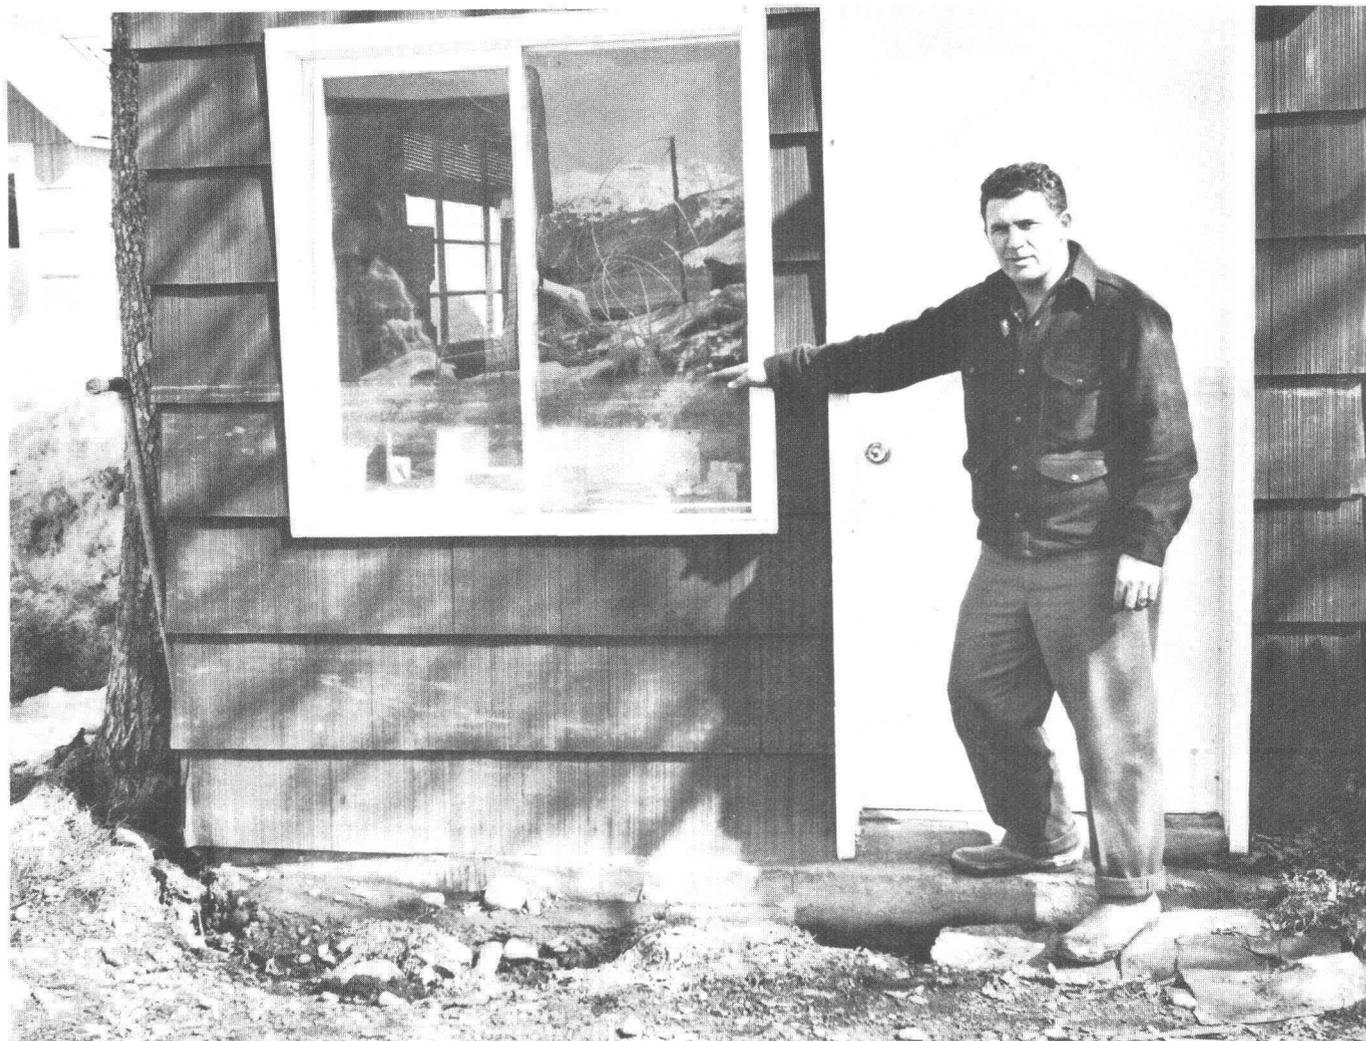
17.—High-water mark from the early-morning wave, about 1:45 a.m., March 28, 1964, on a building on the east side of North Front Street between Rudolph Alley and Dike Street.

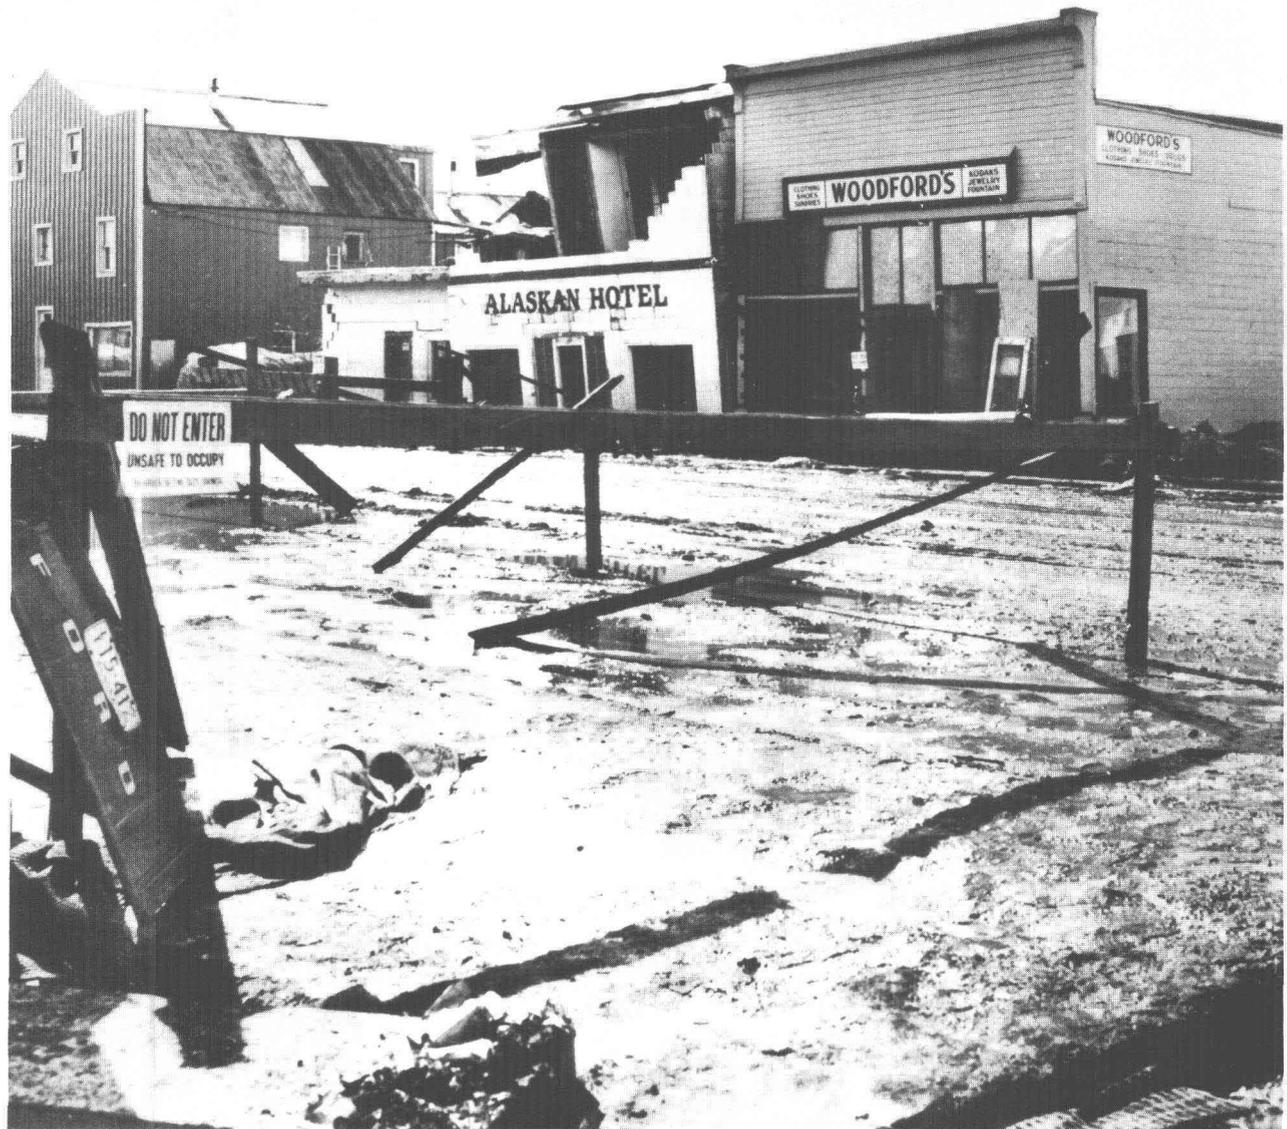
18.—Damage to the Alaskan Hotel on McKinley Street between Alaska Avenue and Broadway. The foundation of this building was intersected by four fissures. Photograph by T. L. Péwé.

tion of the foundations by fissures resulted in the pumping of large volumes of silt and sand into the cellars and crawl spaces. The effects on the commercial cinder-block structures are more apparent (fig. 18).

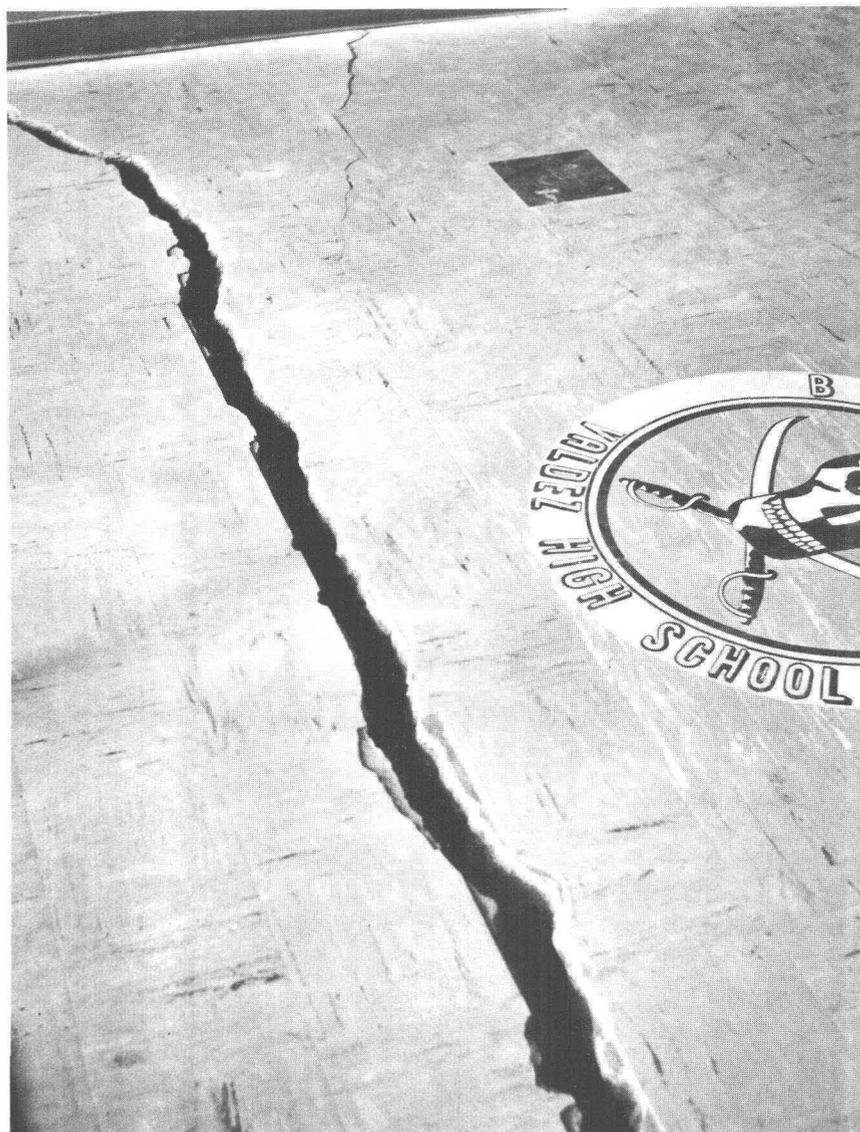
19.—Transverse fissure through the concrete foundation slab of the Valdez High School, Sherman Street and Empire Avenue.

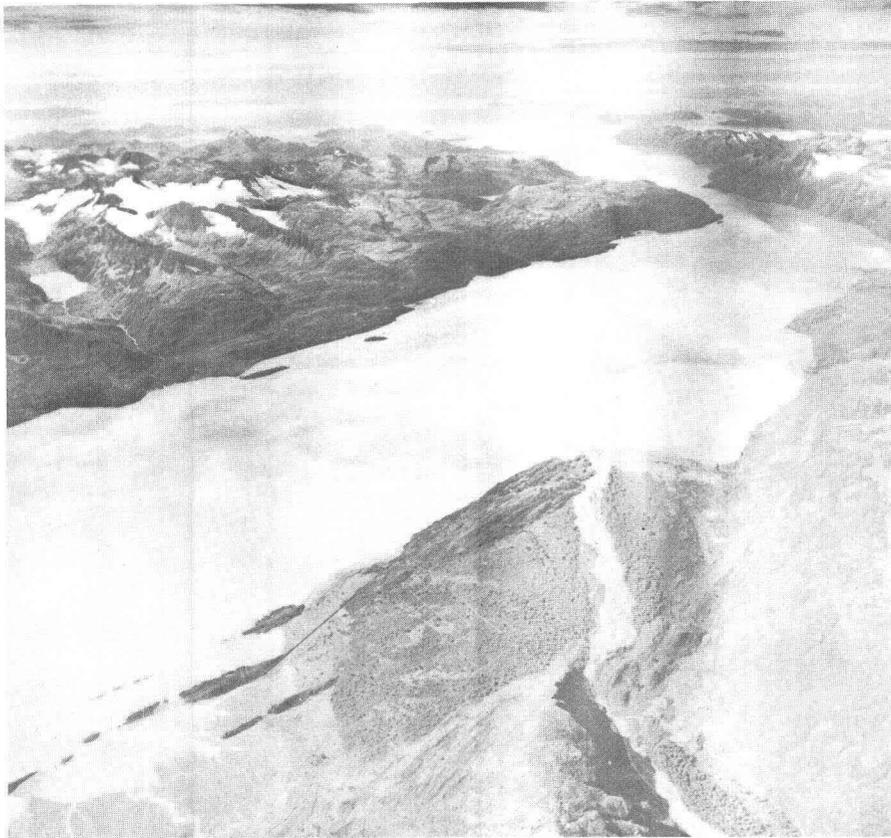
20 (above).—Oblique aerial photograph showing Mineral Creek fan and Mineral Creek islands (foreground), the western end of Port Valdez, Shoup Spit, and Valdez Narrows (background). Photograph by U.S. Air Force.

The absence of evidence of wave damage, of ground breakage and fissures, and of vibration damage to the single dwelling on the Mineral Creek Fan (figs. 20 and 21) indicates a more stable environment there under seismic conditions than exists on the Valdez Delta.

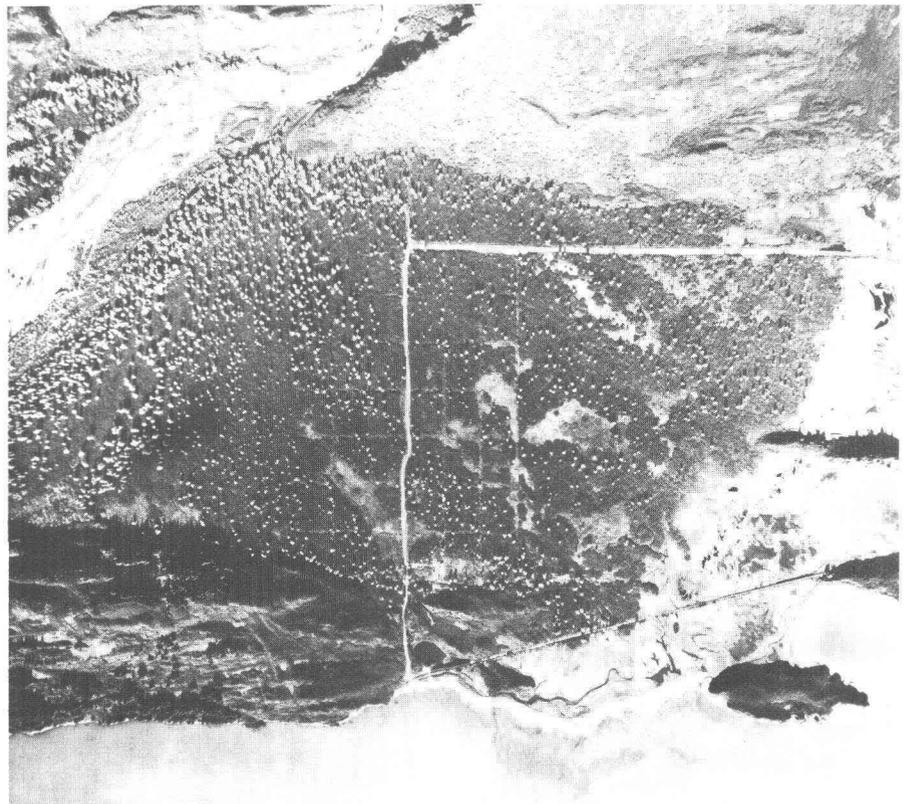
21 (below).—Vertical aerial photograph showing the new location for Valdez on the Mineral Creek fan. Photograph by U.S. Bureau of Land Management.
