EFFECTS OF THE EARTHQUAKE  
OF MARCH 27, 1964  
AT SEWARD, ALASKA

# Effects of the Earthquake Of March 27, 1964, At Seward, Alaska

BY RICHARD W. LEMKE

GEOLOGICAL SURVEY PROFESSIONAL PAPER 542-E

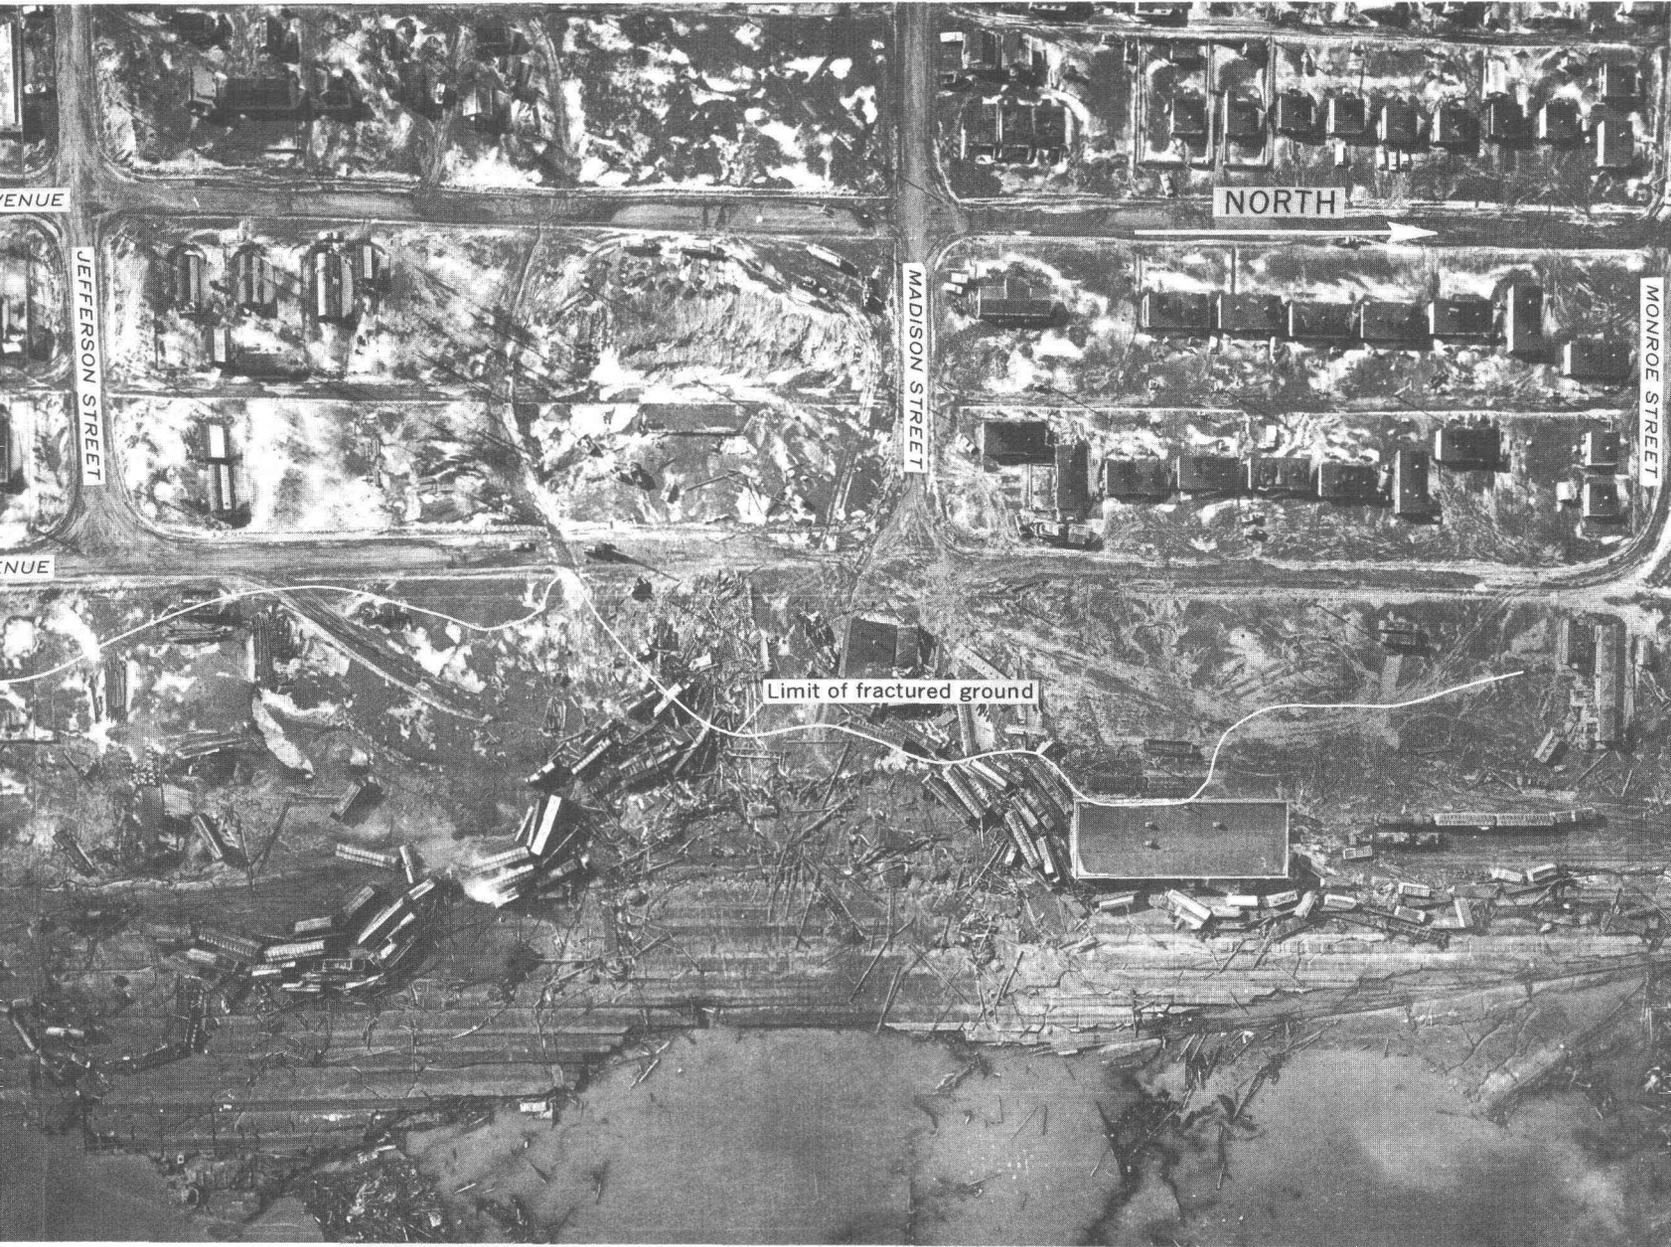
3. Aerial view of the southern part of the Seward waterfront showing extent of ground fracture and earthquake damage. Photographed by the U.S. Army Corps of Engineers.

Ground fracturing along the Seward waterfront (figs. 3, 4) is believed to be closely related to on-shore and offshore landsliding in that area. Horizontal translation and vertical displacement of the ground seaward, as sliding progressed, apparently was the dominant cause of fracturing.

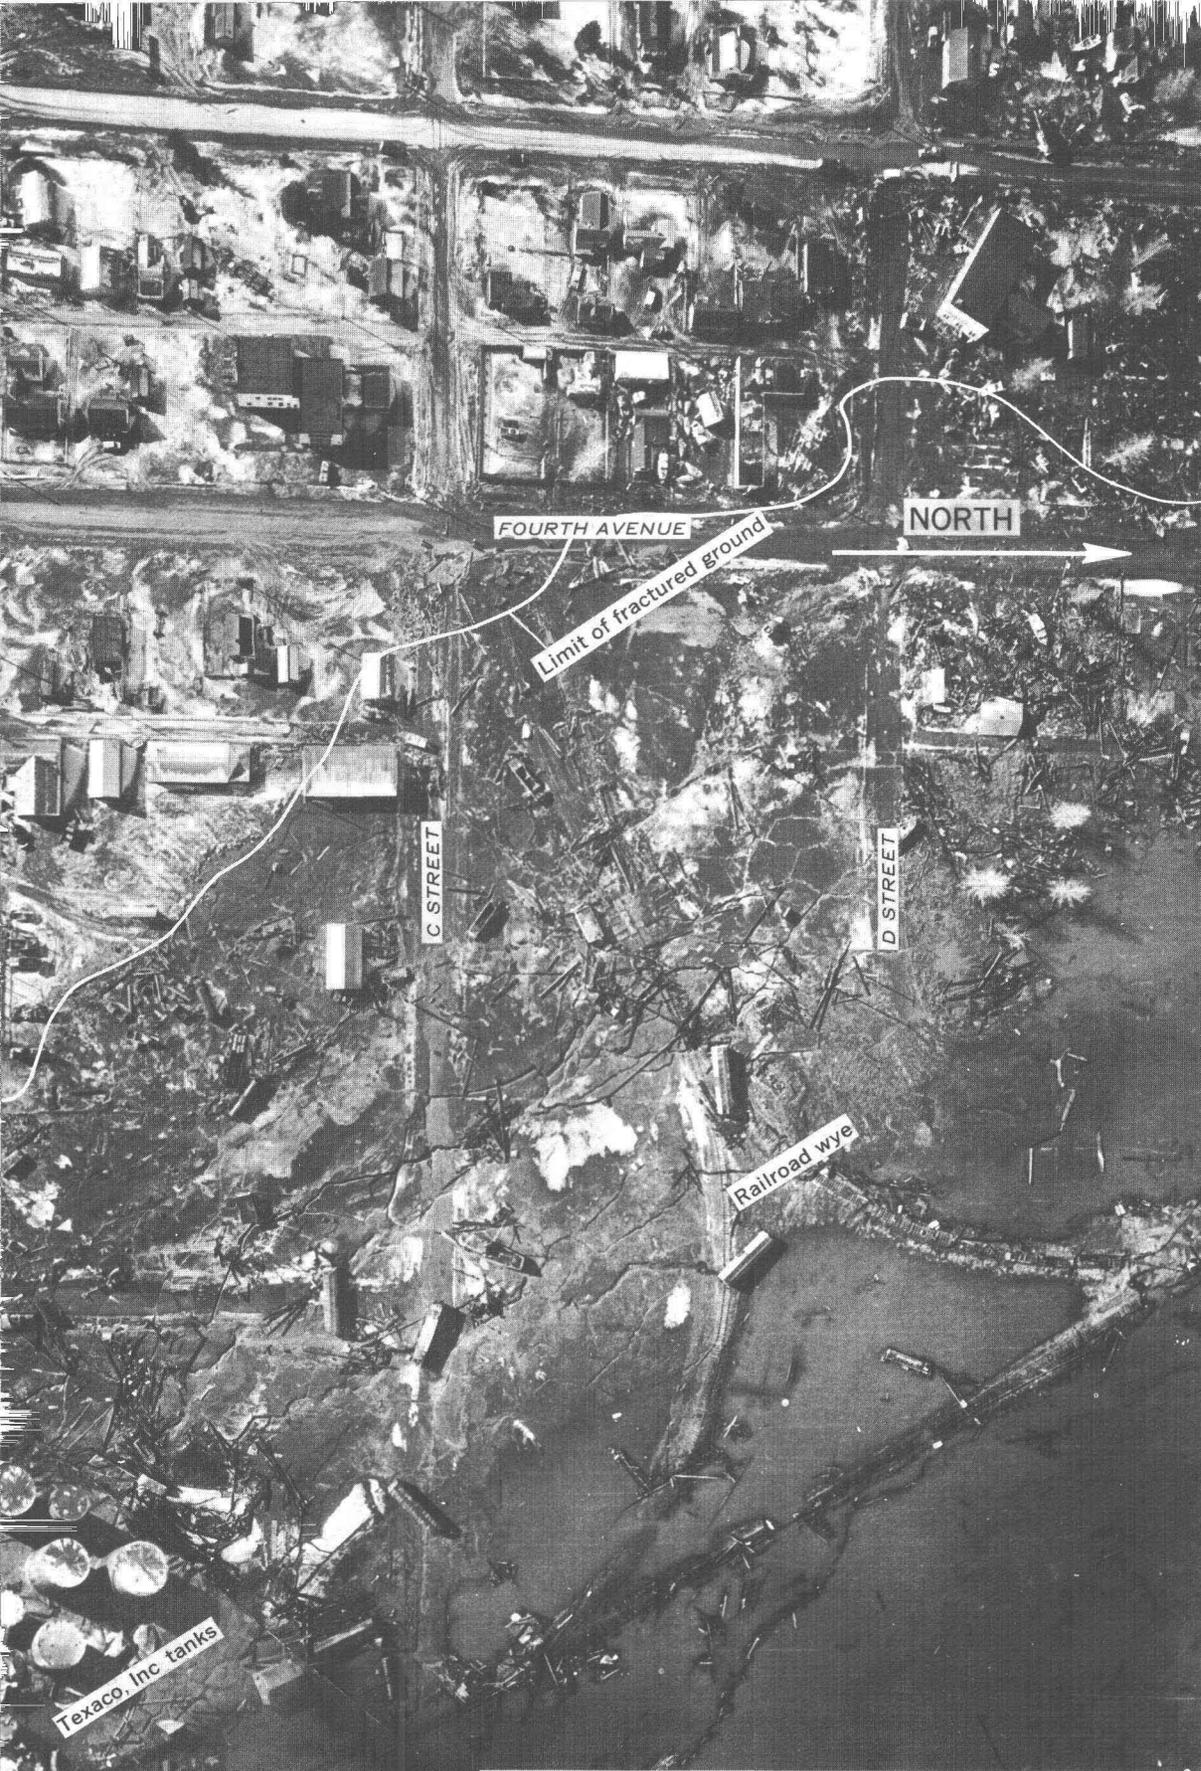
4. Aerial view of the northern part of the Seward waterfront showing extent of fractured ground and earthquake damage. Photograph by U.S. Army; mosaicked by U.S. Geological Survey. Index map (upper left) shows relation of figures 3 and 4.

The total amount of horizontal and vertical displacement in the area of fractured ground could not be determined accurately. It undoubtedly was greatest in the area of the Texaco tanks and became progressively less toward the Standard Oil Co. tanks. Two weeks after the earthquake, the fractures in the area of the Texaco tanks were commonly 0.5–2 feet wide, and a few were as wide as 4 feet. In general, the dominant fracture systems were roughly parallel to the shore. Intersecting transverse fracturing commonly produced a roughly polygonal pattern (fig. 4). In most places, the decreasing width of the fractures

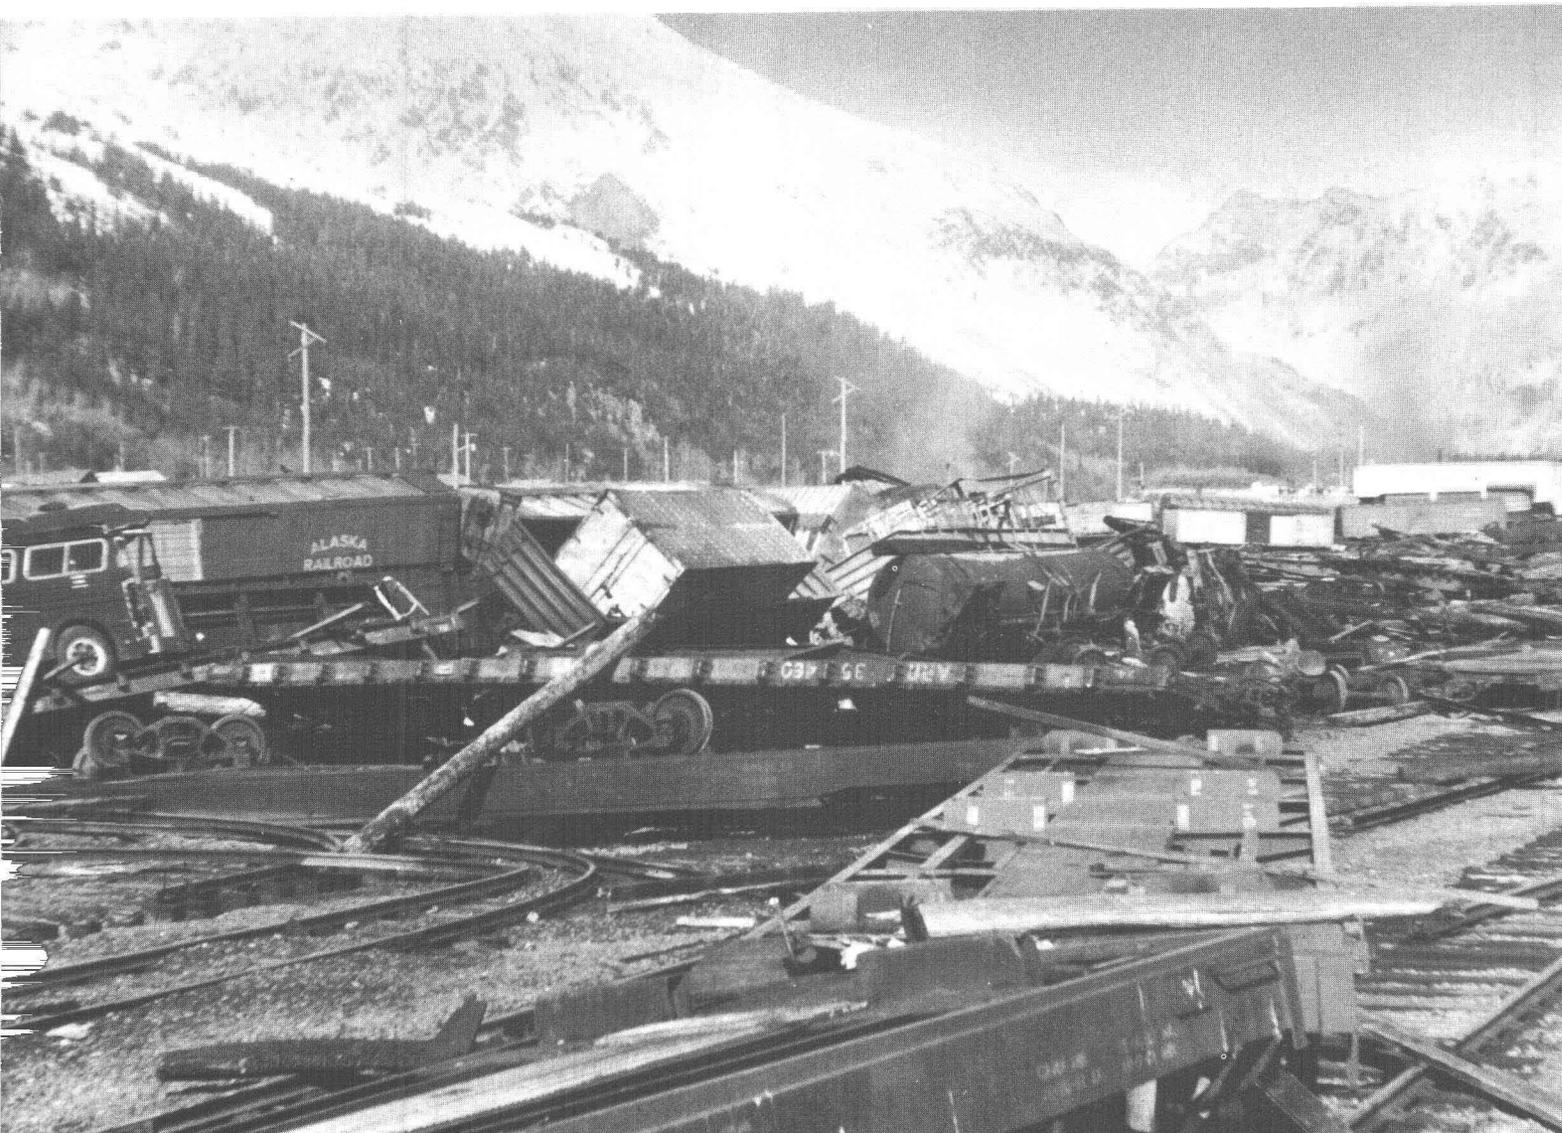
7.—Wave damage in the area of railroad marshalling yards.

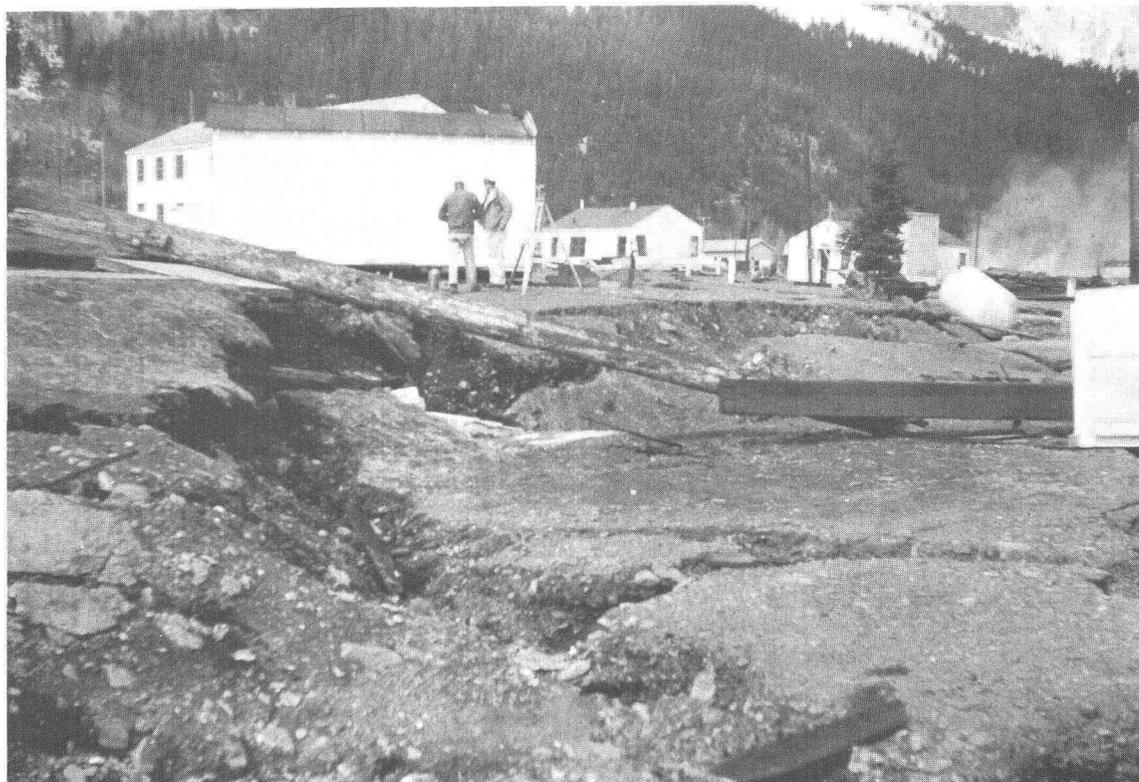
13.—Ground fracture near east end of A Street, about 100 feet from present shoreline, showing vertical displacement of about 4 feet. Downthrown side is toward Resurrection Bay.

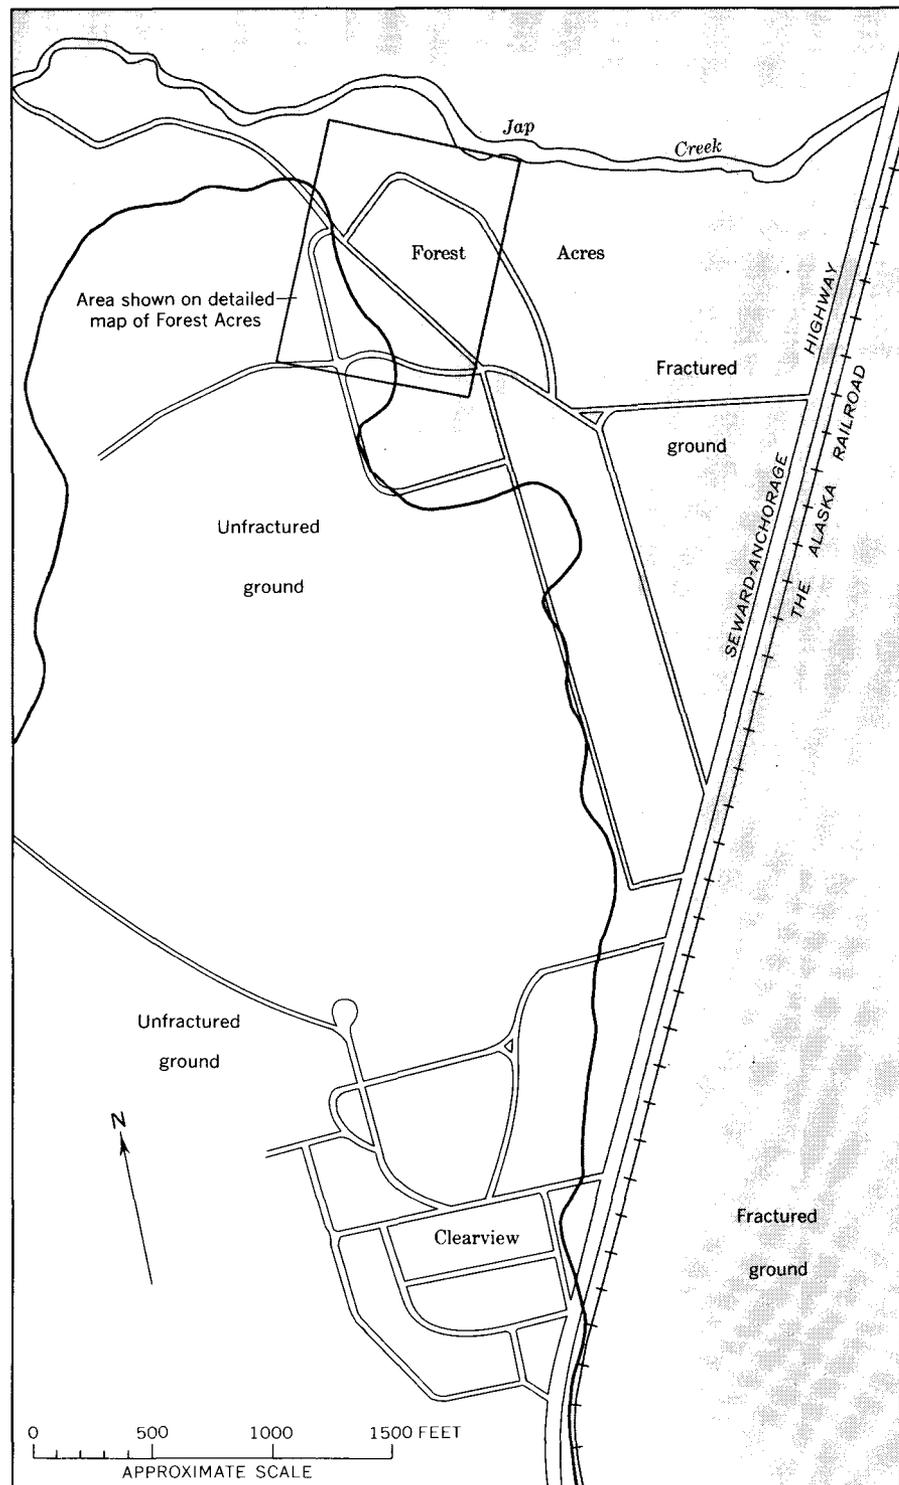
14.—Map of general area of Forest Acres and Clearview subdivisions of Seward showing extent of ground fractured as a result of the earthquake of March 27, 1964.
