THE ALASKA EARTHQUAKE, MARCH 27, 1964:  
REGIONAL EFFECTS

# Surface Faults On Montague Island Associated with the 1964 Alaska Earthquake

*A description and tectonic analysis of ground  
breakage and surface warping along two  
reactivated reverse faults*

GEOLOGICAL SURVEY PROFESSIONAL PAPER 543-G

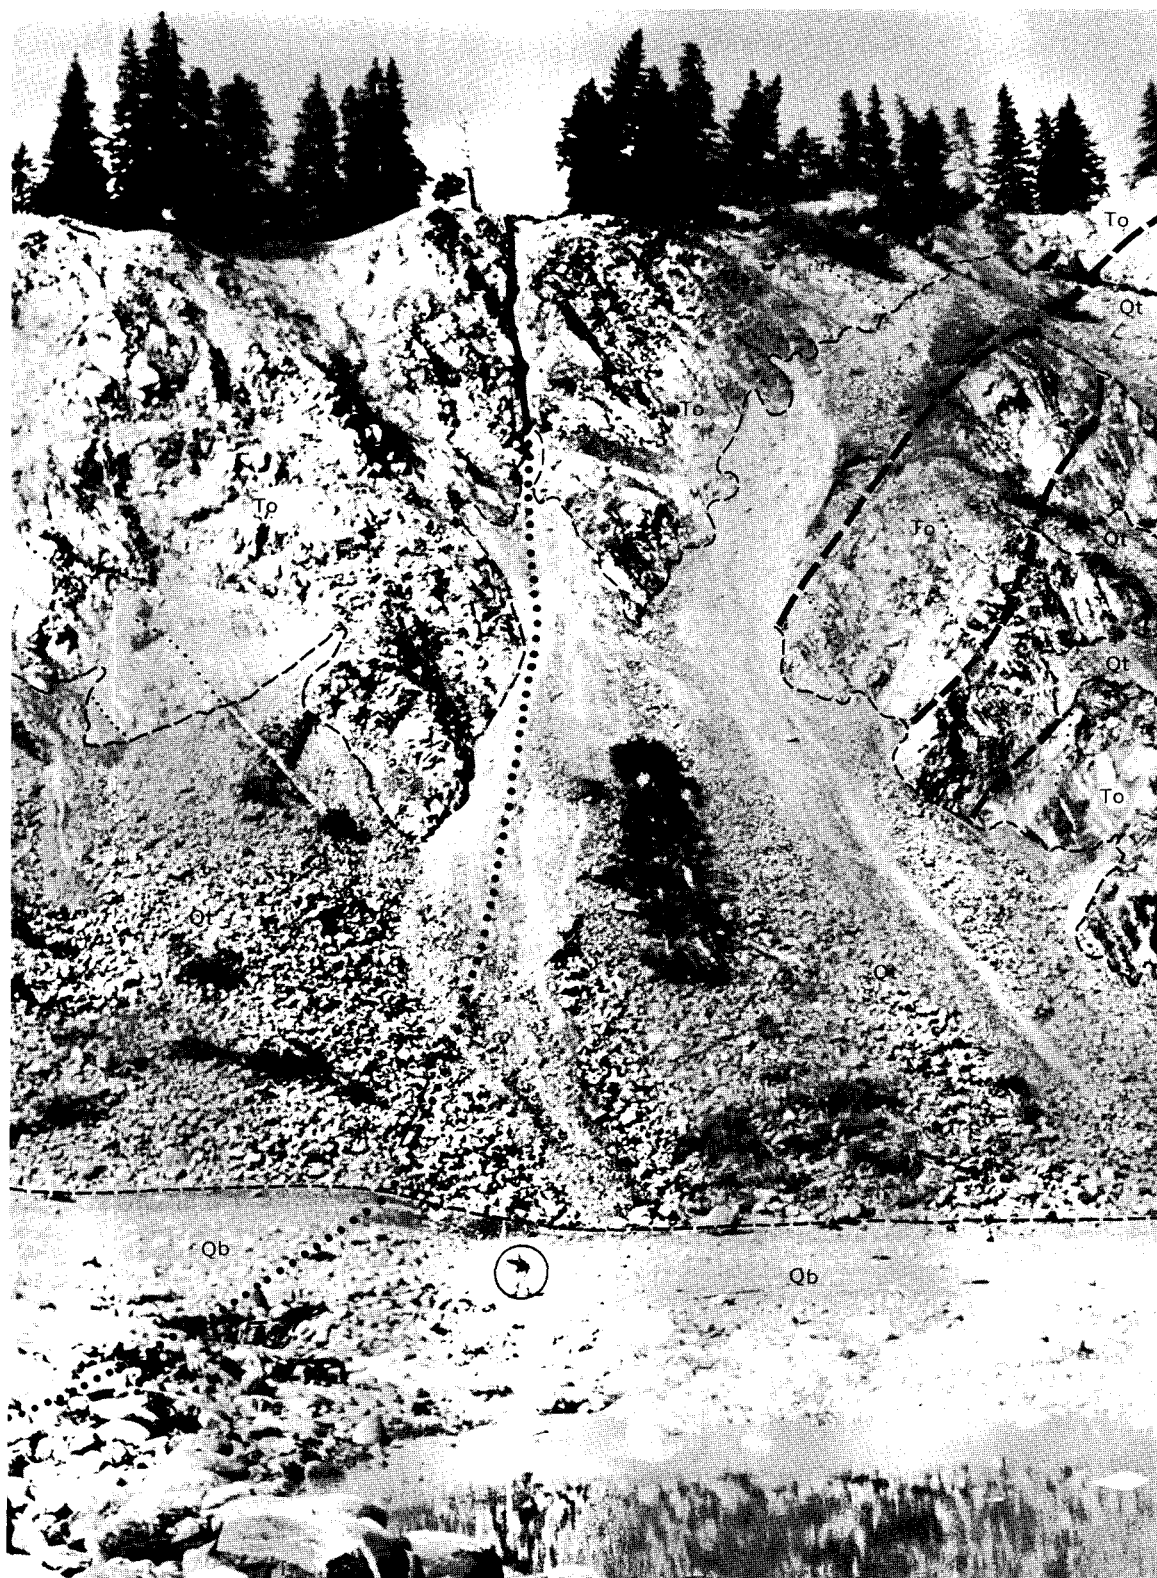
3.—Patton Bay fault (heavy solid and dotted line) at the beach and sea cliff near Jeanie Point. Note the vertical offset of contact between beach deposits (Qb) and talus (Qt). The man (circled) is standing at the base of a scarp 8½ feet high. Light dotted lines are bedding traces in the Orca Group (To); heavy dashed lines are probable fault traces on which there apparently was no movement during the earthquake. Location shown in figure 6.

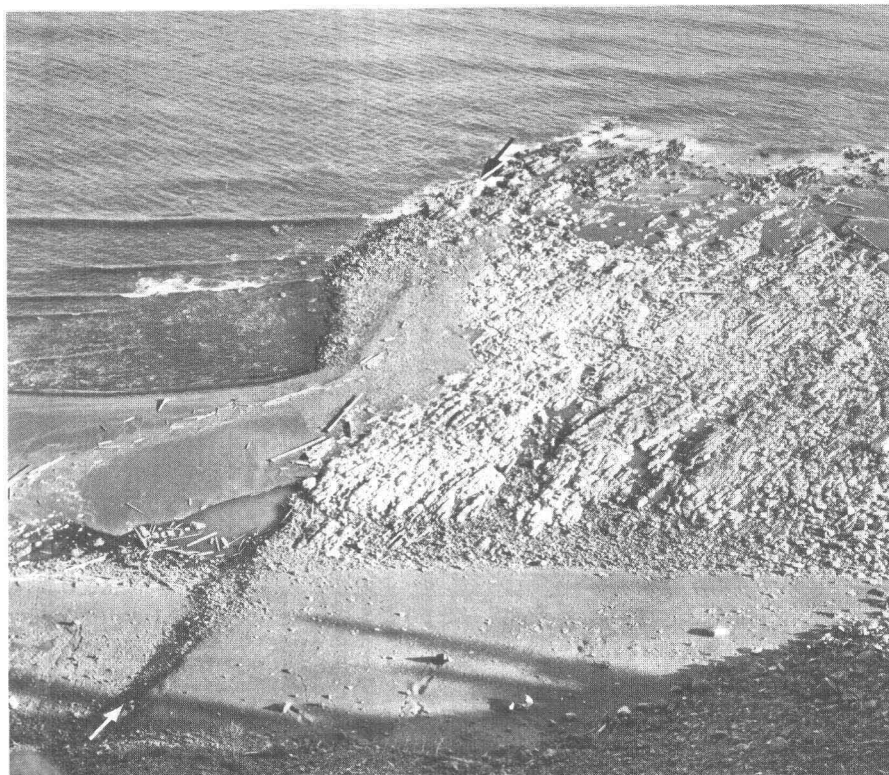
4.—View south from top of the sea cliff in figure 3. Arrows indicate fault trace which displaces the elevated beach prism and cuts obliquely across bedrock structures in the surf-cut platform on the upthrown block. The lower part of the scarp was partially obliterated with newly deposited marine sand and gravel by the time this photograph was taken in August 1965.

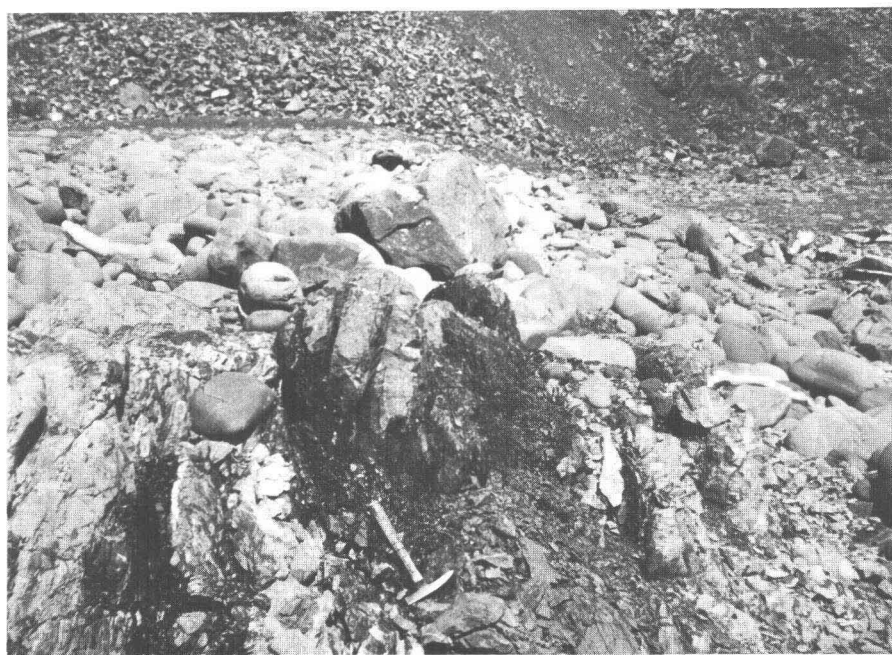
5.—Near-vertical zone of sheared quartz-veined argillite and graywacke along the Patton Bay fault trace at the shore. Location shown in figure 3.

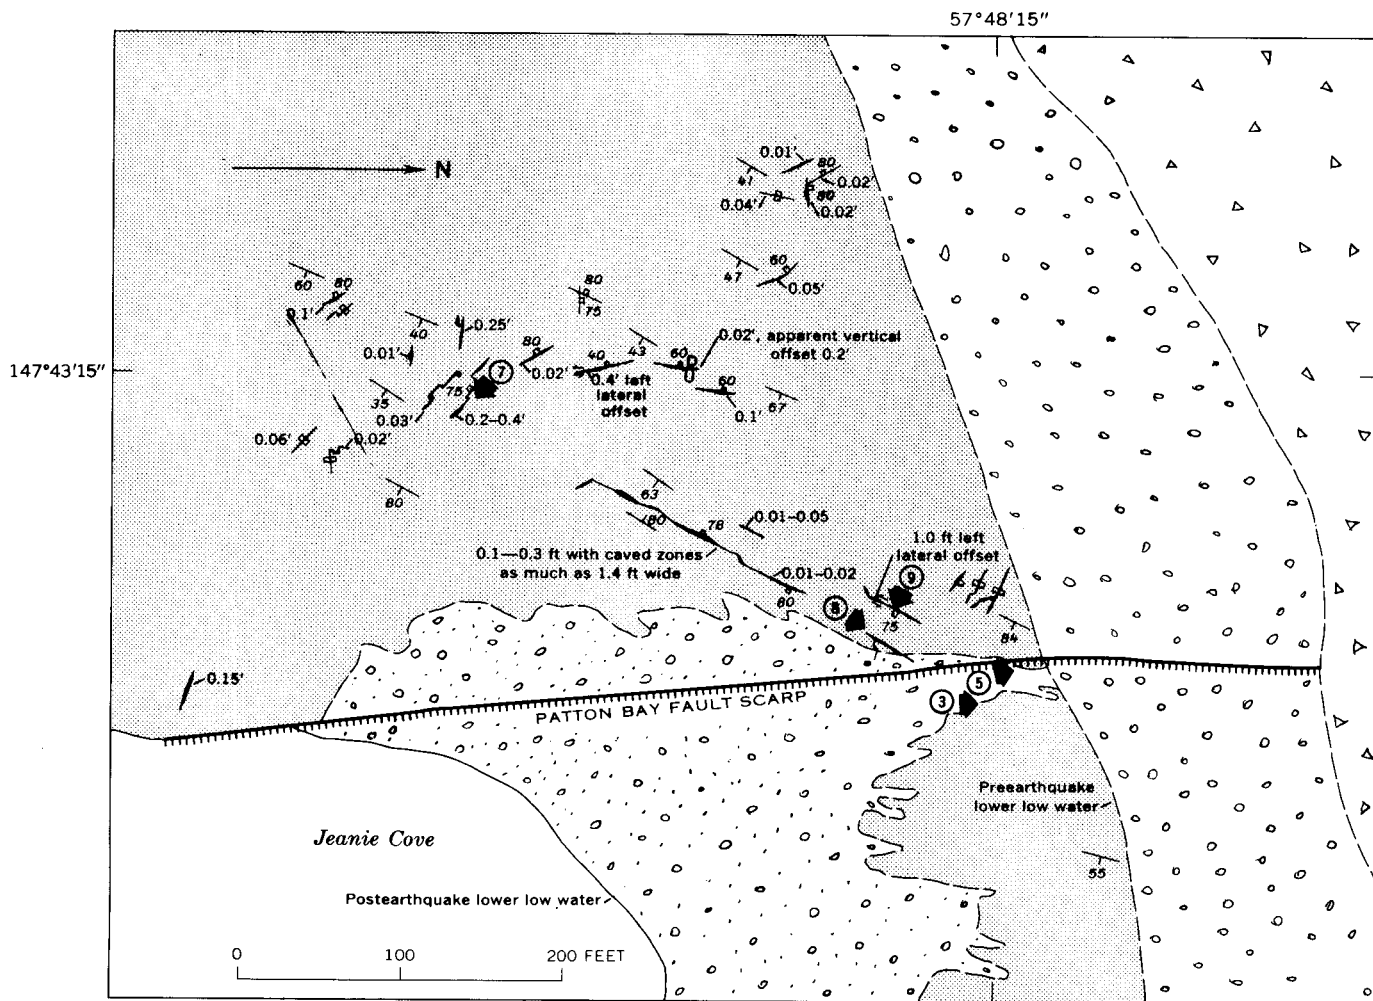
Numerous surface cracks as much as 170 feet long formed in bedrock on the reef part of the upthrown block within 400 feet of the scarp. These newly opened cracks can be readily differentiated from preearthquake cracks because they expose fresh surfaces that do not have a white coating of calcareous algae. Locations, orientations, and displacements of the largest and most conspicuous of these cracks, which were mapped by a pace-and-compass survey, are shown in figure 6. Three typical cracks are illustrated in figures 7-9; the photographs were taken at the locations indicated in figure 6. No newly opened cracks were found near the fault in the downthrown block; close to the fault, however, this block is largely covered by beach deposits.

The cracks all dip steeply or are vertical, and they appear to occur exclusively along bedding planes and preexisting joints. Displacement in the overwhelming majority of cracks is an extension perpendicular to the crack face ranging from less than 0.01 to 0.4 foot. Locally, the cracks are substantially widened where loose narrow wedge-shaped rock slivers as much as 1.4 feet wide have dropped down along them. Left-lateral displacements occurred along two of the cracks. One of the two trends northeast at an oblique angle to the fault scarp and was displaced 1.0 foot (fig. 9). The other crack, which is almost parallel to the scarp, had 0.4 foot of lateral offset.

6.—Sketch map of the scarp and open cracks in the upthrown block of the Patton Bay fault at the shore near Jeanie Point.

The open cracks that occur in the reef on the upthrown block are probably tension cracks associated with the downwarping near the fault. Left-lateral displacements observed on two of these cracks suggest a possible small strike-slip component of movement of less than  $1\frac{1}{2}$  feet on the Patton Bay fault at this locality. No conclusive evidence for horizontal offset of the preearthquake beach strand lines that cross the fault scarp was found on the ground, although an apparent slight tendency for left-lateral bending of these lines was noted on the large-scale vertical aerial photographs.

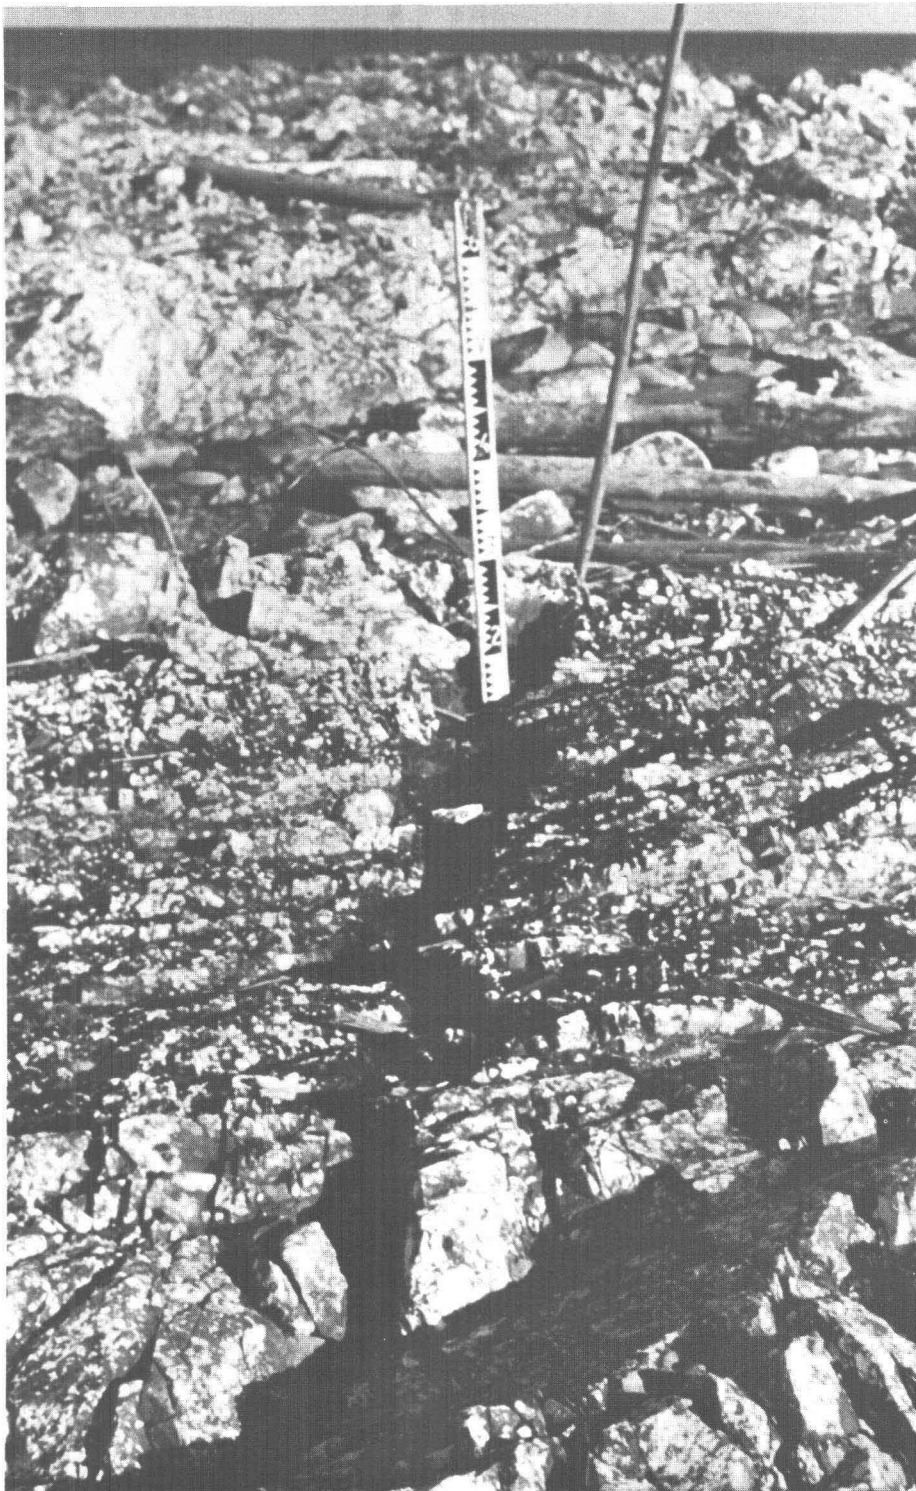
7.—Crack 0.2 to 0.4 foot wide and at least 2 feet deep in the warped relatively up-thrown block of the Patton Bay fault. Crack follows preexisting bedding and joint planes. Location shown in figure 6.

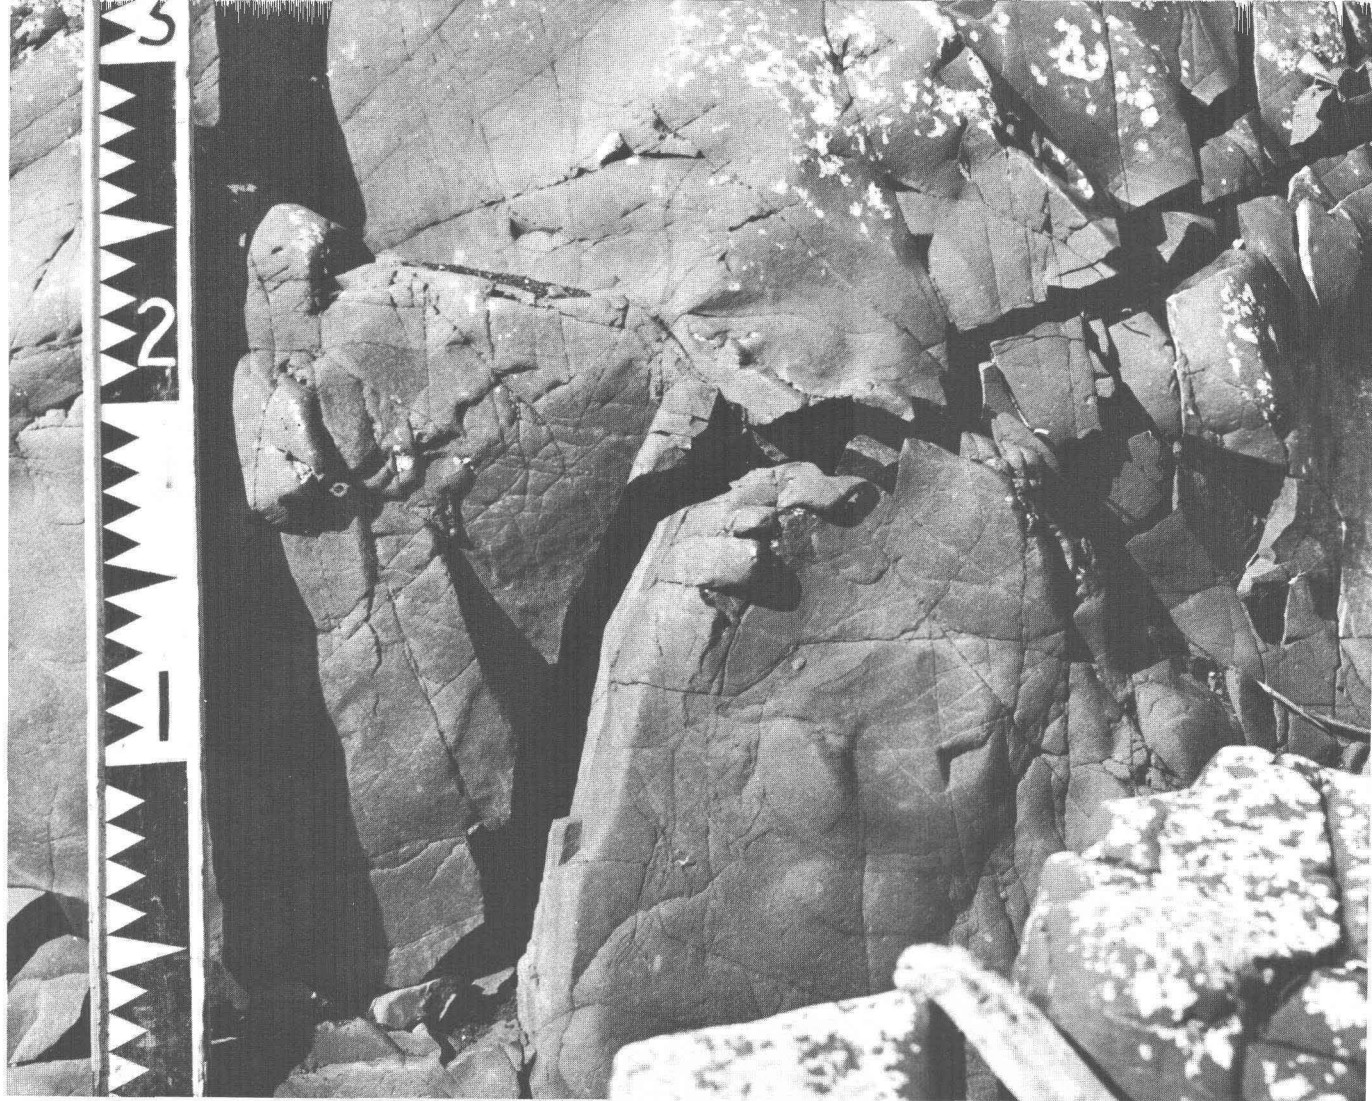
8.—Looking down on vertical crack 0.01 to 0.015 foot wide along preexisting joints in a hard graywacke bed. Location shown in figure 6.

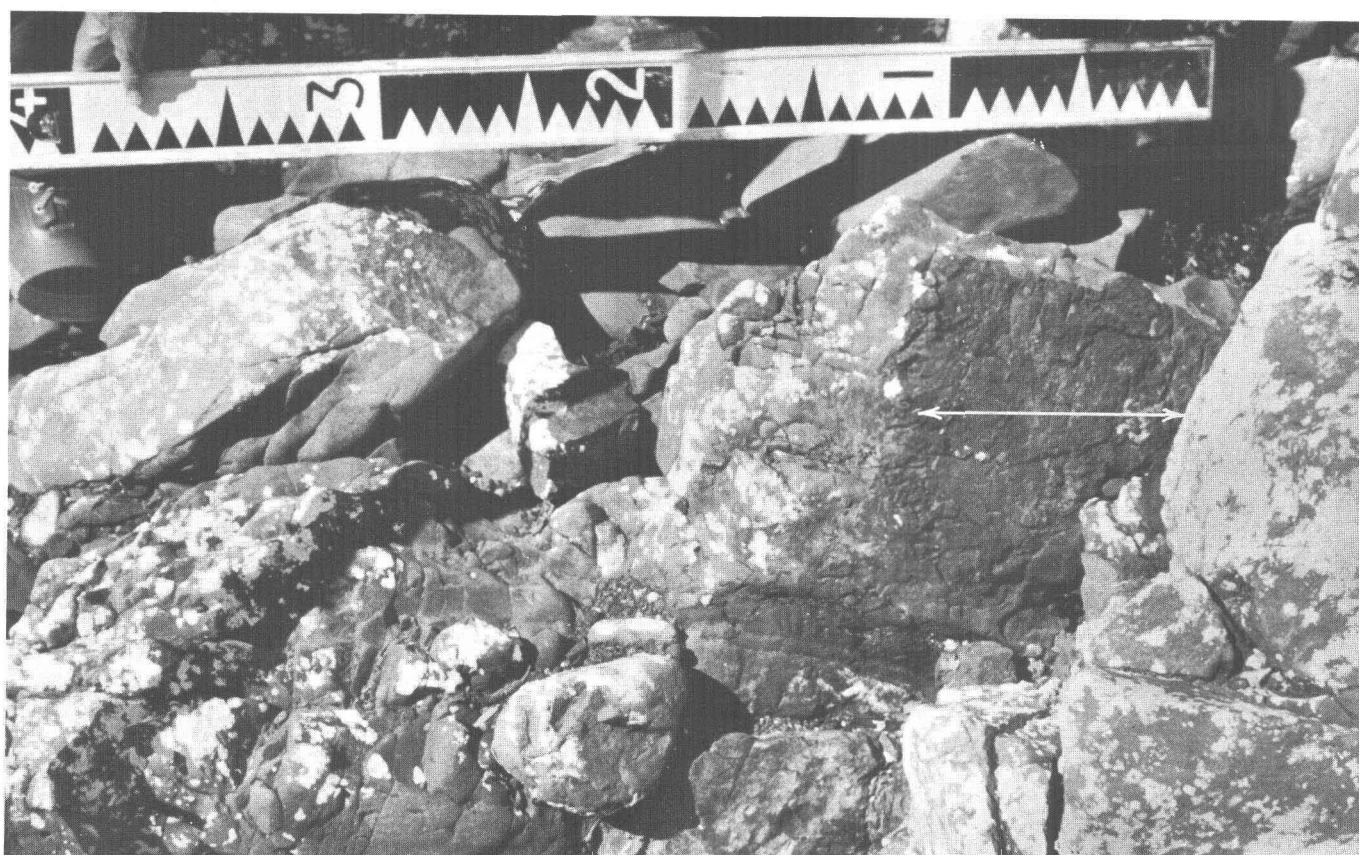
9.—Crack along bedding plane in massive indurated sandstone; 1 foot of left-lateral separation. Location shown in figure 6.

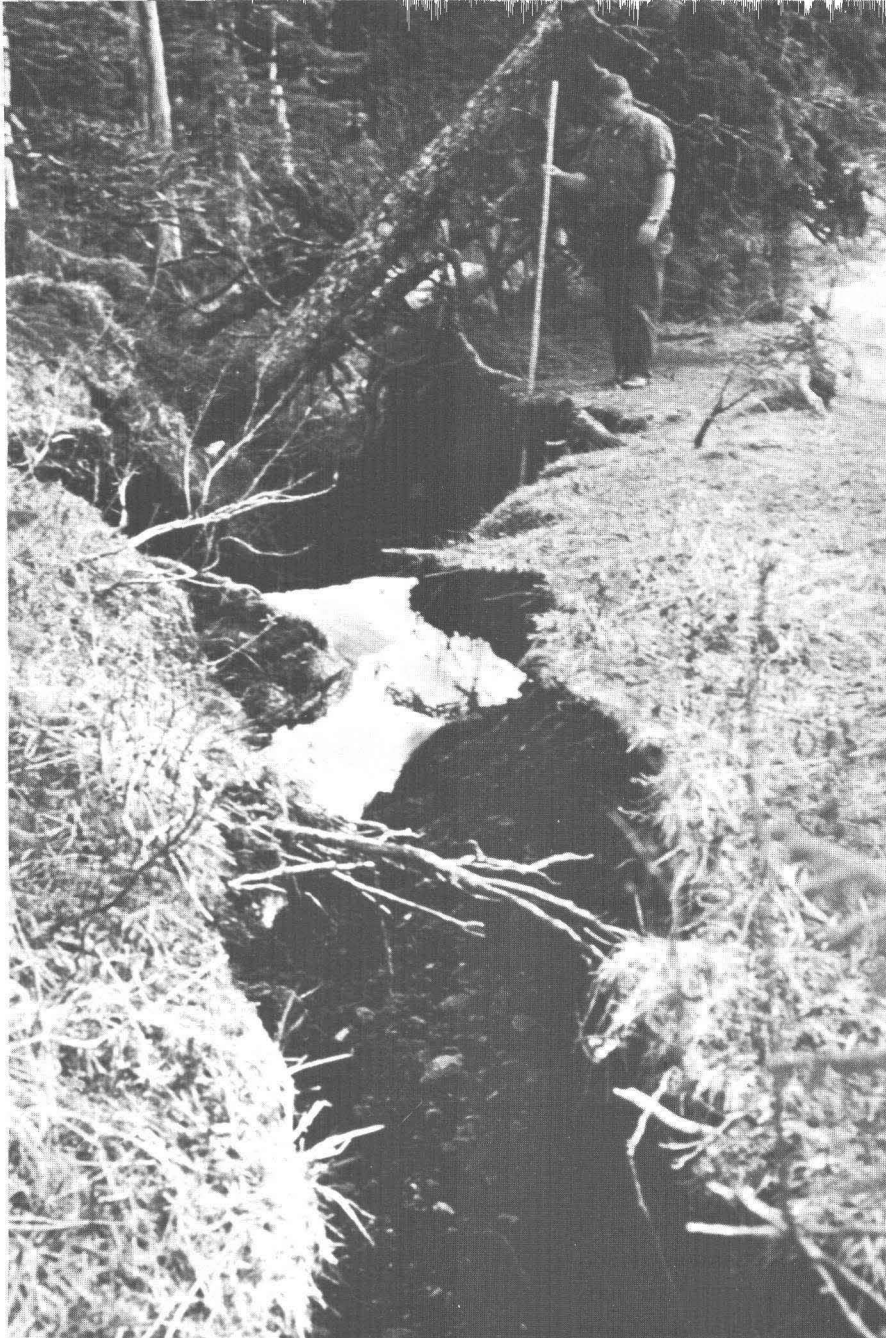
10.—One of the larger fissures along the trace of the Patton Bay fault. The fissure, which is 3 feet wide and 7 feet deep, is in unconsolidated glacial till.

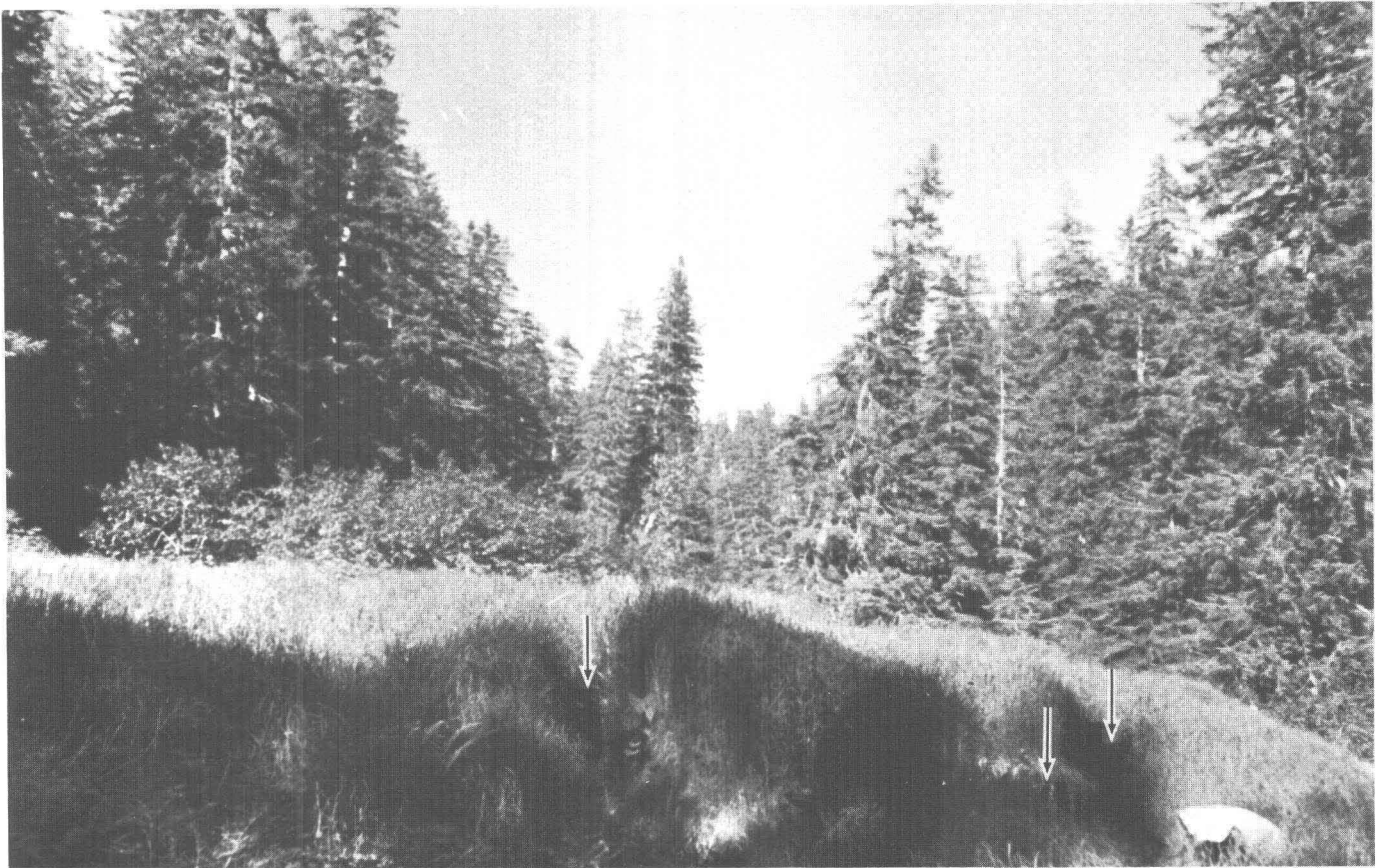
12 (above right).—Warped and fissured muskeg surface along the Patton Bay fault trace. West (left) side of this formerly flat meadow is uplifted 16½ feet relative to the east side. Tilted trees in the background are along the flexure zone that marks the fault trace. Note the characteristic tilt of tree crowns toward the downthrown block. Arrows indicate fissures.

the adjacent wooded area. A continuous sharp flexure about 60 feet wide in the muskeg is broken by a series of open fissures parallel to the trend of the fault that displace the muskeg-covered surface and underlying stream gravel (fig. 12). Relative vertical displacement across the part of the flexure in the bog is roughly  $16\frac{1}{2}$  feet. This estimate of the vertical movement is minimal, because it includes only part of the zone of surface warping associated with the fault. The total width of the zone, as indicated by the distribution of spruce trees which are tilted towards the downthrown block owing to warping of the surface, is roughly 125 feet at this locality.

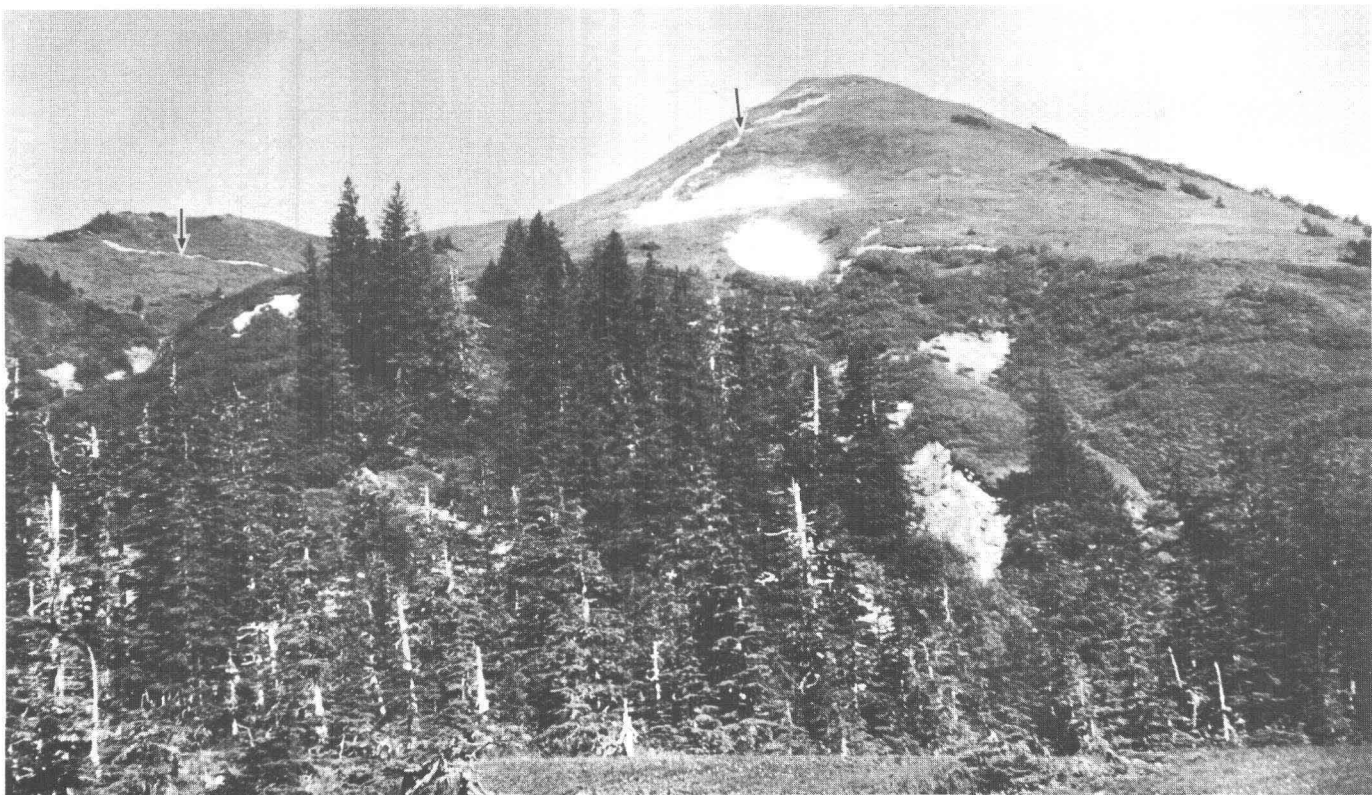
13 (bottom right).—Part of the zone of tectonic fissures north of Tortuous Creek. Two of the larger laterally persistent fissures (arrows) that trend obliquely across the slopes are visible above the brush line. The cracks and scars below the brush line result from earthquake-induced landslides and soil flows. Photograph by M. G. Bonilla.

Immediately to the north of Tortuous Creek, displacement is indicated by a zone of fissuring about half a mile wide that lies between the southern and central segments of the fault (pl. 1; fig. 13). The fissures range from a few hundred to more than 1,000 feet in length, and most have east-facing scarps. The more continuous of these fissures are clearly tectonic features inasmuch as they ignore topography and trend obliquely across mountain slopes and even over ridges as high as

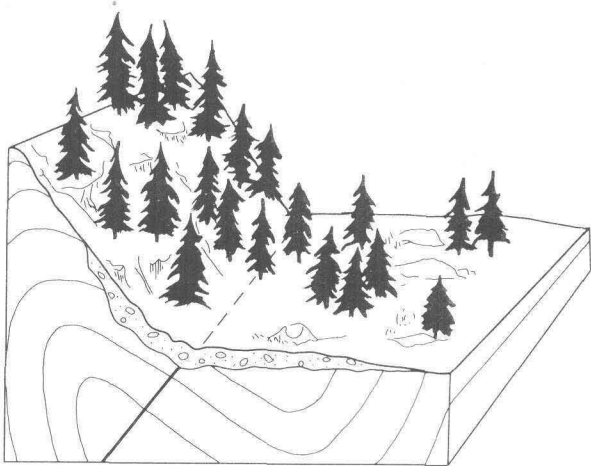
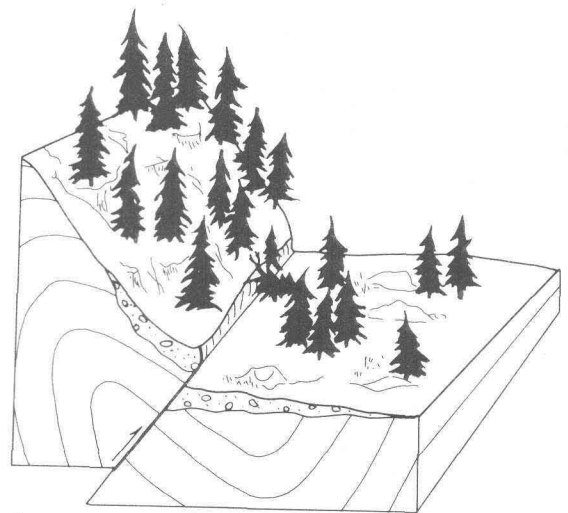
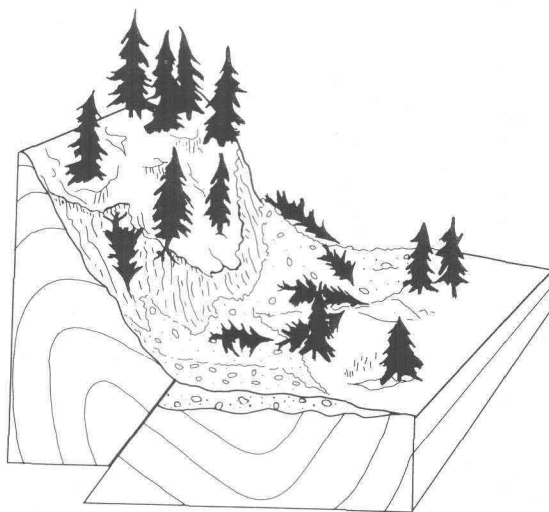
17 (below left).—Sequential diagram illustrating stages in growth of landslides along the base of a fault scarp of the reverse type upon renewed dip-slip displacement. A, preearthquake condition; B, overhanging scarp formed near base of slope by renewed fault movement; C, collapse of unstable slope above the fault scarp.

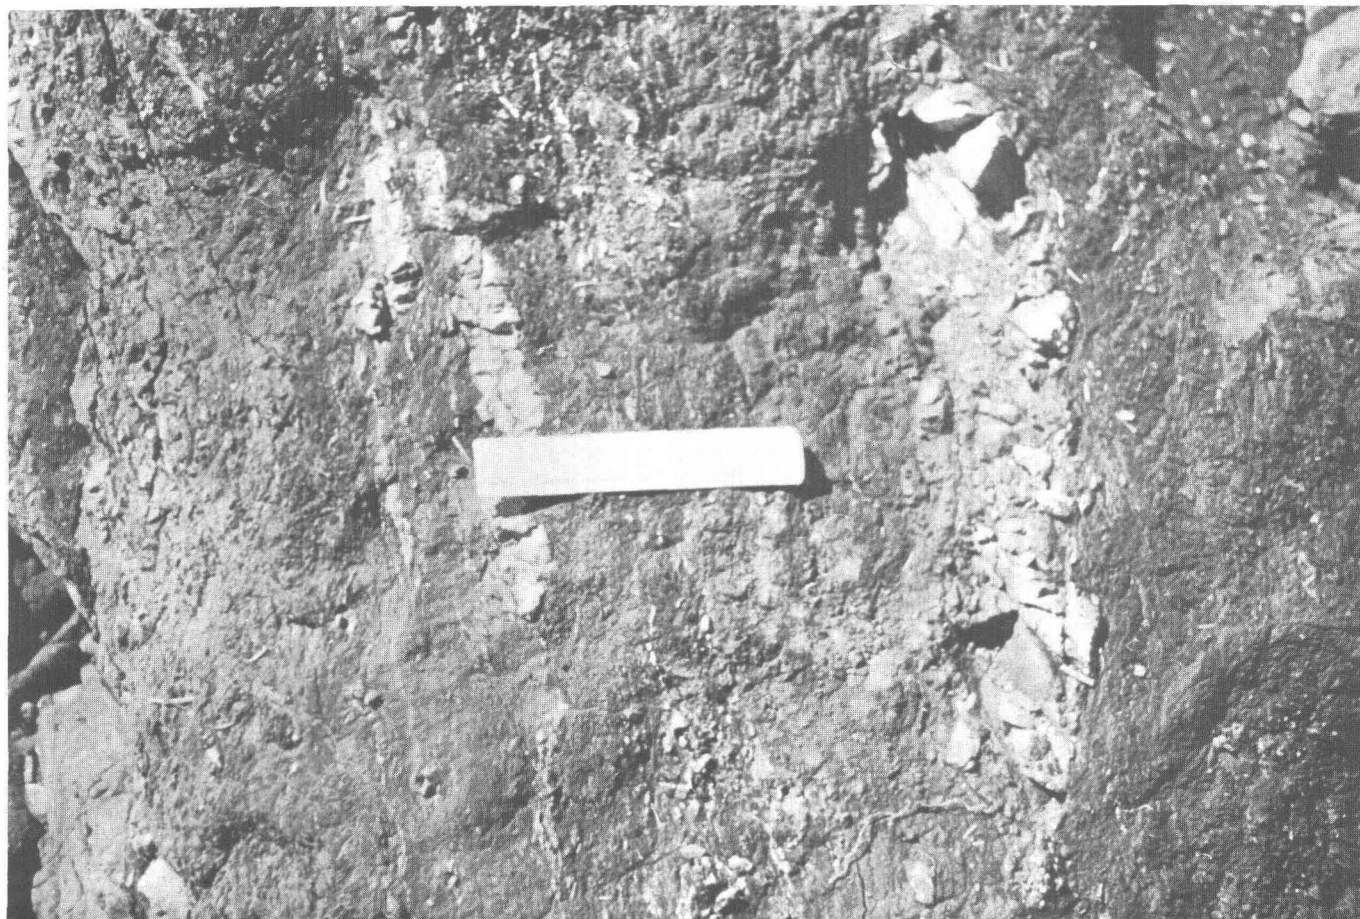
18.—Shattered lenticular boudins of light-gray indurated sandstone in a matrix of sheared black argillite dipping  $75^{\circ}$  to  $85^{\circ}$  northwest along the Patton Bay fault at Jeanie Creek.

Part of the fault zone is exposed in a 3-foot-wide outcrop in the bank of Jeanie Creek. The outcrop consists of shattered lenticular boudins of light-gray fine- to medium-grained arkosic sandstone in a matrix of sheared black argillite (fig. 18) that strikes N.  $65^{\circ}$  E. and dips  $75^{\circ}$  to  $85^{\circ}$  northwest. On the north side of the creek the fault passes through a terrace deposit of stream gravel which has been displaced into four gently sloping steps 10 to 20 feet wide separated by three fissured rises of comparable width that are strongly tilted toward the downthrown (east) block. Minimum cumulative vertical displacement of 10 to 12 feet is represented by the rises that displace the terrace.

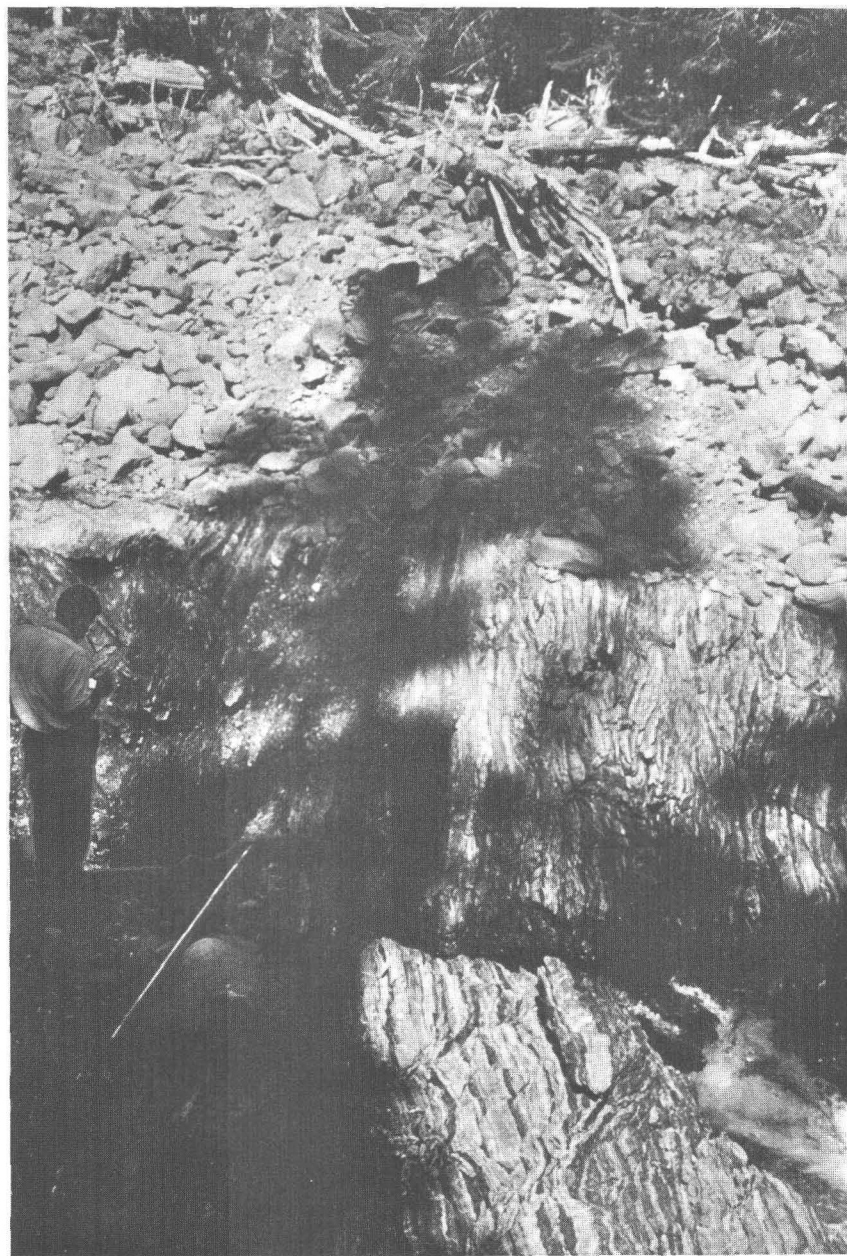
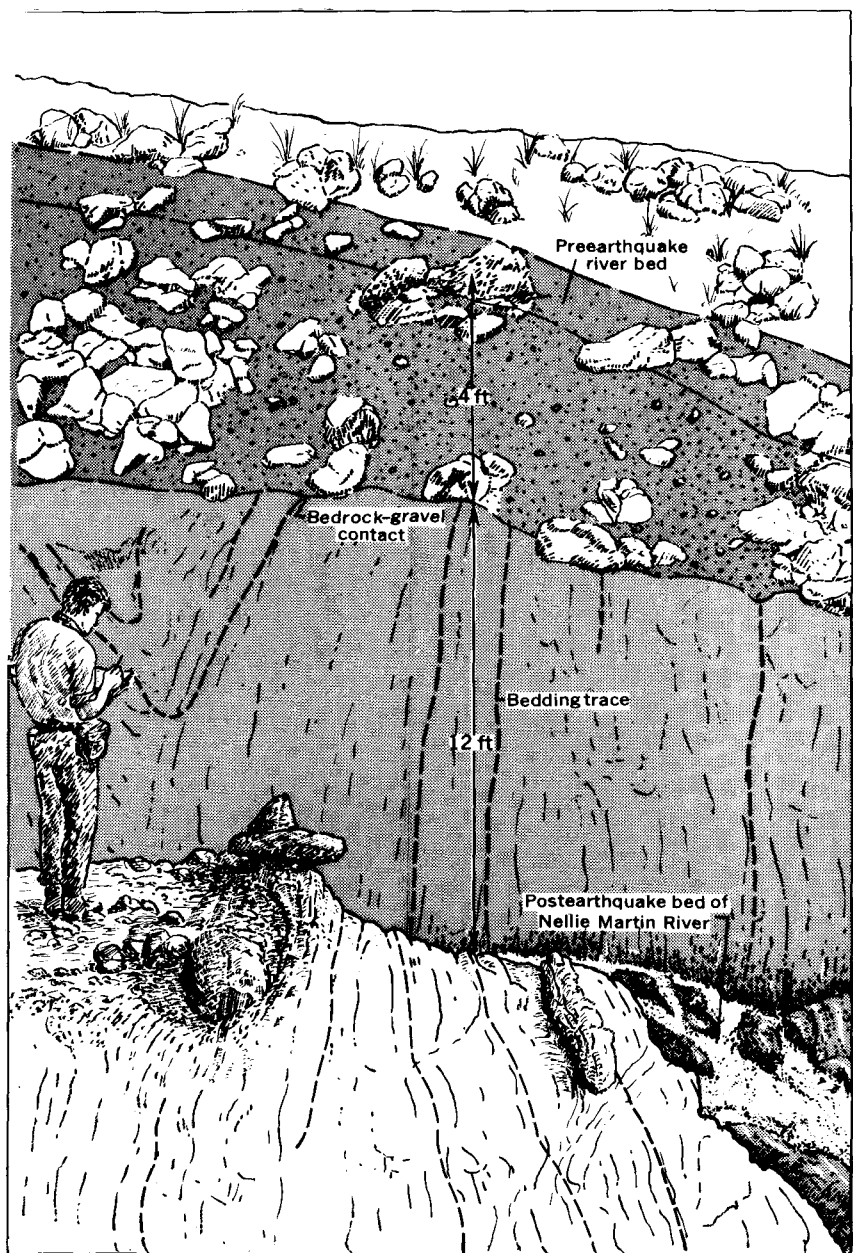
One mile farther north the fault plane is again exposed in the banks of Nellie Martin River; its trace is clearly defined where it crosses the broad alluvial flood plain of the river. The fault zone in the upthrown block along the river consists of 75 feet of intensely sheared siltstone containing veins and lenticular masses of quartz less than half an inch wide; bedrock is concealed by stream deposits in the downthrown block. The siltstone in this zone is so fractured throughout that it can be readily broken into chips by hand. The sheared rock trends N. 35° E. and dips northwest at angles ranging from 50° to near vertical. By August of 1965 the Nellie Martin River, which flows directly across the strike of the bedding and the fault, had incised its channel below the preearthquake level, through 4 feet of stream gravel and 12 feet of bedrock immediately upstream from the fault trace. The amount of incision suggests a minimum of 16 feet of relative vertical displacement across the fault at this locality (fig. 19).

19.—Incised channel of the Nellie Martin River immediately upstream from the gravel and 12 feet of bedrock at this locality between March 27, 1964, and August

Patton Bay fault scarp. The rejuvenated river has eroded about 4 feet of boulder 7, 1965. Photograph by L. R. Mayo.

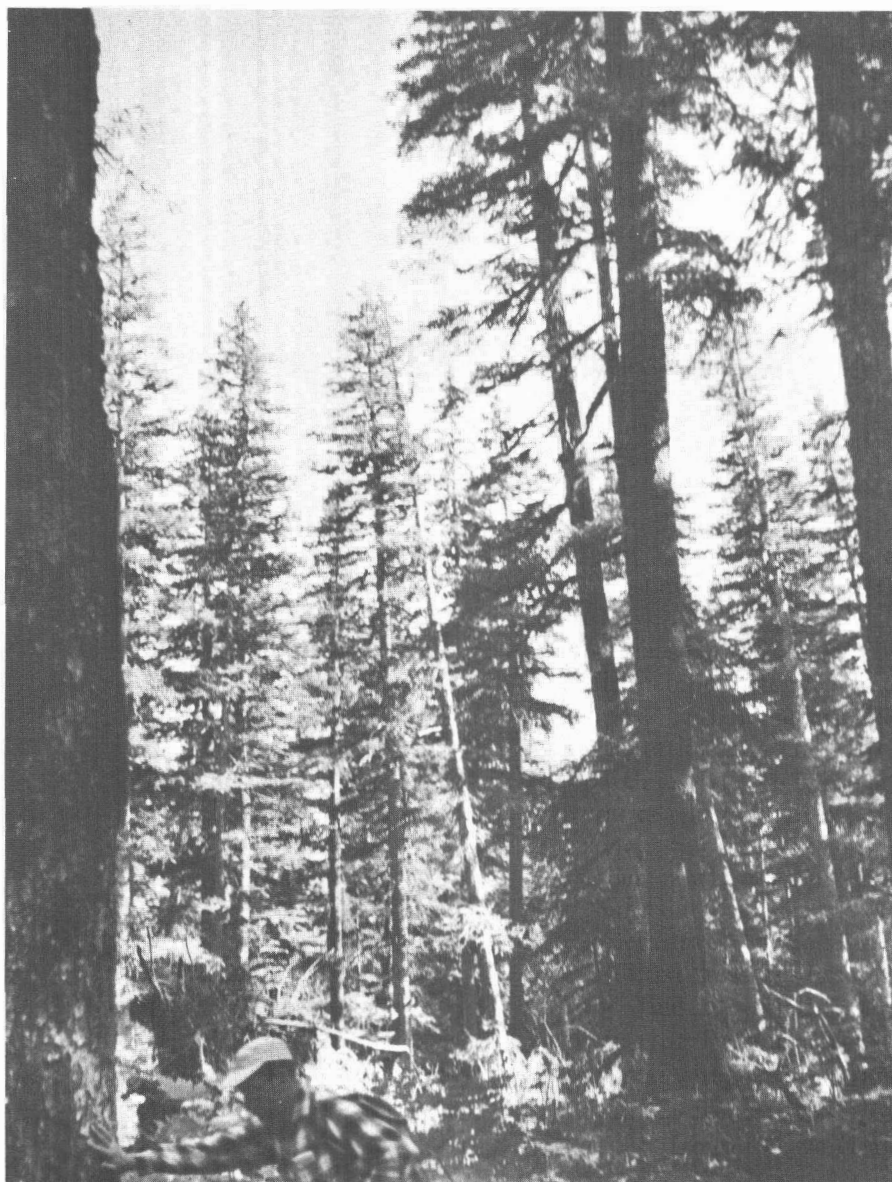
Tilted trees are associated with the line of cracks, particularly south of Patton River (fig. 20), where average tree heights of more than 125 feet make tilts of as little as  $5^{\circ}$  from the vertical readily apparent.

20.—Looking southwest along the Patton Bay fault in the alluviated valley of Patton River. The fault trace is indicated by the tilted giant Sitka spruce trees and by ground fissures that roughly parallel the zone of tilted trees.

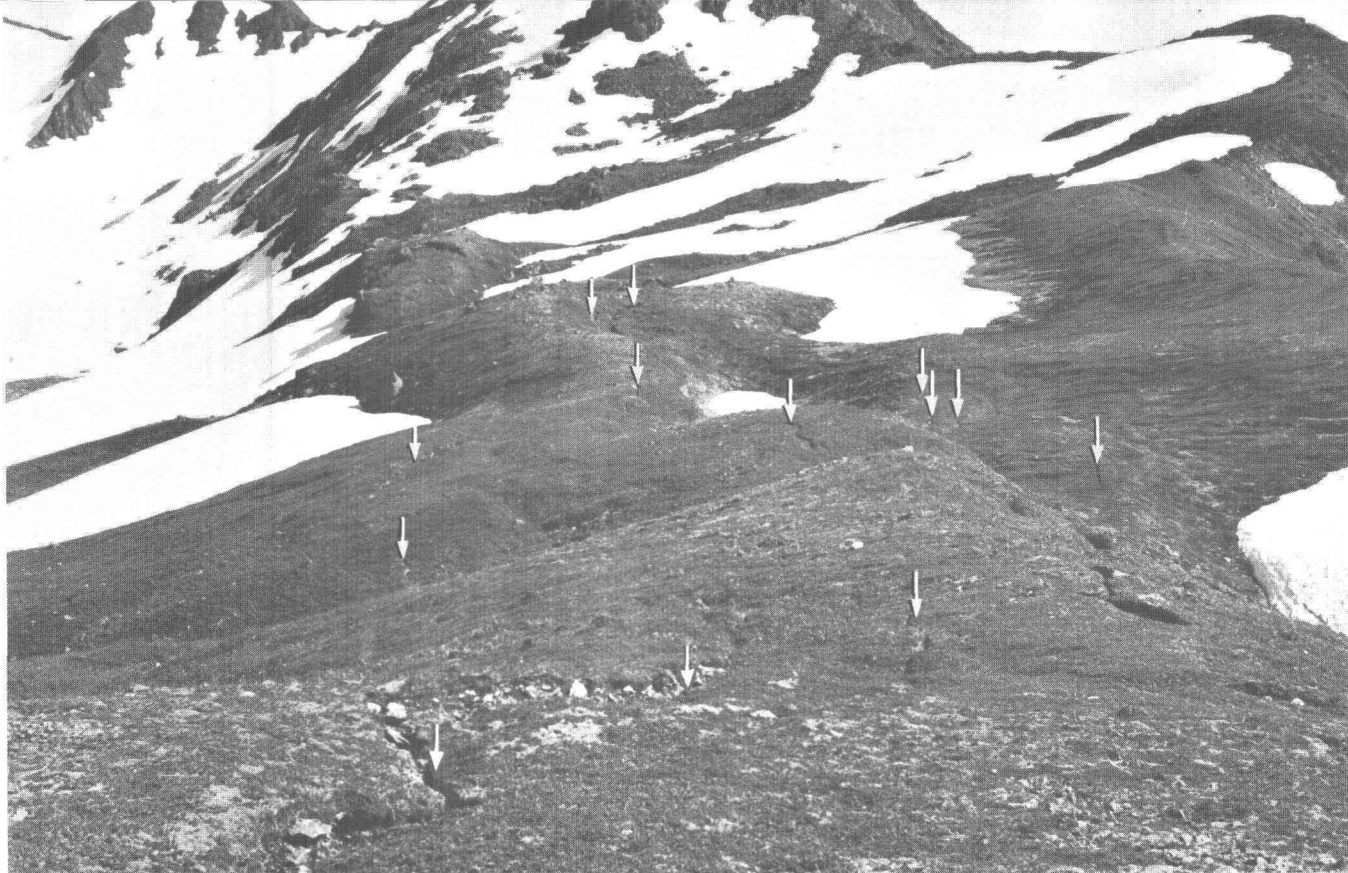
21.—Part of the zone of tectonic fissures at 3,000 feet altitude on the ridge summit north of Patton River. The fissures, some of which are indicated by arrows, could be traced almost continuously to the northeast through the peak (center of photograph) and the notch on the skyline to the left of the peak.

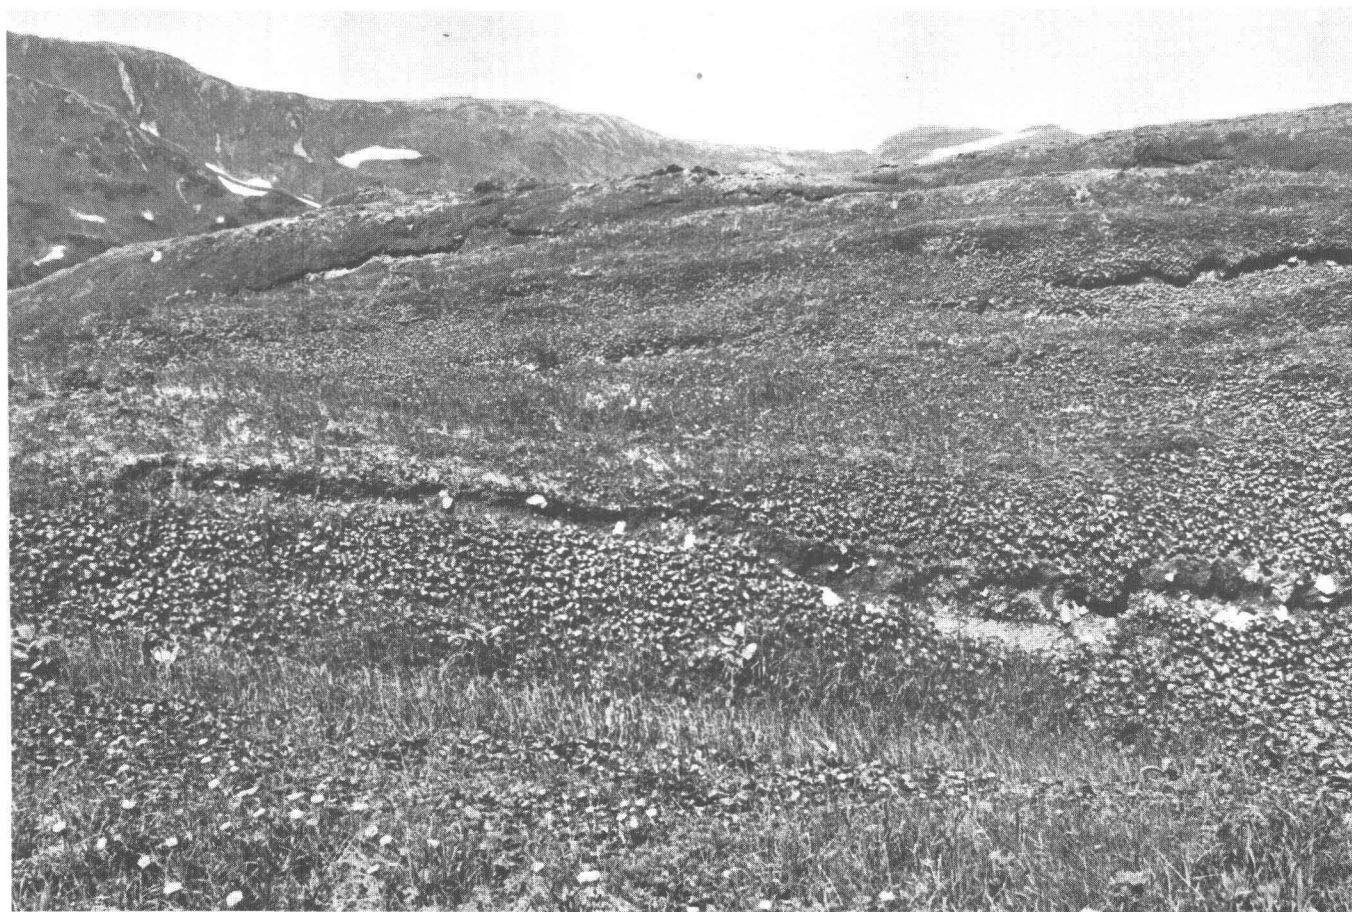
22.—Subparallel minor normal faults within the area shown in figure 21. Note that some of these fissures coincide with pre-existing linear scarps.
