THE ALASKA EARTHQUAKE, MARCH 27, 1964:  
REGIONAL EFFECTS

# Surface Faults On Montague Island Associated with the 1964 Alaska Earthquake

*A description and tectonic analysis of ground  
breakage and surface warping along two  
reactivated reverse faults*

GEOLOGICAL SURVEY PROFESSIONAL PAPER 543-G

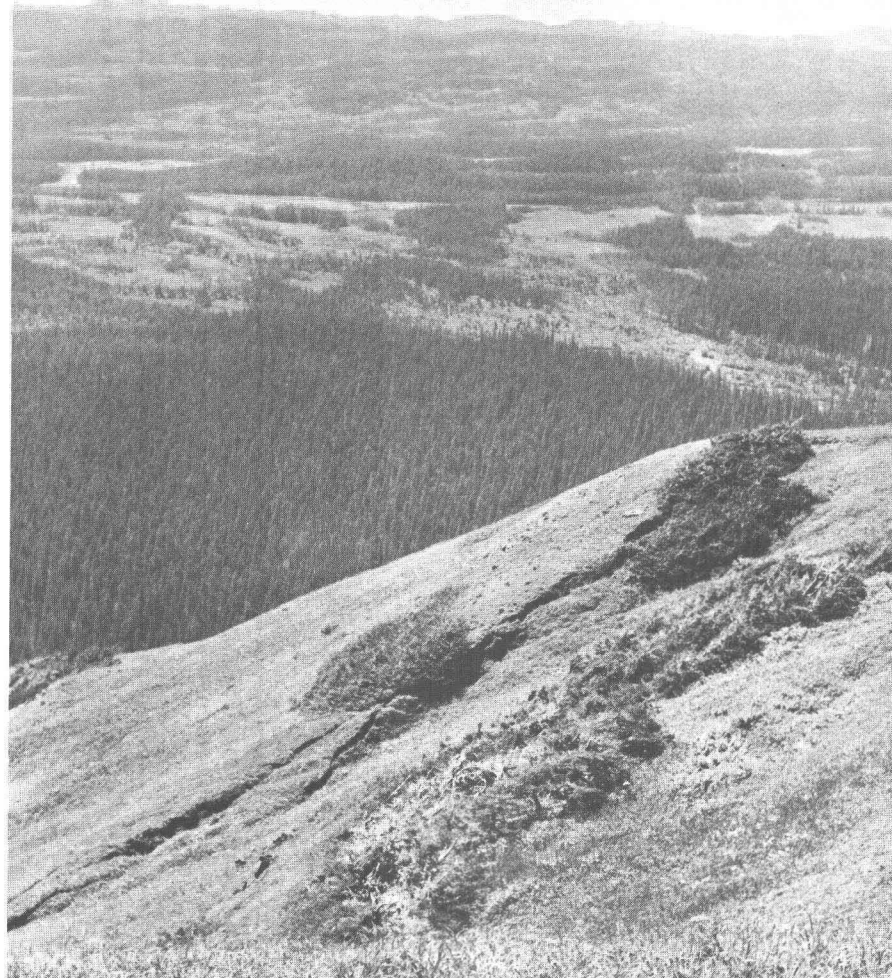
23.—Minor normal faults along a preexisting linear groove on a steep ridge slope. The downhill side is uplifted 16 inches. Patton River valley visible in the background.

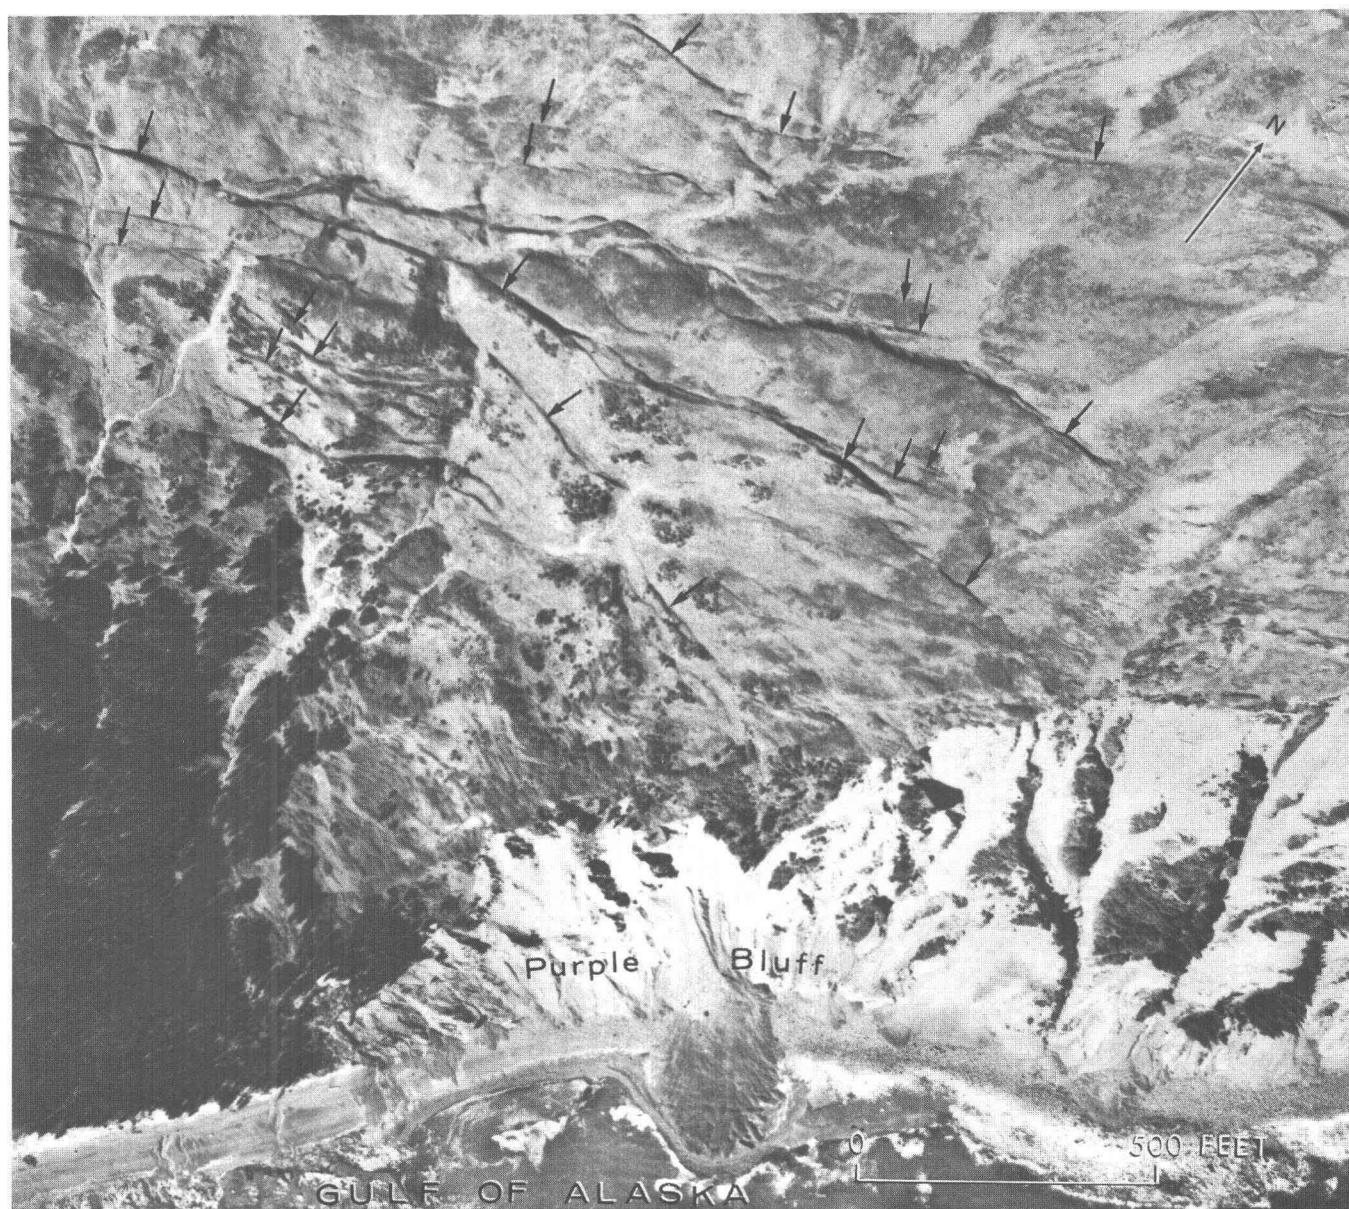
24.—Vertical aerial photograph in the vicinity of Purple Bluff showing conspicuous lineaments (arrows) along the inferred northeastward extension of the Patton Bay fault. Renewed displacement occurred on some of these lineaments after the 1964 earthquake. A large earthquake-induced landslide may be seen at the base of the high bluff at bottom center. Photograph by U.S. Coast and Geodetic Survey, August 25, 1964.

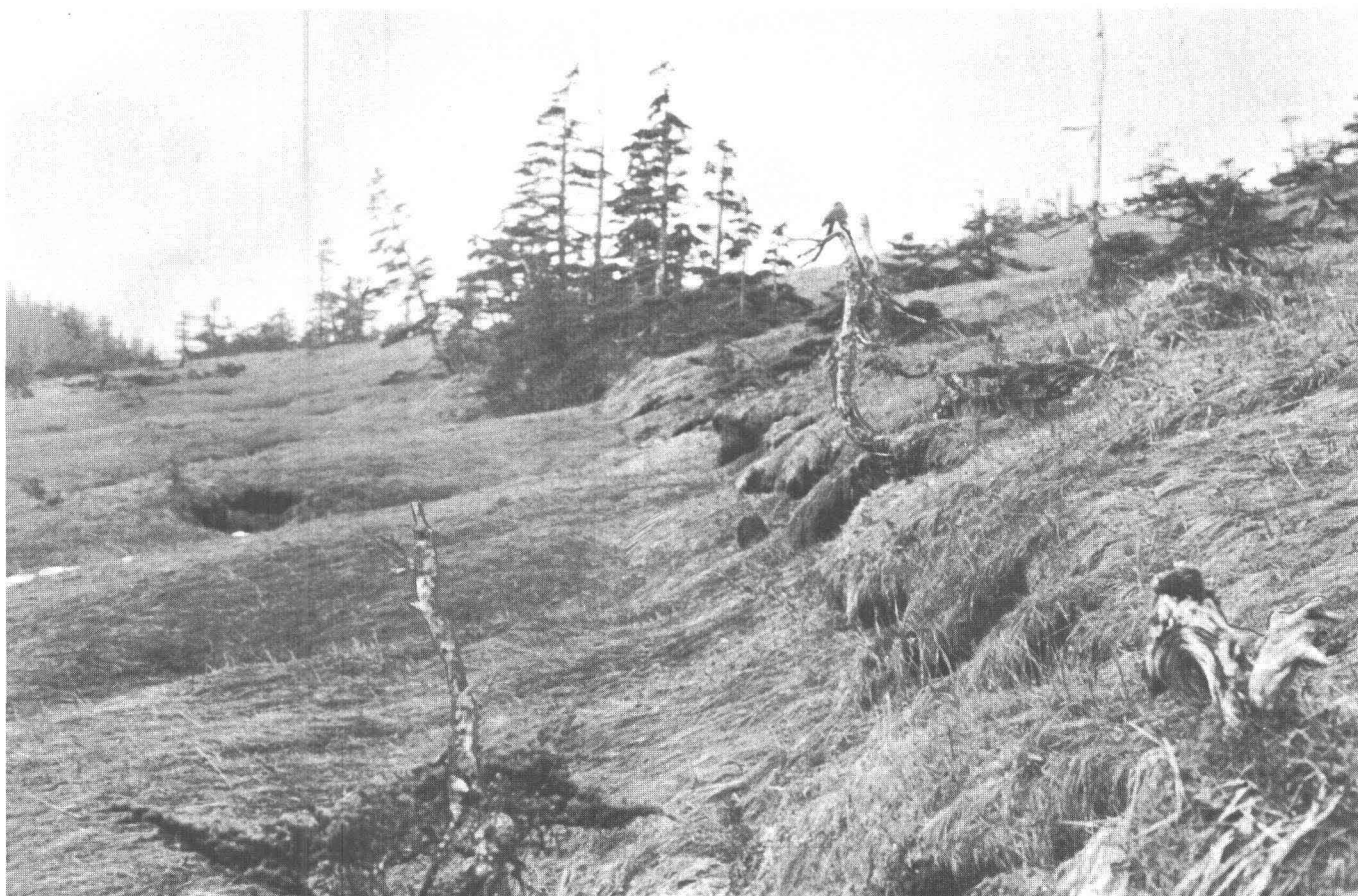
25.—View southwest along Hanning Bay fault. Northwest block (right) has overthrust the southeast block. Note warped surface and overhanging muskeg mat on the scarp in the foreground. Tree in the background has been tilted by the overthrusting. Location shown in figure 27.

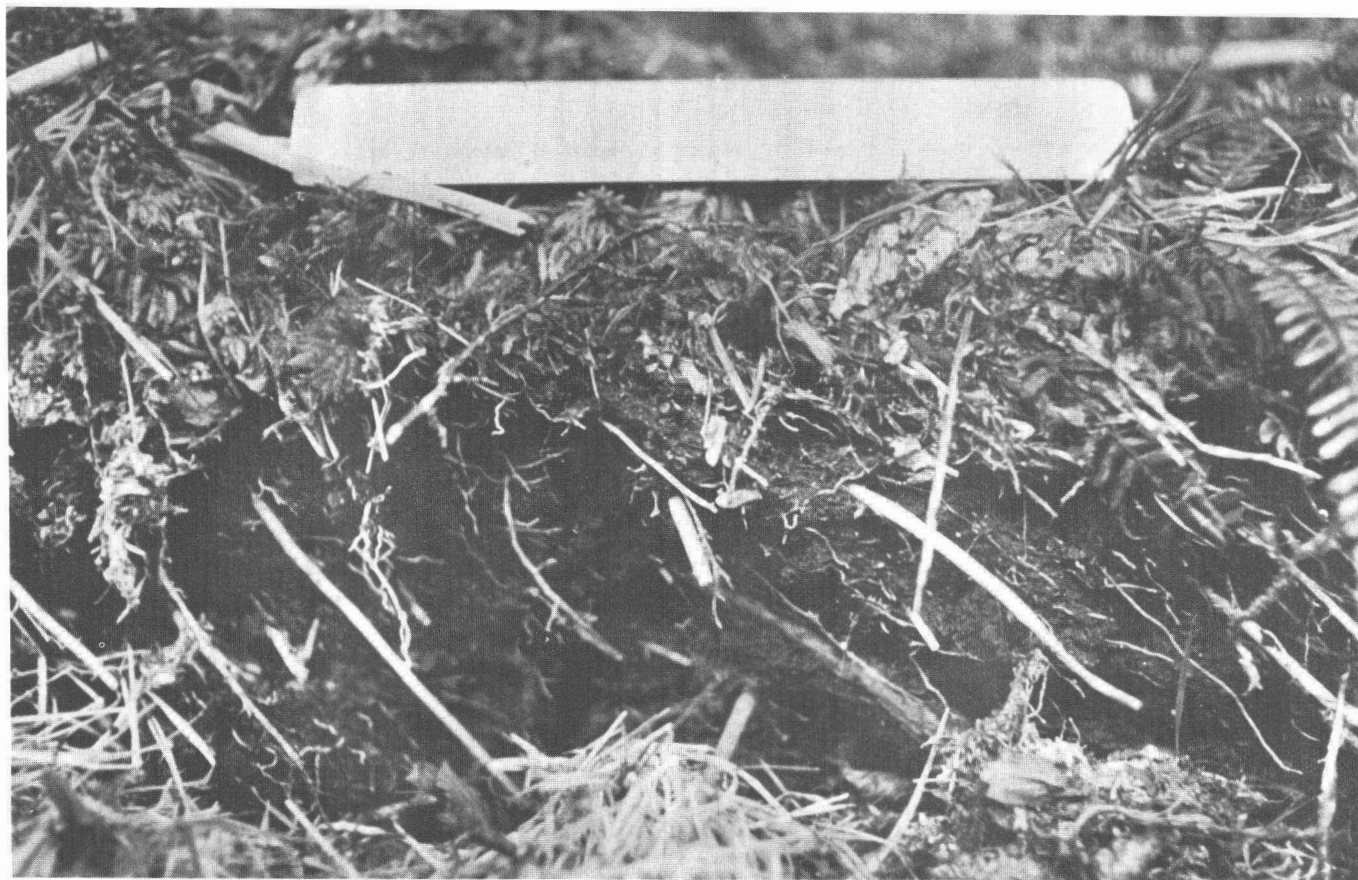
23.—Overhanging scarp of Hanning Bay fault in glacial till dipping  $80^{\circ}$  northwest. About 4 inches of left-lateral displacement is indicated by the rake of roots extending across the scarp. Scale is  $6\frac{1}{2}$  inches long. Location shown in figure 27.

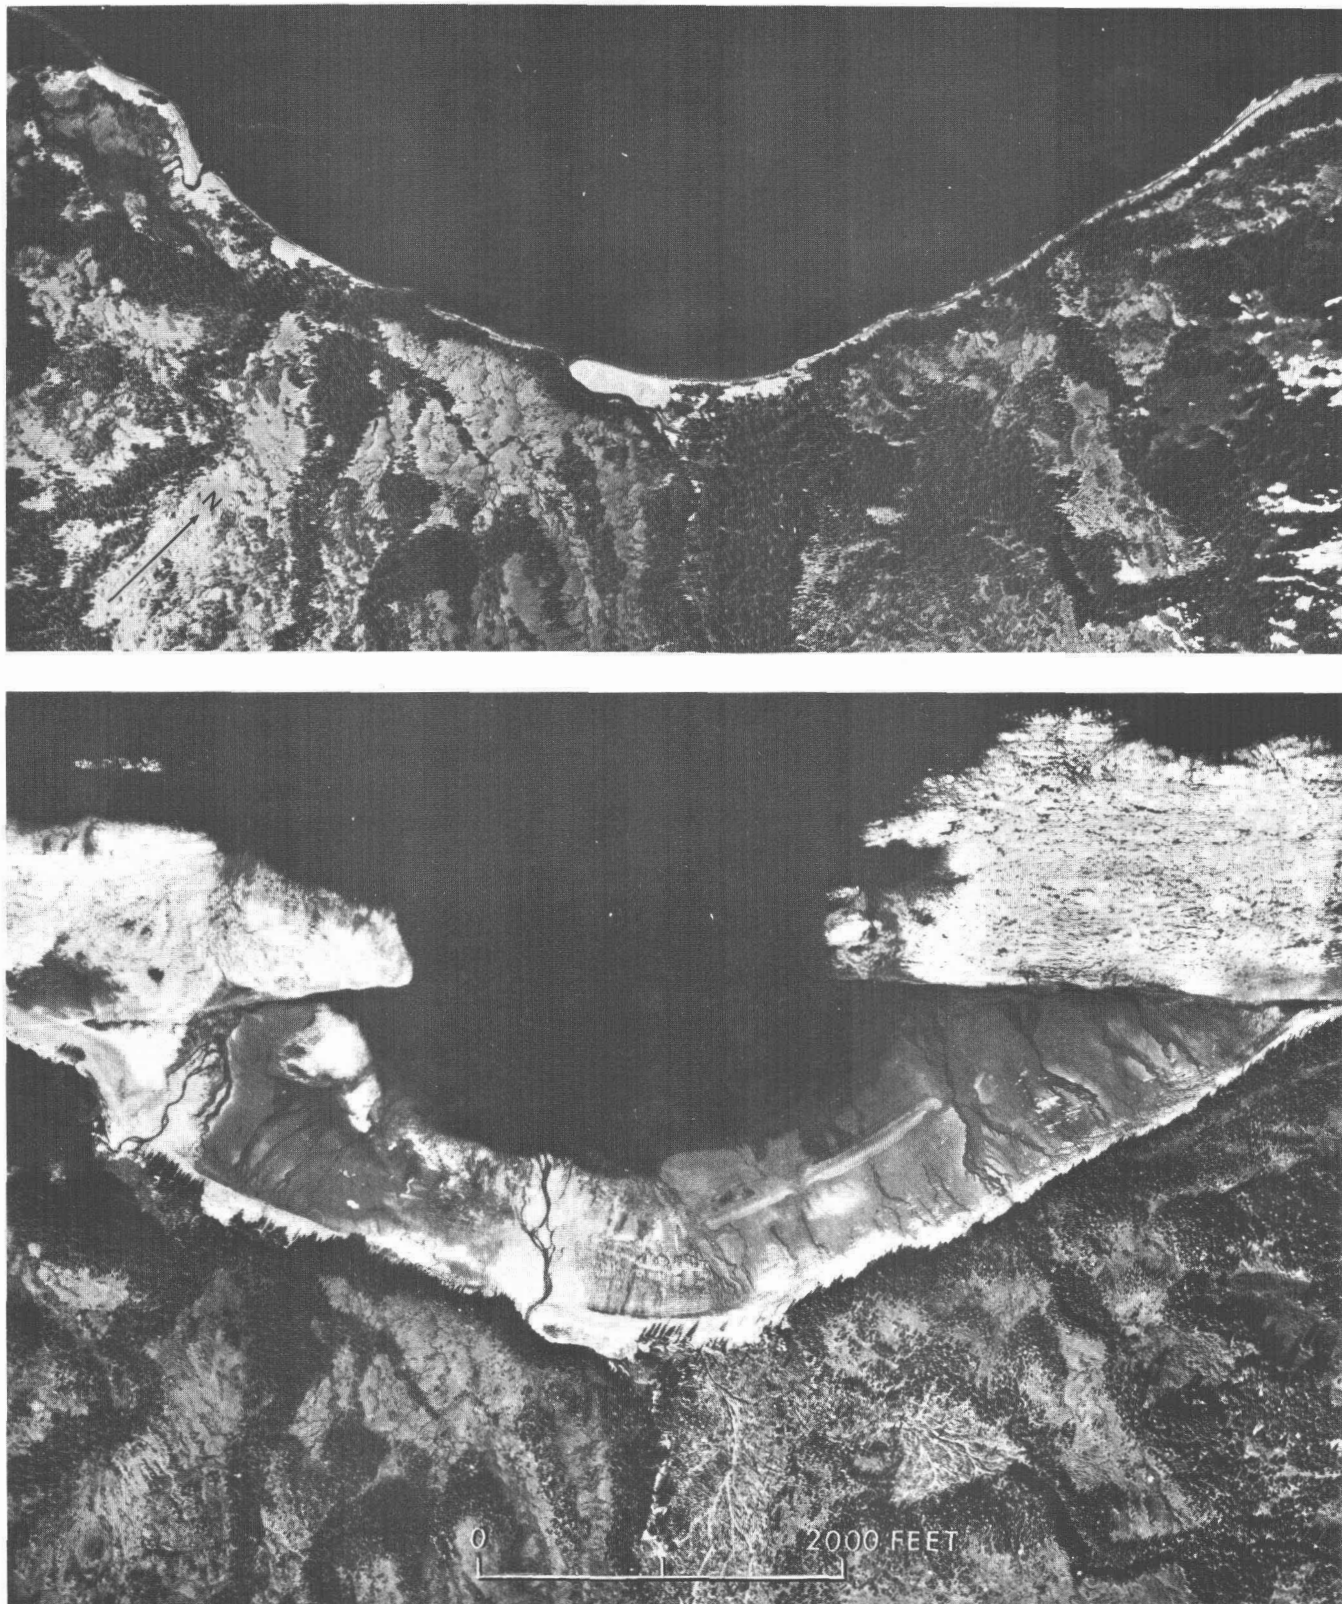
28.—Pre- and postearthquake high-tide shorelines at Fault Cove. The cove was formed by relative uplift of the former sea floor northwest of the fault scarp. The white color on the elevated bedrock surface northwest of the fault results from dessication of calcareous algae and other calcareous marine organisms. Upper photograph by U.S. Forest Service, June 8, 1959; lower photograph by U.S. Coast and Geodetic Survey, April 17, 1964.

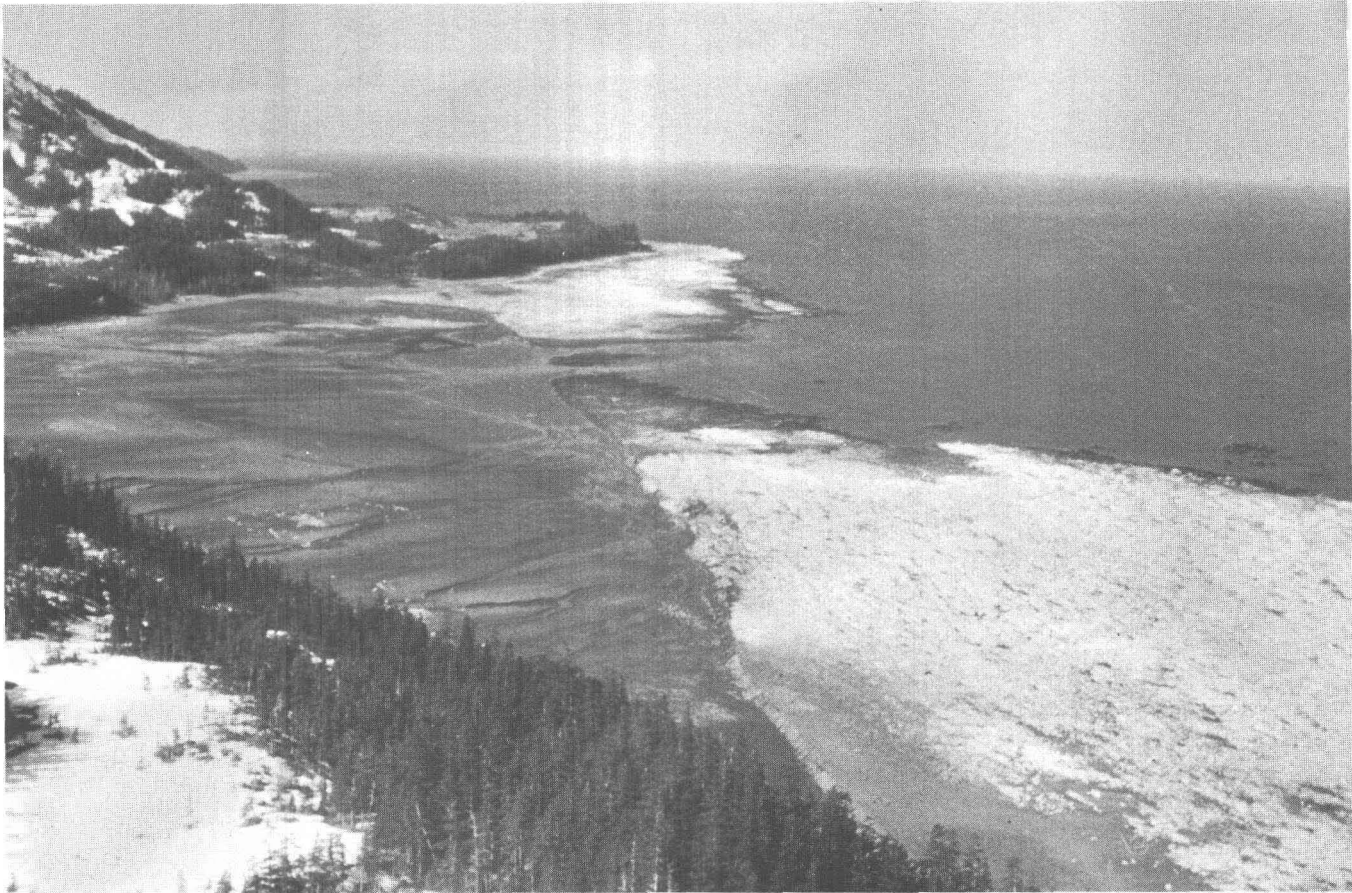
29.—Hanning Bay fault at Fault Cove approximately at low tide. The northwest (right) block is uplifted as much as  $16\frac{1}{3}$  feet relative to the southeast block. Both blocks are uplifted relative to sea level. As a consequence, the cove is virtually dry at low tide, and the elevated beach and former offshore deposits are deeply dissected by streams. Veneer of unconsolidated deposits on the former submarine part of the downthrown block accumulated behind a preexisting fault scarp.

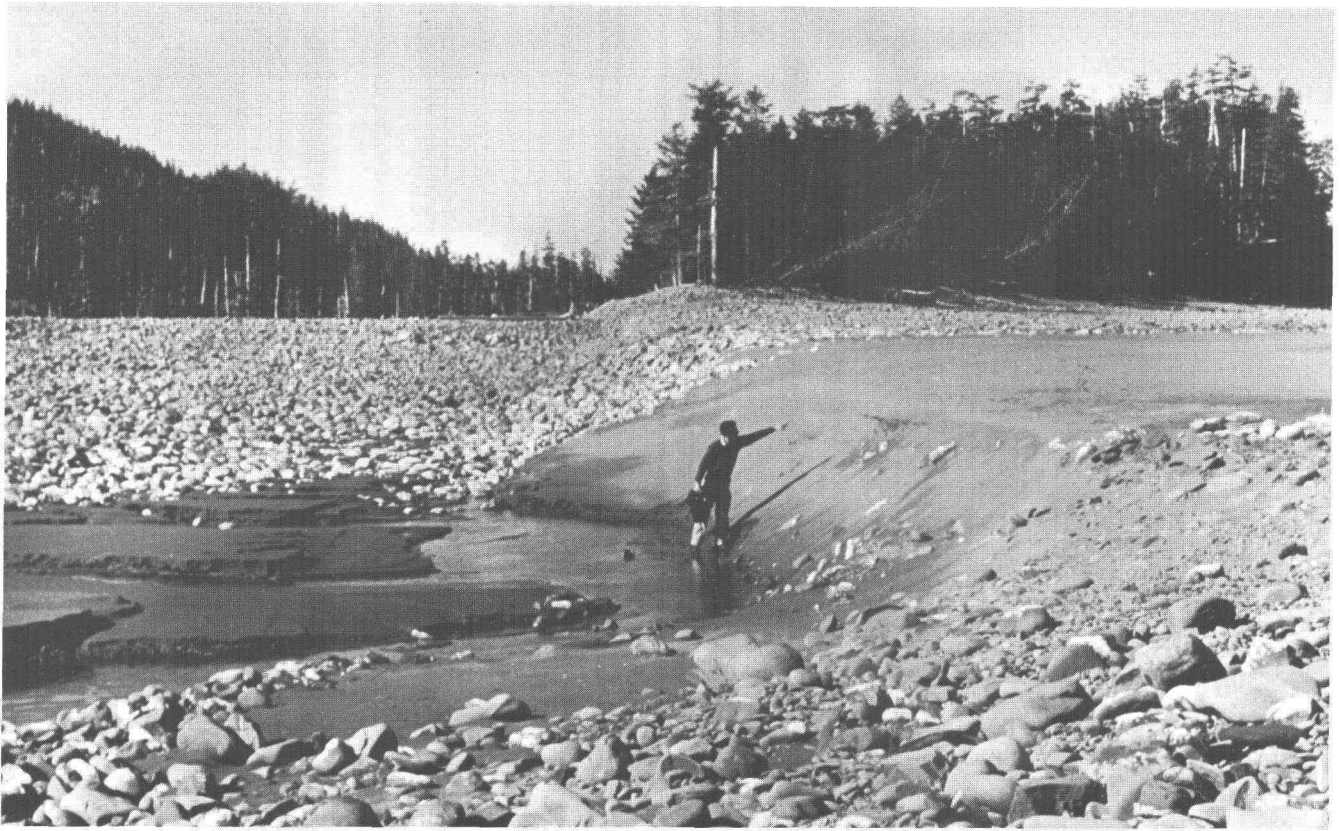
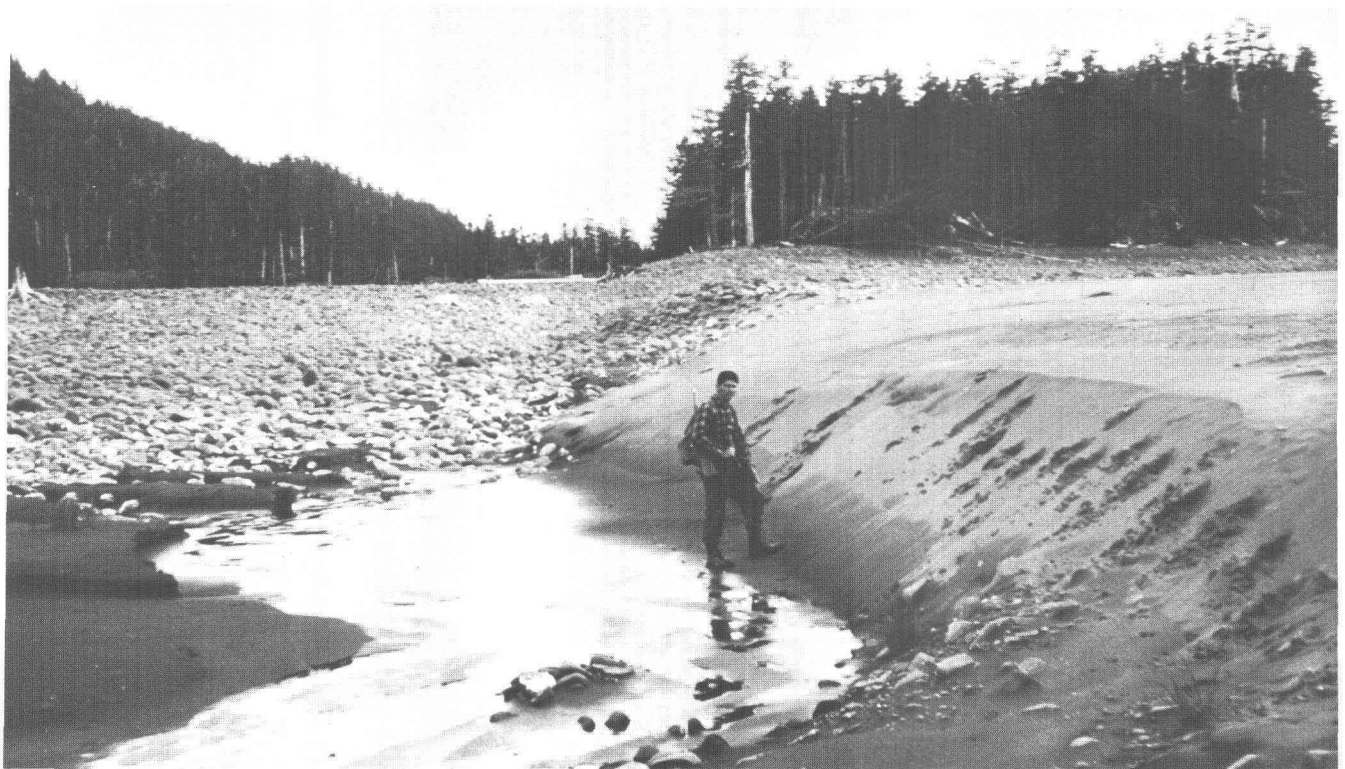
30.—View southwest along Hanning Bay fault. Scarp 8½ feet high has displaced the elevated beach at south side of Fault Cove, and beach deposits draped across the scarp conceal the fault plane. Comparative photographs show that modification of the scarp was negligible between May 30, 1964 (above), and August 4, 1965 (below). Bottom photograph by M. G. Bonilla.

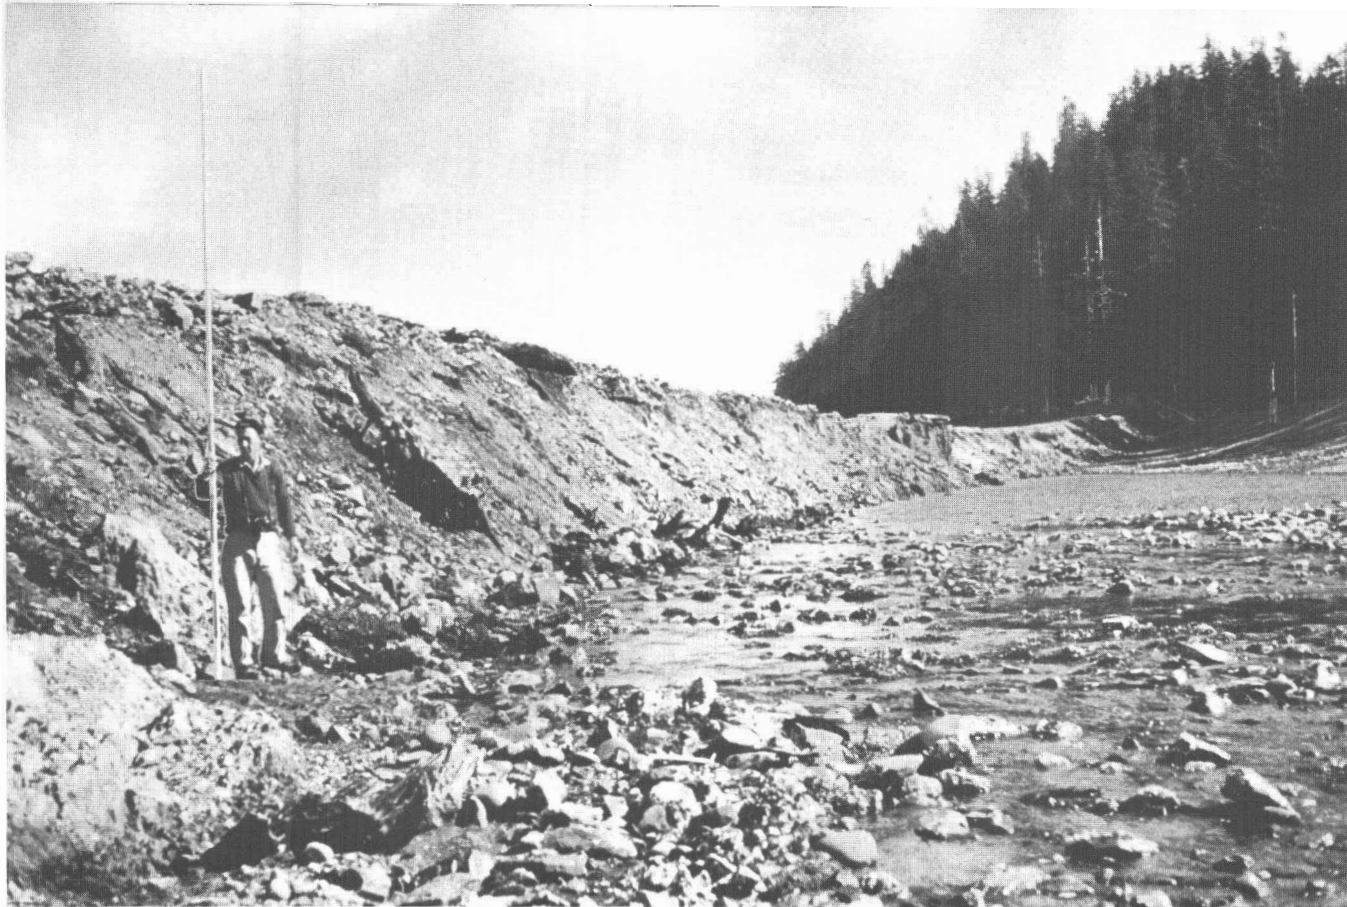
31.—Hanning Bay fault scarp 13½ feet high in bedrock at north side of Fault Cove. The fault dips at about 55° NW. (left), but slumping along the trace has formed a scarp that is nearly vertical or dips steeply southeast. The slumping process is accelerated by erosion along the base of the uphill-facing scarp. Location shown in figure 34.

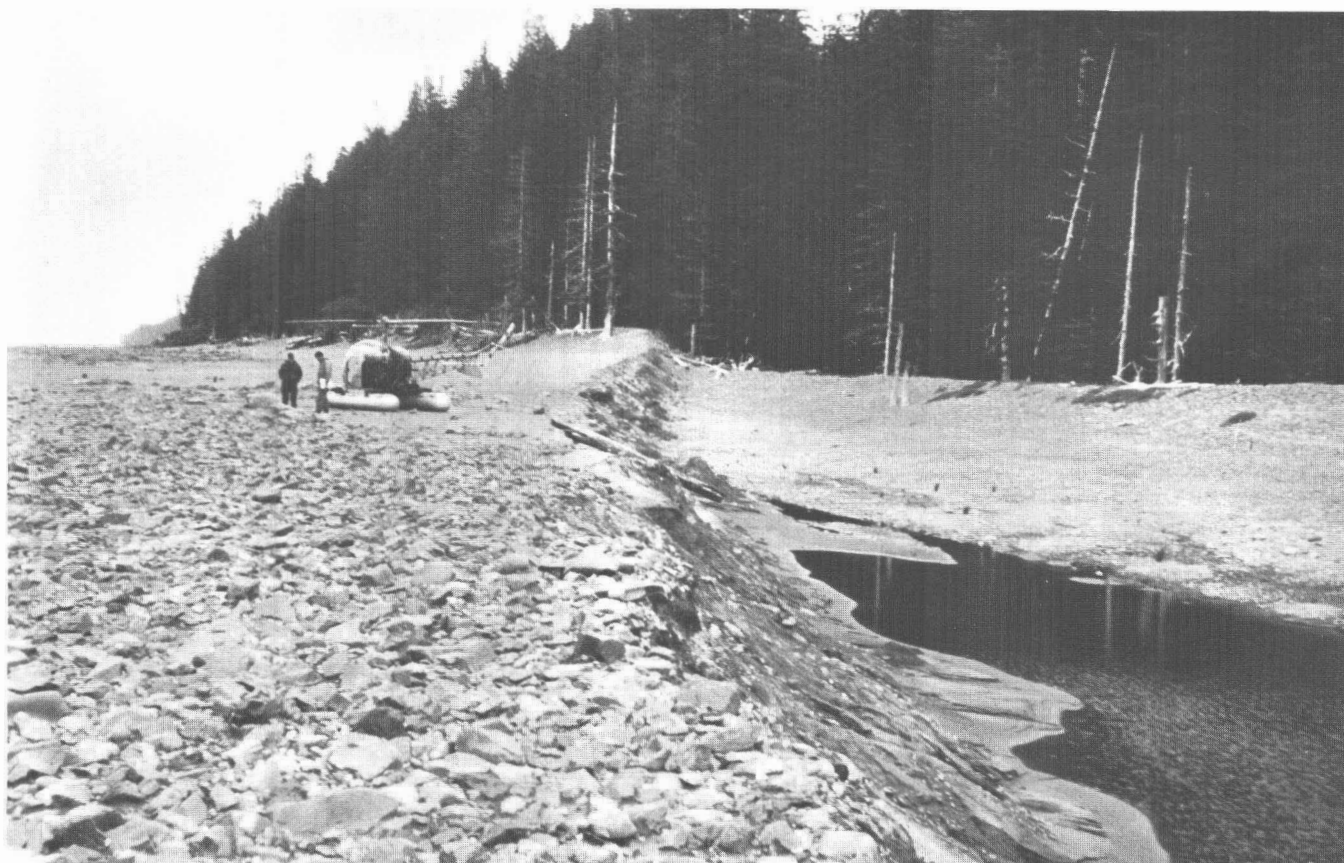
32.—View northwest toward cobble-gravel storm beach at north side of Fault Cove which was displaced 16½ feet vertically across the Hanning Bay fault scarp. Pond at right occupies a shallow tectonic depression. Photograph by M. G. Bonilla.

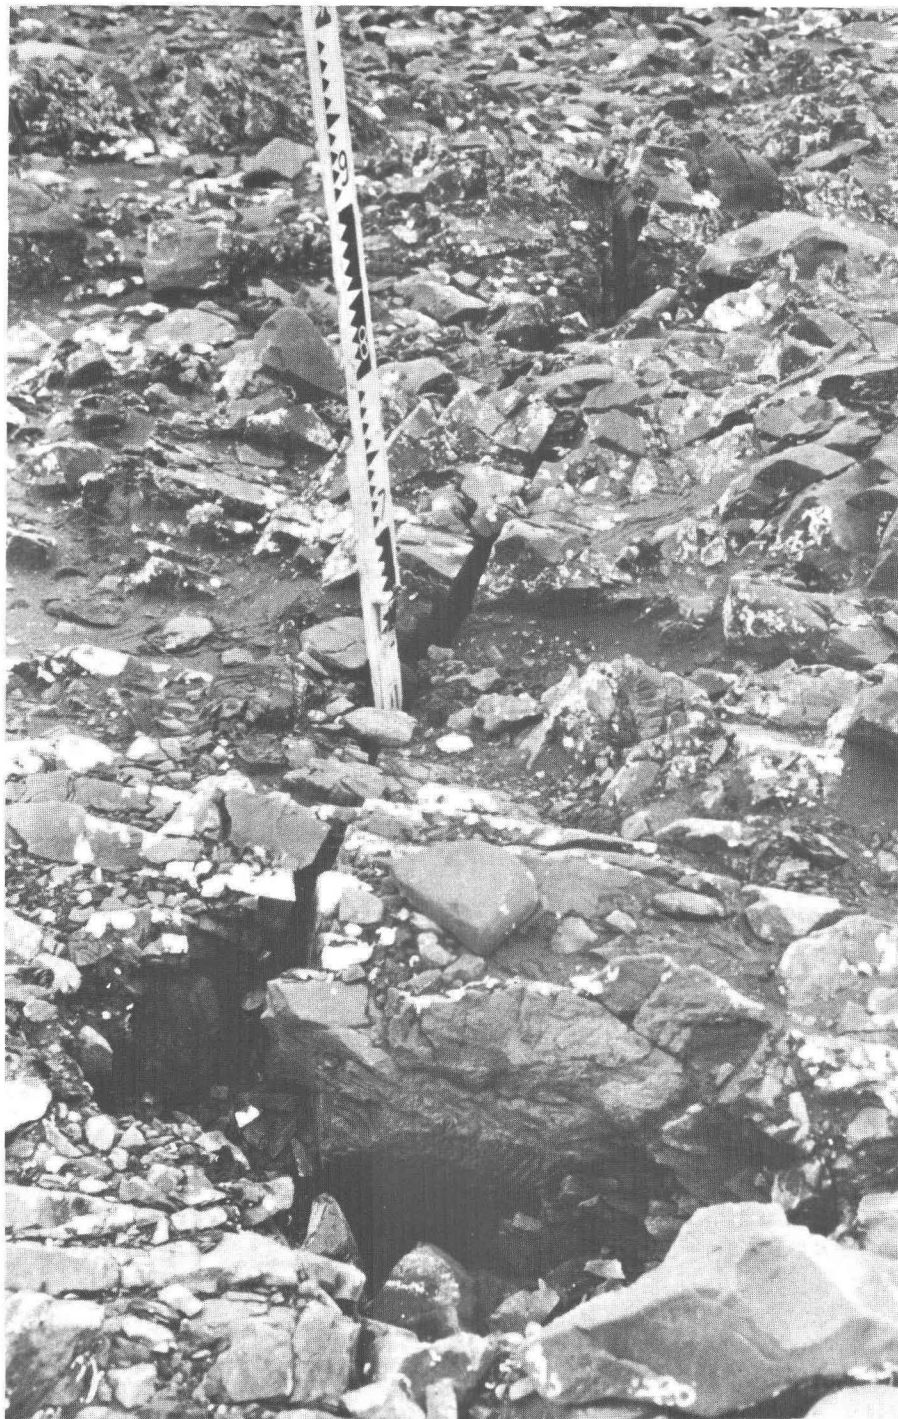
33.—Near-vertical extension crack on uplifted block of Hanning Bay fault at Fault Cove. Crack is 0.2 foot wide and at least 7 feet deep. Hole in foreground is caused by local caving at the intersection of two cracks. Location shown in figure 34.

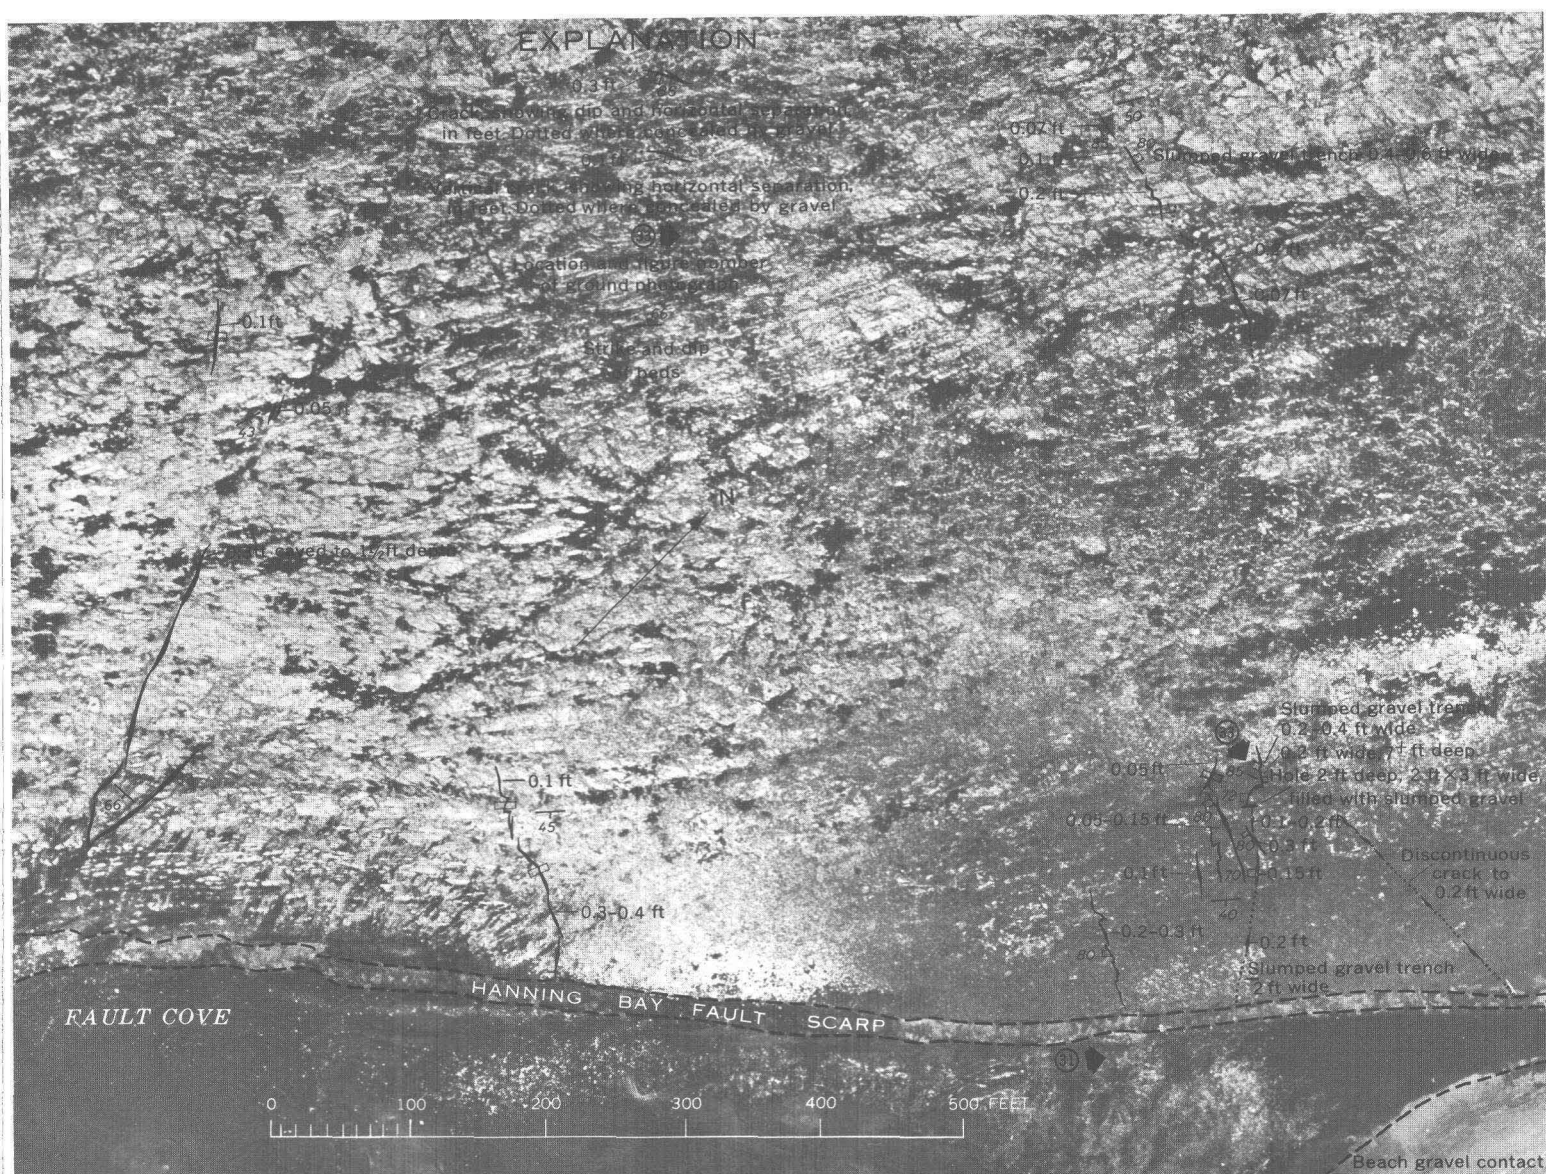
34.—Sketch map of the larger tectonic cracks in the upthrown block of the Hanning Bay fault at Fault Cove. Numerous smaller cracks in the same general area are not plotted. Location of photograph is shown on plate 2. Geology by M. G. Bonilla and George Plafker August 1, 1965. Base photograph by U.S. Coast and Geodetic Survey, July 28, 1964.

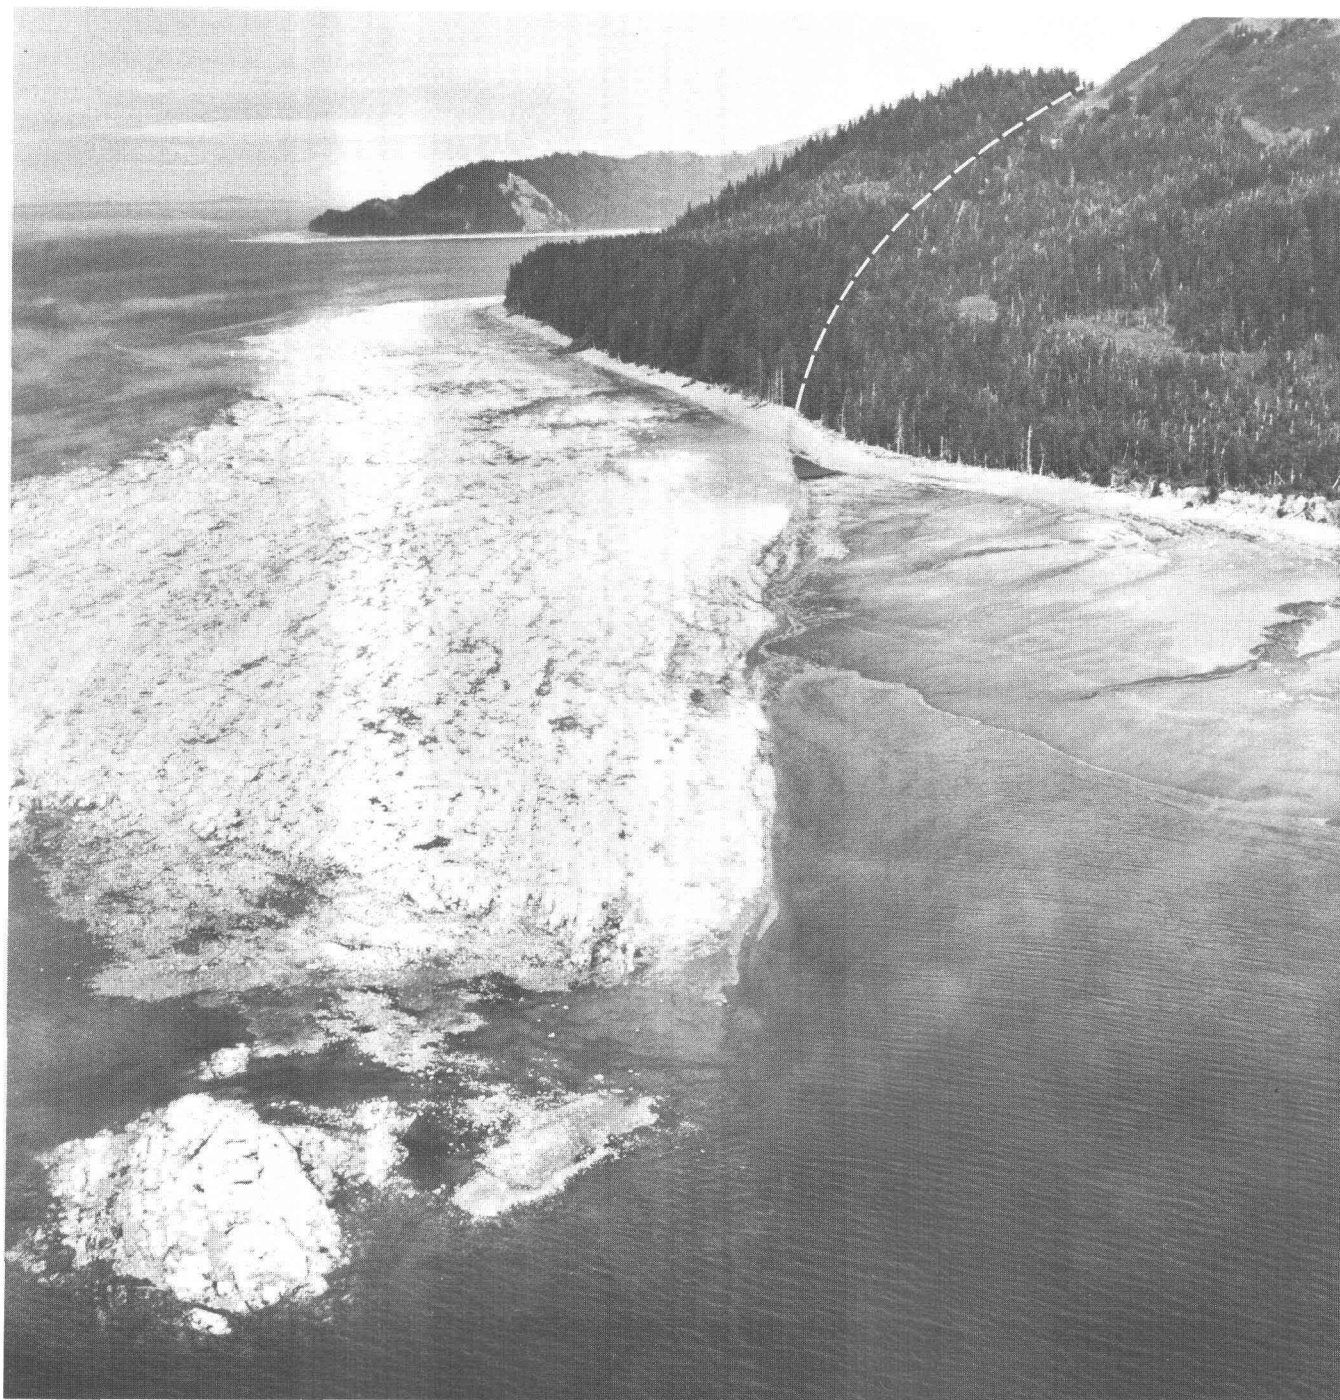
35.—Hanning Bay fault north of Fault Cove. The average  $65^{\circ}$ -NW. (left) dip of this segment of the fault causes the trace (dashed) to be deflected uphill (right) as it crosses the 850-foot-high ridge between Fault Cove and Hanning Bay. The pond, at the intersection of the fault scarp and the former beach ridge, occupies a closed tectonic depression in the downthrown block.

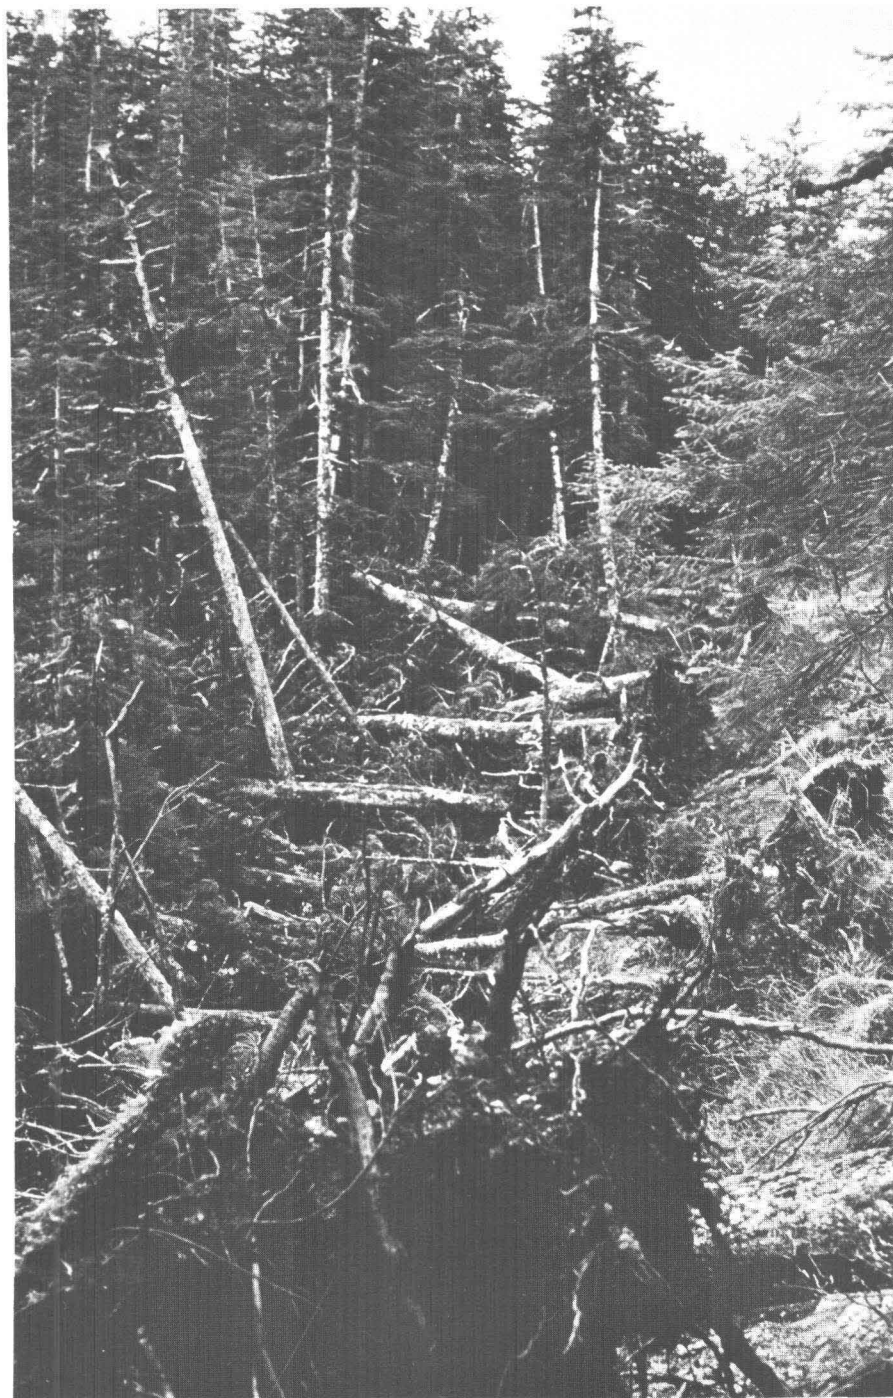
36.—A typical swath of tilted and fallen trees in timbered areas along the Hanning Bay fault. The upthrown block was overthrust from right to left.

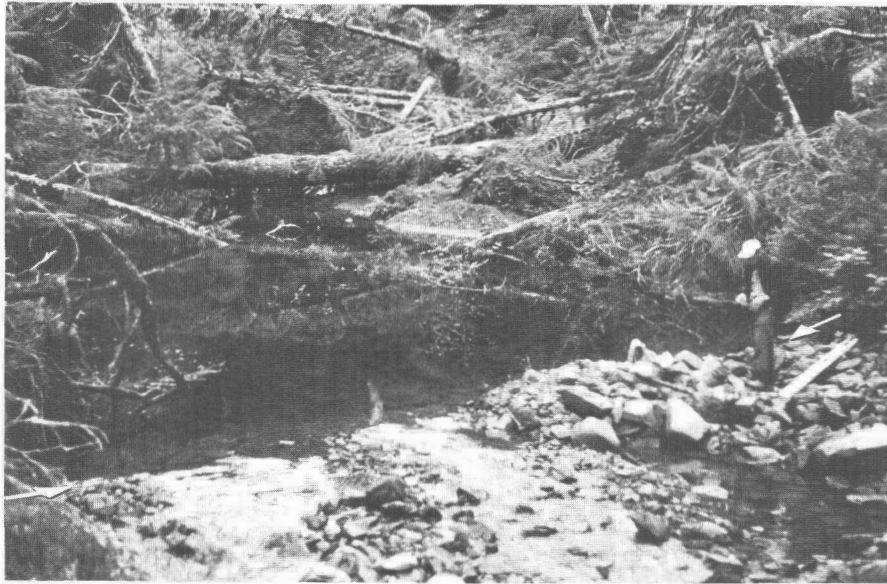
37.—Pond more than 10 feet deep formed where a stream flows across the uphill-facing fault scarp (arrows). Streamflow is toward the observer. Rubble and tangle of fallen trees slid from the steep valley walls.

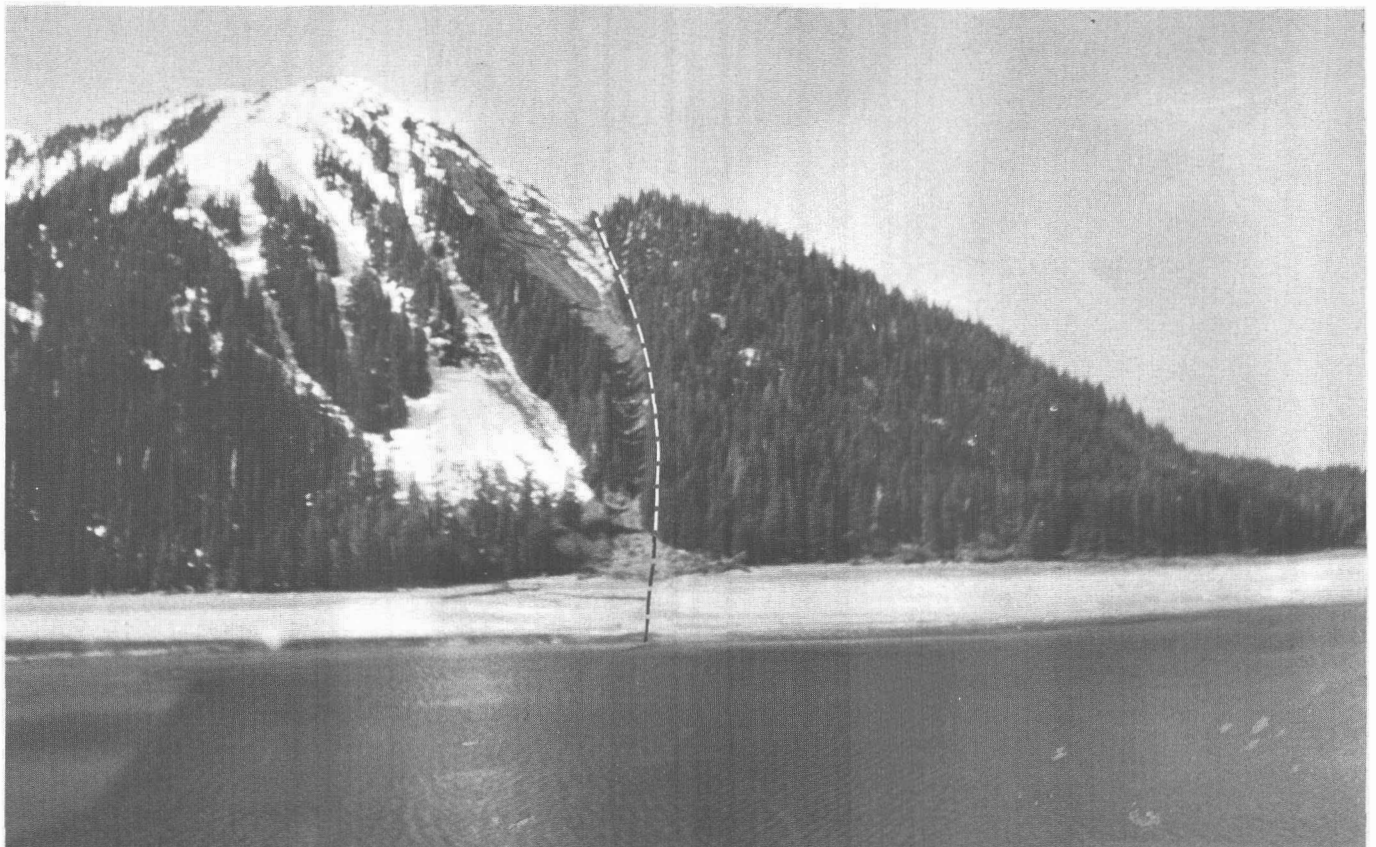
38.—Hanning Bay fault looking southwest from the bay. The fault trace on the ridge is marked by active landslides.

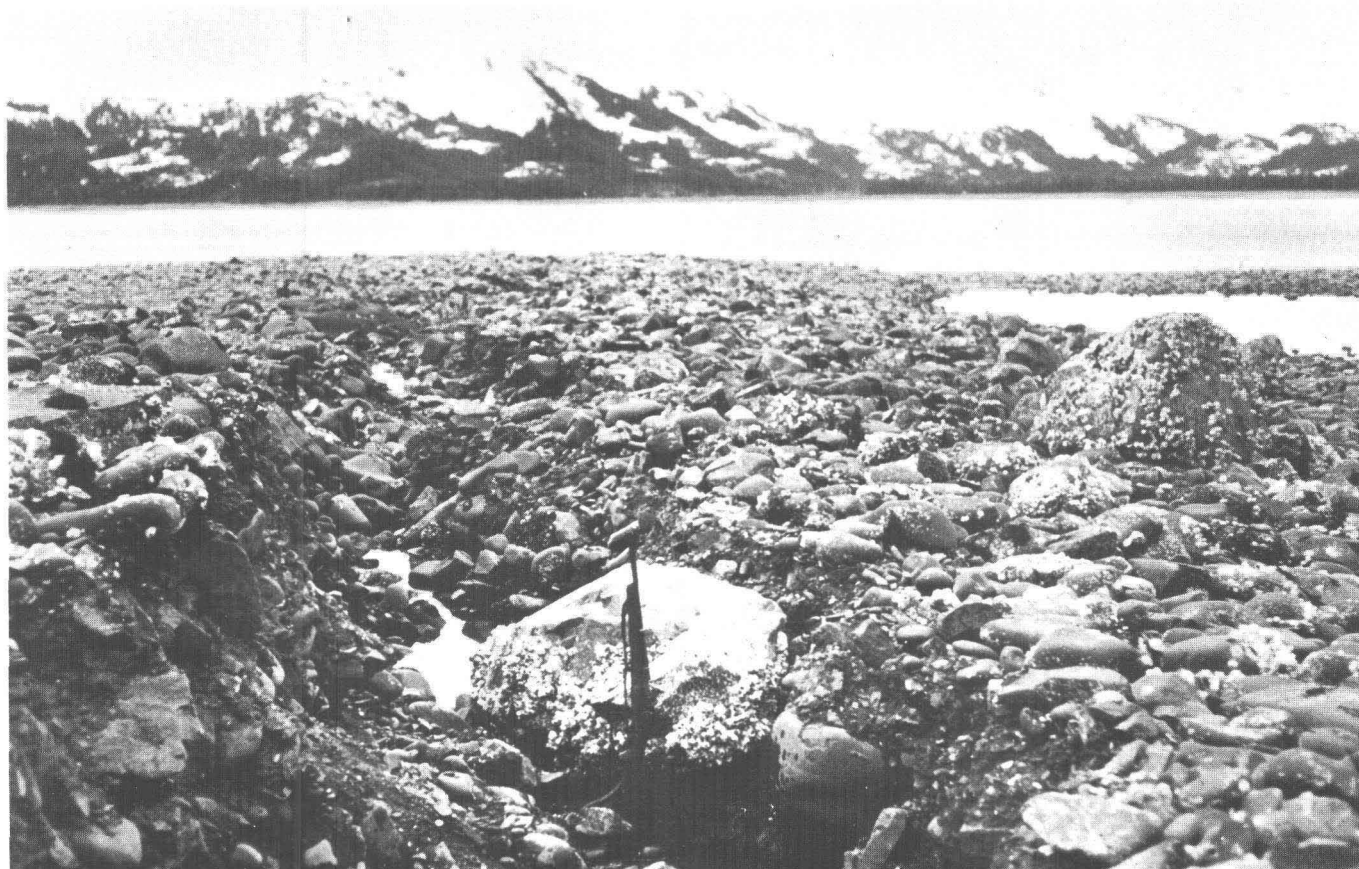
39.—Flexure and scarp with net vertical displacement of 7 feet in boulder-gravel beach along the Hanning Bay fault at south shore of Hanning Bay. Scarp 4 feet high in foreground is at the upper margin, and pond at right side of view is dammed against the base. The fault does not reappear on the north shore of Hanning Bay, which is visible in the background.
