THE ALASKA EARTHQUAKE, MARCH 27, 1964:
EFFECTS ON TRANSPORTATION, COMMUNICATIONS, AND UTILITIES

Effects of the Earthquake of March 27, 1964, on the Alaska Highway System

By REUBEN KACHADOORIAN

GEOLOGICAL SURVEY PROFESSIONAL PAPER 545-C

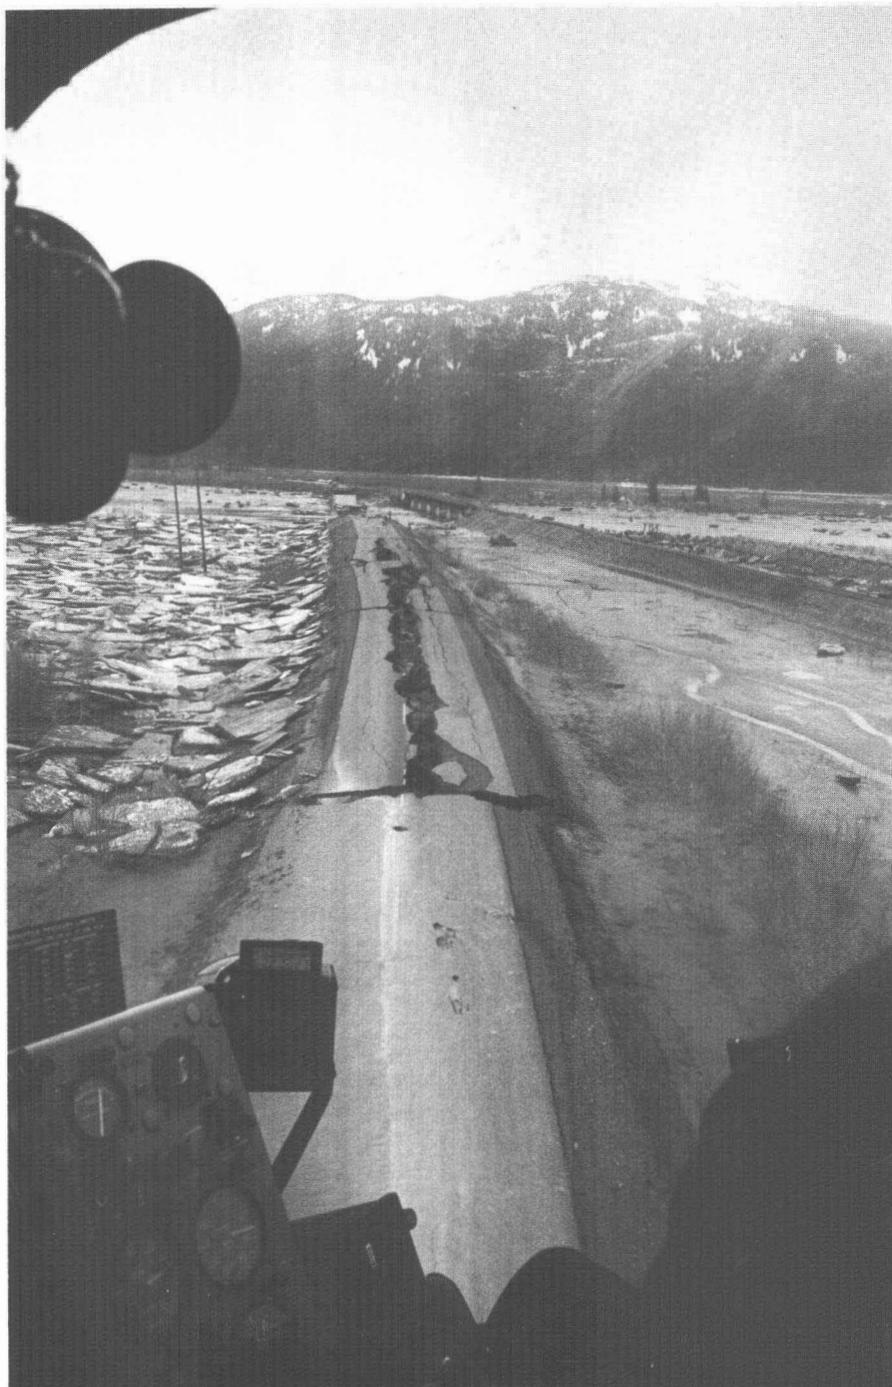
13.—View northwest showing conspicuous centerline fracture and more typical perpendicular fractures on Seward-Anchorage Highway between Portage and Twentymile River. Photograph by D. S. McCulloch.

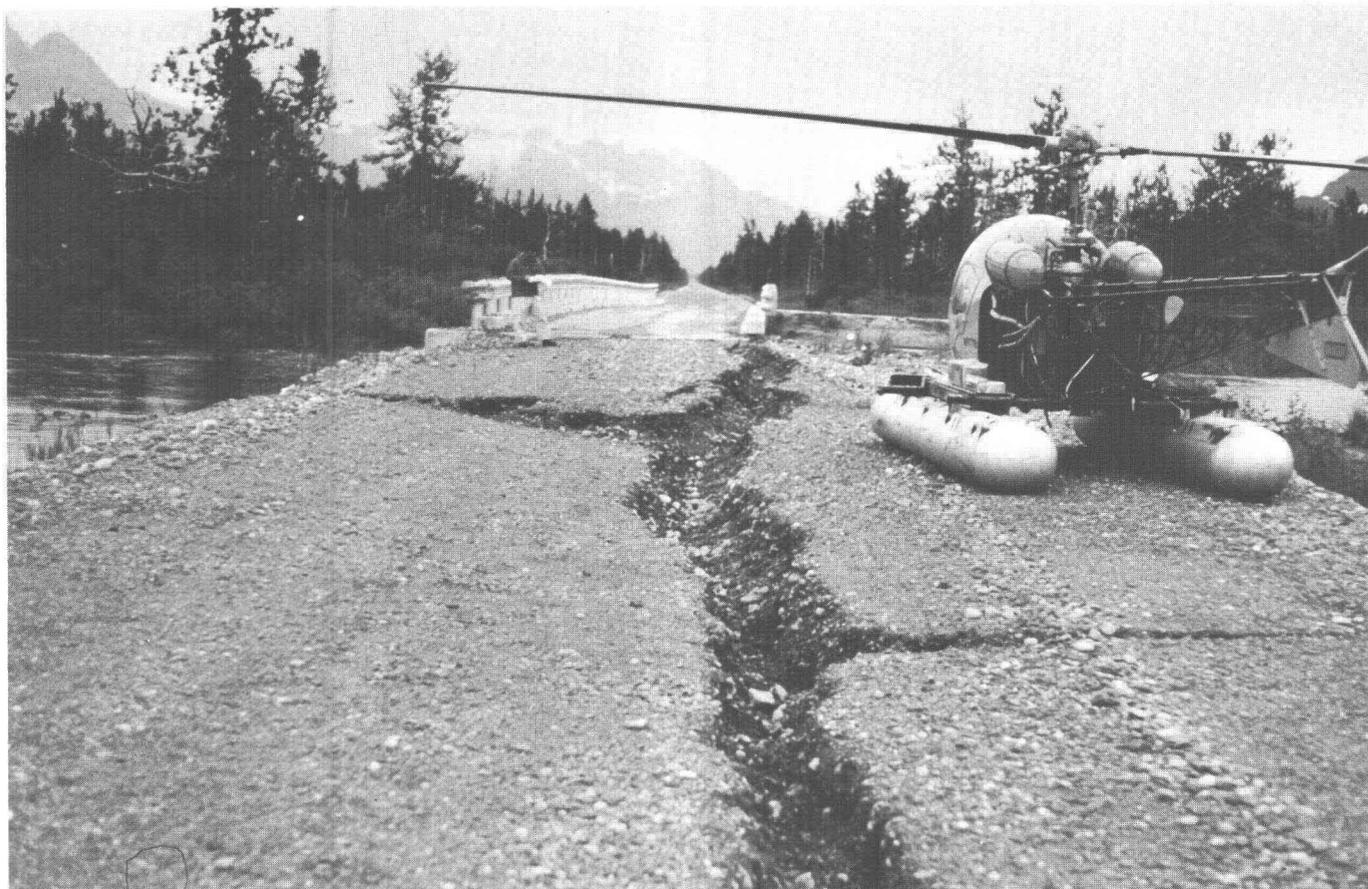
14.—Centerline fracture on unpaved Copper River Highway at south approach of Clear Creek bridge 329 at mile 41.0. Photograph by George Plafker.

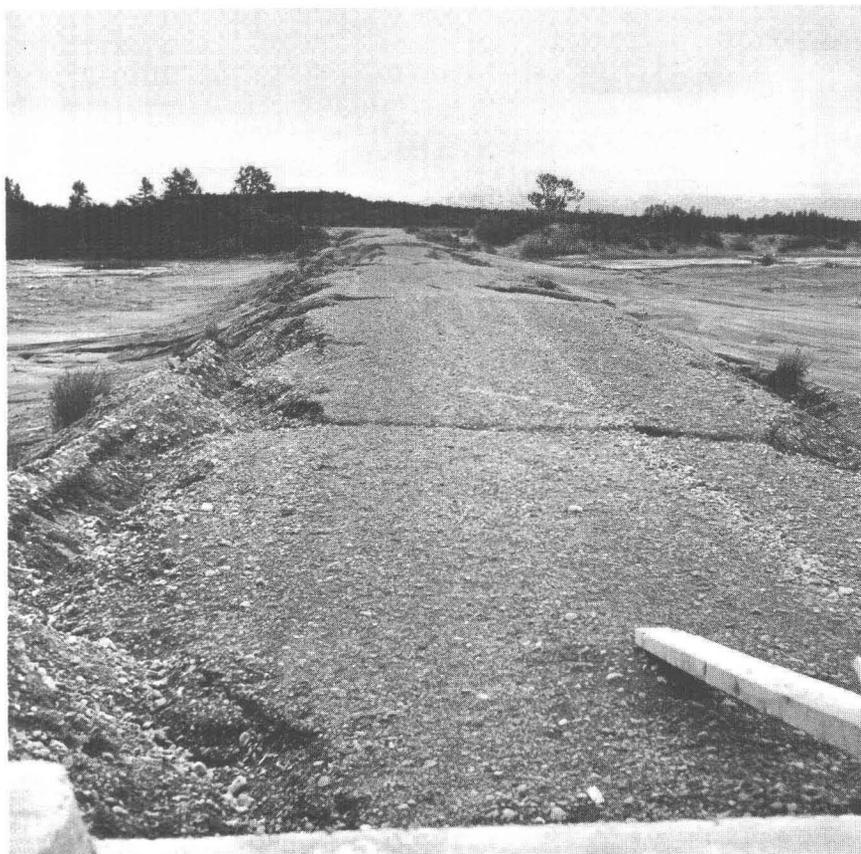
15.—Fractures normal to and along highway edge, Copper River Highway. Looking east from Copper River bridge 2, mile 27.1. Approach subsided 3 feet and fractured.

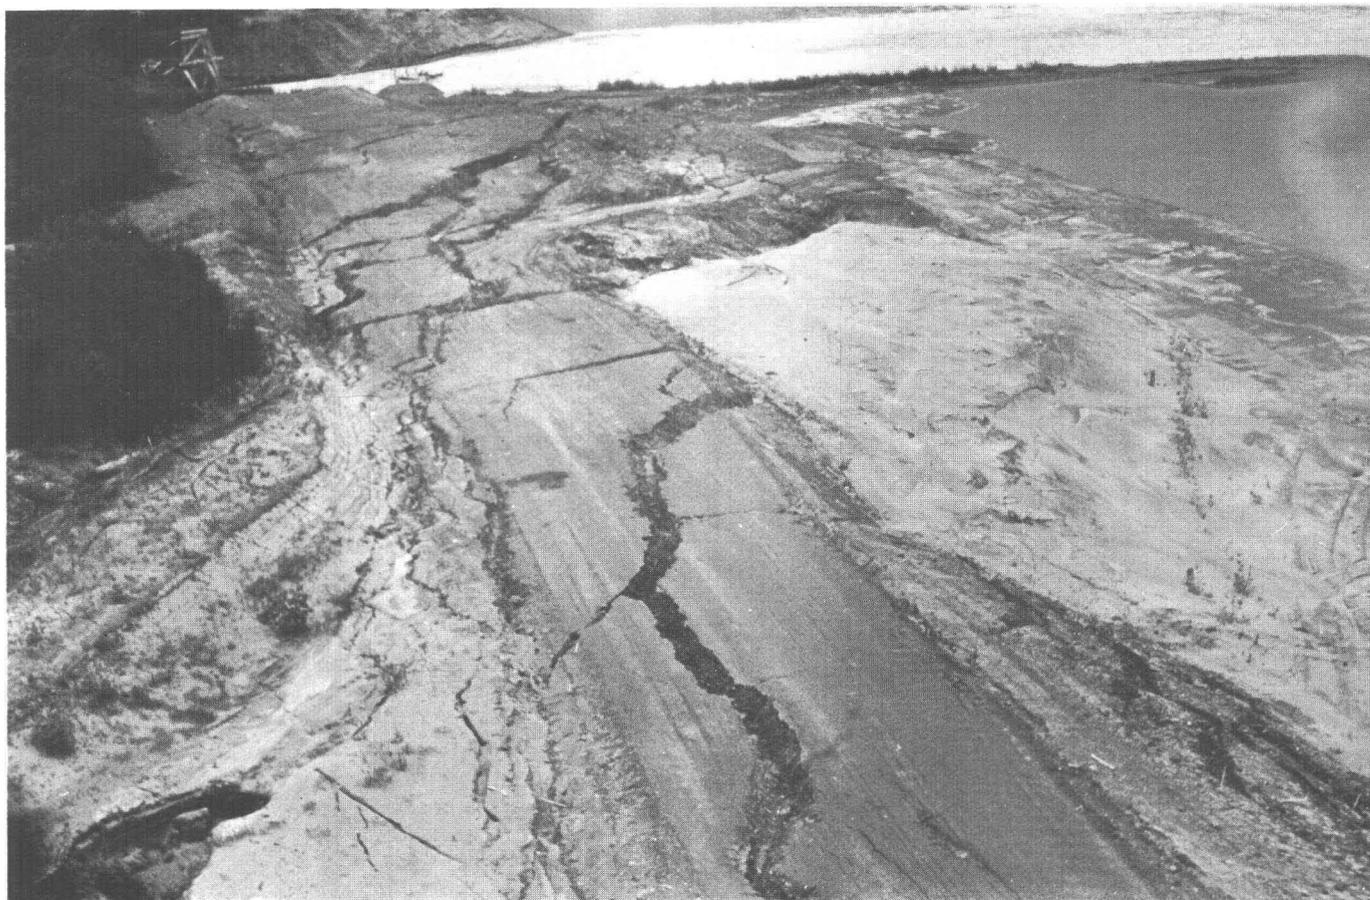
16.—Complex fractures with relatively large lateral and vertical displacements, produced by movement of saturated fine sand and silt toward free faces. View north near mile 58.5, Copper River Highway. The Allen River, which drains Allen Glacier, is in the background.

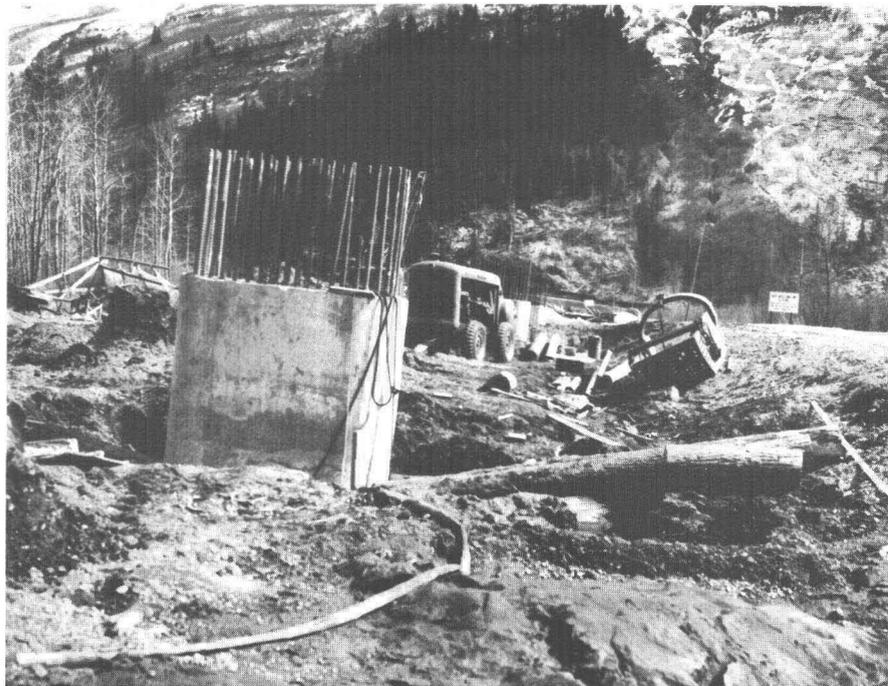
21.—Bridge pier for new crossing at Snow River displaced by compaction of underlying sediments or by liquefaction of fine silts. Photograph by D. S. McCulloch.

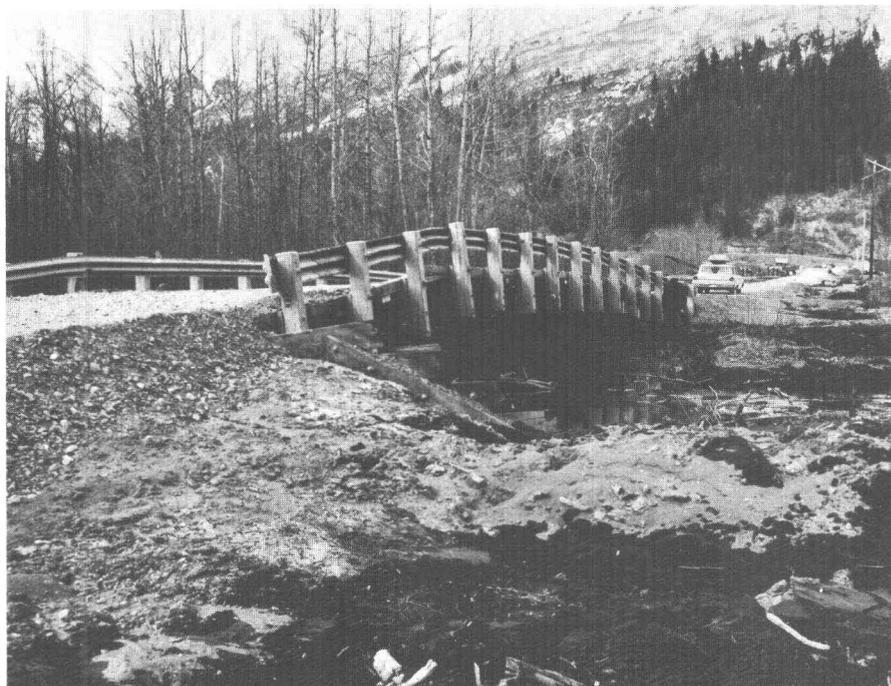
22.—View, looking west, of arched bridge at Snow River Crossing. Note that new fill in foreground was added to compensate for subsidence of approach fills and arching of bridge. Some of the original road fill had to be completely replaced. Photograph by D. S. McCulloch.

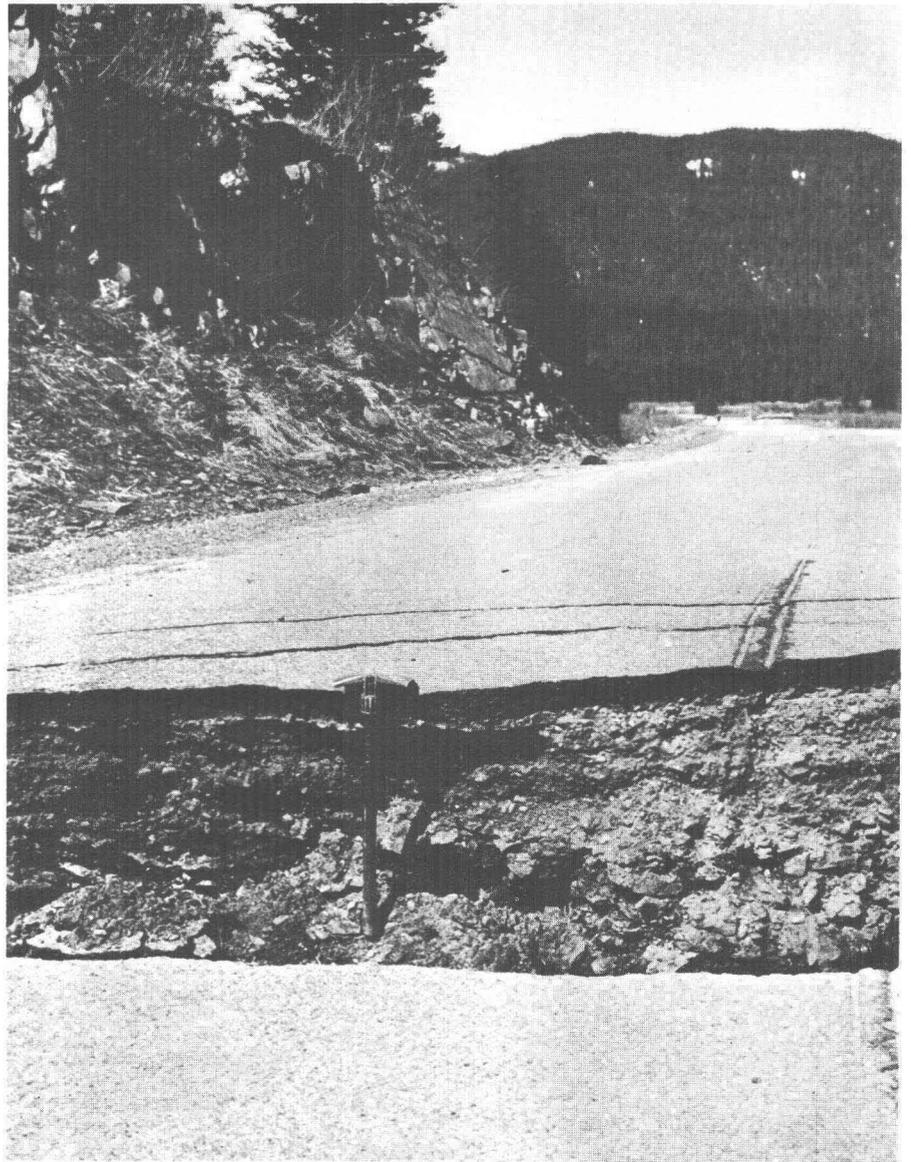
23.—Vertical displacement of roadway southeast of Ingram Creek on the Seward-Anchorage Highway. Pavement in foreground is underlain by sediments; in background, by bedrock. Trench shovel handle is 19 inches long. Photographs by Helen Foster.

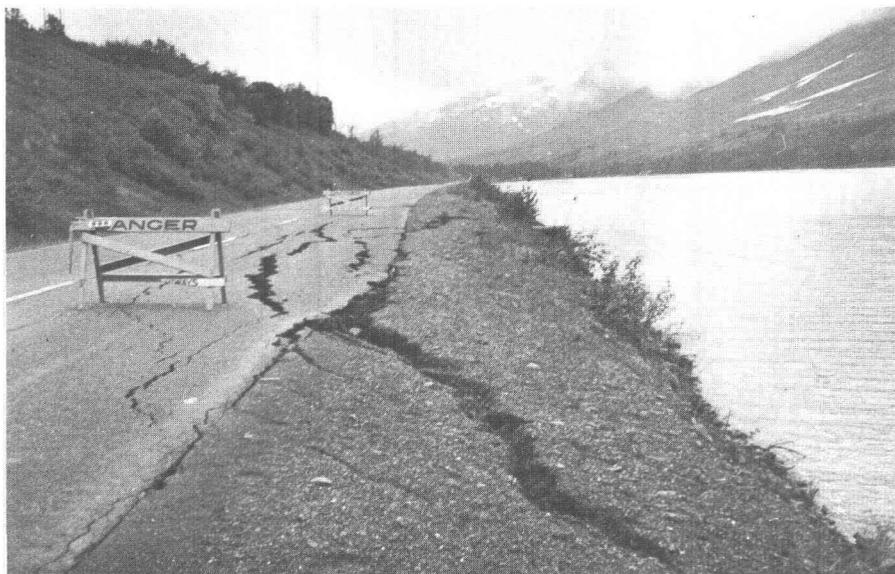
The earthquake triggered numerous small roadway landslides; the locations of slides are shown on figures 2-5. Most were small and only affected part of the roadway; on the Seward-Anchorage Highway near mile 44.5, for instance, about 100 feet of the road-

24.—Small landslide on Seward-Anchorage Highway near mile 44.5, along shore of Summit Lake.

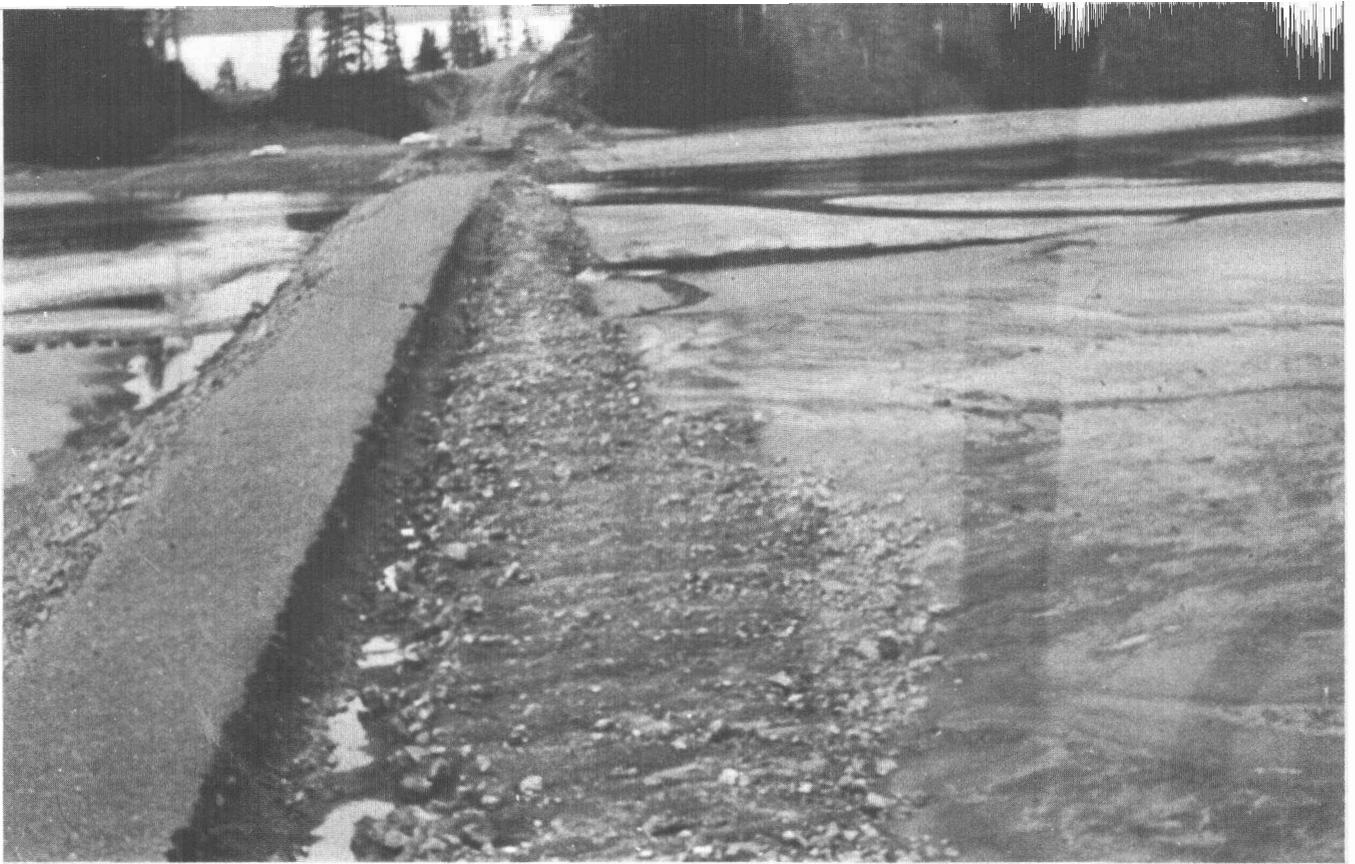
26.—Right side of Point Whitshed Road destroyed by seismic sea waves. Waves advanced over roadway from the left and cut sharp edge on right side of roadway. View northeast; Hartney Bay is to the right.

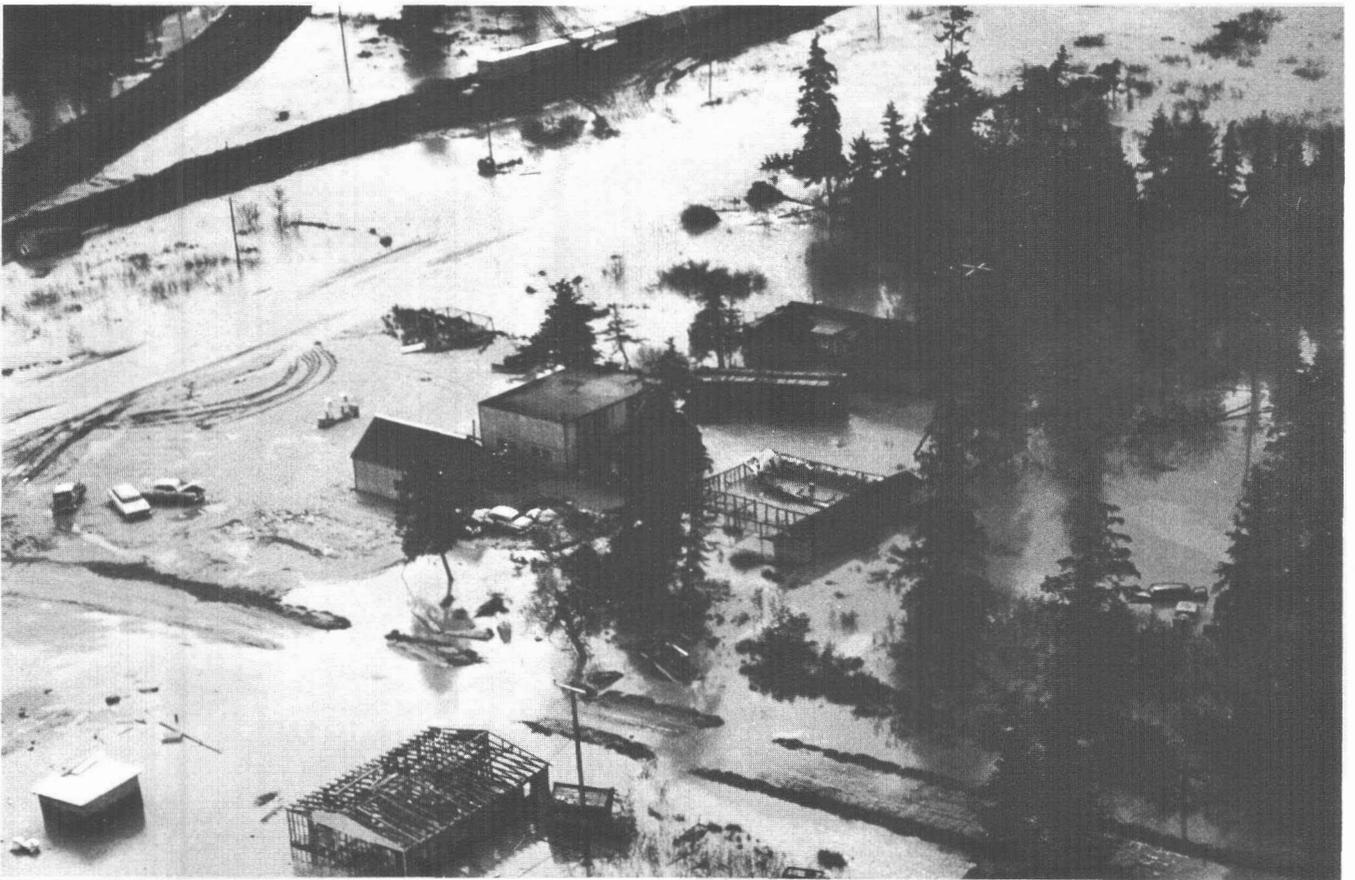
27.—View of Portage on Seward-Anchorage Highway during 28-foot tide, after regional subsidence caused by the earthquake. Highway is under water, just below railroad grade in far background. Photograph taken August 10, 1964.

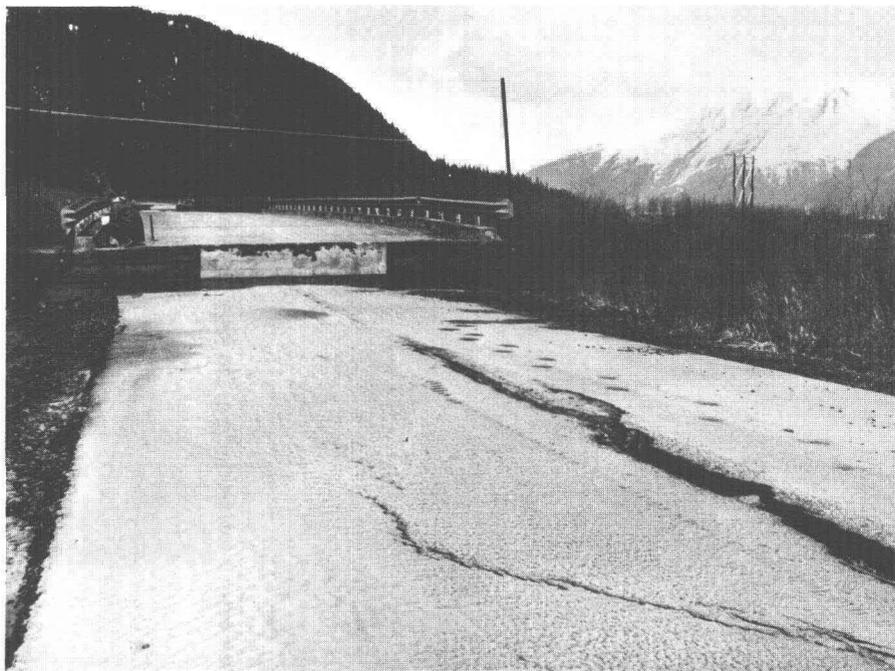
30.—Subsidence of bridge approach fill at Tidewater Slough 2 bridge, mile 76.4, Seward-Anchorage Highway. View is west. Photograph by Helen Foster.

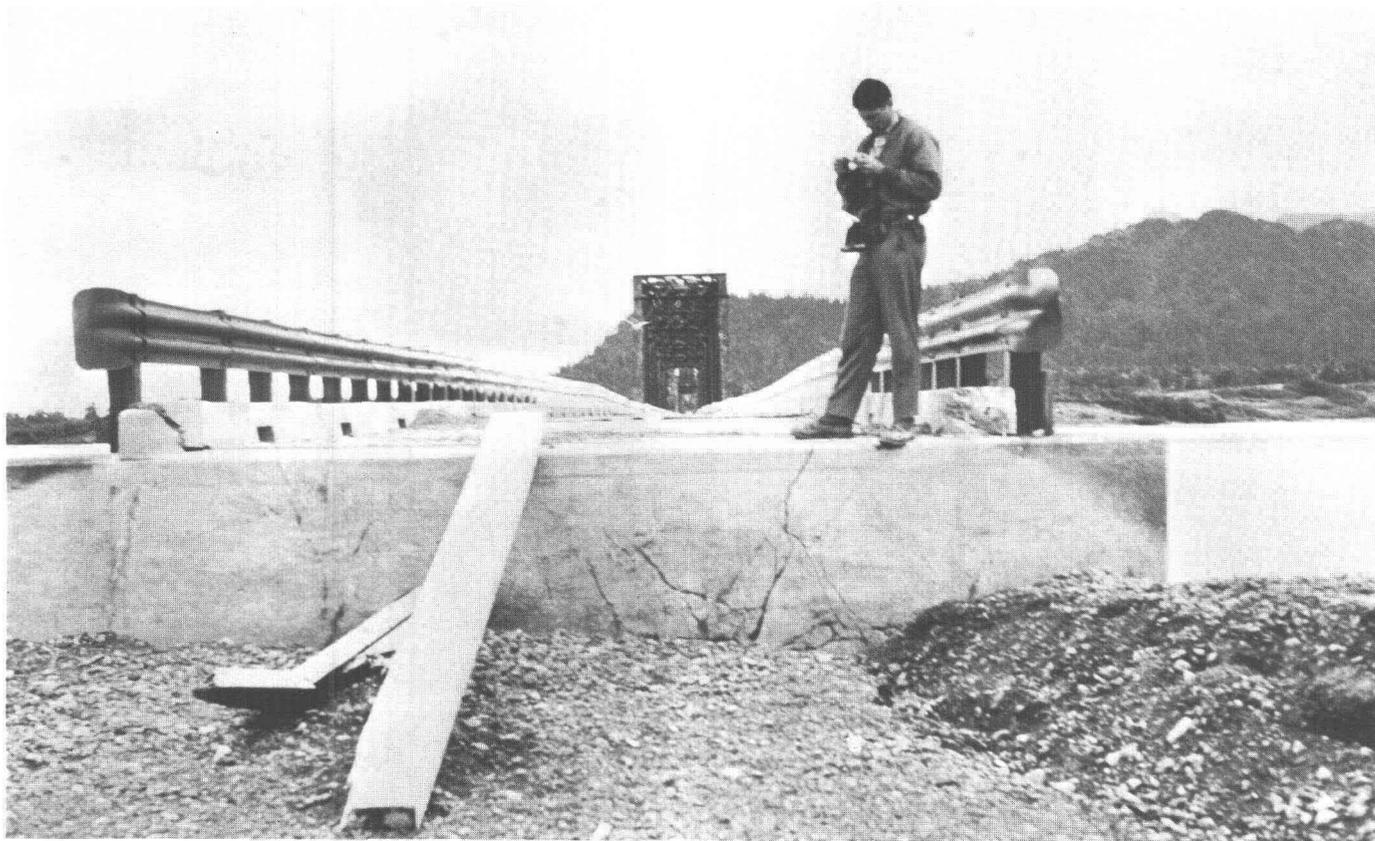
31.—View looking west, Copper River bridge 2, mile 27.1, Copper River Highway. Approach subsided 3 feet as a result of seismic shaking.

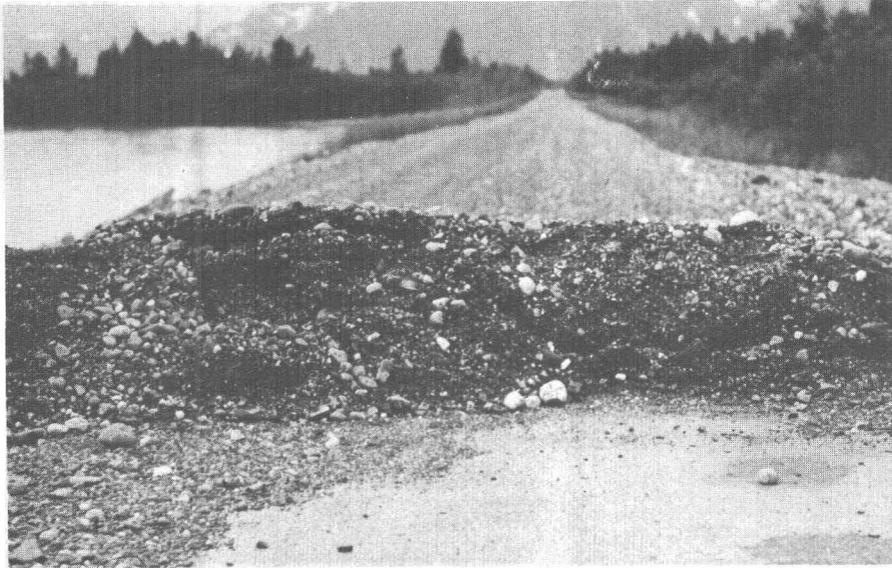
32.—Mound formed by bulldozing of approach fill against bridge deck (foreground), at north end of Copper River 12 bridge, mile 36.9, Copper River Highway.

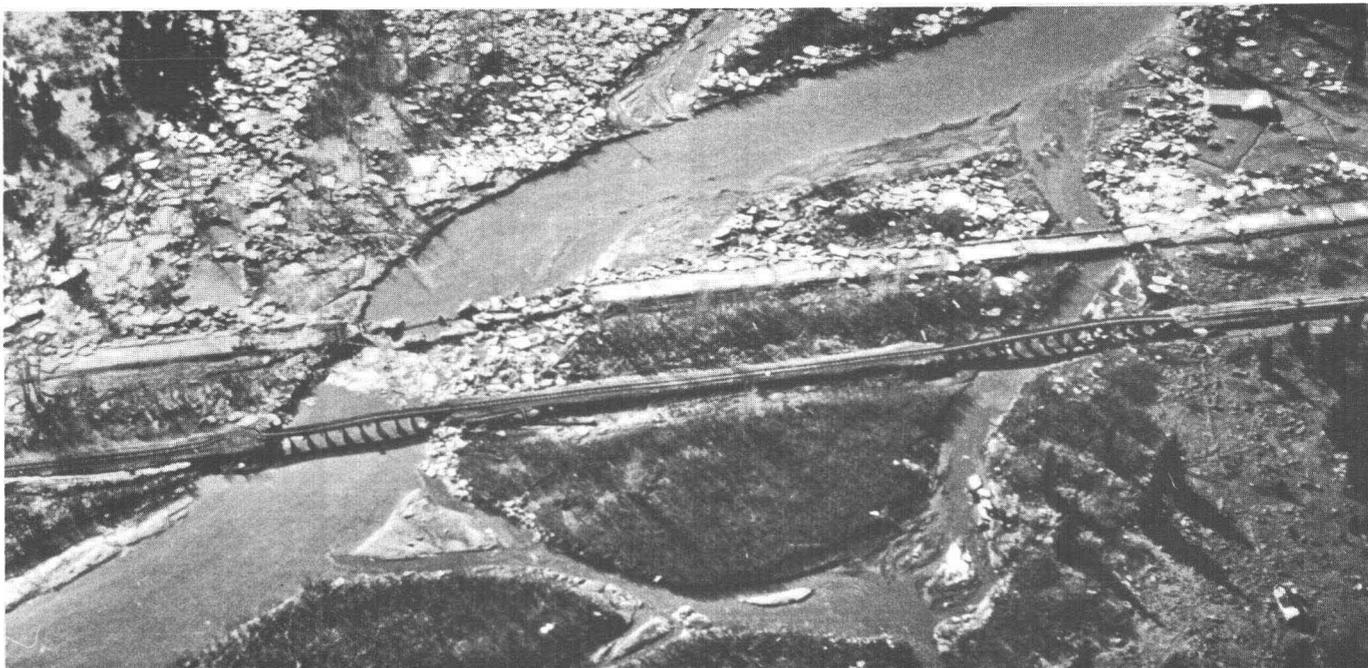
33.—Wreckage of Portage Creek bridges 2 and 3, Seward-Anchorage Highway. The Alaska Railroad grade and bridges are in foreground of highway. Photograph by U.S. Army.

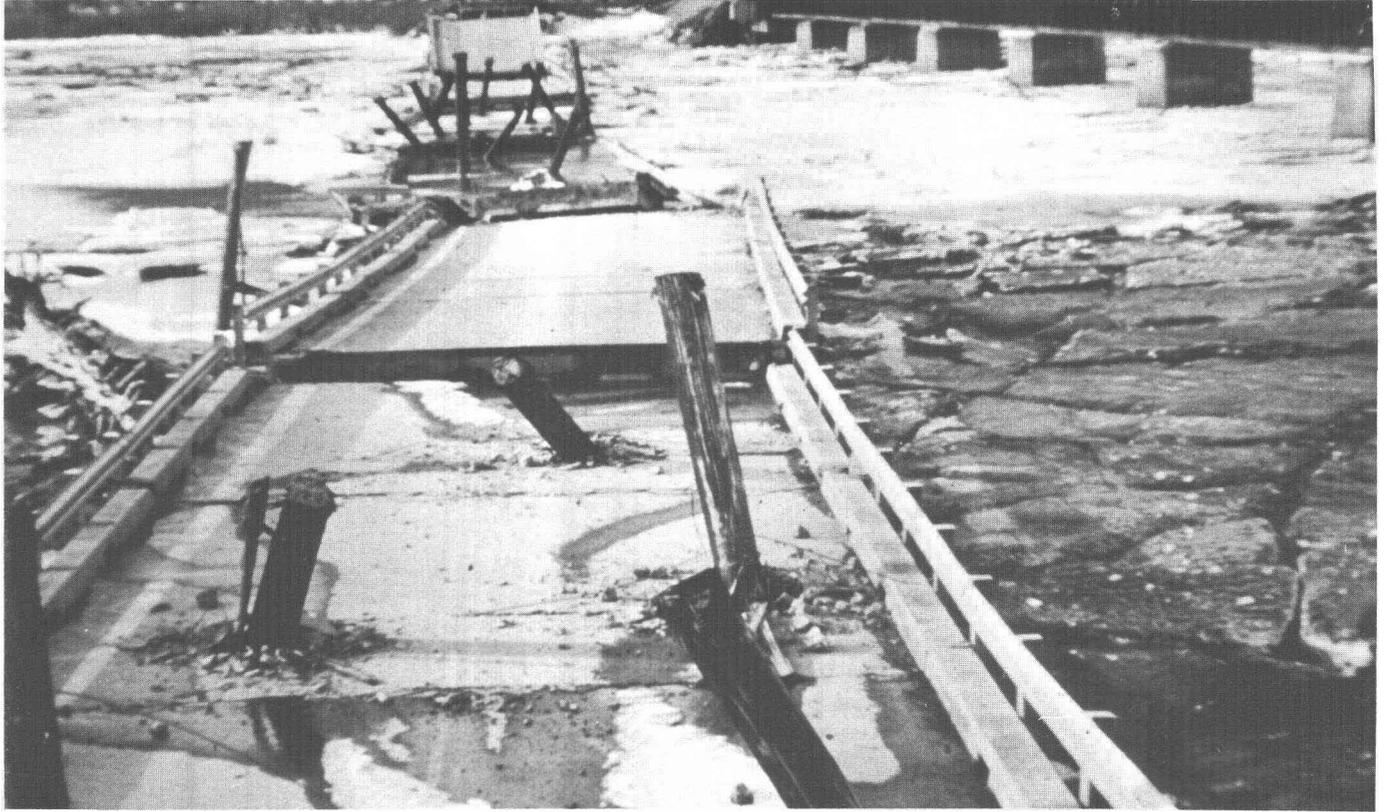
34.—Collapsed bridge across Twentymile River. Railroad bridge in upper right photograph did not collapse.

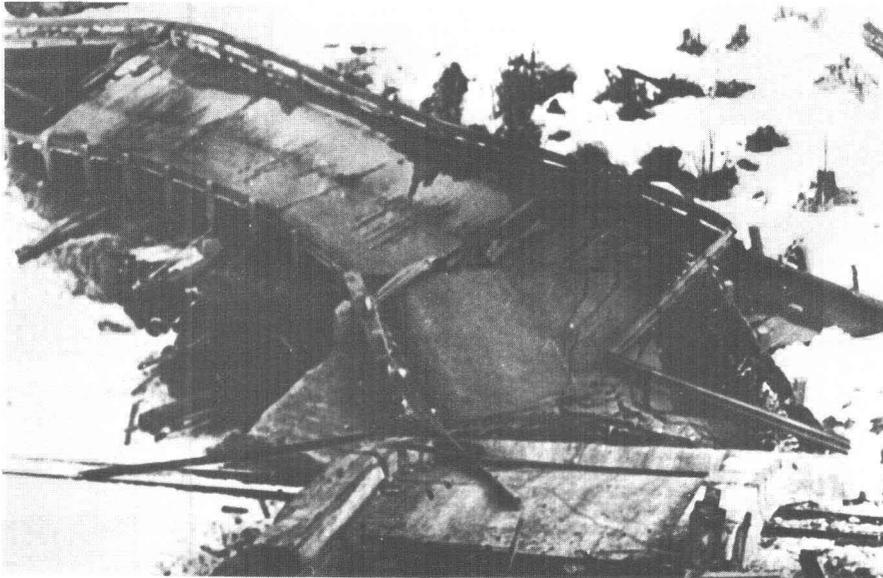
35.—Overhead at east side of Snow River Crossing. Structure collapsed upon tracks of The Alaska Railroad. Photograph by U.S. Army.

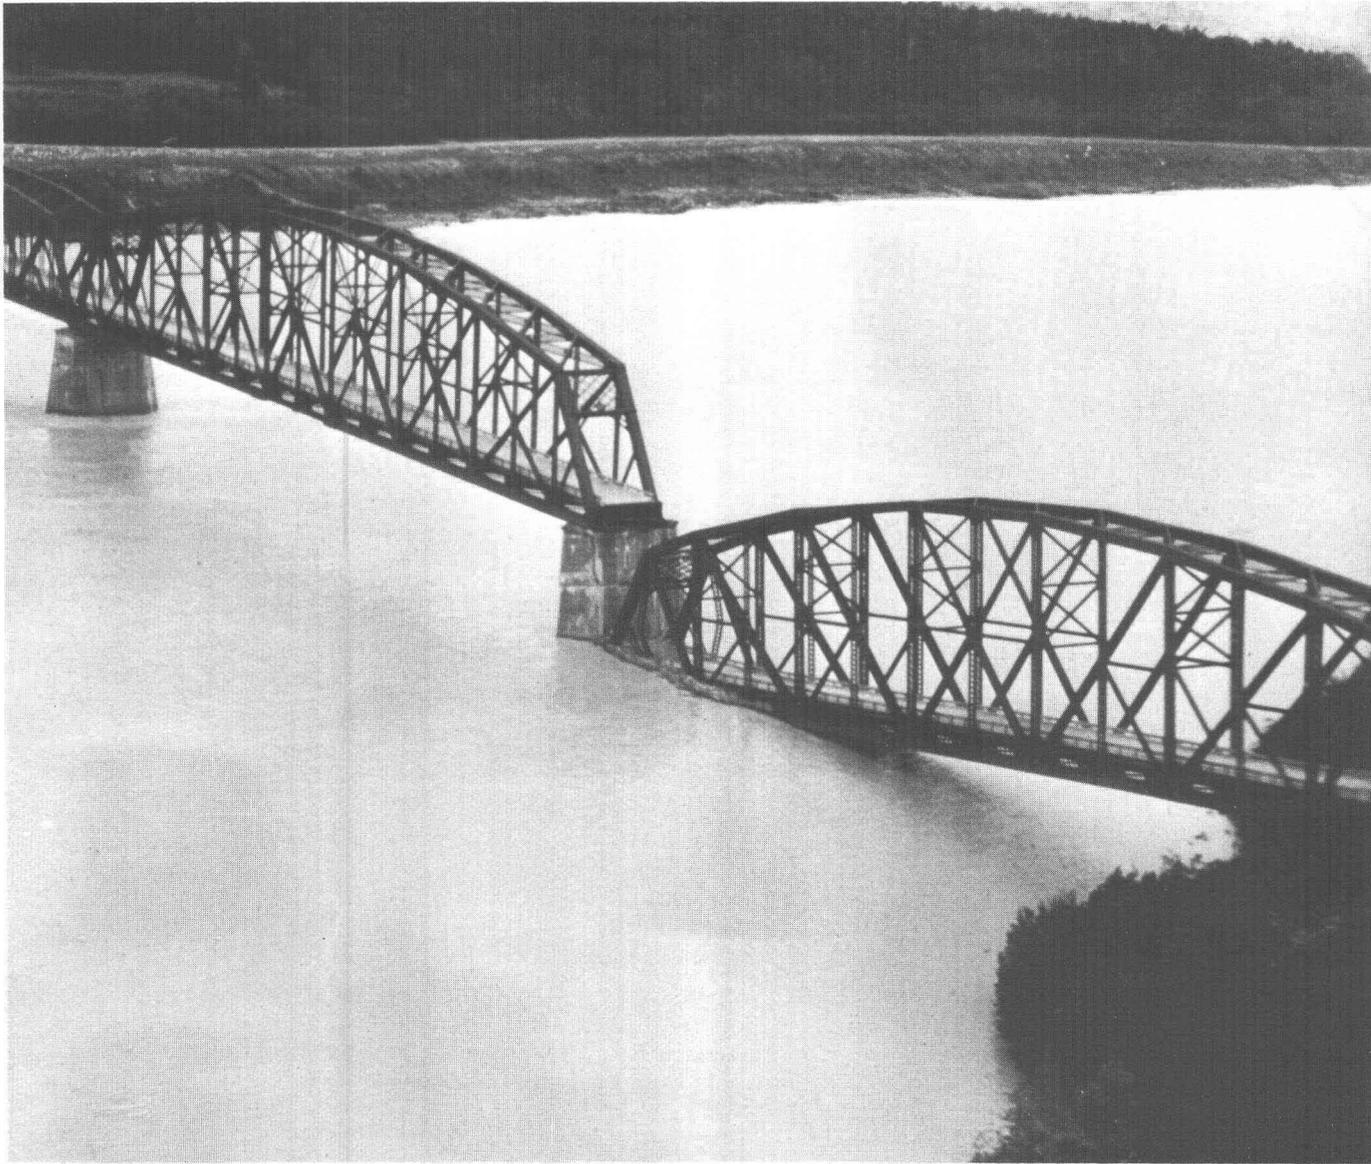
36.—Million Dollar Bridge, Copper River Highway; No. 4 span off No. 4 pier. View is southwest.

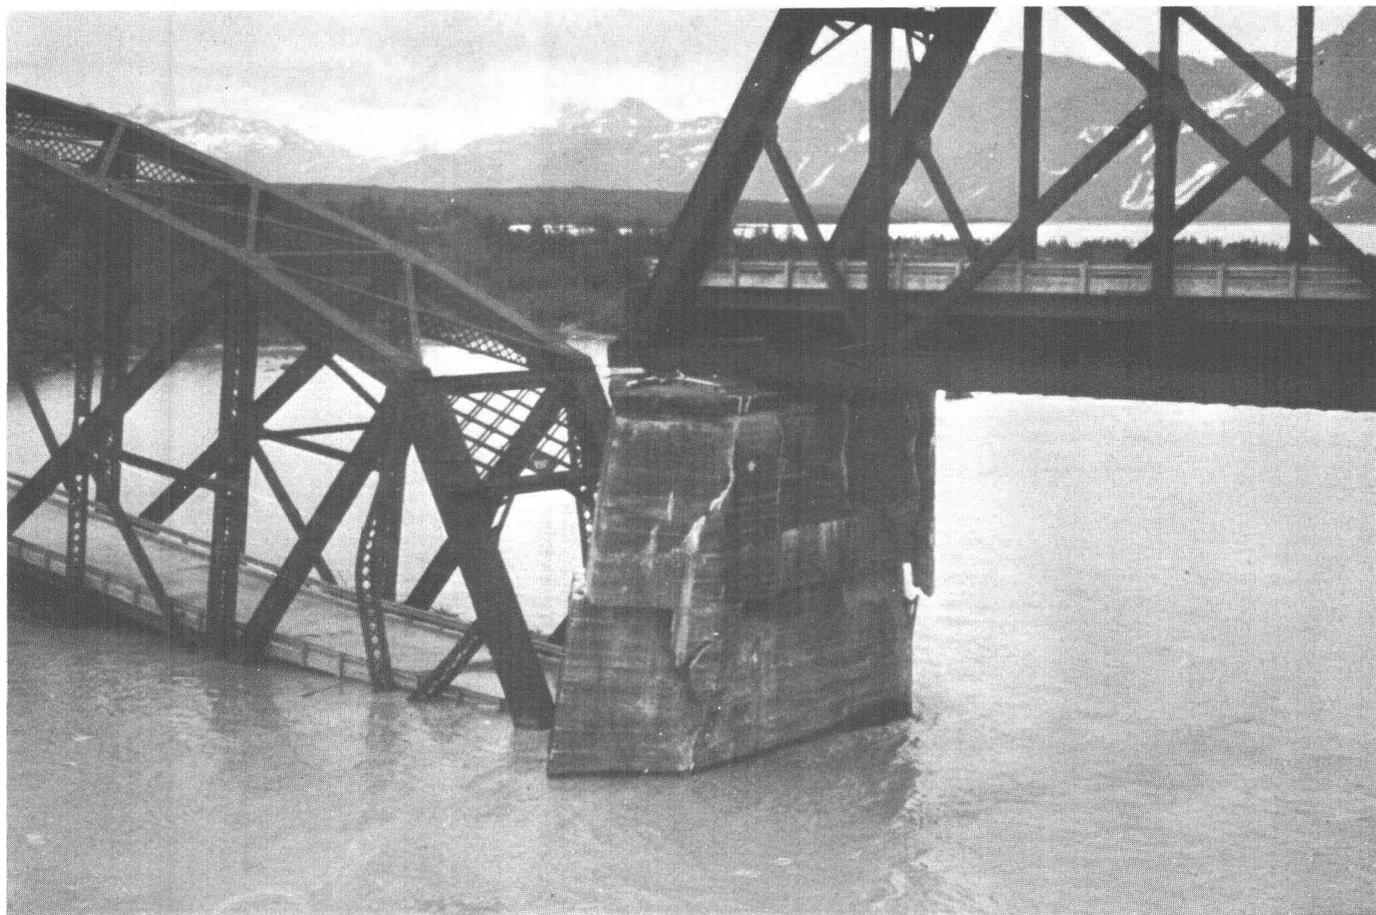
37.—Collapsed No. 4 span and horizontal fracture in No. 4 pier of Million Dollar Bridge, Copper River Highway. View is northeast.

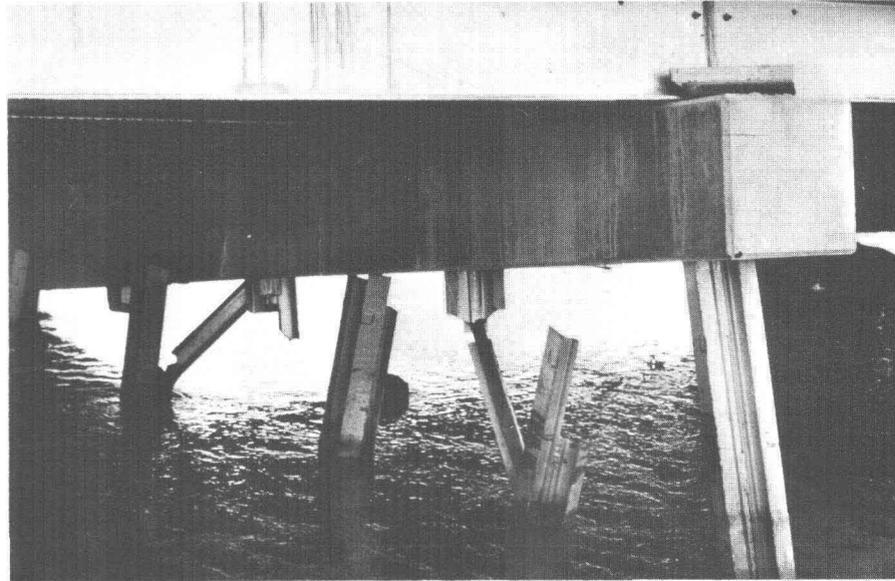
38.—Broken rail piles on Scott Glacier 6 bridge, mile 5.9, Copper River Highway.

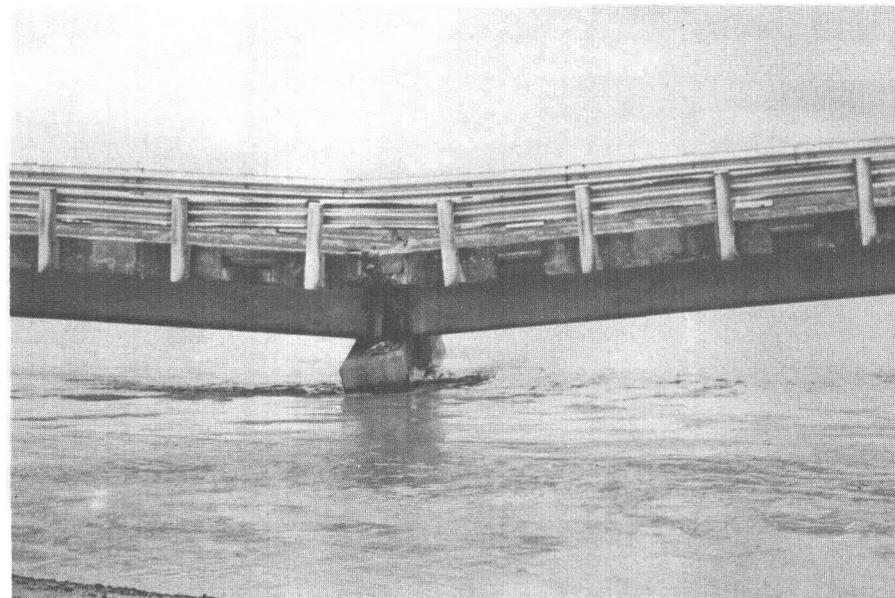
39.—Collapsed bent and deck of Copper River 5 bridge, mile 35.0, Copper River Highway.

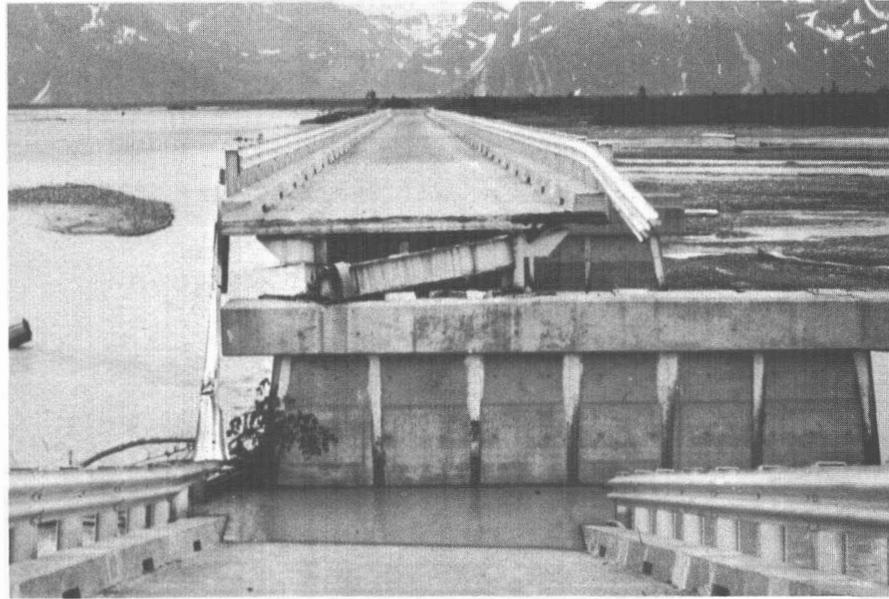
40.—Collapsed deck on Copper River 5 bridge, mile 35.0, Copper River Highway. Concrete between rail piles is to protect rails against ice.

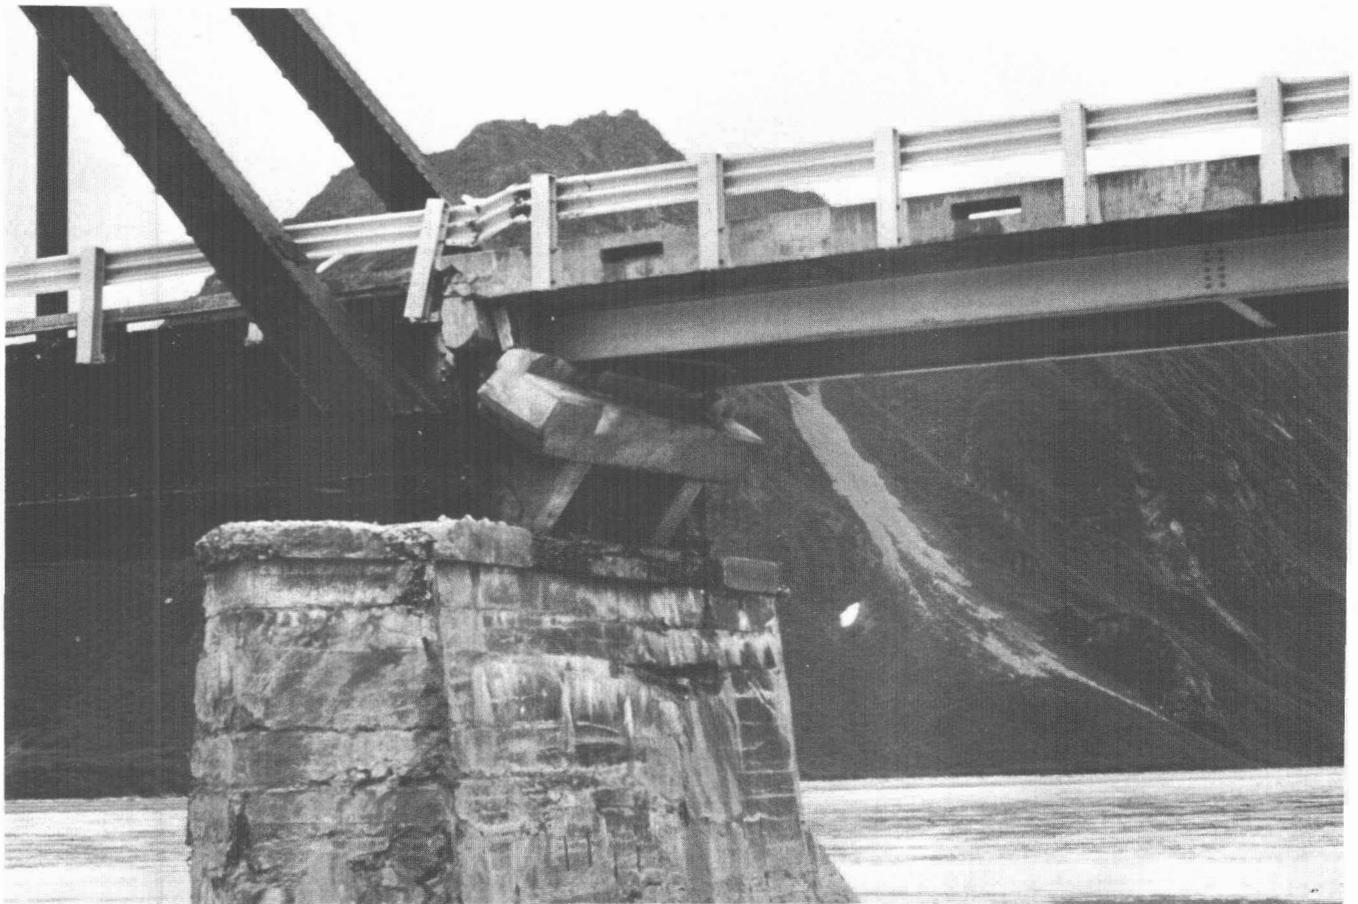
41.—Contact between steel truss and concrete deck on pier 26, Copper River 2 bridge, mile 27.1, Copper River Highway.

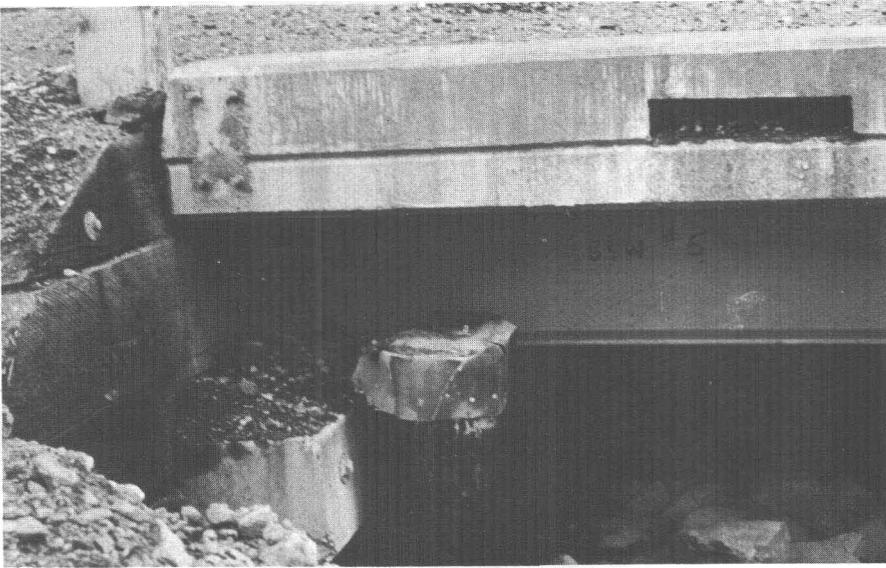
42.—West abutment of Scott Glacier 5 bridge, mile 9.2, Copper River Highway. Concrete cap displaced 2 inches to the left off the pile bent. Compare with figure 43.

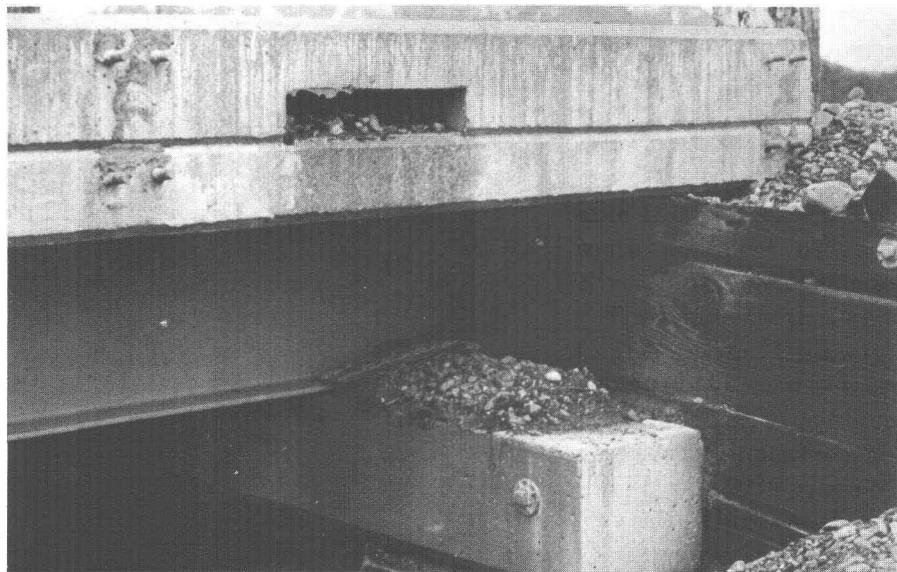
43.—East abutment of Scott Glacier Creek 5 bridge at mile 9.2, Copper River Highway. Superstructure is displaced about 2 feet to the right, relative to the abutment. Compare with figure 42.
