THE ALASKA EARTHQUAKE, MARCH 27, 1964:
EFFECTS ON TRANSPORTATION, COMMUNICATIONS, AND UTILITIES

Effects of the Earthquake of March 27, 1964, on the Alaska Highway System

By REUBEN KACHADOORIAN

GEOLOGICAL SURVEY PROFESSIONAL PAPER 545-C

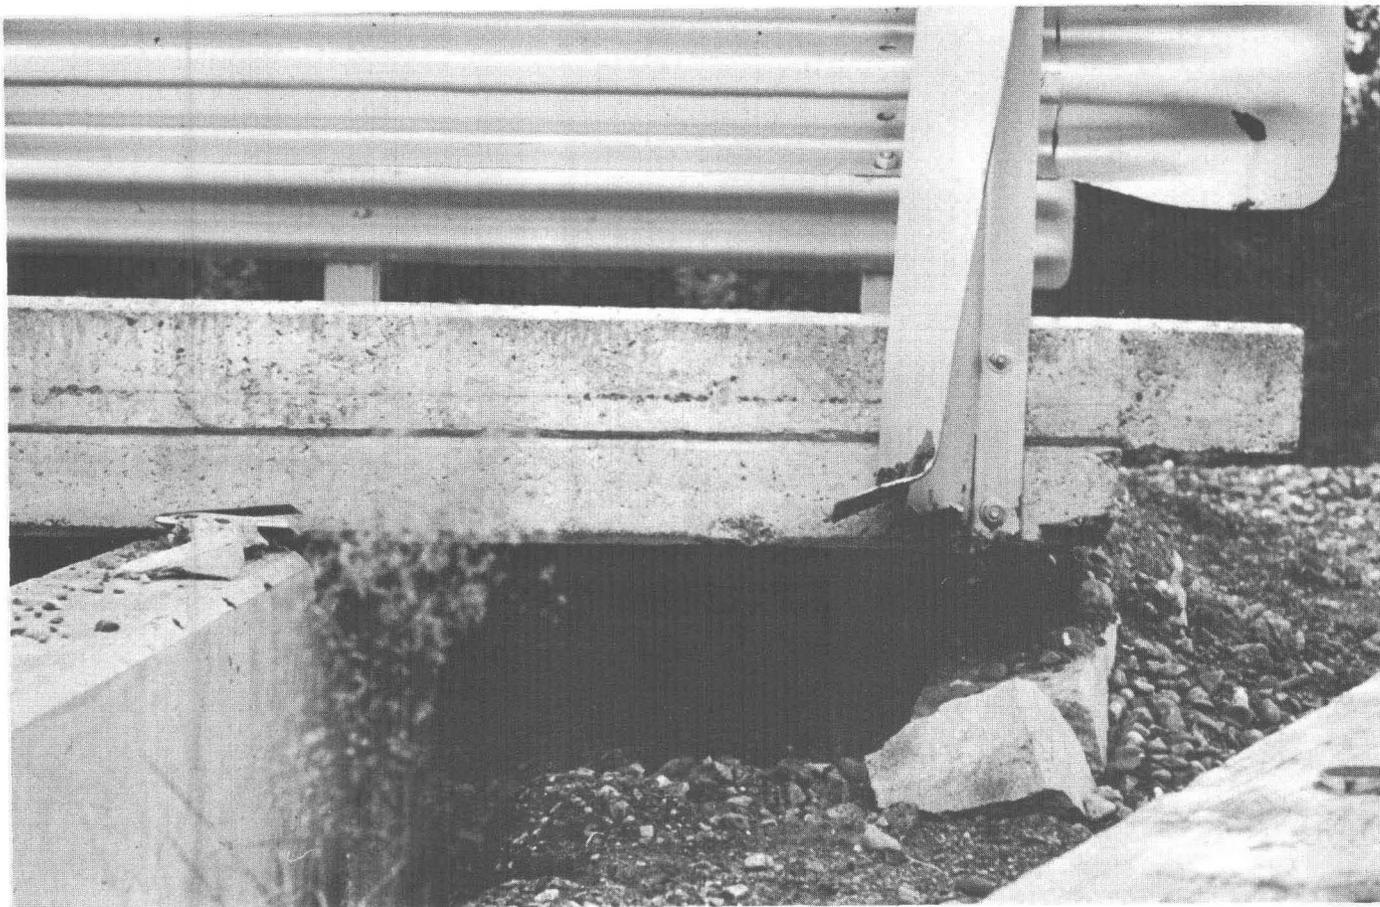
44.—North abutment of Clear Creek bridge 329, mile 41.0, Copper River Highway. Superstructure is displaced to the right relative to the abutment.

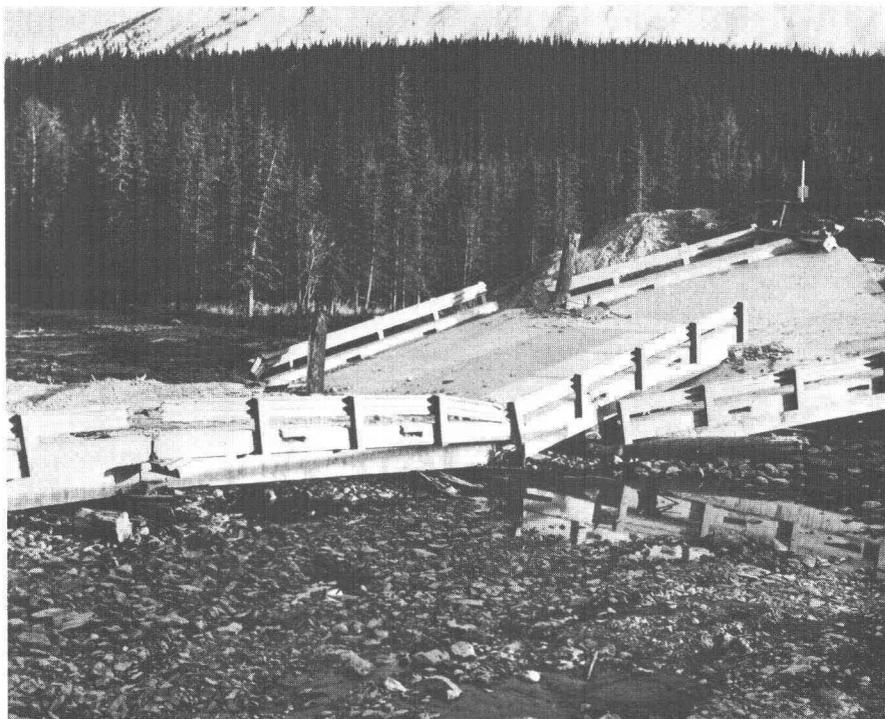
45.—Collapsed bridge across Kenai River at Kenai Lake, mile 48.9, Sterling Highway. Wood piles are driven through the collapsed reinforced concrete deck. Photograph by Helen Foster.

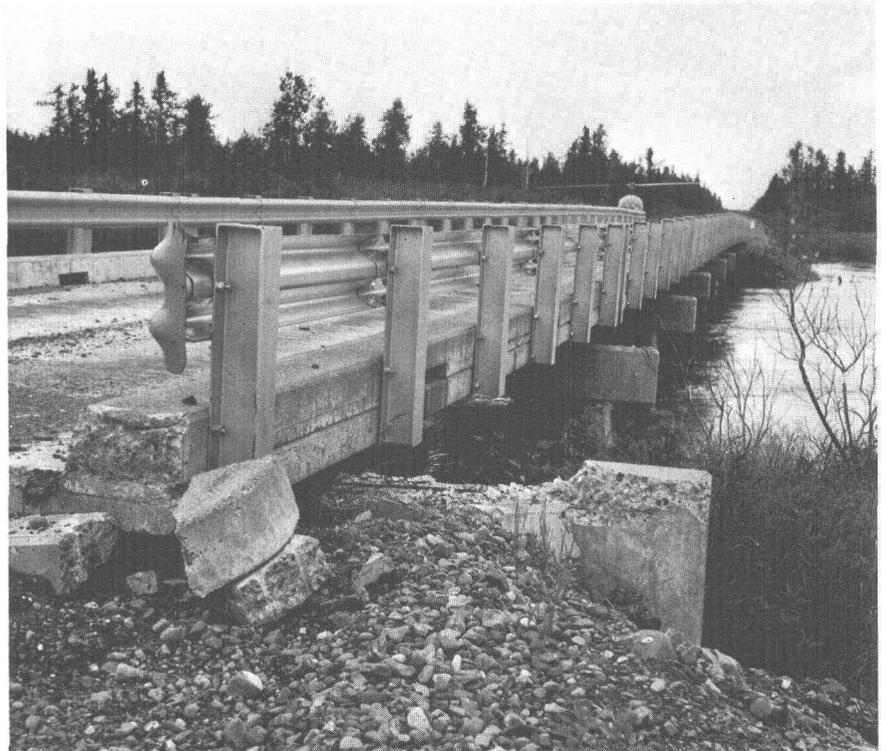
48.—North abutment of Copper River 9 bridge, 338, mile 36.1, Copper River Highway, showing displacement of deck laterally to the left relative to substructure. Photograph by George Plafker.
