FLOOD OF OCTOBER 1986 AT SEWARD, ALASKA

U.S.GEOLOGICAL SURVEY
WATER-RESOURCES INVESTIGATIONS REPORT 87-4278

by Stanley P. Jones and Chester Zenone

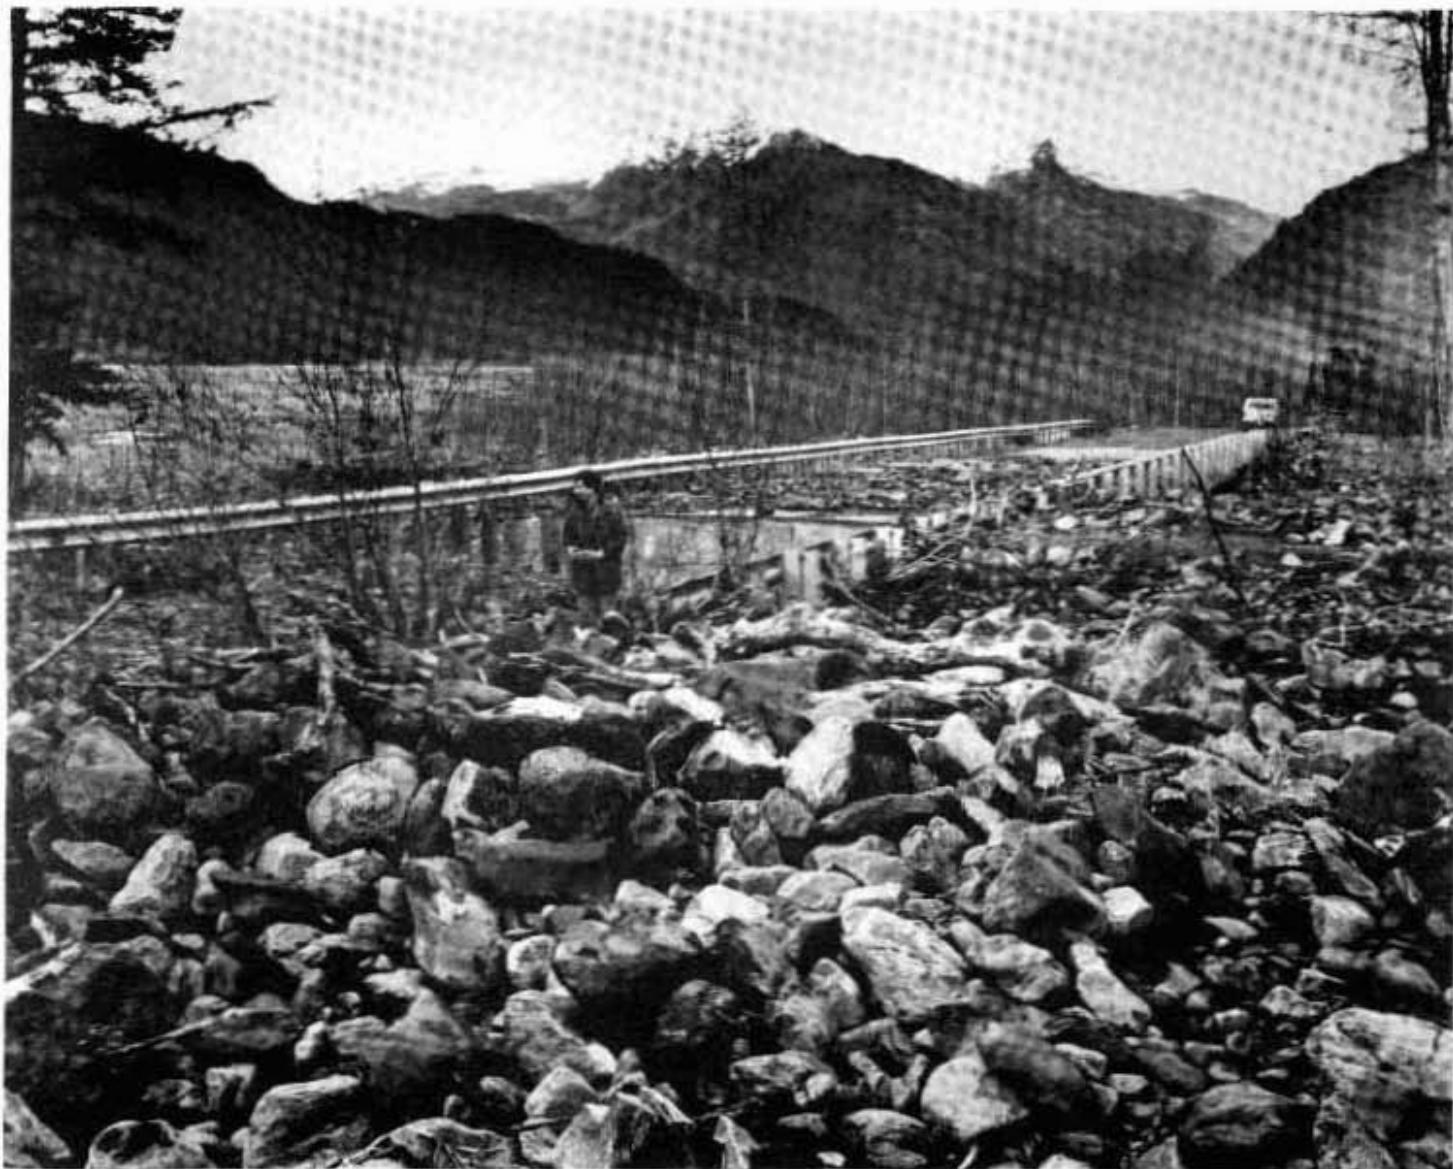
Cover photo: Cobbles and gravel deposits at Bridge 1389, Exit Glacier Road, October 13, 1986.
