Report of Investigation 2021-3 Levelock

EROSION EXPOSURE ASSESSMENT—LEVELOCK

Richard M. Buzard, Mark M. Turner, Katie Y. Miller, Donald C. Antrobus, and Jacquelyn R. Overbeck

Published by
STATE OF ALASKA
DEPARTMENT OF NATURAL RESOURCES
DIVISION OF GEOLOGICAL & GEOPHYSICAL SURVEYS
2021

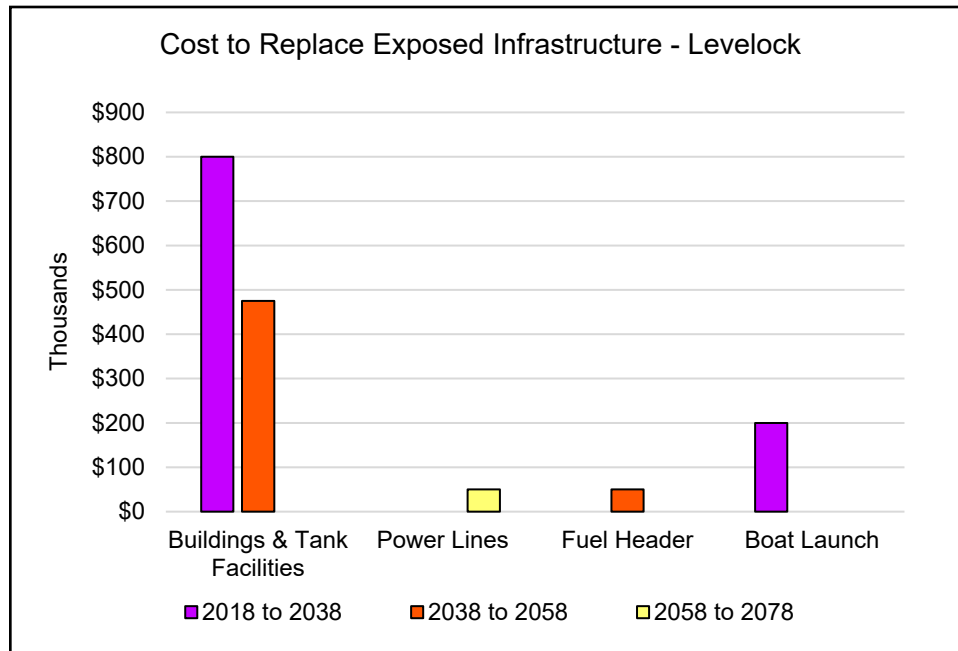
Figure 1. This figure summarizes the replacement cost of all infrastructure in the erosion forecast area. Twenty-year intervals are symbolized by color: purple represents the time interval 2018 to 2038, orange represents 2038 to 2058, and yellow represents 2058 to 2078. The bulk of costs are buildings, especially from 2018 to 2038.

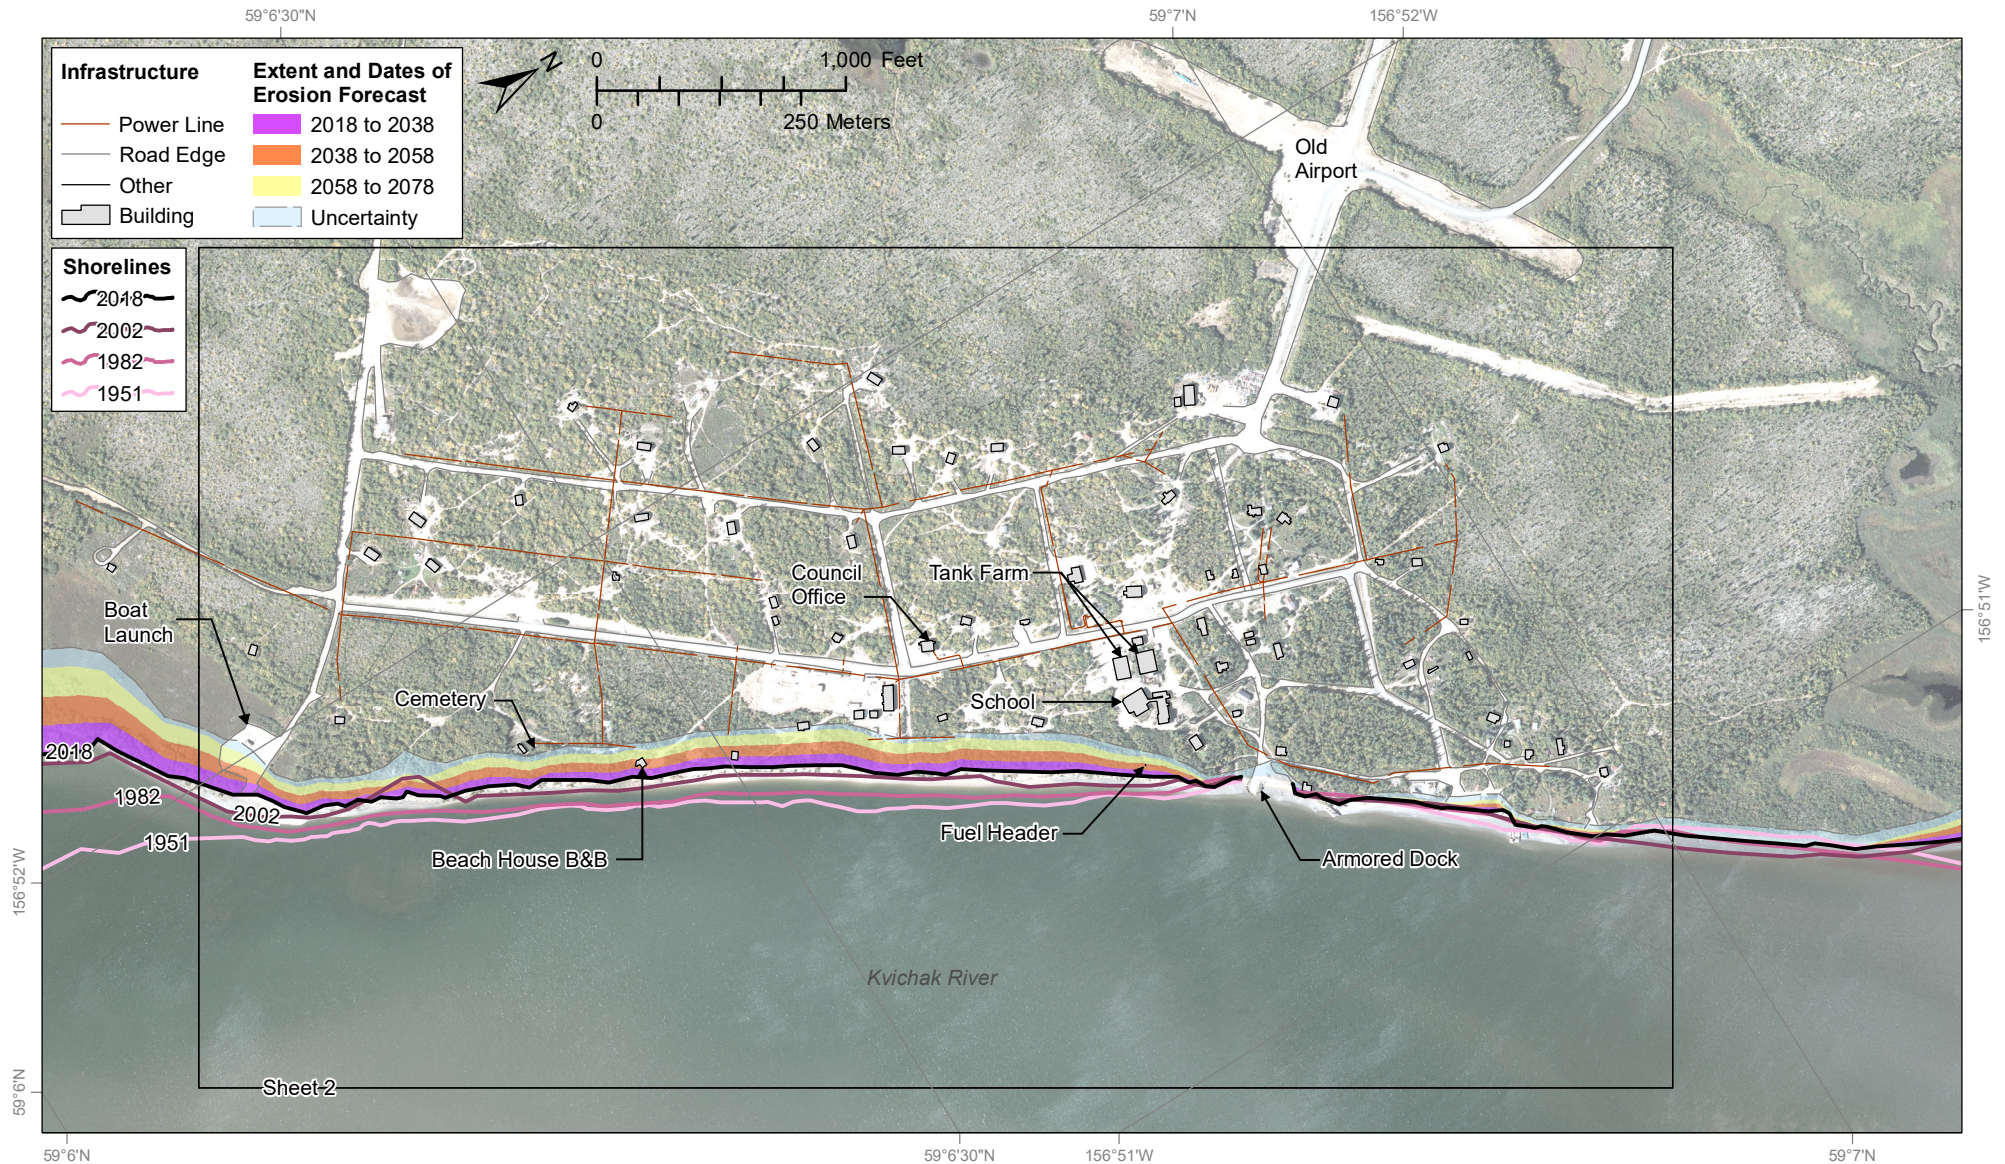
Erosion Forecast Levelock, Alaska

Erosion and accretion of coasts and rivers result in shoreline change. These rates of shoreline change at Alaska communities are calculated from historical and modern shorelines (shorelines shown as lines in pink scale and labeled by year). The long-term (1951 to 2018) shoreline change rate is used to forecast where erosion could impact community infrastructure. Erosion is forecast to reach the colored areas by specified time intervals: 2018 to 2038 (purple), 2038 to 2058 (orange), and 2058 to 2078 (yellow). The area of uncertainty of the 2078 shoreline at a 90 percent confidence interval is light blue. Areas that are not colored by time interval are not forecast to erode by 2078 based on the historical shoreline change rate. For more detailed information about the impacts to infrastructure from erosion at Levelock, refer to the Levelock erosion exposure assessment report.

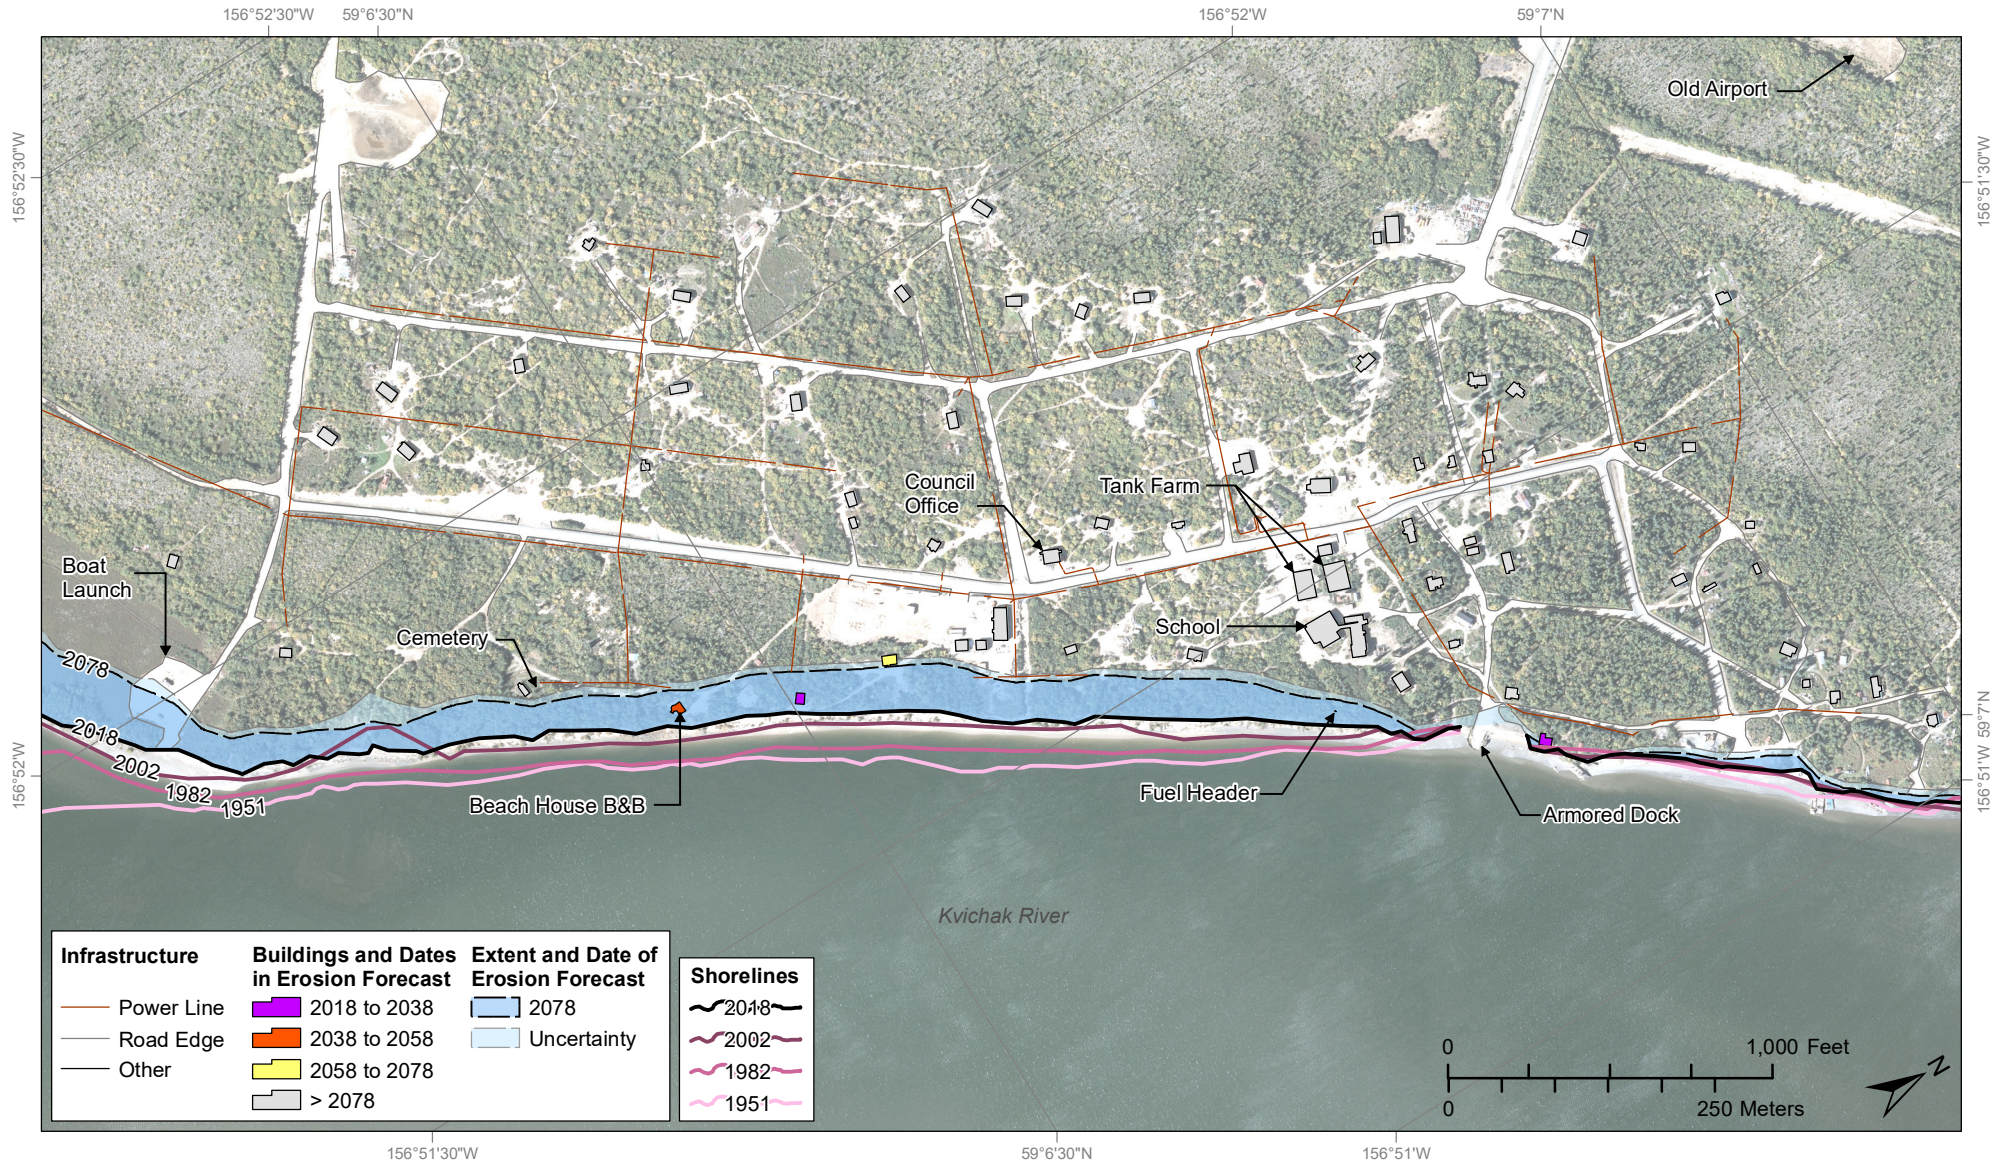
Erosion Exposure Levelock, Alaska

Erosion and accretion of coasts and rivers result in shoreline change. These rates of shoreline change at Alaska communities are calculated from historical and modern shorelines (shorelines shown as lines in pink scale and labeled by year). The long-term (1951 to 2018) shoreline change rate is used to forecast where erosion could impact community infrastructure. Erosion is forecast to year 2078 (dark blue) with a 90 percent confidence interval area of uncertainty (light blue). Buildings forecast to be impacted by erosion are colored by the range of years when the impact is forecast to occur: 2018 to 2038 (purple), 2038 to 2058 (orange), 2058 to 2078 (yellow), and no impacts expected by 2078 (gray). For more detailed information about the impacts to infrastructure from erosion at Levelock, refer to the Levelock erosion exposure assessment report.
