EROSION EXPOSURE ASSESSMENT—PORT HEIDEN

Richard M. Buzard, Mark M. Turner, Katie Y. Miller, Donald C. Antrobus, and Jacquelyn R. Overbeck
Report of Investigation 2021-3 Port Heiden
State of Alaska

PORT HEIDEN EROSION EXPOSURE ASSESSMENT

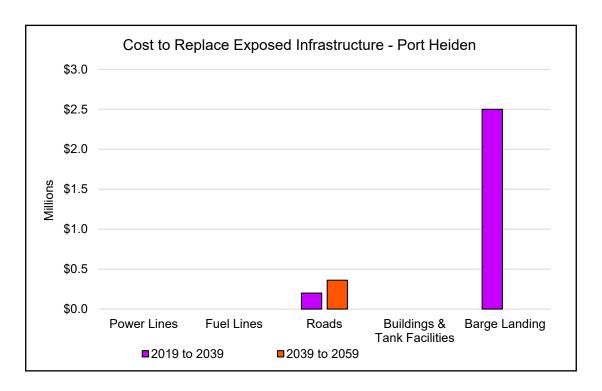
Figure 1. This figure shows the replacement cost of utilities, transportation infrastructure, and buildings and tank facilities that are forecast to erode per 20-year interval. Twenty-year intervals are symbolized by color: purple represents the time interval 2019 to 2039 and orange represents 2039 to 2059. The bulk of costs are the barge landing in the first 20 years (purple).

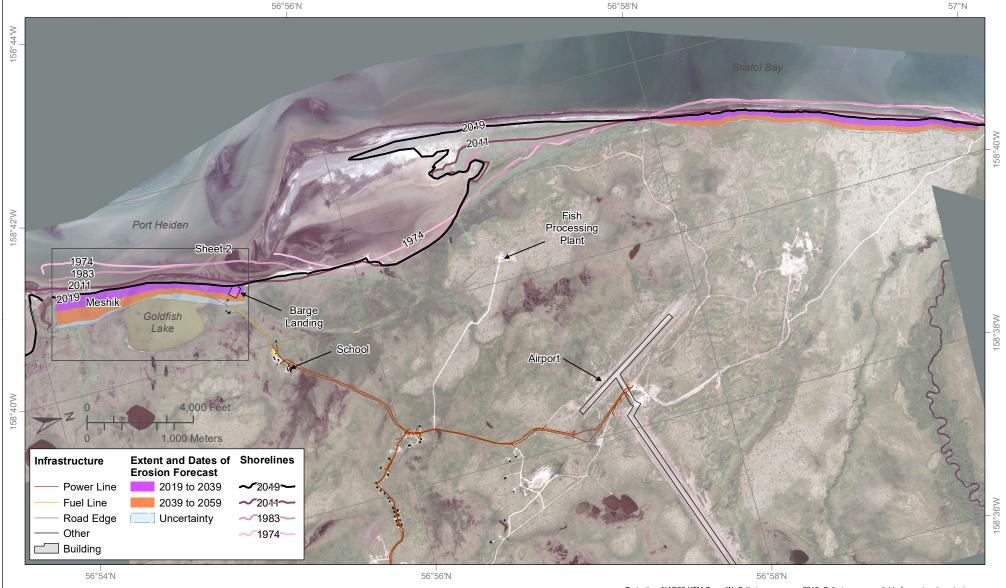
Report of Investigation 2021-3 Buzard and others, 2021 Port Heiden, Sheet 1 of 2

We forecast erosion 40 years from the most recent shoreline (2019) at 20-year intervals to identify the exposure of infrastructure to erosion. The erosion forecast shows nearly the entire footprint of Meshik is exposed to erosion through 2039. There is no visible infrastructure within most of the erosion forecast area by 2059. The greatest impact to current infrastructure in Port Heiden is the barge landing site. Most of the barge landing area is forecast to erode by 2039 (table 1), expanding out the

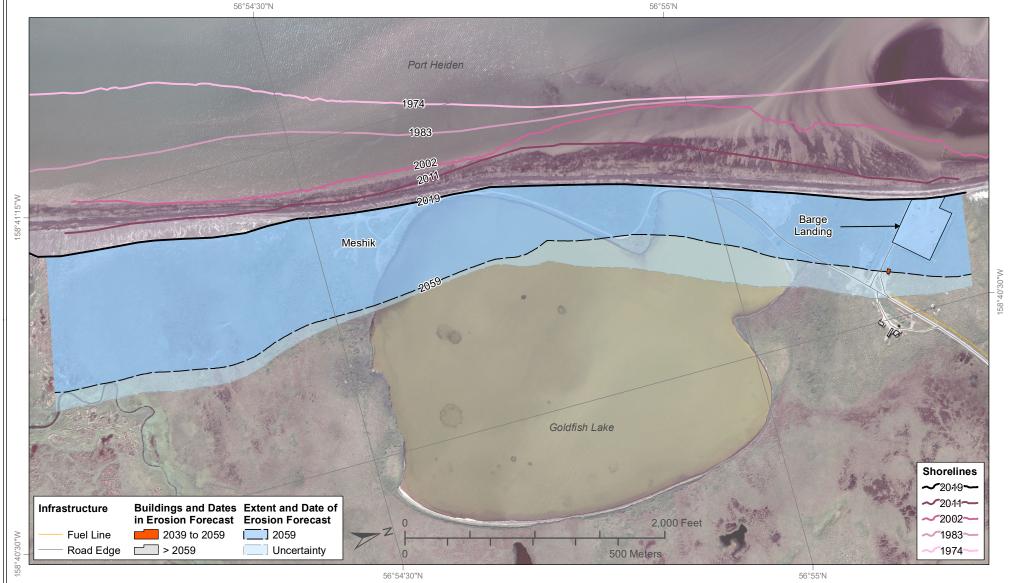
Report of Investigation 2021-3 Buzard and others, 2021 Port Heiden, Sheet 2 of 2

distance from the nearest barge landing pole and the 2039 shoreline to 500 ft. There is one abandoned structure exposed to erosion by 2059. It is possible that erosion will slow if sediment continues to fill in near the barge landing, which also complicates barge operations and navigability. For this reason, we list the barge landing as requiring replacement by 2039. The forecast shows continued undermining of the road to Meshik, which is used for subsistence activities, with up to 1,400 ft exposed in 40 years. The forecast shows erosion of small trail systems on the coast northwest of the community but does not reach the main road to Reindeer Creek by 2059. The total replacement cost of infrastructure exposed to erosion is \$3.06 million (± \$0.92 million) by 2059
