PRELIMINARY INTERPRETIVE REPORT 2013-6

**YUKON RIVER BRIDGE LANDSLIDE:
PRELIMINARY GEOLOGIC AND GEOTECHNICAL EVALUATION**

Rich D. Koehler, Richard D. Reger, Karri R. Sicard, and Eleanor R. Spangler

October 2013

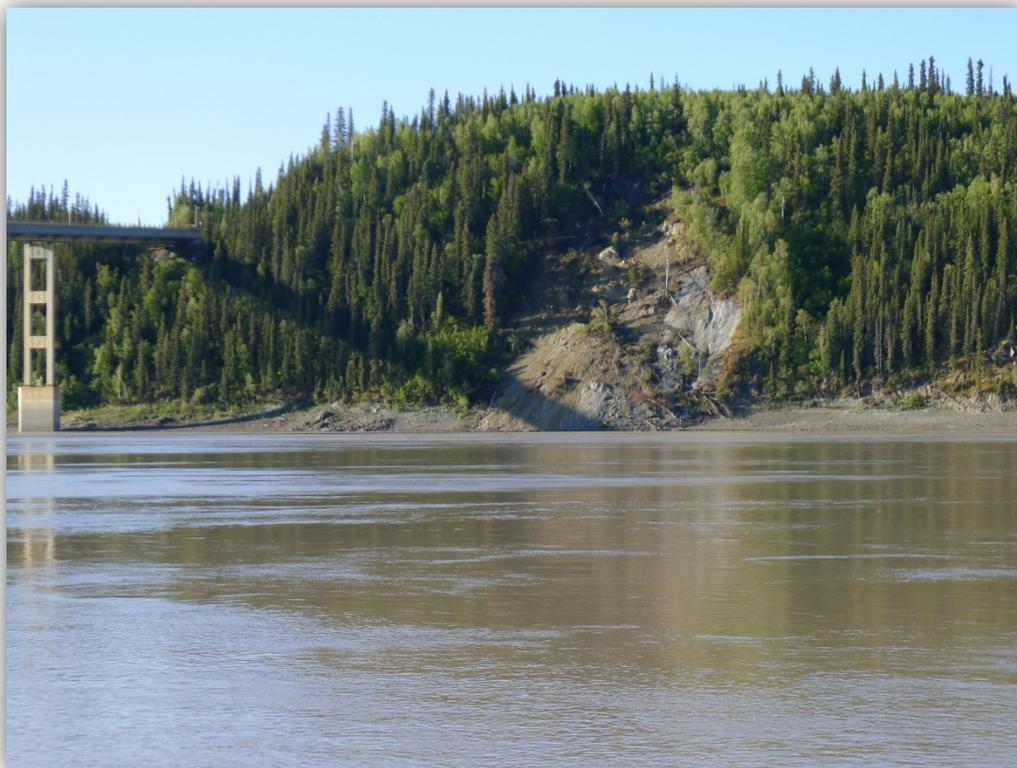
Yukon River bridge landslide viewed from the north bank of the Yukon River. Photo by Rich D. Koehler

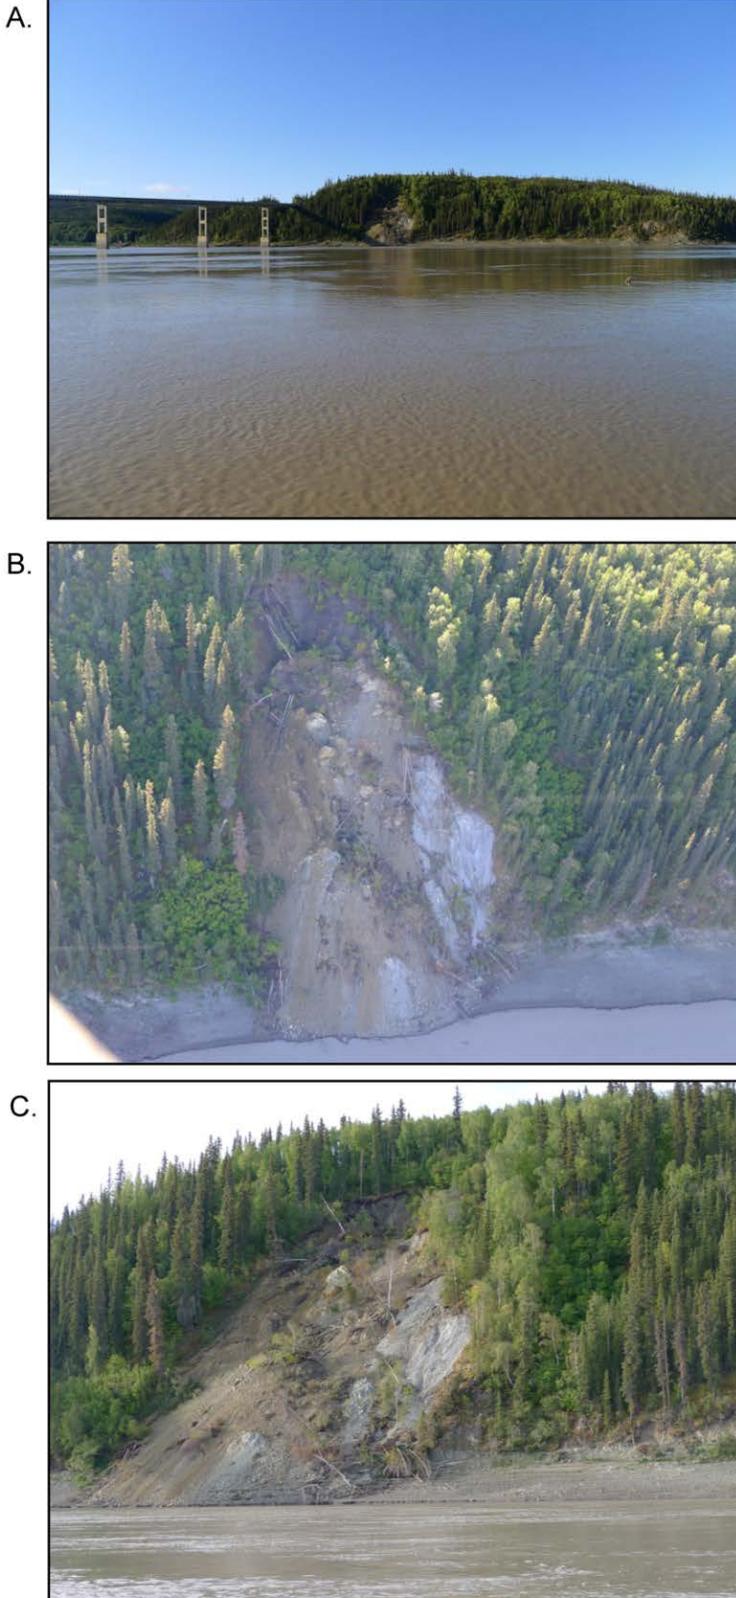
Figure 2. Photographs of the Yukon River landslide. A. View from the north bank of the river. B. Aerial view of slide from helicopter. C. Closer view of slide from the river.

The Yukon River bridge landslide occurred in fall 2012 between approximately 375 and 575 feet west of the bridge (fig. 2). Although there was no damage to the bridge foundation, the landslide’s close proximity to the bridge and concerns over additional failures prompted multiple evaluations, including landslide documentation, drainage assessments, and geotechnical studies, among others. The main purpose of this study is to provide baseline geotechnical and geomorphic observations to supplement concurrent slope-stability analyses being conducted by ADOT&PF, Alyeska Pipeline Service Company, and their consultants.

Sometime during late fall 2012, a landslide occurred on the steep bluff above the south shore of the Yukon River between 375 and 575 feet downriver from the E.L. Patton Bridge (fig. 2). The slide originally was reported by Alyeska security on November 30, 2012. Subsequent field inspections conducted by Alyeska and ADOT&PF on December 7, 2012, and January 18, 2013, determined that the slide may have been controlled by highly fractured and altered weak zones in the rock mass (Frank Wuttig, oral commun.). These weak zones were inferred to be related to a potential fault zone encountered during construction of bridge pier 4. Additionally, it was noted that the slide occurred in perennially frozen ground. Given the 2012 slope failure and the occurrence of potentially adverse ground conditions, it was recommended that additional slope monitoring and geotechnical investigations be undertaken. This report contributes to those ongoing investigations.

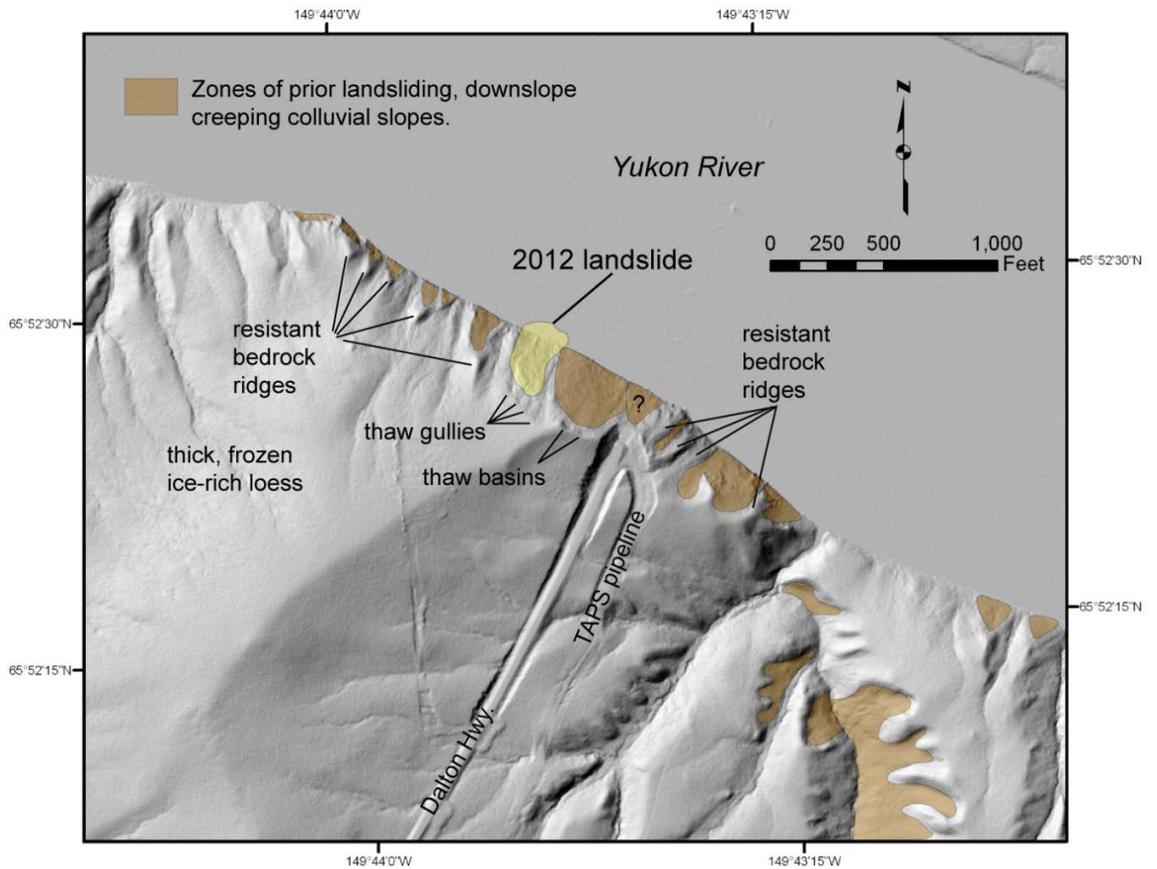
Figure 10. Geomorphic interpretation of the Yukon River bridge area, showing the 2012 landslide and zones of prior slope instability.

General slope conditions and the location of individual slope profiles are shown in figure 8; profiles are in figure 9. A LiDAR interpretation of the location of prior landsliding and/or other downslope colluvial transport processes is shown on figure 10. For the areas upstream and downstream of the bridge, LiDAR imagery of the bluff shows several vegetated possible landslide slopes separated by steep, narrow bedrock ridges that are relatively stable (fig. 10). Surfaces above the crest of the bluff slopes are mantled by thick, frozen ice-rich loess and characterized by gentle slopes and common thaw gullies and basins. Geomorphic features indicative of active faulting are absent on the surface. In particular, there is no indication of recent along-strike activity of the fault identified in the foundation of bridge pier 4. In the field, helicopter surveys and boat reconnaissance were conducted along the bluff to look for evidence of prior landsliding for approximately 2,000 feet upstream and downstream of the bridge; however, no scarps or obvious debris hollows were observed.

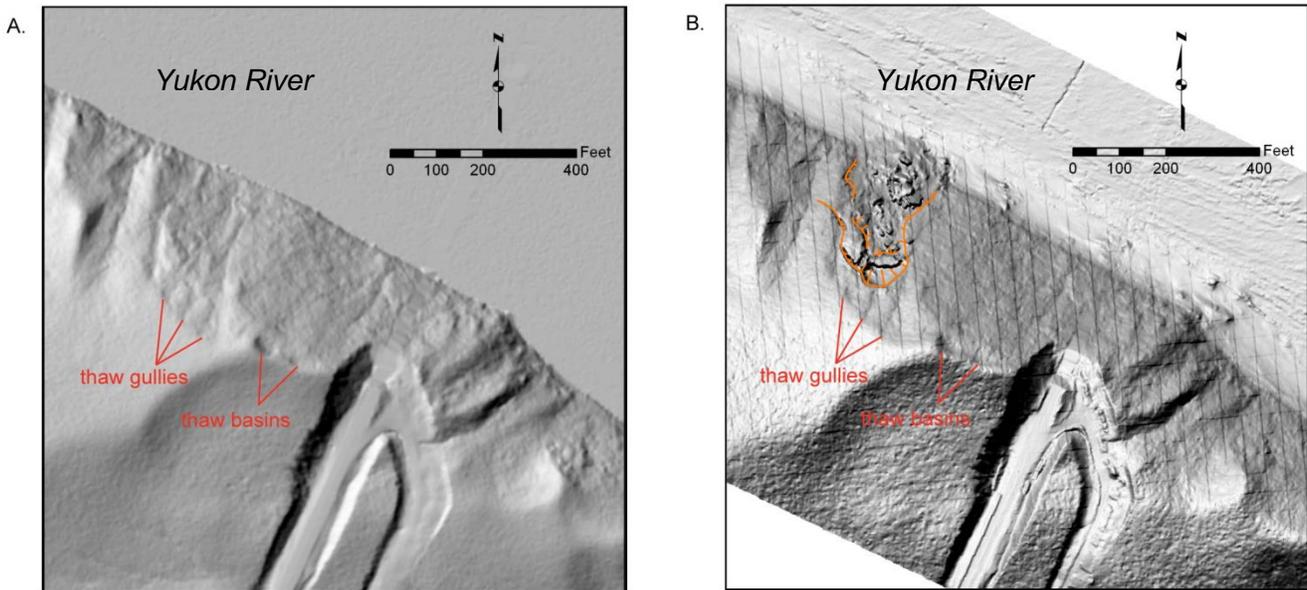
Figure 11. Pre- and post-landslide hillshade images derived from 2010 and 2013 LiDAR data. A. Pre-landslide hillshade. B. Post-landslide hillshade; edges of landslide scarps shown by orange lines.

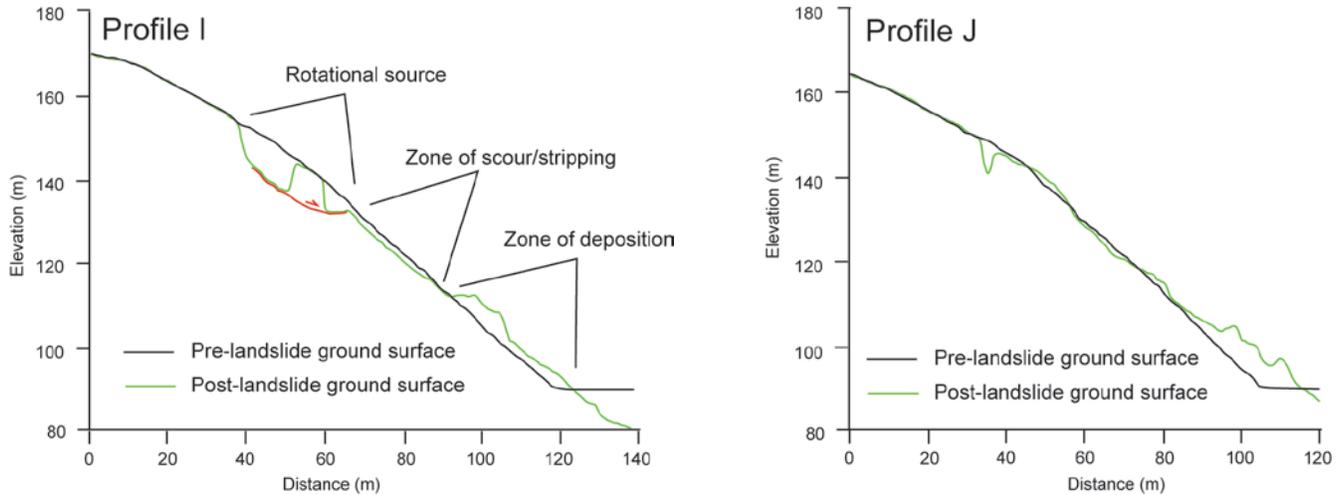
Figure 12. Topographic profiles I and J across the Yukon River bridge landslide showing the pre- and post-landslide ground surface. Pre-landslide ground surface derived from LiDAR data collected by DGGS (Hubbard and others, 2011). Post-landslide ground surface derived from LiDAR data collected by Alyeska Pipeline Service Company in April 2013. Inferred slide plane indicated in orange on Profile I.

Topographic profiles I and J were generated from the pre- and post-landslide LiDAR data across the eastern and western sides of the body of the 2012 landslide. They demonstrate that the crown of the slide is approximately 236 feet above low-water level (fig. 12). The profiles show that the landslide occurred on a slope of approximately 40° and that the post-landslide slope is around $35\text{--}37^\circ$, which was confirmed by direct measurements in the field. Profile I, down the main body of the landslide, shows three distinct zones including an upper block failure, a mid-slope zone of scour and stripping, and a lower zone of slide debris deposition (fig. 12A). Flood deposits on the lower part of the debris cone indicate that break-up floods in spring 2013 did not remove an appreciable amount of slide debris. Profile J, measured on the slope directly west of the main slide body, shows a large tension fracture and only subtle translation of the slope mass (fig. 12B).

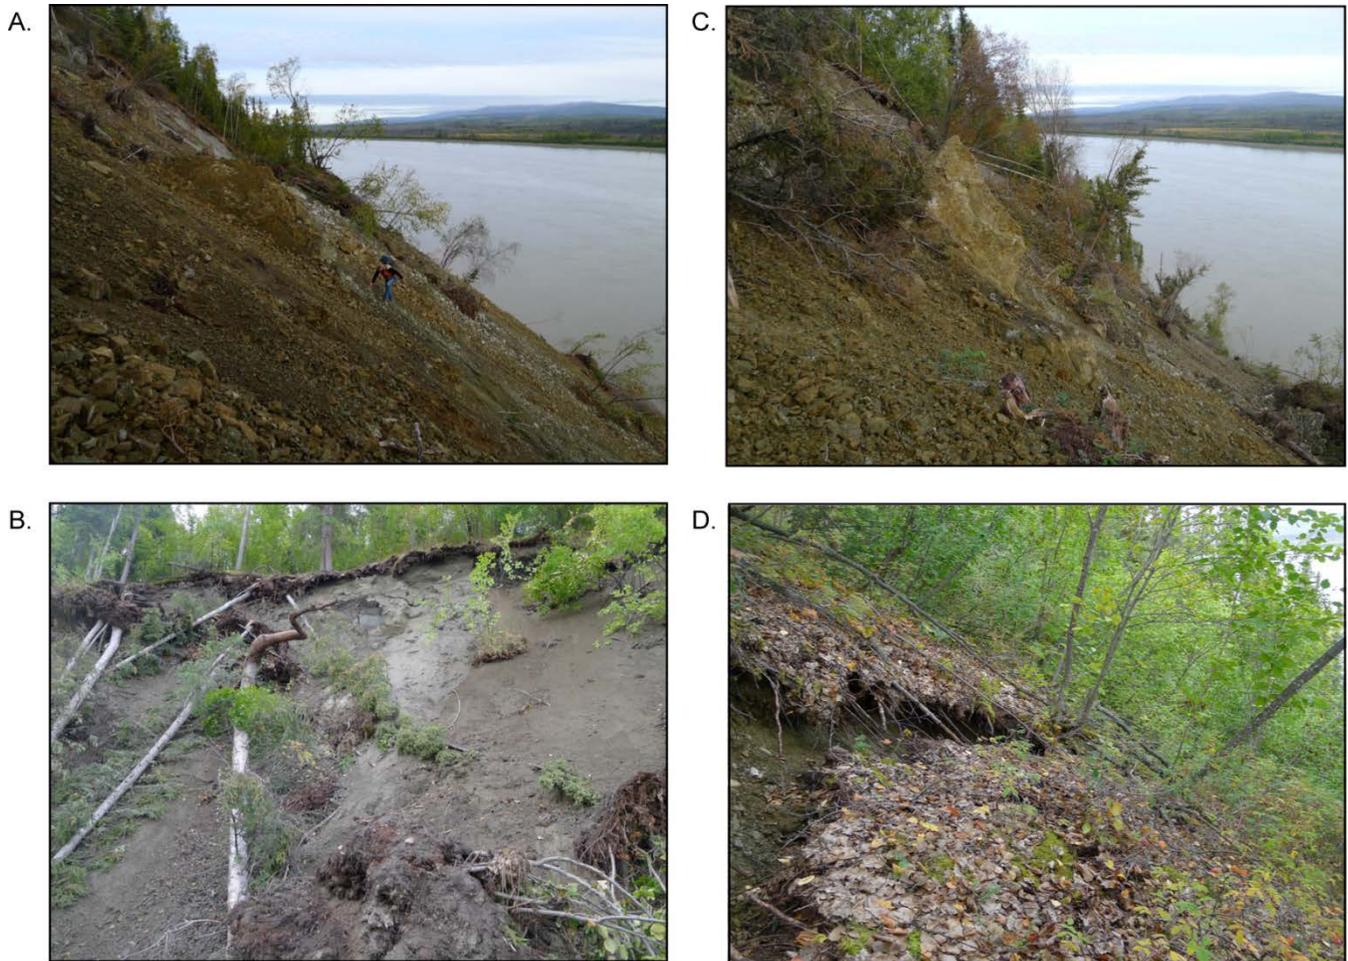
A comparison of the pre- and post-landslide surface and profiles across the landslide are shown in figures 11 and 12, respectively. Photographs of key features on the landslide are shown in Figure 13. In the pre-landslide hillshade image, hummocky topography along the slope indicates the possible presence of previous slope instability. Thaw gullies at the crest of the slope may have contributed to previous slope movements. The 2012 landslide occurred along the downstream end of the thaw gullies. Based on the distribution of headscarps (orange lines on fig. 11B), the 2012 landslide initiated on the east and propagated to the west. Blocks of debris in the mid-slope region and a large debris cone at the base of the slope are clearly visible on the LiDAR. Based on the LiDAR data, the main slide mass, including the area of the debris cone, is approximately 90–100 feet wide and approximately 220 feet long, however the bulk of the debris was sourced from an approximately 90 × 100-foot translational slide block in frozen loess at the top of the slope (fig. 13B). In addition to the frozen loess, a large slab of highly weathered gabbro also failed. Also present are two additional blocks of rock and colluvium that did not catastrophically fail down the slope. An approximately 50 × 50-foot block on the western side of the headscarp separated from the slope across a large fracture. This block is underlain by fairly competent, fractured graywacke metasandstone and was likely made unstable after the main slide eroded the downslope side of the block, removing lateral support and causing slip to occur along fracture planes. Midway along the western margin of the slide a second block, measuring approximately 50 × 100 feet, separated approximately three feet from the adjacent in-place slope (fig. 13D). This block may be susceptible to future sliding.

Field observations indicate that the large landslide blocks of frozen loess, colluvium, and highly weathered bedrock were not rotated during downslope motion but slid on the underlying, more competent bedrock on a shallow, planar, translational slide plane. Northwest-trending transverse open cracks and their ice fillings likely had a significant impact on the locations and sizes of the block failures. Additionally, long-term creep and gelifluction on the slope may have contributed to progressively greater tension that eventually exceeded the tensile strength in the frozen blanket of loess and colluvium. Deeper slide planes may also have developed along

intersecting fracture planes in the highly weathered gabbro, which is altered to seamy clay. After initial failure, the displaced blocks collapsed and cascaded down the steep slope as a debris slide, stripping 2–3 feet of colluvium off the underlying bedrock in the mid-slope region, and depositing a large debris cone over the lower 90 feet or so of the slope. The debris cone is characterized by angular chert, gabbro, and graywacke metasandstone fragments, averaging 4–18 inches in diameter. Several large debris blocks with trees in growth position were deposited on the slope (fig. 13C). The zone of stripping and talus deposition is shown in figure 13A. Although a more detailed site investigation is necessary to more accurately define the slide plane and mechanism of failure, the field observations are consistent with a block glide transitioning downslope to a debris slide (Varnes, 1958).

Figure 13. Photographs of the Yukon River landslide. A. Upper part of debris cone. Light gray color in upper left is exposed graywacke bedrock. B. Intact block of weathered gabbro bedrock on the surface. C. Frozen silt exposed in the headscarp. D. Separation scarp extending west of the middle part of the slide.
