Report of Investigations 2011-2

**FIELD OBSERVATIONS FROM THE JANUARY 12, 2010,  
HAITI EARTHQUAKE: IMPLICATIONS FOR SEISMIC  
HAZARDS AND FUTURE POST-EARTHQUAKE  
RECONNAISSANCE INVESTIGATIONS IN ALASKA**

by  
R.D. Koehler and P. Mann

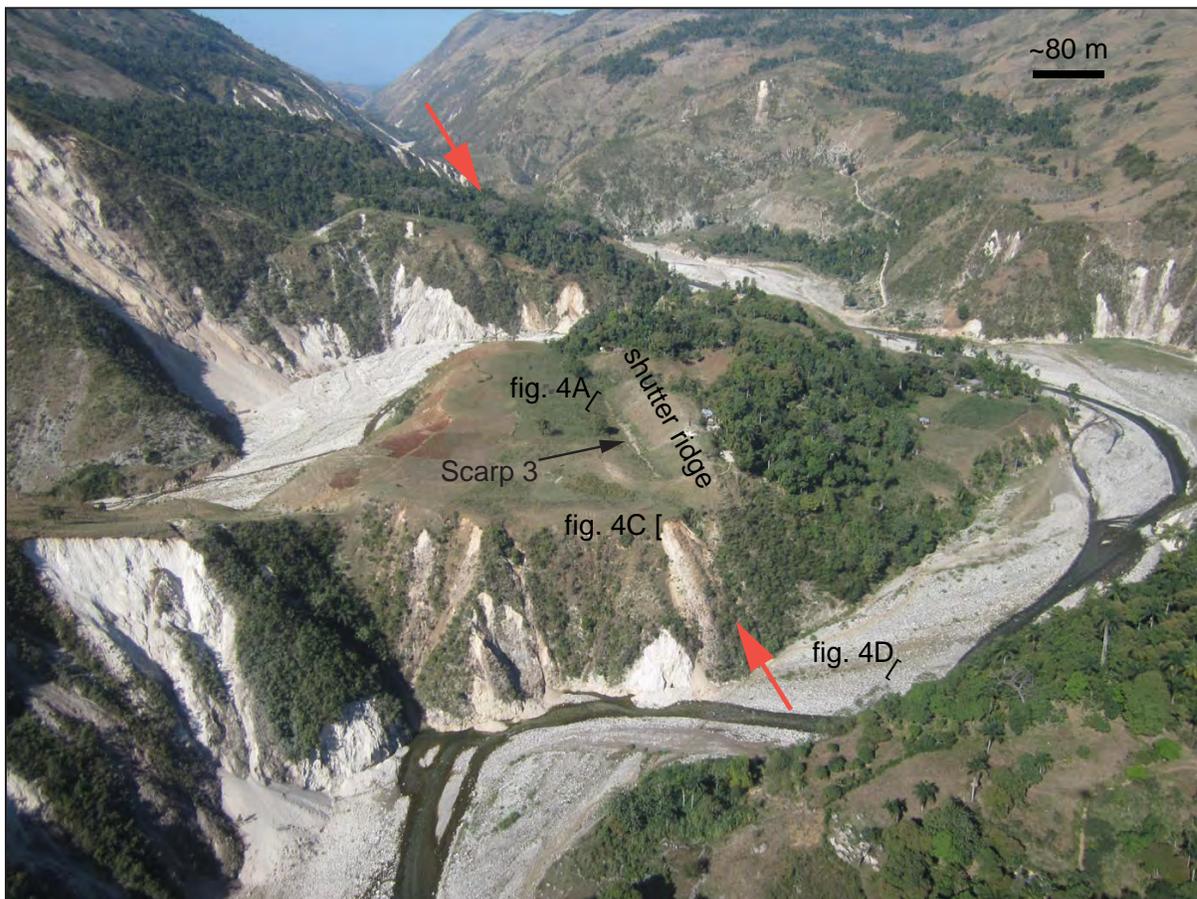
We inspected the fault on the ground near the village of Coupeau west of the drainage divide between the Rivière Momance and Rivière Froide (Site A, fig. 1). At Site A ( $18^{\circ}28'38''\text{N}$ ,  $72^{\circ}25'57''\text{W}$ ), the fault extends across a deeply incised bedrock platform and is characterized by a prominent linear valley bound on the north by a large shutter ridge (fig. 2). At the western side of the linear valley a beheaded channel extends to the north (fig. 3A). Several traverses were walked perpendicular to the fault across the linear valley. We observed two scarps (Scarps 1 and 2) along the southern side of the linear valley and a scarp (Scarp 3) that extends down the middle of the valley (figs. 3B, 3C, and 4A). Scarp 1 is about 0.5 m high and extends along the crest of the southern linear valley wall along the eastern side of the linear valley (fig. 3B). This scarp is not continuous and extends for approximately 30 m. Scarp 2 extends along the base of the southern valley wall of the linear valley (fig. 3C). This scarp has a similar height to Scarp 1 and is also not continuous. Scarps 1 and 2 have rounded

morphology and living vegetation growing on the scarp face, indicating that they were not produced by the 2010 earthquake. We infer that these scarps are related to agricultural practices in the area, or may possibly be related to older earthquakes. Scarp 3 is about 0.5–0.75 m high and is characterized by a south-facing linear mound of cobbles and boulders at the base of the shutter ridge (fig. 4A). The rocks range in size from ~6 cm to >25 cm in diameter and have been colonized by grass and small brush. Freshly exposed surfaces were not observed along Scarp 3. The local farmers indicated that the rocks were excavated off the face of the shutter ridge and rolled down the hill during preparation for farming. Thus, we infer that Scarp 3 is not of tectonic origin. Figures 3A and 4B show a well traveled footpath that extends across the eastern end of the linear valley roughly perpendicular to the fault trace. The path is not displaced, providing additional support for the lack of surface rupture at this location. Several slope-parallel fractures bounding perched topple blocks along the eastern side of the bedrock platform (fig. 4C), and fresh debris avalanches were also observed near Site A (fig. 4D).

Figure 2. Photograph showing trace of Enriquillo fault extending across deeply incised bedrock platform at Site A; view is to the west. Fault extends between red arrows. Scarp 3 extends along the base of a linear valley. Brackets mark locations of photographs A, C, and D in figure 4.

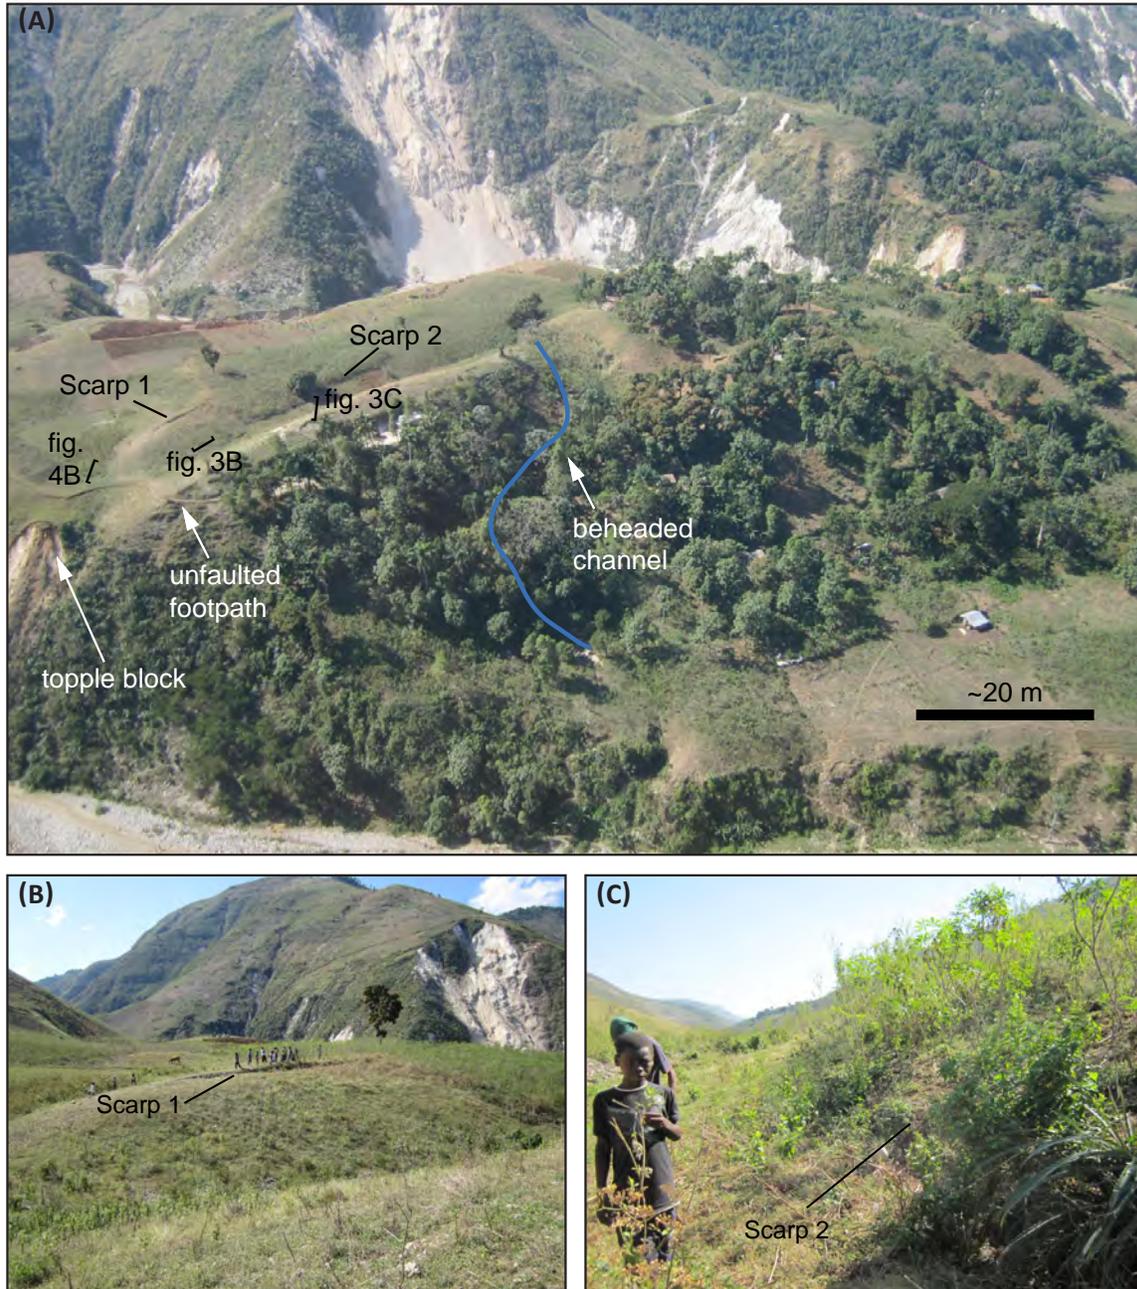
*Figure 3. Photographs from Site A near Coupeau. (A) Looking southwest at linear valley of the Enriquillo fault. Scarps 1 and 2 along the southern side of the linear valley are back-shadowed. Brackets mark locations of photographs in figures 3B, 3C, and 4B. (B) View to the south across linear valley. Local villagers standing on top of Scarp 1 provide scale. (C) Photograph showing vegetated face of Scarp 2. Children provide scale.*

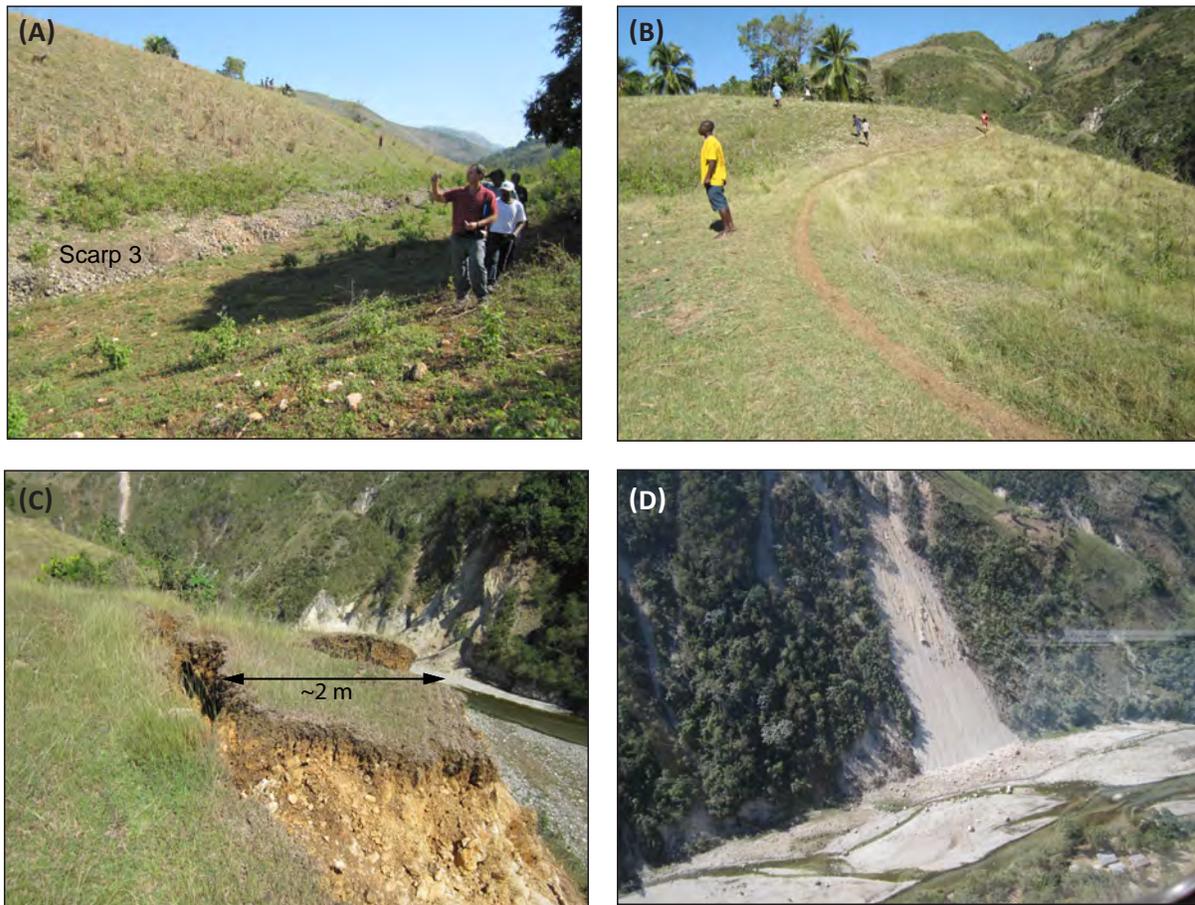
Figure 4. Additional photographs from Site A; their locations are pointed out on figures 2 and 3. (A) Linear mound of cobbles and boulders (Scarp 3) at the base of the shutter ridge; people provide scale. (B) Footpath crosses the fault and is not offset; people for scale. (C) Approximately 2-m-wide perched toppling block separated from hillside by an ~0.5-m-deep fracture parallel to the slope. (D) Rockfall/debris avalanche along the southern valley wall of the main river channel. Scar of the failure is ~60 m high.

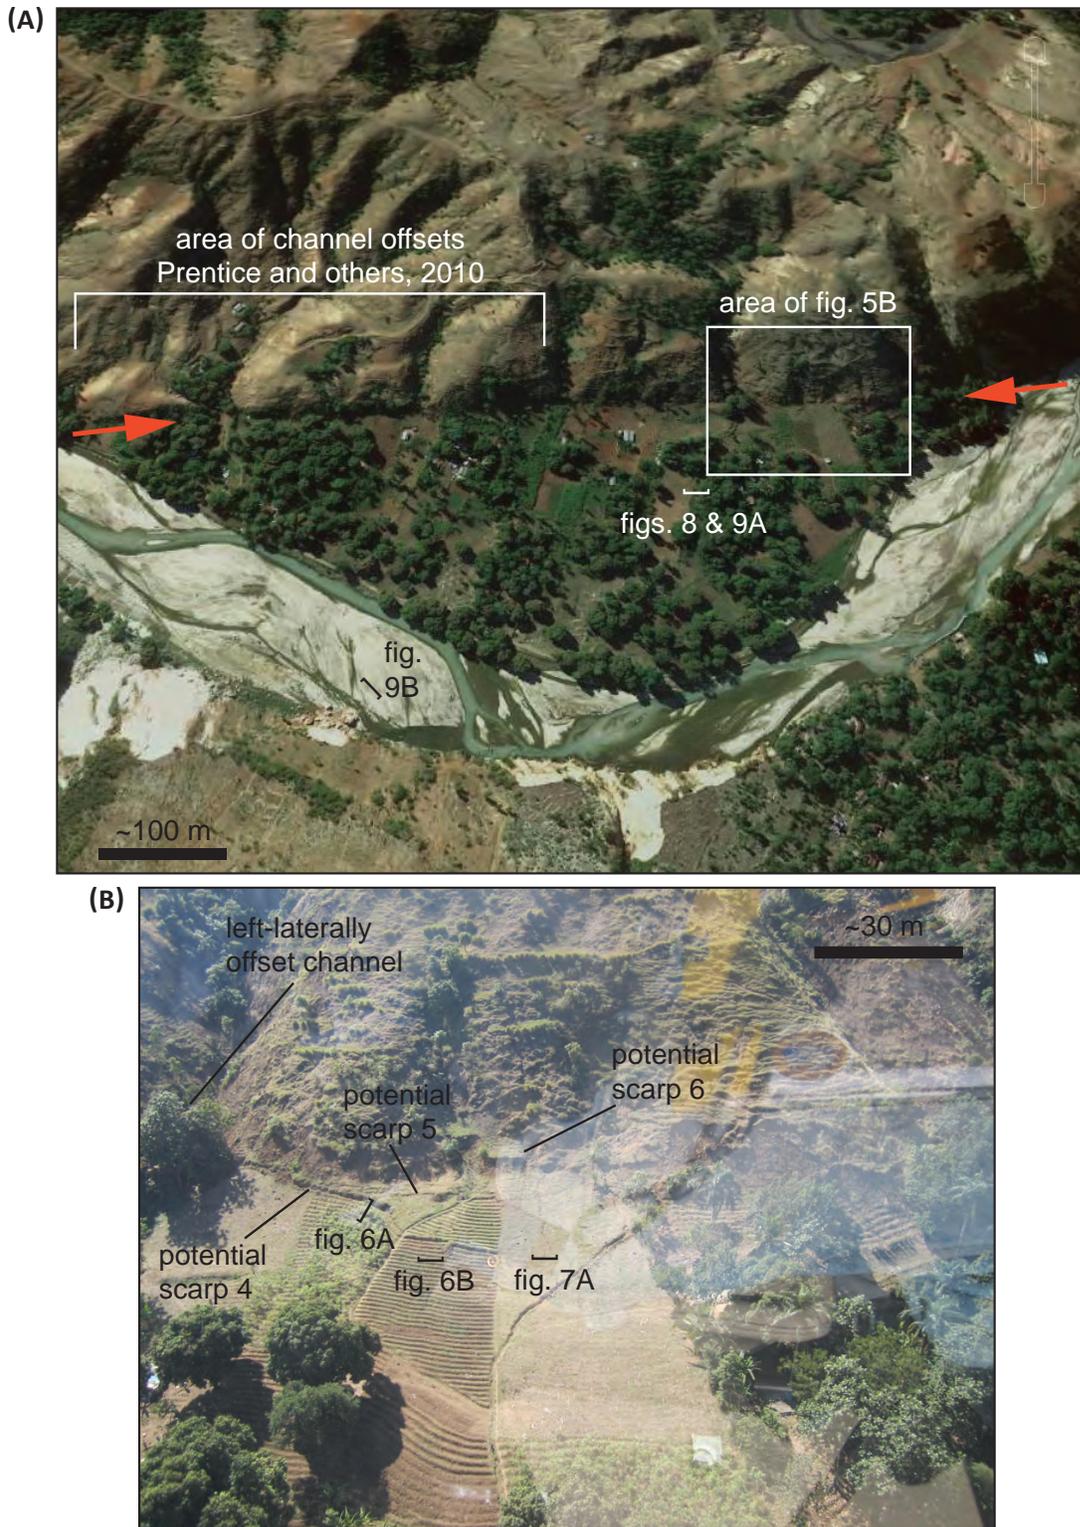
slope observed from the helicopter and on GeoEye, Inc. imagery indicated the possible presence of surface rupture. Figure 5B shows three potential scarps investigated in the field. Observations along these scarps indicate that primary surface rupture did not occur along these features during the 2010 earthquake. Potential scarp 4 projects away from the range front and is a ~1-m-high

Figure 5. Photographs from Site B, east of Fayette. (A) *GoogleEarth* image looking south at Enriquillo fault where it crosses the back edge of a terrace east of Fayette in the village of Jean-Jean. Fault extends between red arrows. Brackets mark locations of photographs in figures 8, 9A, and 9B; white box shows location of figure 5B. (B) Enlarged photograph taken from helicopter showing potential scarps 4, 5, and 6, which were investigated on the ground. Brackets mark locations of photographs in figures 6A, 6B, and 7A.

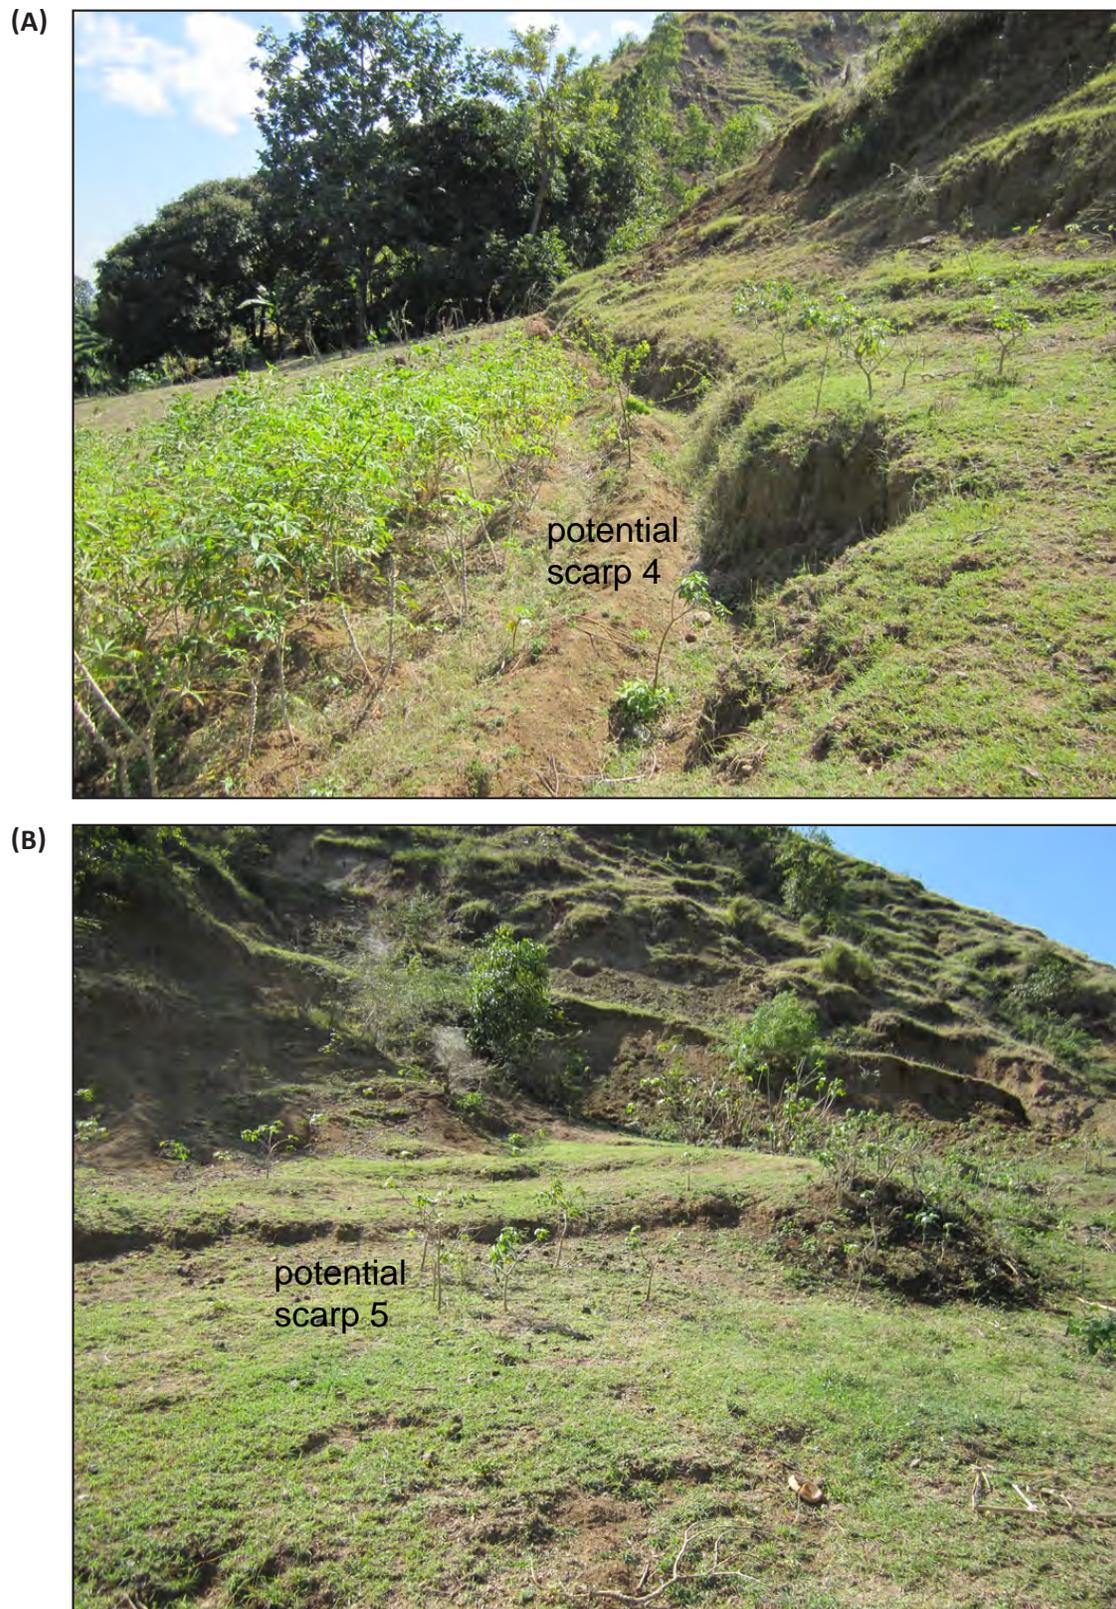
escarpment with a rounded crest, vegetated face, and linear mound of soil that forms a trough parallel to the base of the scarp (fig. 6A). We infer that the mound of soil was constructed by farmers to divert water from the creek east of the scarp to irrigate crops. Potential scarp 5 is about 0.5 m high, has a rounded crest and base, and has been colonized by grass (fig. 6B). Freshly exposed surfaces were not observed along the base of potential scarps 4 and 5. Potential scarp 6 ranges in height from about 1 to 2 m and projects along the base of the range front (fig. 7). Several gullies have incised through the scarp to the base of the slope and the scarp does not cut across these features (figs. 7A and 7B). The base of the scarp is commonly buried by small landslides and topple blocks of soil and vegetation sourced from the crest of the scarp (fig. 7C). Where the base of the scarp is exposed, the profile is smooth and not fractured. Soil is exposed in the face of the scarp; however, sparse grass growing on the face indicates it is not a fresh surface.

Although we cannot preclude that potential fault scarps 4–6 were originally formed by paleoearthquakes, our field observations indicate that they were not created or reactivated during the 2010 earthquake. A left-laterally-offset channel margin (~1 m) was observed directly east of the potential scarps and likely represents offset from a previous earthquake (fig. 5B). Similar channel offsets were observed along the range front east of our site (Prentice and others, 2010).

Figure 6. Photographs of potential scarps along the back edge of a fluvial terrace east of Fayette at Site B; figure 5 shows their locations. (A) Potential scarp 4, approximately 1 m high, and (B) potential scarp 5, approximately 0.5 m high.

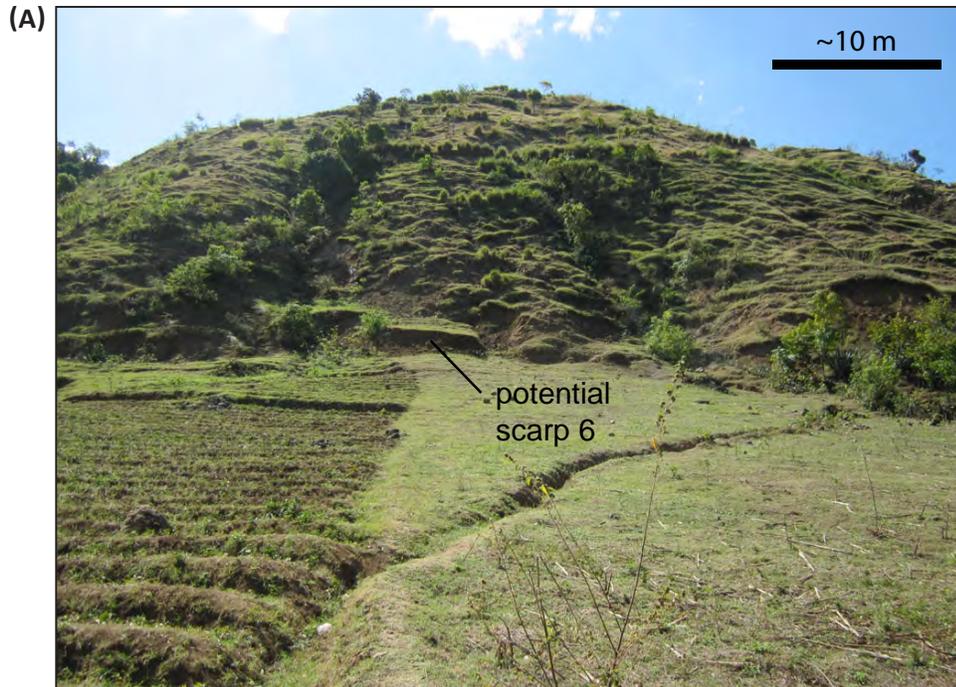
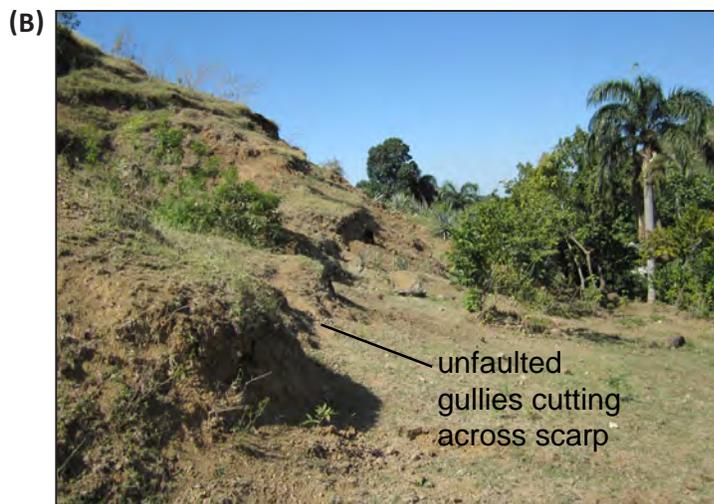
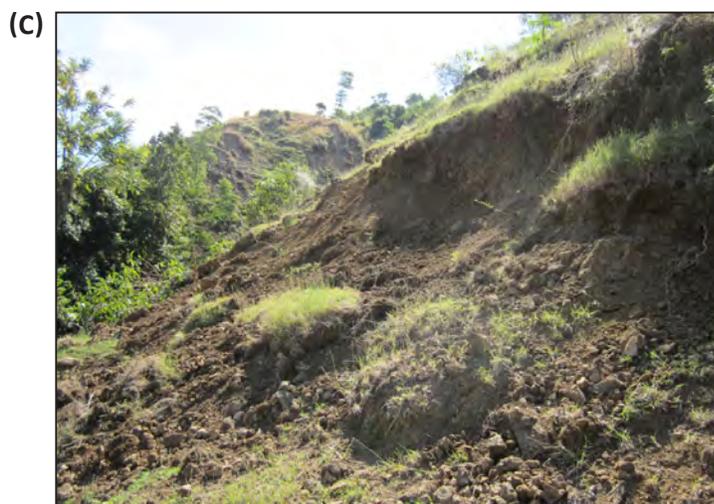
*Figure 7. Photographs of potential scarp 6 at the back edge of a fluvial terrace east of Fayette at Site B. (A) View to the south showing scarp and gullies eroded into scarp; figure 5B shows location. (B) View to the west, and (C) to the east, along the scarp shown in (A).*

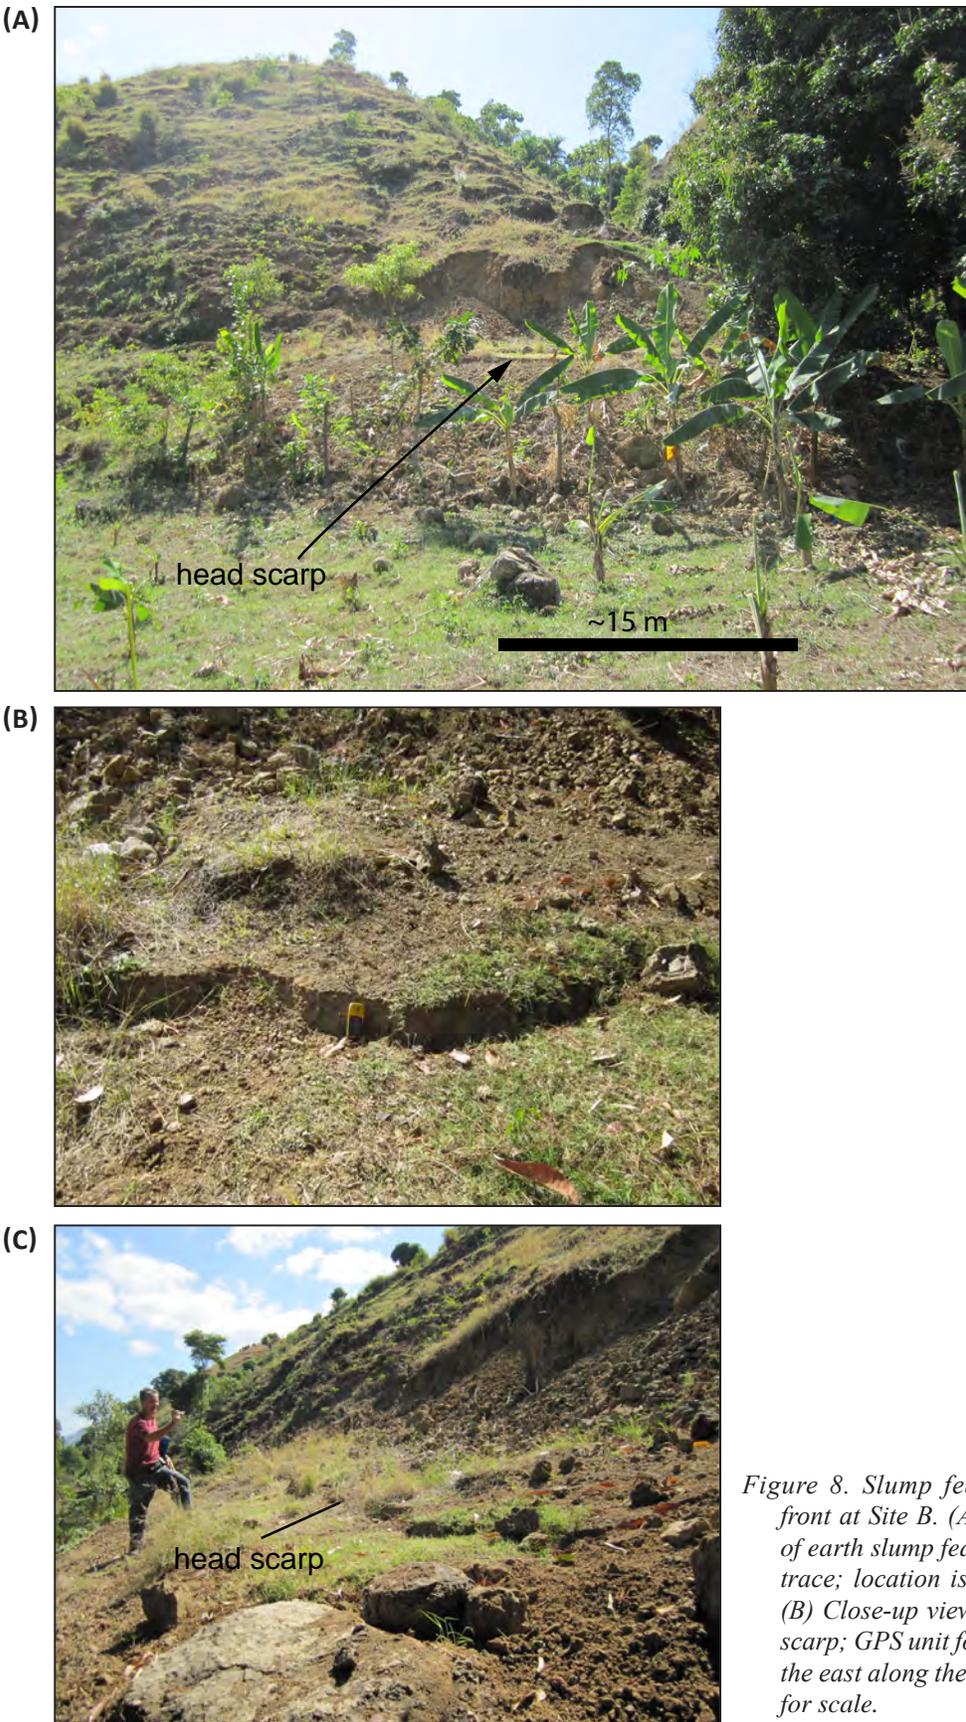
Secondary tectonic features observed at Site B include an earth slump and rockfall. A small earth slump occurs along the fault trace. The location of the slump is shown on figure 5 and photographs of the feature are shown on figure 8. The slump is characterized by a 15-cm-high fresh head scarp that is about 12 m long (fig. 8). The head scarp is slightly arcuate and the vertical separation across it diminishes on either end where the scarp intersects the face of the slope. On the basis of the spatial coincidence of the head scarp with the trace of

Figure 8. Slump feature along range front at Site B. (A) View to the south of earth slump feature along the fault trace; location is shown in figure 5. (B) Close-up view of the slump head scarp; GPS unit for scale. (C) View to the east along the head scarp; person for scale.

the fault, we cannot preclude a surface rupture origin for this feature. However, the scarp is not continuous, and similar features were not observed elsewhere along the scarp. Thus, we infer that this feature is more consistent with an earth slump origin. Large blocks of limestone up to 1 m in diameter occur >10 m from the range front adjacent to the slide feature (fig. 9A). Pervasive rockfall also occurs along the main river valley east and west of Site B (fig. 9B).

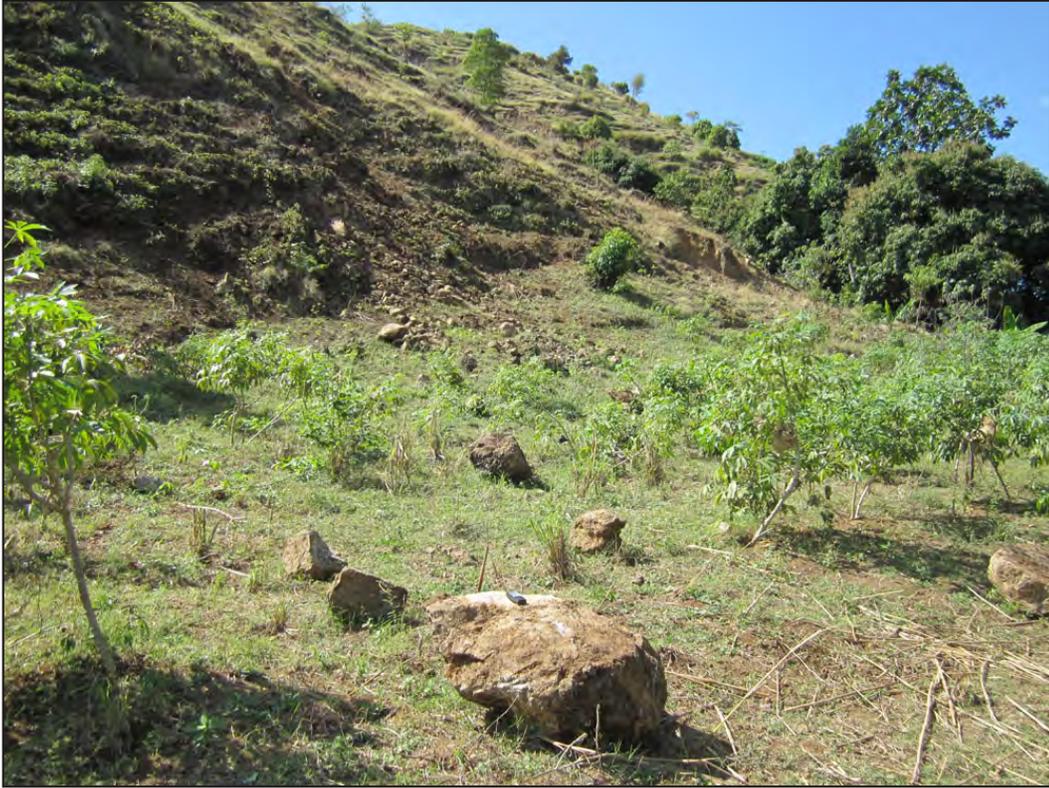
Figure 9. (A) Rockfall along the back edge of the terrace at Site B. Rock in foreground is ~1 m in diameter. (B) Rockfall along the main river channel near Site B. Scar in center of photo is approximately 10 m high.

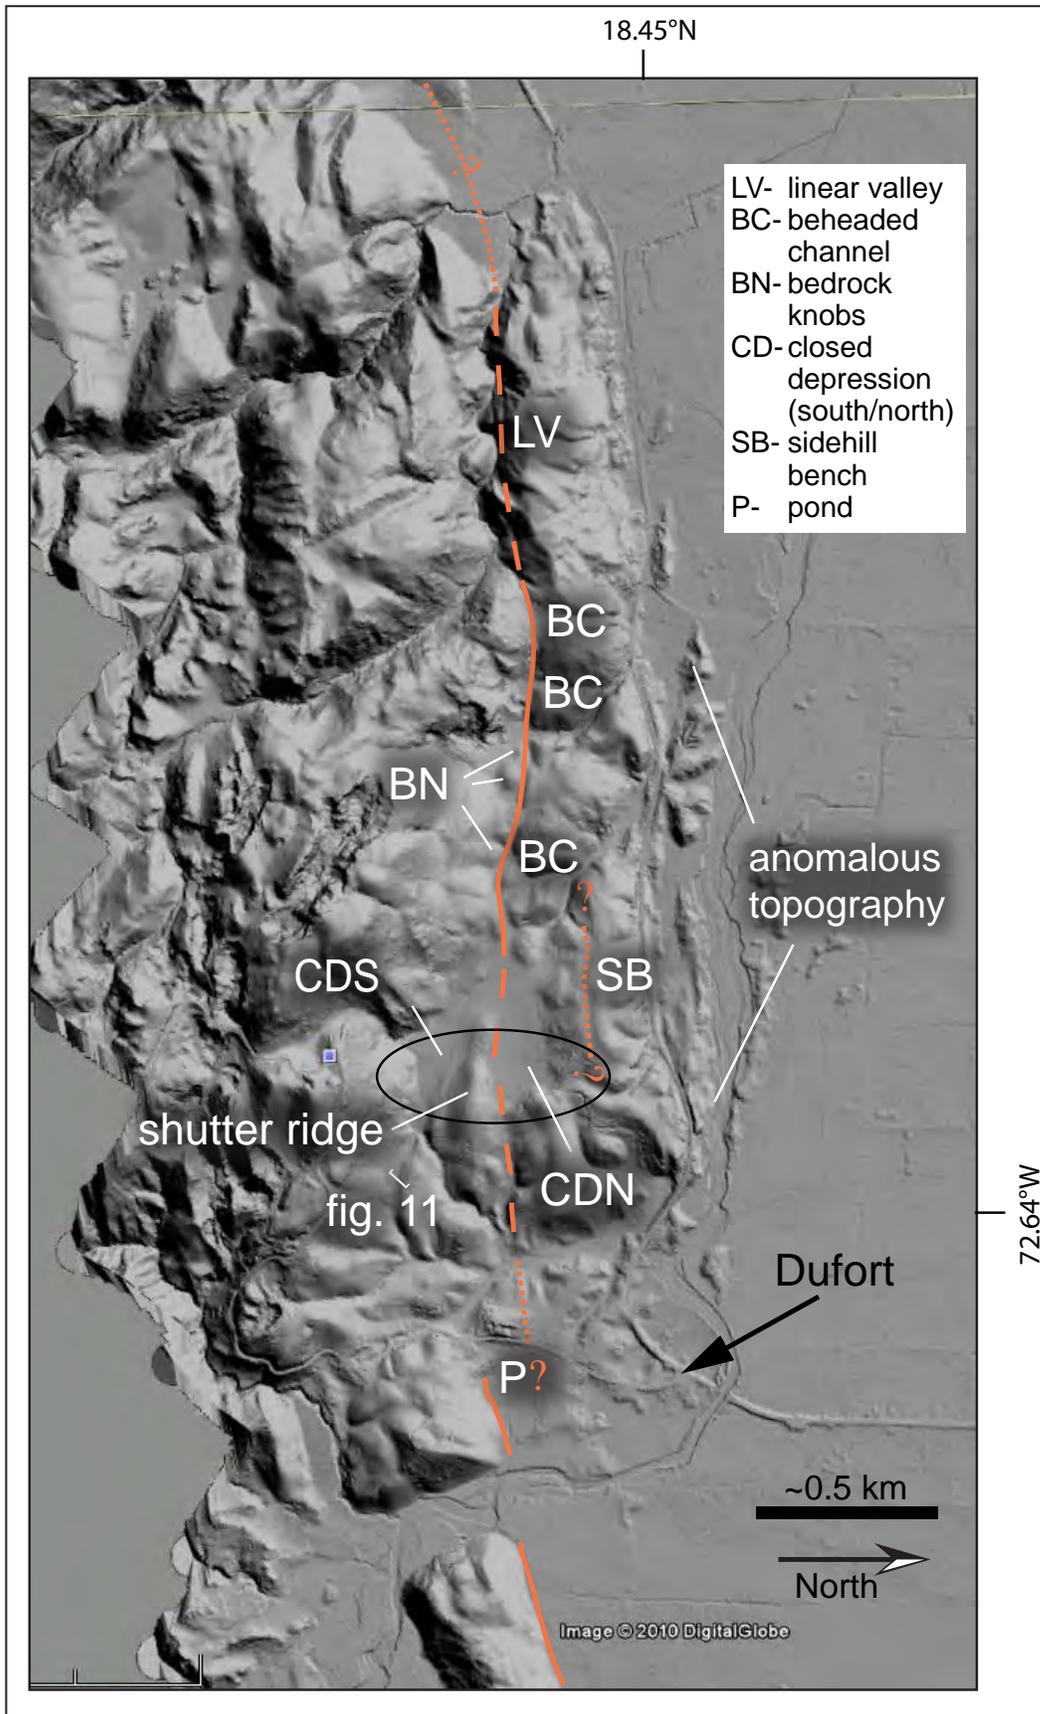
Figure 10 (previous page). LiDAR image of Site C, a fault valley southwest of Dufort. Tectonic geomorphic features are annotated; fault is shown in orange. LiDAR courtesy of Rochester Institute of Technology (RIT), processed by C. Crosby, San Diego Supercomputer Center.

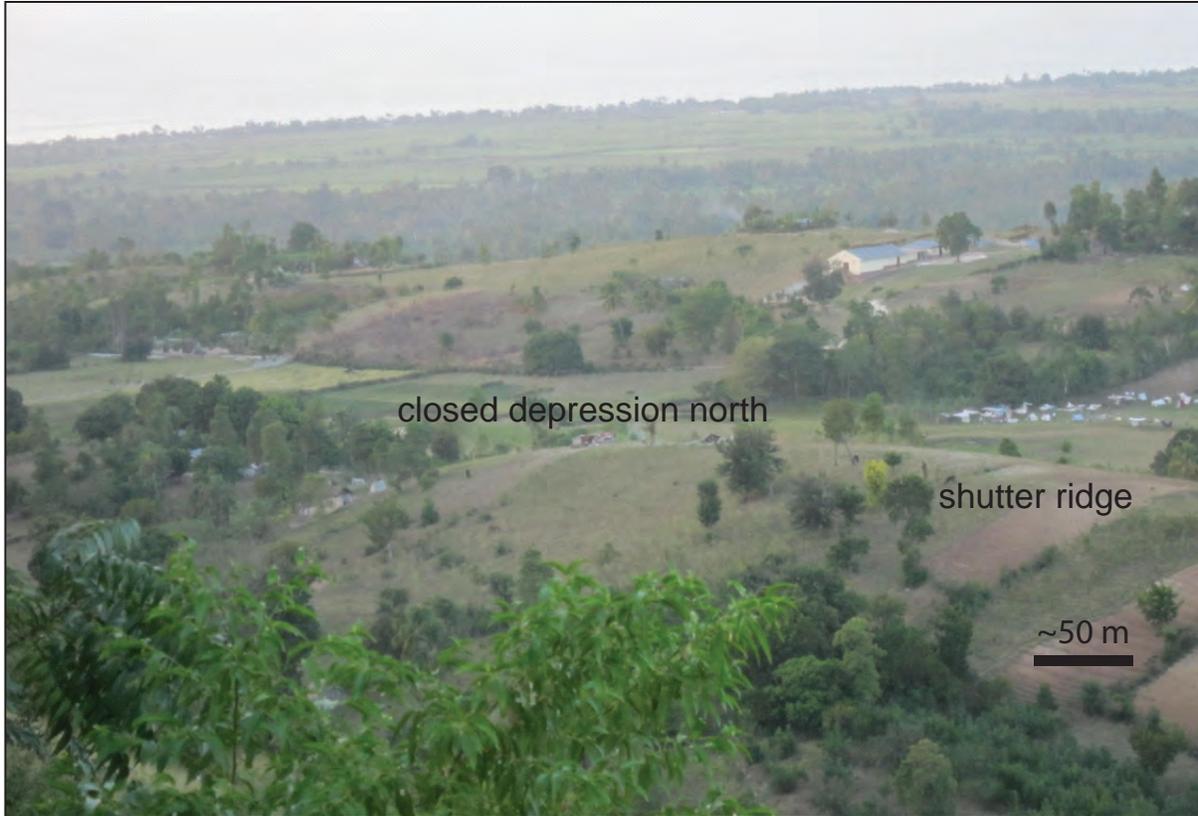
Figure 11. Photograph of the fault valley southwest of Dufort. View is to the northwest, looking across shutter ridge and closed depression north (CDN). Photo location is shown on figure 10.

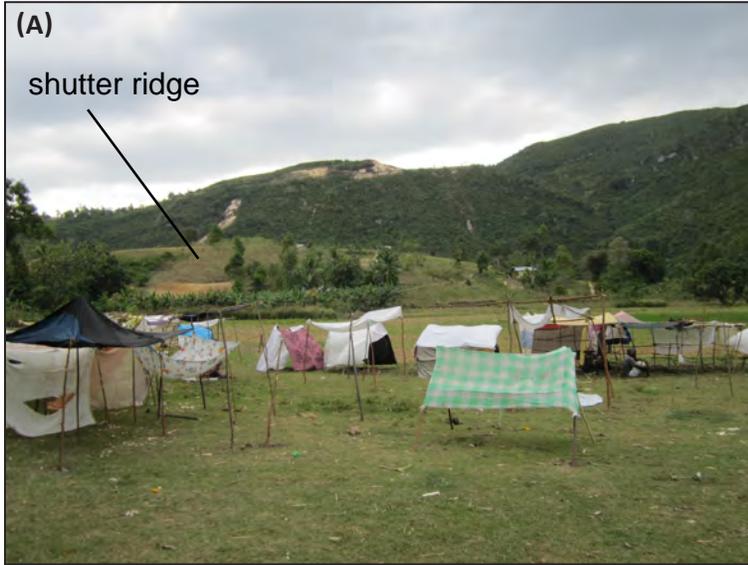
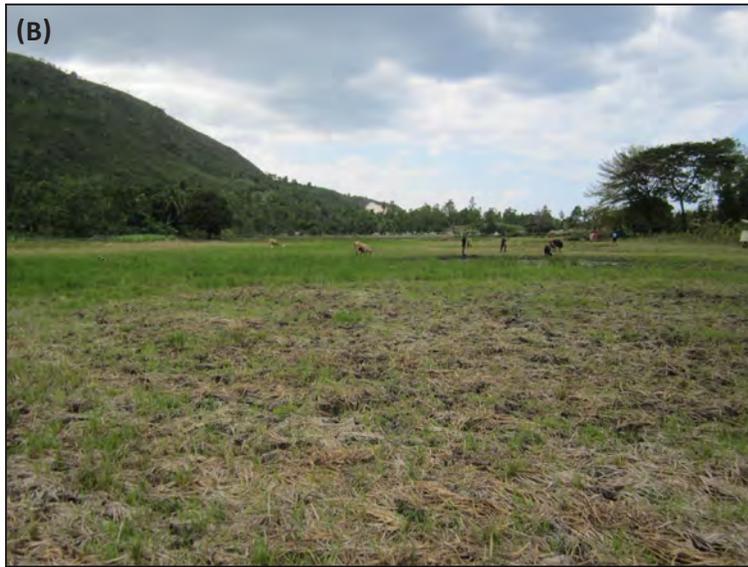
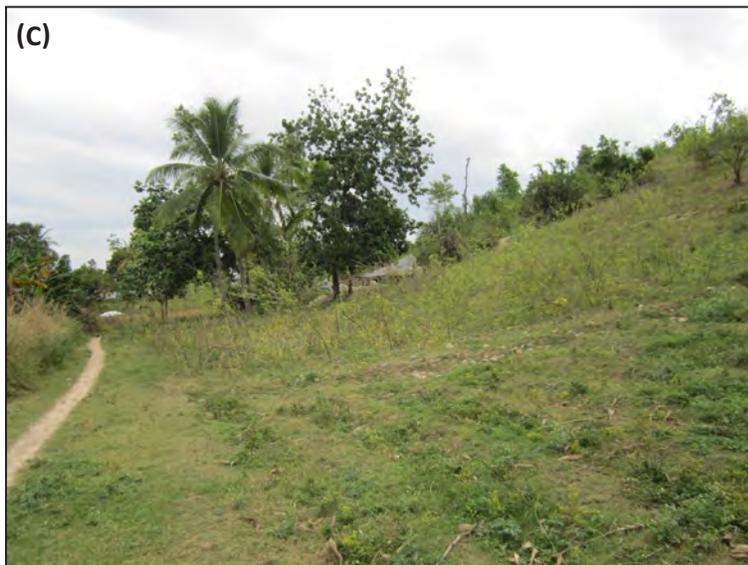
*Figure 12. Photographs at Site C, southwest of Dufort, showing closed depression north (CDN). (A) View to the south across the valley showing the shutter ridge that bounds the southern margin of the valley; relief shelters provide scale. (B) View west down the axis of the valley; cows for scale. (C) Looking east at the base of the shutter ridge; footpath for scale. Photos 12A and 12B taken from the same location (18°21'53"N, 72°38'39"W). Photo in 12C taken from 18°26'48"N, 72°38'42"W.*

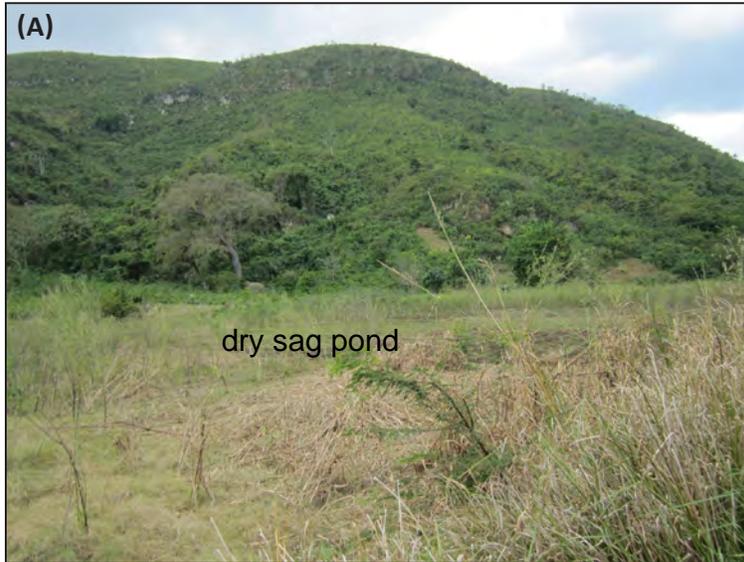
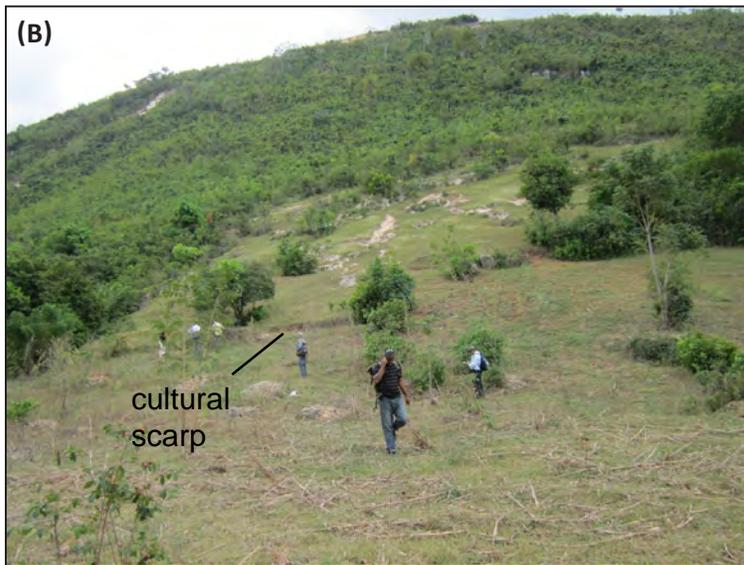
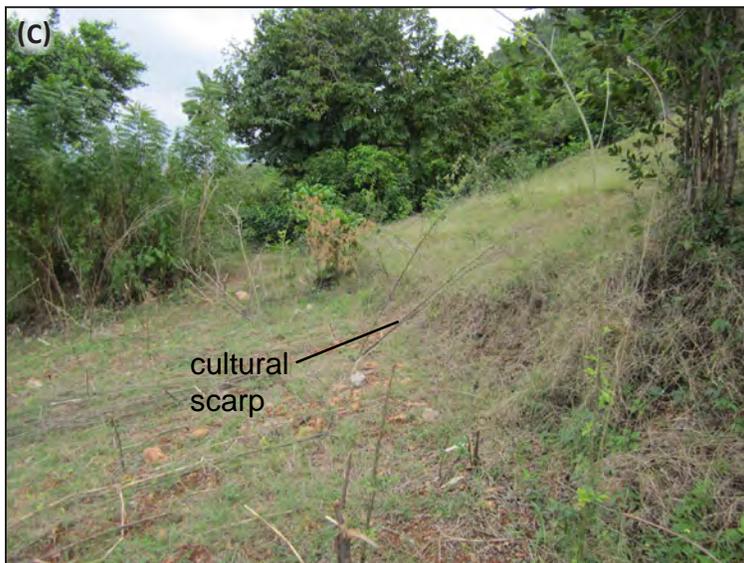
Figure 13. Photographs of Site C, southwest of Dufort, showing closed depression south (CDS). (A) Dry sag pond located at  $18^{\circ}26'42''N$ ,  $72^{\circ}38'44''W$ . (B) Cultural scarp on south side of valley; people for scale. (C) Vegetated face of cultural scarp located at  $18^{\circ}26'40''N$ ,  $72^{\circ}38'38''W$ ; scarp is  $\sim 0.5$  m high.

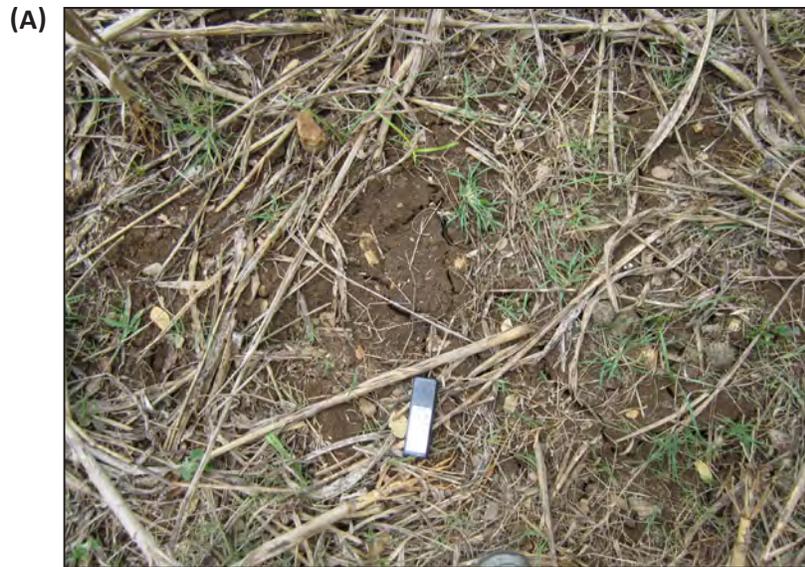
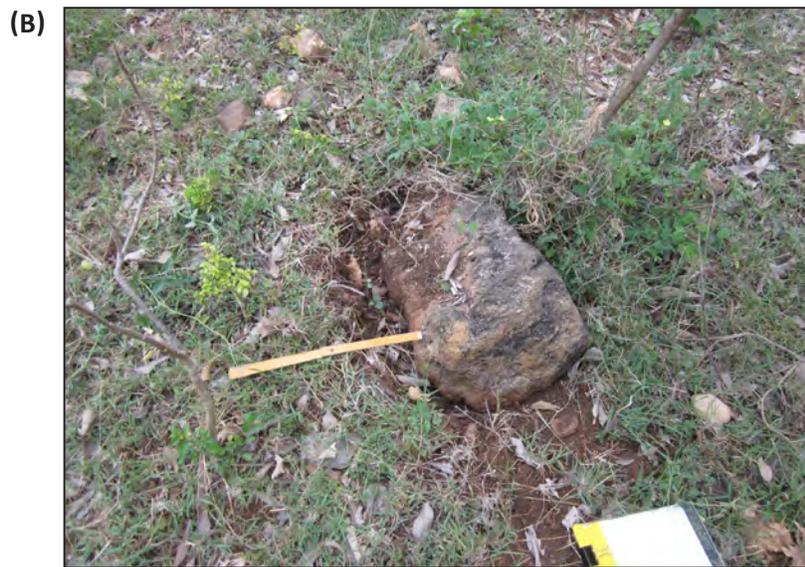
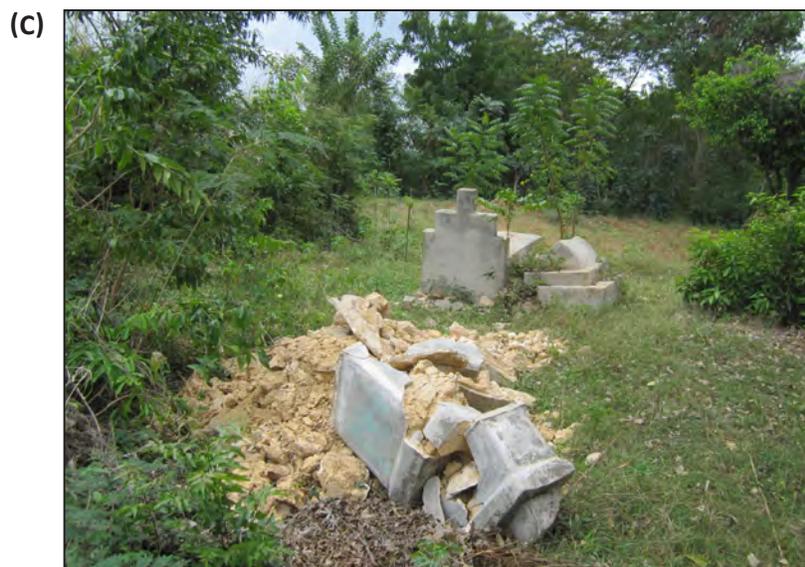
*Figure 14. Additional photographs of Site C. (A) Shrink-swell cracks in floor of closed depression south (CDS), located at  $18^{\circ}26'42''N$ ,  $72^{\circ}38'42''W$ . Tape recorder for scale. (B) Displaced boulder (notebook for scale) and (C) toppled gravestones (standing gravestone is  $\sim 1$  m high) are evidence of strong ground motions on the south-facing slope of the shutter ridge near  $18^{\circ}26'45''N$ ,  $72^{\circ}38'37''W$ .*

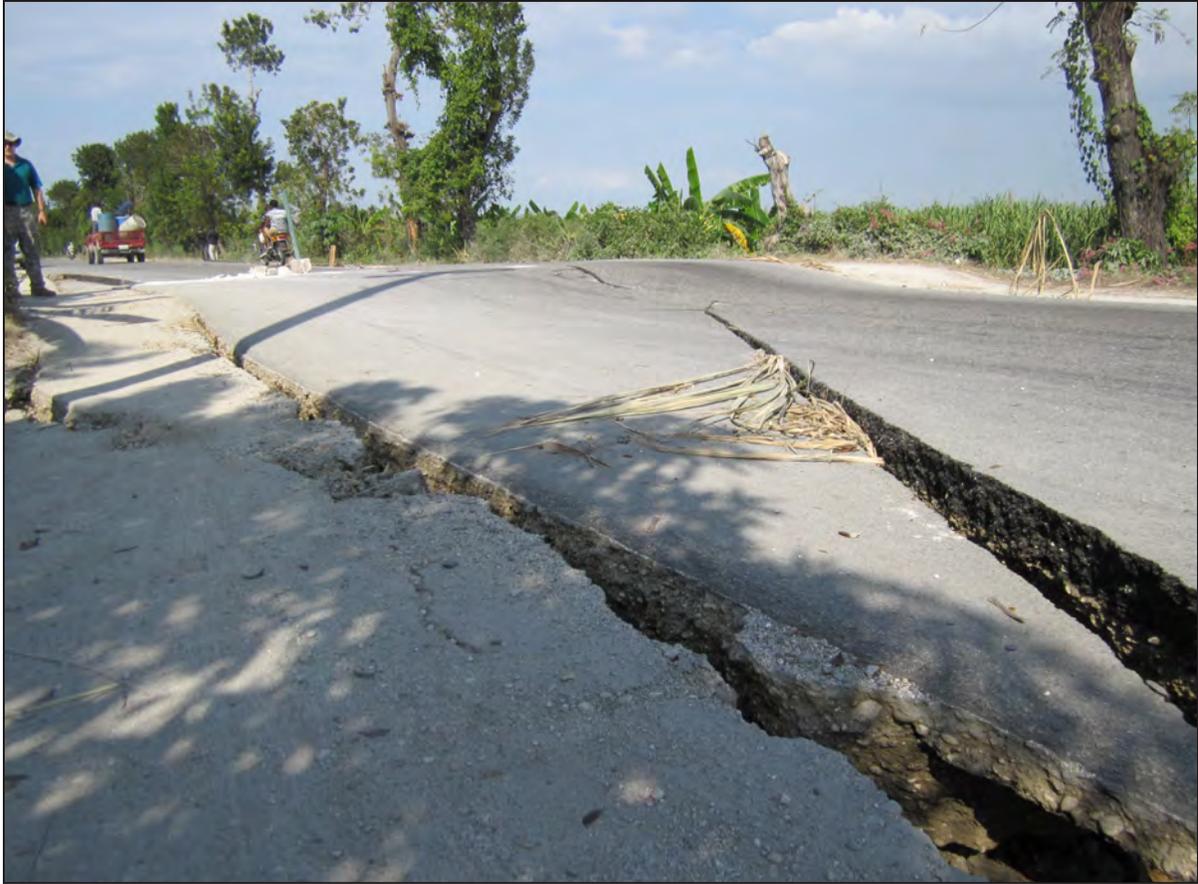
Ground fractures observed on GeoEye Inc. imagery between Dufort and Leogâne that were initially thought to be surface rupture along Route 200 were assessed with geologists and engineers from the Geo-engineering Extreme Events Reconnaissance (GEER) team (Site D, fig. 1). The cracks were restricted to the roadbed and artificial fills (fig. 15) and did not extend into the adjacent lowlands. The cracking may reflect localized settlement and cracking/movement of the road fill and underlying subgrade resulting from deformation of soft, organic, and saturated alluvial soils (GEER, 2010), and are not related to surface rupture. Detailed descriptions and photographs of these features, as well as descriptions of the engineering properties of the surrounding soils, are contained in GEER (2010).

Figure 15. Example of cracks in the pavement along Highway 200 at Site D north of Dufort; people provide scale. Cracking was observed in the road fill prism at nearly every culvert crossing on the highway between Leogâne and Dufort.

Communication was disabled in Haiti within the earthquake zone; however, constant email and text updates with developing information viewed on cell phones provided detailed descriptions and locations (GPS coordinates) of suspected surface rupture and other secondary deformation, and became an essential component of our field reconnaissance. Although our reconnaissance benefited greatly from advances in remote sensing and information-sharing techniques, interpretation of remotely sensed imagery alone resulted in erroneous observations at several locations. For example, cracks in the road prism along Highway 200, interpreted by some geologists as surface rupture, were confined to the road prism and determined by site-specific investigation to be secondary deformation features related to settlement of the road fill prism.
