Report of Investigations 2011-2

**FIELD OBSERVATIONS FROM THE JANUARY 12, 2010,  
HAITI EARTHQUAKE: IMPLICATIONS FOR SEISMIC  
HAZARDS AND FUTURE POST-EARTHQUAKE  
RECONNAISSANCE INVESTIGATIONS IN ALASKA**

by  
R.D. Koehler and P. Mann

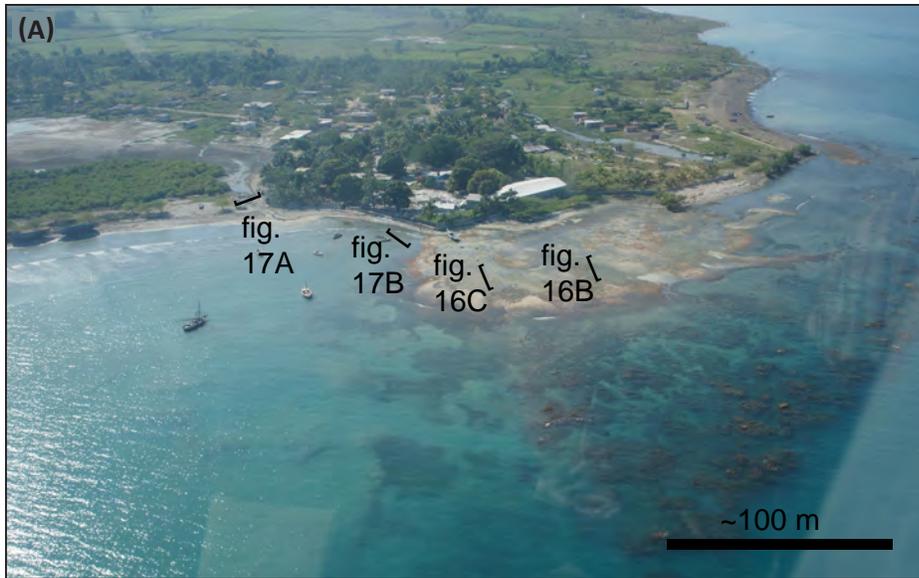
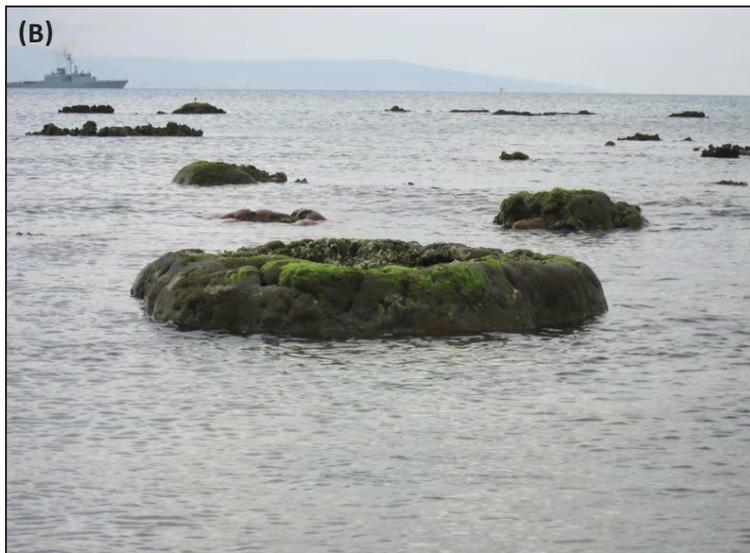
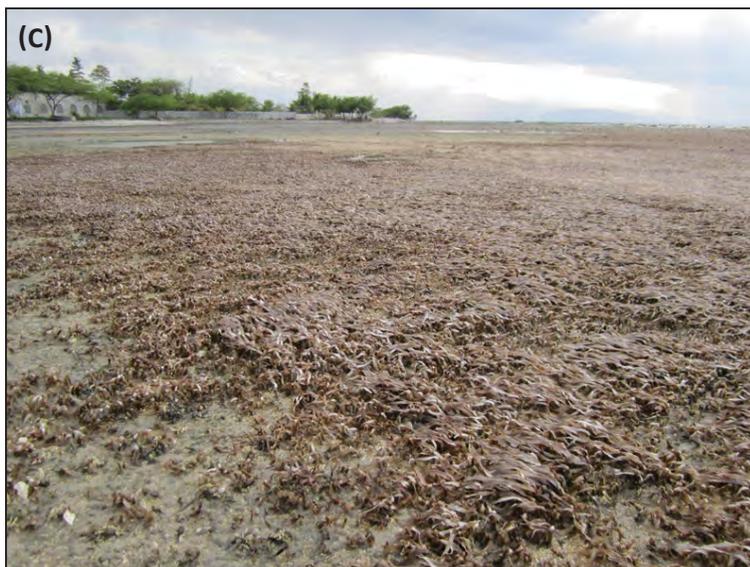
We briefly visited an uplifted coral reef along the coast west of Leogâne (Site E, figs. 1 and 16A, 18°31'31"N, 72°39'4"W) with the GEER team. Observations consistent with local uplift include many coral heads exposed above the water level, a drained intertidal lagoon adjacent to the reef, and a broad, subaerially exposed reef platform supporting subtidal sea grass (fig. 16 and 17A).

*Figure 16. Photographs of Site E, uplifted reef west of Leogâne. (A) View of the site from helicopter (photo courtesy of Rodger Bilham). Brackets indicate locations of photographs in figures 16B, 16C, 17A, and 17B. (B) Uplifted coral heads; U.S. military relief ship provides scale. (C) Subtidal sea grass is exposed on uplifted reef platform. Concrete wall in background is ~2 m high.*

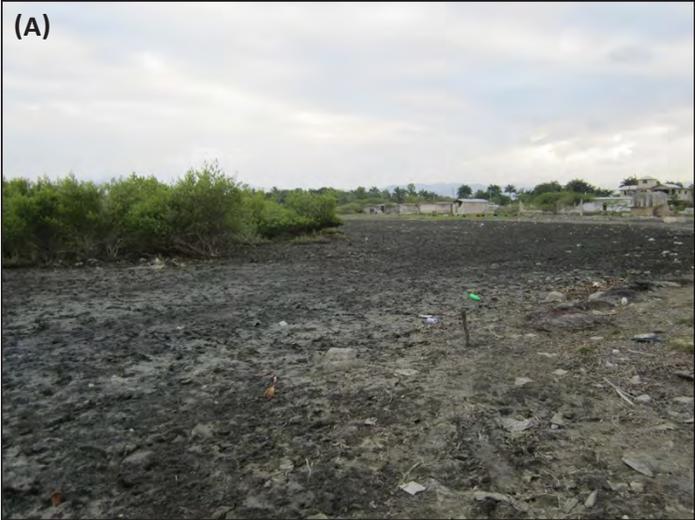
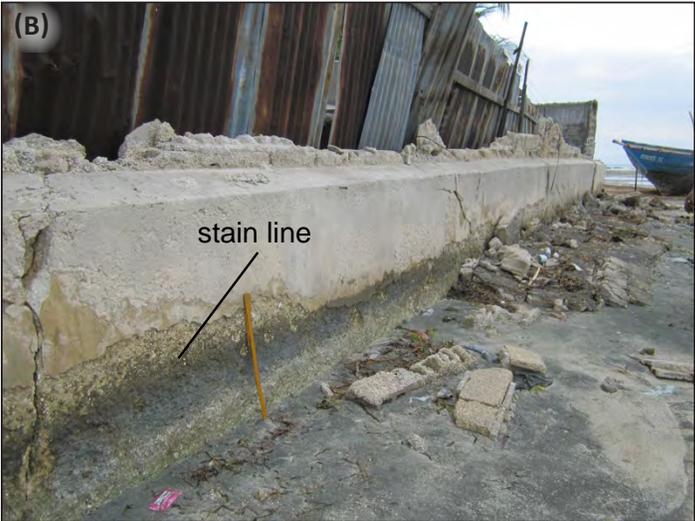
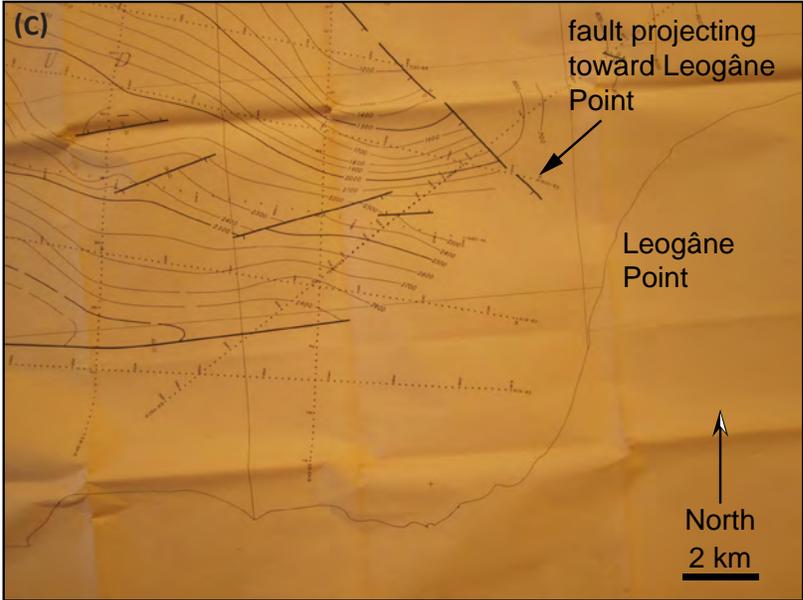
A distinct black stain line along a concrete wall associated with French colonial Fort Leogâne at the back edge of the beach was interpreted to represent the former high tide line (fig. 17B). We used this line as an elevation datum to assist in calculations of the amount of uplift. At 4:43 p.m. local time, we measured the elevation difference from this line to (1) the water level at the time of our visit (78 cm); and (2) the level of the last high tide (63 cm). We also measured the difference in elevation between the last high tide and the water level at the time of our visit (17 cm). Additionally, we collected a sample of the coral head. Measurements from the top of the coral head and the top of the sample to the water elevation were 20 cm and 15 cm, respectively. The estimate of the previous high tide elevation was tenuous because there was only a subtle litter line and minor escarpment to mark its location. Local residents indicated that the subtle litter line was the elevation of the last high tide,

We uncovered several industry seismic lines and maps from the 1980s, by crawling into the damaged library of the Bureau des Mines et de l'Énergie Haiti (fig. 17C). These data show a northwest-trending fault with a north-side-up sense of motion intersecting the coast south of Leogâne Point. The sense of motion is consistent with the regional pattern of uplift and may indicate sympathetic rupture on this fault.

Figure 17. Photographs of Site E, uplifted reef west of Leogâne. (A) Drained tidal marsh adjacent to reef; houses in background for scale. (B) Former high-tide elevation marked by the black stain line on concrete wall. Yellow measuring stick ~30 cm tall provides scale. (C) Map from the Bureau des Mines et de l'Energie Haiti showing fault with up-on-the-north sense of motion in the vicinity of Leogâne Point.

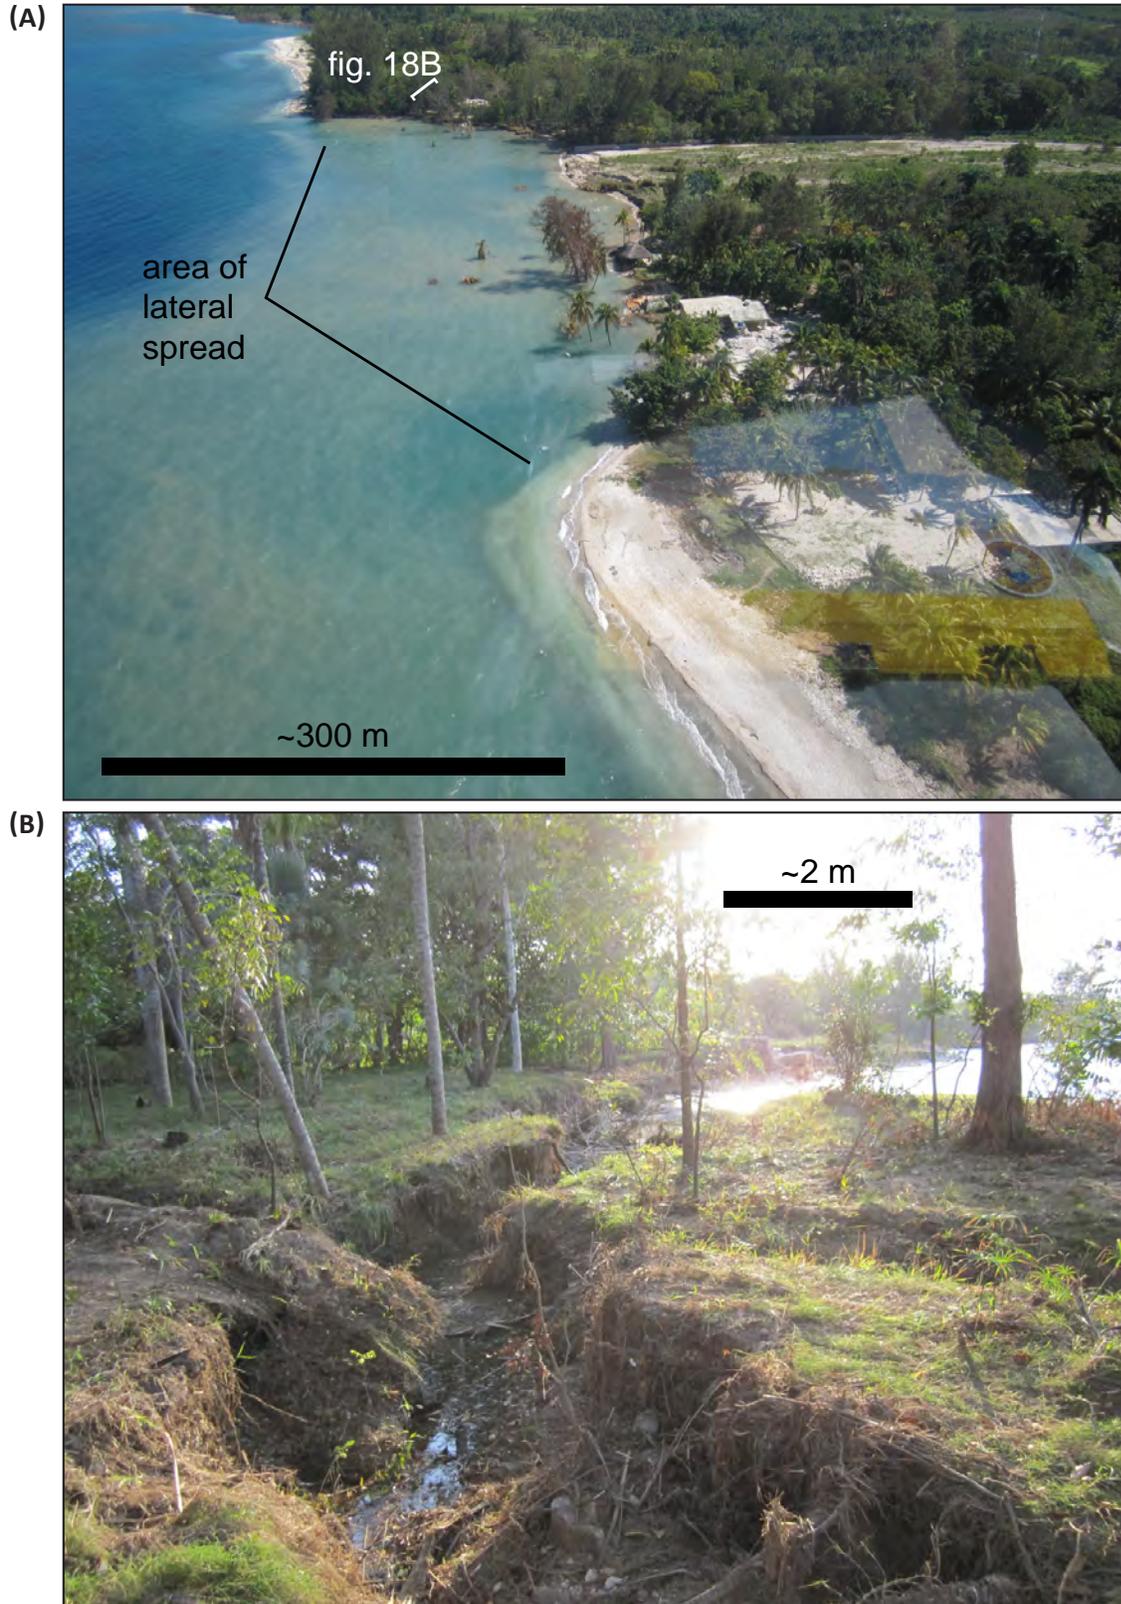
A limited amount of time was spent looking at a ground-failure feature at the mouth of the Fauche River delta (Site F, fig. 1,  $18^{\circ}25'34''\text{N}$ ,  $72^{\circ}43'35''\text{W}$ ). At this location a ~300-m-wide section of the delta fan and the beach were transported into the ocean (fig. 18A). The delta alluvium is characterized by interbedded lenses of sand, gravel, and rounded 4–10 cm cobbles in a sand matrix. Many submerged trees were observed in both straight growth position and tilted toward the coast, indicating seaward transport of intact blocks. Along the eastern side of the feature, coast-parallel cracks and grabens occur up to 15 m inland from the coast and are associated with vented sand and gravel. One prominent graben 15 m long by 2 m wide by 1 m deep extends along the backside of a laterally transported block (fig. 18B). A ~1.5-m-high headscarp occurs in the center of the delta fan. About a dozen coast-parallel cracks with several centimeters of coast-side-down displacement occur within a ~10-m-wide zone inland of the headscarp. The saturated condition of the alluvium, presence of loose lenses of fine- to medium-grained sand, and liquefaction

Figure 18. Photographs of Site F near Fouche. (A) Cuspate area labeled is a large lateral spread indicated by missing beach, coast-parallel cracks, and submerged trees. (B) Head scarp cracks up to 2 m wide and 1 m deep appear along eastern side of lateral spread.
