Report of Investigations 2012-2  
Version 1.1

**COASTAL HAZARD FIELD INVESTIGATIONS  
IN RESPONSE TO THE NOVEMBER 2011  
BERING SEA STORM, NORTON SOUND, ALASKA**

by  
Nicole E.M. Kinsman and Meagan R. DeRaps

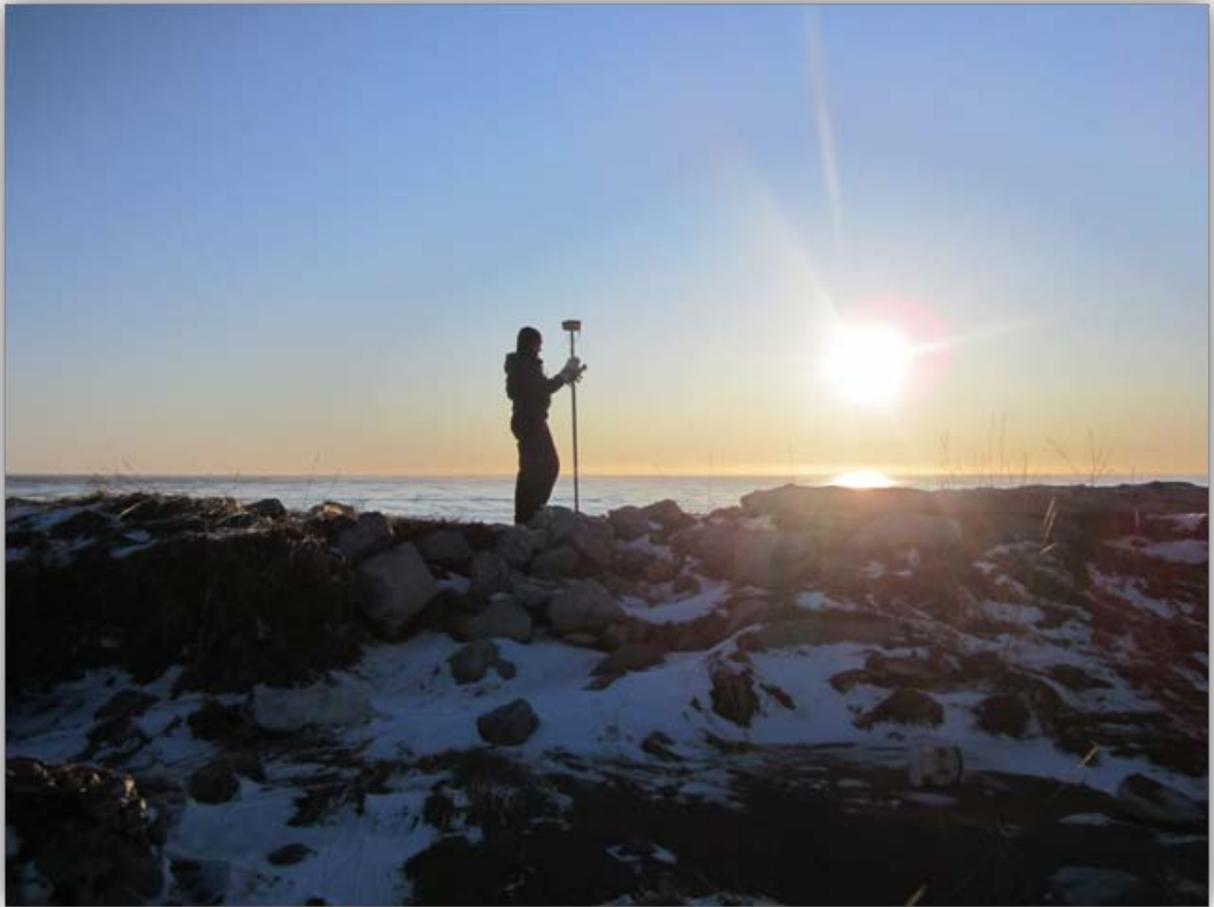
**COVER PHOTO:** *DGGS geologist Meagan DeRaps measures the crest elevation of a minor blowout in a rock revetment along the Nome–Council Road. The blowout occurred during the November 2011 Bering Sea Storm.*

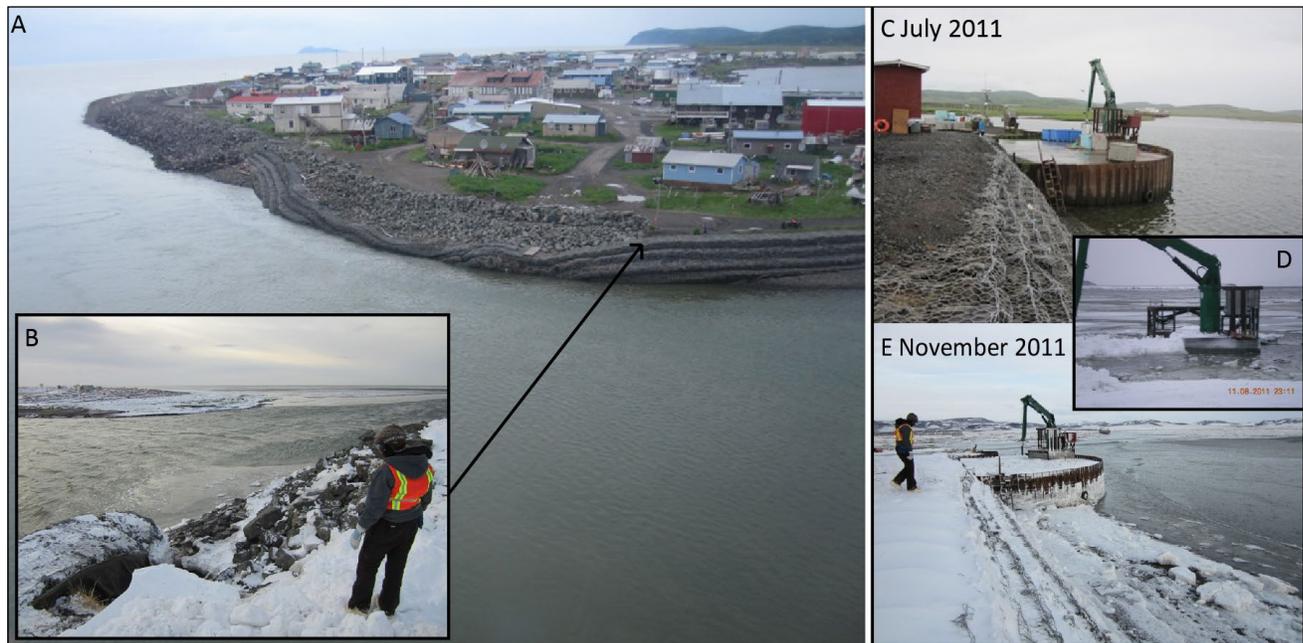
Figure 7. Coastal modifications along the northern side of the Unalakleet River mouth including the armor rock revetment, gabion wall and sheet pile dock. The gabion wall is shown (a) in a pre-storm oblique aerial photo and (b) when a blowout was observed post-storm. The sheet pile dock is shown (c) pre-storm, (d) at the peak surge (photo by Maggie Halleran), and (e) again post-storm. MP14 in table 2 was collected at the crane site.

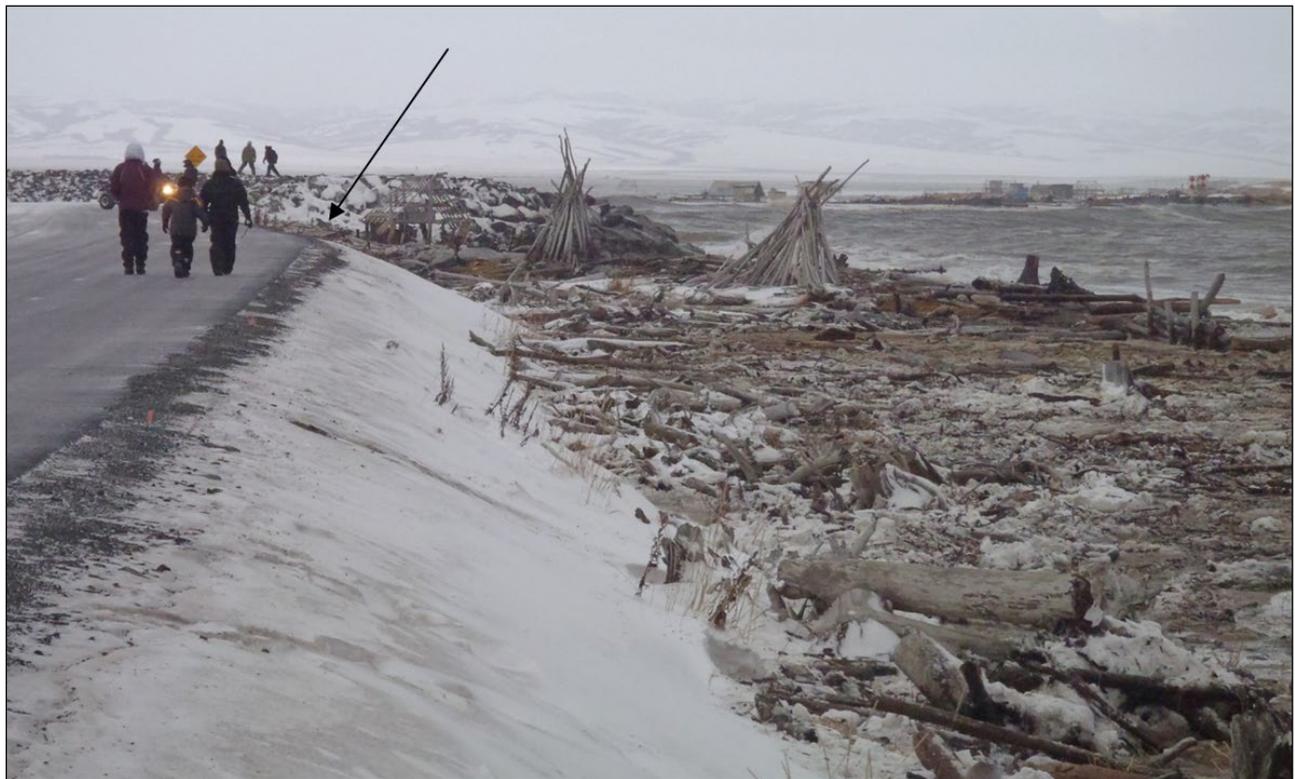
Figure 8. Beach Front Road in Unalakleet, which runs along the coast exposed to Norton Sound, was raised approximately 3 ft (0.9 m) in 2005. The western terminus of the armor rock revetment is visible in the photo and the arrow points to a location along the road where runup measurements MP06 and MP07 (table 2) were collected (photo by Steve Ivanoff).

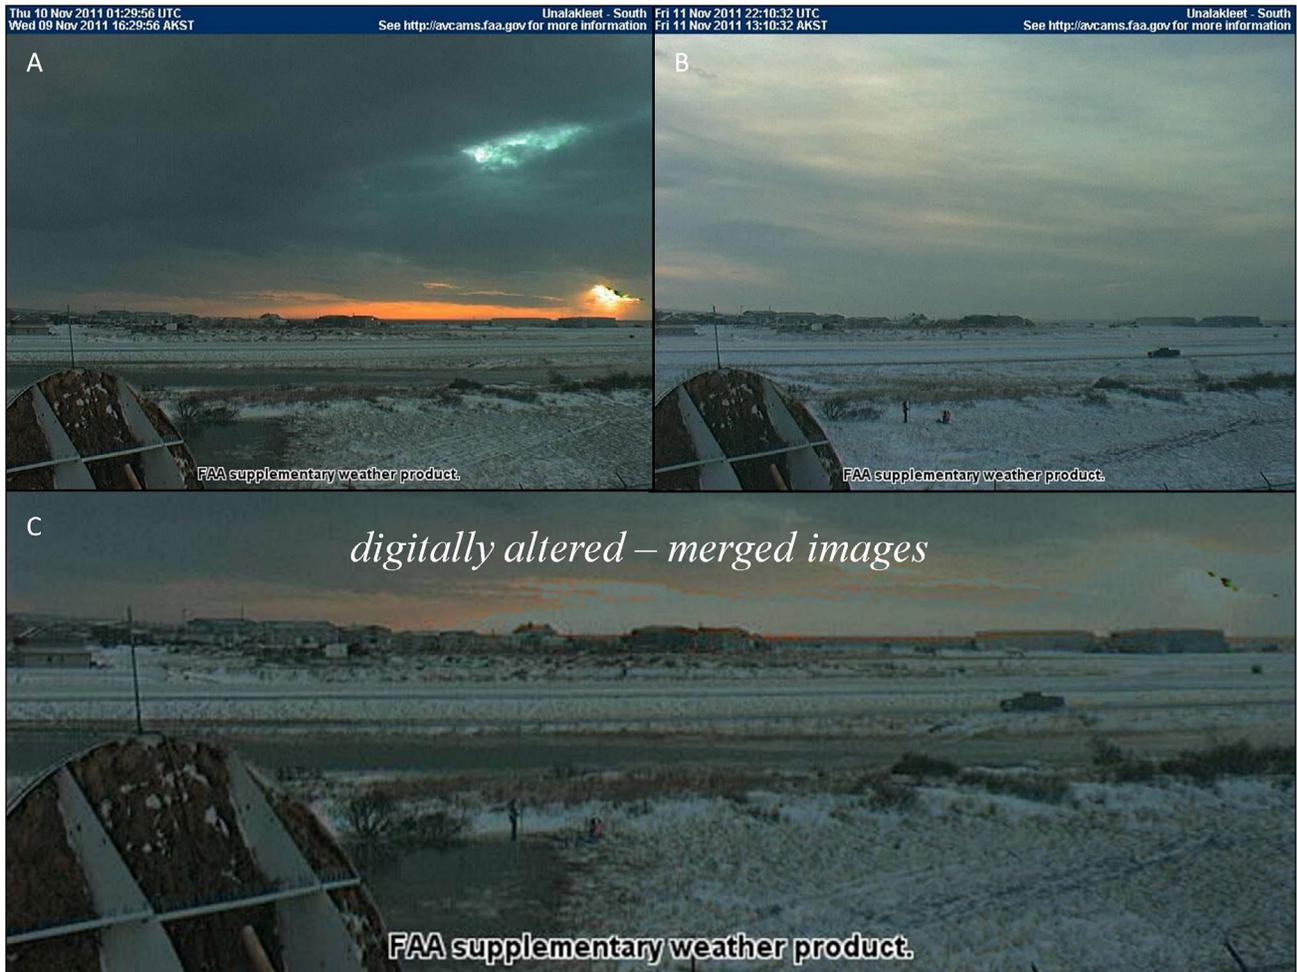
Figure 9. Collection of MP05 (table 2), a flood inundation limit on the eastern side of the Unalakleet airport, which was visible in an FAA webcam adjacent to Runway 26. (a) Image taken on the afternoon of November 9, 4:29 pm AKST, following the peak surge. (b) Image taken at 1:10 pm November 11 as DGGs workers collected an elevation measurement. (c) Digitally stitching images (a) and (b) together allows us to view the position of the workers relative to the inundation limit.

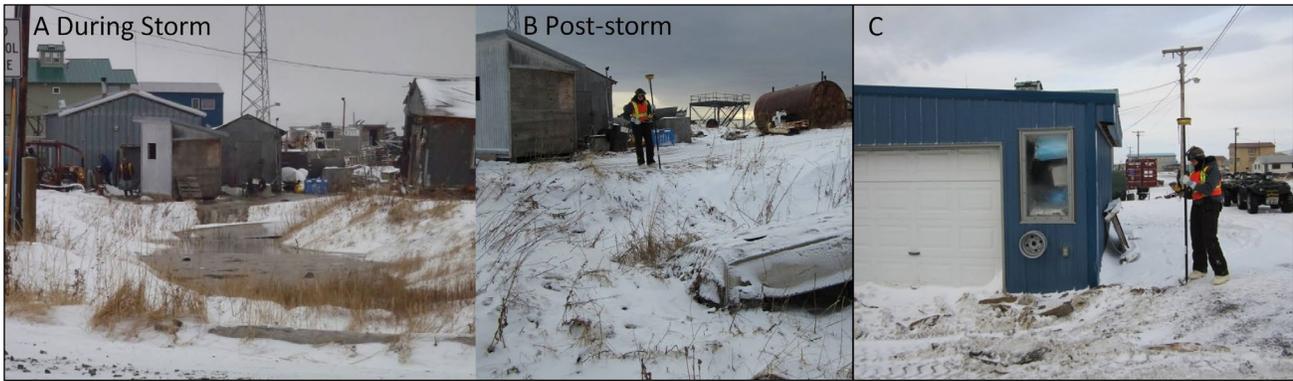
Figure 10. Photographs of flooded areas on open ocean side of Unalakleet provided an estimate of the TWL along the front of the community where the water surface was elevated above the storm tide level by nearshore wave setup. A spillover point photographed by Steve Ivanoff during the storm (a) was measured as MP11 in table 2 (b) and a slush limit adjacent to flooded garage provided the elevation for MP08 (c).

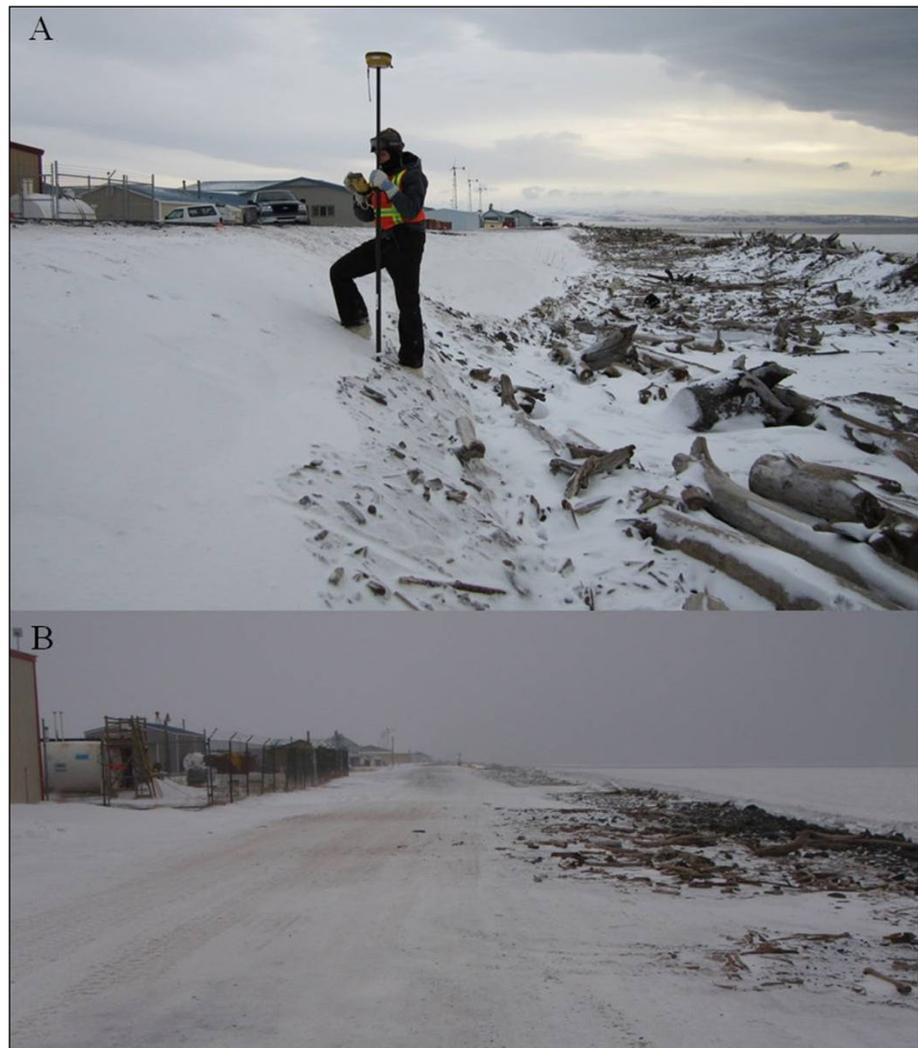
Figure 11. (a) Level of runup on side of raised Beach Front Road, Unalakleet, along Coastal Profile 15 near the school. (b) Runup level in driftwood where waves have overtopped the crest of the dynamically stable beach project on the road to the airport.

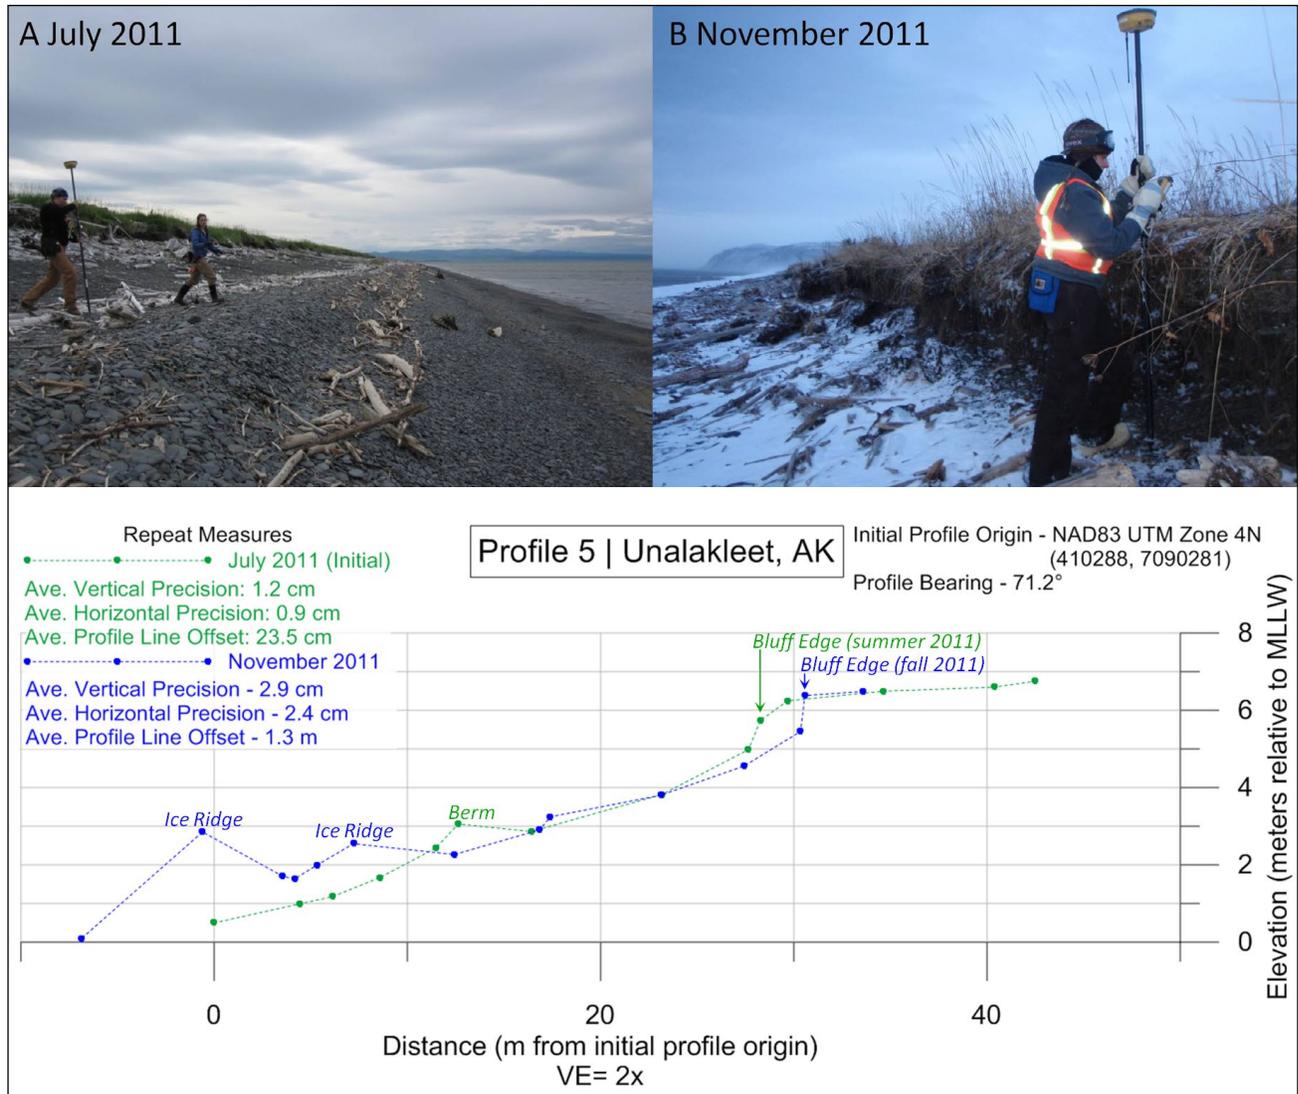
Figure 12. (a) Coastal Profile 05, north of the Unalakleet barge landing, showing a well-developed mid-beach berm and rounded low bluff, and (b) erosion of the bluff toe caused by waves during the November 2011 storm. The plots illustrate change in the morphology of the beach cross section at this location including the removal of the berm, erosion at the bluff, and the accretion of ice ridges on the lower beach.

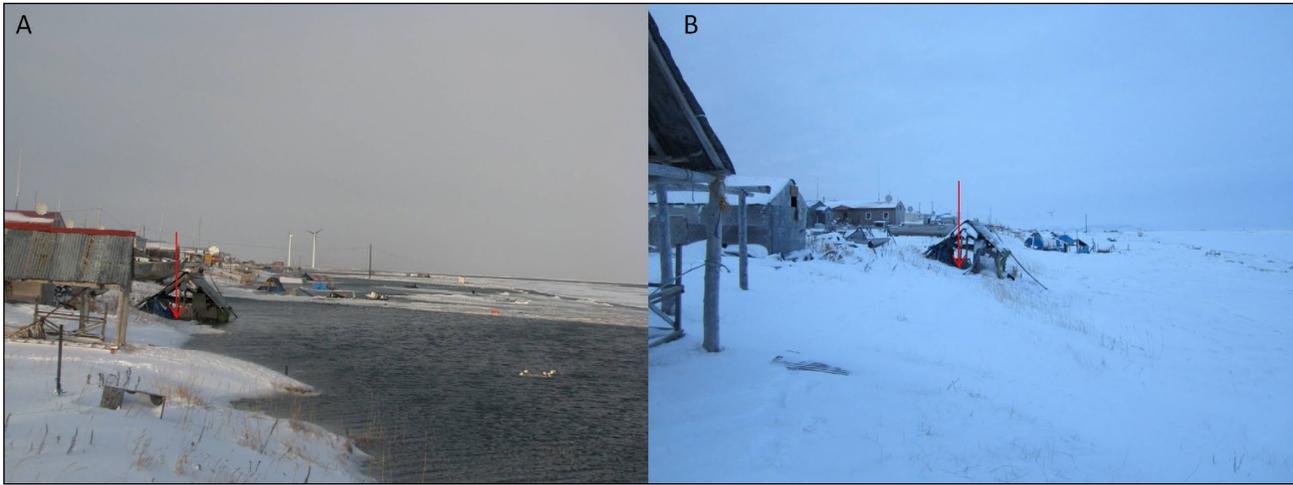
*Figure 14. (a) Location of elevated water level on the bank of Tagoomenik River as photographed by Elmer Bekoalok on November 9, 2011, and (b) the measured point MP13\_09 (table 3) as determined by the position of the water relative to the upright support on the fish drying rack highlighted by the red arrow in both photos.*

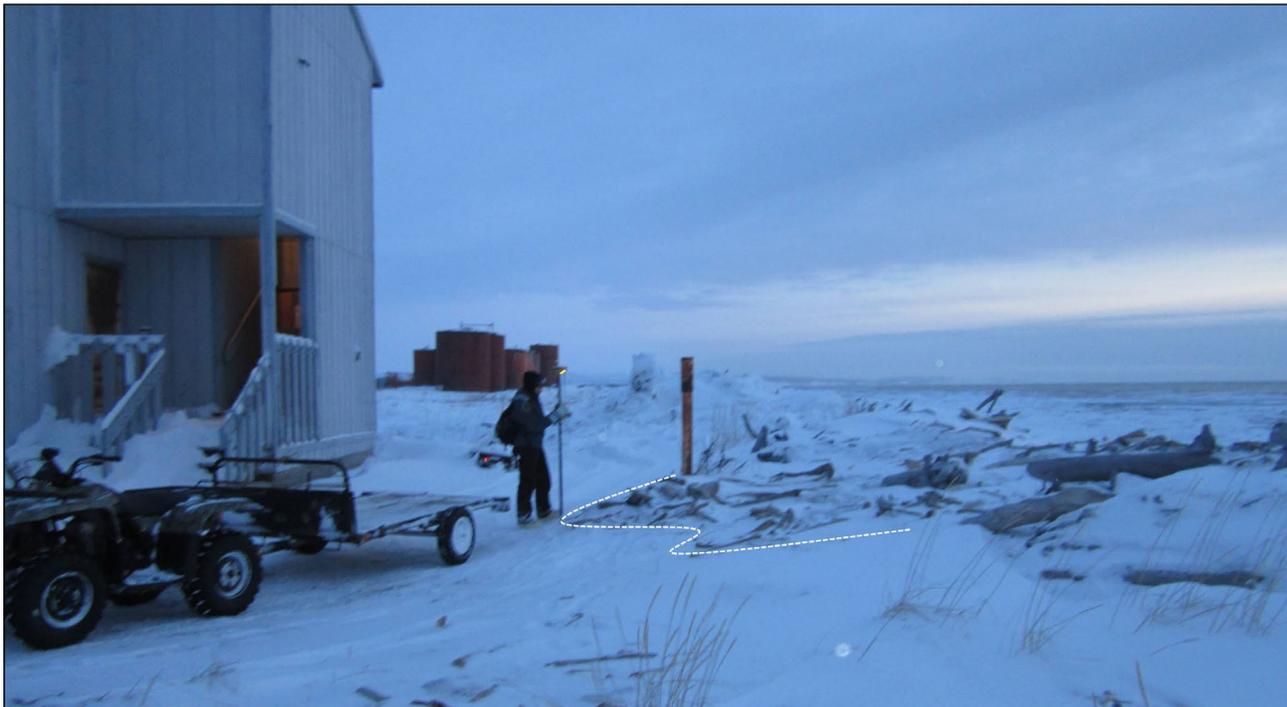
*Figure 15. Inland limit of a runup deposit (highlighted by white dashed line) that overtopped the driftwood debris pile in front of the Native corporation building (MP13\_11 and MP13\_12, table 3).*

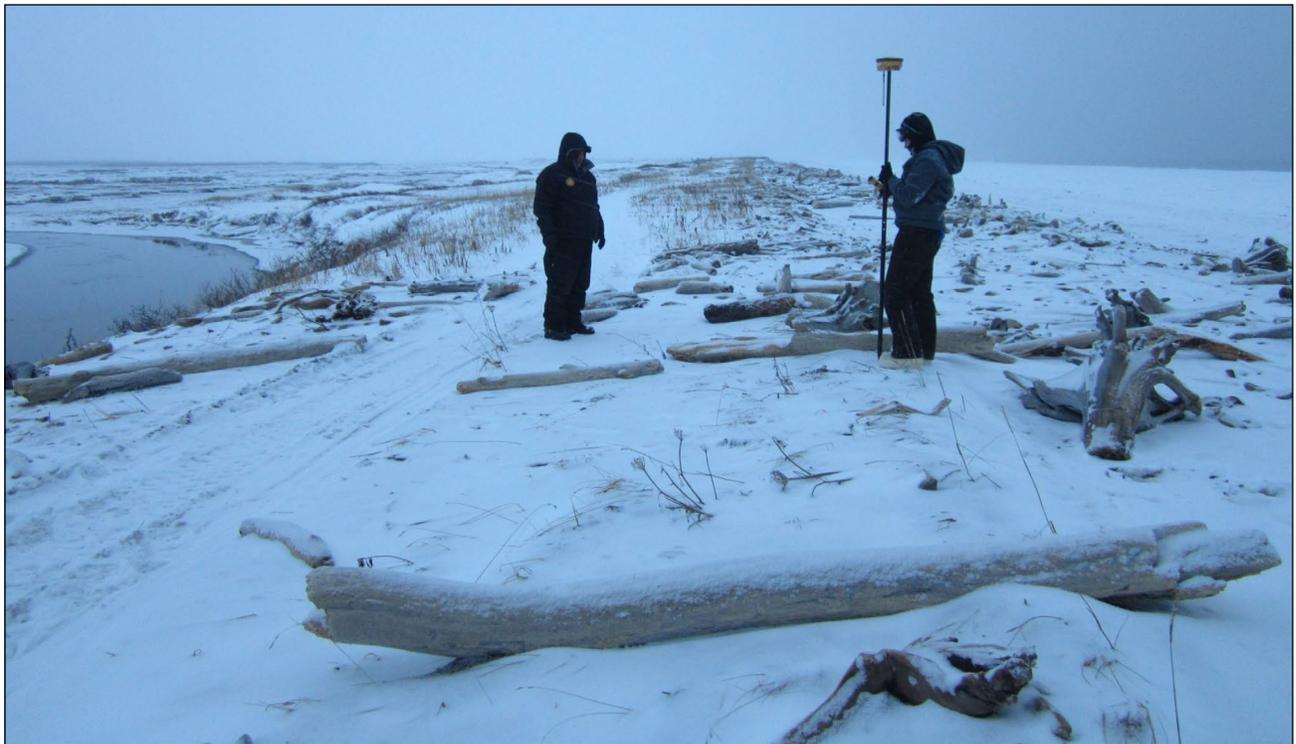
Figure 16. Photograph, looking to the south, of an area on the runway at the old Shaktoolik community site, where the barrier spit was overtopped and water flowed from Norton Sound into Tagoomenik River, visible on the left side of the photograph (MP12\_06, table 3).

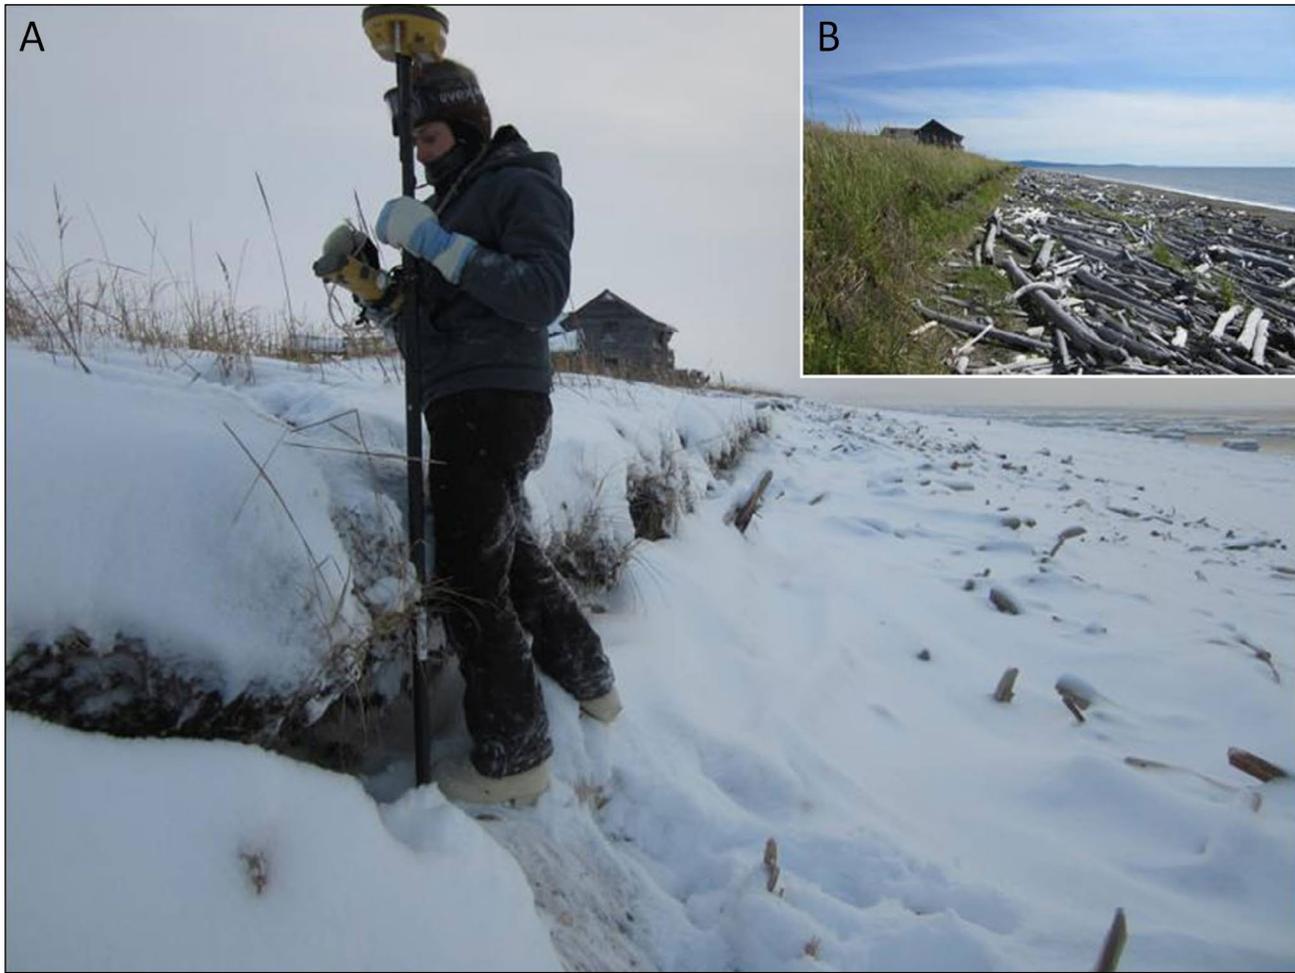
Figure 17. (a) Basal notching 60 cm into the low coastal bluff at the old community site was observed in areas that had a vegetated talus toe prior to the November 2011 storm (inset photo b).

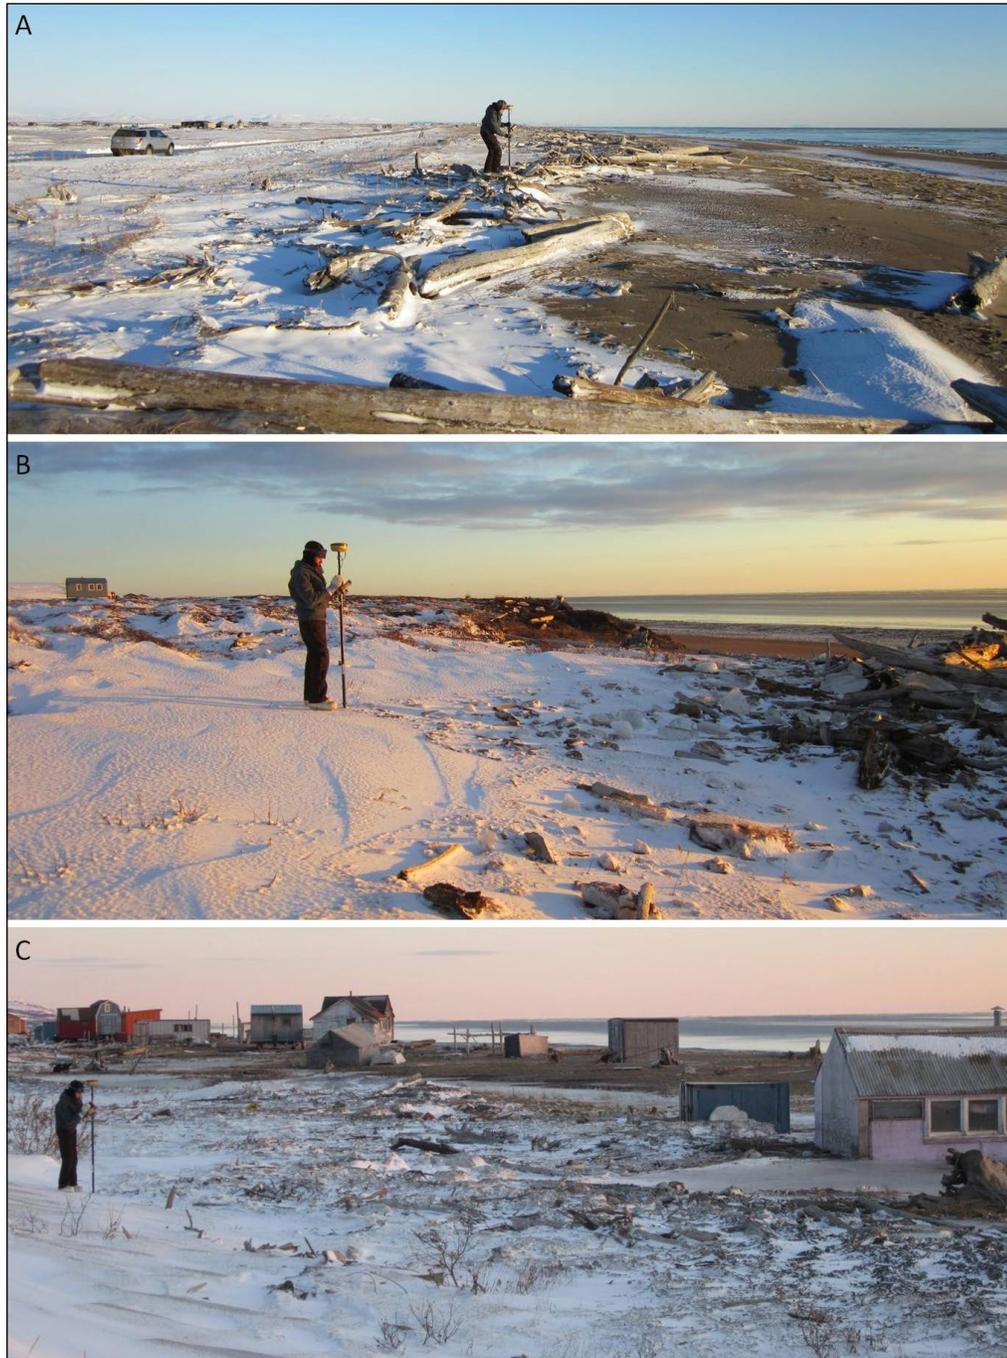
Figure 19. Examples of measured flood indicators along the Nome–Council Road from east to west: (a) Inland limit of flooding along Profile S (S\_03, table 4); (b), slush line (MP09, table 4) atop a coastal bluff near Profile M; and (c) inundation limit on open-ocean coast behind beach cabins (MP12, table 4).

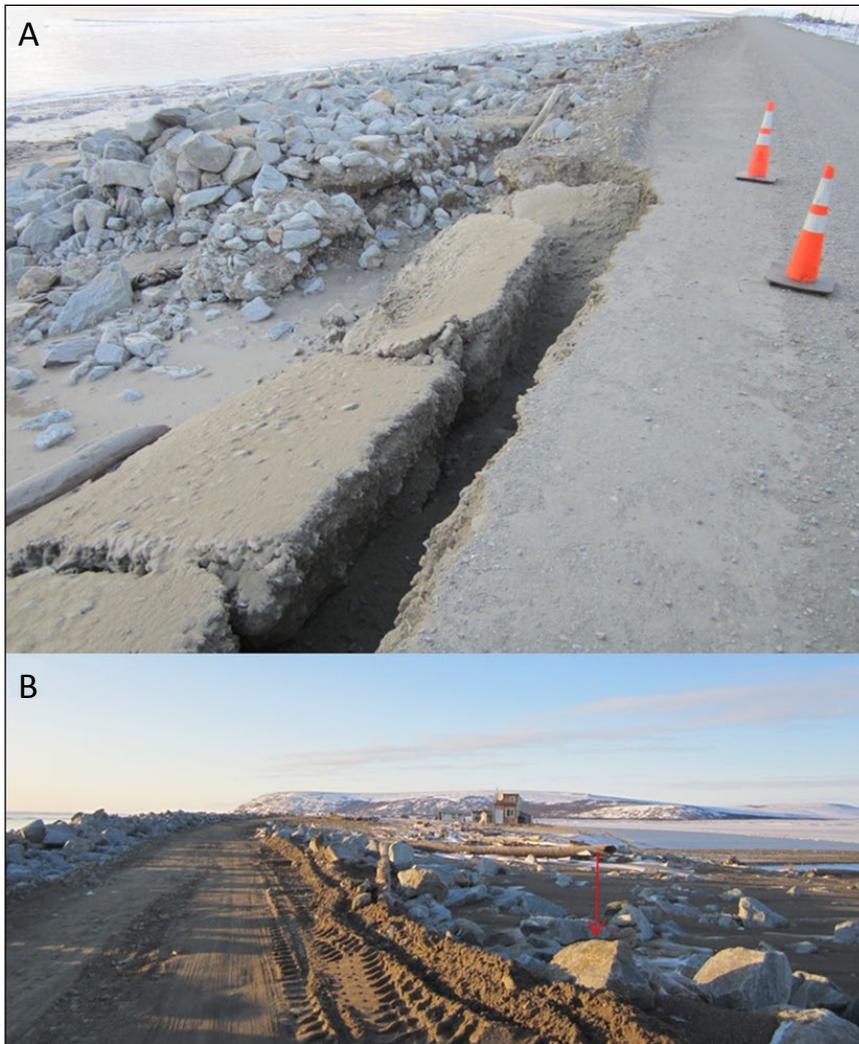
Our team observed extensive damage to the roadway and rubble mound revetments along much of the Nome–Council Road that we visited. One day prior to our arrival, portions of the road were still closed to vehicle access and clean-up efforts were in progress as we were collecting measurements. Just west of Nome River, a breach in the armored revetment exposed the road to undermining (fig. 20a). Additional breaches to revetments along the road were also observed, particularly along the coast adjacent to Safety Sound. Near Mile 17 on the Nome–Council Road, large pieces of riprap were washed across the road during the storm and deposited both atop the spit and in the Sound (fig. 20b). The three coastal profiles that were established in Nome are not presented in this report but will be included in a future DGGs publication once more profiles have been established.

*Figure 20. Significant modification to coastal engineering structures and damages along the Nome–Council Road included (a) undermining of the paved road and (b) the removal/transport of armor rock from the revetment near Mile 17. For scale, the rock highlighted by the red arrow in (b) was approximately 0.6 m in diameter.*

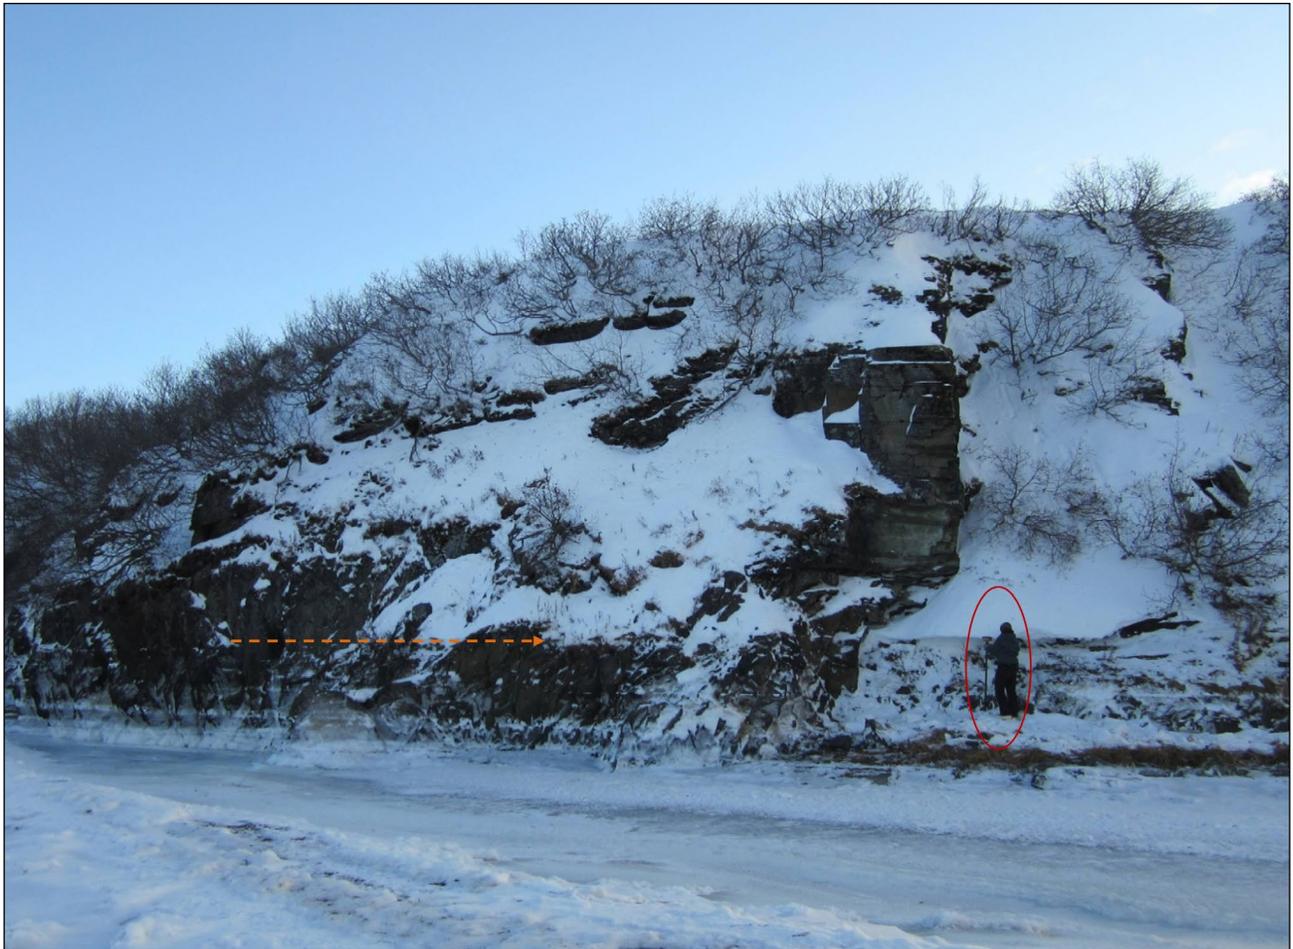
Figure 23. Total floodwater level as preserved in a truncated snowdrift on the sedimentary cliffs to the north of town, along the Golovnin Lagoon shoreline. The peak water line is highlighted by the orange arrow; the elevation of the line was measured at the location shown with the person in the red ellipse (GLV\_32, table 5).

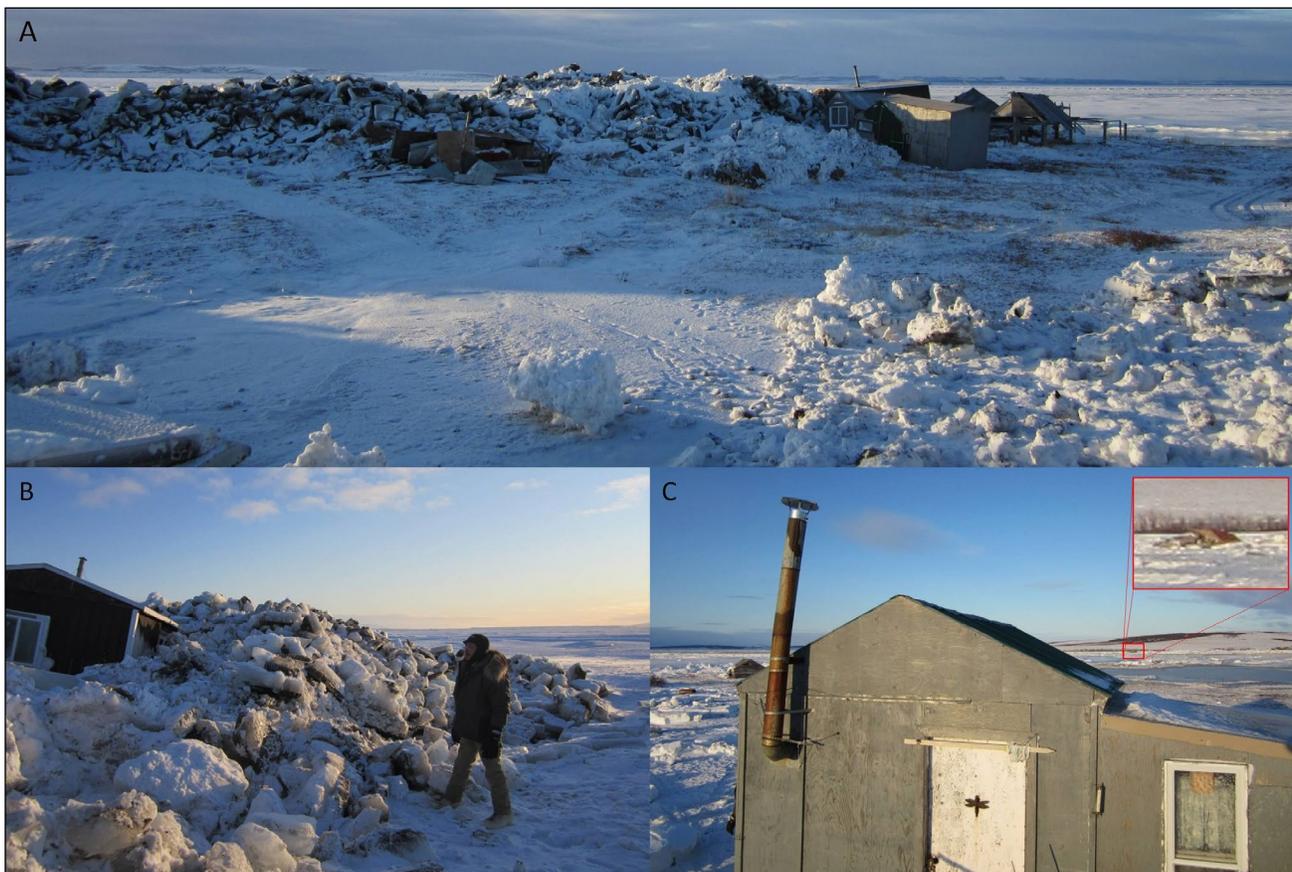
Figure 24. Photos documenting the ivu that occurred at the mouth of Kachauik River: (a) Looking southwest across the fish camp at the forward edge of the ivu that damaged all of the cabins on the site; (b) Toby Anungazuk, a cabin owner, stands beside a building that was transported by the ivu; and (c) a photo taken from the fish camp shows a cabin in the distance (red inset) that floodwater rafted approximately 0.5 km to the northeast.

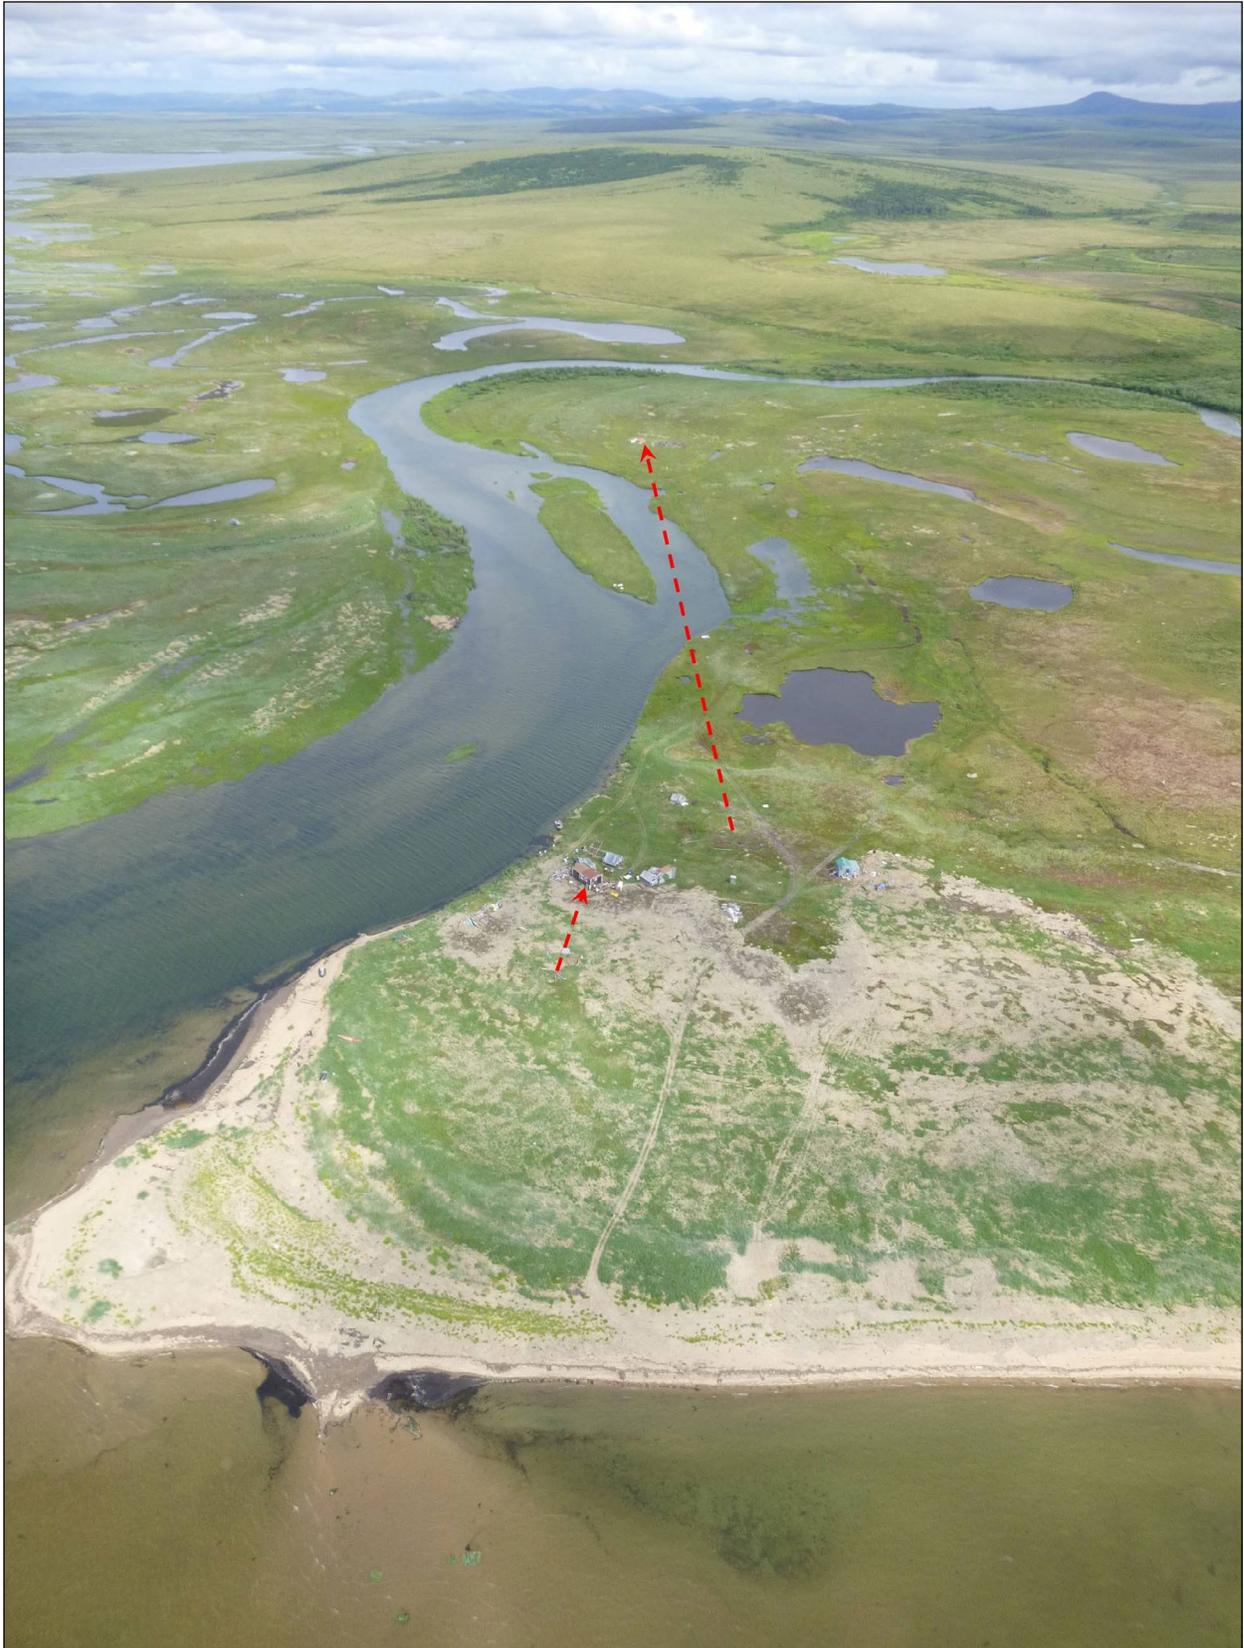
Figure 25. Oblique aerial image of the fish camp at the mouth of Kachauik River taken July 2012, eight months after the storm. The approximate transport distances of two cabins from their pre-storm foundation locations are depicted by red arrows and the deposition of ice-rafted sediment up to 150 m inland is apparent.

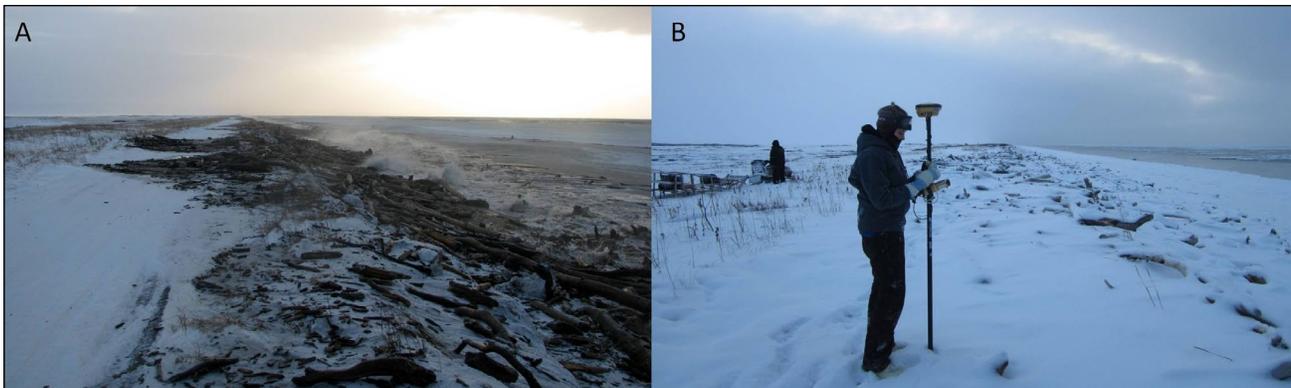
Figure 27. These two photos taken near the runway at the old community site south of Shaktoolik illustrate the importance of a rapid response to collect useful measurements of storm surge elevations. The slush and debris lines clearly visible (a) within a day of the storm (photo by Elmer Bekoalok) were already being obscured by snow (b) less than four days after the event.
