Report of Investigation 2021-1A Nunam Iqua

COASTAL FLOOD IMPACT ASSESSMENTS FOR ALASKA COMMUNITIES—NUNAM IQUA

Richard M. Buzard, Jacquelyn R. Overbeck, and Katie Y. Miller

Published by
STATE OF ALASKA
DEPARTMENT OF NATURAL RESOURCES
DIVISION OF GEOLOGICAL & GEOPHYSICAL SURVEYS
2021

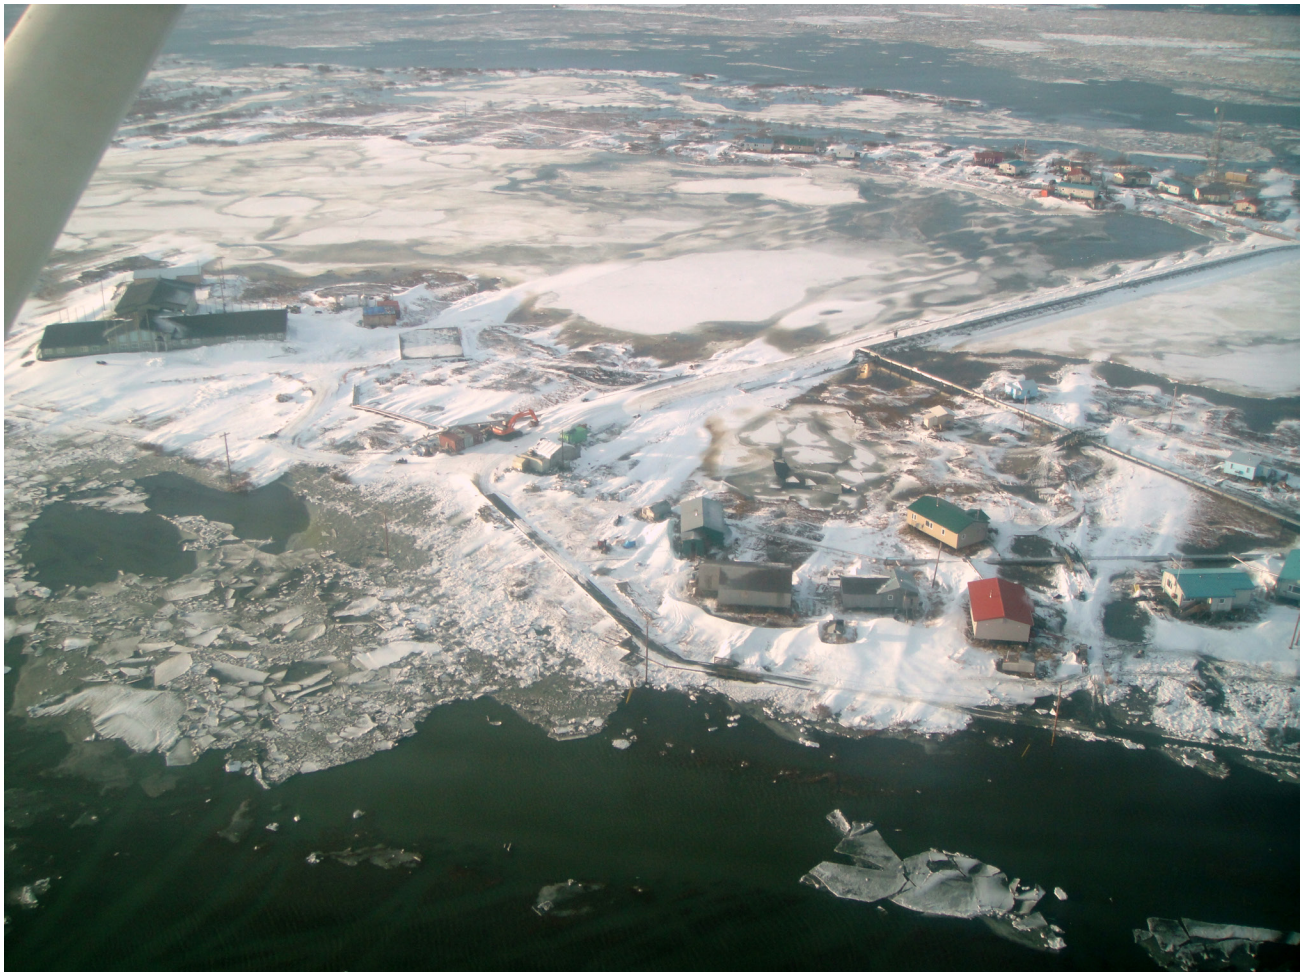
Major flooding during the November 2011 flood. Photo: Alaska Division of Homeland Security & Emergency Management.

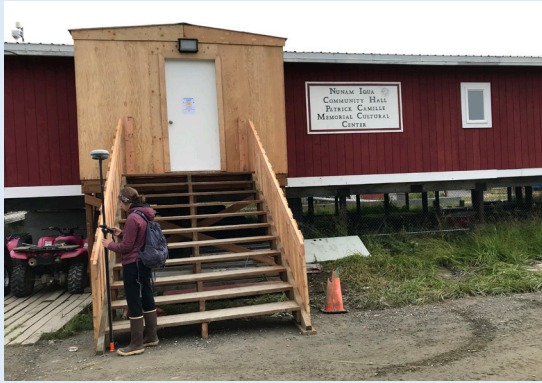
The October 2004 storm caused major impacts (NIAPB, 2008; NOAA, 2004). The freshwater source for drinking water was contaminated with saltwater. The pump itself is 3.5 ± 0.1 ft MHHW (fig. B9), but the depth of water needed to salinate the freshwater source is unknown. Water reached under a home at 4.9 ± 0.1 ft MHHW, but the total height above ground is not known (Carin Finch, oral commun., 2019). Residents drove and parked boats at the steps of Community Hall, so we estimate the water depth to be 2.5 ± 0.5 ft above ground level (Carin Finch, oral commun., 2019). The ground height at the base of the steps is 4.7 ± 0.1 ft MHHW (fig. 1; table B1). Only the Community Hall measurement provides an estimate of maximum flooding, so the estimated still water height is 7.2 ± 0.5 ft MHHW (table 7).

Figure 1. Elevation of the ground at Community Hall. Water was high enough to drive boats but did not reach the first floor.

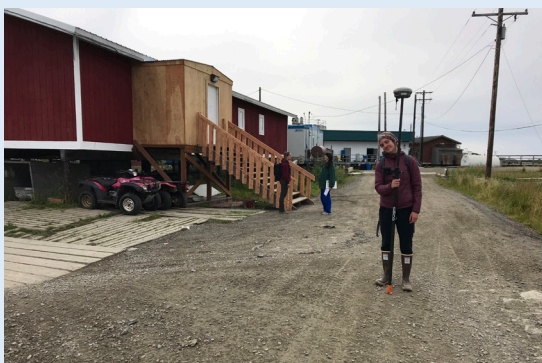
This storm surge surrounded the tank farm and reached Community Hall but caused fewer impacts than the 2004 storm (NIAPB, 2008). The base of the 2019 tank farm embankment is 2.71 ft MHHW (fig. B5E; table B1). We do not know the height water reached above the base. The road in front of Community Hall is 5.1 ± 0.1 ft MHHW (fig. 2; table B1). We estimate water was between 0.5 and 1.5 feet above the road height because residents felt comfortable wading through it (Carin Finch, oral commun., 2019). This is lower than the 2004 flood, consistent with accounts. The September 2005 flood is estimated to have reached 6.1 ± 0.5 ft MHHW (table 8).

Figure 2. Elevation of the crown of the road in front of Community Hall. Water covered the road but was low enough to wade through in the September 2005 flood.

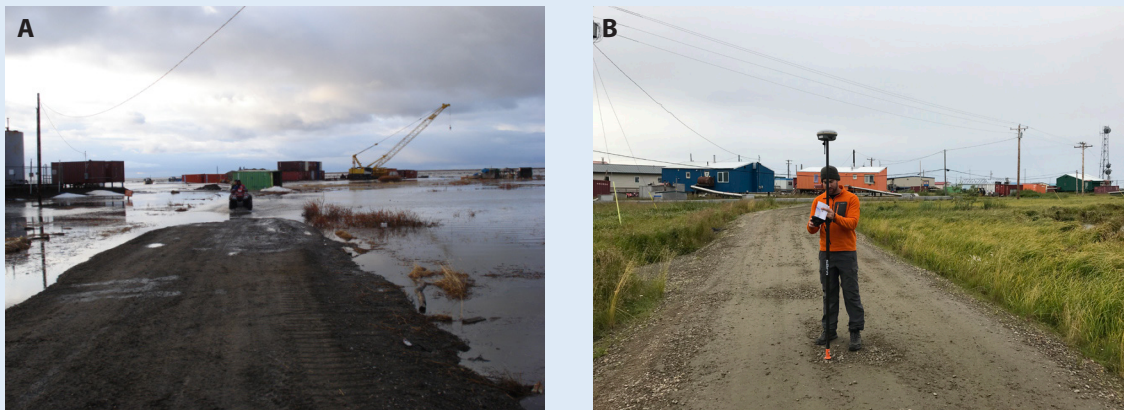
The timing of the spring 2008 flood is considered atypical and thought to be a combination of high tides, setup, and raised river water levels due to ice-jam flooding (NIAPB, 2008). Several images are provided that show the extent of flooding (Carin Finch, oral commun., 2019). The road leading to the tank farm is 4.2 ± 0.1 ft MHHW (table B1) and appeared flooded (fig. 3), whereas the road in front of Community Hall was not flooded (5.1 ± 0.1 ft MHHW; fig. 2). Floodwaters reached the height of the boardwalks on Blackberry Street (fig. 4A). The boardwalks have since been replaced with a higher system, but we measured remnants of the old boardwalks (fig. 4B–D), averaging 2.8 ± 0.1 ft MHHW (table B1). The tank farm was surrounded by water but not flooded. We cannot use the tank farm to estimate the height, because it was replaced before the 2015 DSM. The road to the tank farm serves as the best estimate of a maximum visible still water height. We assume flooding could have reached up to 1 foot (0.5 ± 0.5 ft) above this visible water line to reach 4.7 ± 0.5 ft MHHW (table 9).

Figure 3. **A.** Road to tank farm partially flooded during the spring 2008 flood. Photo: Carin Finch. **B.** Elevation measurement at road crest in 2019. The photos are taken facing opposite directions.

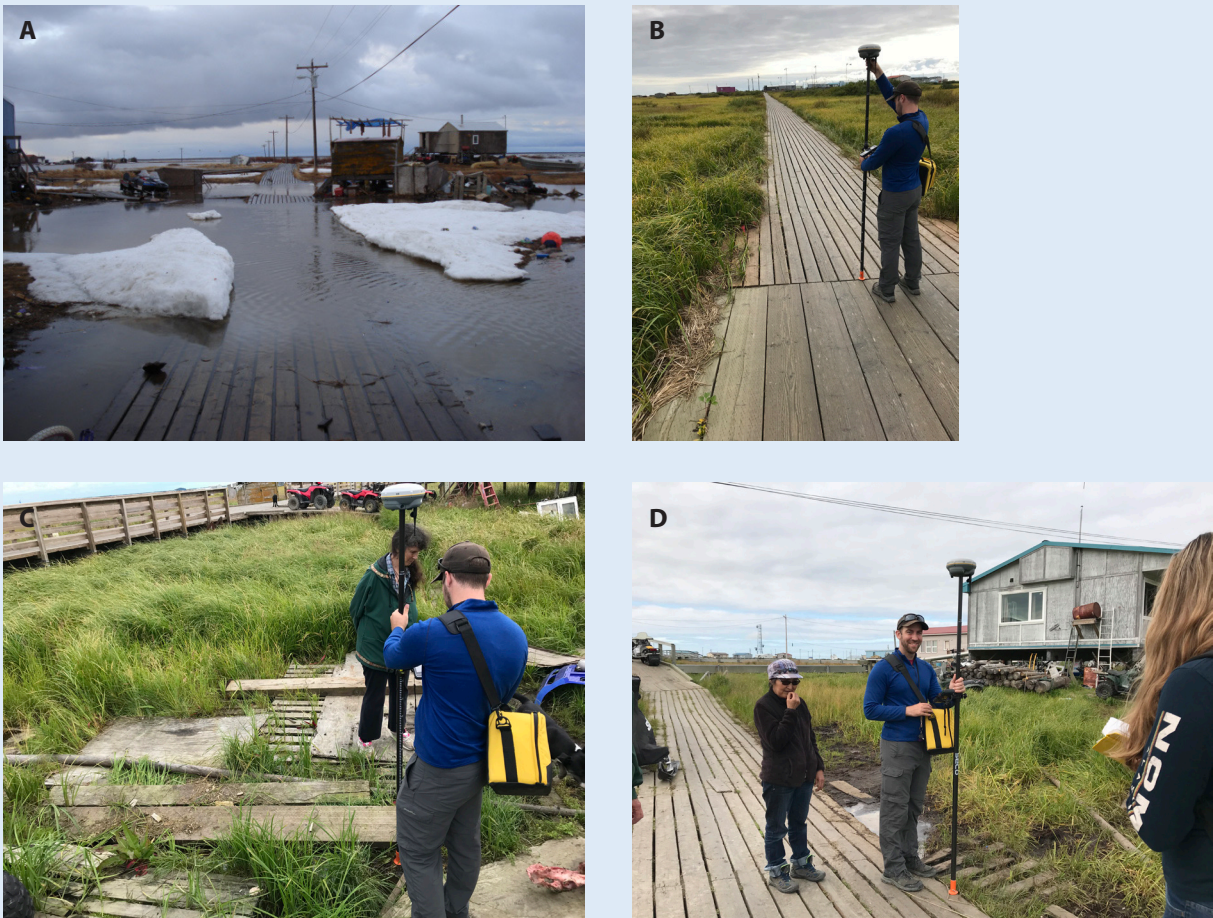
Figure 4. **A.** Flooding of the boardwalks in the Blackberry Subdivision in 2008. Photo: Carin Finch. **B.** Elevation measurement of the old boardwalk north of the subdivision (photo in opposite direction to A). **C, D.** Elevation measurement of old boardwalk in the subdivision.

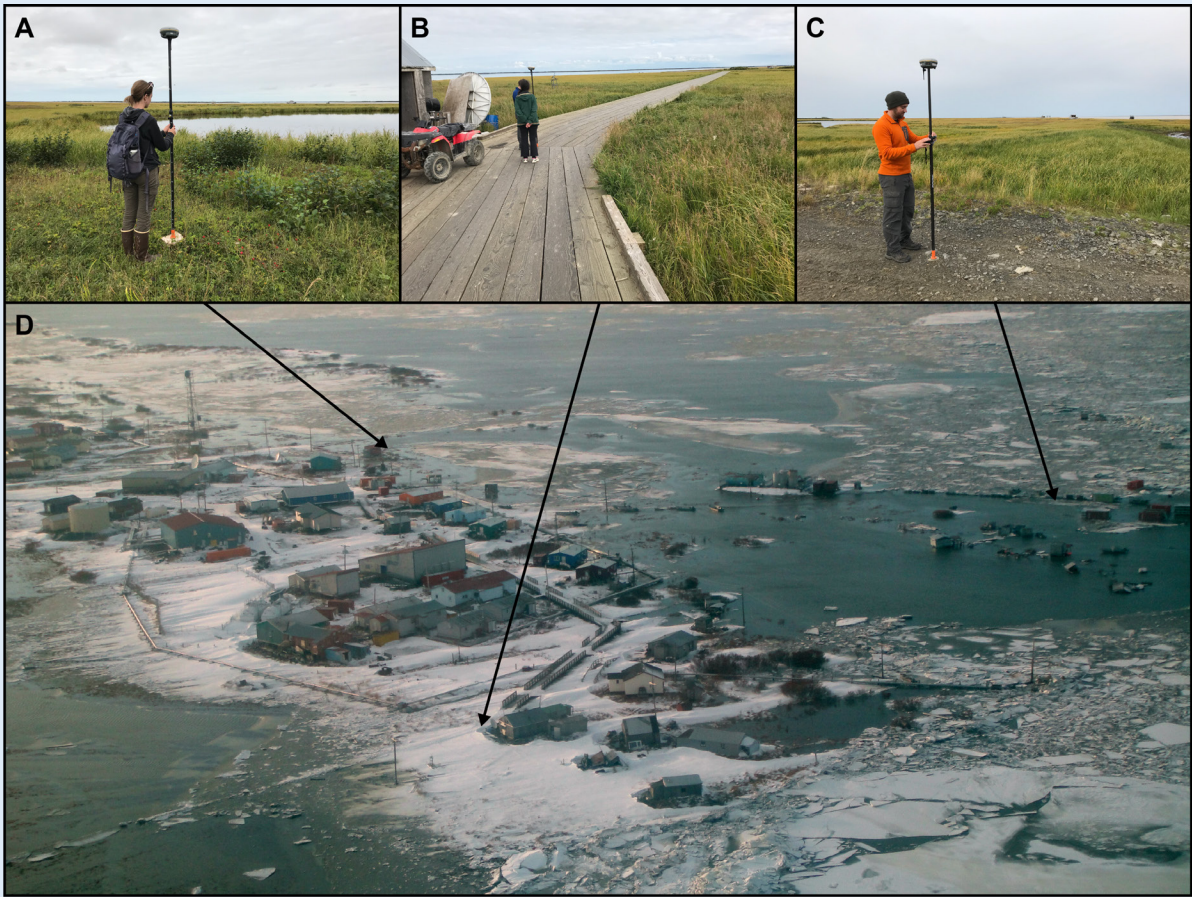
The 2011 storm caused widespread flooding throughout Nunam Iqua, peaking at 3:15 pm local time on November 9th (NOAA, 2011). DHS&EM (unpub. data, 2019) took photos from an airplane that are date-stamped at November 9, 2011, at around 4:45 pm. Given the timing, we assume the photos represent peak flood levels. We compare three GNSS points taken near the visible high water line to estimate the height (fig. 5; table 11). We increase the uncertainty to 0.5 ft to consider that the observation may not be at peak flooding and the GNSS locations may not be directly on the water line. We estimate the November 2011 flood reached 4.1 ± 0.5 ft MHHW.

Figure 5. GNSS measurements (**A**, **B**, and **C**) used to estimate highest water from the November 2011 flood (**D**). **A** and **C** are taken at the high water line, while **B** is above the water. The aerial photo is taken around peak flooding by DHS&EM.

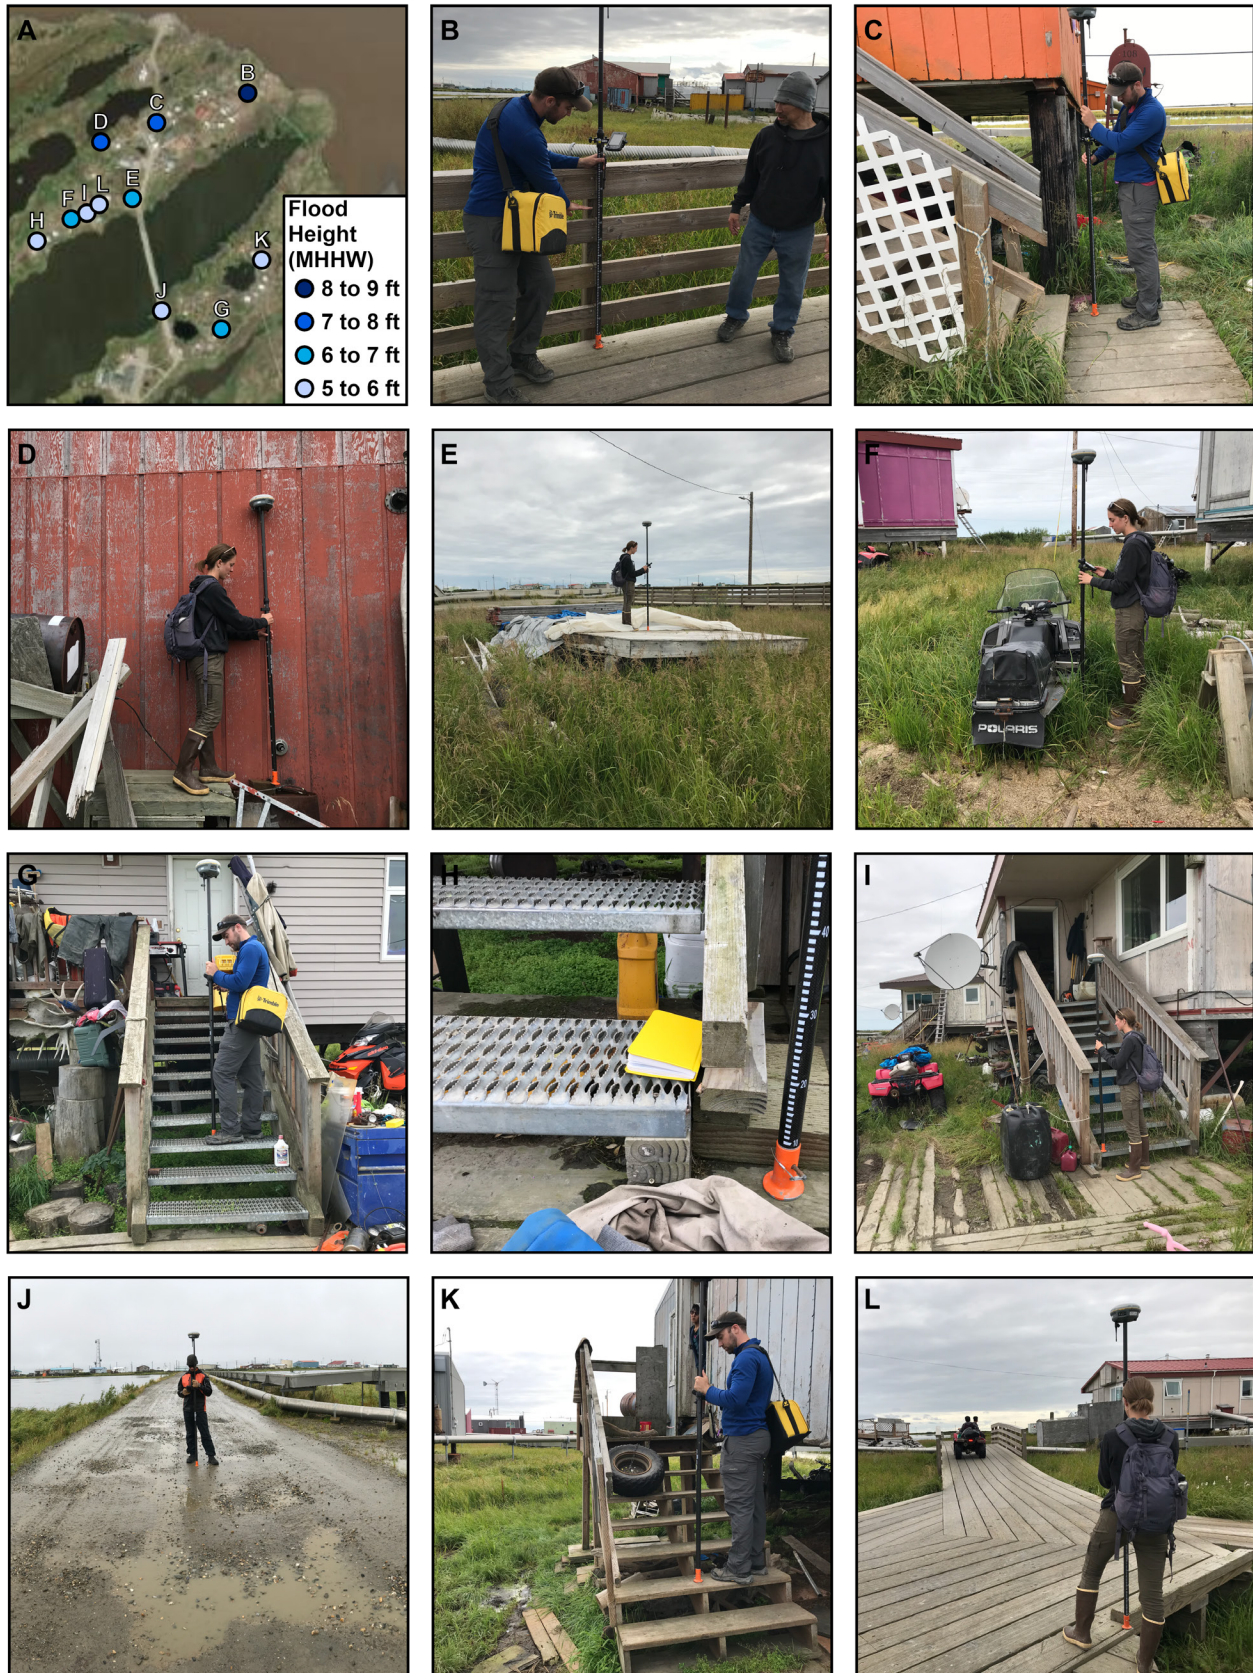
Residences are raised high above the ground and are recommended to be at least 8 feet above mean sea level (MSL), which is 6.8 ft MHHW (USACE, 1993; table 4). Only one residence was flooded in 2013, the highest estimated flood, when water reached 7.2 ± 0.1 ft MHHW (fig. 6D; table 12). This is identified as the lowest residence by NIAPB (2017).

The 2013 storm reached the highest water level in memory, possibly even higher than in 1972 (NIAPB, 2017). Floodwaters washed away four major boardwalks, portions of the road to the barge landing, and displaced solid waste from the dump site (NIAPB, 2017). We spoke with residents and measured observed peak flood heights with GNSS (table 12; fig. 6). The highest flood estimate is 8.5 ± 1.0 ft MHHW. Flooding reached between 7 and 8.5 ft MHHW along the north section of the community closest to the coast. Flood water indicators were at least 5.5 ft MHHW in all other parts of town. The November 2013 storm is estimated to have reached 8.5 ± 1.0 ft MHHW. See Other Flood Information section for a discussion on this storm surge flood event.

Figure 6. GNSS measurements used to estimate highest water from the November 2013 storm. Panel A shows a map where the GNSS points (B to L) are collected, along with the estimated flood height. The flood was between 7 and 9 ft MHHW in the north (B to D) and 5 to 7 ft MHHW elsewhere.

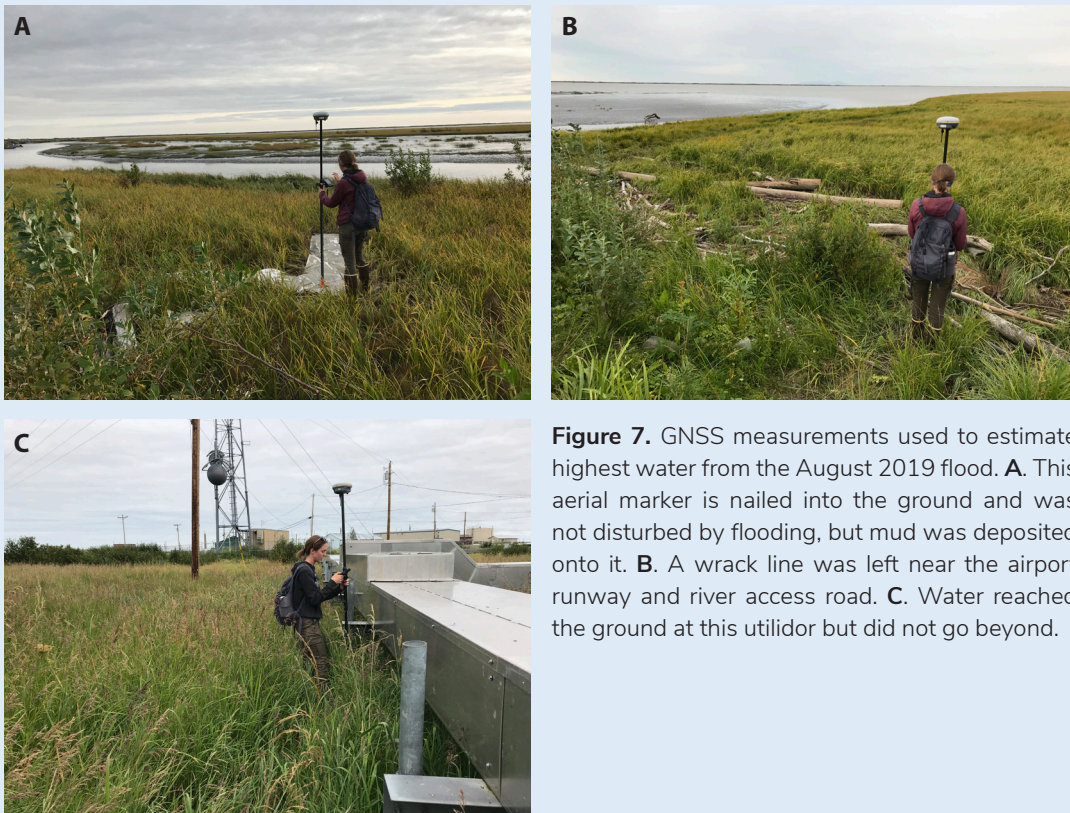
Figure 7. GNSS measurements used to estimate highest water from the August 2019 flood. **A.** This aerial marker is nailed into the ground and was not disturbed by flooding, but mud was deposited onto it. **B.** A wrack line was left near the airport runway and river access road. **C.** Water reached the ground at this utilidor but did not go beyond.

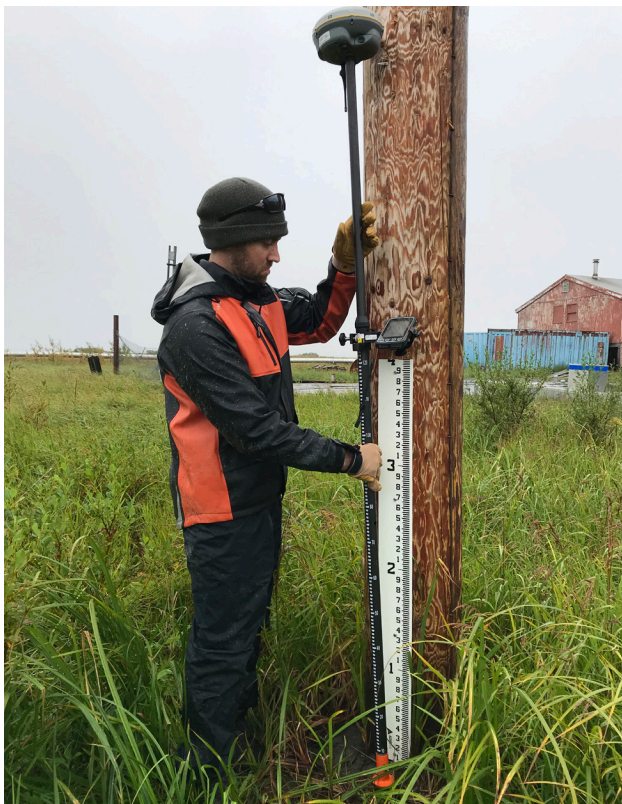
Figure 8. Flood staff on power pole northeast of the old school, in a field by the old basketball court. The 0 mark on the staff is 3.9 ft MHHW (table B1).

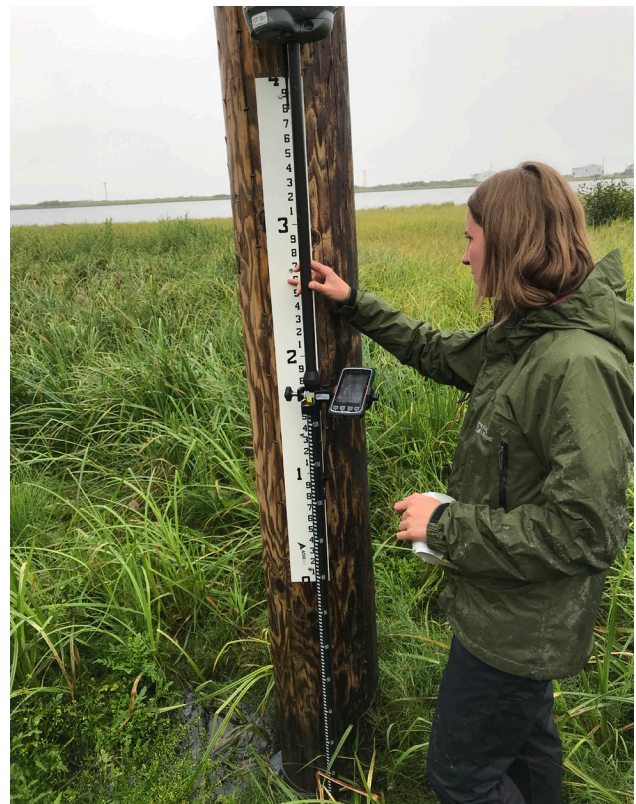
Figure 9. Flood staff on power pole northwest of the current school, between the school and Swan Lake. The 0 mark on the staff is 5.0 ft MHHW (table B1).

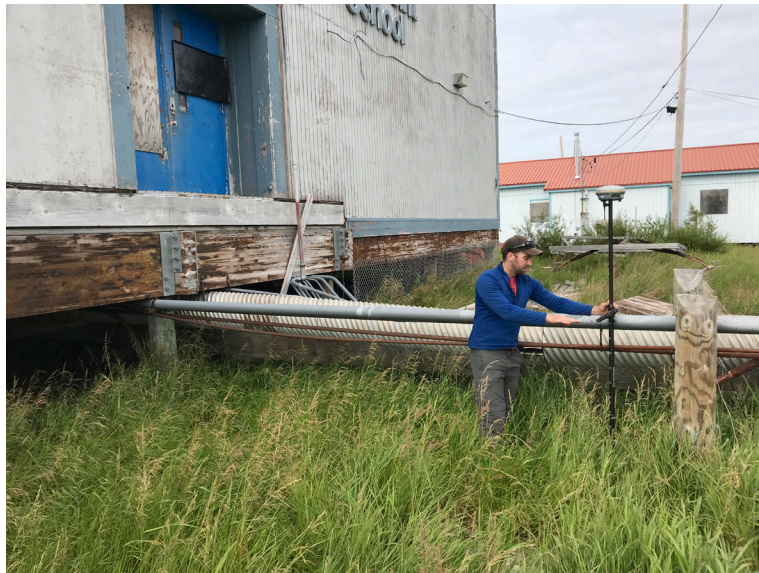
Figure B1. The elevation of the abandoned high school grate is measured to compare with the survey by USACE (1993). The GNSS receiver could not get adequate satellite coverage at the grating, so the height of this level pipe above is measured, and the height between the pipe and the grating is added to get the height of the grating. The elevation of the ground surveyed in the photo is 5.41 ft MHHW (3.63 ± 0.04 m NAVD88). The top of the pipe is 4.20 ft (1.28 m) above the ground. The grating is 3.44 ft (1.05 m) above the pipe. We estimate this method has a vertical uncertainty of 0.13 ft (0.04 m) in addition to the 0.10 ft (0.03 m) uncertainty from GNSS. Using the RSS, this makes the height of the grating 13.1 ± 0.1 ft MHHW (5.96 ± 0.05 m NAVD88).

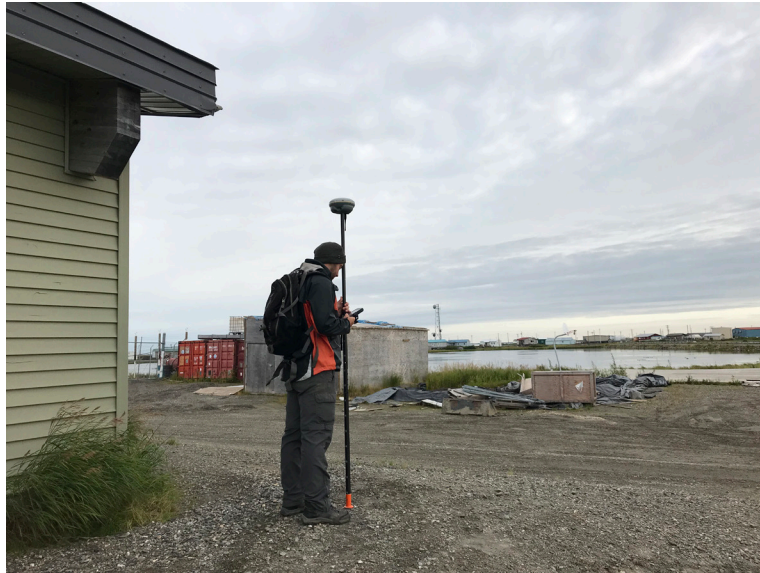
Figure B2. Elevation point measured at the northeast corner of the school.

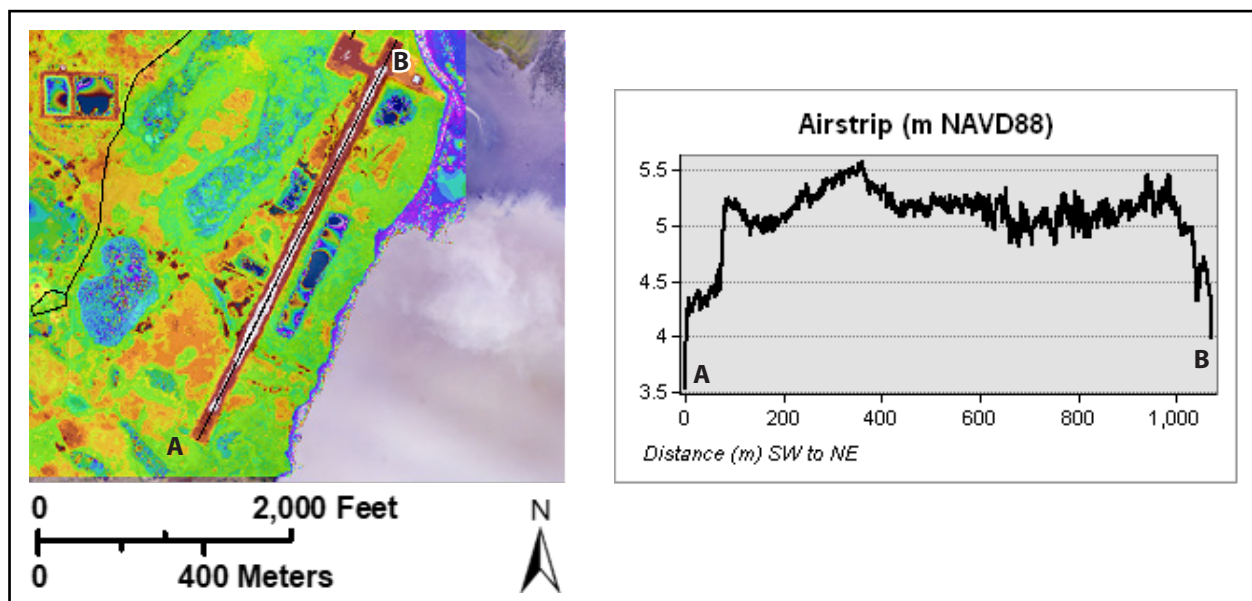
Figure B3. (Left) Elevation map of airstrip with cold colors representing low elevation and hot colors high elevation displayed over imagery. The long brown and white feature is the airport runway with a black elevation profile line drawn down the center. (Right) Elevation profile of airstrip shows mean height of 10.5 ± 1.1 ft MHHW (5.17 ± 0.33 m NAVD88) in the section before the drop-offs at either end.

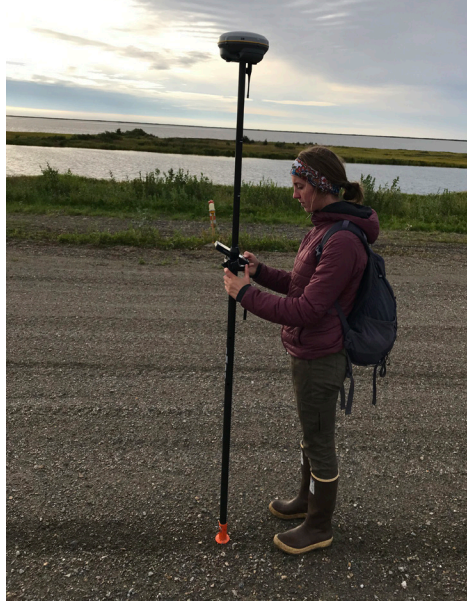
Figure B4. Elevation of highest visible point on airport runway.

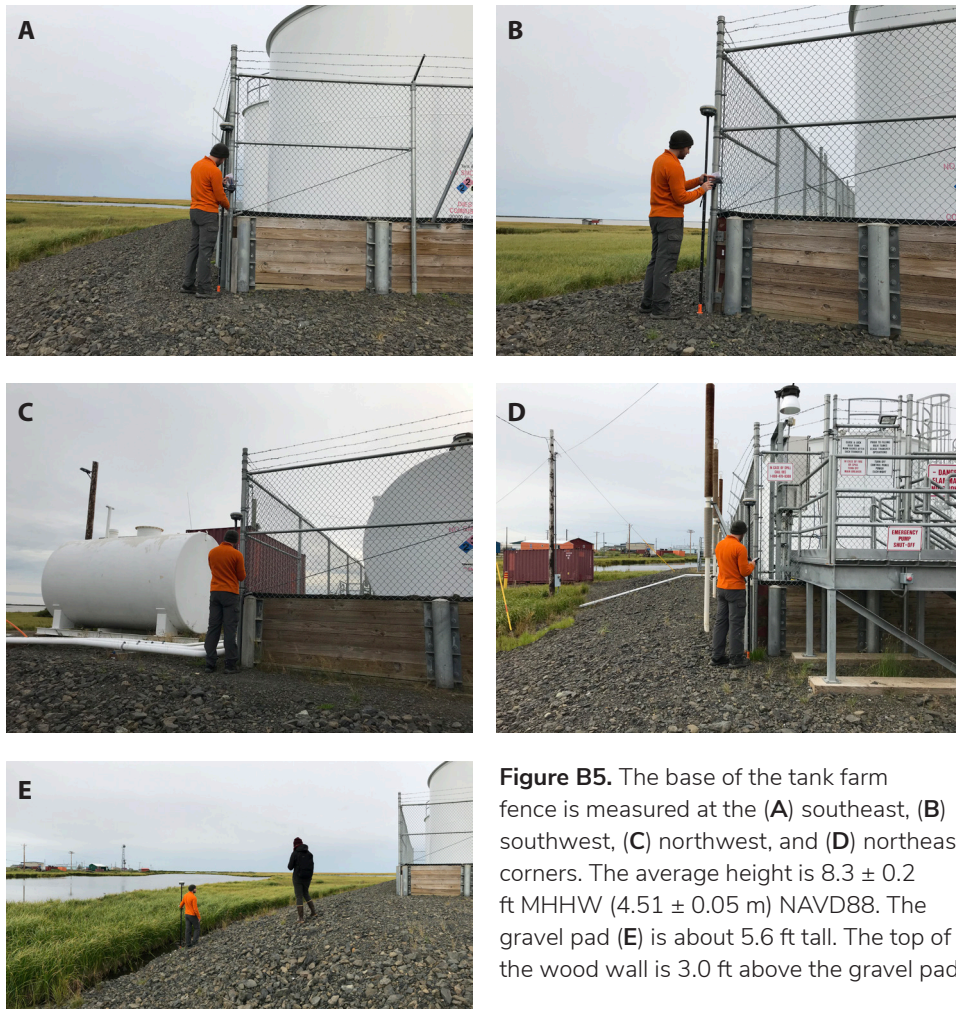
No sources cite damage to the fuel tanks. The tank farm was remodeled after the 2006 community profile map (DCRA, 2006) and sits on a raised gravel pad. The ground at the four corners averages 8.3 ± 0.2 ft MHHW (fig. B5). The wood barrier is 3.0 ft above the ground. Fuel lines and facilities are on the ground outside the fence, so the average ground height is considered the major flooding indicator.

Figure B5. The base of the tank farm fence is measured at the (A) southeast, (B) southwest, (C) northwest, and (D) northeast corners. The average height is 8.3 ± 0.2 ft MHHW (4.51 ± 0.05 m) NAVD88. The gravel pad (E) is about 5.6 ft tall. The top of the wood wall is 3.0 ft above the gravel pad.

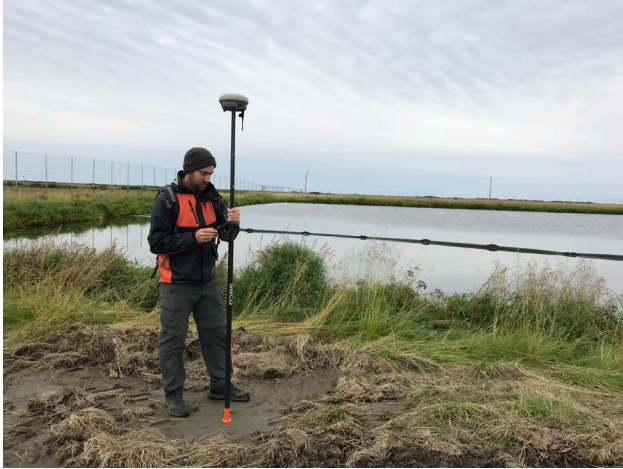
Figure B6. The low point on the east side of the wastewater lagoon boundary where water can travel into the lagoon.

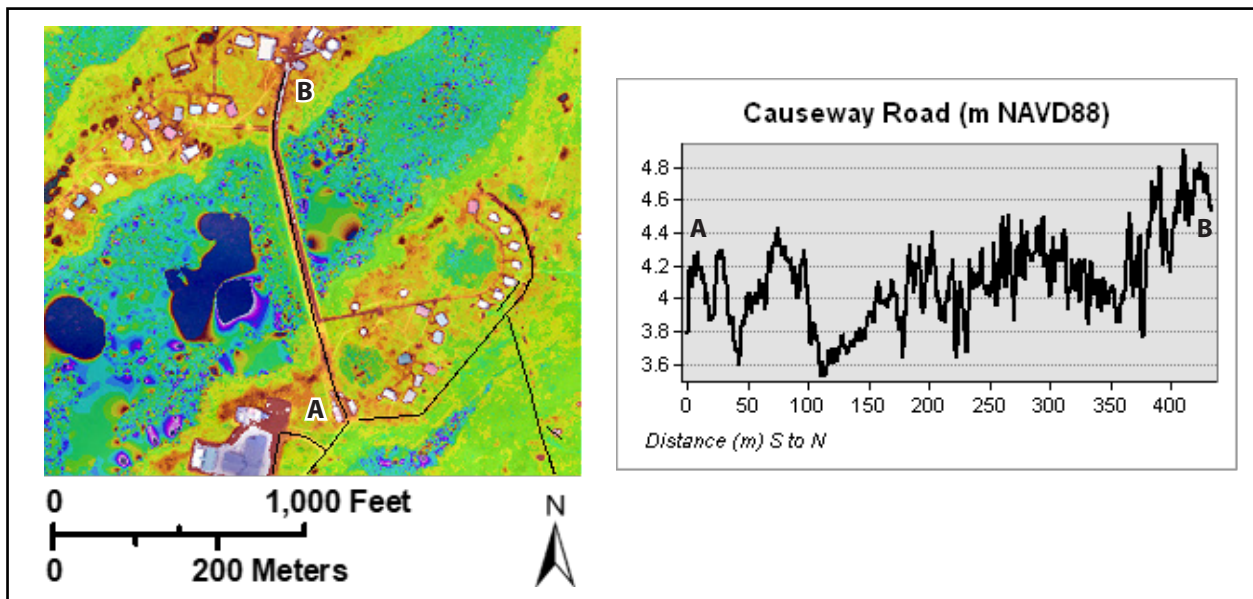
The Causeway Road connects vital community resources. Its lowest section averages 6.8 ± 1.3 ft MHHW (fig. B8). Part of the road washed out during the November 2013 storm (Carin Finch, oral commun., 2019).

Figure B8. (Left) Elevation map of Causeway Road shows lower section in the south. The raised portion on the east side of the road is a water line. (Right) Elevation profile of the road shows that the majority of the road is 6.8 ± 1.3 ft MHHW (4.04 ± 0.41 m NAVD88).

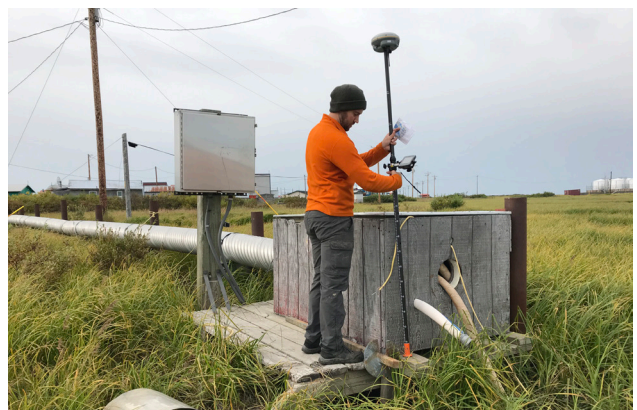
The drinking water intake pump platform is at 3.5 ± 0.1 ft MHHW and at risk of erosion (fig. B9; USACE, 2009). Disaster declarations for the 2004 and 2011 storms (7.2 ± 0.5 ft and 4.1 ± 0.5 ft MHHW; table 1) involved loss of drinking water (NIAPB, 2017). Based on observed impacts, the 2011 storm height is used to identify this flooding indicator.

Figure B9. The water intake pump platform is 3.5 ± 0.1 ft above MHHW (4.04 ± 0.04 m NAVD88).

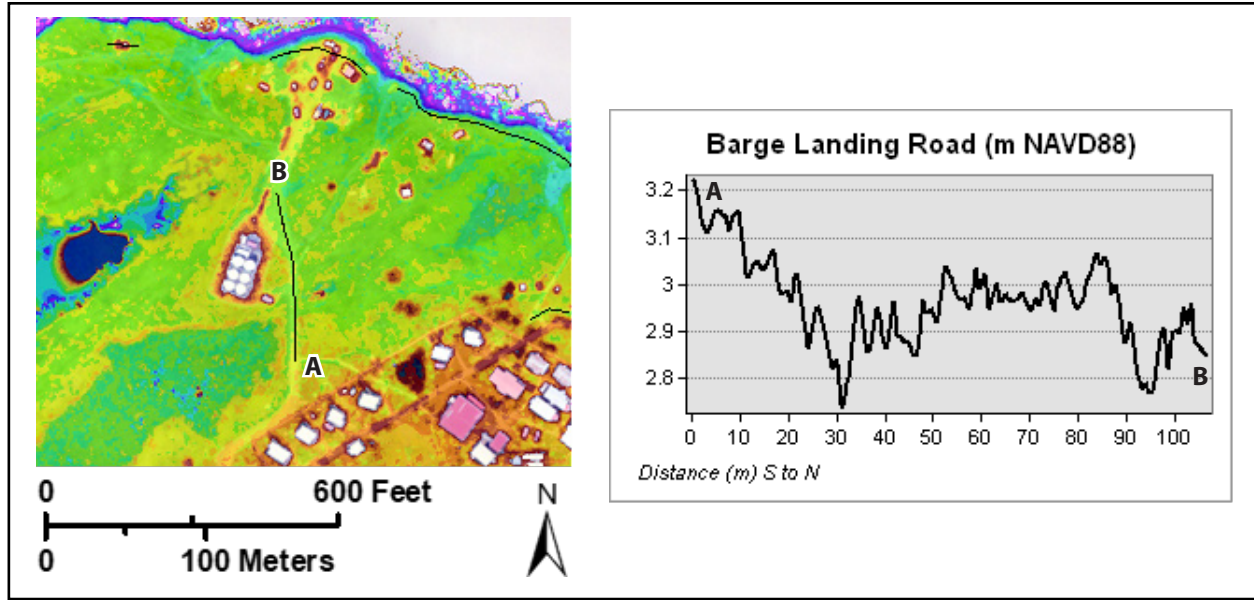
Figure B10. (Left) Elevation model showing lowest section of only road to barge landing and fuel tanks in green. (Right) Elevation profile of road averages 3.2 ± 0.5 ft MHHW (2.94 ± 0.15 m NAVD88).

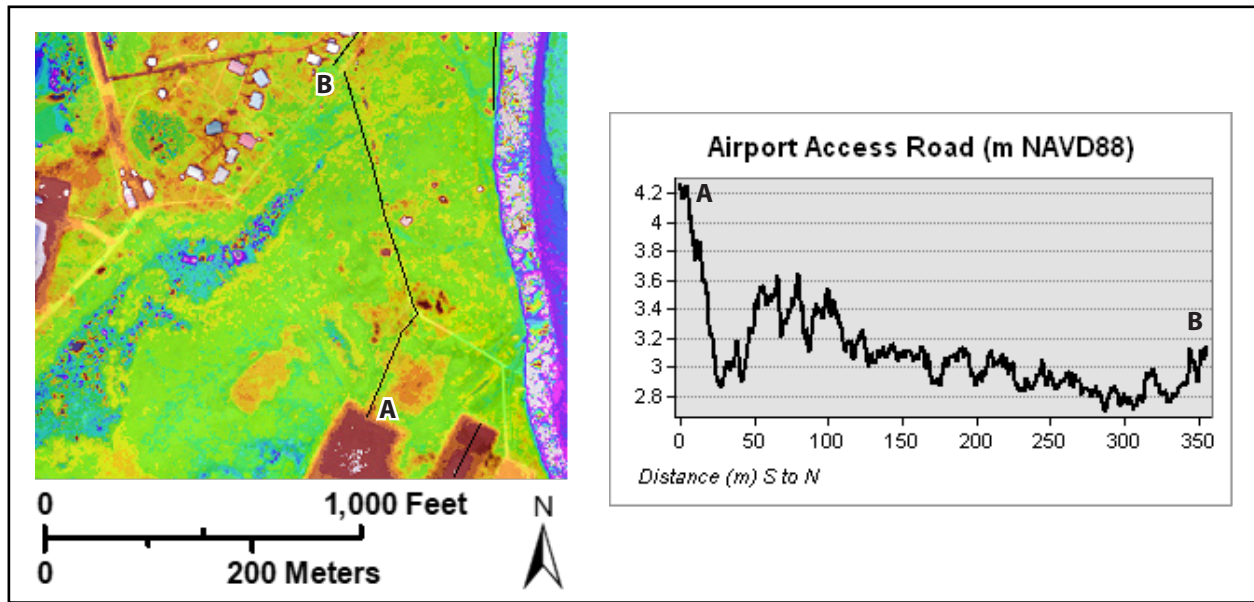
Figure B11. (Left) elevation map with access boardwalk to airstrip annotated in black. (Right) elevation profile shows that the boardwalk is 3.5 ± 1.3 ft MHHW (3.1 ± 0.4 m NAVD88).

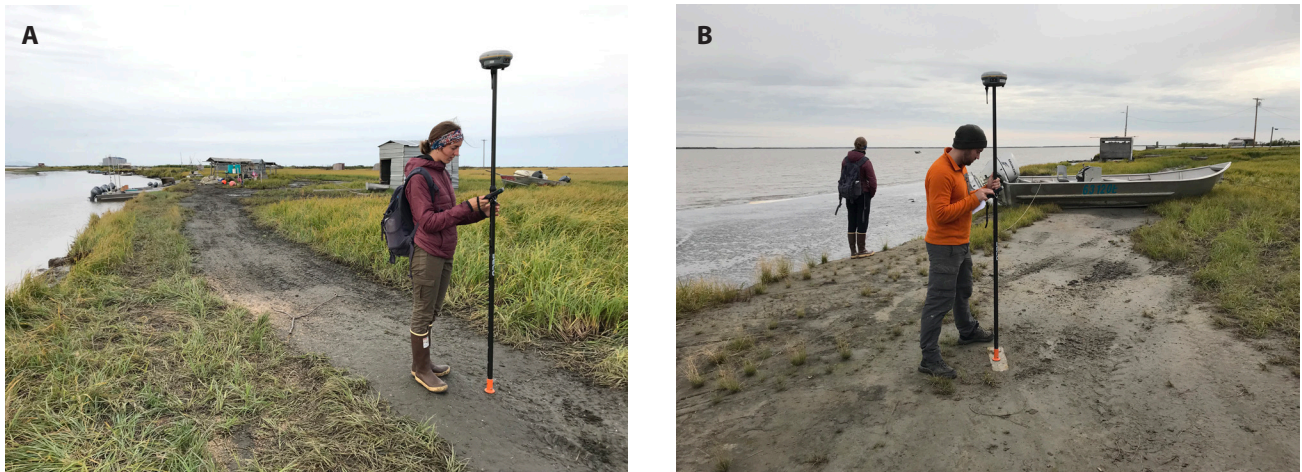
Figure B12. Ground elevations near the riverbank on the north shore (A) and the east slough (B) average 2.1 ± 0.1 ft MHHW (2.61 ± 0.04 m NAVD88).
