COASTAL FLOOD IMPACT ASSESSMENTS FOR ALASKA COMMUNITIES—KOTLIK

Richard M. Buzard, Jacquelyn R. Overbeck, Marvin M. Turner, and Jessica E. Christian

Report of Investigation 2021-1C Kotlik

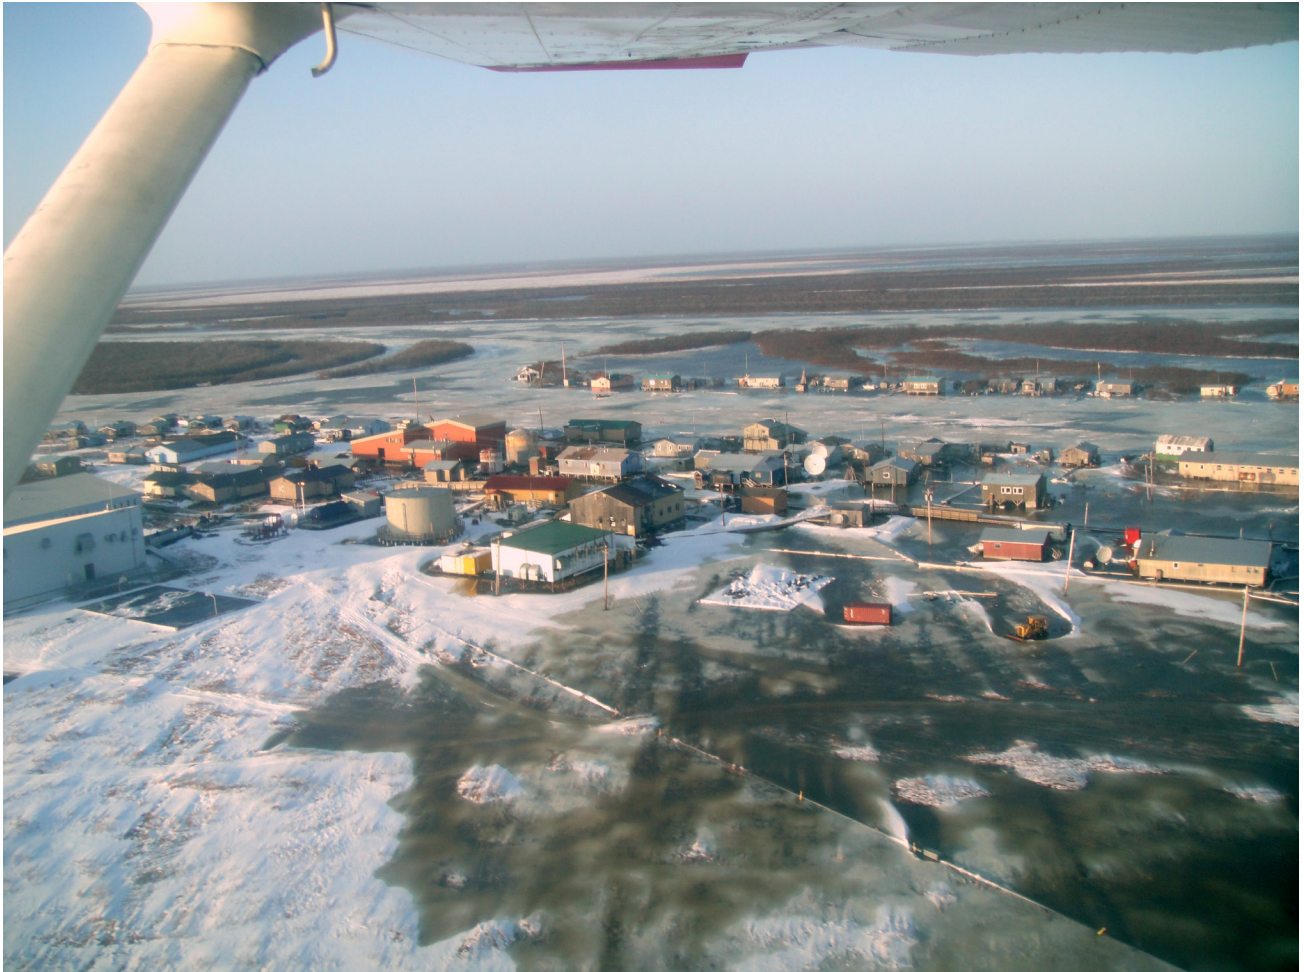
Photo from plane looking at flooding in Kotlik during the November 2011 storm. Photo: Alaska Division of Homeland Security & Emergency Management.

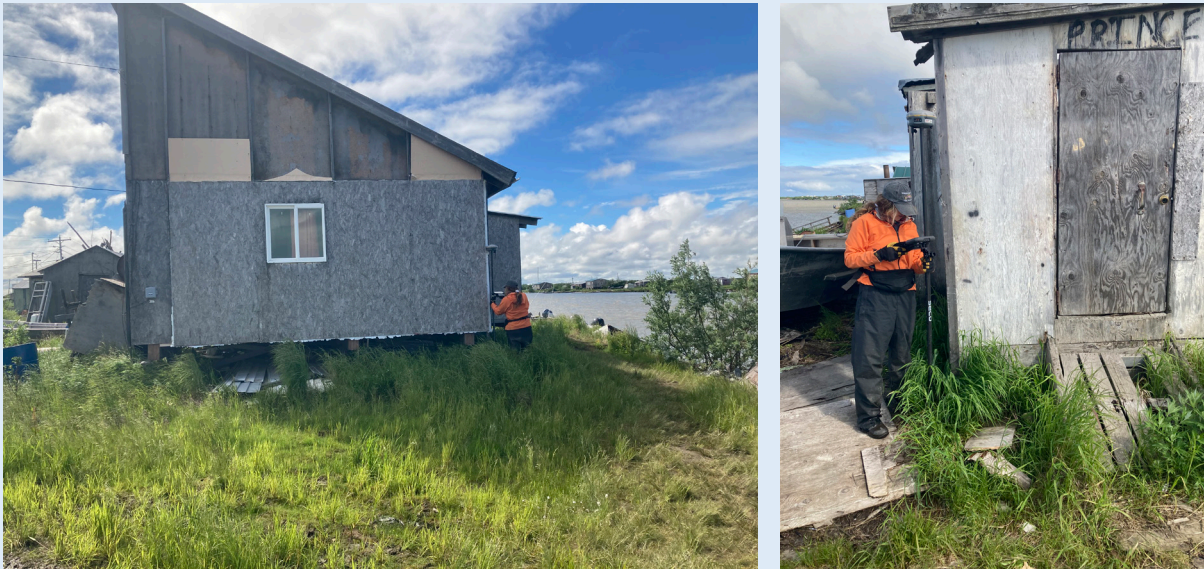
BMS (oral commun., 2021) identified two structures from this period that were not raised or renovated. The doorsill of the old clinic is 5.7 ± 0.1 ft MHHW (table B2; fig. 1). In the residential area frequently flooded, the doorsill of one house is 5.7 ± 0.1 ft MHHW (table B2; fig. 1). These buildings were relatively high off the ground for this time period. Given only six homes were flooded, we assume water reached 0.5 ± 1.0 ft of above the doorsill height. The spring 1964 flood estimate is 6.2 ± 1.0 ft MHHW (table 5). This is consistent with the observation of the flood reaching 6 feet above the normal high water line.

Figure 1. GNSS floor measurements of the old clinic (left) and a residence from the 1970s (right).

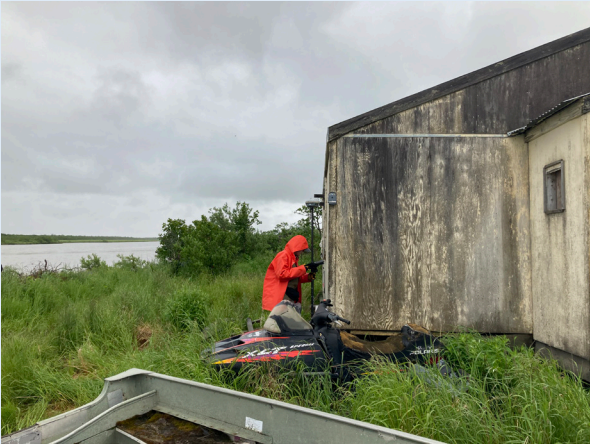
The November 1975 storm caused 3 ft of flooding, damaging fish camps and flooding 5 homes (USACE, 1982). BMS (oral commun., 2021) identified the area where homes were flooded in the 1975 aerial image. One home remains (the rest eroded). The ground at this home is 3.1 ± 0.1 ft MHHW (table B2; fig. 2) and the first-floor height is 5.0 ft MHHW (CRW, unpub. data, 2021). Flooding of 2 ft would begin to enter the home. We add 2.5 ± 1.0 ft of water to estimate the November 1975 flood reached 5.6 ± 1.0 ft MHHW (table 6).

Figure 2. GNSS measurement of ground at residence from the 1970s.

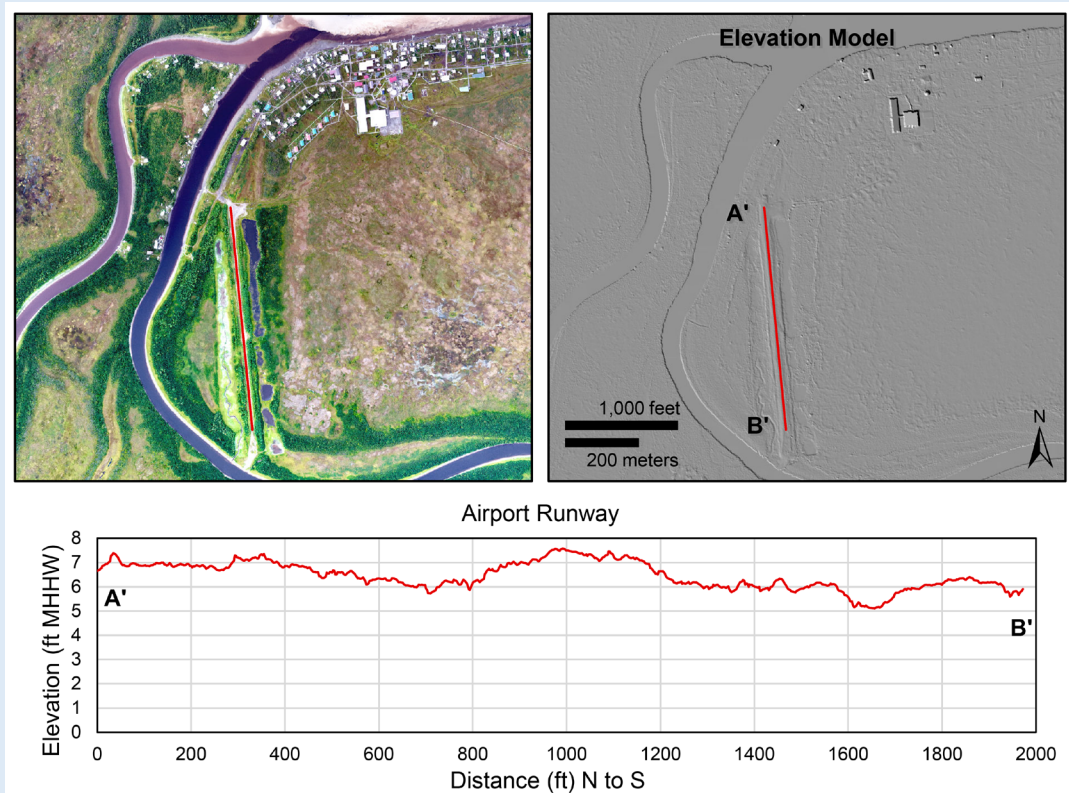
runway averages 6.5 ± 1.1 ft MHHW (fig. 3), and the new runway averages 5.4 ± 1.1 ft MHHW (fig. B3). BMS (oral commun., 2021) explains that flood water has never entered the teen center. The ground at the teen center is 3.1 ft MHHW and the floor is 6.8 ± 0.1 ft MHHW (table B2; fig. 4). Given these observations, water likely reached as high as 2.0 ± 1.0 ft above the teen center ground height. We estimate the October 1987 flood reached 5.1 ± 1.0 ft MHHW (table 8).

Figure 3. (Top) Image and elevation model (DTM hillshade) of the old airport runway. The elevation profile (red line) drawn on the image is graphed below. The average height is 6.5 ft MHHW (standard deviation = 0.6 ft).

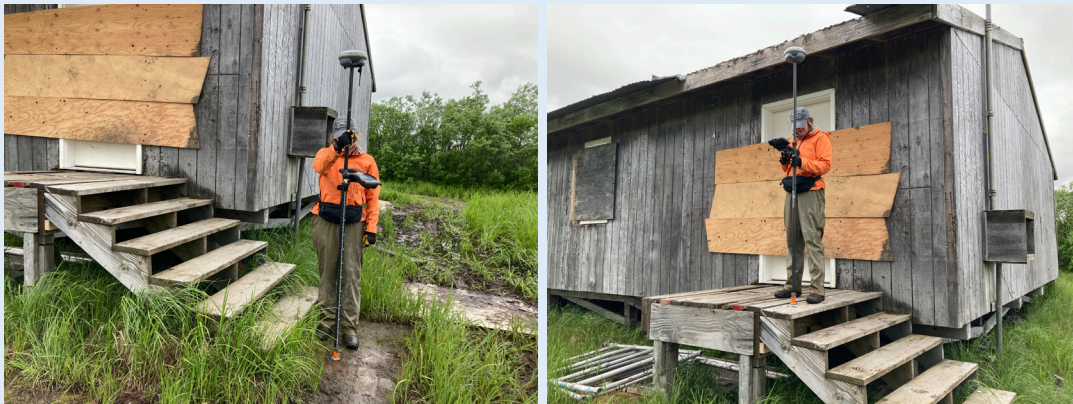
Figure 4. GNSS measurements of teen center ground (left) and porch (right).

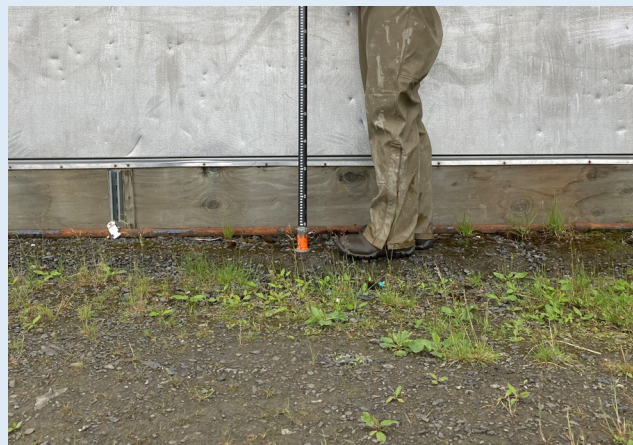
The October 18, 2004, storm flooded several communities in the Yukon-Kuskokwim Delta, Norton Sound, and Kotzebue Sound (NOAA, 2004). In Kotlik, water surrounded the school and reached the bottom of the skirting (NOAA, 2004; BMS, oral commun., 2021). The skirting around the school is 5.7 ± 0.1 ft MHHW (table B2; fig. 5). We include 0.5 ft uncertainty for the water level observation to estimate the October 2004 storm reached 5.7 ± 0.5 ft MHHW.

While water reached the school skirting, it appeared to not reach as high in other parts of the community. NOAA (2004) explain that "ocean water rose two to three feet and floated boardwalks off their supports." In photos taken during the flood, grass tops are clearly visible, there are no high water lines on structures, and water appears calm and about 1 ft above the ground. The storm passed through Kotlik before Nome, where it peaked around 11:00 AM AKDT on October 19 (water level data accessible from tidesandcurrents.noaa.gov/waterlevels.html?id=9468756). The photos in Kotlik are likely taken after the peak and water levels have receded. Still, it seems water was 1 to 2 ft lower around the rest of the community.

Figure 5. GNSS measurement of the metal skirting placed around the school base.

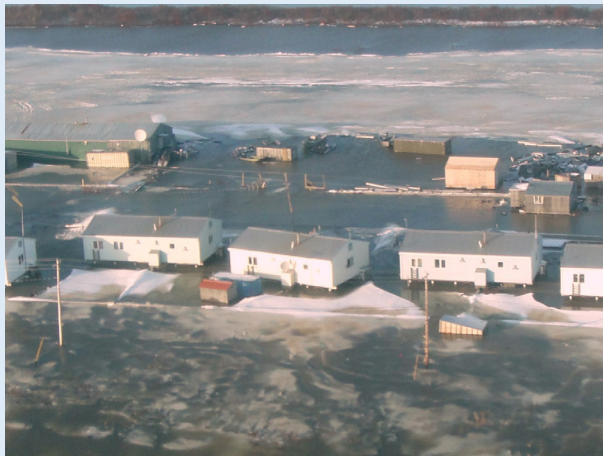
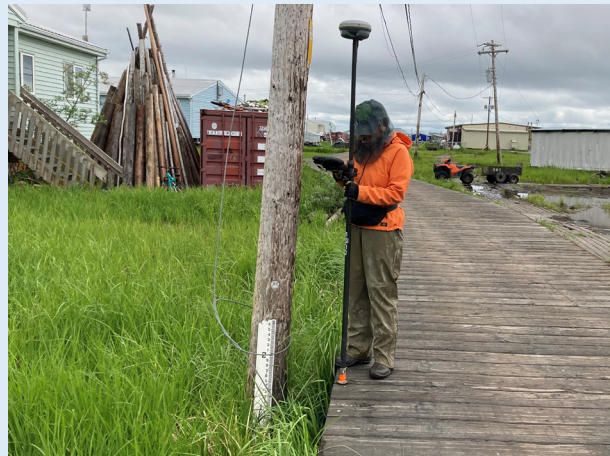
The November 2011 storm caused major flooding in several western Alaska communities (NOAA, 2011). In Kotlik, flooding peaked on November 9th at 11:30 AM AKST (NOAA, 2011). The Division of Homeland & Security Management (DHS&EM, unpub. data, 2019) acquired aerial photographs of Kotlik on November 9th around 4:00 PM. Although the photos are 4 hours past peak flooding, water remains underneath most structures in town and surrounds the old and new runways. Floodwater crossed between the town and sewage lagoon but did not appear to reach the school or inland behind the school. The only damage reported was to the teen center foundation, city storage shed contents, and one shop. We found no record of flood water entering the teen center (BMS, oral commun., 2021) The ground at the teen center is 3.1 ft MHHW and the floor is 6.8 ft MHHW (table B2; fig. 4). The aerial photos show water is below the boardwalk at the flood staff (4.2 ± 0.1 ft MHHW; table B2; fig. 6). We estimate the November 2011 flood reached 3.6 ± 0.7 ft MHHW (table 12).

Figure 6. (Left) Photo from plane taken 4.5 hours after peak flooding in Kotlik. Water is below the boardwalk by the telephone pole where the flood staff is installed. (Right) GNNS measurement of boardwalk by the flood staff.

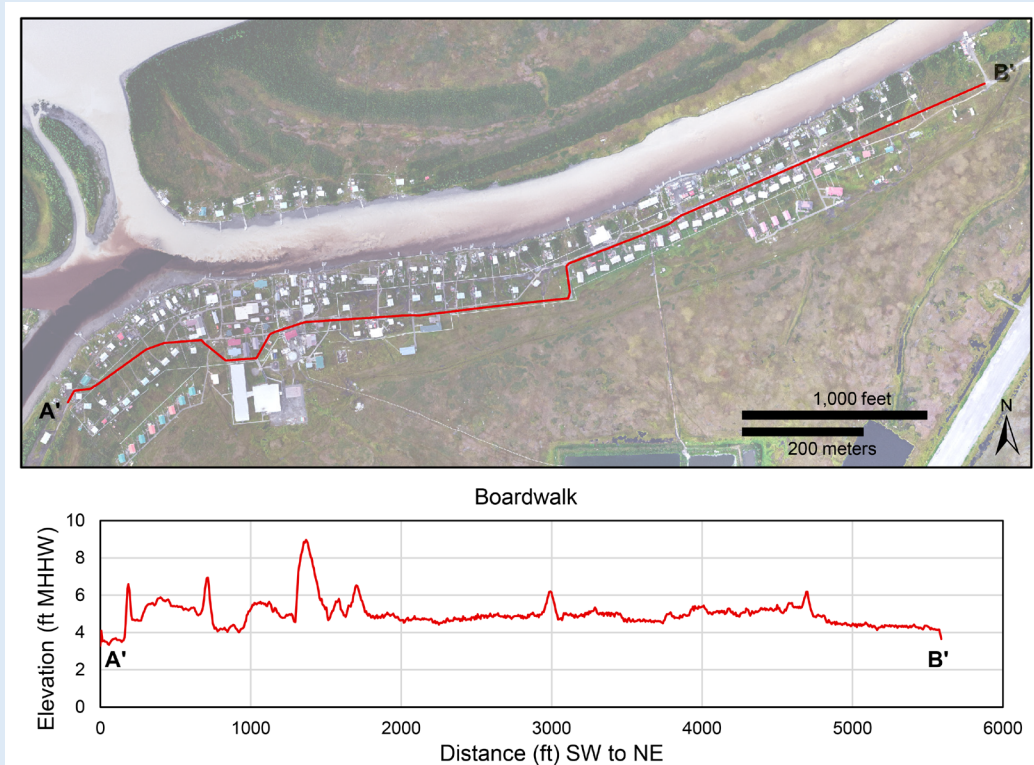
The main boardwalk had 1.5 ± 0.5 ft of water during peak flooding (FEMA and DHS&EM, 2014). The boardwalk averages 5.0 ± 1.4 ft MHHW (fig. 7), so the water level is 6.5 ± 1.5 ft MHHW (using the RSS error of uncertainties). BMS (oral commun., 2021) identified one structure where water reached 1.2 ± 0.3 ft inside. The porch height is 5.2 ± 0.1 ft MHHW and approximately equal to the inner floor height (table B2; fig. 8). The water height estimate is 6.4 ± 0.3 ft MHHW. These heights agree and are consistent with accounts, so we use the average and root-mean-square error of uncertainties to estimate the November 2013 flood reached 6.4 ± 1.1 ft MHHW.

Figure 7. Elevation of the main, elevated boardwalk through Kotlik. Elevation extracted from the 2021 DSM.

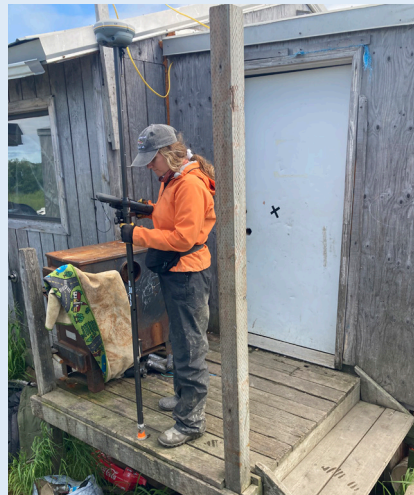
By our estimates, the 2013 flood was the third highest in Kotlik's history, and a total of five floods have reached similar or higher levels since 1964. The 2013 flood caused the most damage because there is more infrastructure in Kotlik than when the previous record floods occurred.

Figure 8. The November 2013 flood exceeded this porch step.

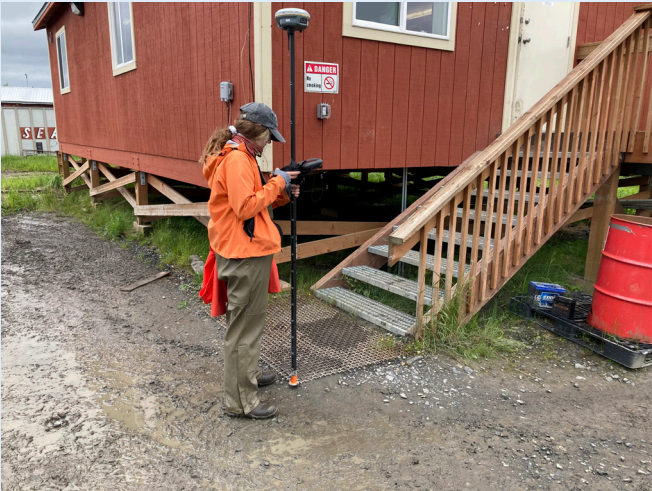
The November 21, 2017, storm caused flooding from Bristol Bay to Norton Sound (AIJ, 2017a). In Kotlik, water exceeded the riverbank (2.2 ± 0.6 ft MHHW) at 8:30 PM and peaked around 11:30 PM (AIJ, 2017a). Water, blocked by snowbanks, did not go inland far enough to reach the flood staff (2.6 ± 0.1 ft MHHW). Water surrounded the new building near the tank farm (AIJ, 2017a). The ground height at this building is 3.7 ± 0.1 ft MHHW (table B2; fig. 9). Water appears to be just above the 4 x 4 block supports resting on the ground underneath the vertical supports (AIJ, 2017a). We assume this is near the peak water level and estimate water is 0.6 ± 0.5 ft above the ground. We estimate the November 21, 2017, flood reached 4.3 ± 0.5 ft MHHW (table 14).

Figure 9. GNSS measurement of ground at new building by tank farm where water was pictured underneath.

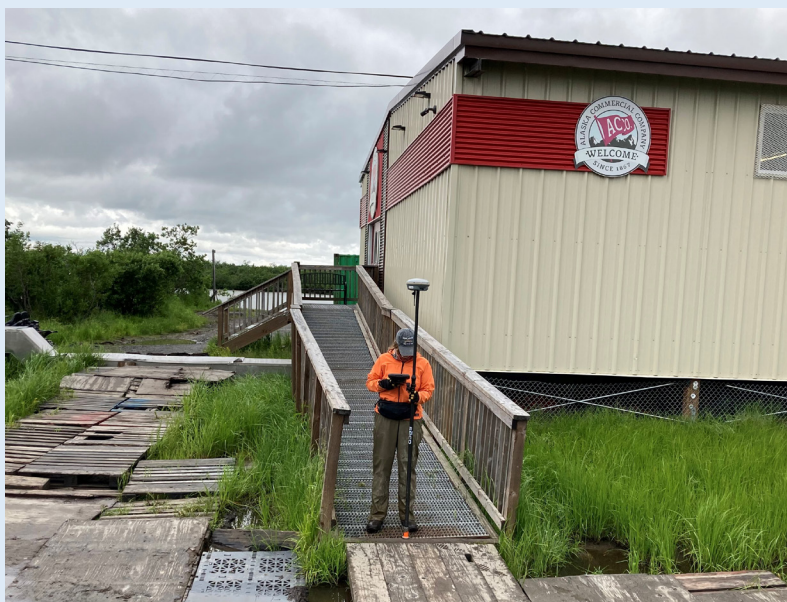
The December 2017 storm caused flooding in the Yukon-Kuskokwim Delta (AIJ, 2017b). In Kotlik, water exceeded the riverbank (2.2 ± 0.6 ft MHHW) and reached the lower boardwalks by the Alaska Commercial store. The top of the boardwalk and base of the ramp at the store is 2.8 ± 0.1 ft MHHW (table B2; fig. 10). We estimate that the December 2017 flood reached halfway between the riverbank and the ramp, 2.5 ± 0.6 ft MHHW.

Figure 10. GNSS measurement of the base of the ramp at the Alaska Commercial store.

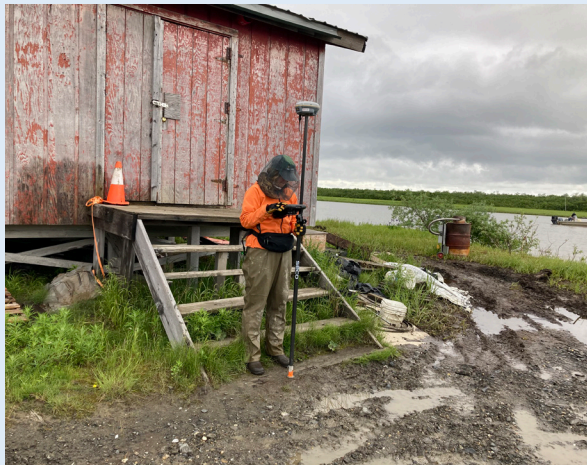
Figure 11. GNSS measurement of step where March 2019 flood reached.

The March 2019 storm caused minor flooding in Kotlik, reaching similar heights as on February 28, 2019 (AIJ, 2019b). At the Nome tide gage, the storm surge reached a similar height as the two February 2019 storms. BMS (oral commun., 2021) identified a porch step near the tank farm where water peaked at 3.0 ± 0.1 ft MHHW (table B2; fig. 11). This height is consistent with AIJ (2019b) accounts that no buildings were flooded, and the coastal flood advisory predicted water reaching between 2 and 4 ft above the normal high tide. We increase uncertainty to 0.5 to account for possible variations in flood level throughout the community. We estimate the March 2019 flood reached 3.0 ± 0.5 ft MHHW.

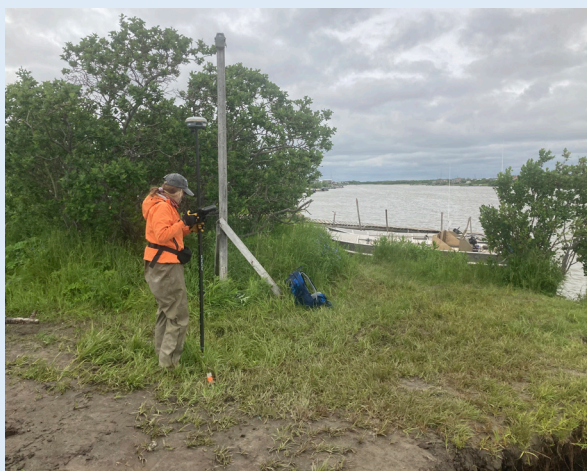
Figure 12. GNSS measurement of flooded ground near erosion camera.

The July 2019 storm caused minor flooding in Kotlik. Photos taken near peak flooding show water reaching the ramp of the new tank farm building's west ramp where the railing begins. This is 3.3 ± 0.2 ft MHHW as measured from the 2021 DSM. In a second photo taken near the center of town where DGGS has installed an erosion monitoring camera, we estimate 0.5 ± 0.3 ft of water covers the ground. We measured the ground height with GNSS (table B2; fig. 12) to find a water level estimate of 3.4 ± 0.3 ft MHHW. We use the average of these calculations (and RSS of uncertainty) to estimate the July 2019 flood reached 3.4 ± 0.5 ft MHHW.

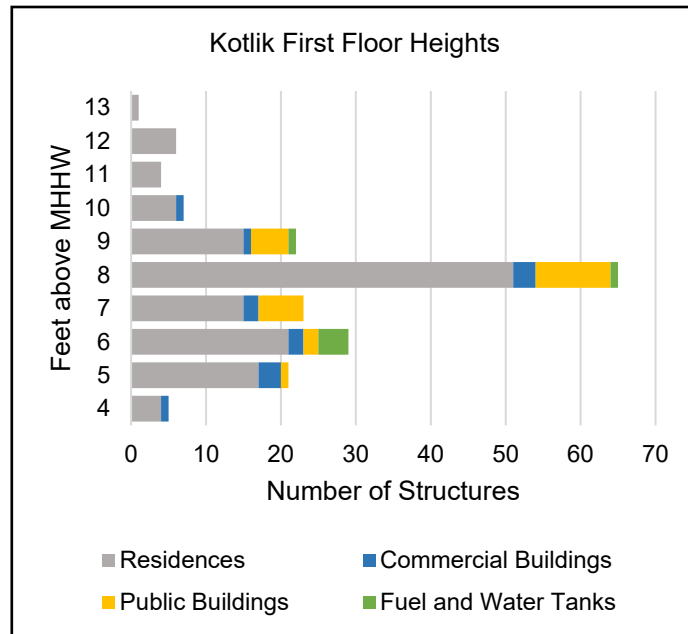
Figure B1. Histogram of building first-floor elevations in Kotlik. Most structures are at or above 8 ft MHHW.

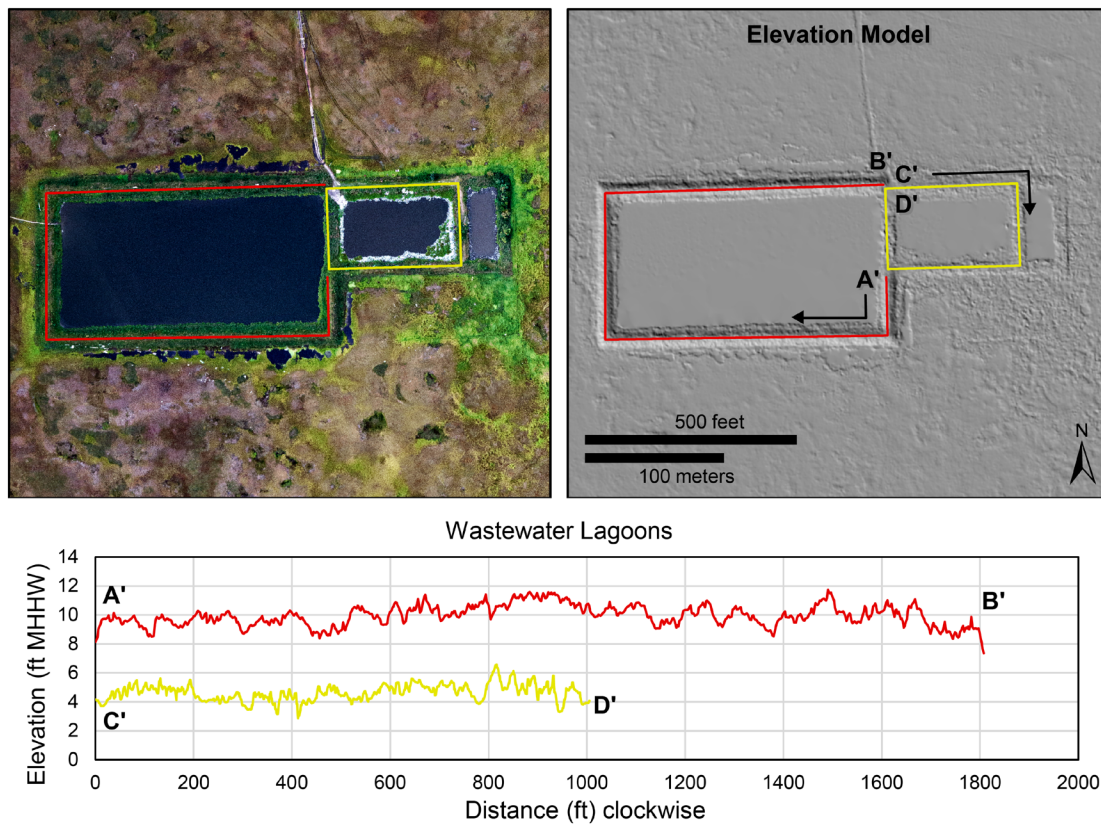
The wastewater lagoon has three sections. The hauled waste lagoon barrier averages 4.6 ± 1.1 ft MHHW (fig. B2). The larger lagoon, where wastewater is piped in, has a barrier averaging 10.0 ± 1.4 ft MHHW as well as a fence to help contain material (fig. B2). Floods overtopping the lower lagoon have the potential to spread effluent into town. However, floods reaching near 4.6 ft MHHW have only caused minor to moderate impacts, and we found no reports of the lagoon being breached. The 2013 flood (6.4 ± 1.1 ft MHHW) is the only reported event to have breached the lagoon. The lagoon is approximately 1500 ft from the riverbank, so floods may be slightly lower this far inland than at the riverbank where most of Kotlik is situated. We estimate water reaching 1.0 ± 0.5 ft above the barrier height can begin to contaminate floodwaters. This is 5.6 ± 1.2 ft MHHW, using the root-sum-square (RSS) error of uncertainties.

Figure B2. Kotlik's west wastewater lagoon (red) receives wastewater from the water treatment plant via pipe. The east lagoon (yellow) receives untreated hauled waste. Both have berms and cyclone fence reaching approximately 5 feet above the berm. Elevation profiles drawn on DTM show the west lagoon berm ranges between 8 and 12 ft MHHW. The east lagoon berm ranges between 3 and 6 ft MHHW.

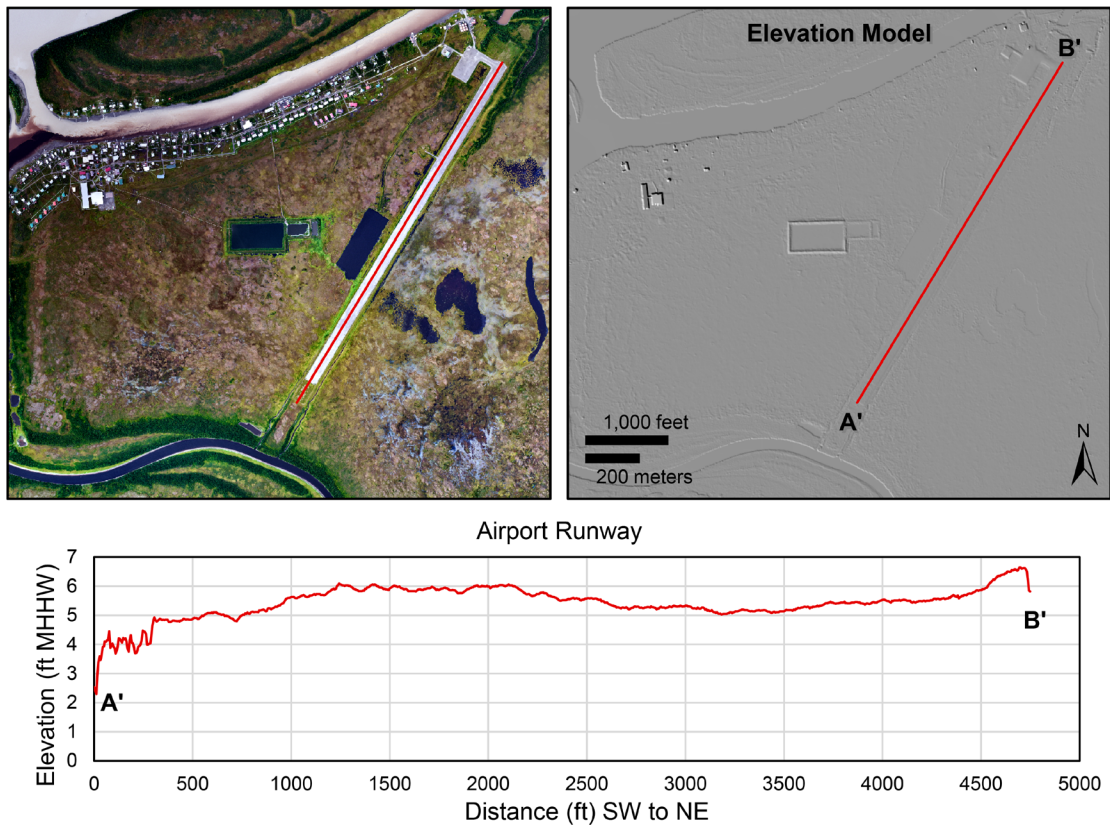
Figure B3. Elevation profile drawn on DTM shows the airport runway ranges between 5 and 7 ft MHHW.

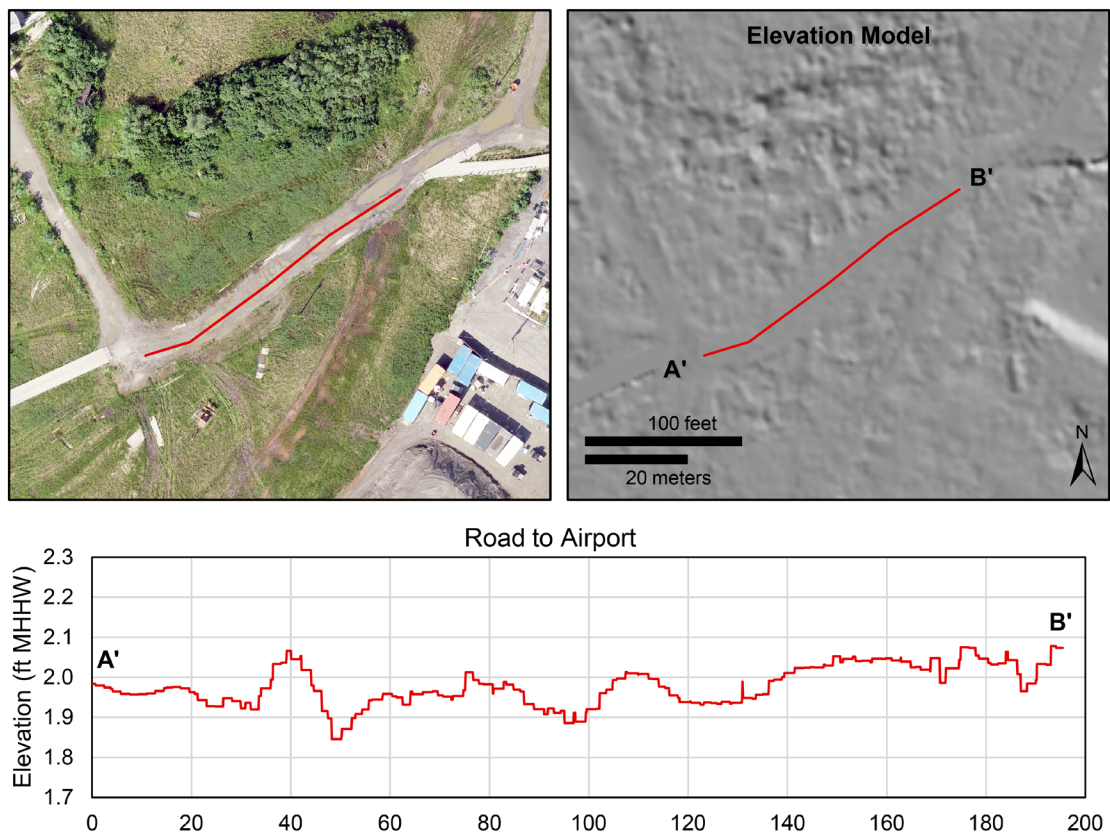
The May 2009 ice jam flood caused minor flooding in Kotlik (NOAA, 2009). The roads near the new airport were covered with water but were passable, and no homes were flooded. The average road height in the low section between the boardwalk and the airport averages 2.0 ± 0.1 ft MHHW (fig. B4). Water was likely 1.0 ± 0.5 ft above the low section of road in order to be covered but passable with a four-wheeler. We estimate the May 2009 flood reached 3.0 ± 0.5 ft MHHW (table 11).

Figure B4. (Top) Image and elevation model (DTM hillshade) of the lowest section of road between the boardwalk system and the airport in Kotlik. The elevation profile (red line) drawn on the image is graphed below. The average height is 2.0 ft MHHW (standard deviation = 0.05 ft).

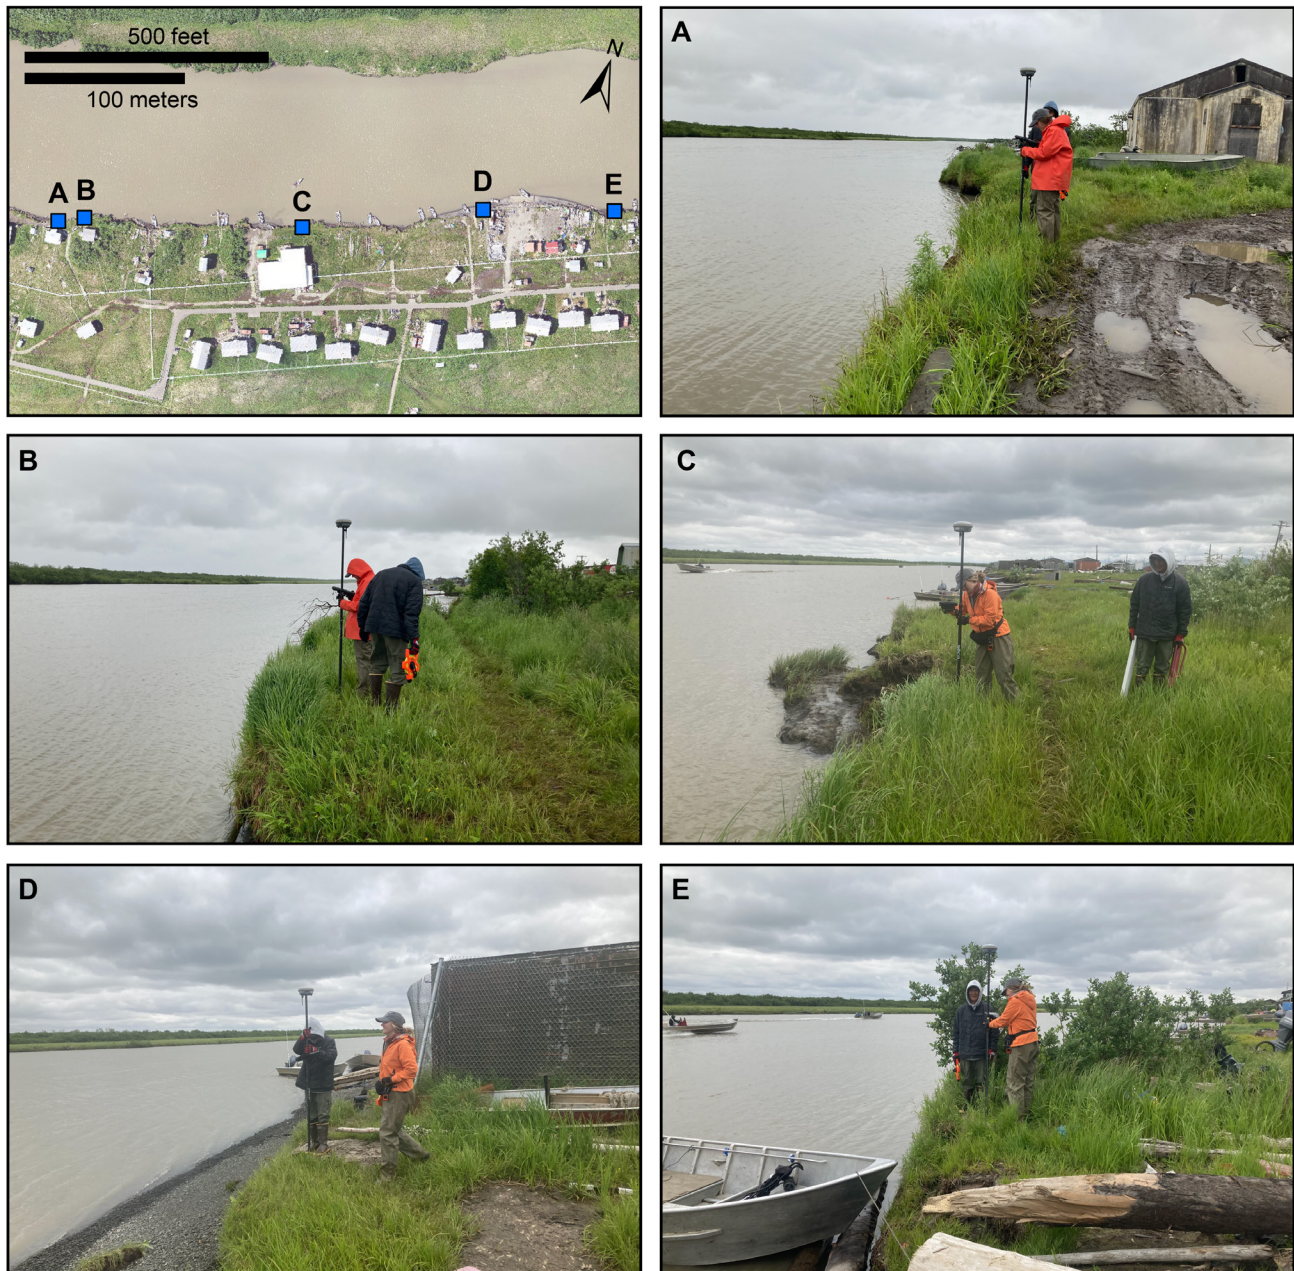
Boats, fishing equipment, and property left on the ground are the most common damages during minor flood events. Water exceeding the riverbank can cause damage this property, especially if there is high flow, debris, or broken sea ice. The riverbank is 2.2 ± 0.6 ft MHHW (table B2; fig. B5).

Figure B5. GNSS measurements used to estimate riverbank height are taken around the Alaska Commercial store. The first panel shows a map of measurement locations with labels corresponding to the following panel photos.
