COASTAL FLOOD IMPACT ASSESSMENTS FOR ALASKA COMMUNITIES—HOOPER BAY

Report of Investigation 2021-1F Hooper Bay

State of Alaska
Department of Natural Resources
Division of Geological & Geophysical Surveys

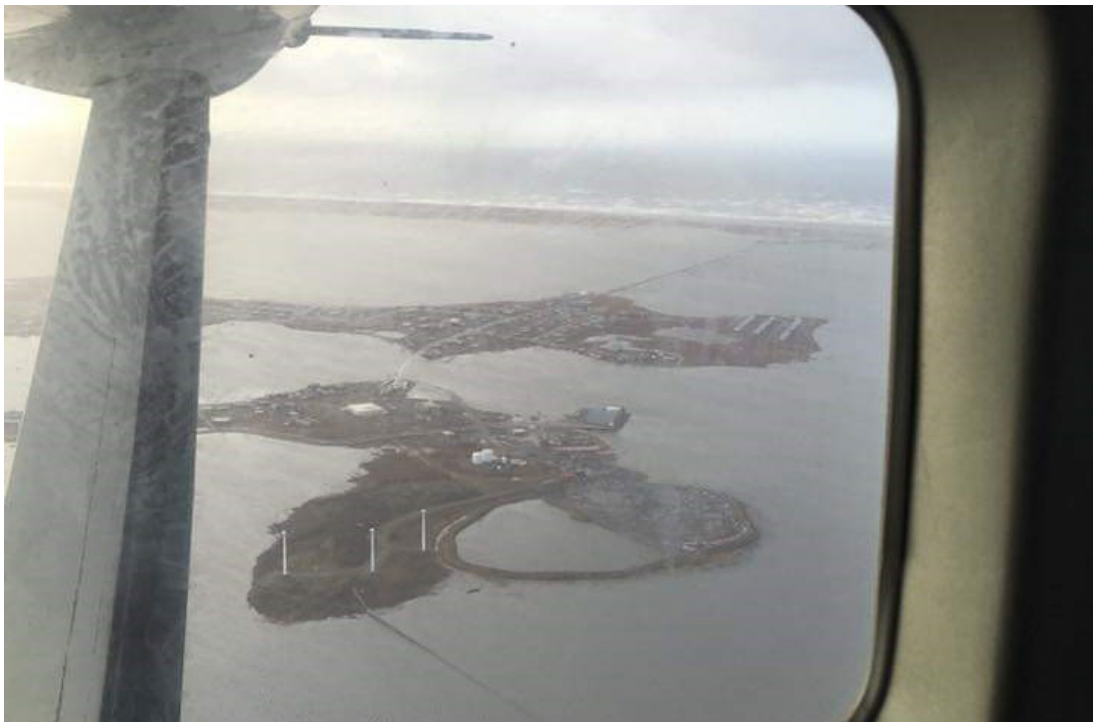
Flood waters surround the town of Hooper Bay and cut off access across the center. The airport road remains mostly above water. Photo: William Naneng, September 16, 2016.

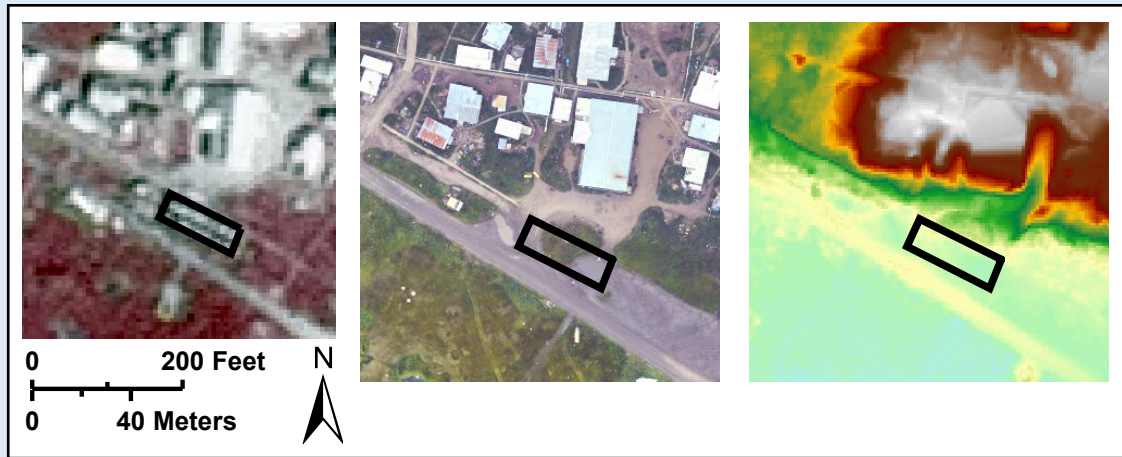
The ground height at the old tank farm averaged 4.1 ± 0.8 ft MHHW (fig. 1). The ground cover had changed since removal of the tank farm. It was still a 1-ft-lower area than the nearby boardwalk, as it appeared in the 1968 photos, so it was estimated that the bare-earth height may have changed by 1 ft at most. The storm was estimated to have reached 7.1 ± 1.7 ft MHHW (table 5). Flooding at this height would have reached the steps of three homes near the dock, which no longer exist.

Figure 1. (Left) Image from 1980 of Hooper Bay tank farm outlined in black. (Middle) 2015 orthoimage with previous tank farm location outlined in black. (Right) Lidar bare-earth model of the same location.

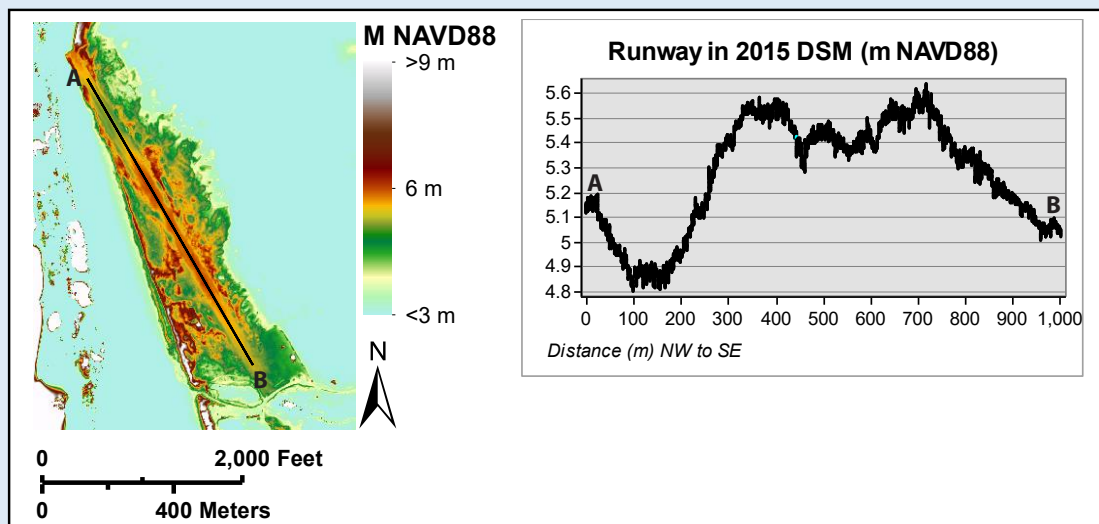
The runway was rebuilt between the acquisition of the 2015 DSM and the 2016 DEM. The runway, as identified in the 2015 orthoimagery, matched the runway shown in a 2004 land use map (City of Hooper Bay and others, 2007). From the DSM, the runway averaged 10.5 ± 1.4 ft MHHW, with a maximum height 11.7 ft MHHW toward the center (fig. 2). Since the airport is adjacent to the open ocean, the peak flood estimate was assumed to include wave runup at 10.5 ± 1.8 ft MHHW (table 8).

Figure 2. (Left) Digital surface model of Hooper Bay runway in 2015, before it was rebuilt. (Right) Elevation profile of the runway shows it varied in elevation by up to 0.8 m (2.6 ft).

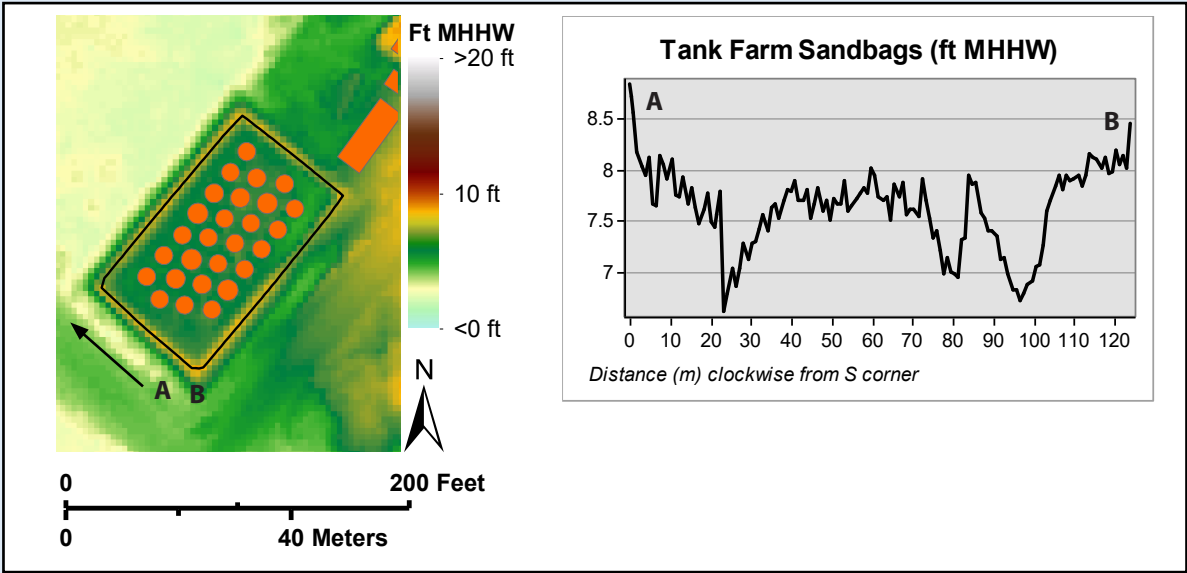
When looking at aerial imagery, the fuel tank farm appeared mostly unchanged from 2004 to 2015, so it was assumed that the height in the DEM was the same height in 2005. City of Hooper Bay and others (2007) said the fuel tanks were “topped,” but their tops were 21 ft MHHW, so this more likely meant the sandbags were topped. A profile of the sandbags ranged between 6.6 and 8.8 ft MHHW and averaged 7.6 ± 0.8 ft MHHW (fig. 3). Since the degree of overtopping was not specified, a more conservative uncertainty method was applied, and the estimated height was 7.7 ± 1.4 ft MHHW (table 9).

Figure 3. (Left) Digital elevation model of tank farm with fuel tanks delineated in orange and profile line drawn in black. (Right) Elevation profile of tank farm sandbag wall shows low sections on the west corner and southeast wall.

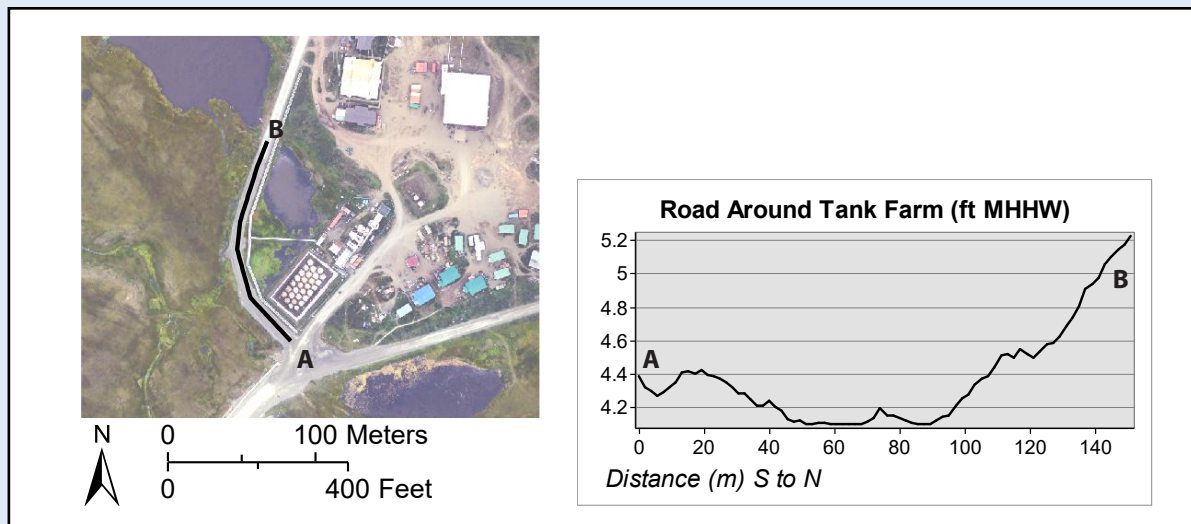
A photo of this flood shows water surrounding the entire community (Division of Homeland Security & Emergency Management, 2013). The airport access road appeared partially submerged near the runway. The lowest part of this road was 4.0 ft MHHW, and flooding of 4.8 ft MHHW would submerge the majority (fig. B3). Water slightly overtopped the road going around the tank farm to the washeteria, allowing water to pool in the low area north of the tank farm. The flood must have reached at least 4.1 ± 0.3 ft MHHW to overtop this road (fig. 4). It was not known whether the photo was acquired during the highest part of the flood and no impacts were reported, so the total uncertainty was increased to make the final estimate 4.1 ± 1.0 ft.

Figure 4. (Left) Image of tank farm area with an elevation profile line drawn in black on the road around tanks. (Right) Elevation profile of tank farm sandbag wall shows low sections on the west corner and southeast wall.

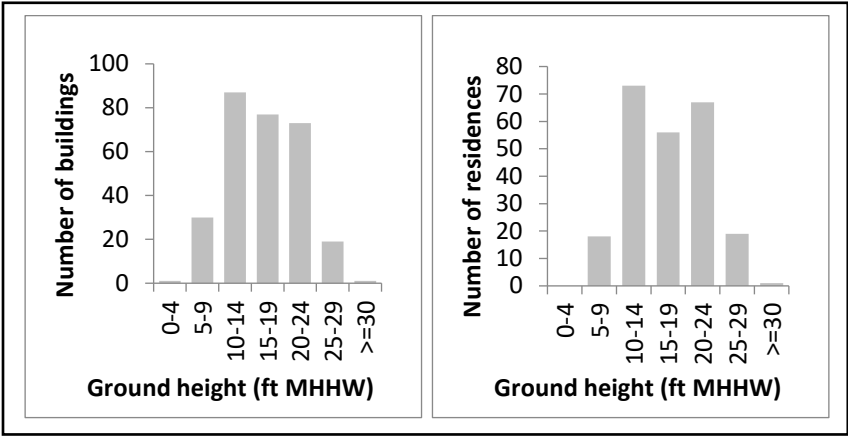
Figure B1. (Left) histogram of the highest ground height below all buildings in Hooper Bay. (Right) histogram of the highest ground height below all residences. Of 234 identified residences, only 18 were on ground below 10 ft MHHW. The highest ground height is not the first floor height.

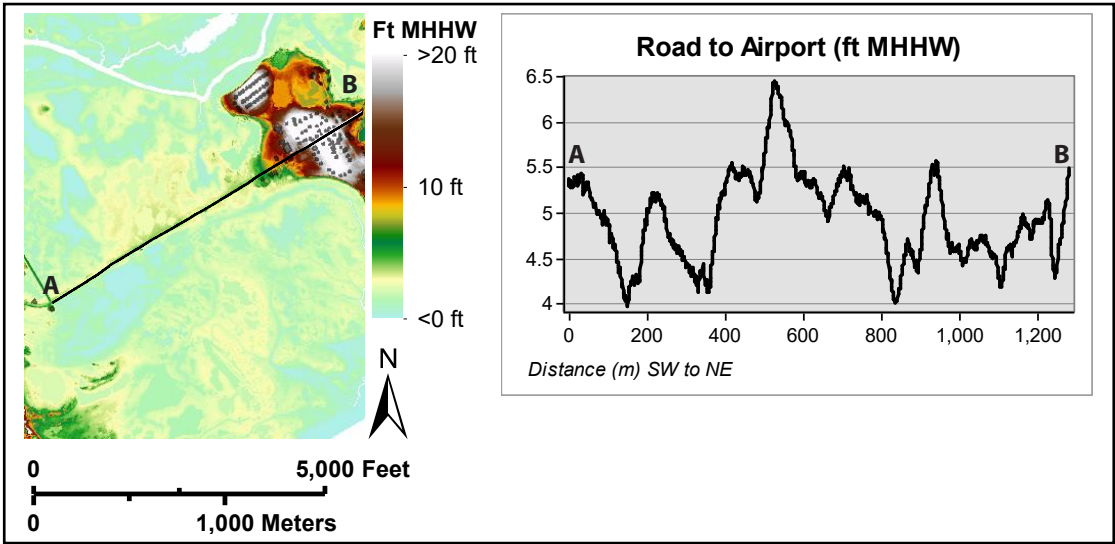
The USACE (2007) erosion report stated, "Loss of the access road or airstrip, even temporarily, could cause considerable social and economic stress to the community." The road to the airstrip ranged from 4.0 to 6.5 ft MHHW and averaged 4.9 ± 1.0 ft MHHW. At the average height, half of the road would be under 0.9 ft of water or less, cutting off access.

Figure B2. (Left) Elevation heat map with black profile line drawn along Airport Road. (Right) Elevation profile showing ground height around between 4.0 and 6.5 ft MHHW.

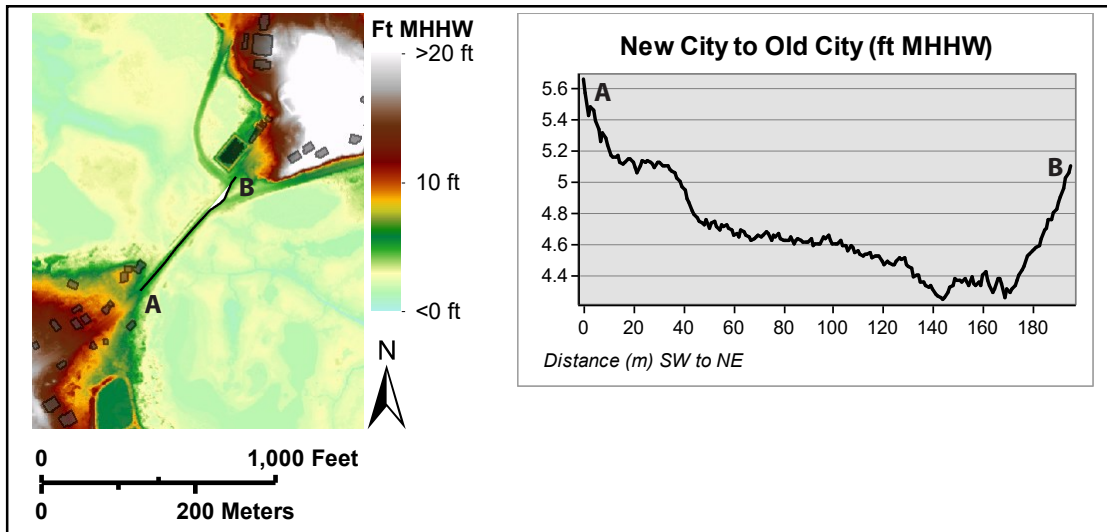
Figure B3.(Left) Elevation heat map with black profile line drawn along road connecting New City to Old City. (Right) Elevation profile showing road is mostly below 4.8 ft MHHW.

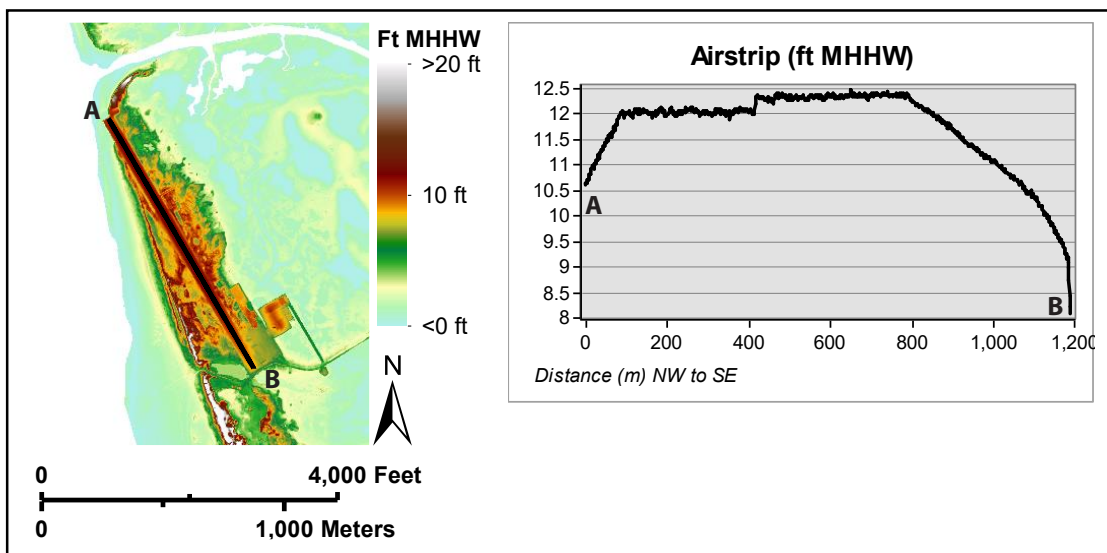
Figure B4.(Left) The 2016 lidar elevation model of the airport with a black line drawn where the elevation profile was extracted. A berm protects the majority of the airstrip from direct wave runup. (Right) Elevation profile of airstrip shows it is below 12.5 ft MHHW.

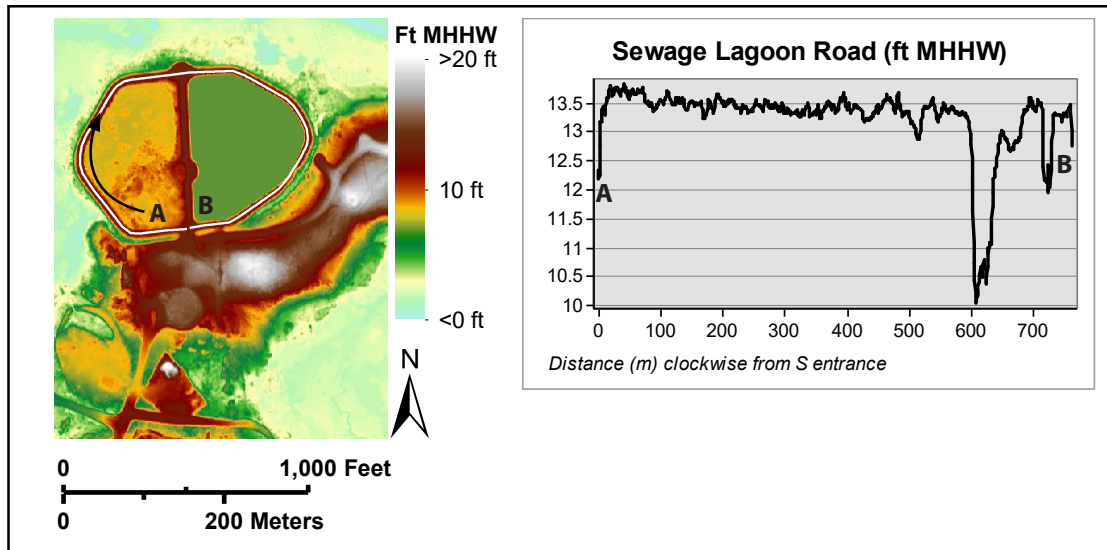
Figure B5.(Left) Digital elevation model of wastewater pond and dump area, with white line drawn on the barrier roadway where elevation profile was collected. (Right) Elevation profile of barrier roadway, which is mostly above 13 ft MHHW except for the SE section that drops to 10 ft MHHW.
