EROSION EXPOSURE ASSESSMENT—DEERING

Report of Investigation 2021-3 Deering

State of Alaska
Department of Natural Resources
Division of Geological & Geophysical Surveys

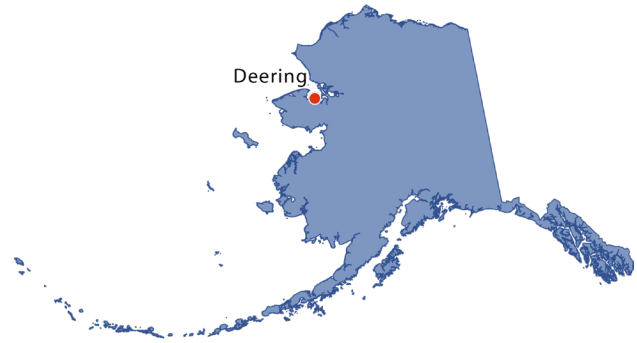
Deering is located on the north coast of the Seward Peninsula where Smith Creek exits into Kotzebue Sound. The community is constructed on a vegetated spit. Storm surge scours beach sand along the spit. Accretion also occurs after storm events. Due to this process, the shoreline appears stable in historical imagery from 1978 to 2016 (Overbeck and others, 2020). We cannot forecast erosion at

Deering because of the relatively stable erosion rate and protection structures in place. While the spit appears stable over the long-term, erosion from storm surge can scour sand and undercut infrastructure. A 2017 storm exposed a pre-existing concrete block revetment fronting the spit (Oliver, 2017; Overbeck and others, 2020). Mitigation projects have mixed success in Deering (U.S. Army Corps of Engineers, 2007). There likely will be continued costs related to erosion and mitigation. Beach erosion can be measured from repeated beach elevation surveys using GPS or digital elevation models. DGGs collected beach elevations in 2018. Continued monitoring and a longer record of beach elevation data can help identify whether and when infrastructure may become exposed to erosion.
