EROSION EXPOSURE ASSESSMENT—EGEGIK

Report of Investigation 2021-3 Egegik

State of Alaska
Department of Natural Resources
Division of Geological & Geophysical Surveys

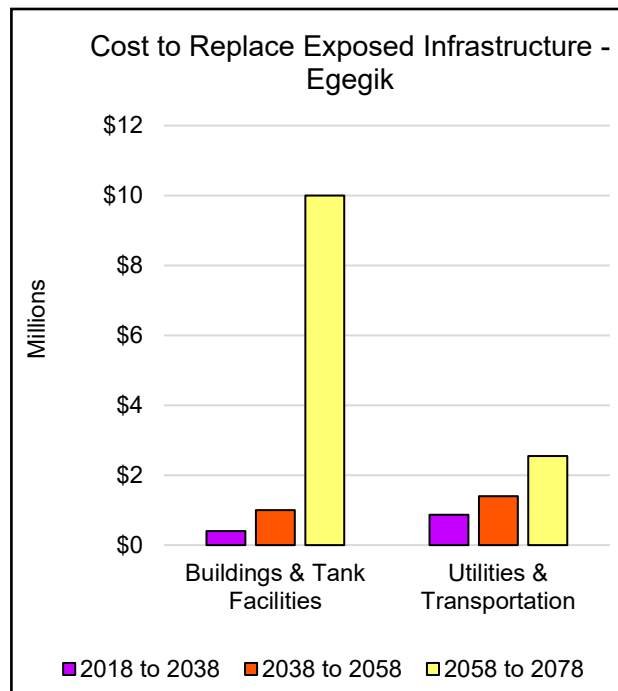
Figure 1. This figure summarizes the replacement cost of all infrastructure in the erosion forecast area. Twenty-year intervals are symbolized by color: purple represents the time interval 2018 to 2038, red represents 2038 to 2058, and yellow represents 2058 to 2078. The bulk of costs are buildings, especially from 2058 to 2078.

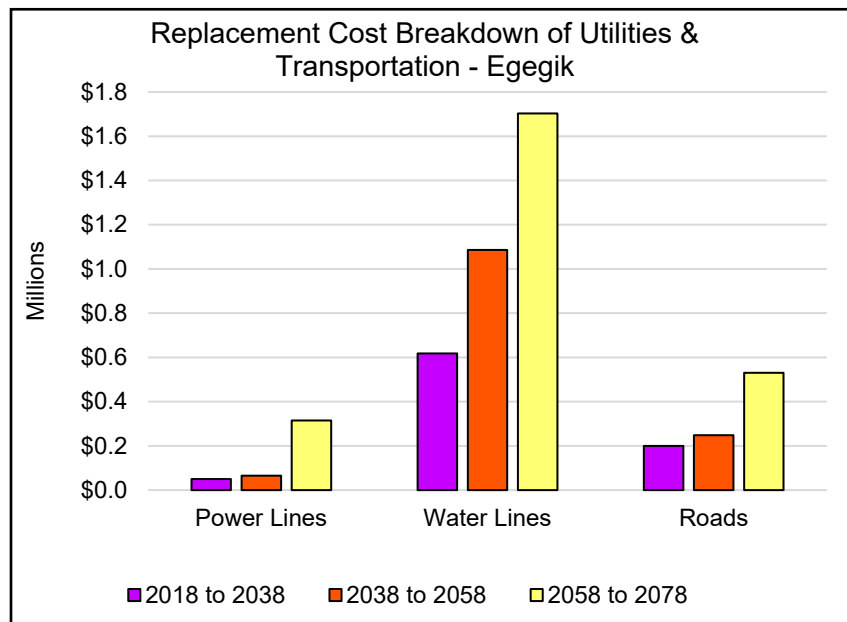
Figure 2. This figure breaks down the replacement cost of all utilities and transportation. The greatest cost is erosion of the water lines from 2058 to 2078.

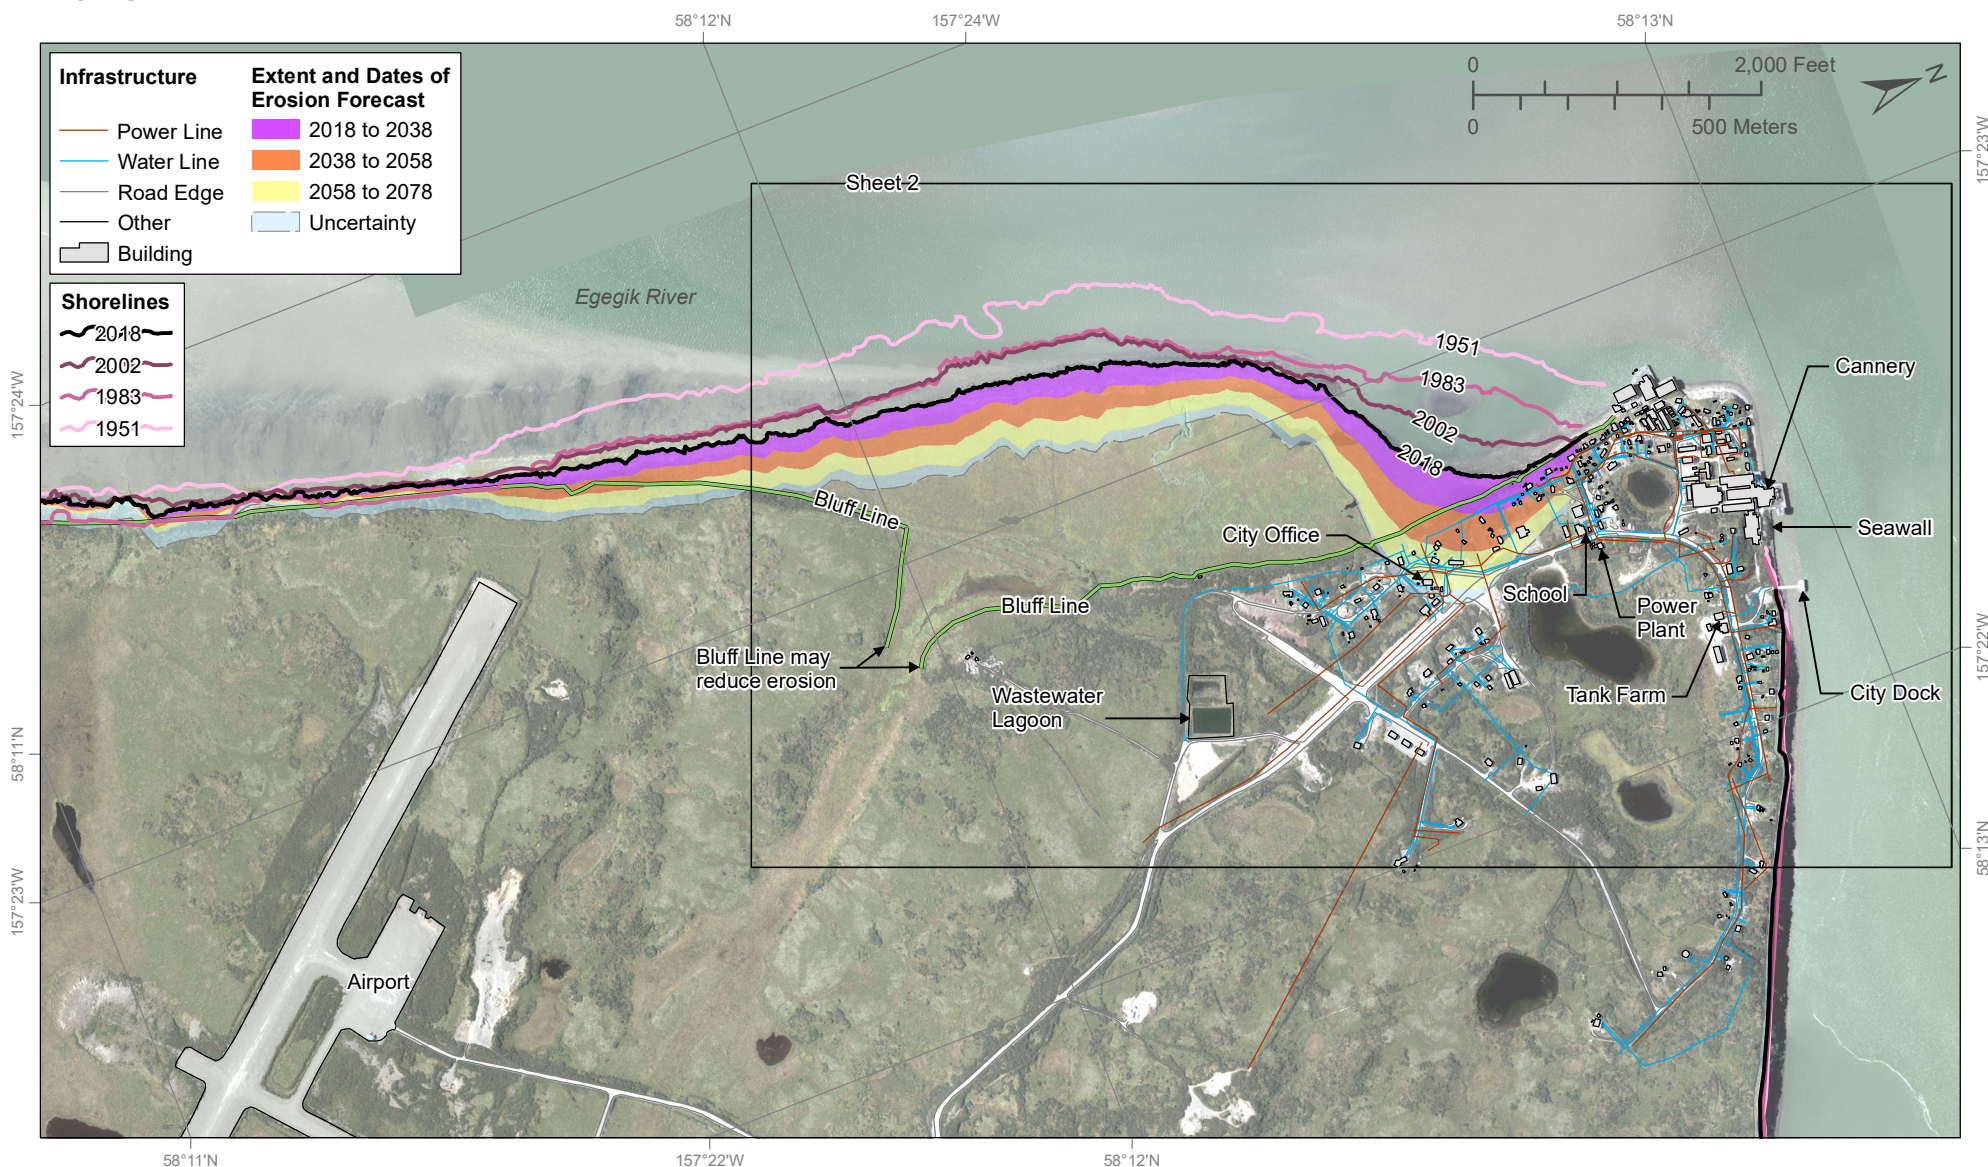
Erosion Forecast Egegik, Alaska

Erosion and accretion of coasts and rivers result in shoreline change. These rates of shoreline change at Alaska communities are calculated from historical and modern shorelines (shorelines shown as lines in pink scale and labeled by year). The long-term (1951 to 2018) shoreline change rate is used to forecast where erosion could impact community infrastructure. Erosion is forecast to reach the colored areas by specified time intervals: 2018 to 2038 (purple), 2038 to 2058 (orange), and 2058 to 2078 (yellow). The area of uncertainty of the 2078 shoreline at a 90 percent confidence interval is light blue. Areas that are not colored by time interval are not forecast to erode by 2078 based on the historical shoreline change rate. For more detailed information about the impacts to infrastructure from erosion at Egegik, refer to the Egegik erosion exposure assessment report.

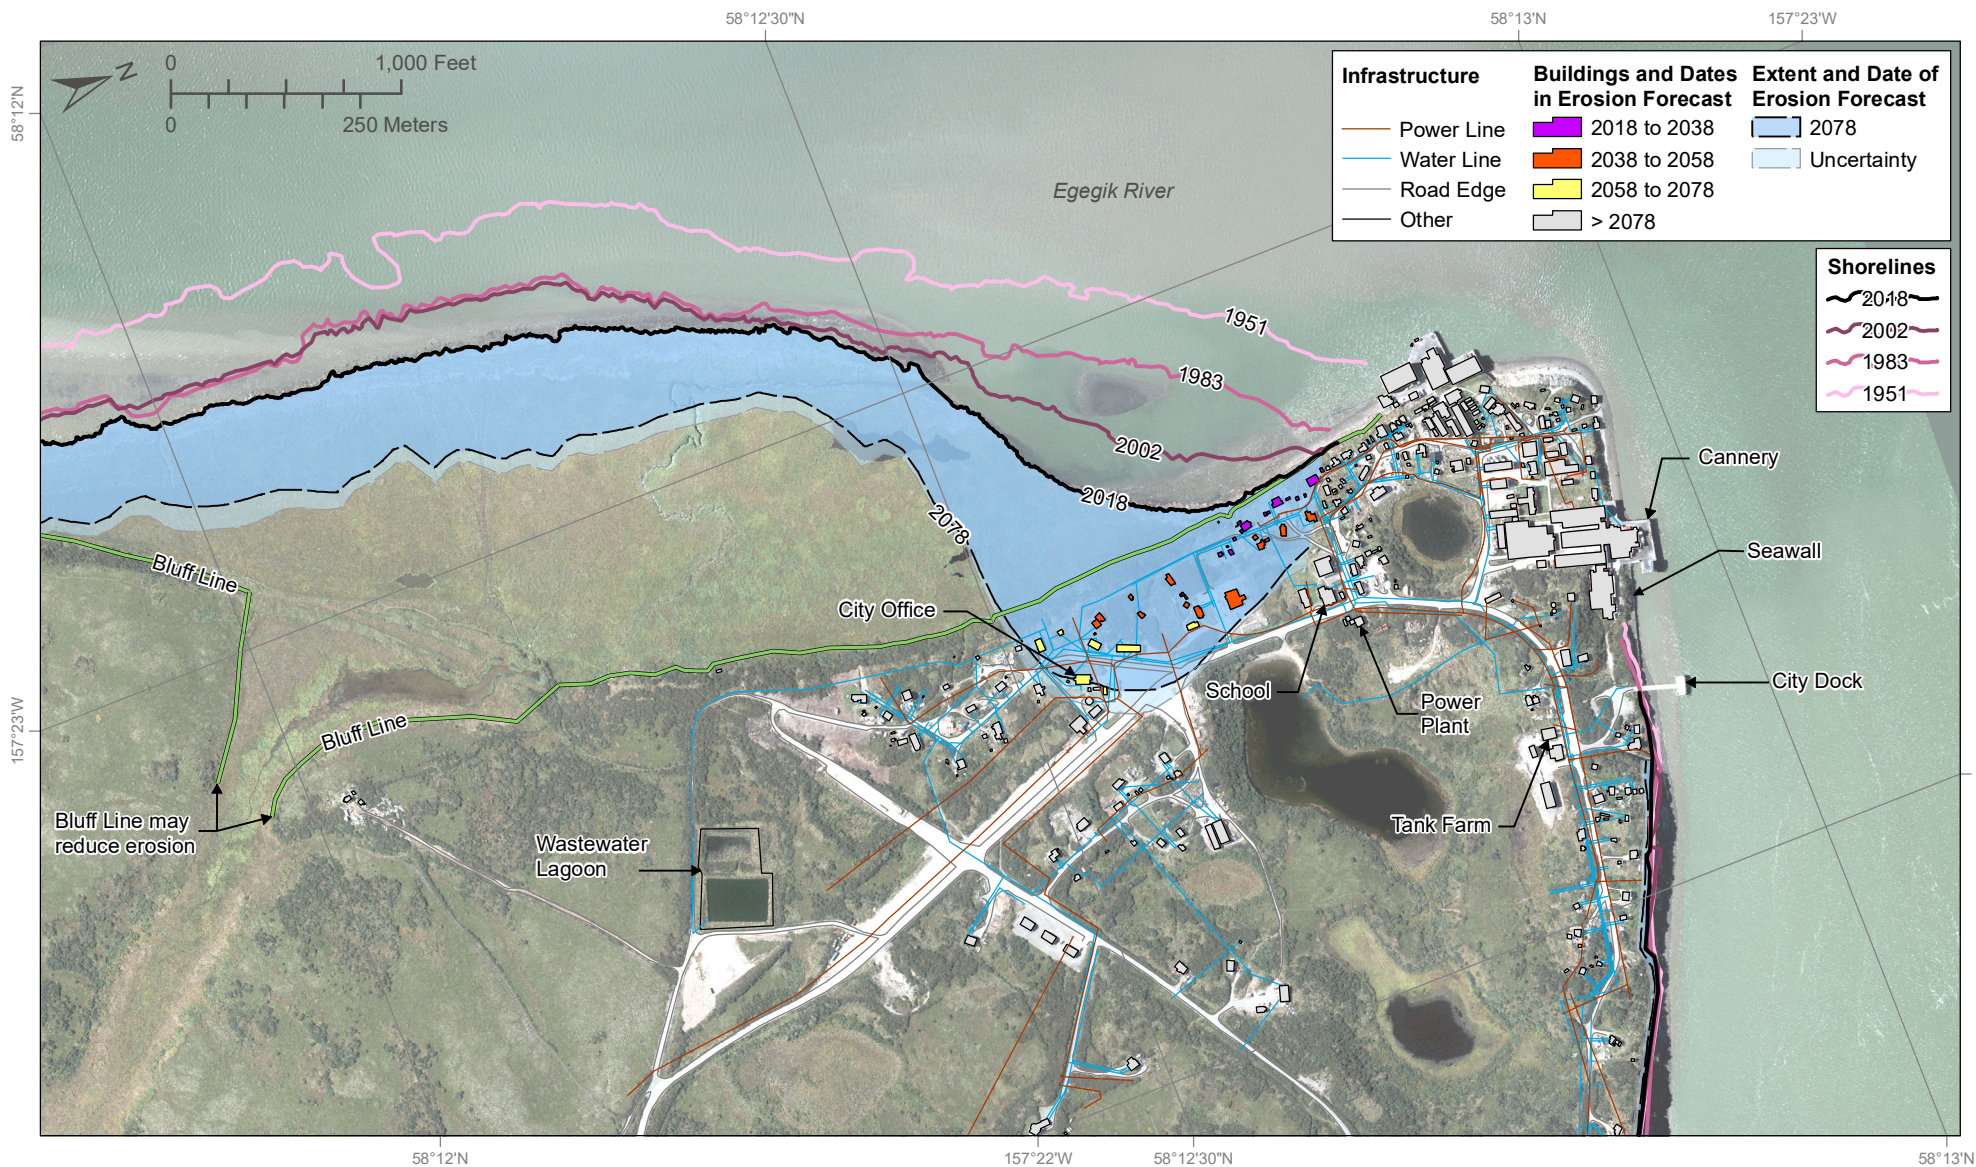
Erosion Exposure Egegik, Alaska

Erosion and accretion of coasts and rivers result in shoreline change. These rates of shoreline change at Alaska communities are calculated from historical and modern shorelines (shorelines shown as lines in pink and labeled by year). The long-term (1951 to 2018) shoreline change rate is used to forecast where erosion could impact community infrastructure. Erosion is forecast to year 2078 (dark blue) with a 90 percent confidence interval area of uncertainty (light blue). Buildings forecast to be impacted by erosion are colored by the range of years when the impact is forecast to occur: 2018 to 2038 (purple), 2038 to 2058 (orange), 2058 to 2078 (yellow), and no impacts expected by 2078 (gray). For more detailed information about the impacts to infrastructure from erosion at Egegik, refer to the Egegik erosion exposure assessment report.
