EROSION EXPOSURE ASSESSMENT—EMMONAK

Report of Investigation 2021-3 Emmonak

EMMONAK EROSION EXPOSURE ASSESSMENT

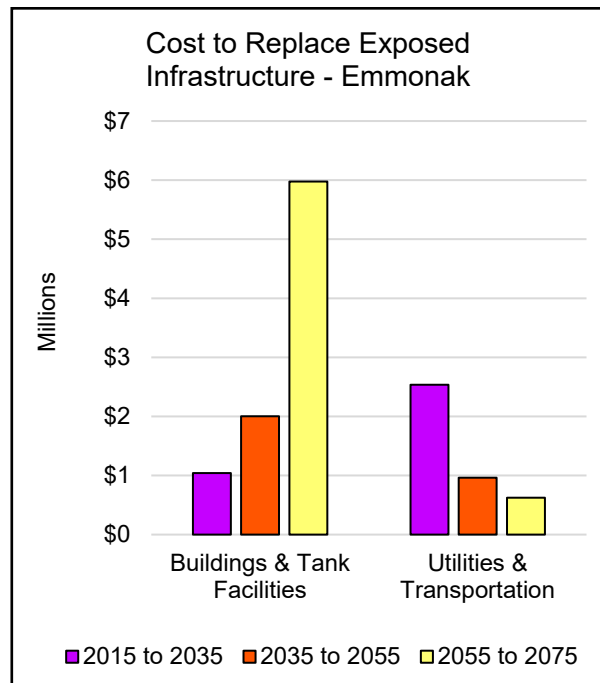
Figure 1. This figure summarizes the replacement cost of infrastructure in the erosion forecast area. Twenty-year intervals are symbolized by color: purple represents the time interval 2015 to 2035, red represents 2035 to 2055, and yellow represents 2055 to 2075. Bulk of costs occur from 2055 to 2075 when 14 buildings are at risk from erosion.

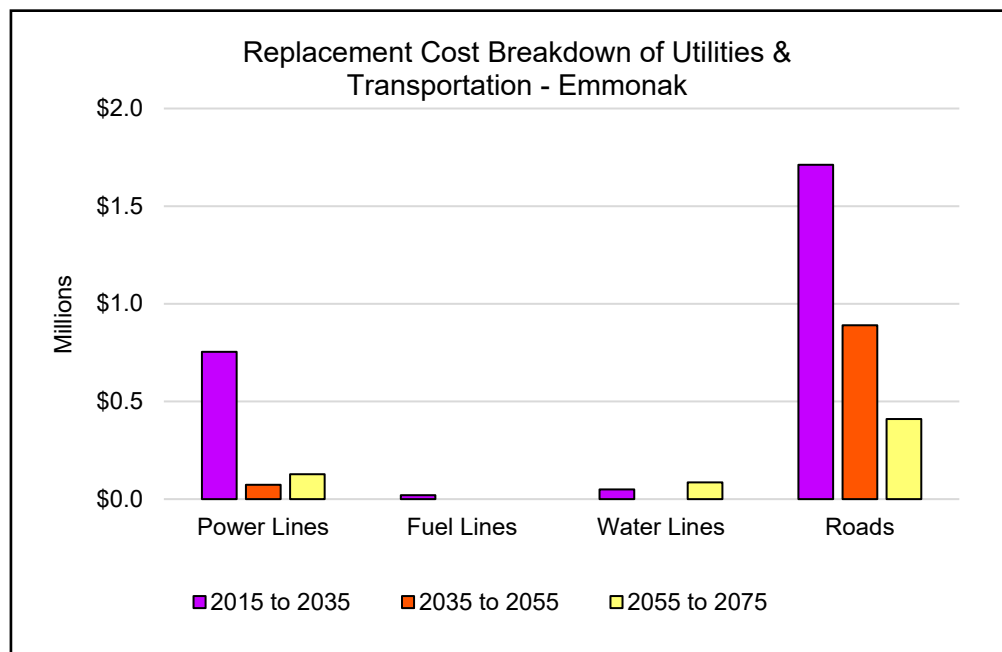
Figure 2. This figure summarizes the replacement cost of utilities and transportation infrastructure that are exposed to erosion per 20-year interval.

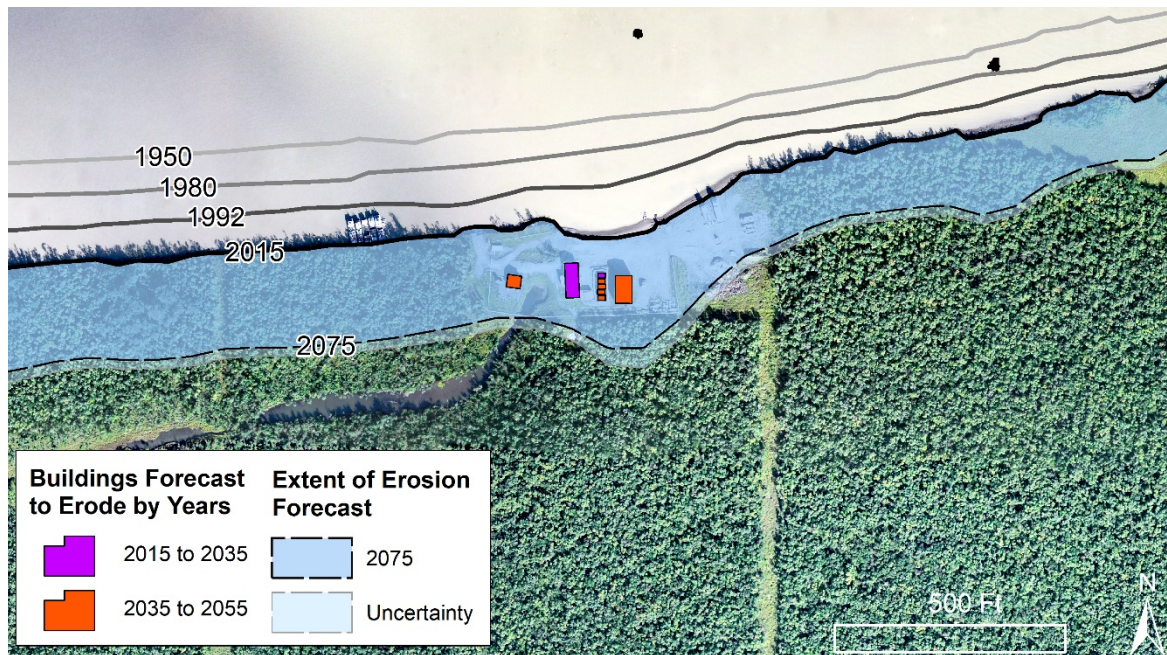
Figure 3. Buildings across river from Emmonak exposed to erosion between 2015 and 2055. Cost of erosion exposure is not included in this analysis because the buildings are not identified on the Emmonak community profile map provided by the Division of Community & Regional Affairs (2006).

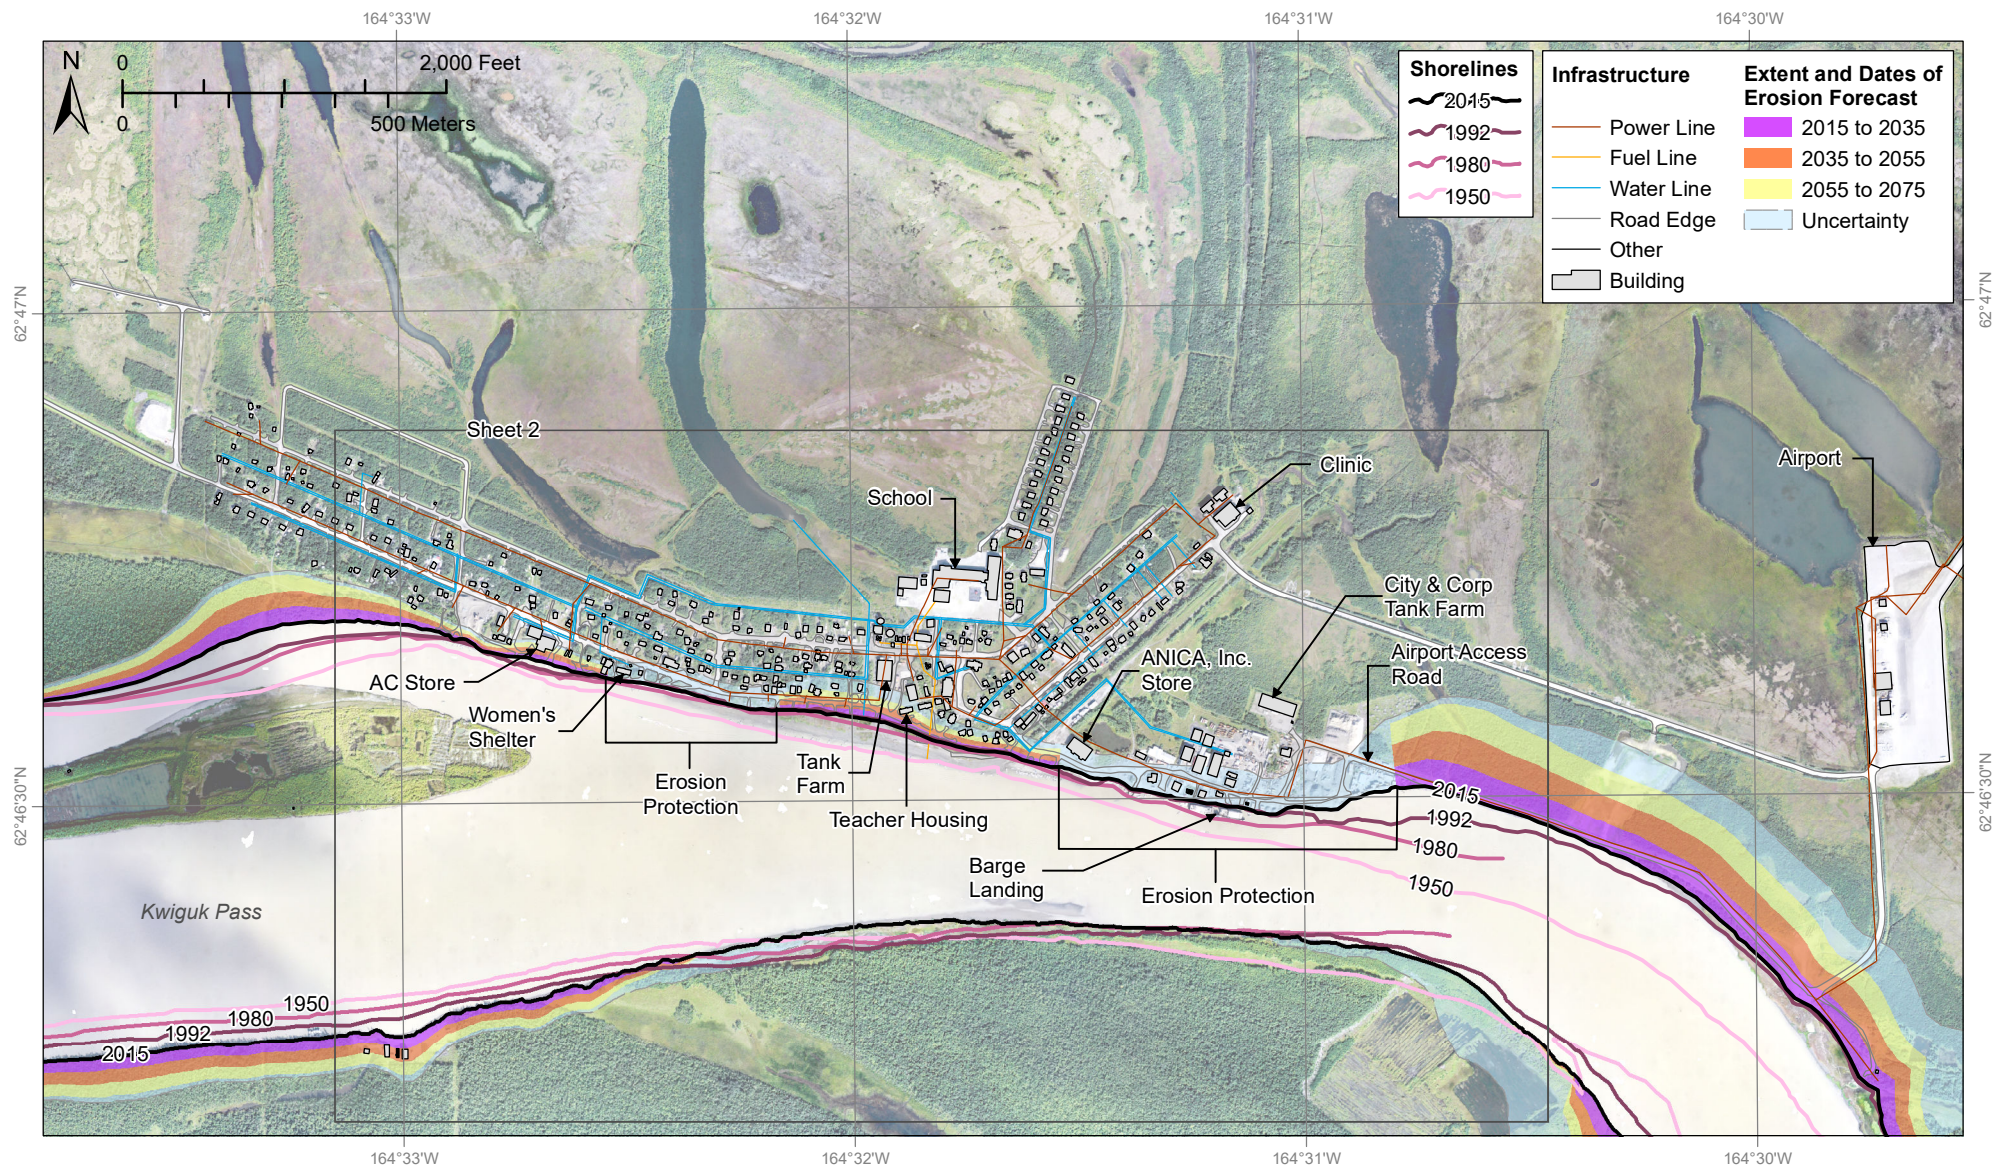
Erosion Forecast Emmonak, Alaska

Erosion and accretion of coasts and rivers result in shoreline change. These rates of shoreline change at Alaska communities are calculated from historical and modern shorelines (shorelines shown as lines in pink scale and labeled by year). The long-term (1950 to 2015) shoreline change rate is used to forecast where erosion could impact community infrastructure. Erosion is forecast to reach the colored areas by specified time intervals: 2015 to 2035 (purple), 2035 to 2055 (orange), and 2055 to 2075 (yellow). The area of uncertainty of the 2075 shoreline at a 90 percent confidence interval is light blue. Areas that are not colored by time interval are not forecast to erode by 2075 based on the historical shoreline change rate. For more detailed information about the impacts to infrastructure from erosion at Emmonak, refer to the Emmonak erosion exposure assessment report.

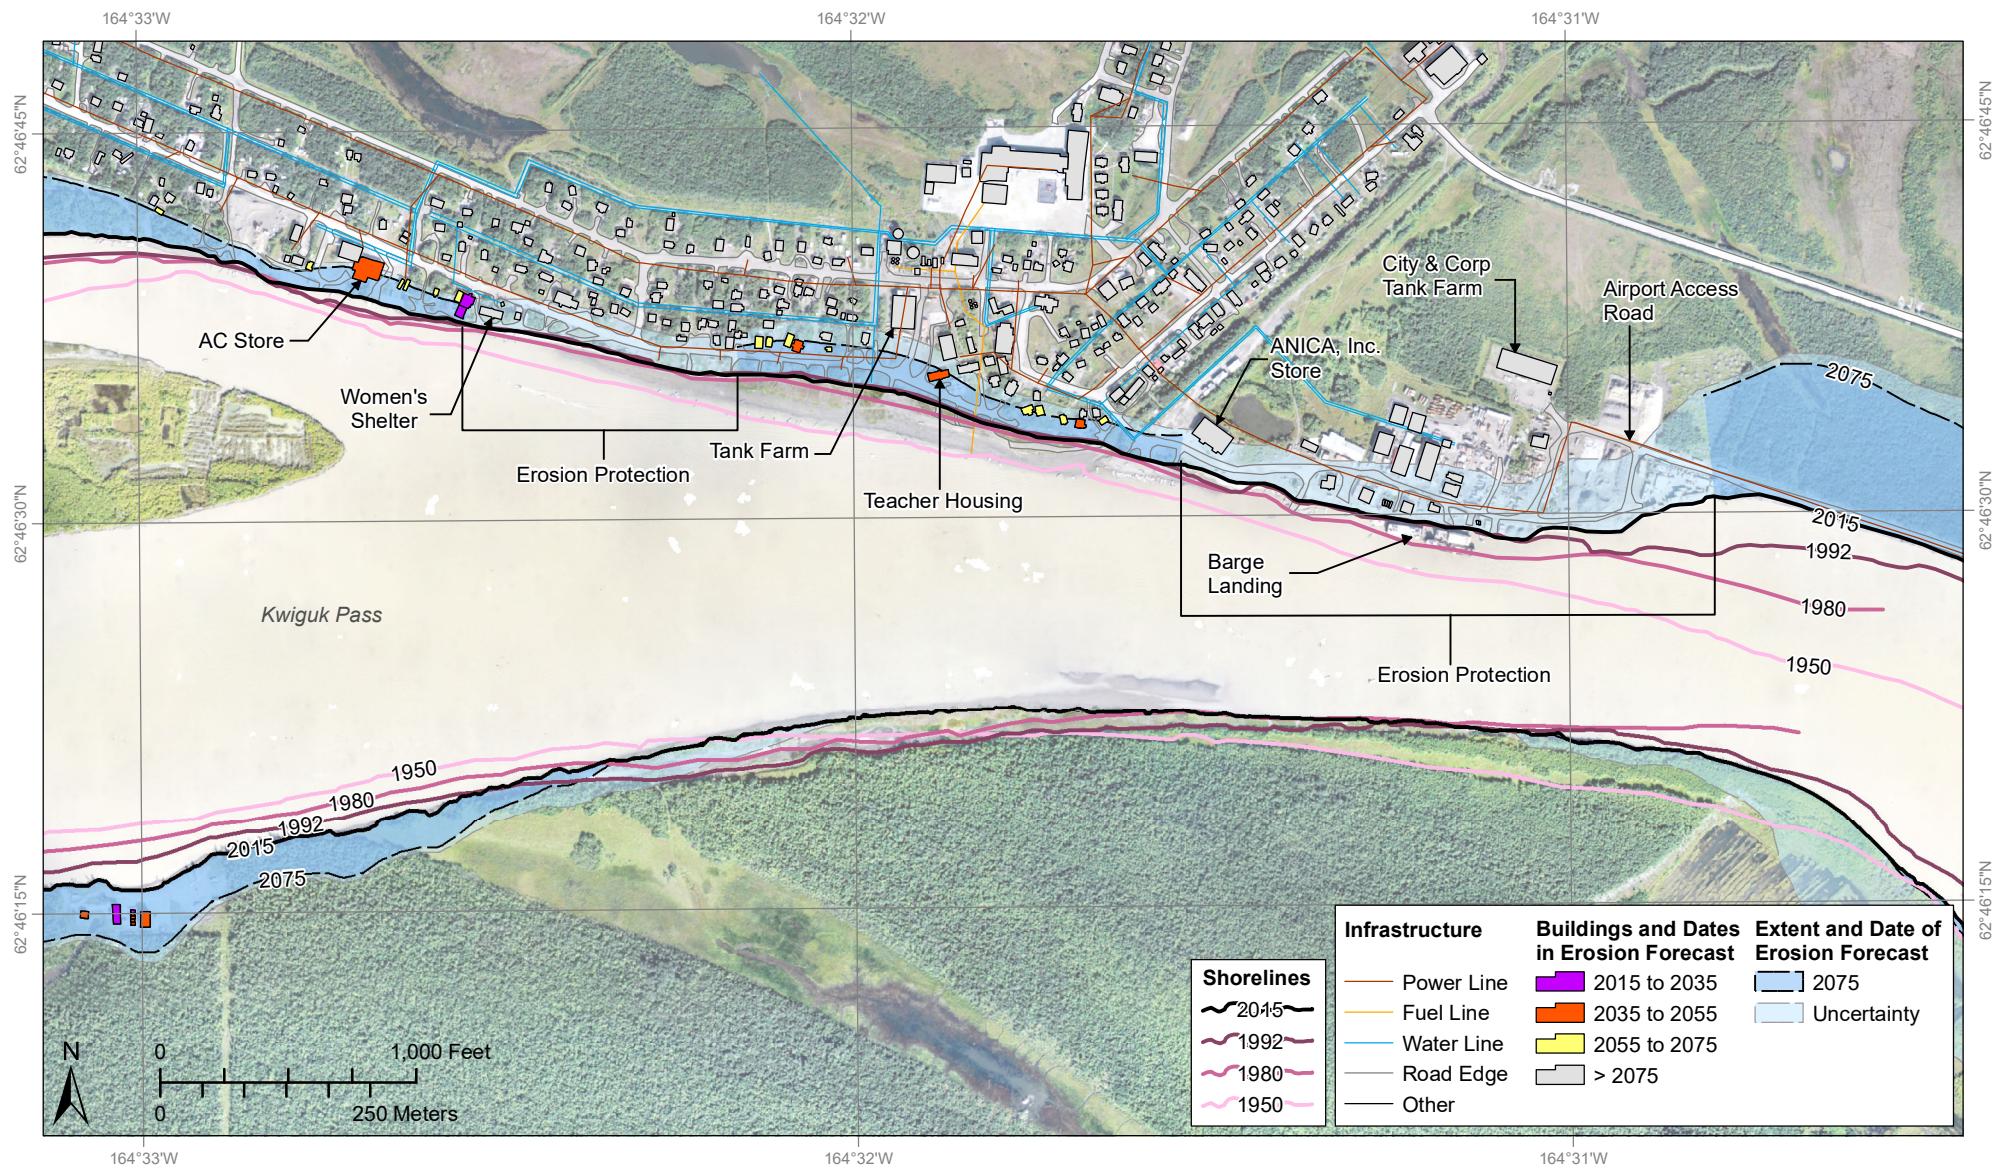
Erosion Exposure Emmonak, Alaska

Erosion and accretion of coasts and rivers result in shoreline change. These rates of shoreline change at Alaska communities are calculated from historical and modern shorelines (shorelines shown as lines in pink scale and labeled by year). The long-term (1950 to 2015) shoreline change rate is used to forecast where erosion could impact community infrastructure. Erosion is forecast to year 2075 (dark blue) with a 90 percent confidence interval area of uncertainty (light blue). Buildings forecast to be impacted by erosion are colored by the range of years when the impact is forecast to occur: 2015 to 2035 (purple), 2035 to 2055 (orange), 2055 to 2075 (yellow), and no impacts expected by 2075 (gray). For more detailed information about the impacts to infrastructure from erosion at Emmonak, refer to the Emmonak erosion exposure assessment report.
