EROSION EXPOSURE ASSESSMENT—HOOPER BAY

Report of Investigation 2021-3 Hooper Bay

HOOPER BAY EROSION EXPOSURE ASSESSMENT

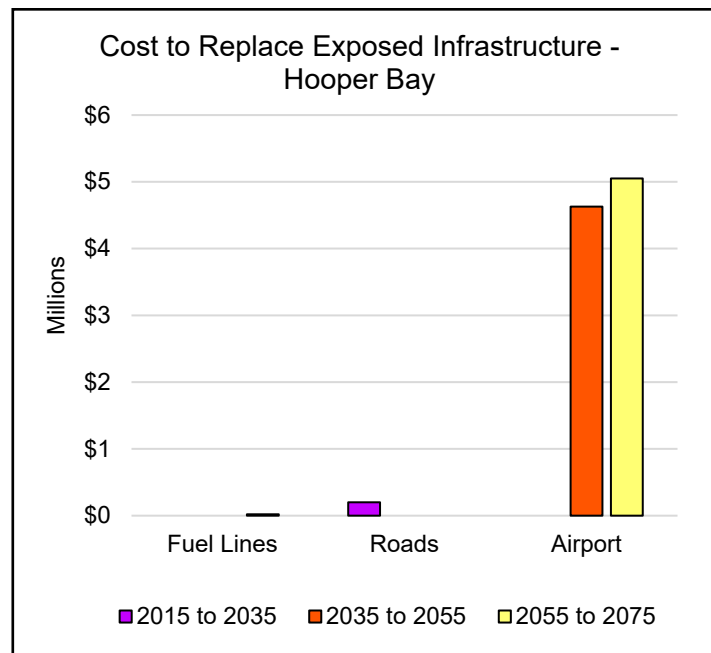
We forecast erosion 60 years from the most recent shoreline (2015) at 20-year intervals to identify the exposure of infrastructure to erosion. From 2015 to 2075, the erosion forecast area extends along almost 1000 feet of runway and over 300 feet of roadway near the boat docking area on the Napareayak Slough (table 1). The greatest cost comes from the runway between 2035 and 2055 (table 2; fig. 1). The roadway is the greatest cost in the period up to 2035. No buildings were found in the erosion forecast area. The total replacement cost of infrastructure exposed to erosion is \$9.9 million (\pm \$3.0 million) by 2075 (table 2; fig. 1).

**Figure 1.** This figure summarizes the replacement cost of all infrastructure in the erosion forecast area. Twenty-year intervals are symbolized by color: purple represents the time interval 2015 to 2035, red represents 2035 to 2055, and yellow represents 2055 to 2075. The greatest cost is the airport from 2035 to 2075.

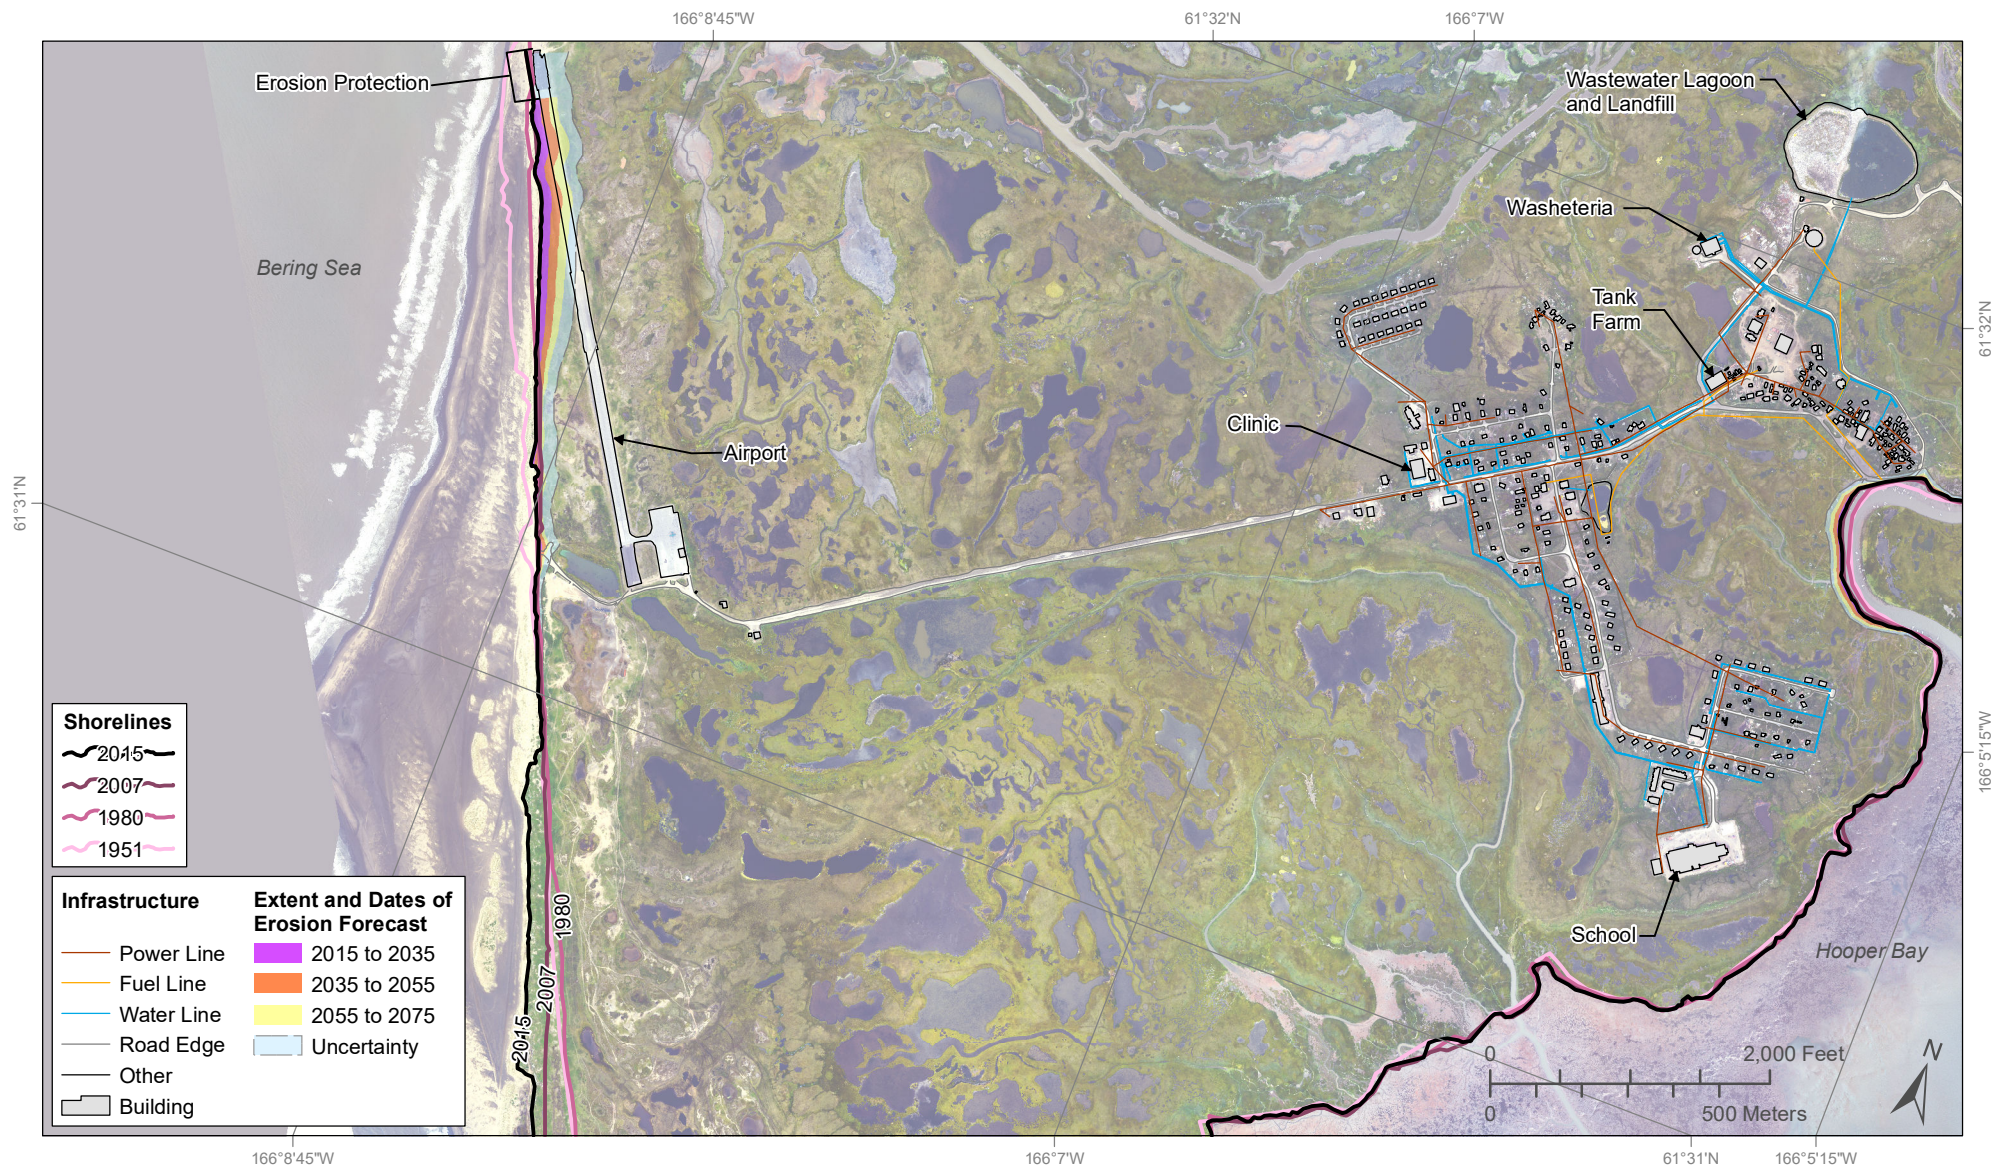
Erosion Forecast Hooper Bay, Alaska

Erosion and accretion of coasts and rivers result in shoreline change. These rates of shoreline change at Alaska communities are calculated from historical and modern shorelines (shorelines shown as lines in pink scale and labeled by year). The long-term (1951 to 2015) shoreline change rate is used to forecast where erosion could impact community infrastructure. Erosion is forecast to reach the colored areas by specified time intervals: 2015 to 2035 (purple), 2035 to 2055 (orange), and 2055 to 2075 (yellow). The area of uncertainty of the 2075 shoreline at a 90 percent confidence interval is light blue. Areas that are not colored by time interval are not forecast to erode by 2075 based on the historical shoreline change rate. For more detailed information about the impacts to infrastructure from erosion at Hooper Bay, refer to the Hooper Bay erosion exposure assessment report.
