Report of Investigation 2021-3 Kivalina

EROSION EXPOSURE ASSESSMENT—KIVALINA

KIVALINA EROSION EXPOSURE ASSESSMENT

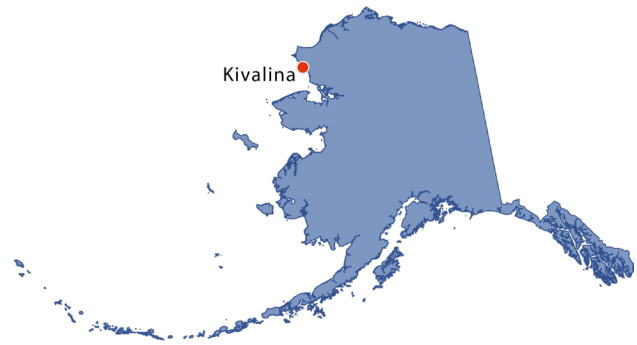
Kivalina is built on vegetated dunes at the end of an eight-mile barrier island off the southwest coast of the Lisburne Peninsula. From 1952 to 2016, the island experienced a mix of erosion and accretion that resulted in a net-stable shoreline (Overbeck and others, 2020; U.S. Army Corps of Engineers [USACE], 2009). However, storm surge can erode soil and undercut infrastructure close to the coastline.

Despite long-term stability, USACE (2009) forecast major erosion impacts. A rock revetment was built in 2010 to protect most of the community from erosion. Comparisons of historical and modern aerial imagery show that the expansion of the airport runway changed the position of the shoreline, and some erosion protection was placed in the area as well. We cannot forecast erosion in Kivalina due to the shoreline modifications that are present along the entire shoreline of the community. Unprotected lengths of shoreline are exposed to erosion from storm events. The revetment appears to have stabilized the shoreline, reducing anticipated erosion exposure. The revetment may require upkeep. Beach erosion can be measured from repeated beach elevation surveys using GPS or digital elevation models. Continued monitoring and a longer record of beach elevation data can help identify whether and when infrastructure may become exposed to erosion.
