EROSION EXPOSURE ASSESSMENT—KOYUK

Report of Investigation 2021-3 Koyuk

KOYUK EROSION EXPOSURE ASSESSMENT

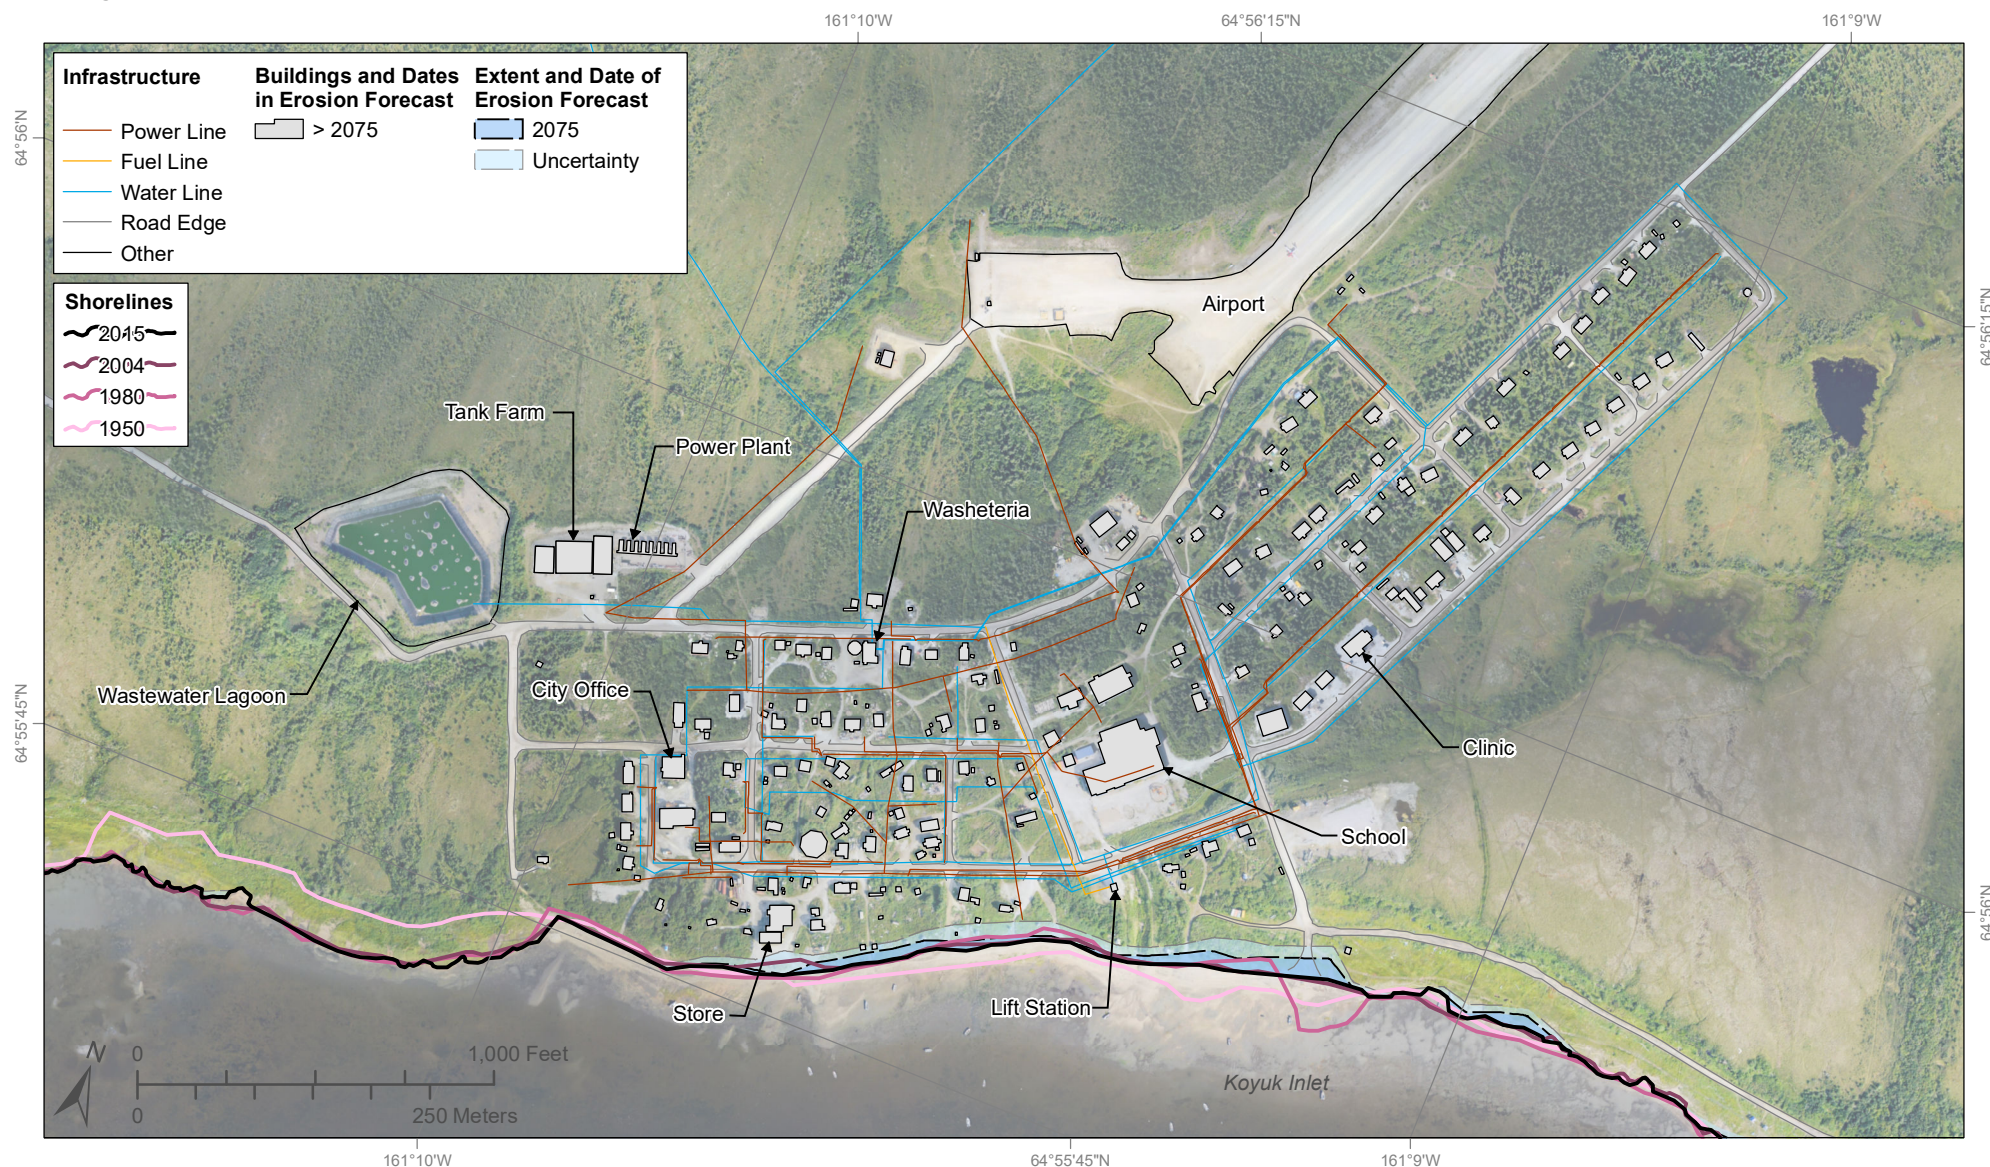
Report of Investigation 2021-3
Buzard and others, 2021
Koyuk, Sheet 1 of 1

We forecast erosion 60 years from the most recent shoreline (2015) at 20-year intervals to identify the exposure of infrastructure to erosion. One road on the eastern side of town is within the 2075 erosion forecast area (tables 1 and 2). The total estimated cost of replacement due to exposure of the road to erosion is \$200 thousand (\pm \$60 thousand) by 2035 (table 2).
