EROSION EXPOSURE ASSESSMENT—SHAKTOOLIK

Report of Investigation 2021-3 Shaktoolik

SHAKTOOLIK EROSION EXPOSURE ASSESSMENT

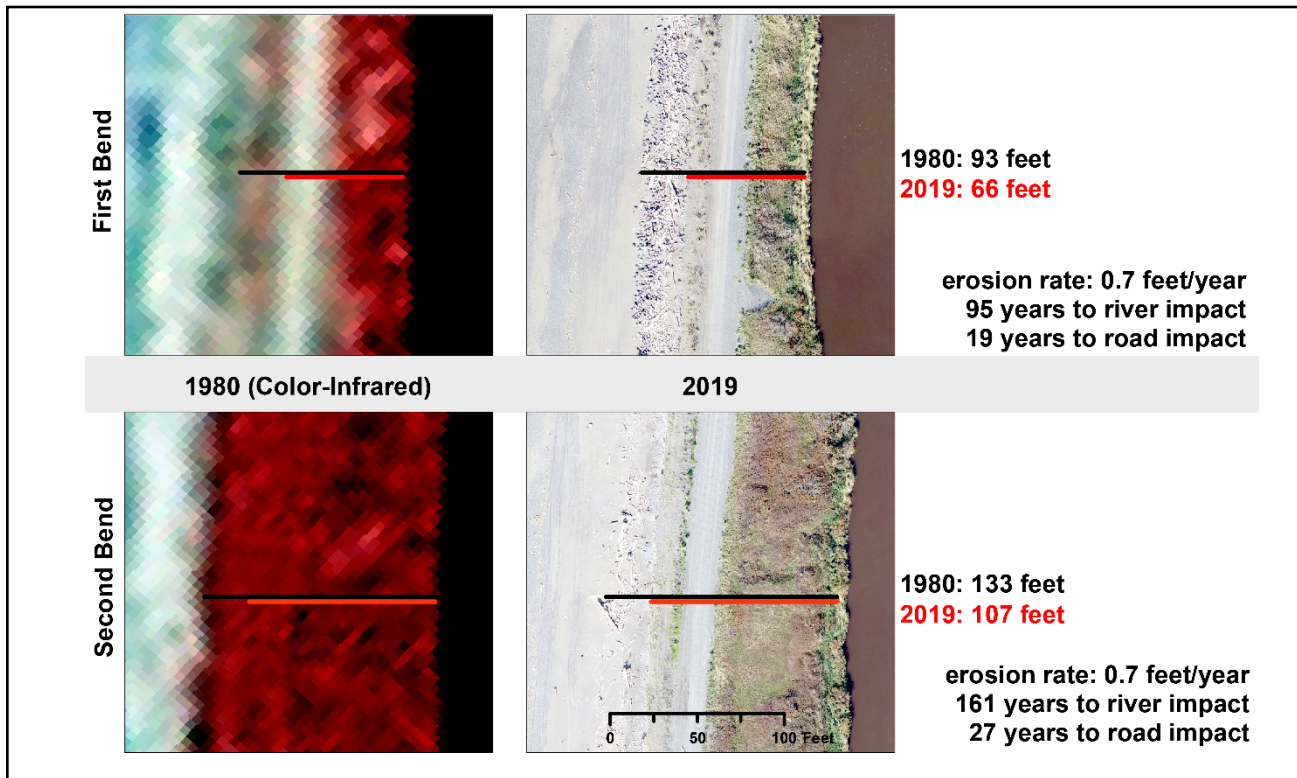
Figure 1. Erosion estimates at the thinnest points of First Bend (top) and Second Bend (bottom). The black line shows the distance from the 1980 coastal vegetation edge to the riverbank. The red line shows the distance as of 2019. At First Bend, the vegetation line eroded 33 feet from 1980 to 2019 (0.7 feet per year), and 66 feet remain. The 1980 image is color-infrared, so vegetation appears red and water black.

erode through to the river,” citing the erosion rates assumed by USACE (2009). Measurements from aerial imagery show erosion rates from 1980 to 2019 are 0.7 feet per year at First and Second Bend (fig. 1). This rate predicts the earliest breach occurring in 95 years at First Bend. The long-term rates may be slower than recent observations because few major storms impacted Shaktoolik in the 1980s and 1990s (Native Village & City of Shaktoolik and others, 2009). Many factors can increase erosion rates beyond the historical record (such as reduced sea ice during the storm season or unprecedented storm surge). These findings suggest that a breach is not imminent but is likely to occur within 100 years, depending on the frequency of storms that reach the bluff. Erosion of the road at both First and Second Bend is a more immediate concern.

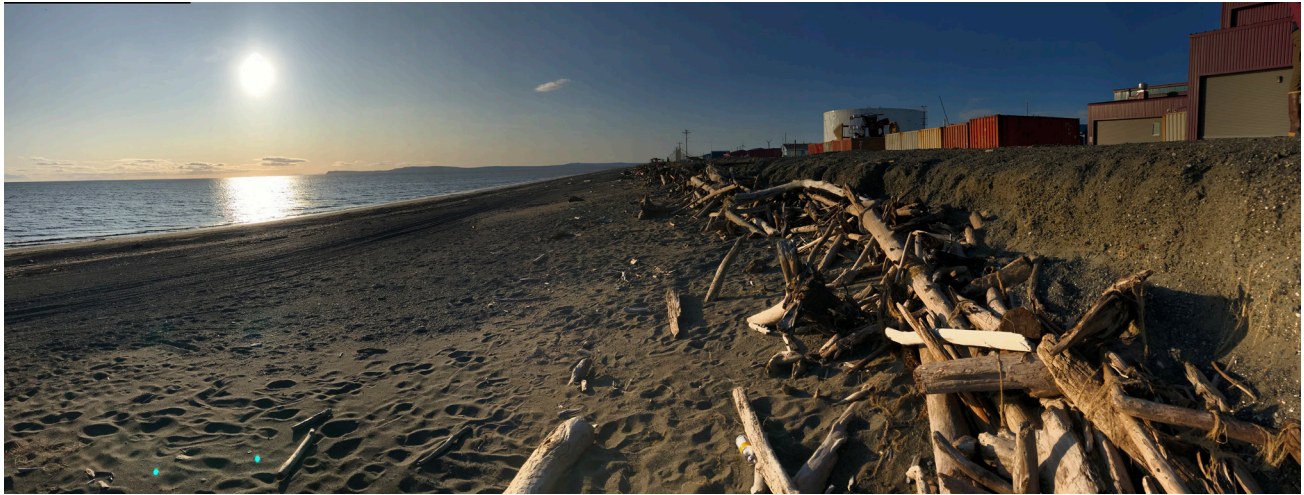
Figure 2. The eroded berm at Shaktoolik in front of the school and water tower after the August 2019 storm. The storm eroded much of the gravel, leaving the woody debris it was built upon.

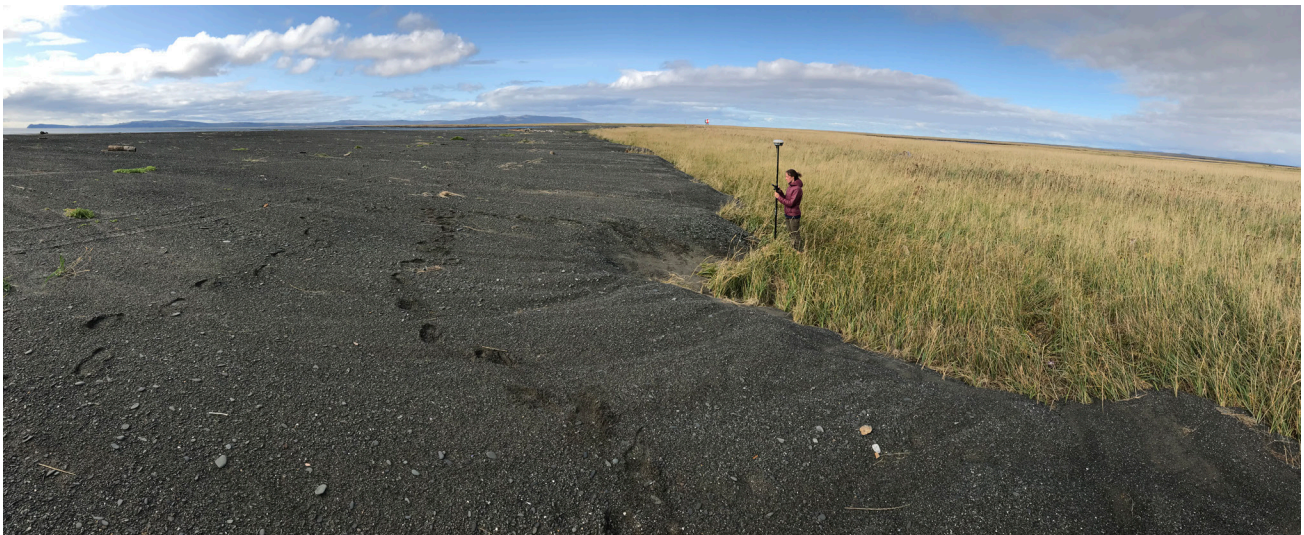
Figure 3. This broad gravel sheet on the northwest section of the spit was deposited by storms. The deposit ranges from 1 to 3 feet above the ground elevation (geologist for scale). The August 2019 storm added to the deposit, causing net accretion at the tip of the spit.
