EROSION EXPOSURE ASSESSMENT—TUNUNAK

Report of Investigation 2021-3 Tununak

TUNUNAK EROSION EXPOSURE ASSESSMENT

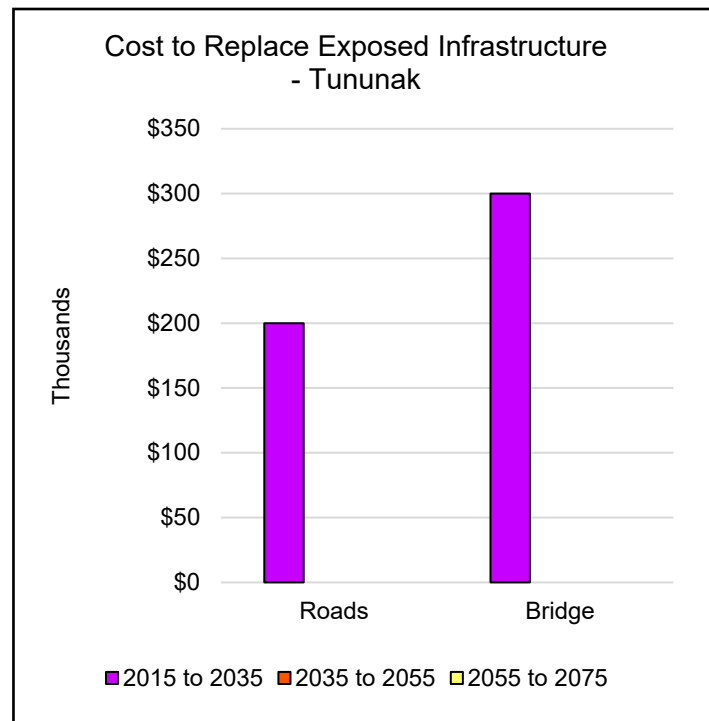
the bridge is likely exposed to erosion. Given this forecast and community observations of continued bridge foundation erosion, we include the bridge replacement cost estimated by The Native Village of Tununak (2015; table 2; fig. 1). The timing of exposure is estimated to be the same as the road. The total estimated cost of infrastructure exposed to erosion is \$500 thousand (\pm \$150 thousand) by 2075 (table 2; fig. 1).

Figure 1. This figure summarizes the replacement cost of all infrastructure in the erosion forecast area. The road and bridge are both within the 2035 (purple) forecast.

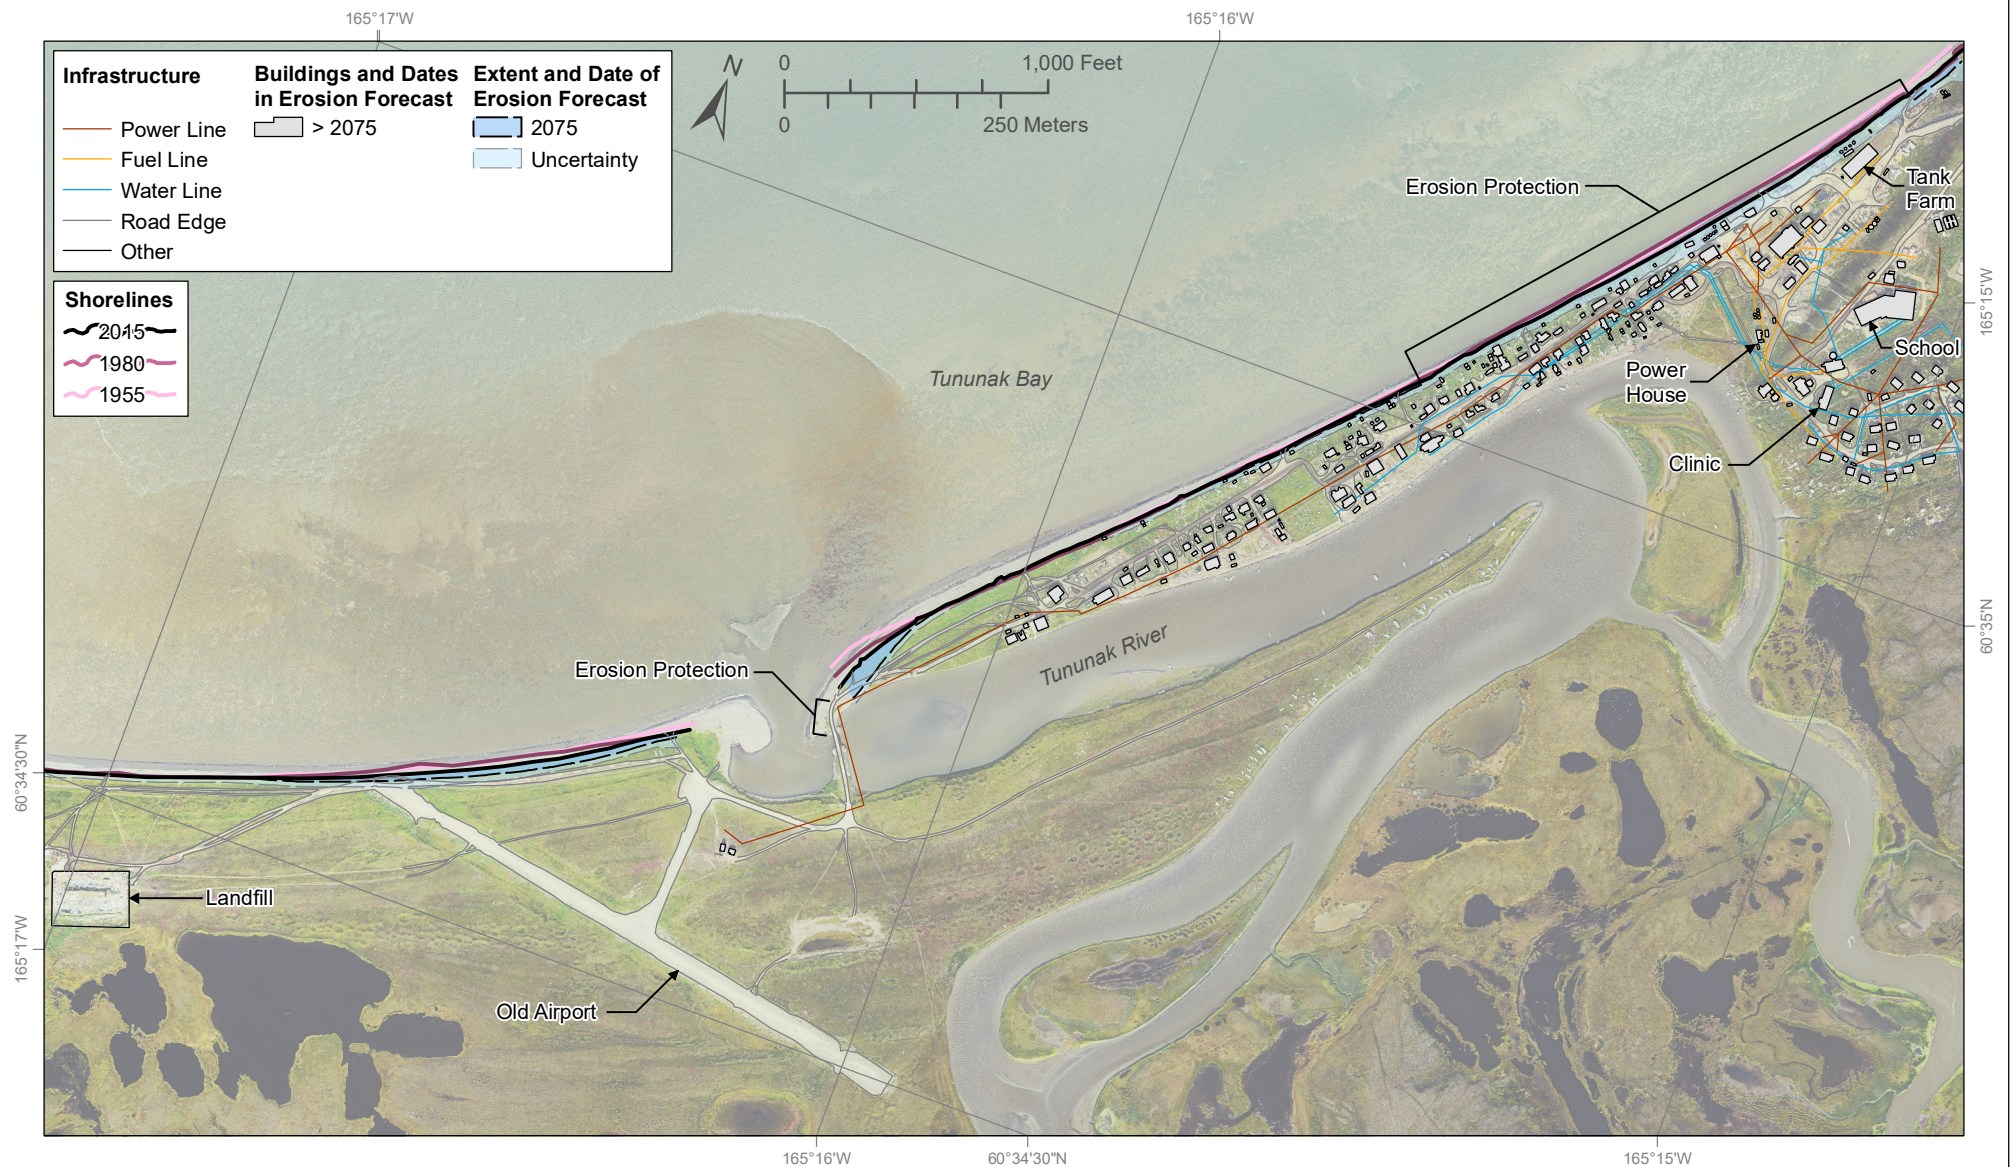
Report of Investigation 2021-3
Buzard and others, 2021
Tununak, Sheet 1 of 1

Erosion and accretion of coasts and rivers result in shoreline change. These rates of shoreline change at Alaska communities are calculated from historical and modern shorelines (shorelines shown as lines in pinkscale and labeled by year). The long-term (1955 to 2015) shoreline change rate is used to forecast where erosion could impact community infrastructure. Erosion is forecast to year 2075 (dark blue) with a 90 percent confidence interval area of uncertainty (light blue). Buildings forecast to be impacted by erosion are colored by the range of years when the impact is forecast to occur: 2015 to 2035 (purple), 2035 to 2055 (orange), 2055 to 2075 (yellow), and no impacts expected by 2075 (gray). For more detailed information about the impacts to infrastructure from erosion at Tununak, refer to the Tununak erosion exposure assessment report.
