PRELIMINARY LANDSLIDE INVENTORY OF PARTS OF THE FAIRBANKS NORTH STAR BOROUGH, ALASKA

Report of Investigation 2022-1

State of Alaska
Department of Natural Resources
Division of Geological & Geophysical Surveys

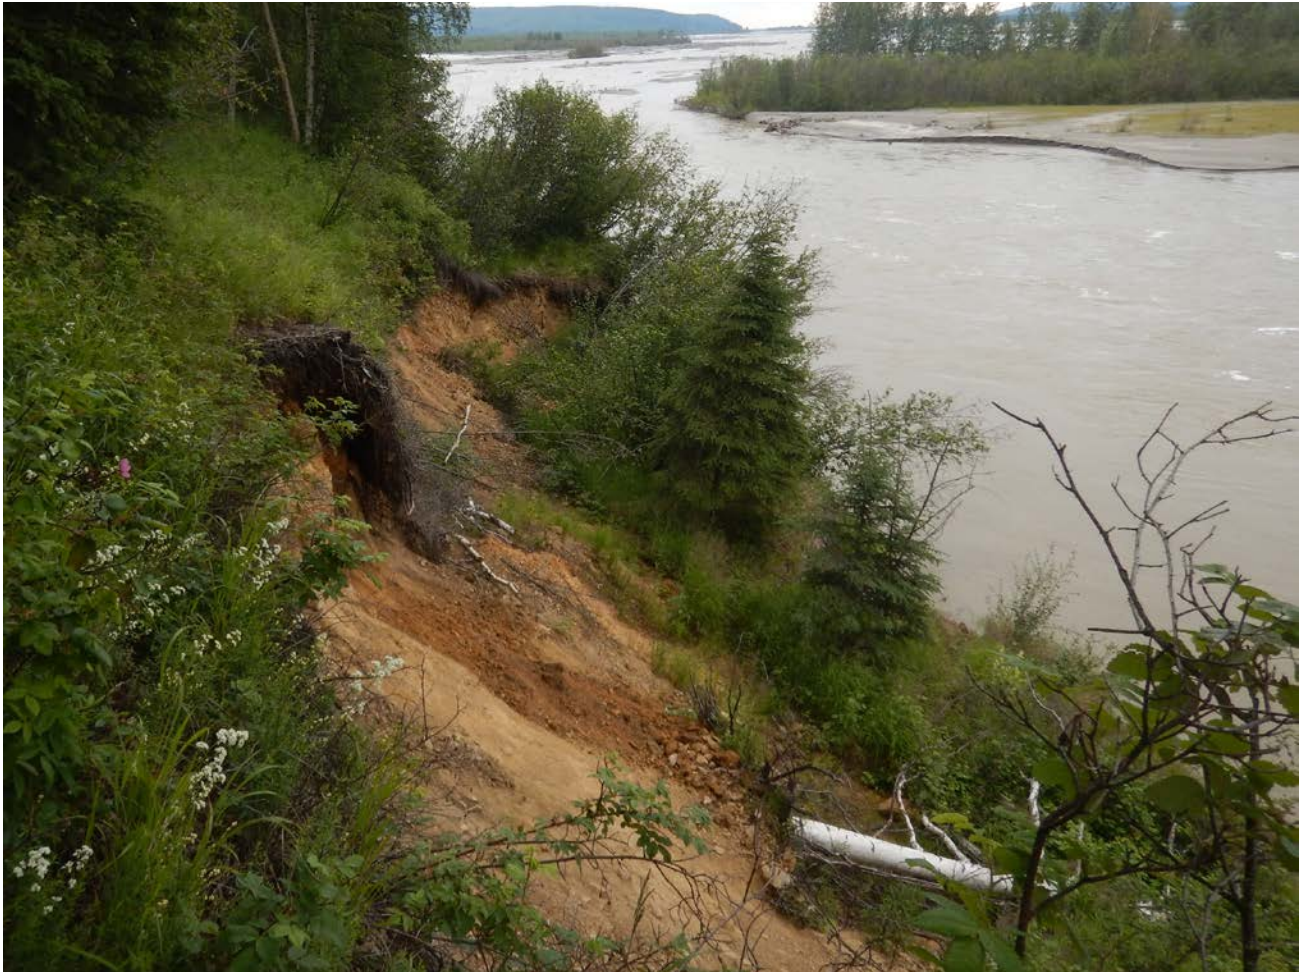
Photograph of the small head scarp of a landslide in colluvium adjacent to the Tanana River.

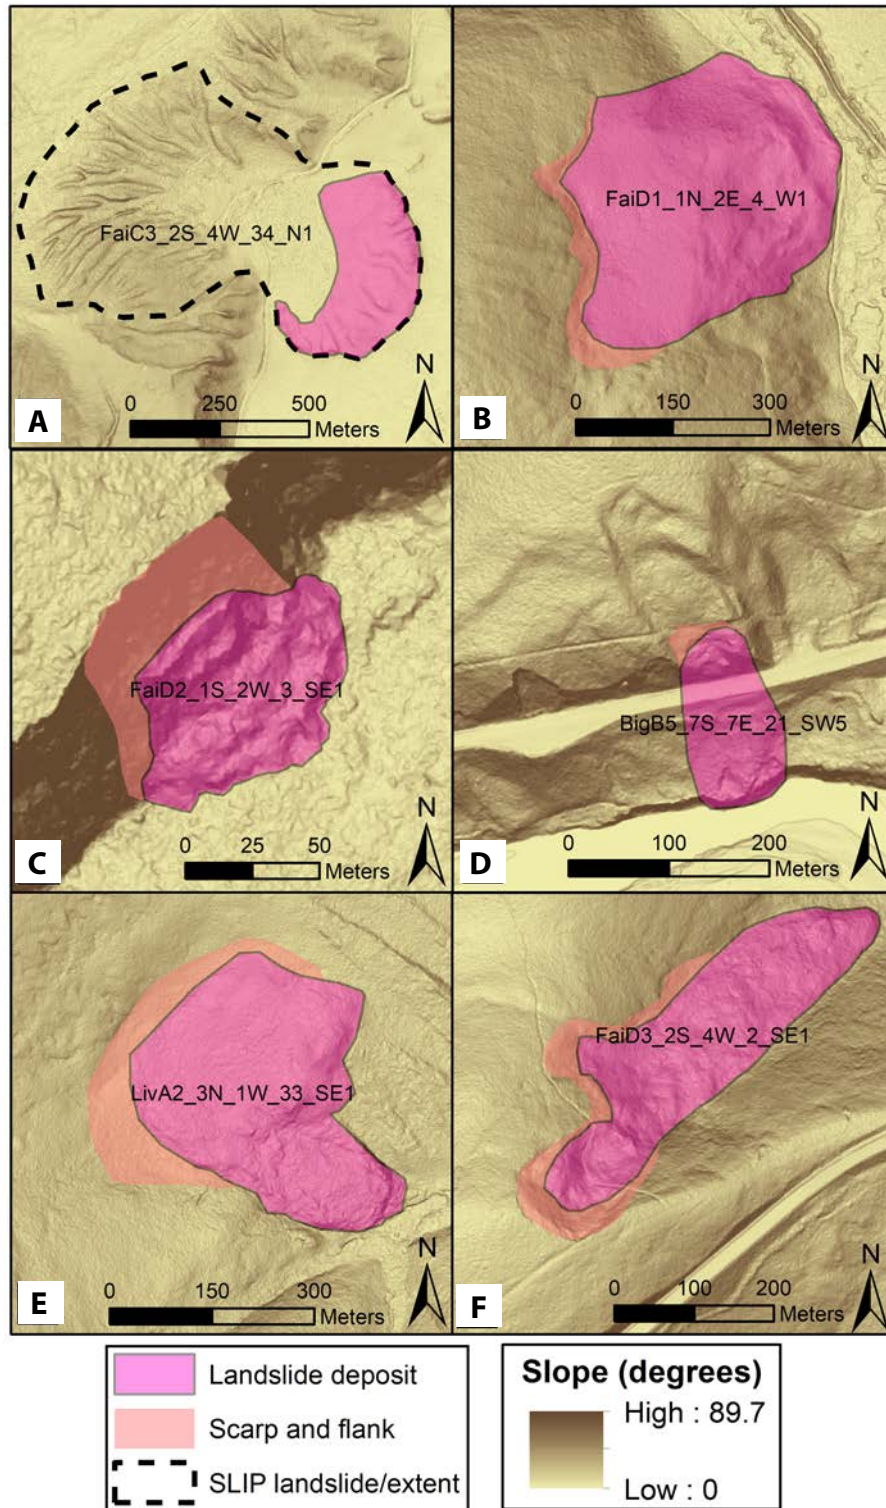
Figure 6. Representative field-checked landslides of various ages and material types: prehistoric landslides in (A) soil (deposits of other slides are also present in the imagery) and (B) bedrock; historic landslides in (C) soil and (D) bedrock (scarps of prehistoric slides are also present in the imagery); modern landslides in (E) soil and (F) bedrock. The background is lidar-derived slope map.

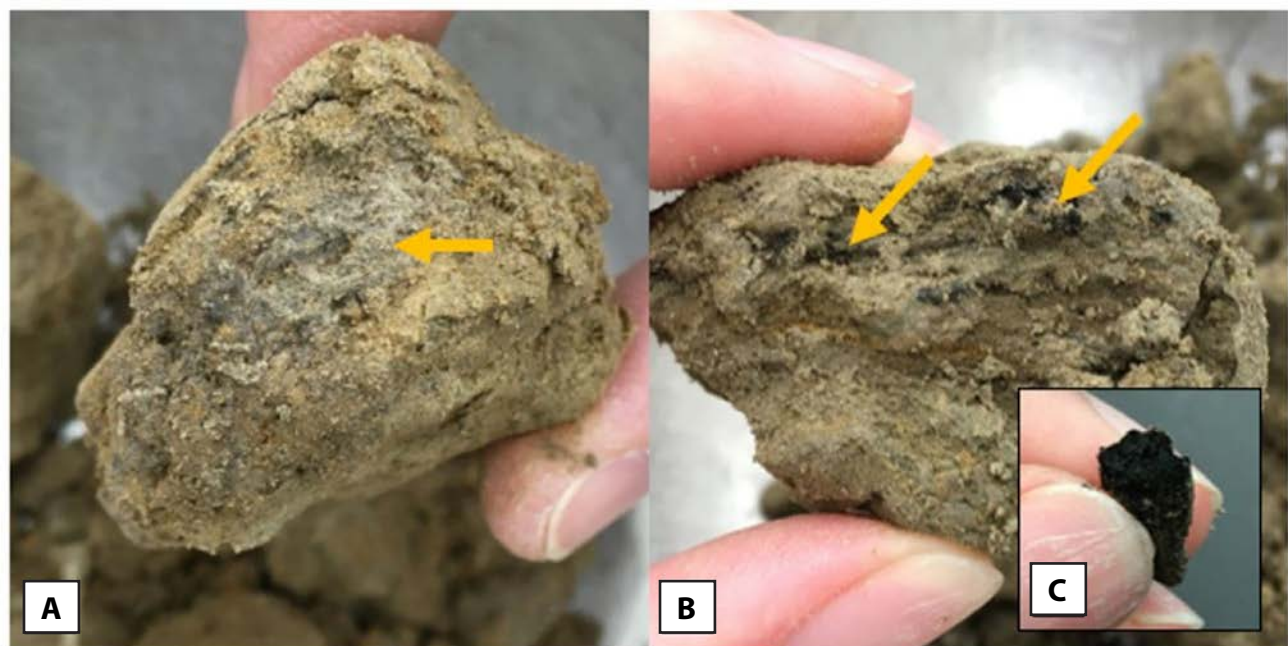
Figure 7. Photos of organic samples submitted for radiocarbon dating. **A.** TH06 paleosol layer (indicated by arrow). **B.** TH08 charcoal pieces within the soil mass (indicated by arrows). **C.** TH08 charcoal piece extracted from the soil.

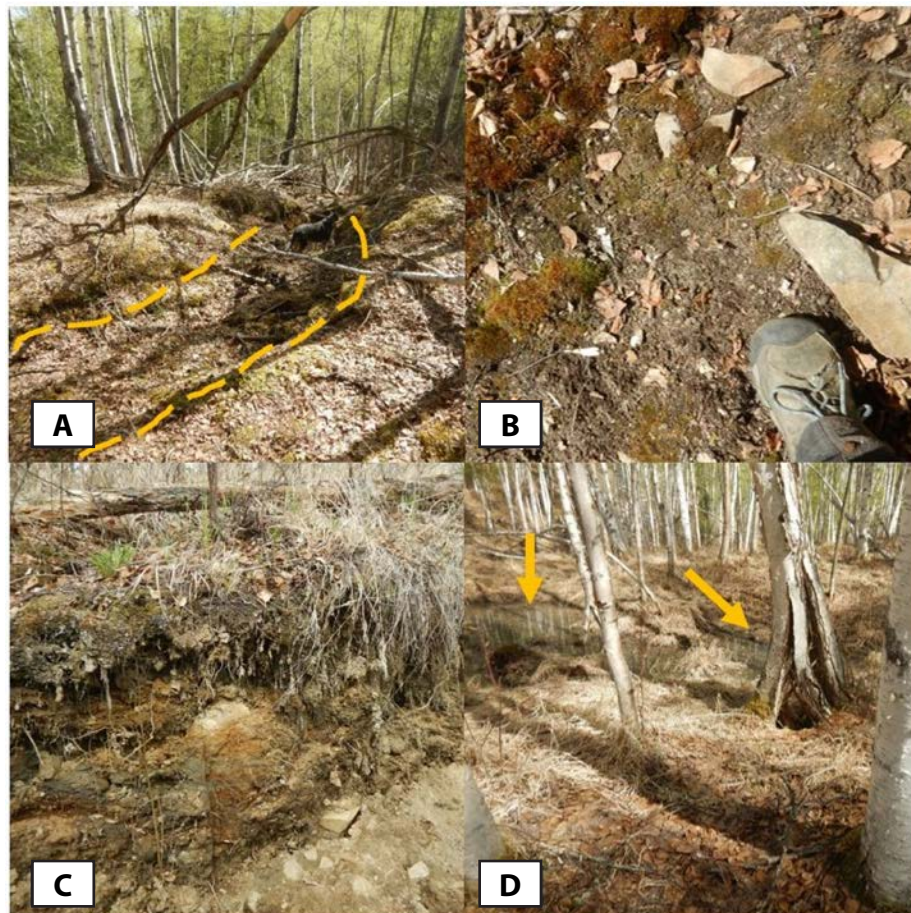
We accessed the landslide (fig. B1) from the west, walking down the right flank (10) to the toe area (10), and then returning uphill along the left flank until we intersected an internal scarp (10). At that point, we followed the same path away from the landslide. The morphology indicates a large, prehistoric landslide event, which occurred north of the currently active area, that forms a relatively flat area followed by a large hill mid-slope. Part of the mid-slope hill failed historically, forming the current, smaller, lower landslide. The forest covering the area contains many leaning and split trees, multiple transverse and longitudinal cracks, sag ponds, grabens, and minor scarps. Splits in most of the trees appear to be old, and the way that some of the birch trees and spruce trees have recovered suggests that the historic event occurred at least 50 years ago. One of the split spruce trees above and to the west of the main internal scarp indicates more recent splitting, suggesting that the landslide is currently active.

Figure A1. Images of LivA2_3N_1W_33_SE1 from May 15, 2020. **A.** Dashed lines indicate extent of crack (dog for scale), **(B)** rock and soil at the toe, **(C)** exposed soil at the main internal scarp, and **(D)** a split, leaning tree (right arrow) and sag pond in a graben (left arrow). Photographs taken by MD.

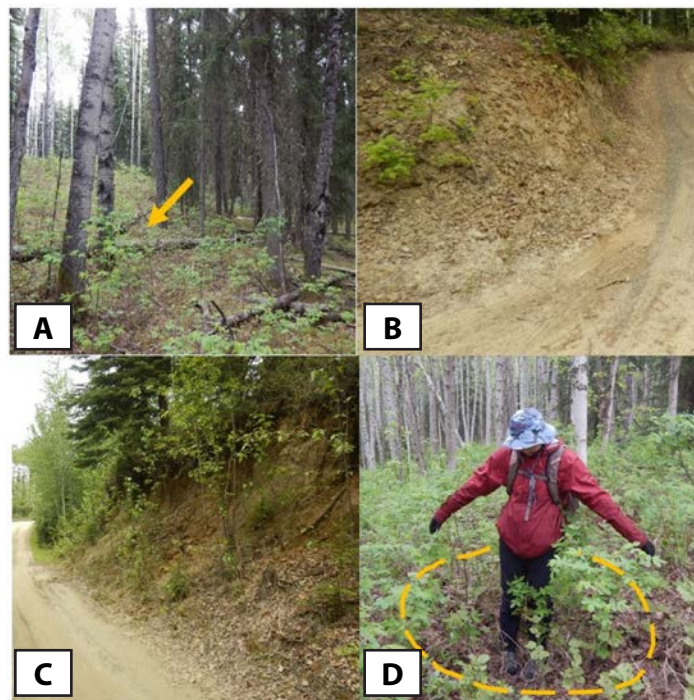
Figure A2. Images of FaiD3_2S_3W_12_W1 from May 28, 2020. **A.** Vegetation transition at the toe (indicated by arrow) from birch forest to black spruce, **(B)** silt exposure along the right flank, **(C)** silt exposure along the inner toe, and **(D)** JAS standing in a depression (outlined by dashed line) near the head scarp. Photographs taken by MD.

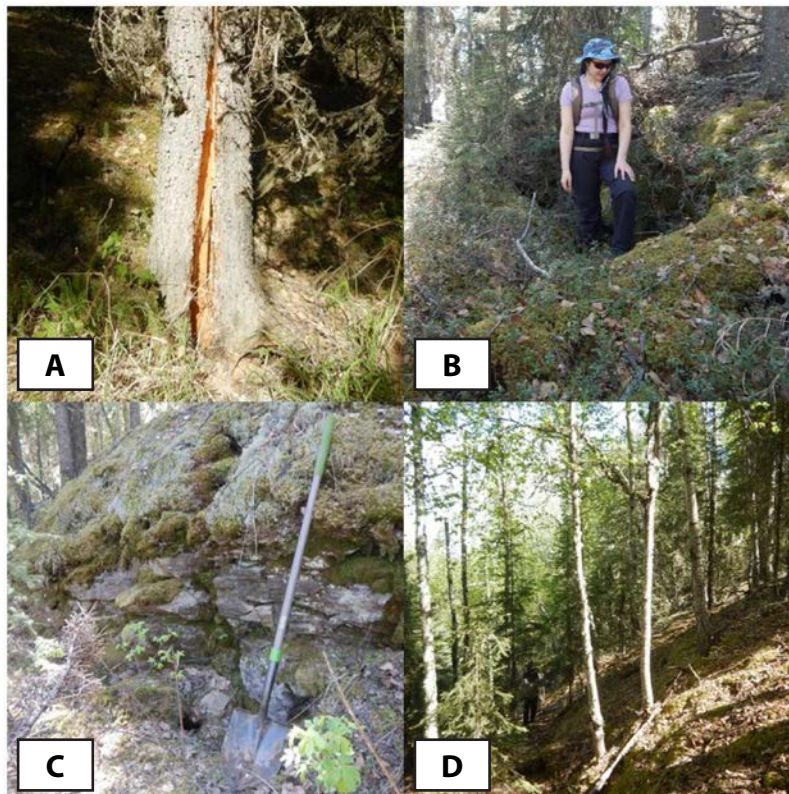
This landslide (fig. B3) is adjacent to and north of the Parks Highway. We accessed the landslide from the south, walking north across the head scarp then downslope along the body to the toe. We returned to the road following a similar route. We observed strong evidence of the head scarp (10), flanks (10), toe/deposits (10), and morphology (10). Observed morphology included internal scarps, closed depressions, hummocky topography, mid-slope terraces, tension cracks, seeps, wetland areas, and fresh soil/rock at the toe. Vegetative indicators of slope movement included jayed, leaning, and cracked trees throughout the landslide body. We observed schist exposures at the head scarp, throughout the body, and along the flanks; thus the material type was predominantly schist bedrock, with silt and other granular debris present near the toe. The vegetation shifted from white spruce and birch at the head to black spruce and moss across the bottom part of the landslide body. This vegetation change may indicate the presence of frozen ground at the toe. We also observed surface wetness at the toe. Overall this landslide is prehistoric, with apparent historic movement and current, ongoing movement at the toe. It is possible that the movement at the toe is due to creep, and the landslide is similar in morphology and movement to frozen debris lobe (FDL) features observed in the Brooks Range.

Figure A3. Images of FaiD3_2S_4W_2_SE1 from May 29, 2020. **A.** Fresh cracked spruce tree near the head scarp, **(B)** JAS standing in a crack on the slide surface, **(C)** schist bedrock exposure at the scarp (shovel for scale), and **(D)** the right flank viewed from the head scarp area (RD for scale). Photographs taken by MD.

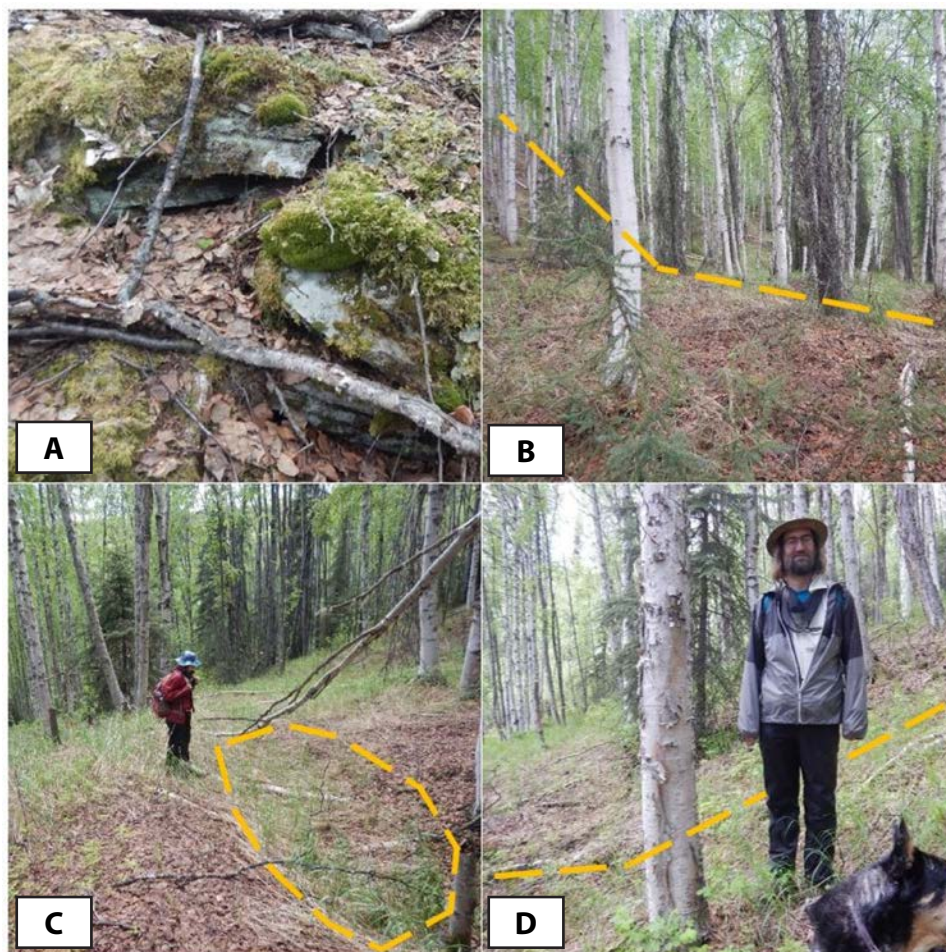
We hiked down to the head scarp region, then traveled along the left flank toward the toe. We visited other landslides (fig. B4) before we returned along the right flank and back up the head scarp. The key features were the head scarp (10), flanks (7), toe (10), and morphology (10). Morphology included closed depressions, mid-slope terraces, cracks, and prehistoric swales. The flanks were less obvious in the field compared to the lidar data, but we accurately located them as our GPS field station points were comparable to the mapped landslide. We saw exposed schist bedrock at the landslide head, and took one strike and dip measurement of 020/26. Ridges and internal roughness were due to the presence of bedrock. We saw a few jayed trees, but these were not due to landslide movement. The vegetation on the landslide was mature birch and spruce forest.

Figure A4. Images of FaiD3_1N_4W_1_NE1 from June 2, 2020. **A.** Bedrock exposure near the head scarp, **(B)** dashed line indicates slope break along the left flank, **(C)** JAS standing at the edge of a closed depression (dashed line indicates extent), and **(D)** RD and dog along the slope break at the toe (indicated by dashed line; view to the southwest). Photographs taken by MD.

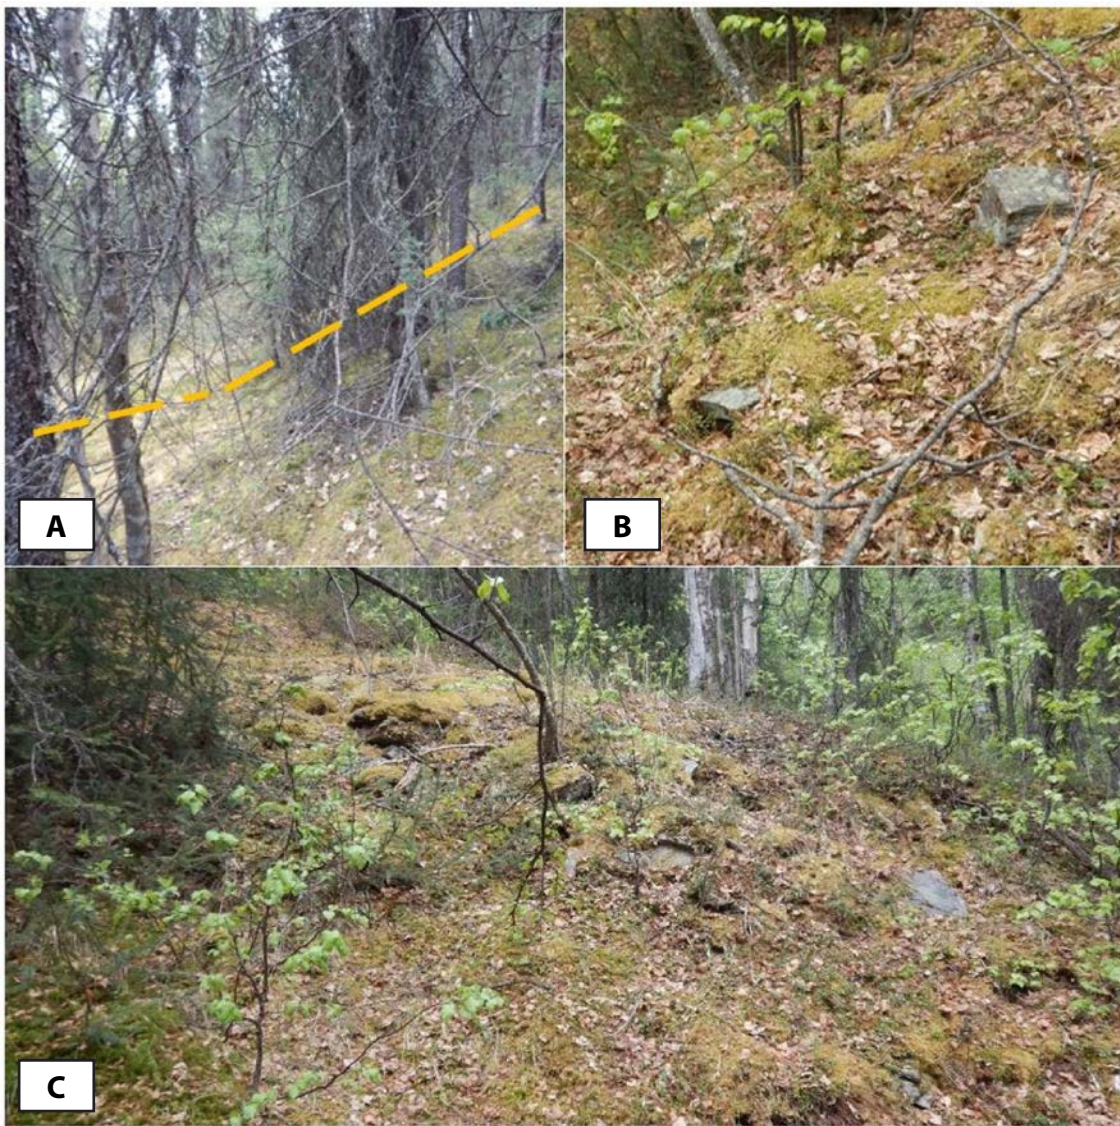
Figure A5. Images of FaiD3_1N_4W_1_NE3 from June 2, 2020. **A.** Slope break near the head scarp region (indicated by dashed line), **(B)** small bedrock exposure near the toe, and **(C)** weathered bedrock exposure near the toe. Photographs taken by MD.

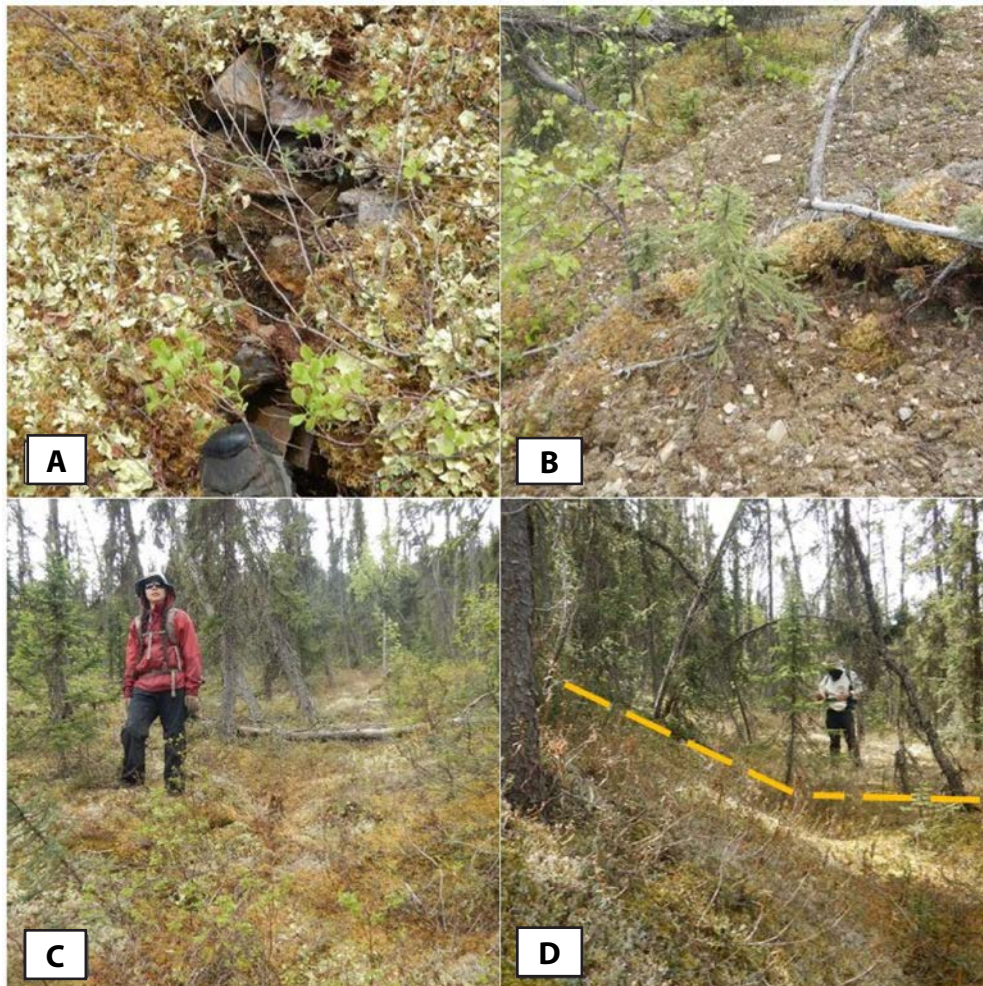
Figure A6. Images of FaiD3_1N_4W_1_NE2 from June 2, 2020. **A.** Bedrock exposure in a moss crack, **(B)** bare mineral soil on the slope adjacent to the right flank, **(C)** JAS standing among the typical vegetation of moss, lichen, and black spruce on the landslide body, and **(D)** slope break at the head scarp (RD as scale). Photographs taken by MD.

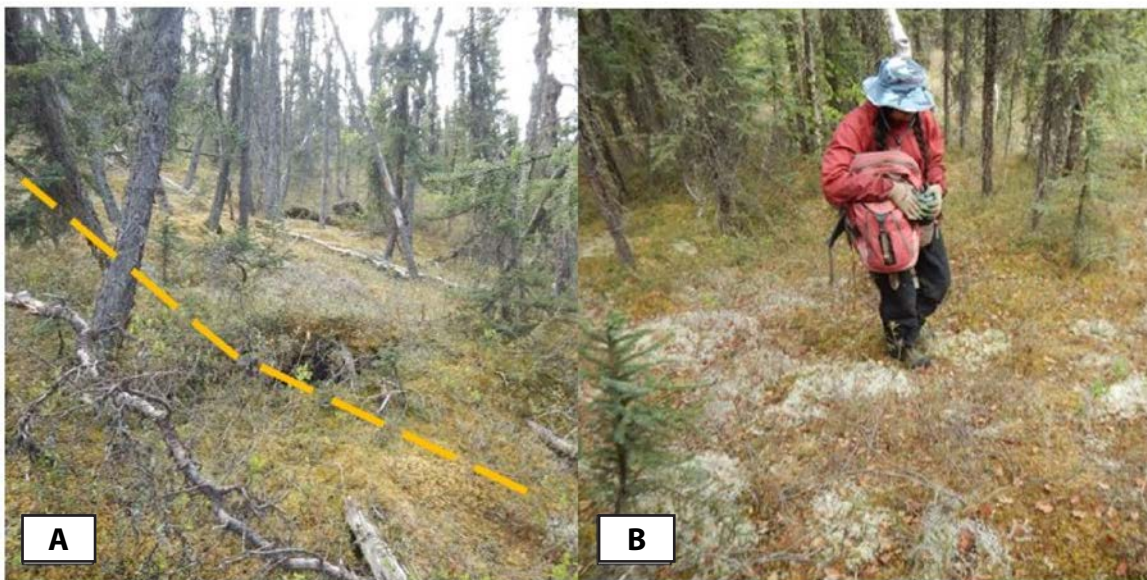
Figure A7. Images of FaiD3_1N_3W_6_NW1 from June 2, 2020. **A.** Subtle upslope slope break at the head scarp region (indicated by dashed line), and **(B)** JAS standing on a bedrock ridge covered with lichen slightly upslope of the head scarp region. Photographs taken by MD.

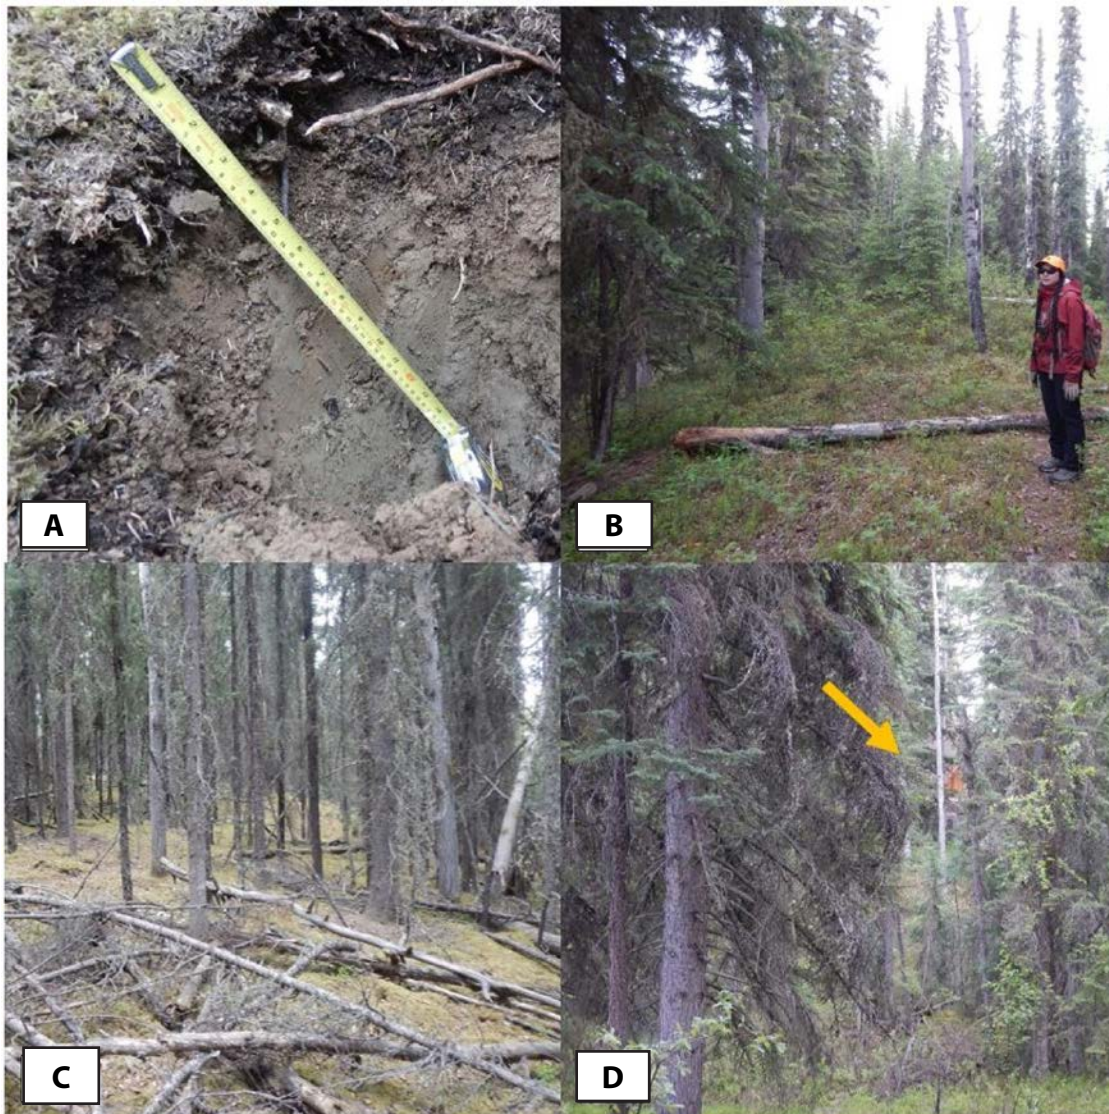
Figure A8. Images of FaiD2_1N_1W_30_SE1 from June 5, 2020. **A.** Silt in a small test pit (tape measure for scale; silt was cold to the touch), **(B)** JAS standing on the middle toe bump, **(C)** the view along a toe bump ridge, and **(D)** a house built on a toe bump (indicated by arrow). Photographs taken by MD and JAS.

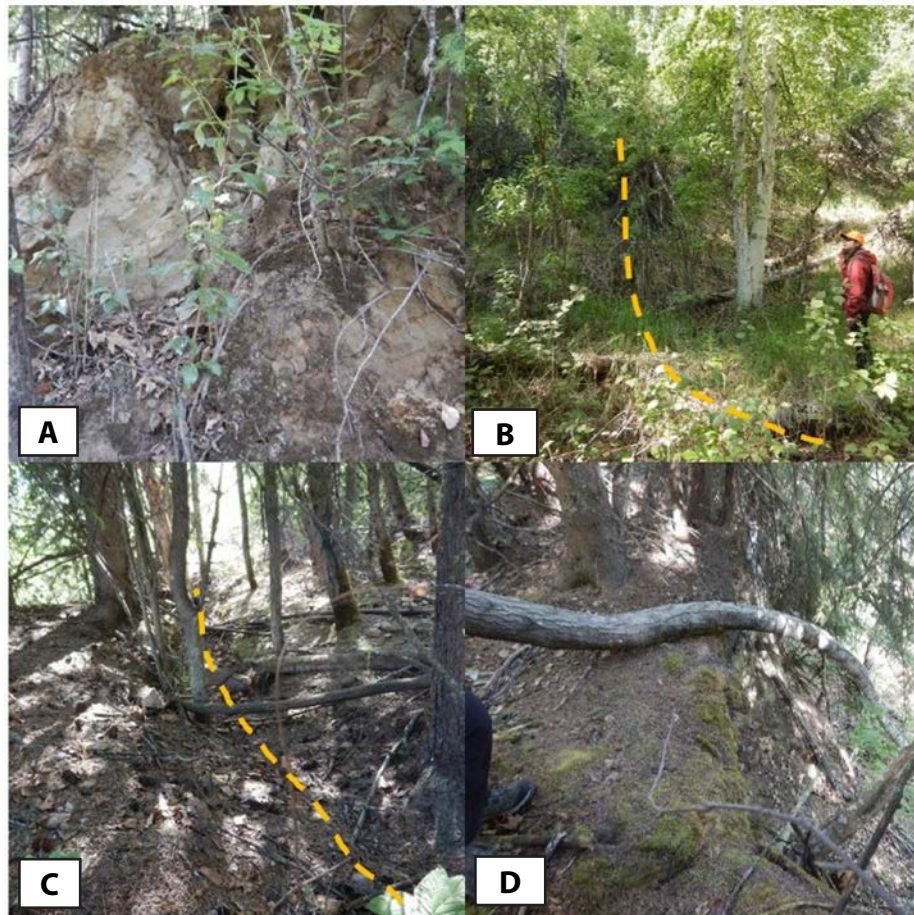
Figure A9. Images of FaiD2_1S_2W_3_SE1 from June 5, 2020. **A.** Silt exposure at a minor scarp, **(B)** JAS standing in a gaben (indicated by dashed line), **(C)** tension crack above the scarp (indicated by dashed line), and **(D)** looking along the steep head scarp. Photographs taken by MD.

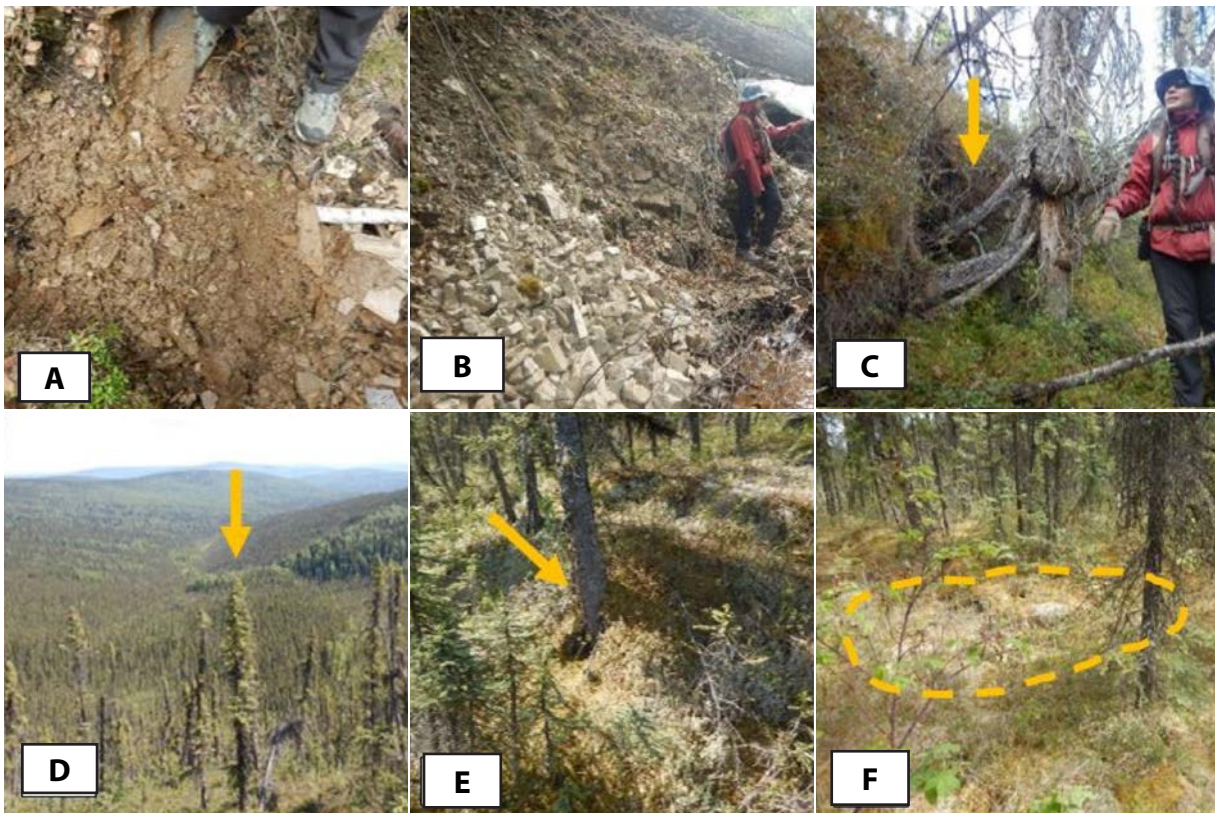
Figure A10. Images of FaiD2_2N_1W_17_SW2 from June 8, 2020. **A.** Colluvium at the toe, **(B)** JAS next to exposed bedrock across the creek from the landslide toe, **(C)** JAS standing next to a tree being overrun by the landslide toe (indicated by arrow), **(D)** view down the landslide body toward the toe (location indicated with an arrow), **(E)** solifluction lobe flowing around a tree (indicated by arrow), and **(F)** dashed line delineating a closed depression on the toe. Photographs taken by MD.

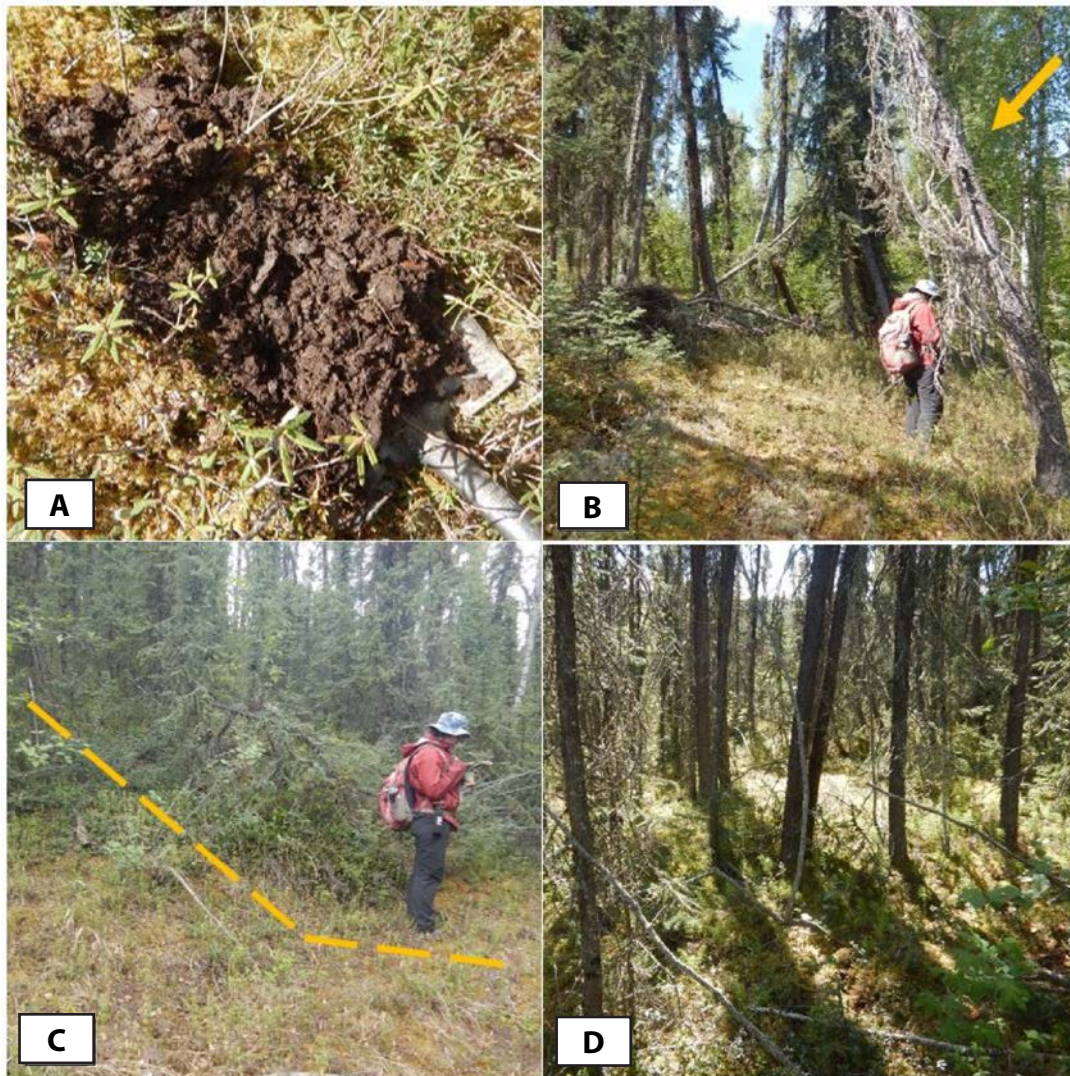
Figure A11. Images of FaiD2_2N_1W_17_SW1 from June 8, 2020. **A.** Organic silt with wood pieces observed in a test pit along the left flank, **(B)** JAS standing amongst leaning trees, **(C)** JAS standing on a faint slope break along the left flank, and **(D)** typical vegetation and surface roughness on the body. Photographs taken by MD and JAS.

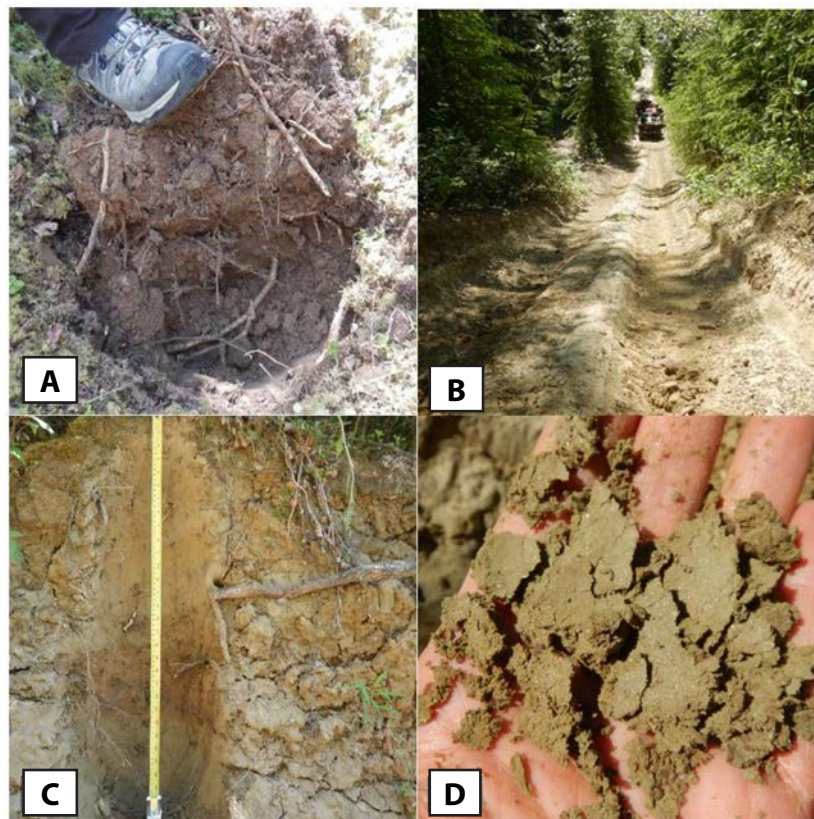
Figure A12. Images of FaiD3_2S_3W_10_NE2 from June 11, 2020. **A.** Test Pit 6 in silt, **(B)** view down the trail that steeply descends a toe bump, **(C)** cleaned silt exposure at the top of the toe bump, and **(D)** close view of the micaceous silt from the silt exposure. Photographs taken by MD and JAS.

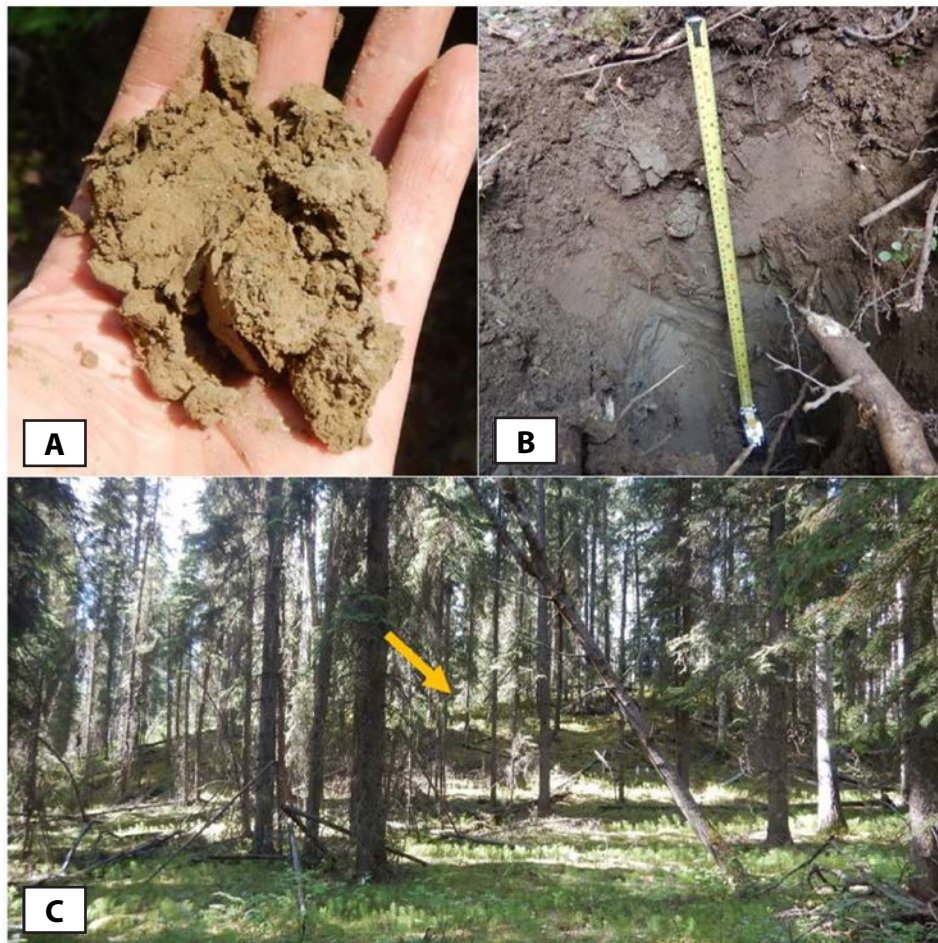
Figure A13. Images of FaiD3_2S_3W_10_NE1 from June 11, 2020. **A.** Silt from TP3, **(B)** TP5 dug in silt to frost depth, and **(C)** view of one of the numerous toe bumps (arrow indicates the upper surface). Photographs taken by MD and JAS.

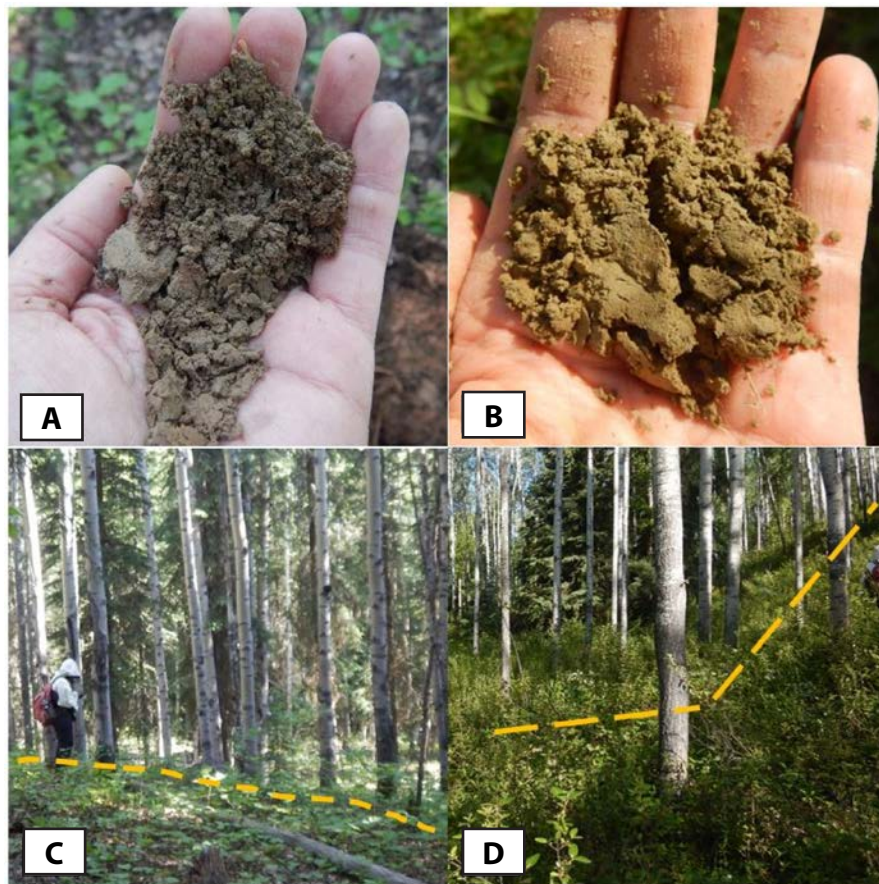
Figure A14. Images of FaiC3_2S_4W_32_SW1 from June 12, 2020. **A.** Silt from a test pit dug on a toe deposit, **(B)** silt from a test pit dug near the left flank, **(C)** JAS standing along the slope break boundary at the end of the toe deposit (dashed line), and **(D)** slope break (dashed line) on a dropped block along the left flank. Photographs taken by MD.

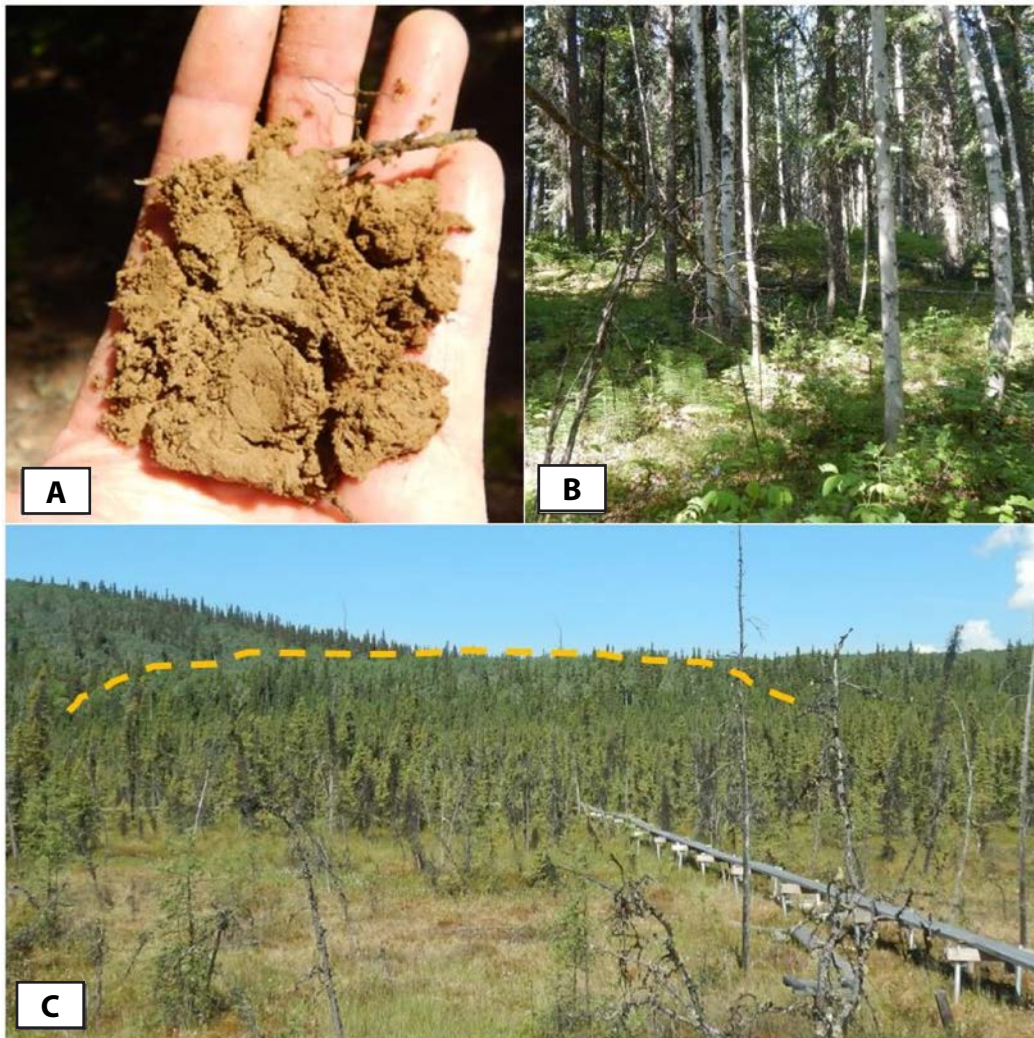
Figure A15. Images of FaiC3_2S_4W_34_N1 from June 12, 2020. **A.** Silt from a test pit dug on a toe deposit, **(B)** view of a toe deposit, and **(C)** view of the toe deposits (location indicated by dashed line) from the fen downslope of the landslide. Photographs taken by MD.

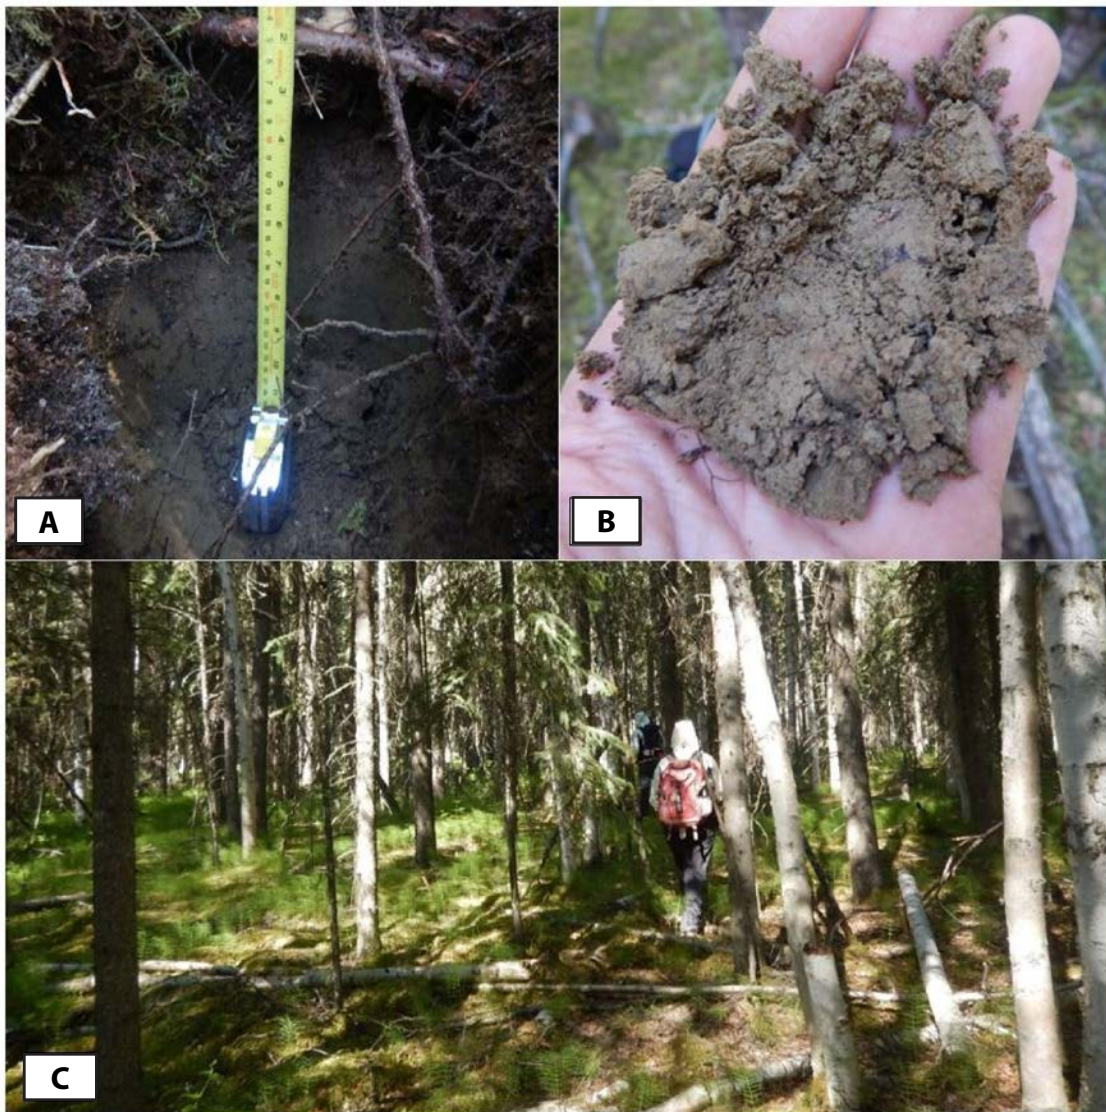
Figure A16. Images of FaiC3_2S_4W_34_NE1 from June 12, 2020. **A.** Test pit dug into silt on a toe deposit, **(B)** silt taken from the test pit in **(A)**, and **(C)** JAS and RD amongst the typical vegetation on the toe deposits. Photographs taken by MD and JAS.

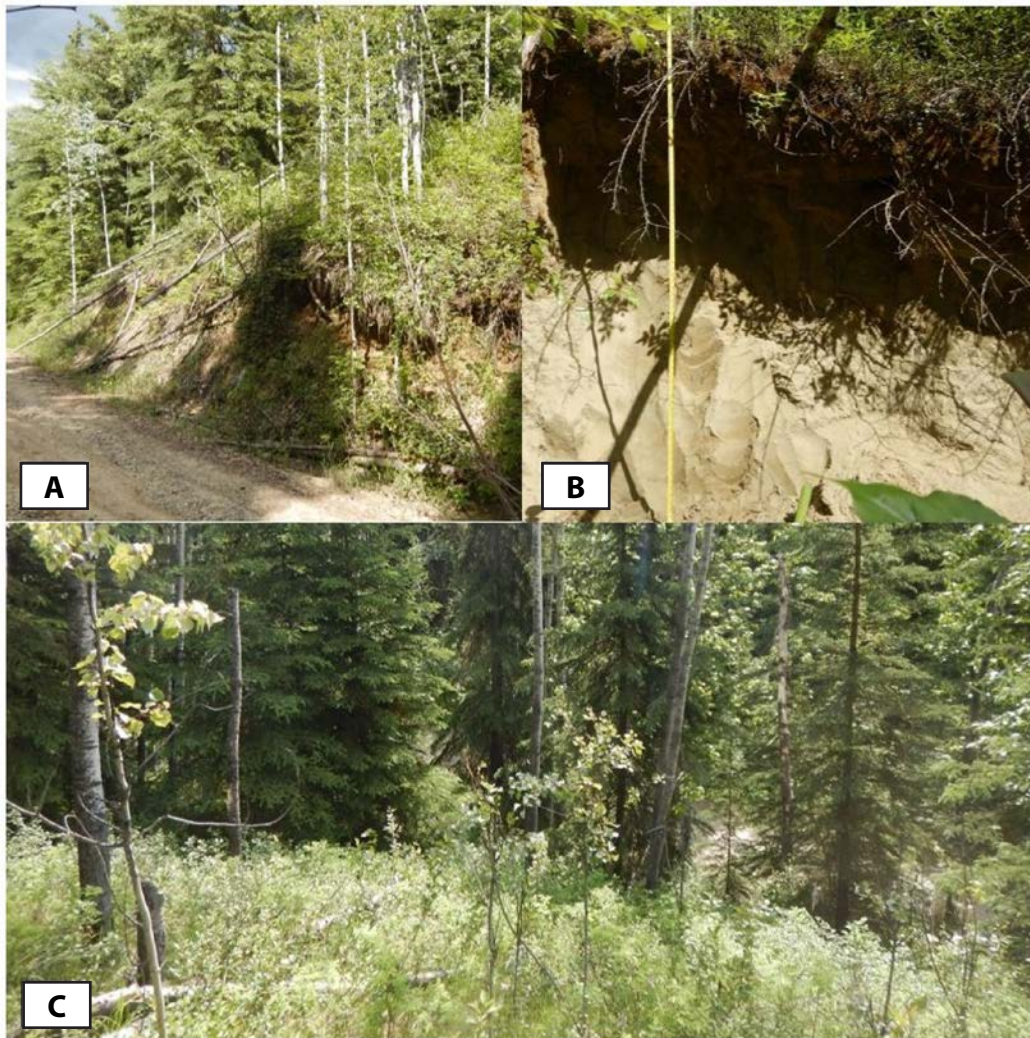
Figure A17. Images of FaiC3_2S_4W_27_SE2 from June 12, 2020. **A.** Silt exposure along the road cutting into the toe deposits, **(B)** cleaned off silt exposure at Site 2, and **(C)** view down the steep distal slope of the toe deposit toward the road. Photographs taken by MD and JAS.
