PRELIMINARY LANDSLIDE INVENTORY OF PARTS OF THE FAIRBANKS NORTH STAR BOROUGH, ALASKA

Report of Investigation 2022-1

State of Alaska
Department of Natural Resources
Division of Geological & Geophysical Surveys

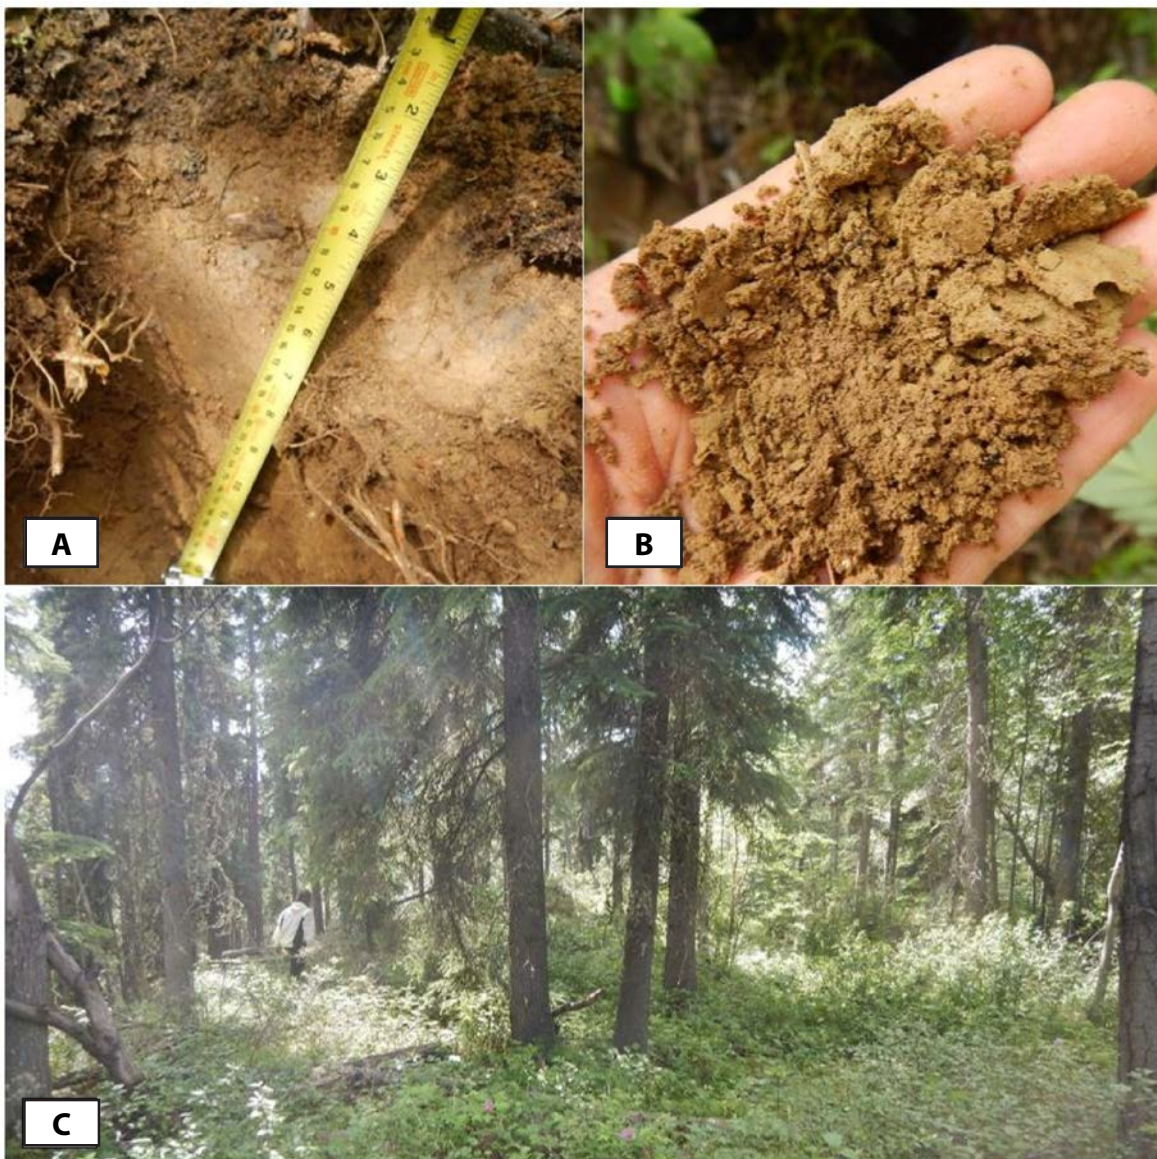
Figure A18. Images of FaiC3_2S_4W_27_SE1 from June 12, 2020. **A.** Test pit in silt dug in the head scarp region, **(B)** silt sample from the test pit, and **(C)** RD and typical vegetation on the upper landslide body near the left flank. Photographs taken by MD and JAS.

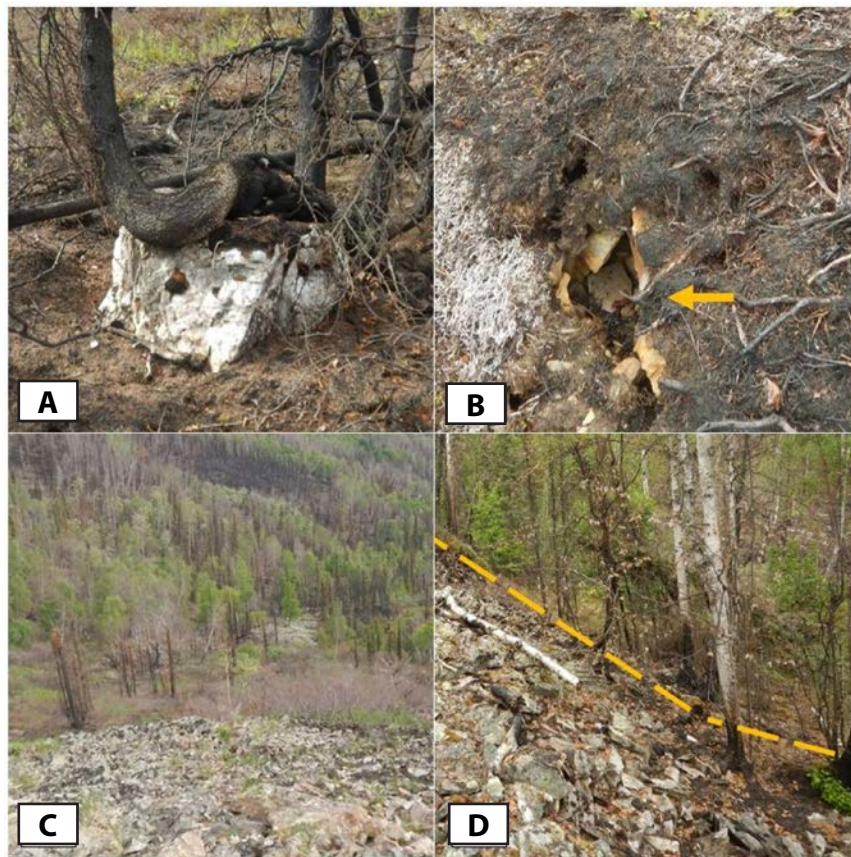
Figure A19. Images of FaiD3_2N_4W_34_SE1 from June 15, 2020. **A.** An exposed quartz boulder near the head scarp region, **(B)** cracks in the vegetation (indicated with arrow) due to the burn or to landslide movement, **(C)** view down the landslide body toward the toe with lichen-covered rock debris, and **(D)** lichen-covered rock debris forming the toe deposit, with slope break indicated by dashed line. Photographs taken by MD and JAS.

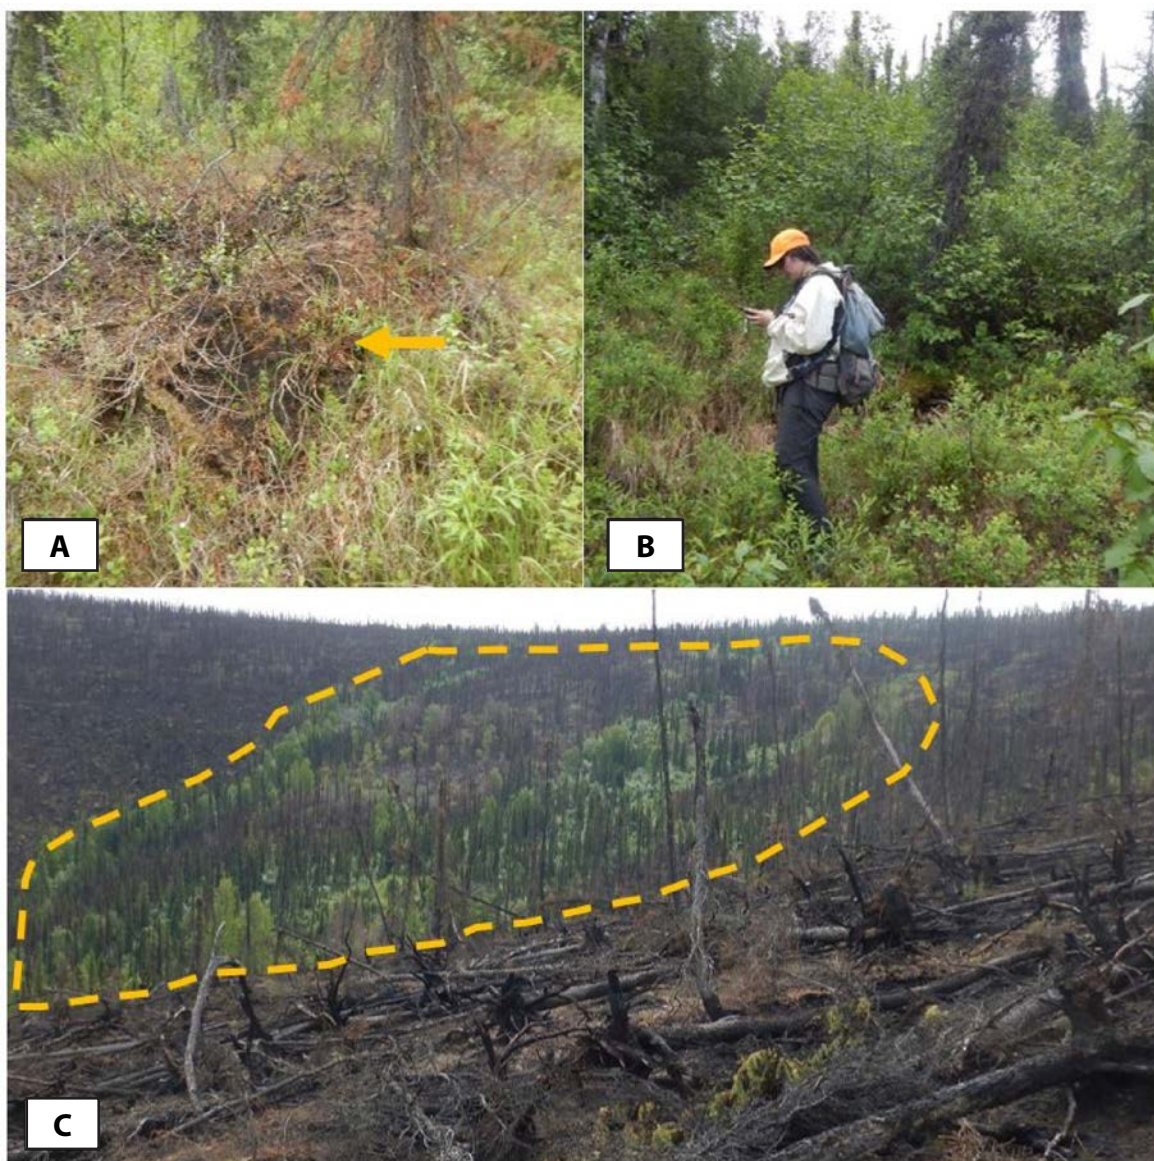
Figure A20. Images of FaiD3_2N_4W_35_SW1 from June 15, 2020. **A.** Possible solifluction lobe along the left flank (indicated by arrow, and burned from recent fire), **(B)** JAS standing in a wet area at the toe, and **(C)** view of the landslide (delineated by dashed line) looking south. Photographs taken by MD.

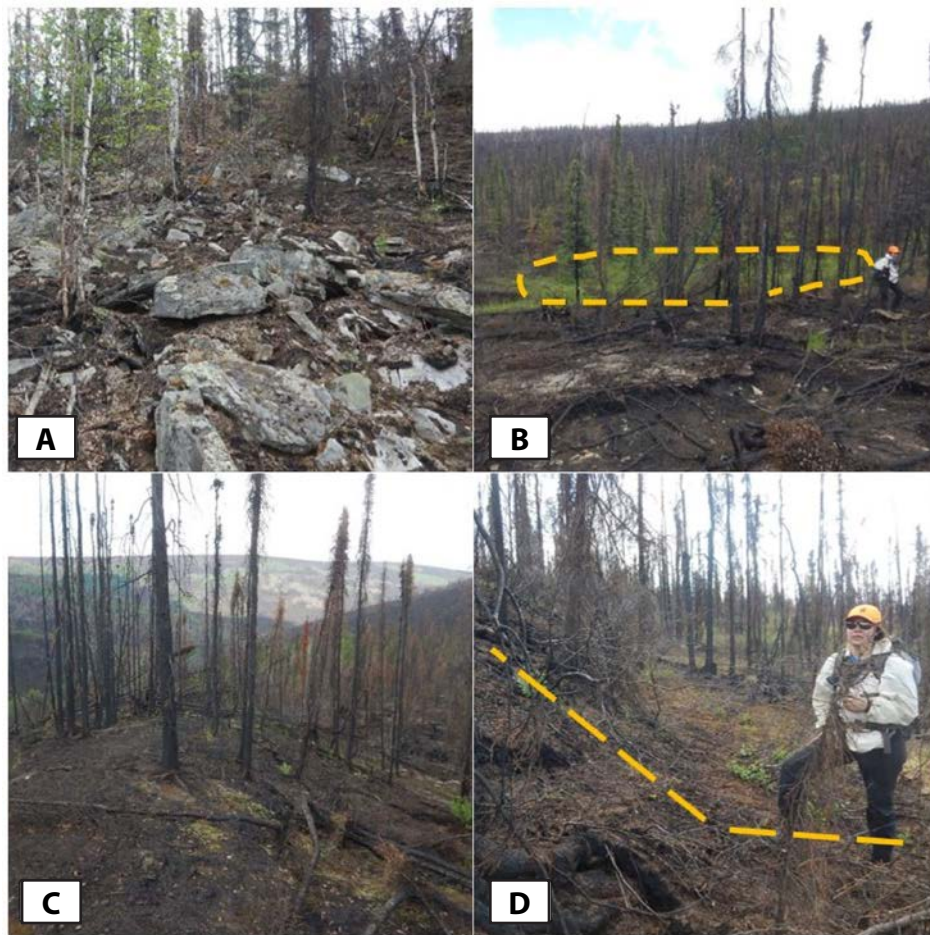
Figure A21. Images of FaiD3_2N_4W_35_SE1 from June 15, 2020. **A.** Looking upslope of the toe deposit covered with weathered rock debris, **(B)** JAS standing in front of a graben (delineated by dashed line) on the landslide body, **(C)** ridge on the landslide body, and **(D)** JAS standing on the slope break at the head scarp (delineated by dashed line), looking towards the left flank. Photographs taken by MD.

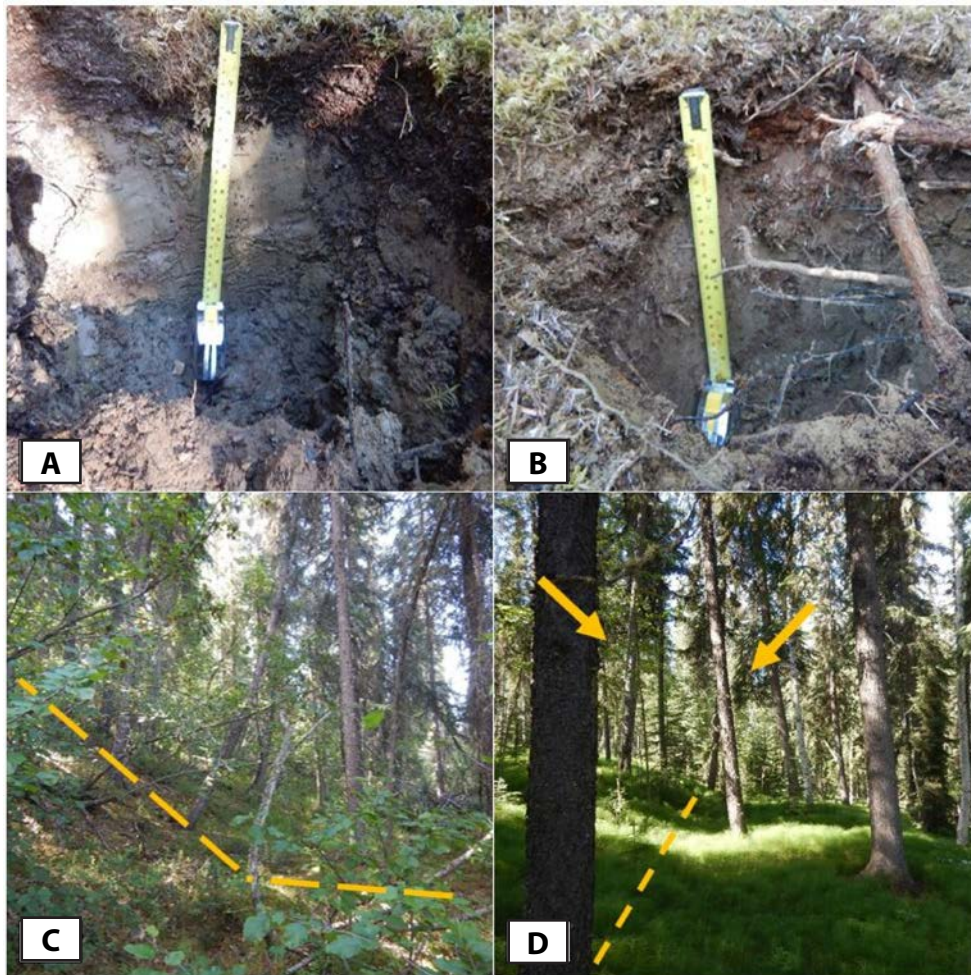
Figure A22. Images of FaiD2_1N_1W_18_SE1 from June 18, 2020. **A.** Silt profile with frozen soil at depth at first inner toe bump to the east, **(B)** silt profile with dry to moist soil on the large, inner toe bump, **(C)** slope break (indicated by dashed line) and leaning trees along the distal slope of a toe bump, and **(D)** leaning trees (indicated by arrows) along a linear feature (indicated by dashed line) on an inner toe bump. Photographs taken by MD and JAS.

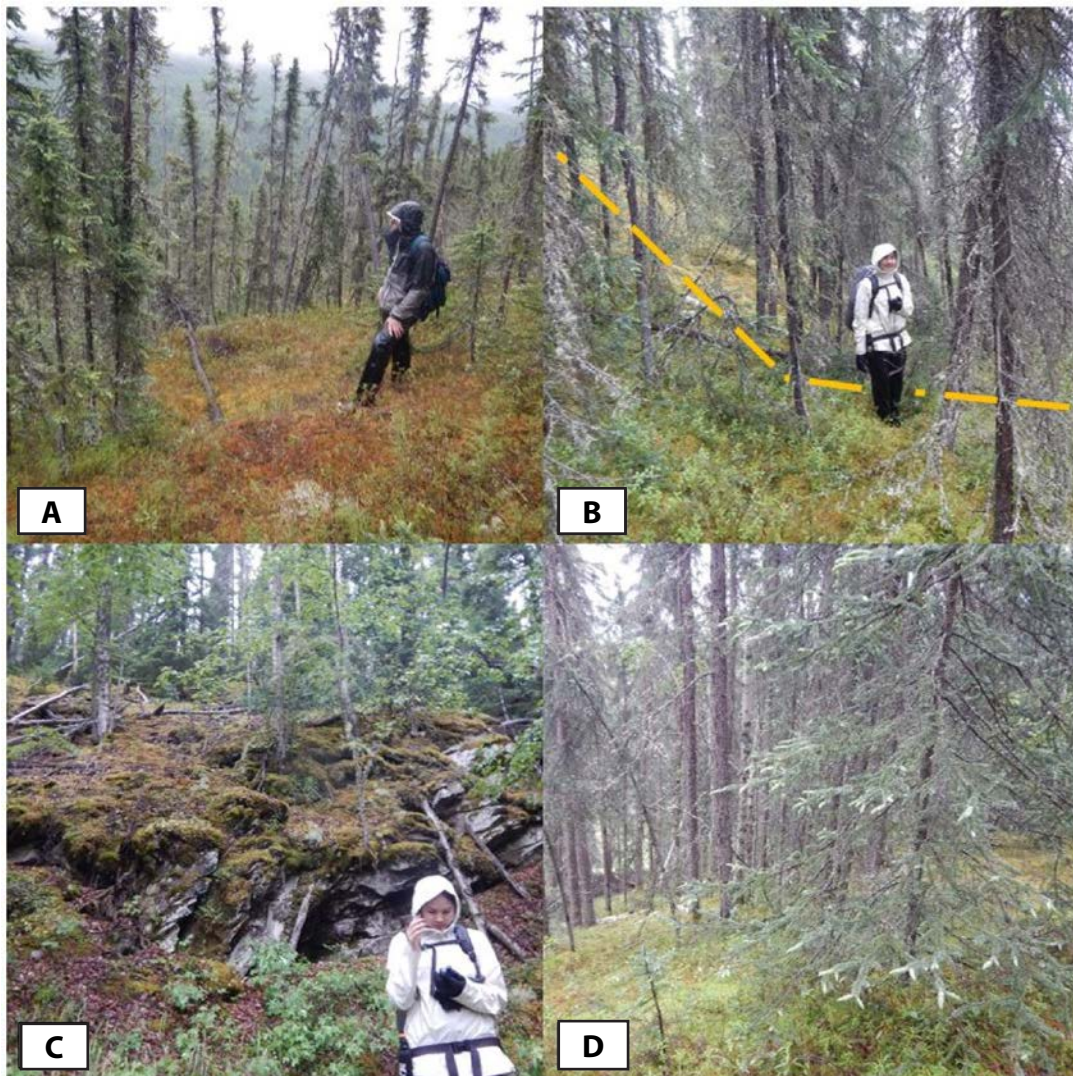
Figure A23. Images of FaiD1_1N_2E_4_W1 from June 19, 2020. **A.** RD standing on hummocky topography on the landslide body, **(B)** JAS standing along the slope break (indicated by dashed line) of the left flank and body, **(C)** JAS standing in front of the steep head scarp with exposed schist bedrock, and **(D)** view down the steep distal slope of the toe. Photographs taken by MD.

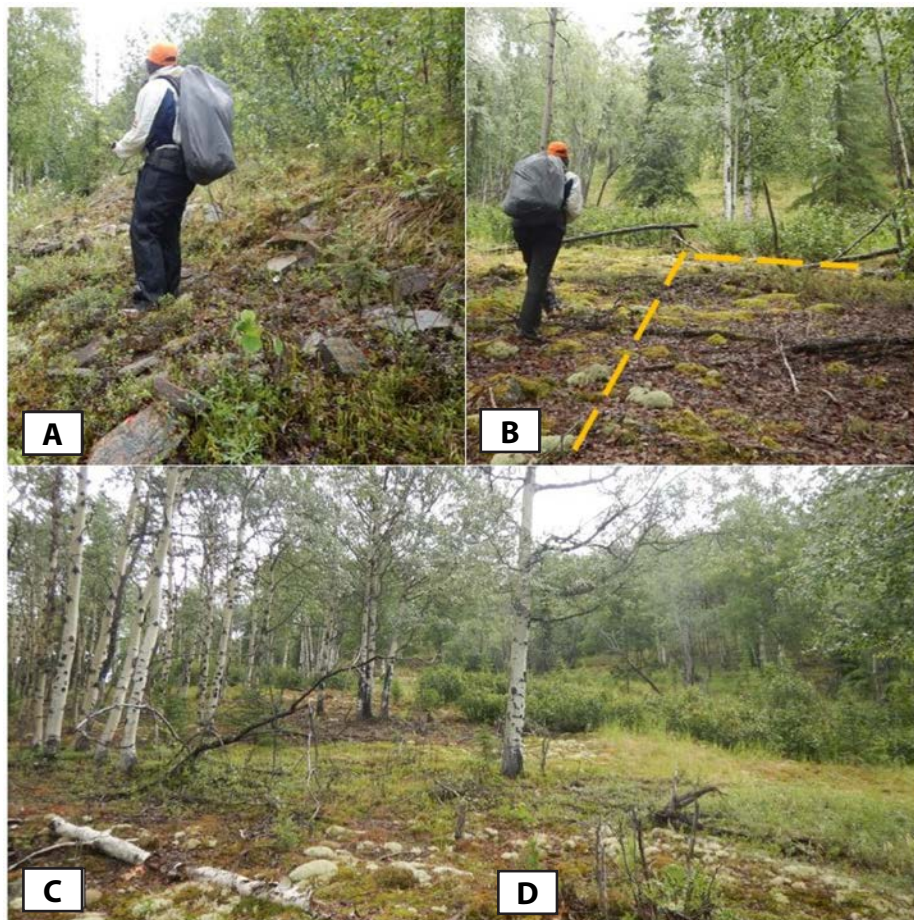
Figure A24. Images of FaiD3_1N_3W_36_NW1 from June 24, 2020. **A.** JAS standing in a rocky area along the right flank, **(B)** JAS hiking upslope toward a bench on the landslide body (slope break indicated by dashed line), and **(C)** typical vegetation of poplar, grasses, and low brush in the center of the landslide. Photographs taken by MD.

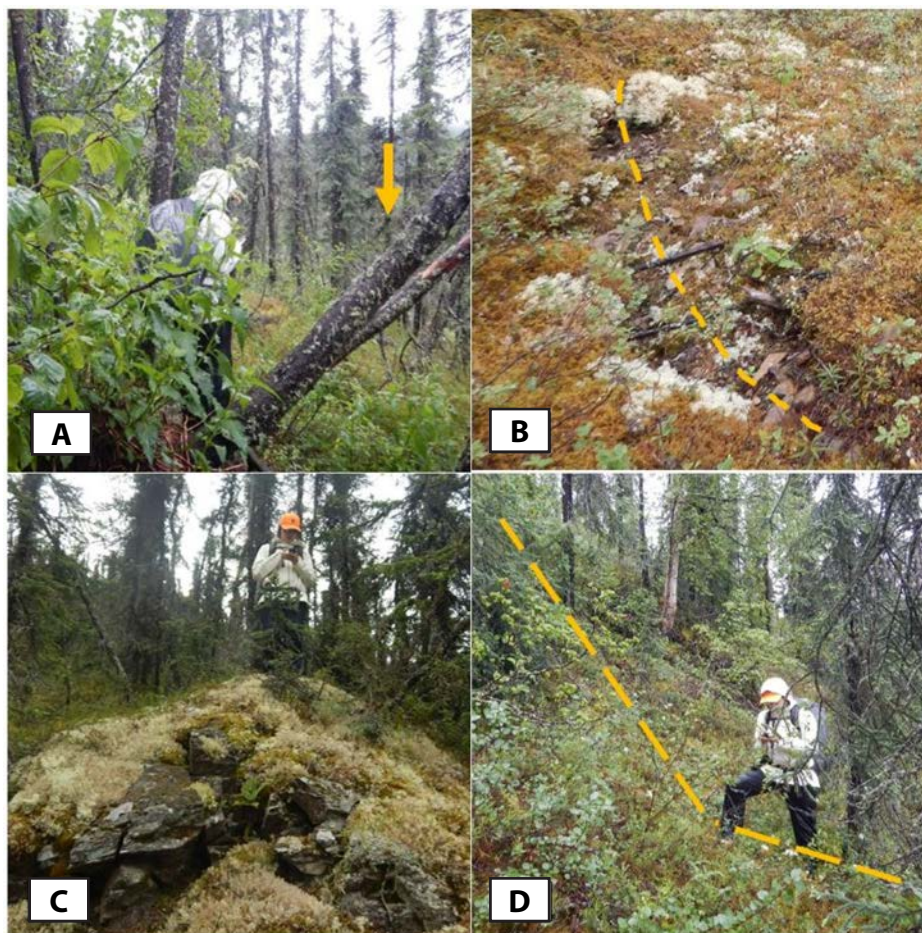
Figure A25. Images of FaiD3_1N_3W_35_NE1 from June 24, 2020. **A.** JAS standing in front of some leaning trees (indicated by arrow) at the head scarp, which may be related to permafrost degradation, **(B)** stretched organic mat (delineated by dashed line) near the head scarp revealing rocky debris underneath, **(C)** JAS standing on an exposed bedrock ridge near the left flank, and **(D)** JAS standing along a steep slope break (indicated by dashed line) near the left flank. Photographs taken by MD.

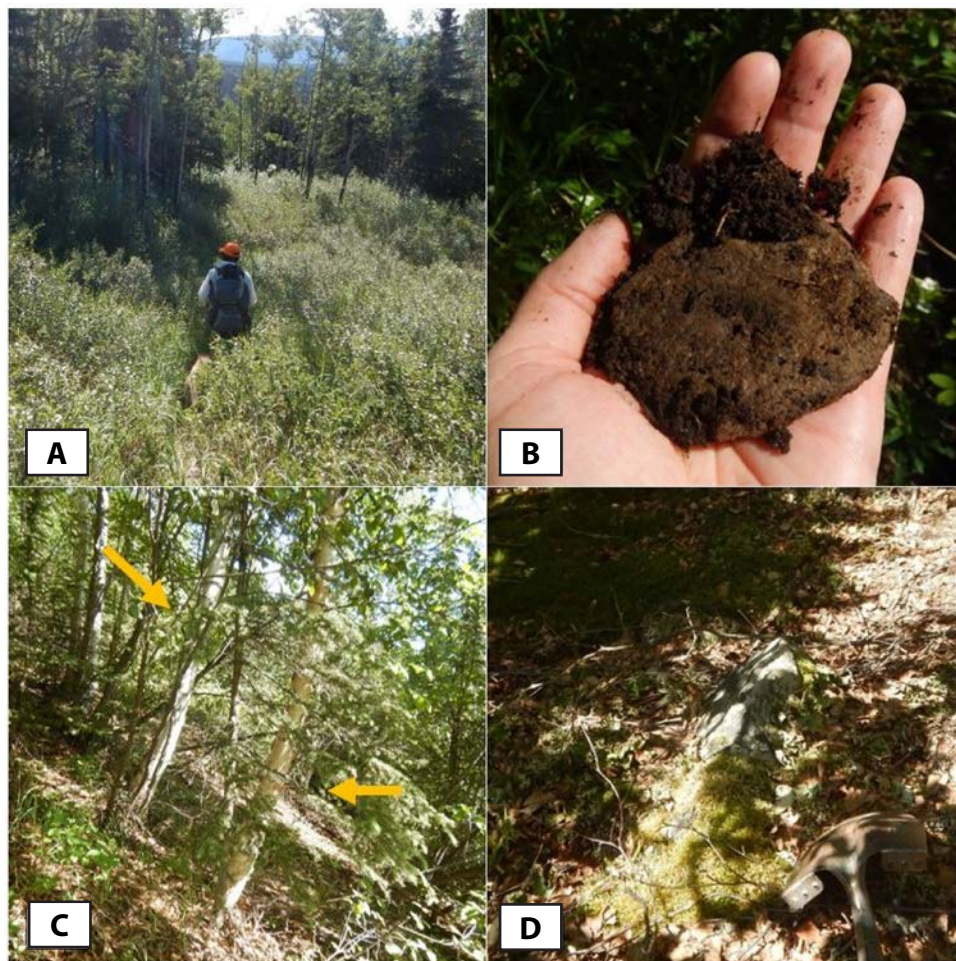
Figure A26. Images of FaiD3_1N_4W_3_NW1 from June 25, 2020. **A.** JAS standing on a down-dropped block, **(B)** rock piece found in a soil pit dug along the right flank, **(C)** steep slope with jayed trees (indicated by arrows) along the right flank, and **(D)** exposed weathered bedrock along the right flank. Photographs taken by MD.

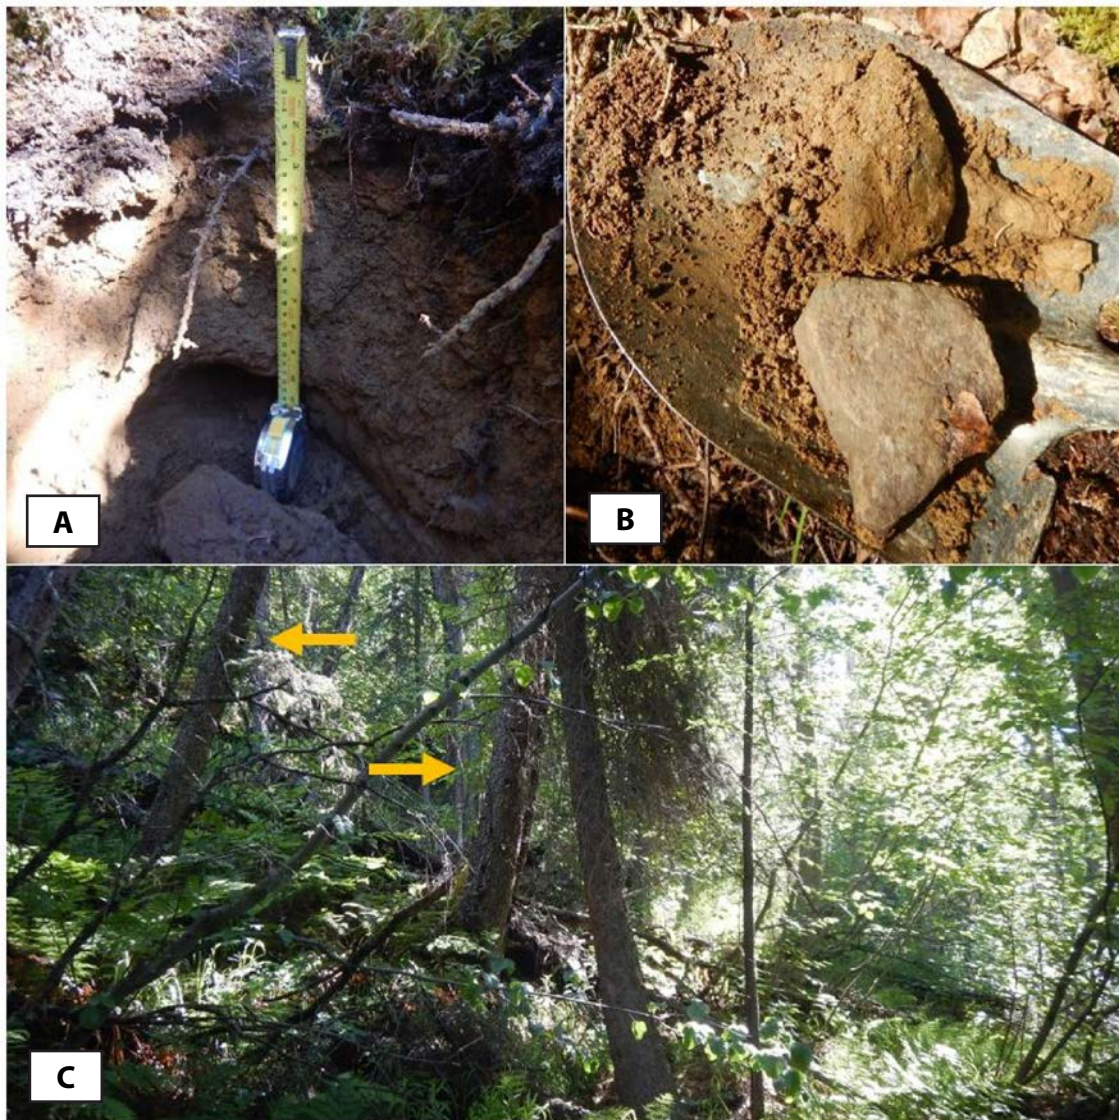
Figure A27. Images of FaiD3_1N_4W_3_SW1 from June 25, 2020. **A.** A soil pit with silt and rock debris dug near the left flank, **(B)** rock debris and silt found in a tree throw on the landslide body, and **(C)** leaning trees (indicated by arrows) near the toe region. Photographs taken by MD and JAS.

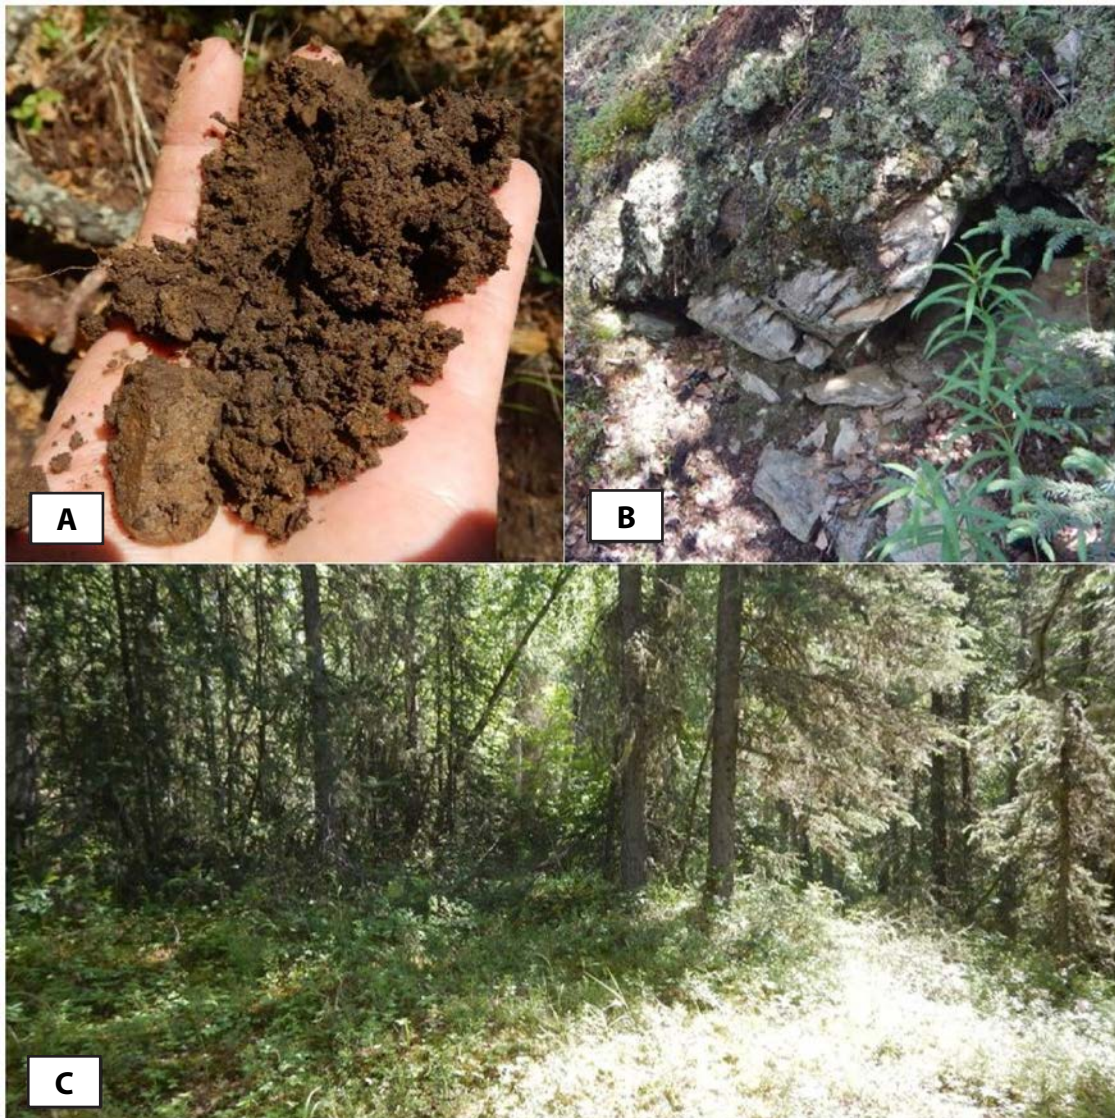
Figure A28. Images of FaiD3_1N_4W_3_NE1 from June 25, 2020. **A.** Rocks and silt in a tree throw at the head scarp, **(B)** exposed weathered bedrock on the landslide body, and **(C)** a relatively flat area near a slope break on the landslide body. Photographs taken by MD.

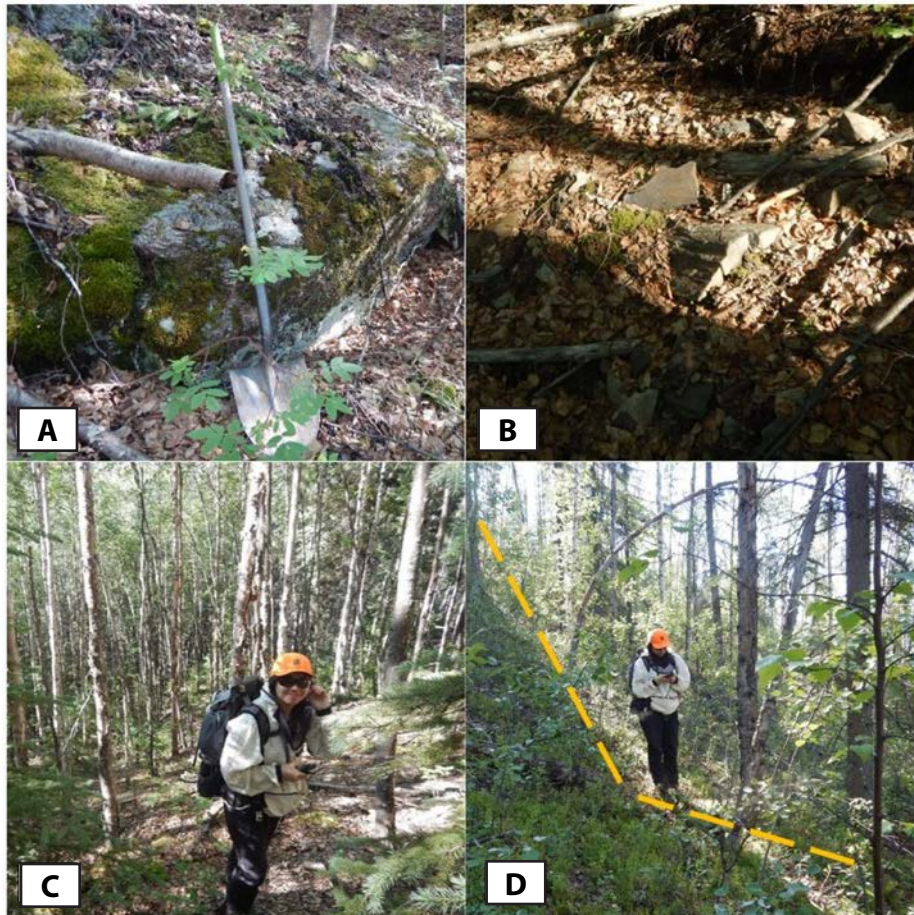
Figure A29. Images of LivA1_5N_3E_36_NE1 from June 26, 2020. **A.** A large boulder at the head scarp area, **(B)** rock debris in a tree throw near the head scarp, **(C)** JAS standing at the head scarp, and **(D)** JAS standing on a slope break (indicated by dashed line) along the left flank. Photographs taken by MD.

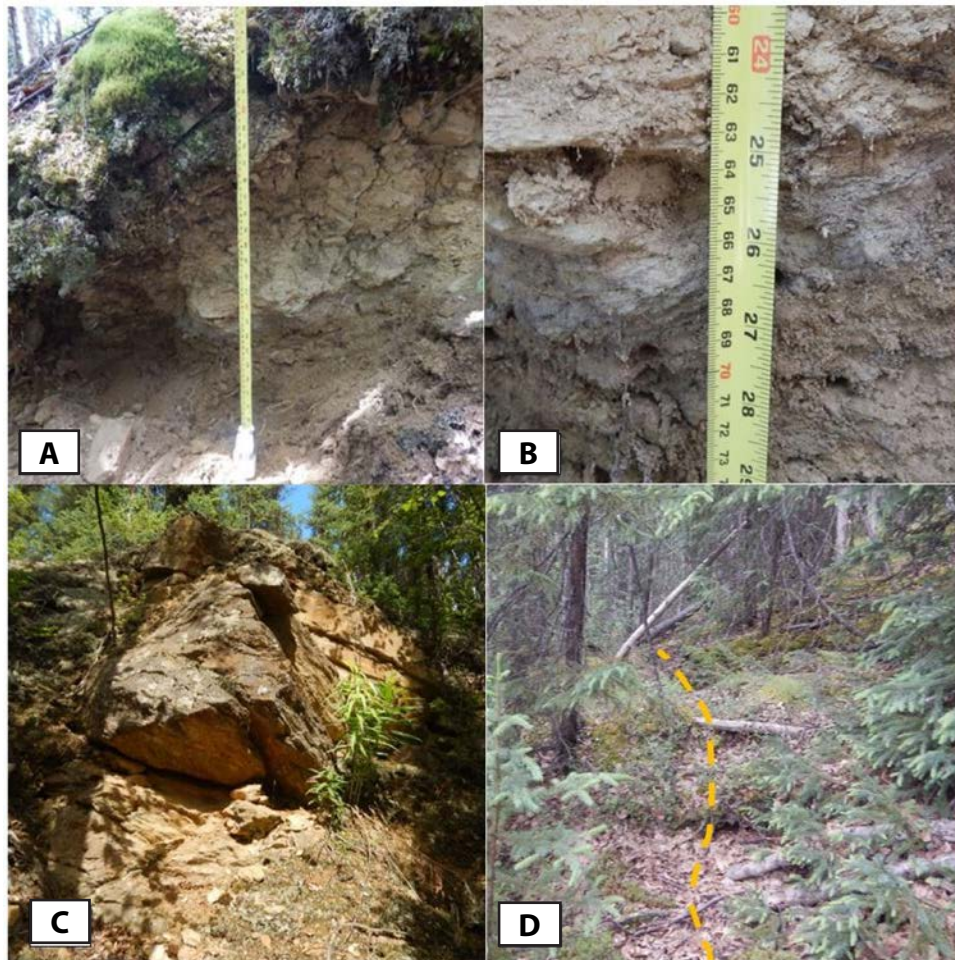
Figure A30. Images of CirA6_5N_4E_32_NW1 from June 26, 2020. **A.** Silt exposure with gray-white ash layer along the left flank, **(B)** closer image of the gray-white ash layer in place, **(C)** possible schist bedrock outcrop along the toe, and **(D)** view down a tension crack (indicated by dashed line) with vegetation stretching near the toe. Photographs taken by MD and JAS.

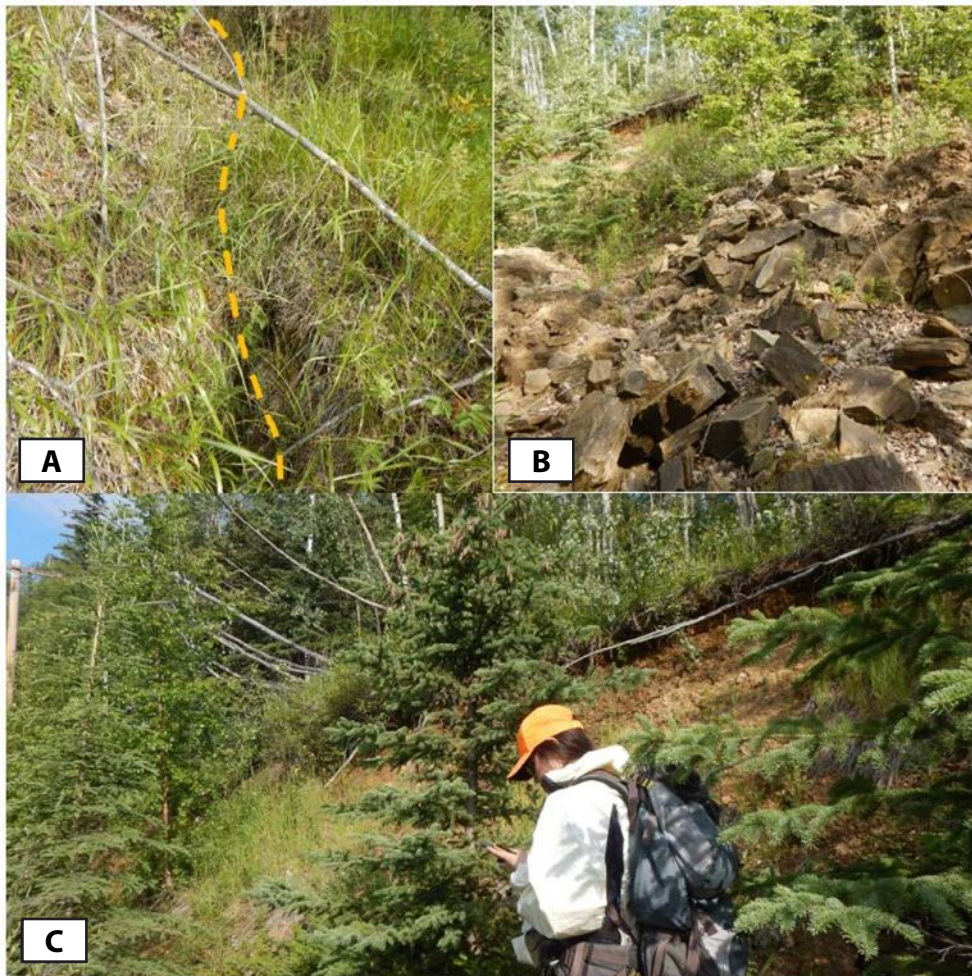
Figure A31. Images of BigB5_7S_7E_21_SW5 from July 1, 2020. **A.** Crack (indicated by dashed line) in the vegetation near the head scarp, **(B)** rock debris near the head scarp, and **(C)** JAS standing at the head scarp. Photographs taken by MD.

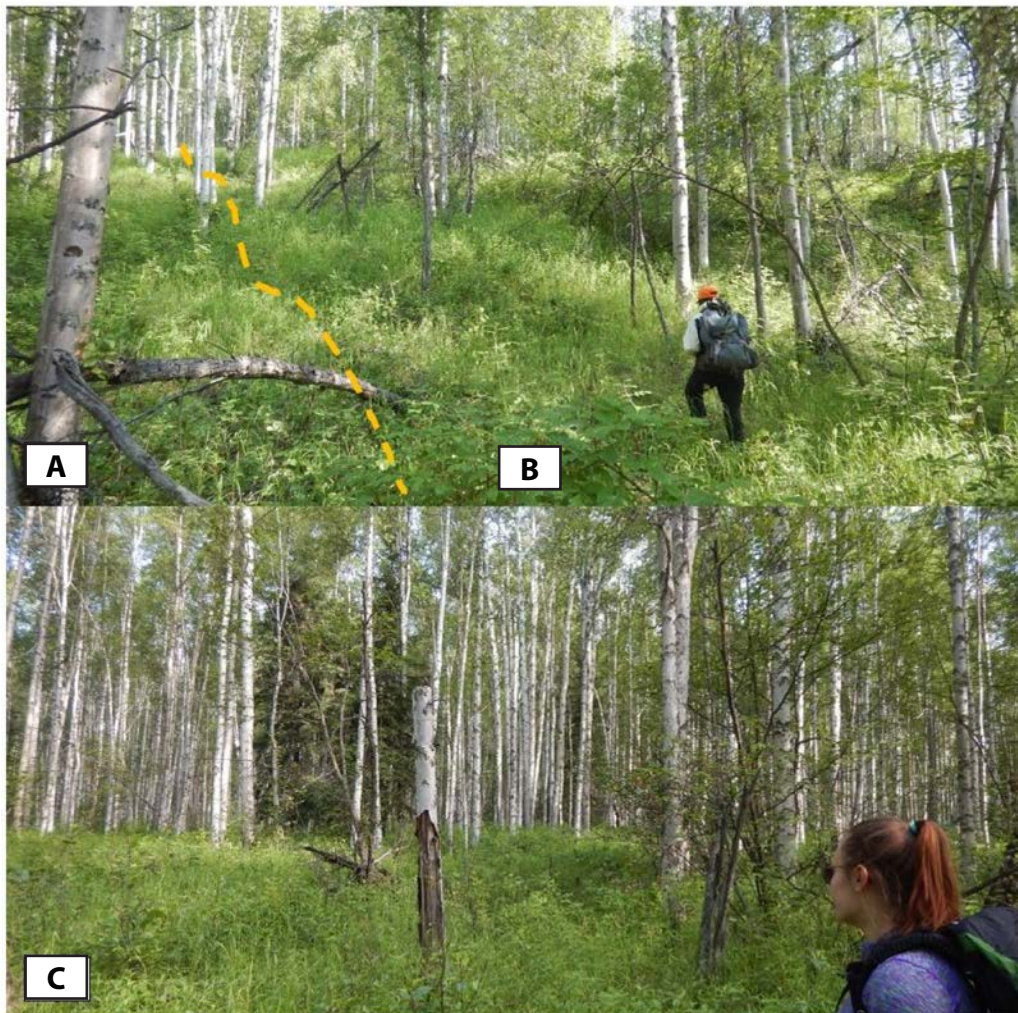
Figure A32. Images of BigB5_7S_7E_21_SW4 from July 1, 2020. **A.** JAS hiking upslope toward down-dropped blocks near the head scarp (slope breaks indicated by dashed line), and **(B)** PP looking toward the uniform, flatter slope above the head scarp. Photographs taken by MD.

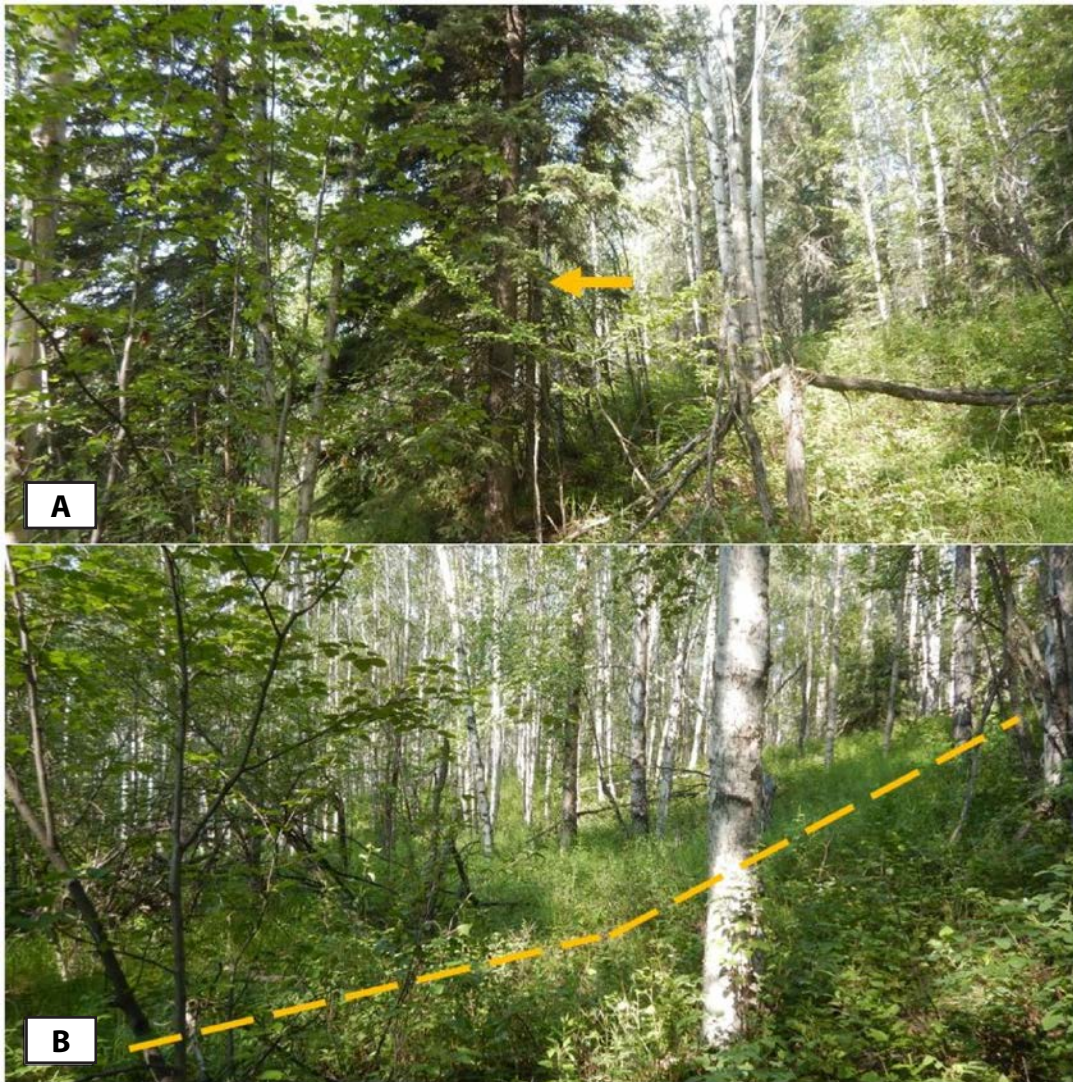
Figure A33. Images of BigB5_7S_7E_21_SW8 from July 1, 2020. **A.** A straight, mature spruce (arrow indicates location) growing at the head scarp, and **(B)** view to the west walking along the head scarp (slope break indicated by dashed line). Photographs taken by MD.

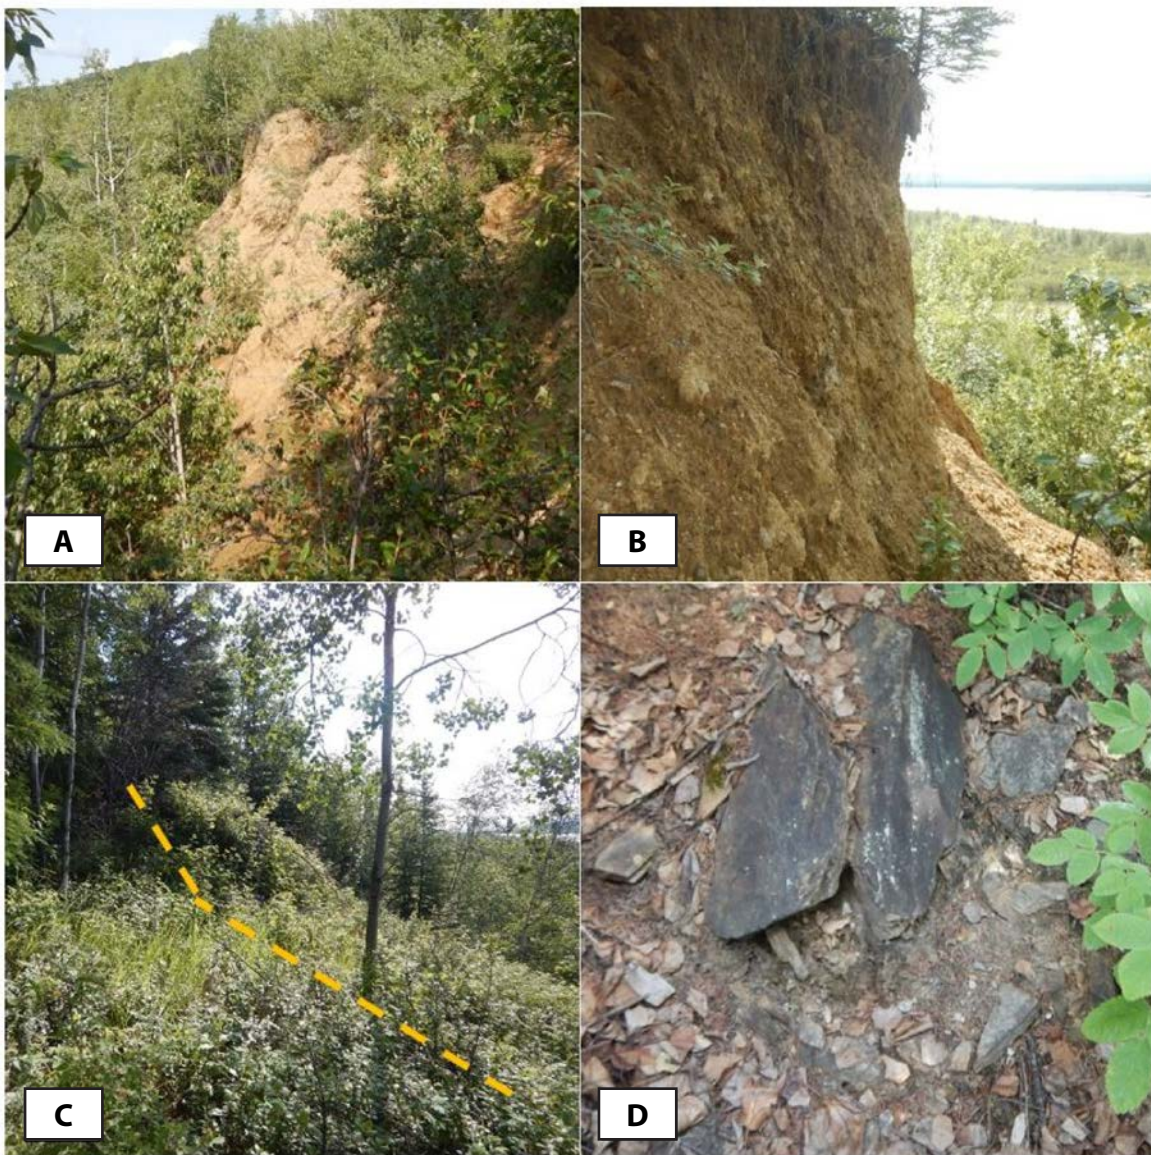
River erosion—Along the Richardson Highway, several historic and active bedrock landslides were caused by the Tanana River eroding toe deposits of paleoslides at the slope base (figs. A34, A36,

Figure A34. Images of BigB5_7S_7E_20_SE2 from July 1, 2020. **A.** Head scarp with exposed soil, **(B)** closer image of the head scarp in alluvium, **(C)** the left flank of the landslide (slope break indicated by dashed line), and **(D)** exposed rock debris on the landslide body surface. Photographs taken by MD.

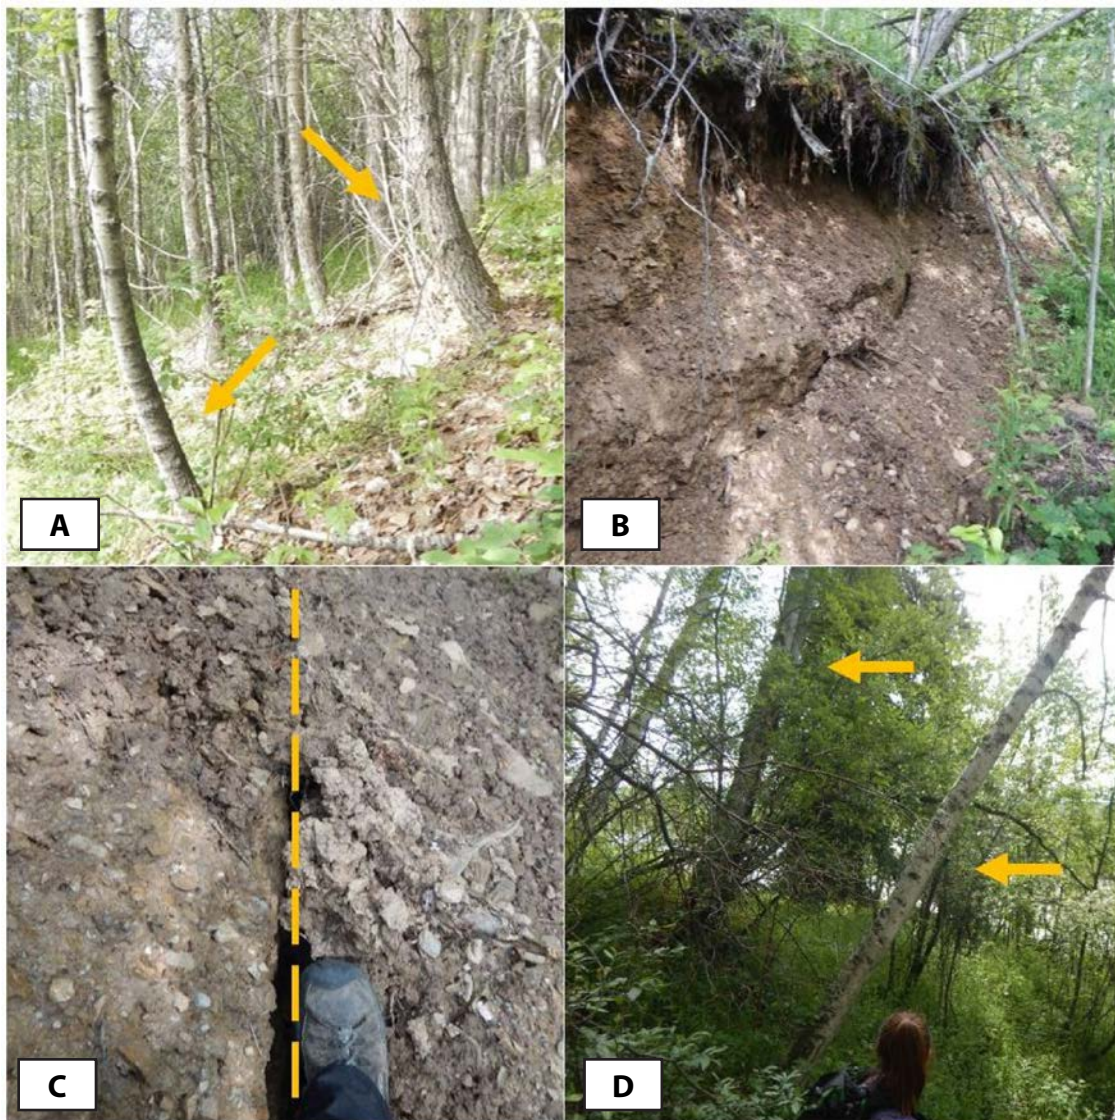
Figure A35. Images of BigB5_7S_7E_20_SE1 from July 1, 2020. **A.** Jays trees (indicated by arrows) on the lower landslide body, **(B)** an exposure indicating recent movement along the right flank, **(C)** a fresh crack (indicated by dashed line) in the alluvium along the left flank, and **(D)** leaning trees at the toe (indicated by arrows). Photographs taken by MD.

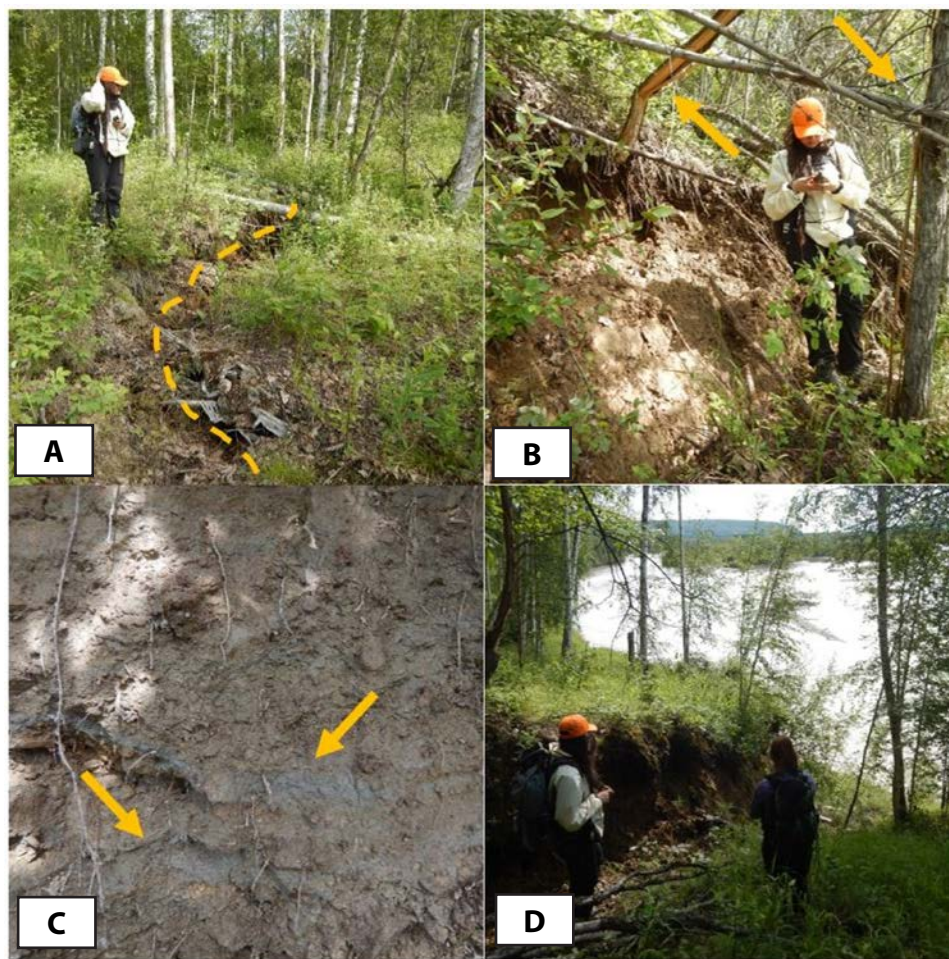
Figure A36. Images of BigB5_7S_7E_21_SW6 from July 1, 2020. **A.** JAS standing near a large crack (indicated by dashed line) above the head scarp, **(B)** JAS standing under a stretched, cracked tree (each side of split tree indicated by an arrow) at the head scarp, **(C)** gray ash layers exposed in the head scarp (noted by arrows), and **(D)** JAS and PP standing along the left flank exposure. Photographs taken by MD and JAS.

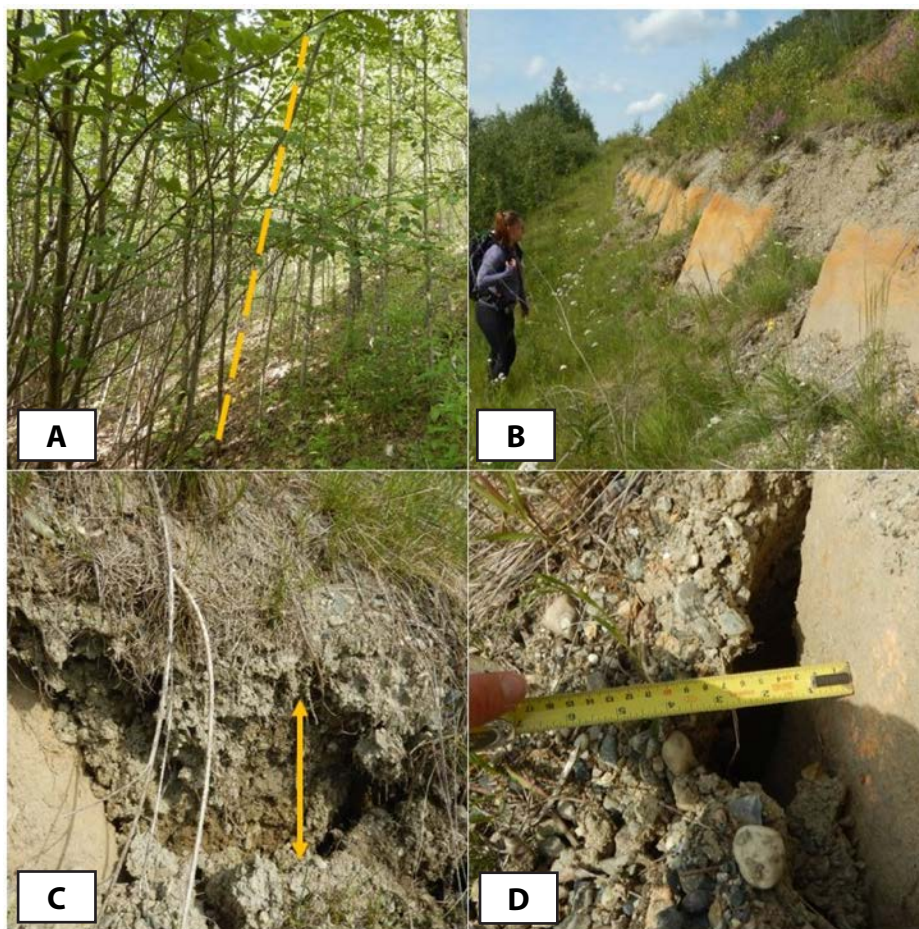
and A37). These areas have multiple episodes of movement, commonly resulting in nested landslide complexes (fig. B15A). During our field work, we observed active movement within several landslides that we attributed to river erosion. One historic landslide was successfully mitigated at Richardson Highway milepost 296 (fig. A31). Its displacement above the road was stopped, but smaller downslope sections are still actively moving due to the river eroding the toe deposit.

Figure A37. Images of BigB5_7S_7E_21_SW7 from July 1, 2020. **A.** Trees rotating upslope (dashed line indicates direction of lean) on the upper landslide body just below the head scarp region, **(B)** dropped soil below the road at the head scarp region, exposing buried tie-back blocks used to mitigate BigB5_7S_7E_21_SW5, **(C)** recent movement possibly due to preceding rainfall event, and **(D)** the measured separation of approximately 8 cm between soil and concrete block below the road. Photographs taken by MD.
