PRELIMINARY LANDSLIDE INVENTORY OF PARTS OF THE FAIRBANKS NORTH STAR BOROUGH, ALASKA

Report of Investigation 2022-1

State of Alaska
Department of Natural Resources
Division of Geological & Geophysical Surveys

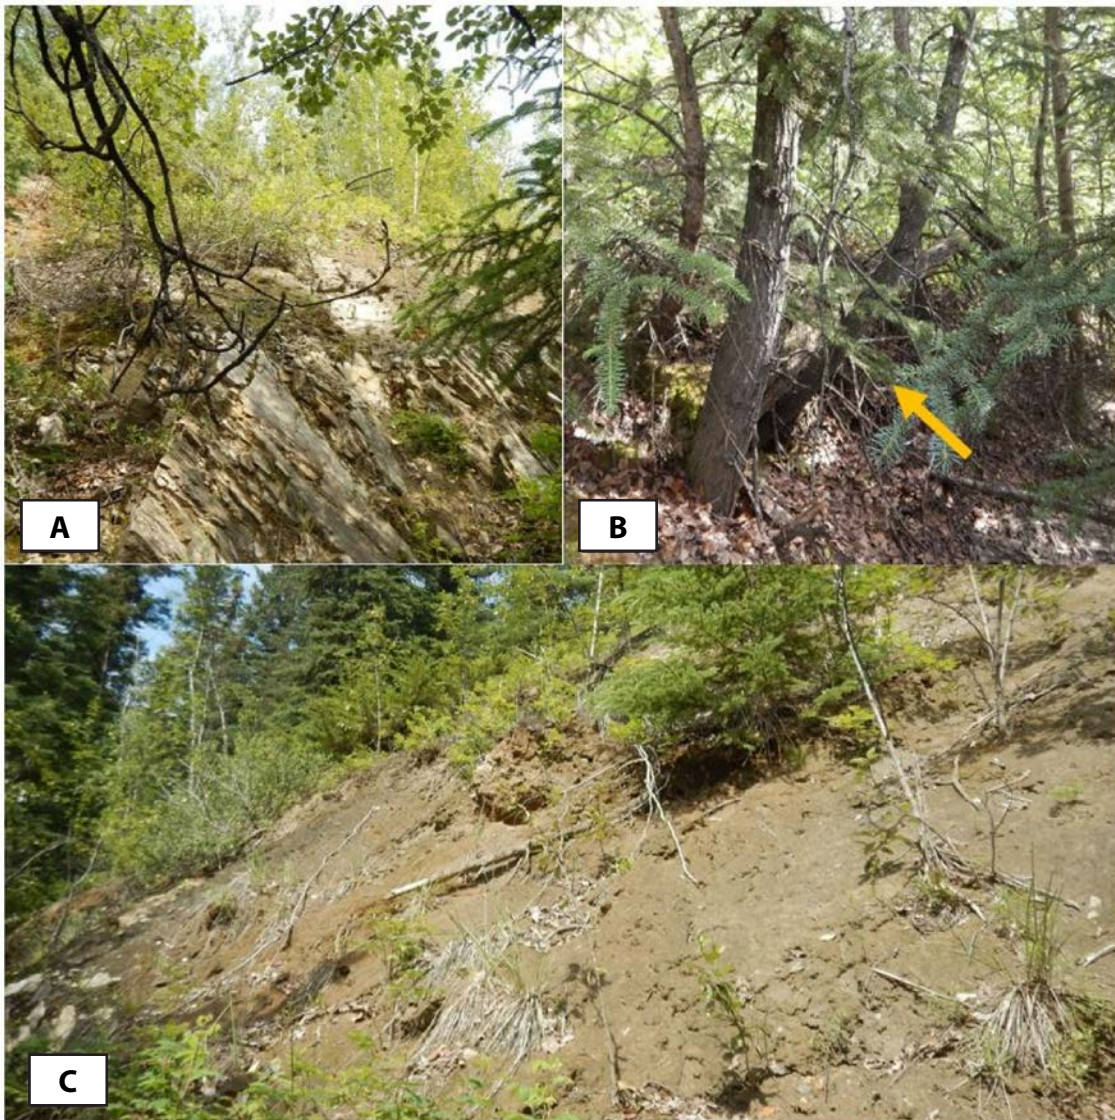
Figure A39. Images of BigB5_7S_6E_24_SW3 from July 1, 2020. **A.** View from the toe looking upslope at exposed bedrock, **(B)** toe deposit material pushing and causing the trees to jay (indicated by arrow), and **(C)** view of exposed mineral soil at the head scarp. Photographs taken by MD.

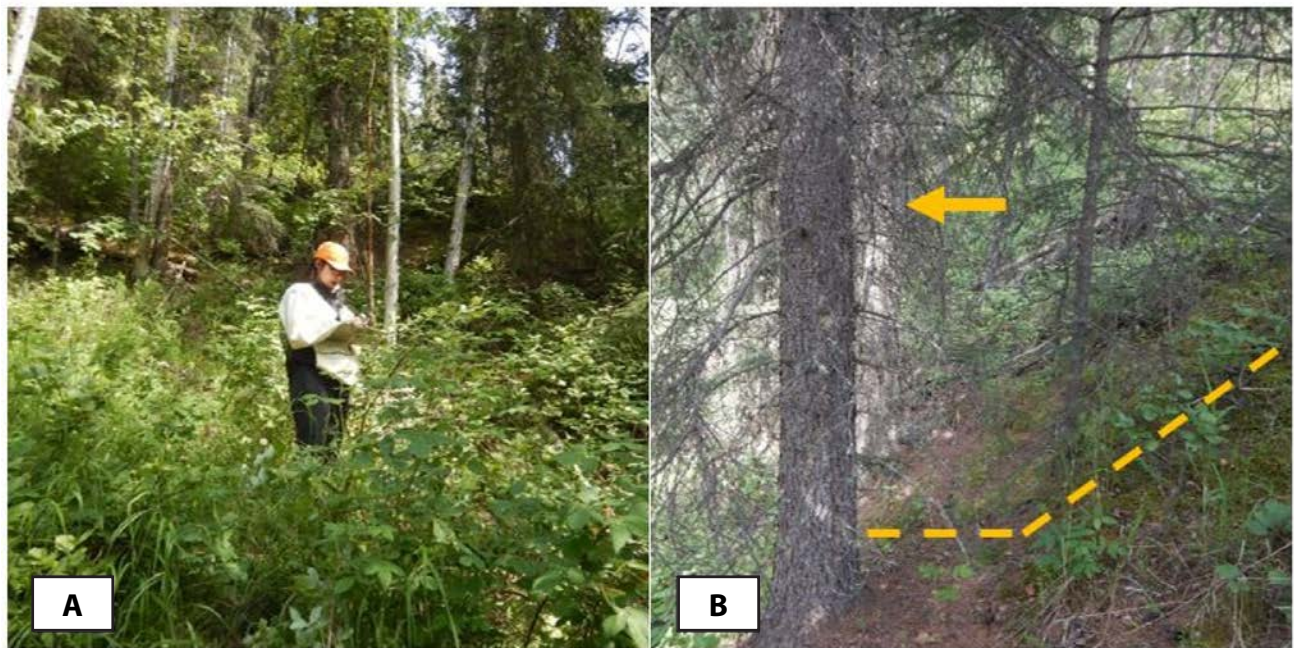
Figure A40. Images of BigB5_7S_6E_24_SW2 from July 1, 2020. **A.** JAS standing at the head scarp, and **(B)** an example of a straight mature spruce tree (indicated by arrow) growing on a narrow bench (indicated by dashed line) on the landslide body. Photographs taken by MD.

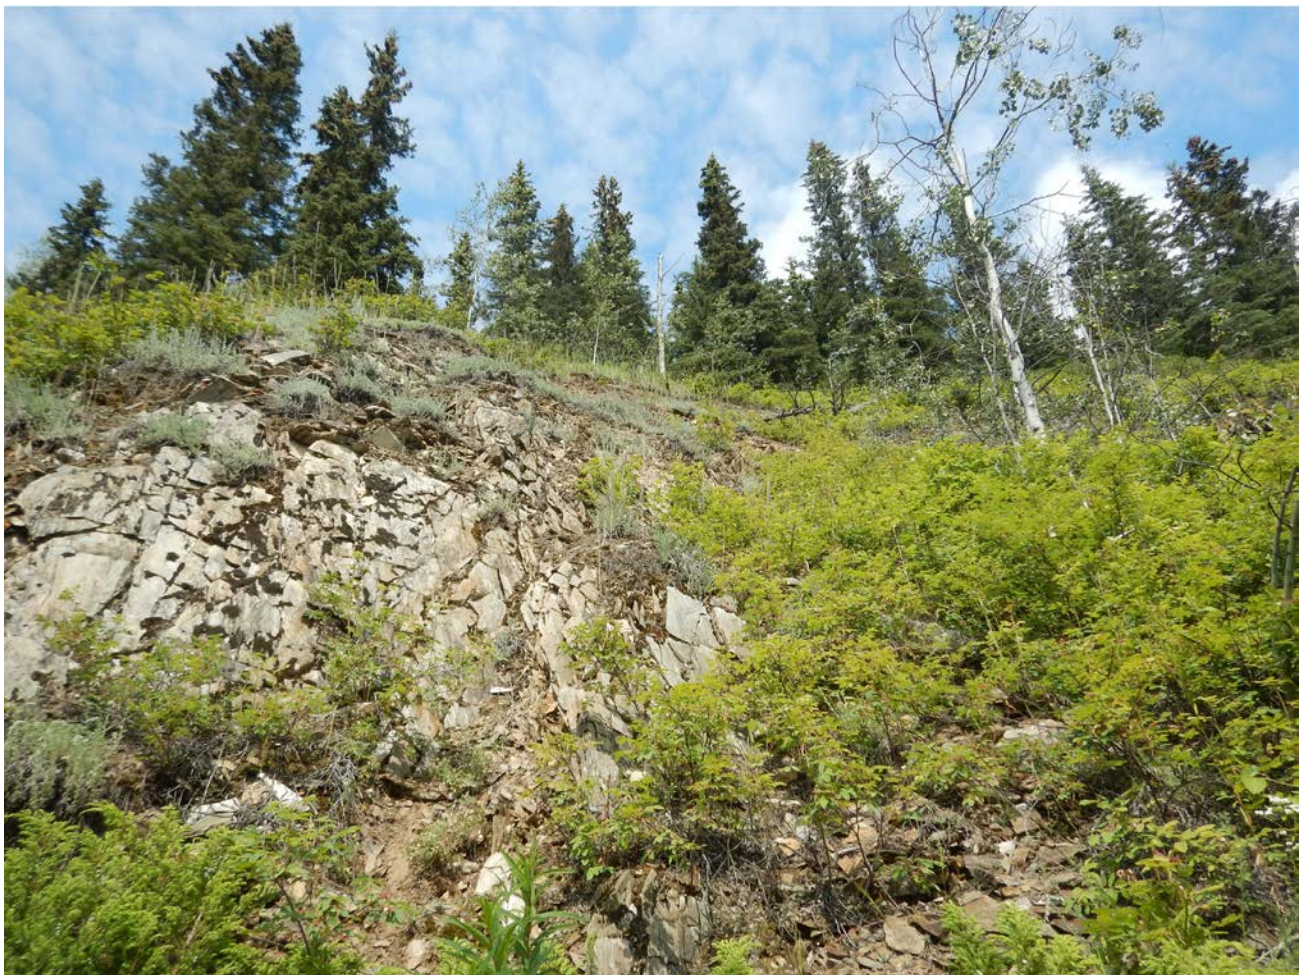
Figure A41. Image of BigB5_7S_6E_24_SW1 from July 1, 2020. This view is looking upslope at the head scarp region and exposed bedrock outcrop. Photograph taken by MD.

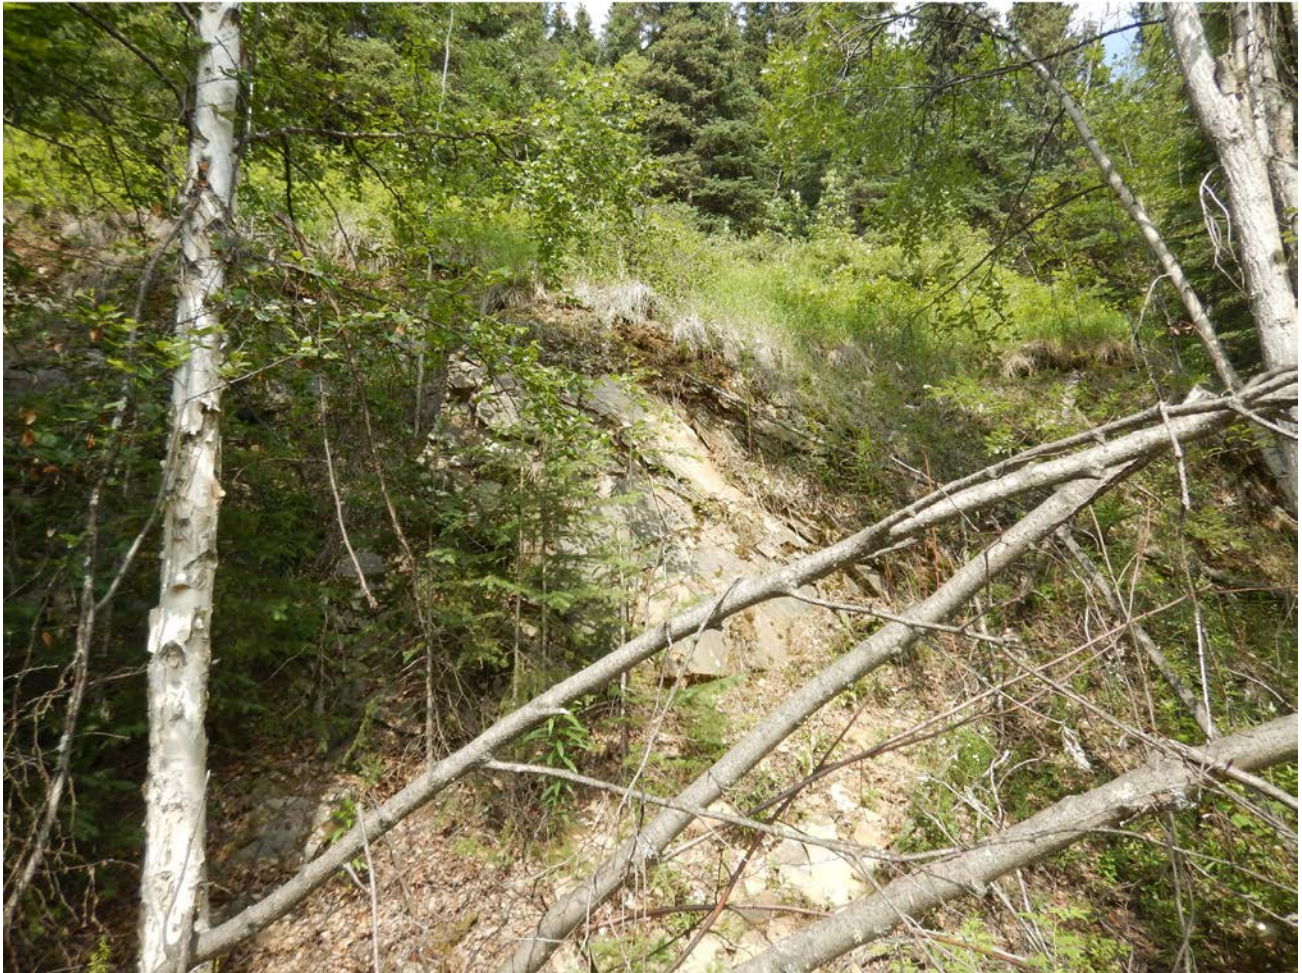
Figure A42. Image of BigB5_7S_6E_24_SE3 from July 1, 2020. Large rocky debris is exposed in the lower landslide body. Photograph taken by MD.

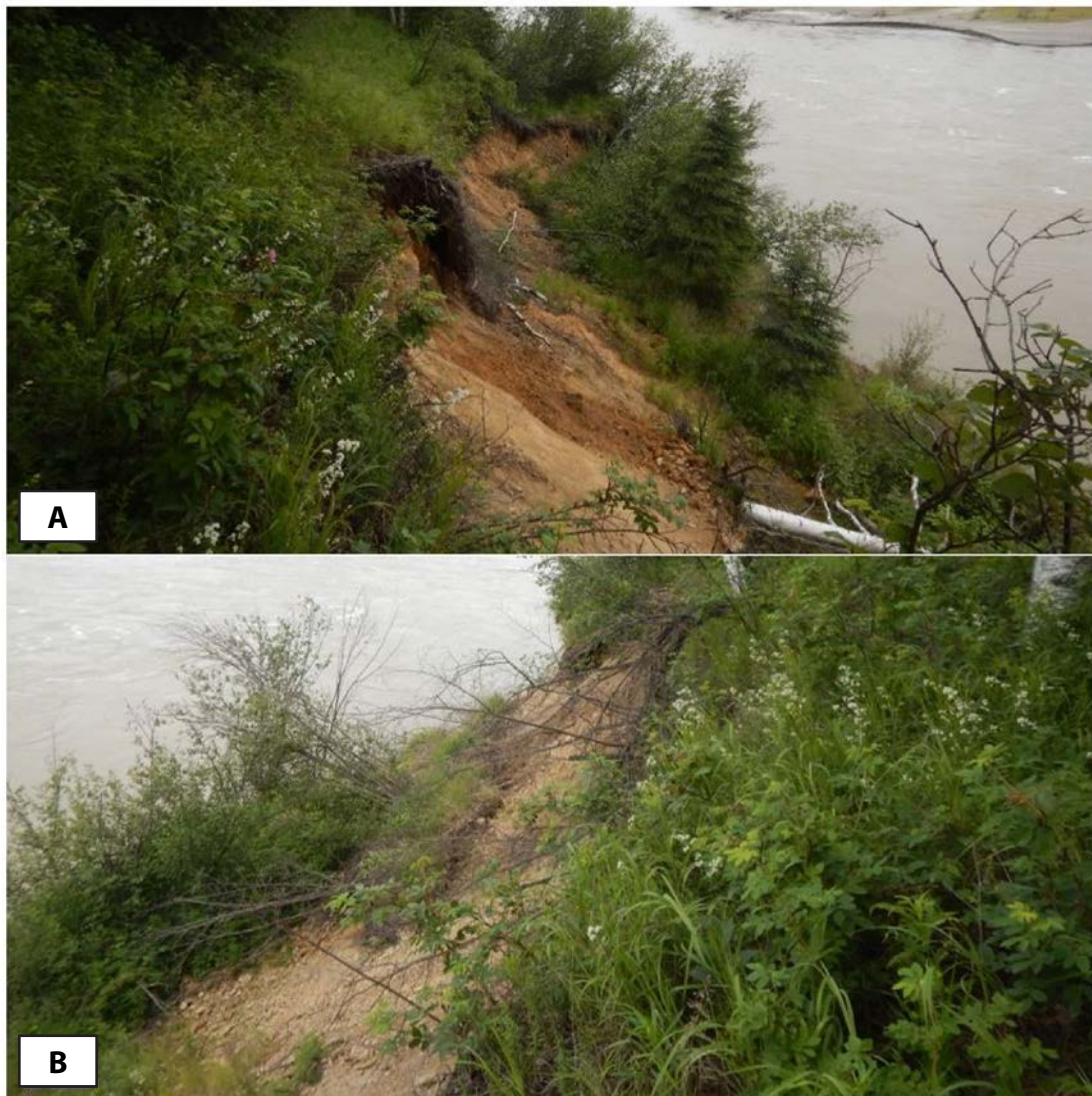
Figure A46. Images of BigB5_7S_7E_20_SW7 from July 2, 2020. **A.** View of the fresh soil exposed at the head scarp to the east, and **(B)** view of the head scarp with exposed soil to the west. Photographs taken by MD.
