Stability of the West Slope of Government Hill Port Area of Anchorage, Alaska

By DAVID J. VARNES

GEOLOGICAL SURVEY BULLETIN 1258-D

*An evaluation of the stability of
gravel-capped bluffs of Bootlegger
Cove Clay under static and
seismic conditions*

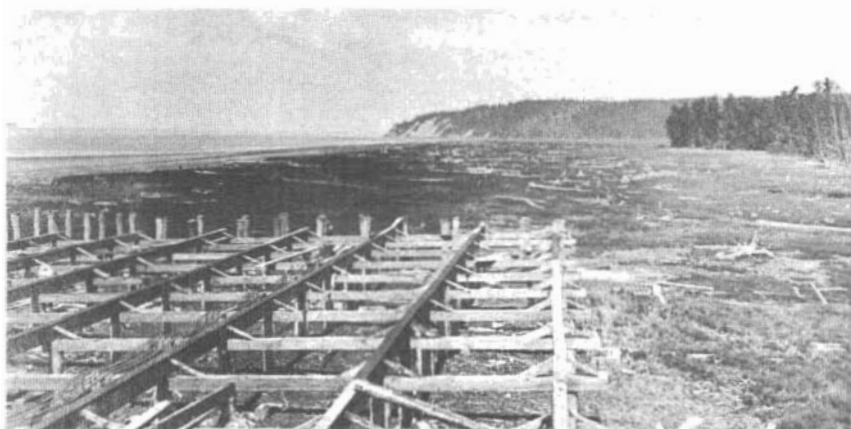
FIGURE 4.—Coal-bunker site as seen from marine ways, Anchorage, Alaska, July 1, 1917. Toe of flow slide is in the woods (on the right). Photograph by Alaskan Engineering Commission.

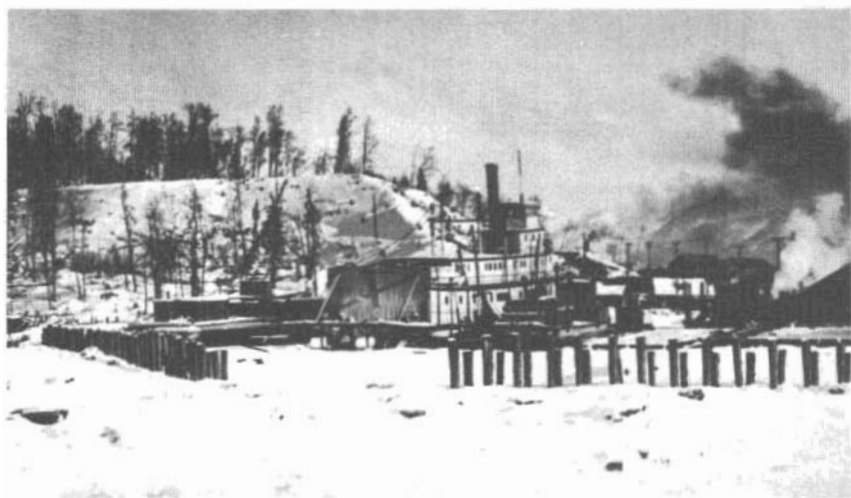
FIGURE 5.—Ships ways, Anchorage, Alaska. Nose at southwest end of Government Hill is visible (on the left) with landslide deposits at the toe of the slope. Photograph by Alaskan Engineering Commission, March 1, 1917.

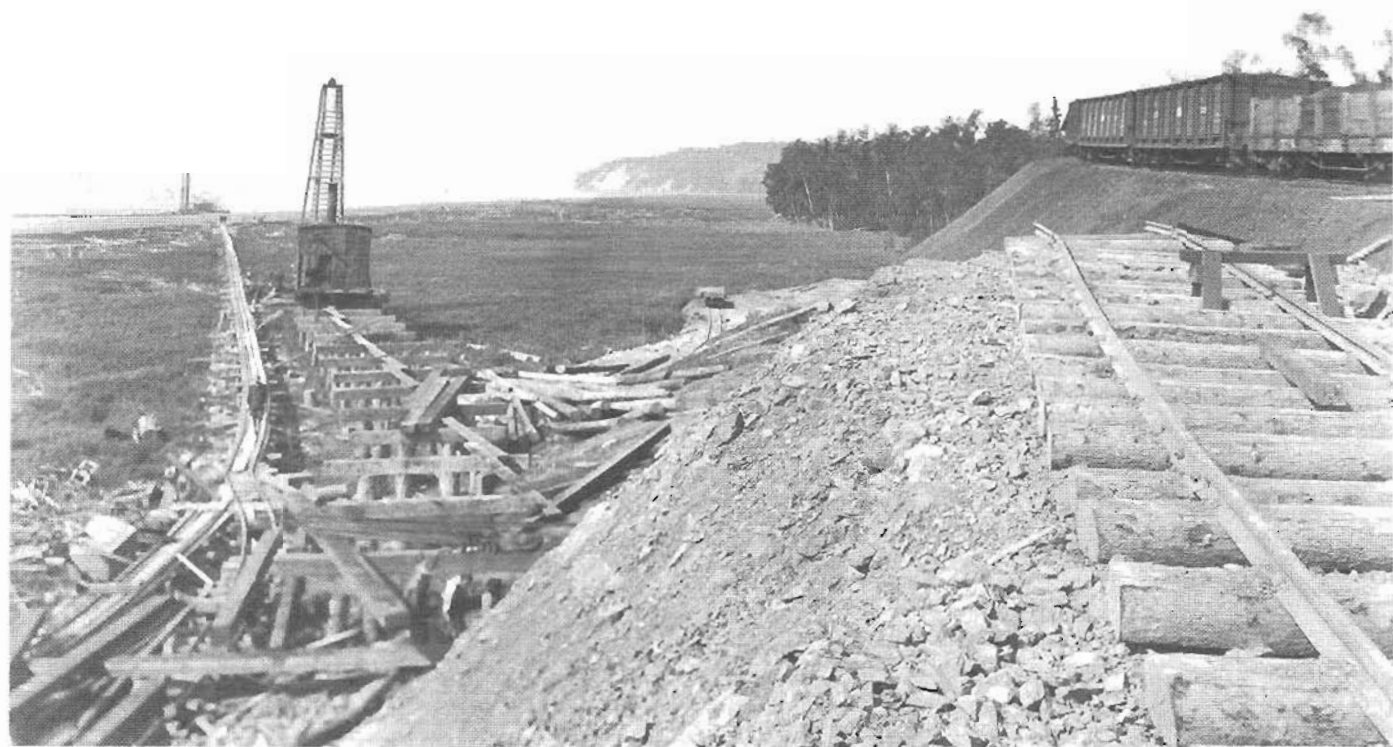
FIGURE 7.—Coal-dock site, Anchorage, Alaska, June 27, 1918. Note fallen trees at toe of flow slide in the middle distance at right. Railway cars are on the coal-storage bunker. Photograph by Alaskan Engineering Commission.

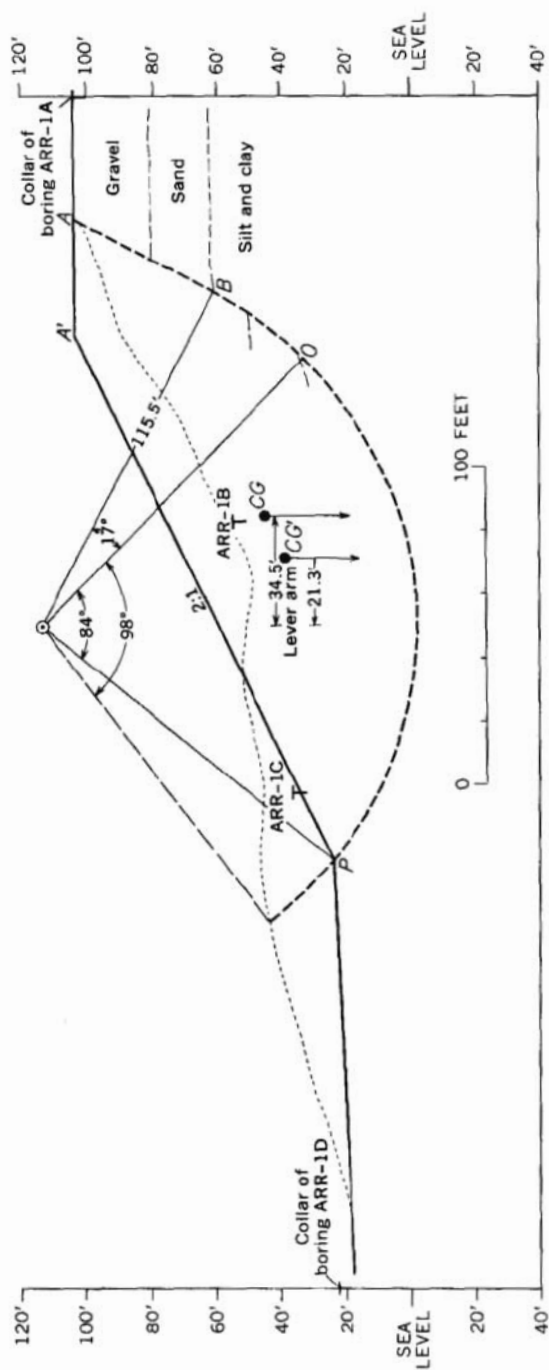
In figure 21 the probable configuration of the pre-1916 slide is shown with an assumed circular arc failure in the Bootlegger Cove Clay. A stability analysis was made to estimate cohesion of the clay, independent of laboratory test results. Also, if it is assumed that the ground surface defined by the 1916(?) contours, and shown by the dotted line, represents the general shape of the slide at cessation of movement ($S.F.=1$), then a measure of the loss of cohesion upon sliding may be estimated, assuming that the angle of internal shearing resistance, ϕ , remains equal to zero. The original face of the bluff is shown as extending from point A' , whose position is determined by the balancing procedure outlined in figure 22, downward to P at a

FIGURE 21.—Probable configuration of pre-1916 slide in section along boring line 1. Stability analysis was made to estimate the original cohesion and the amount that cohesive strength decreases upon sliding. Point A', the crest of the slope prior to sliding, was determined by the balancing procedure sketched in figure 22. The assumed original slope is shown by the solid line, and the ground surface after sliding by the dotted line, which is constructed from contours on the Alaskan Engineering Commission's unpublished 1916(?) map.

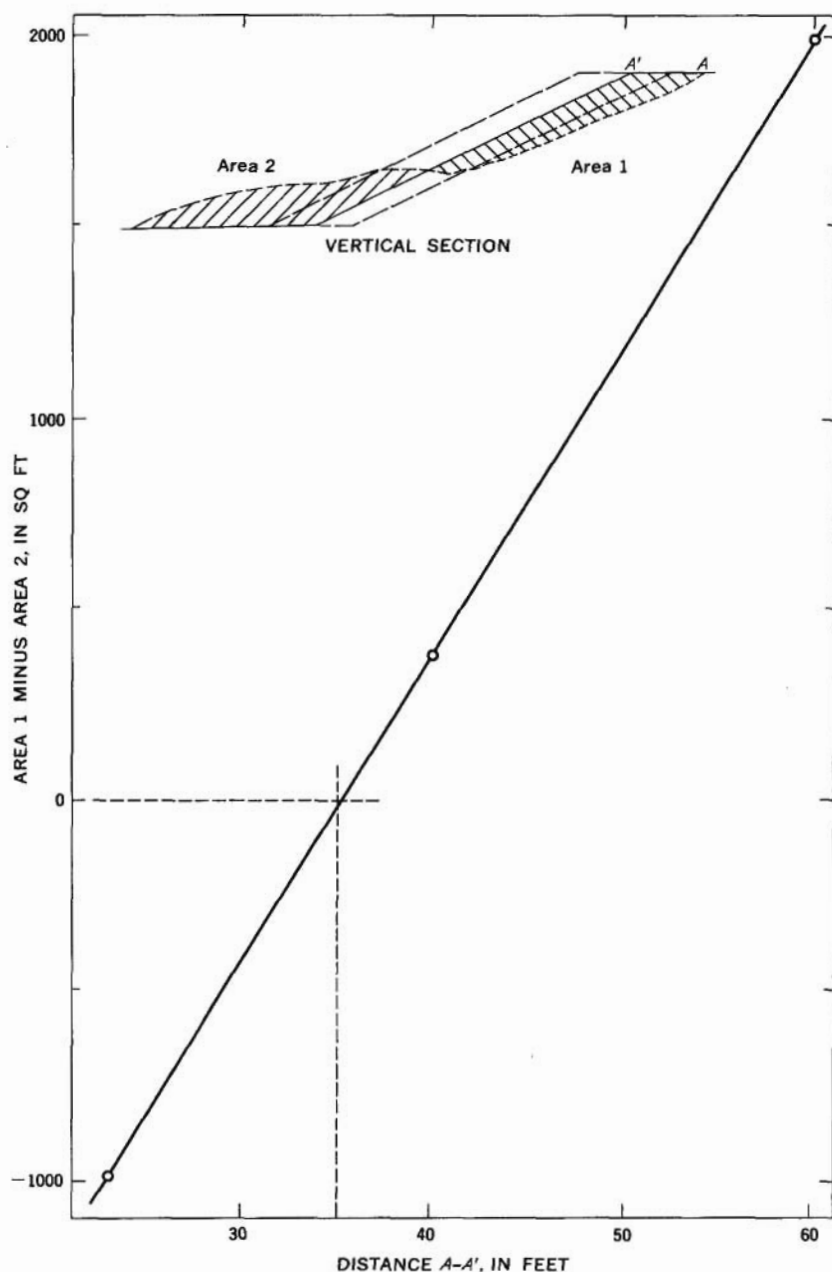
FIGURE 22.—Determination of position of former crest of slope, A' , boring line 1. Various initial positions of the slope are sketched. The one chosen achieves a balance of cross-sectional area between (1) the material that was removed from beneath the original ground surface, at the head of the slide, and (2) the material that came to rest above the original ground surface, in the lower part of the slide. Balance is obtained at 35 feet of retreat of crest.

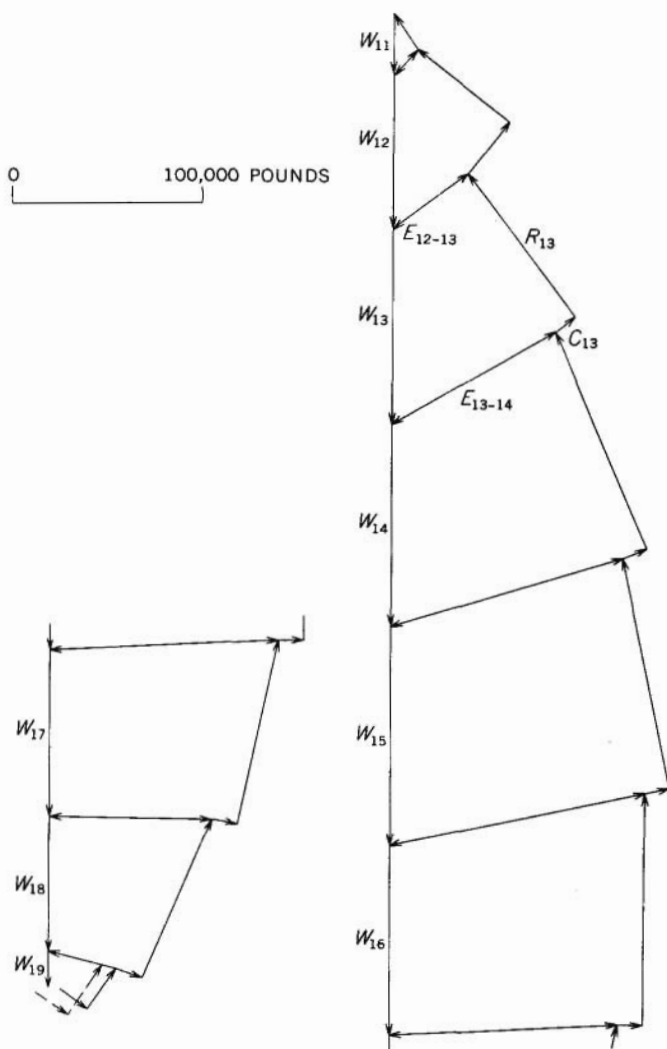
The two methods agree in indicating that failure along arc *ABCJ* under static conditions is unlikely unless the toe of the slope is removed. If the ground was removed to the level of *GH* (base of warehouse), the stability along arc *ABCJ* (through the removal of wedge *JNHI*) would be reduced markedly.

FIGURE 23.—Force-polygon stability analysis of potential failure along circular arc $ABCJ$, line 1, under static conditions, wedge $JNHI$ in place. (See pl. 3.) Assumption that safety factor equals 1.4 (dashed lines, last polygon) leads to excess resistance; assumption that safety factor equals 1.5 (solid lines) leads to deficiency. True safety factor is about 1.44.

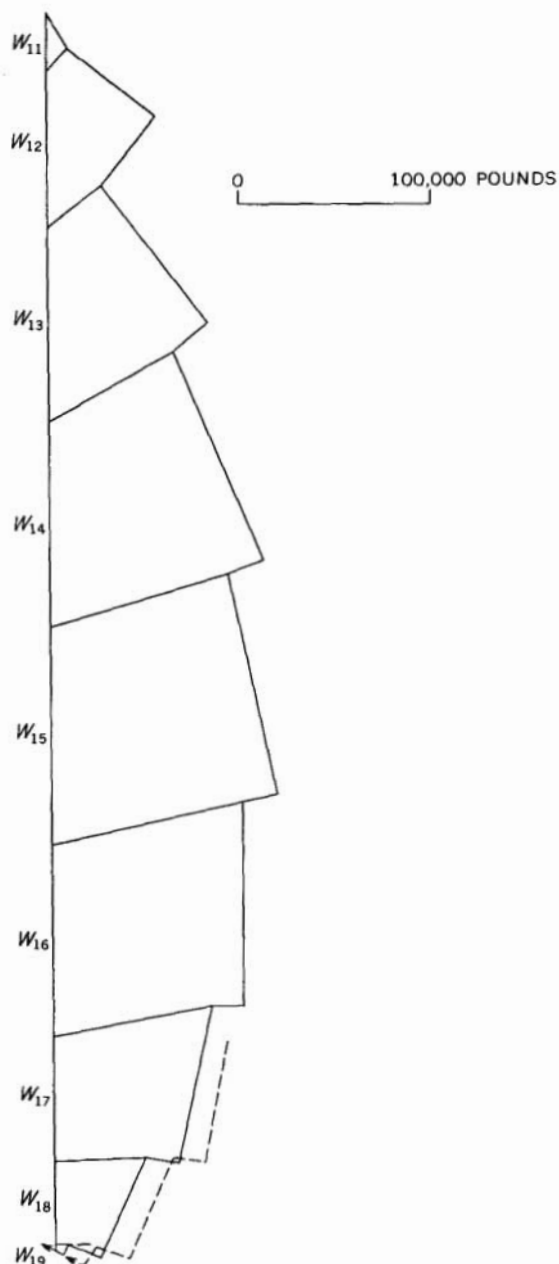
FIGURE 24.—Force-polygon stability analysis of potential failure along circular arc $ABCN$, line 1, under static conditions, wedge $JNHI$ removed. (See pl. 3.) Assumption that safety factor equals 1.1 (solid lines) leads to excess resistance of 5,600 pounds; assumption that safety factor equals 1.2 (dashed lines in last polygons) leads to deficiency of 6,000 pounds. True safety factor is about 1.15.

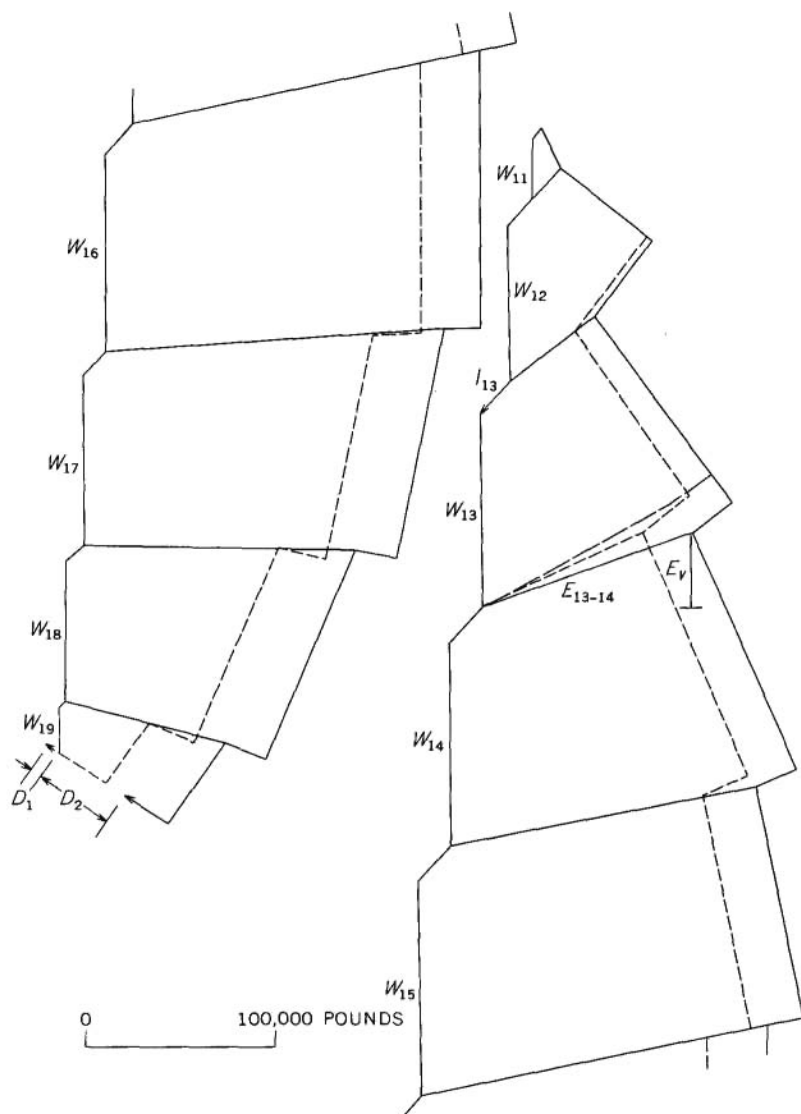
According to the stability computations that follow, failure along circular arc *ABCJ* under seismic conditions seems to be less probable than failure along an almost horizontal surface. Nevertheless, figure 25 shows that the mass above circular arc *ABCJ* has a safety factor of only 0.83 with respect to available cohesion, if combined seismic coefficients of 0.15 horizontal and 0.15 vertical are used in stability computations. If the available cohesion were completely used, an estimated seismic coefficient on the order of 0.06–0.065 would reduce the safety factor to a seismic value of 1.0 from its static value of 1.44.

FIGURE 25.—Force-polygon stability analysis of potential failure along circular arc $ABCJ$, line 1, under seismic coefficients of 0.15 horizontal and 0.15 vertical. Inertial forces are shown by force vectors, such as I_{13} . Assumption that safety factor equals 0.8 (short dashes) leads to excess resistance, D_1 , of 7,000 pounds. Assumption that safety factor equals 1.0 (solid lines) leads to deficiency, D_2 , of 41,000 pounds. True safety factor is about 0.83 with respect to available cohesion. Direction of action of E_{13-14} is lowered from long dashed line so that vertical force component, E_v , on face 13-14, does not exceed available cohesion.

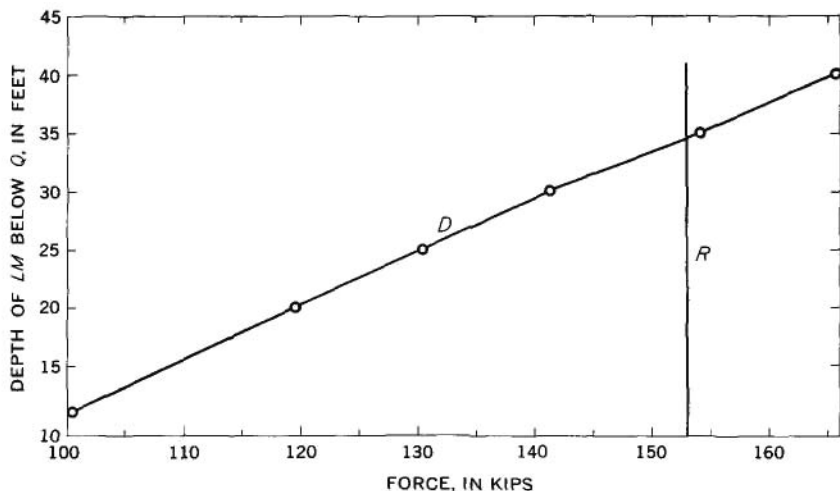
The depth of LM shown on plate 3 was chosen so that safety factor is 1.0 for assumed conditions.

FIGURE 26.—Determination of depth of potential failure surface LM , boring line 1, for static conditions. Depth must be such that driving force ($E_a - E_p$) shown by D line exceeds resistance offered by cohesion along LM shown by R line.

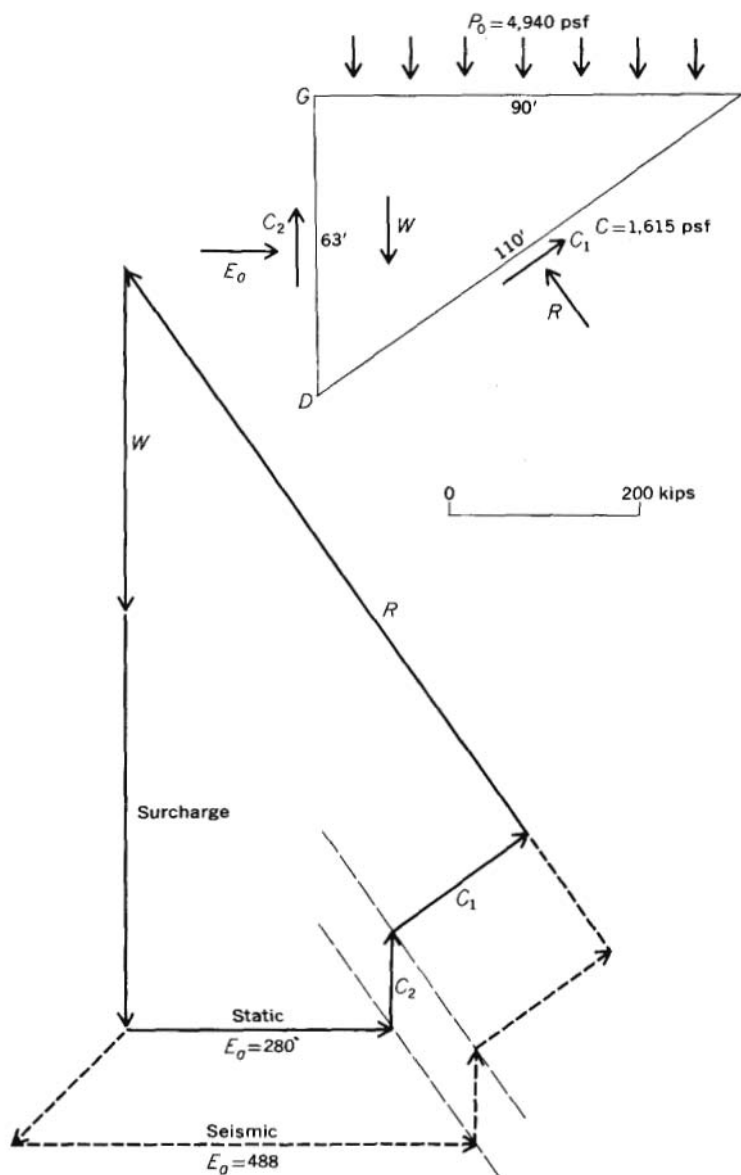
FIGURE 28.—Graphical determination of active pressure E_a on GD , boring line 2.

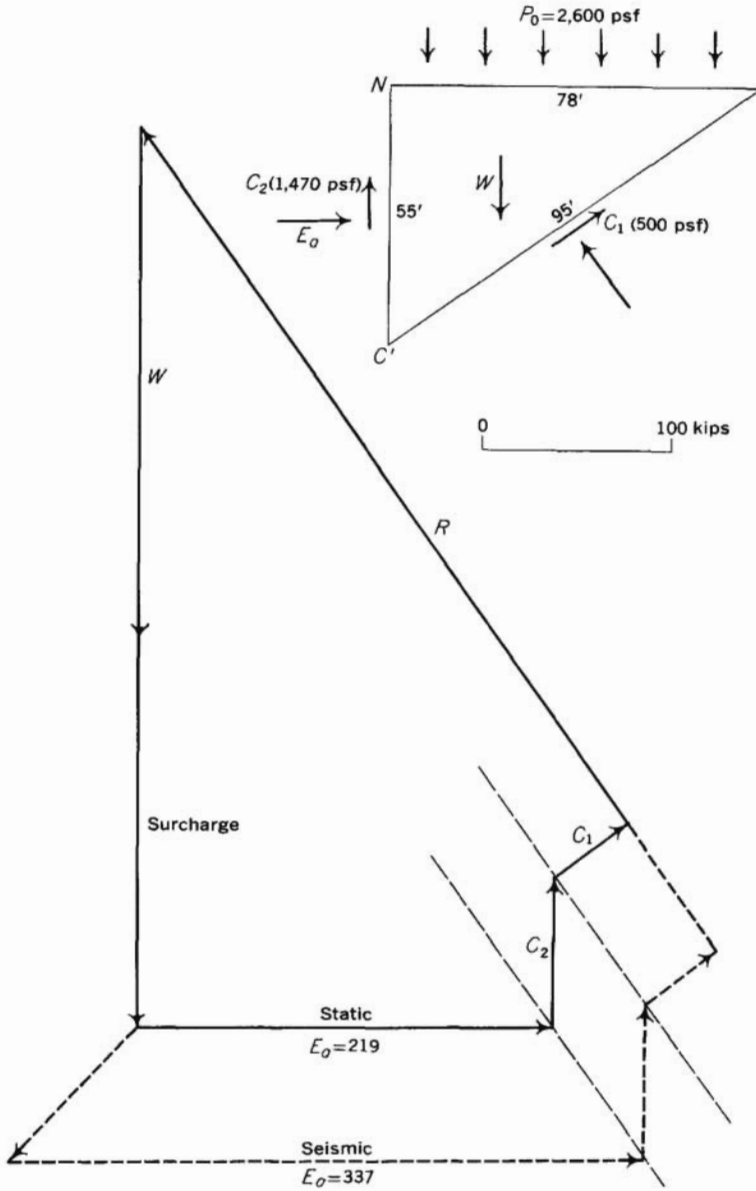
FIGURE 29.—Graphical determination of active pressure E_a on NC' , boring line 2.
