Alaska Railroad Terminal
Reserve, Anchorage
Soil stability study

Stability in the vicinity of
Boring Lines 1 and 2

David J. Varnes

Open-file report

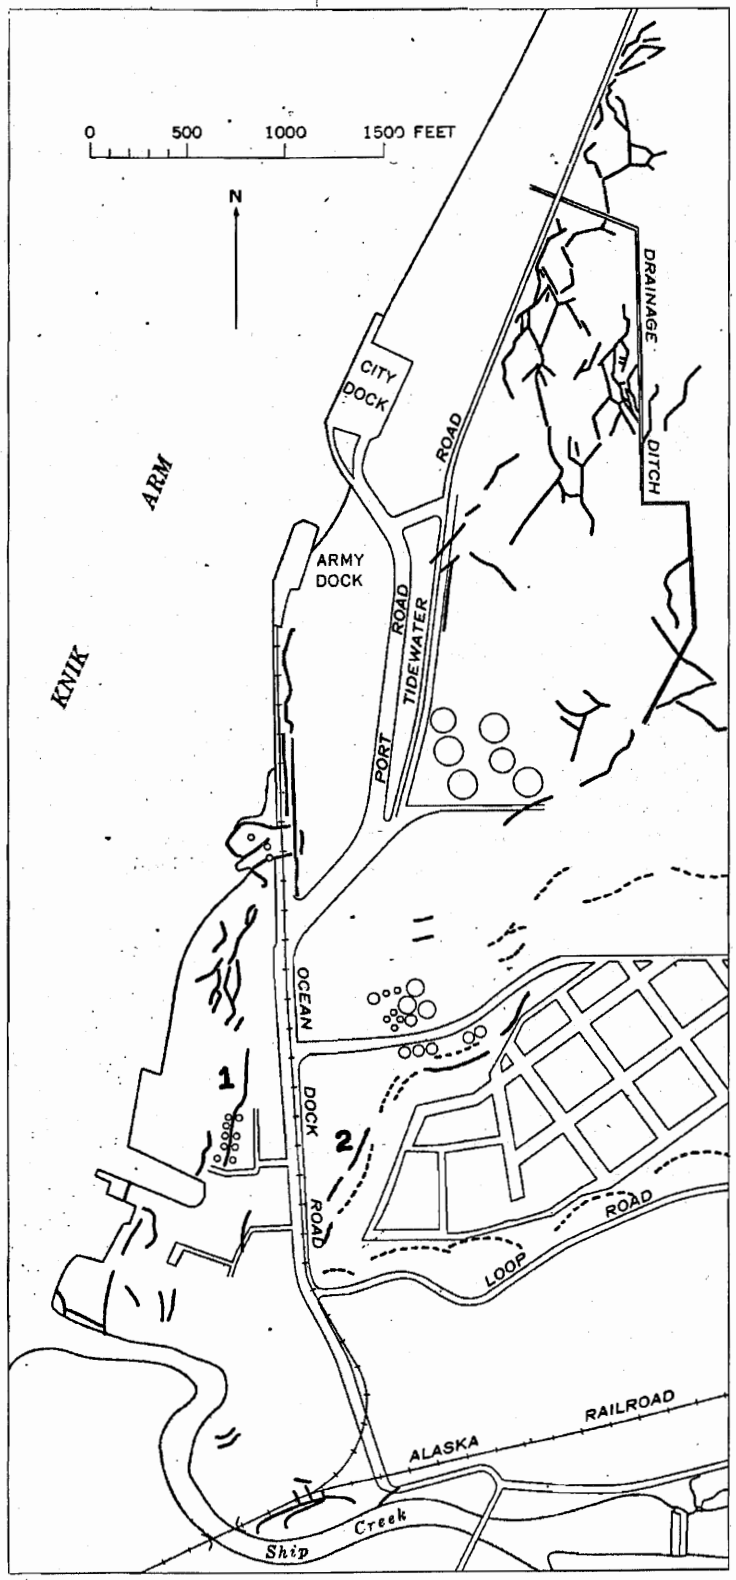
Studies made by the writer in the field in 1966 and 1967 and of aerial photographs taken in the period shortly after the earthquake added a few details to the pattern of ground cracking presented by Hansen; his map with additions is shown in figure 21.

Two items of present interest are shown by the numbers on figure 21. Number 1 refers to a crack in the fill in the area of the asphalt tanks of Union Oil Company. Figure 4 shows a line of hachures that passes under these same tanks. This line, transferred from the 1914 topographic map, indicates the break in slope between grass-covered marsh, to landward, and the bare inclined slippery clay surface, to seaward, that extends to the surface of the water. This boundary is well shown in the left center parts of figures 5 and 9. It seems likely that the underlying shore topography influenced cracking in the fill during the 1964 earthquake, for most of the cracks west of Ocean Dock Road shown in figure 21 are at or below the break in slope of the old shore.

Number 2 on figure 21 refers to a crack east of the Independent Lumber Company warehouse at the base of the slope. It may be seen in the upper right in figure 22, and is of interest because it crosses Boring Line 1, and gives some direct evidence for the potential instability under seismic shaking that is inferred in analyses to follow. The crack has since been obscured by regrading.

Figure 21
 Ground cracks following the March 27, 1964, earthquake (solid) and scarps of old landslides (dashed), Port of Anchorage and vicinity. From Hansen (1965, fig. 14), with additions. The number cracks are discussed in the text.

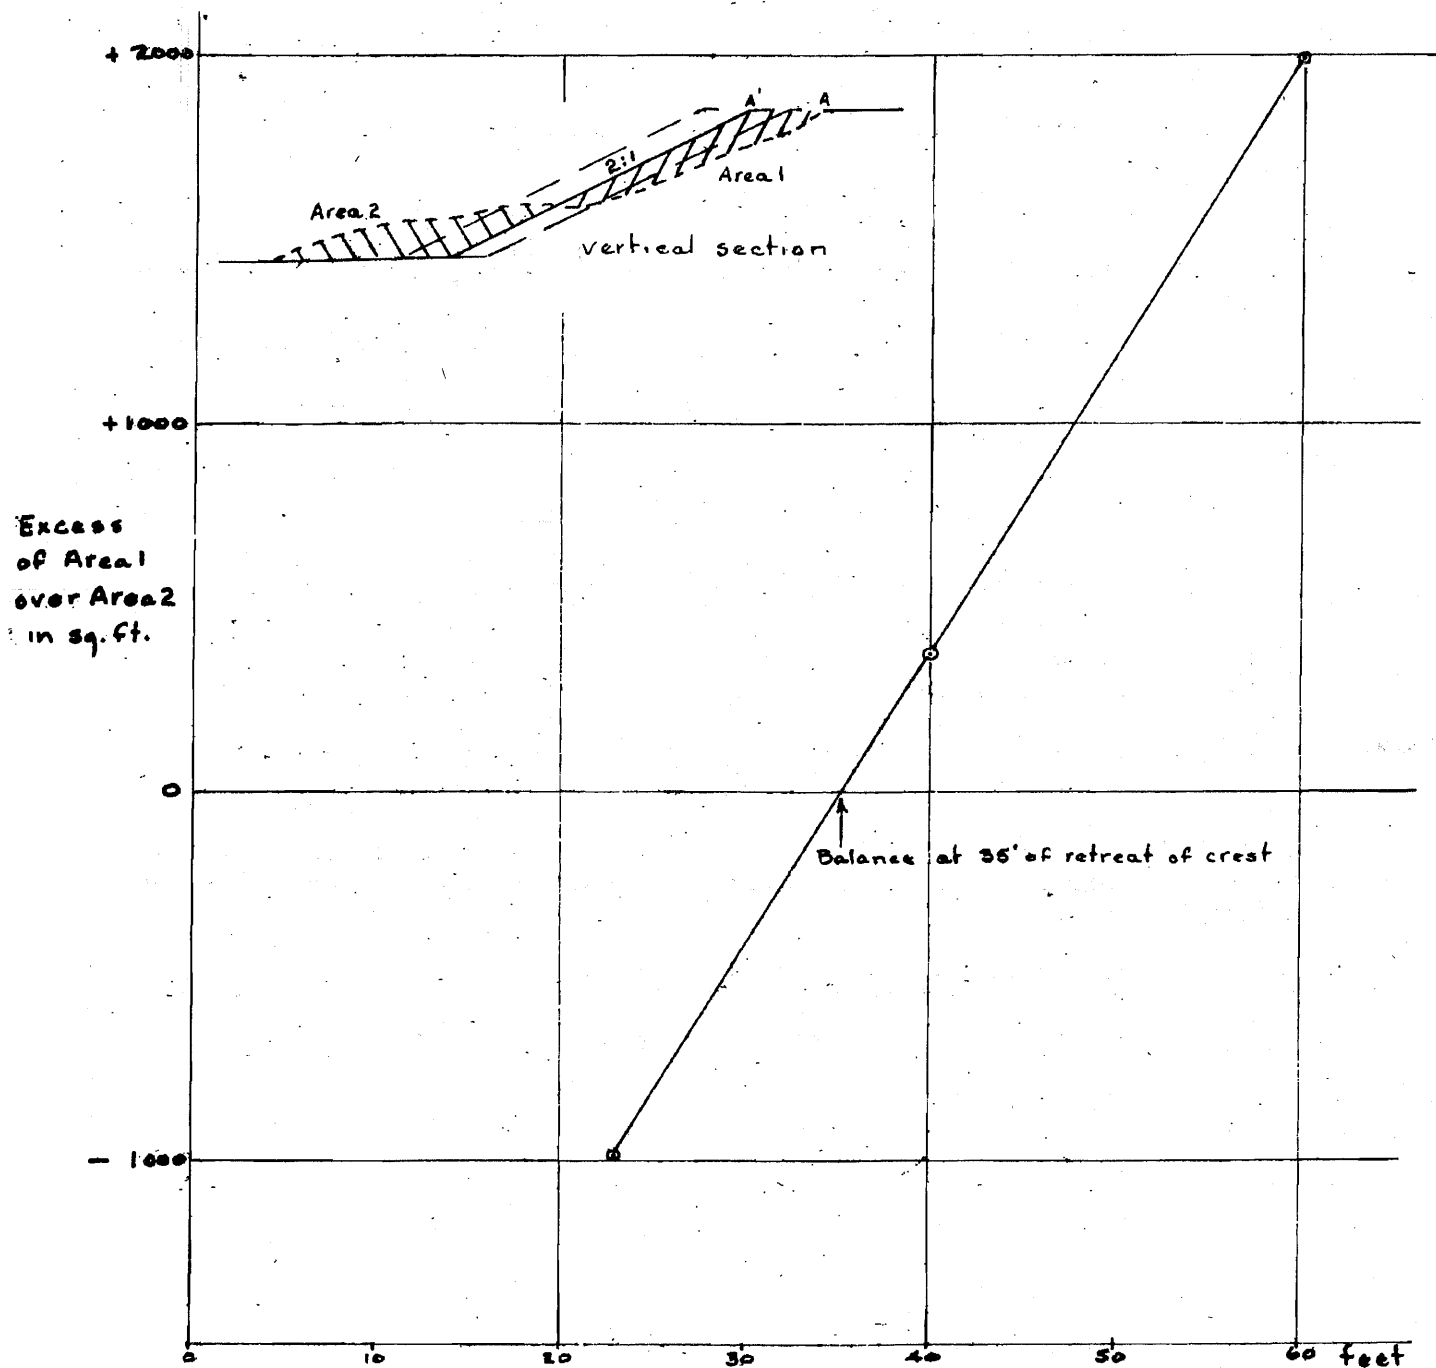
Figure 26

The old slides may have moved along surfaces such as ABCFDE or ABCFG in figure 24 or ABOP in figure 25 (in pocket). The position of the crest of the slope prior to the last period of major sliding is inferred by the construction in figure 26. It is assumed that the last major movement was bounded at the head by surface ABB'. Owing to removal of material from the old slide, particularly at the toe, and reconsolidation of the soft sediments beneath the coal stockpile placed in 1918-21, I believe that the present most dangerous potential failure surfaces would crop out east of the warehouse.

Estimated distance of former crest of slope, A' seaward from present crest, A, in figure 24

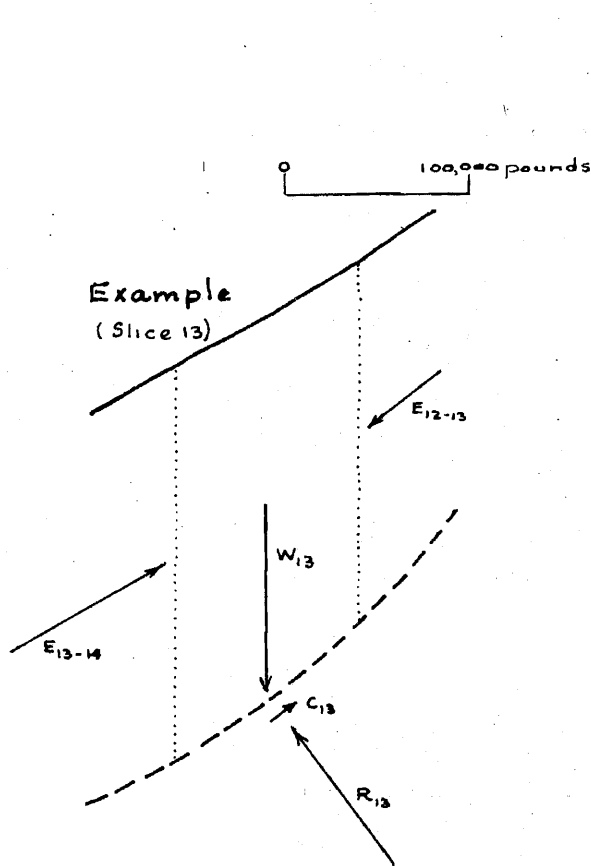
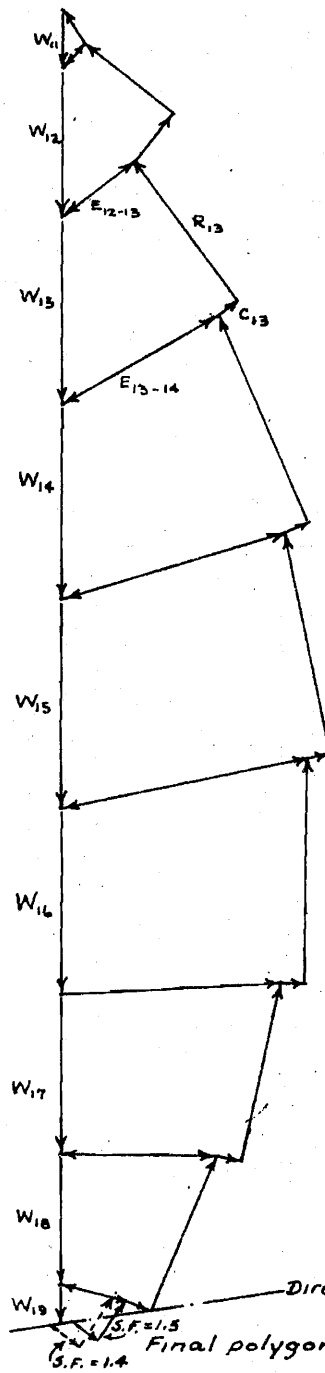
Figure 27

The two methods agree in indicating that, under static conditions, failure along arc ABCJ is unlikely unless the toe of the slope is removed. If the ground was removed to the level of GH (base of warehouse) the stability along arc ABCJ (through the removal of wedge JNHI) would be reduced markedly.

STABLE

Force polygon stability analysis of potential failure along circular arc ABCJ, line l, under static conditions, wedge JNHI in place.

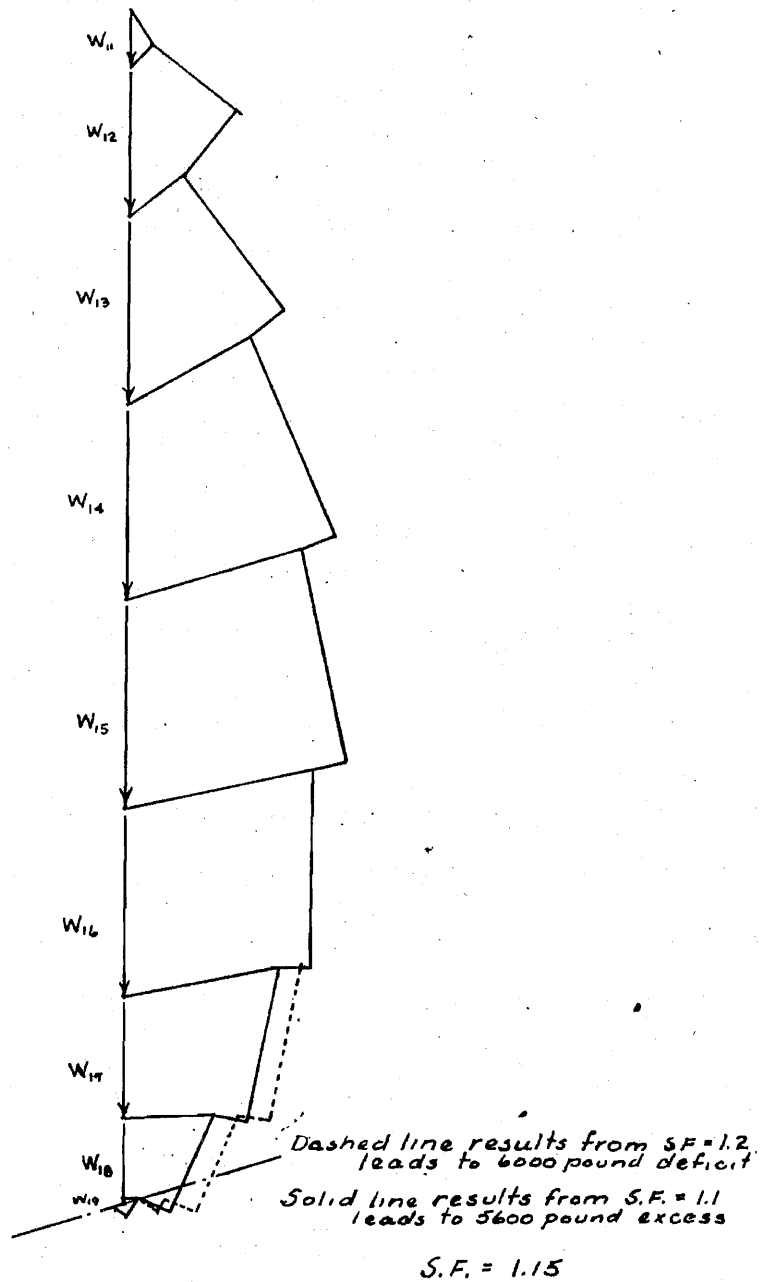
Figure 28

DOUBTFULLY STABLE

Force polygon stability analysis of potential failure along circular arc ABCN, line 1, under static conditions, wedge JNHI removed.

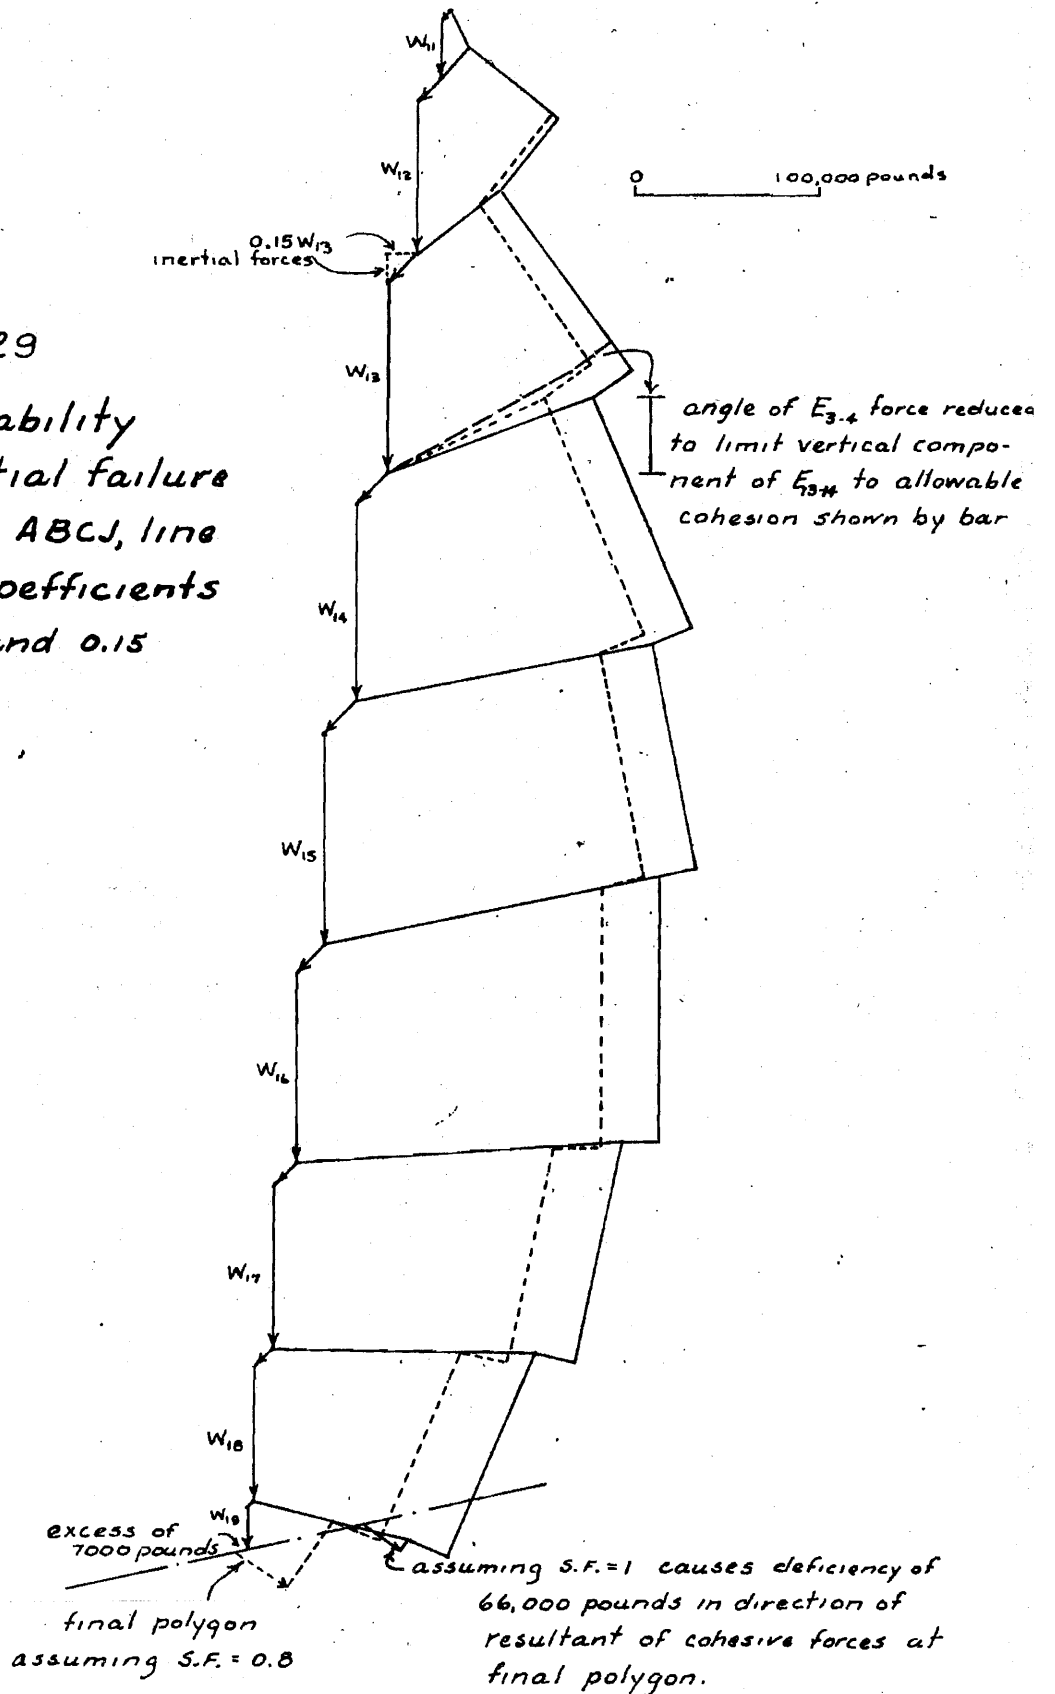
According to the stability computations that follow, failure along a circular arc under seismic conditions appears less likely than failure along a more or less horizontal surface. Nevertheless, figure 29 shows that the mass above circular arc ABCJ has a safety factor of only 0.82 with respect to available cohesion if seismic coefficients of 0.15 horizontal and 0.15 vertical combined are used in stability computations. It is estimated that, if the available cohesion were completely used, a seismic coefficient of the order of 0.06-0.065 would reduce the safety factor to 1.0 from its static value of 1.44.

Figure 29
 Force polygon stability analysis of potential failure along circular arc ABCJ, line 1, under seismic coefficients of 0.15 horizontal and 0.15 vertical.

final polygon assuming S.F. = 0.8

S.F. = 0.82 with respect to available cohesion

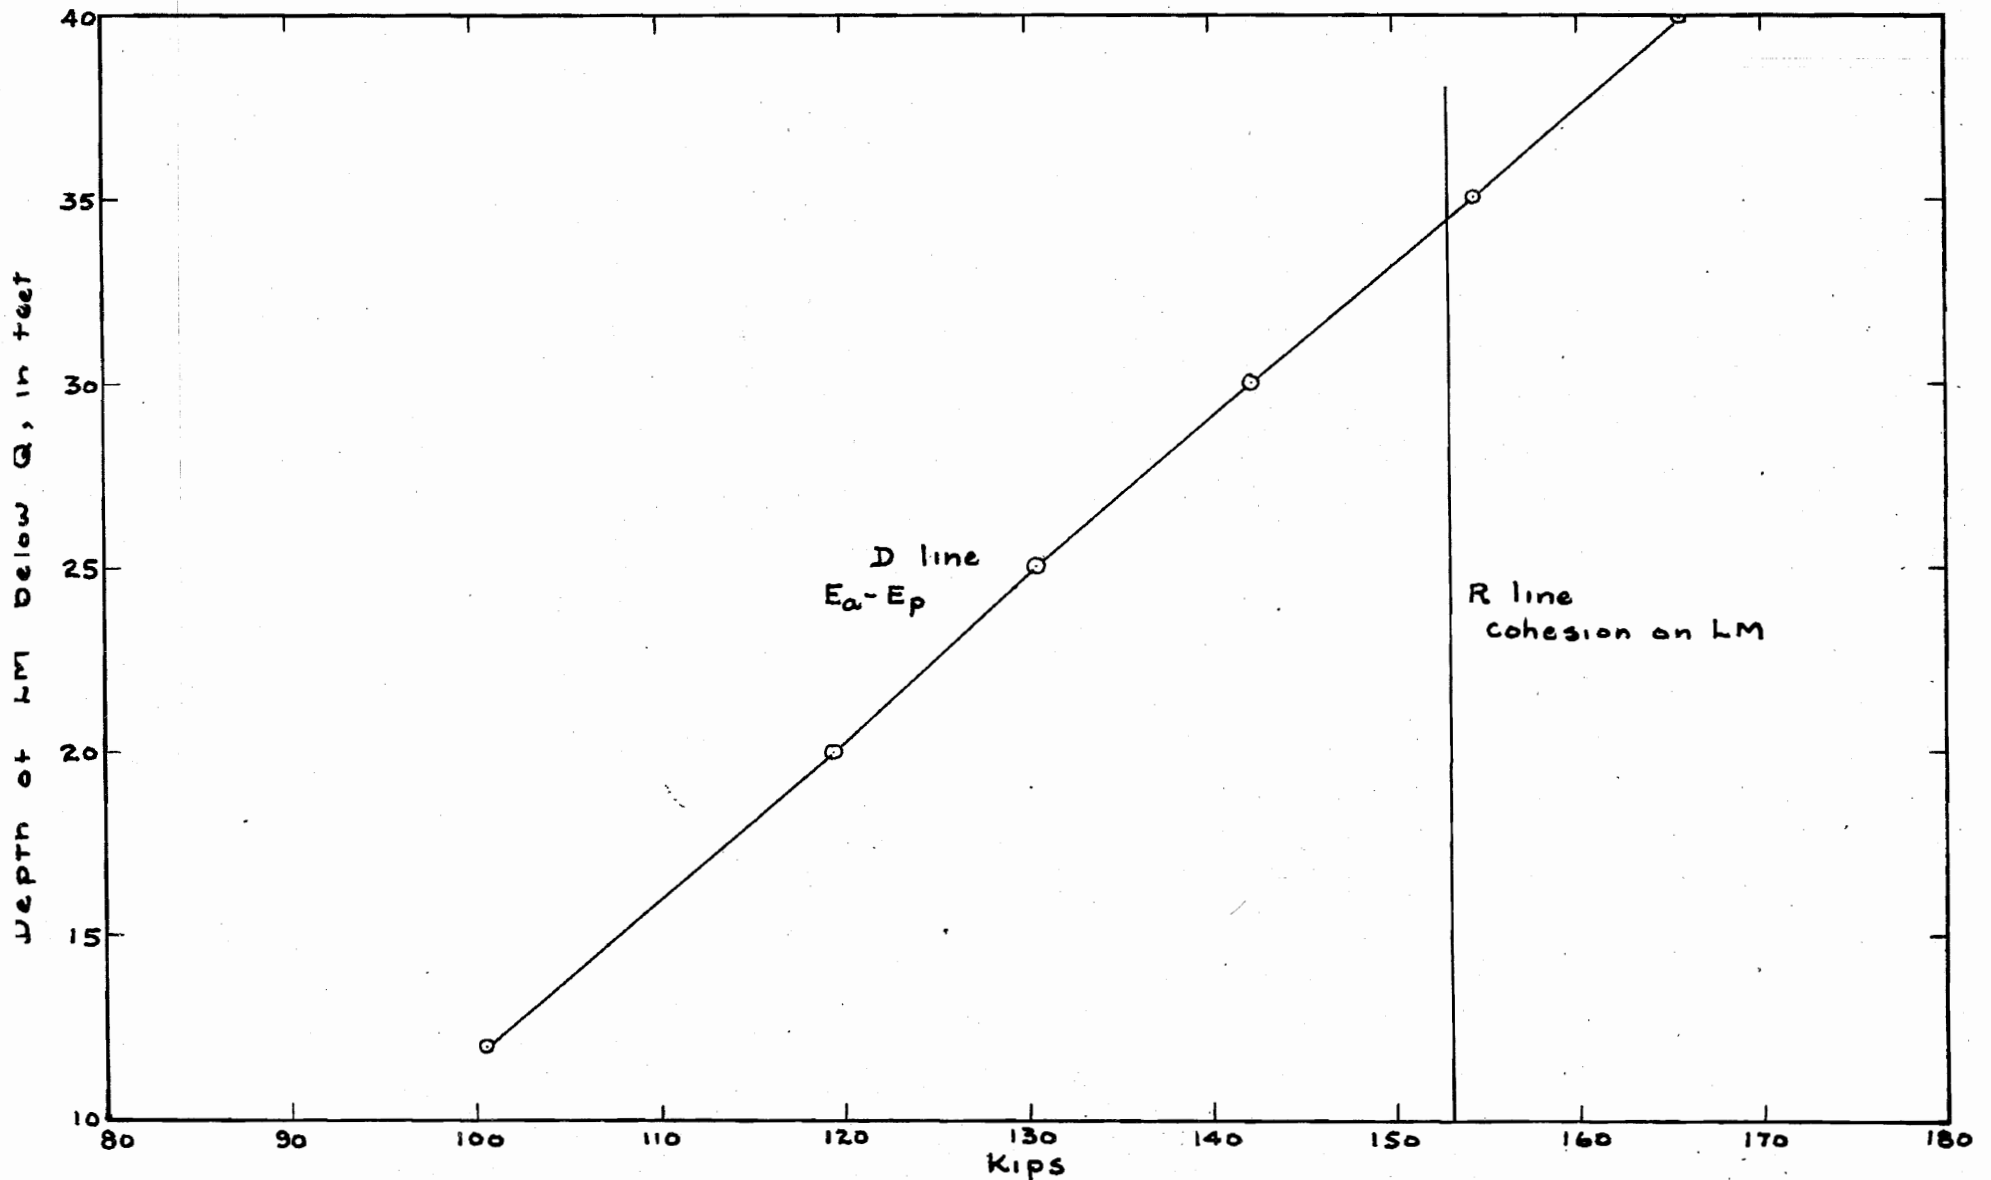
FIGURE 30

- (1) Surface of potential failure will be taken to be at the shallowest location of LM at which active pressure on MA (E_a) requiring mobilization of block MSRA, exceeds passive resistance on LQ (E_p) plus cohesion on LM, see figure 30 and Appendix A^P.

Determination of depth of potential failure surface LM, Boring Line 1, for static conditions. Depth must be such that driving force $E_a - E_p$ shown by D line exceeds cohesion along LM shown by R line.

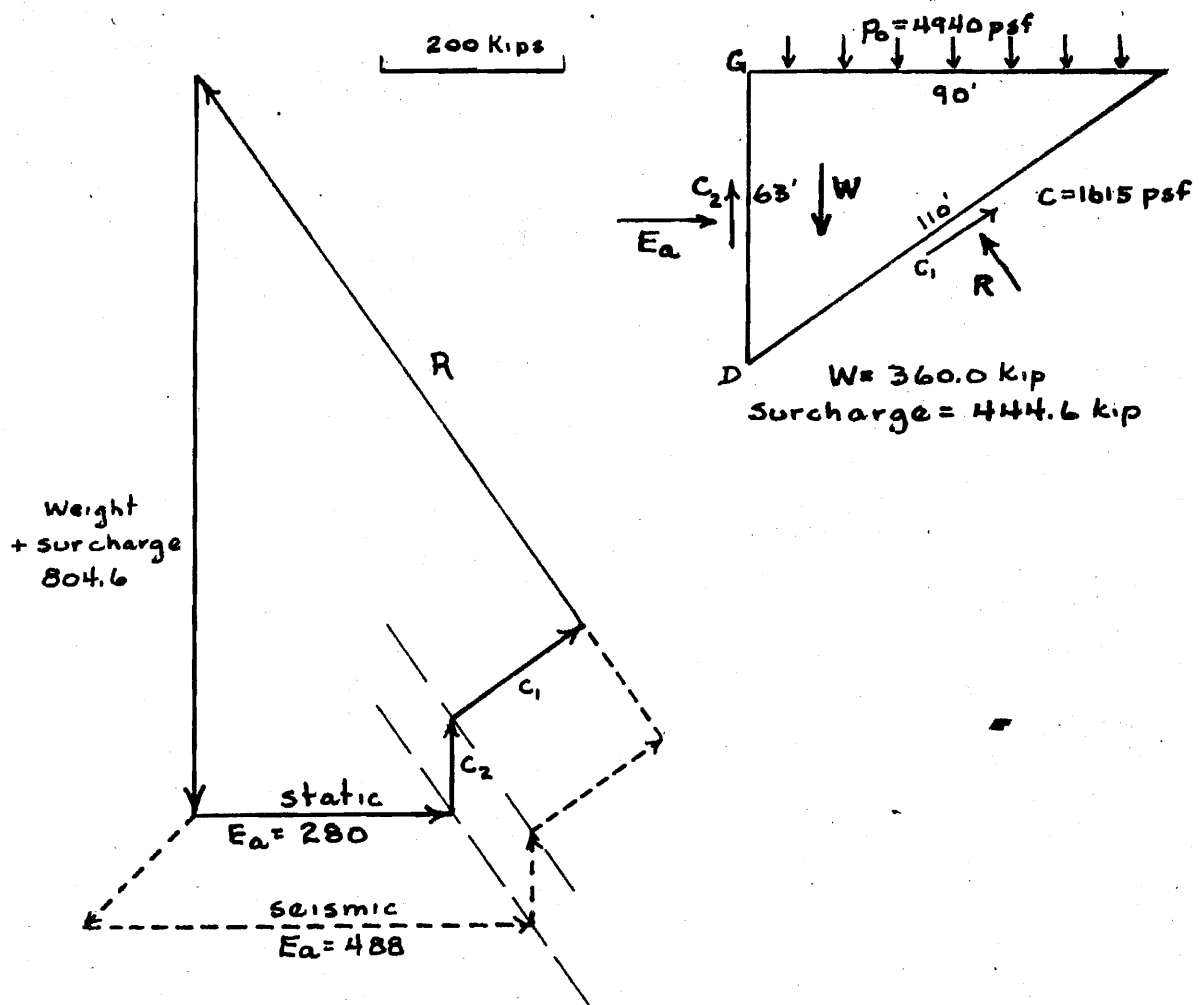
FIGURE 34

Graphical determination of active pressure E_a on GD, Boring Line 2.

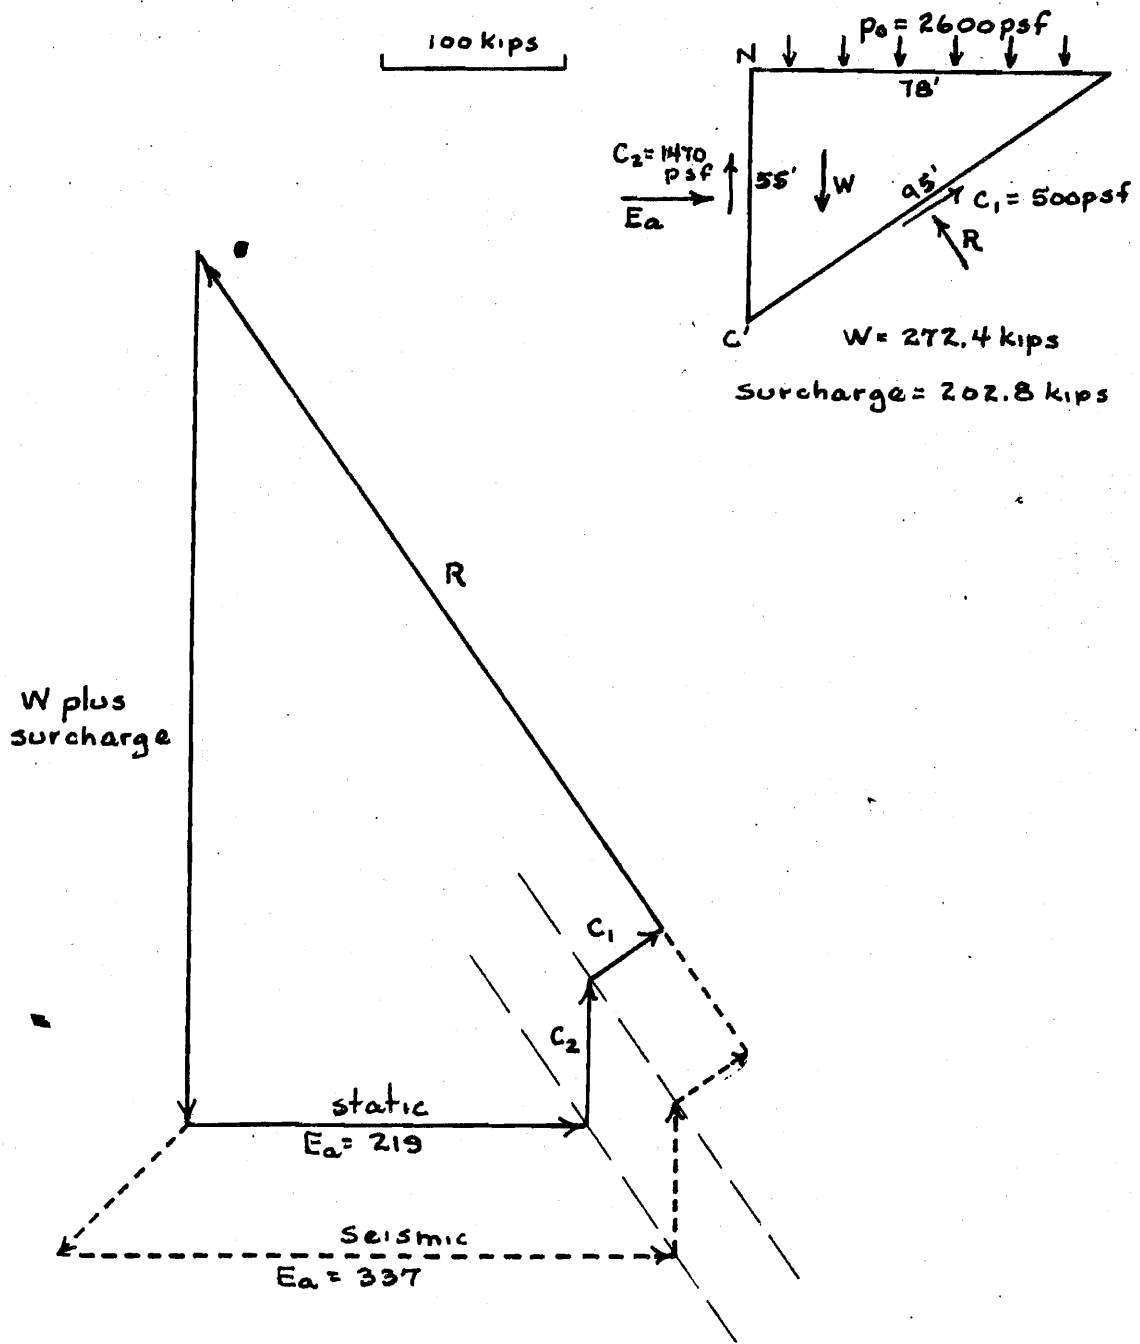
FIGURE 35
Graphical determination of active pressure E_a on NC' , Boring Line 2.

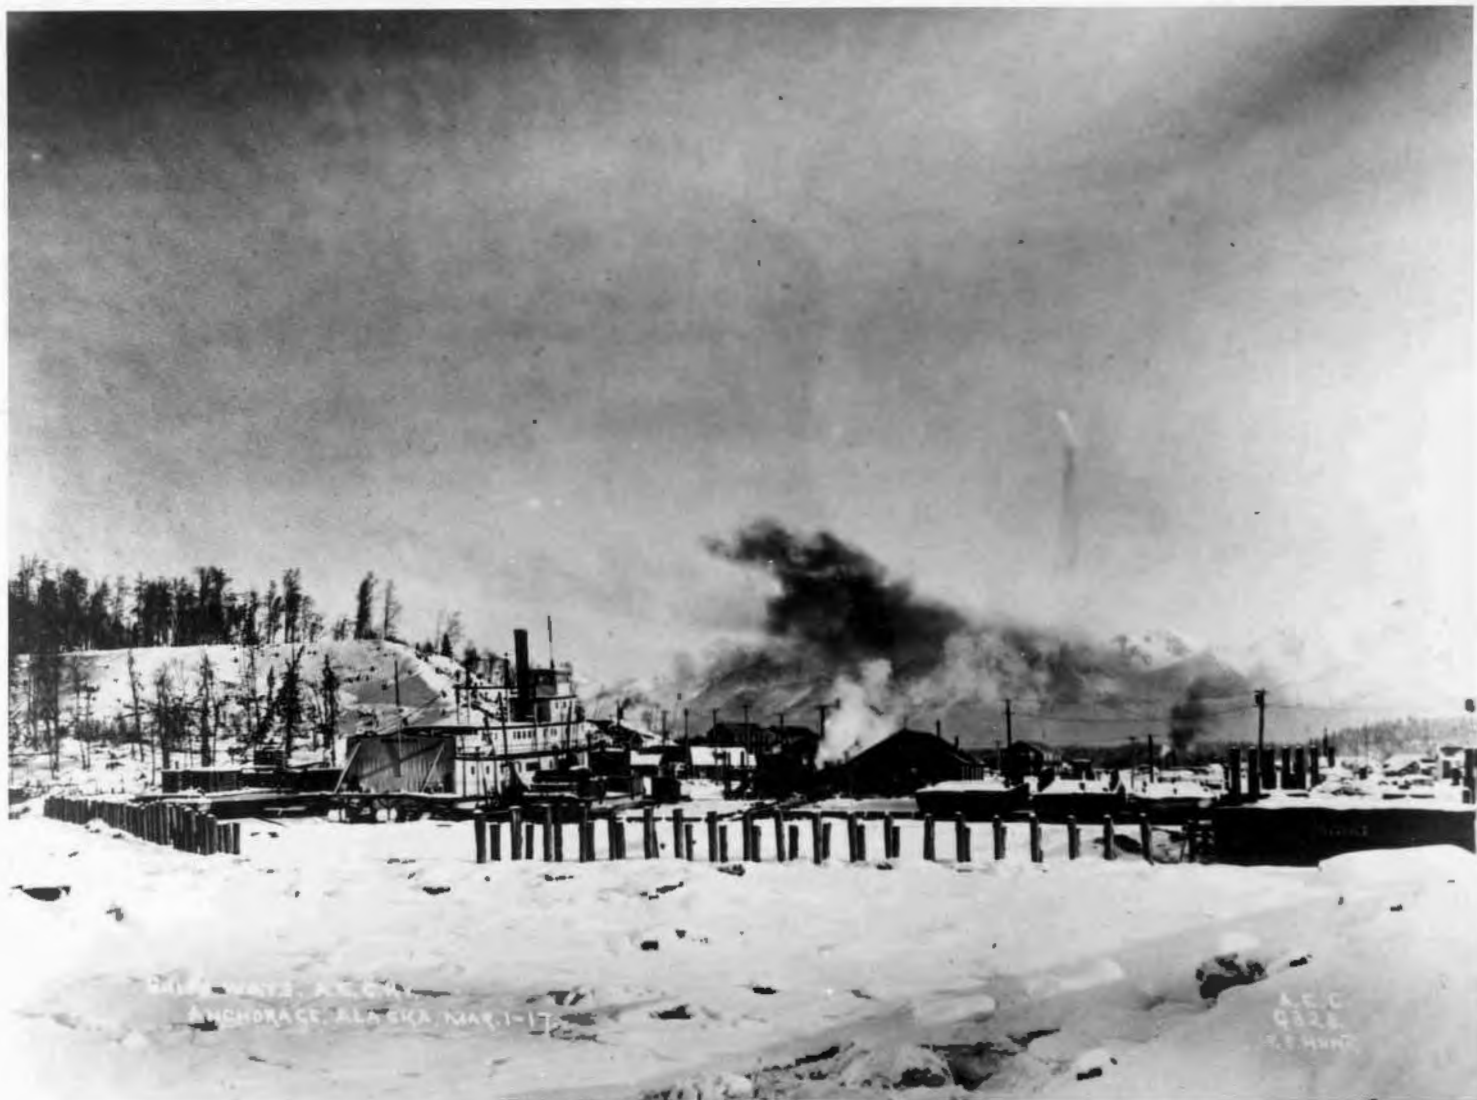
Fig. 6

Figures 5-10 are reproductions of photographs taken by the Alaskan Engineering Commission of parts of the present Terminal Reserve in the years 1917-21, following the initial settlement in 1915. The approximate positions from which these photographs were taken are indicated on figure 3. The toe of the flow-slide shows on the right in figures 5, 7, and 8. The size of the trees growing on the slide indicates that the flow was probably several decades old in 1918, yet trees at the toe are leaning and fallen indicating, perhaps, some continued movement and tidal erosion. The slide in the area of Boring Line 1 is shown on the

left in figure 6 and in the foregrounds of figures 7 and 9. It, too, looks old, judging from the upright mature conifers shown in figure 7. For reference, a few trees are identified by number on figures 7 and 9. Figures 6 and 10 show that almost all the trees were removed from the nose of Government Hill at an early date. Figure 10 shows the discharge pipe of the dredge operating at the site of Army Dock (then called Ocean Dock); it is emptying landward from the railroad trestle and illustrates the beginning of the process of artificial filling that has continued along the shore ever since.

The presence of old slides in the lower part of the slope crossed by Boring Line 1, indicated by the early topographic map and photographs (figs. 4, 6, and 7), is confirmed also by the logs of borings ARR 1-A, B, and C, made late in 1966. Summary logs and results of tests on samples from the borings are attached to the vertical section figure 24 (in pocket). The difference in elevation of the top of the Bootlegger Cove Clay in borings 1-A and 1-B indicates offset by sliding and positions of the same contact in boring 1-C and in a nearby earlier boring, DM 64-13, suggest a slight backward tilting of the slide block or blocks. No doubt the distribution of the silt and clay beneath the slumped surface of granular materials is more complicated than can be shown on the basis of available information. Regrading has obscured the topographic form of the slides and much material has been removed from the present location of the lumber warehouse. The ground surface as of about 1916 is shown based on a map prepared by the Alaskan Engineering Commission about 1916, similar to but more detailed than that shown in figure 4.

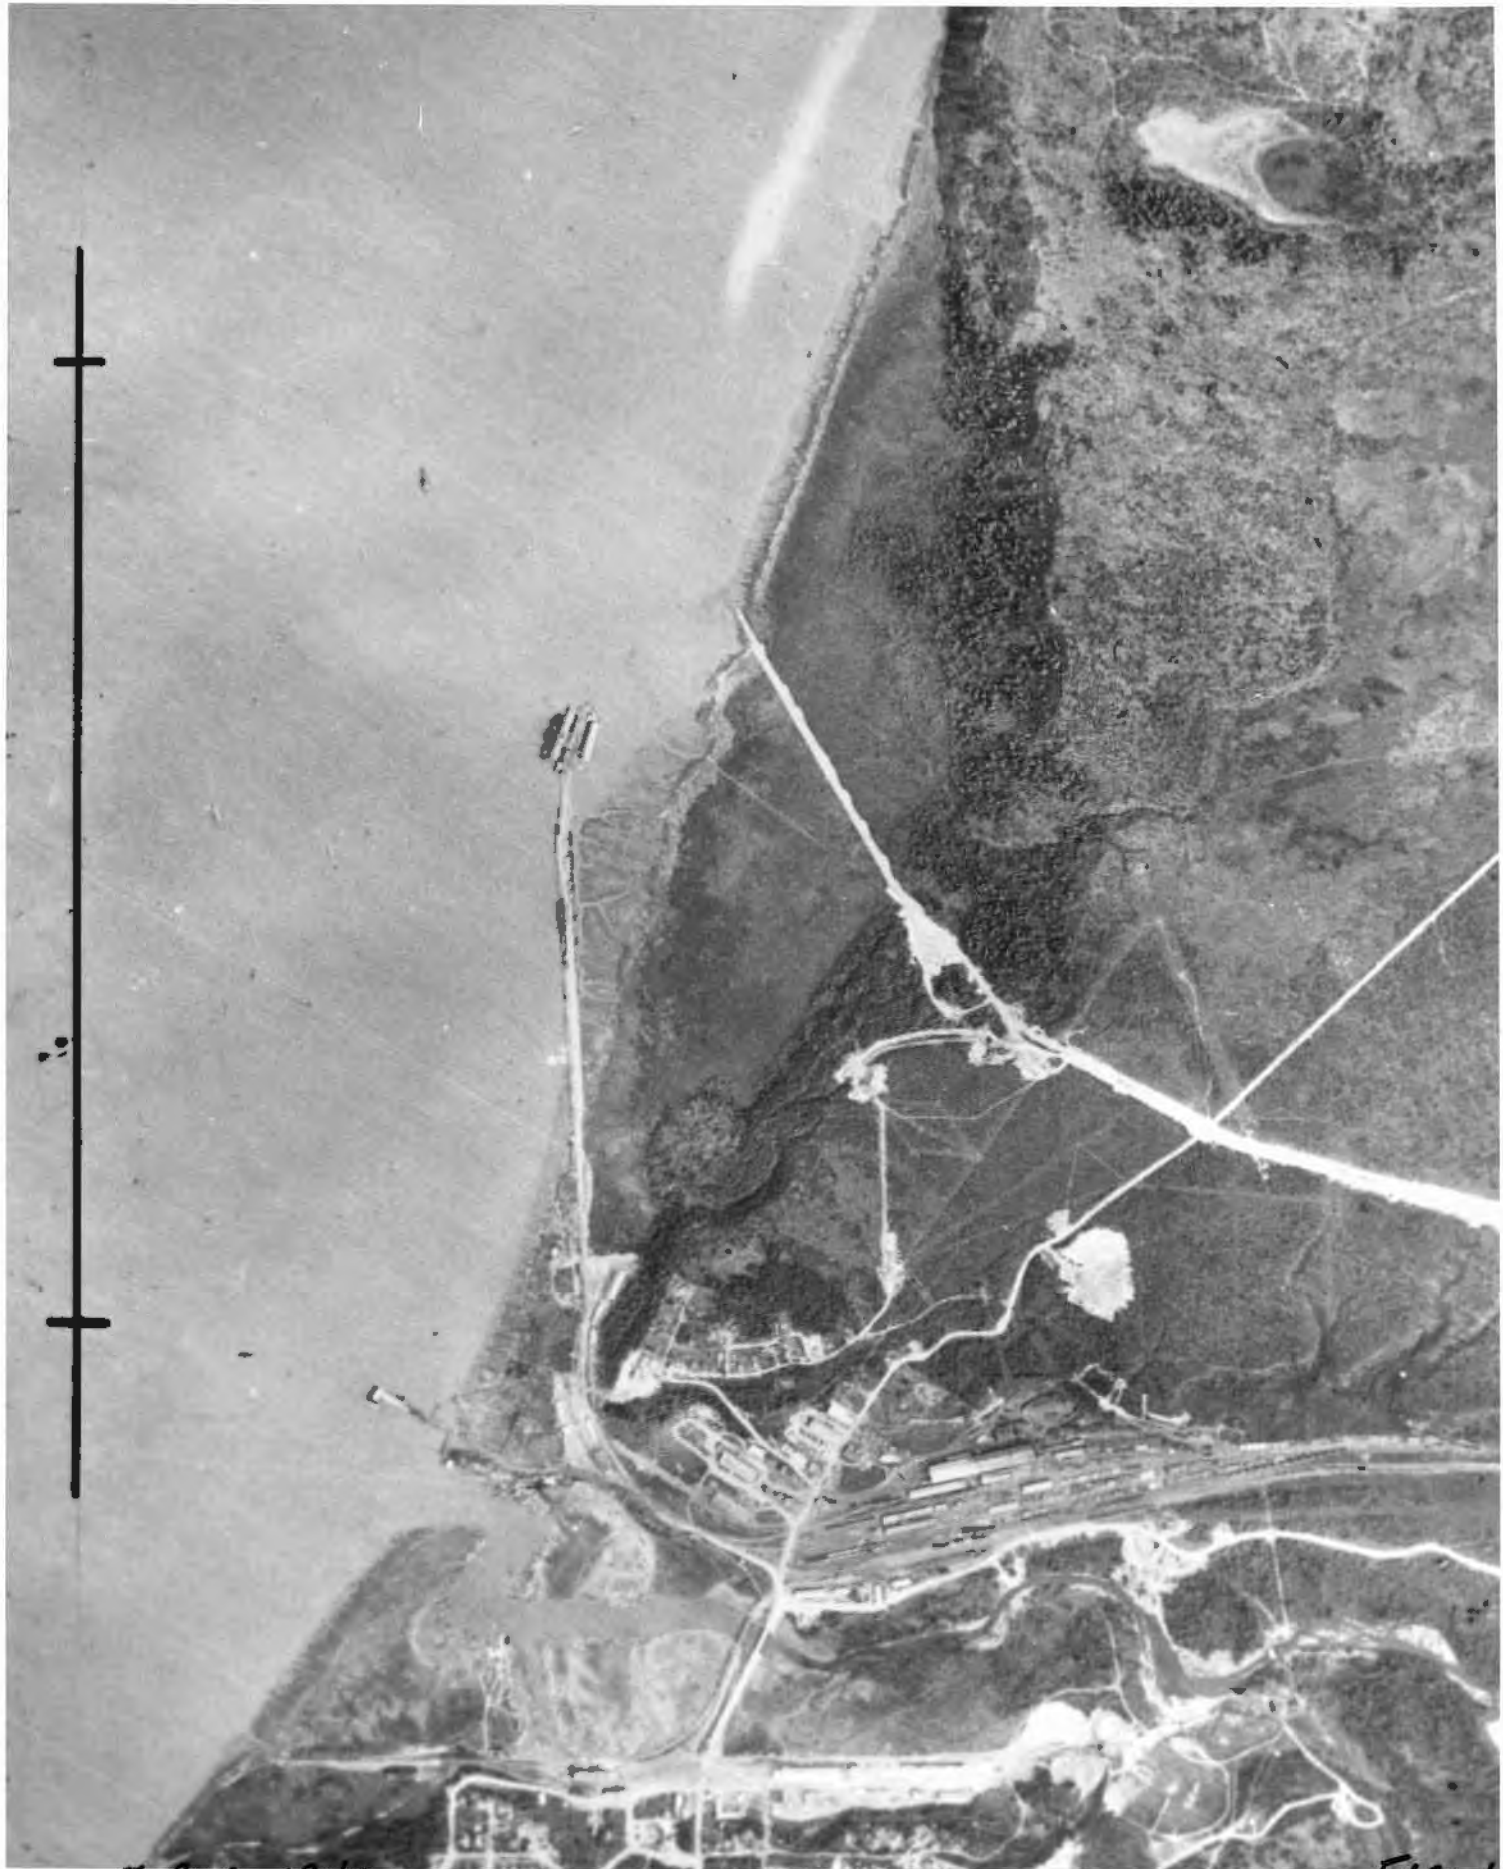
FIG. 11

In figure 11, the elongated triangular flat of the port area is modified only by the white trace of the Elmendorf sewer outfall and by the developed areas near the southwest corner of Government Hill. The west slope of Government Hill is clearly broken into long furrows by slide blocks and interrupted by the nearly circular outline of the flow slide. North from the outfall, the crest of the slope consists of a half dozen or more shallow arcs marking the heads of old slides. Faint remnants of the removed material show as lobes of somewhat higher ground supporting a growth of bushes on the flat,

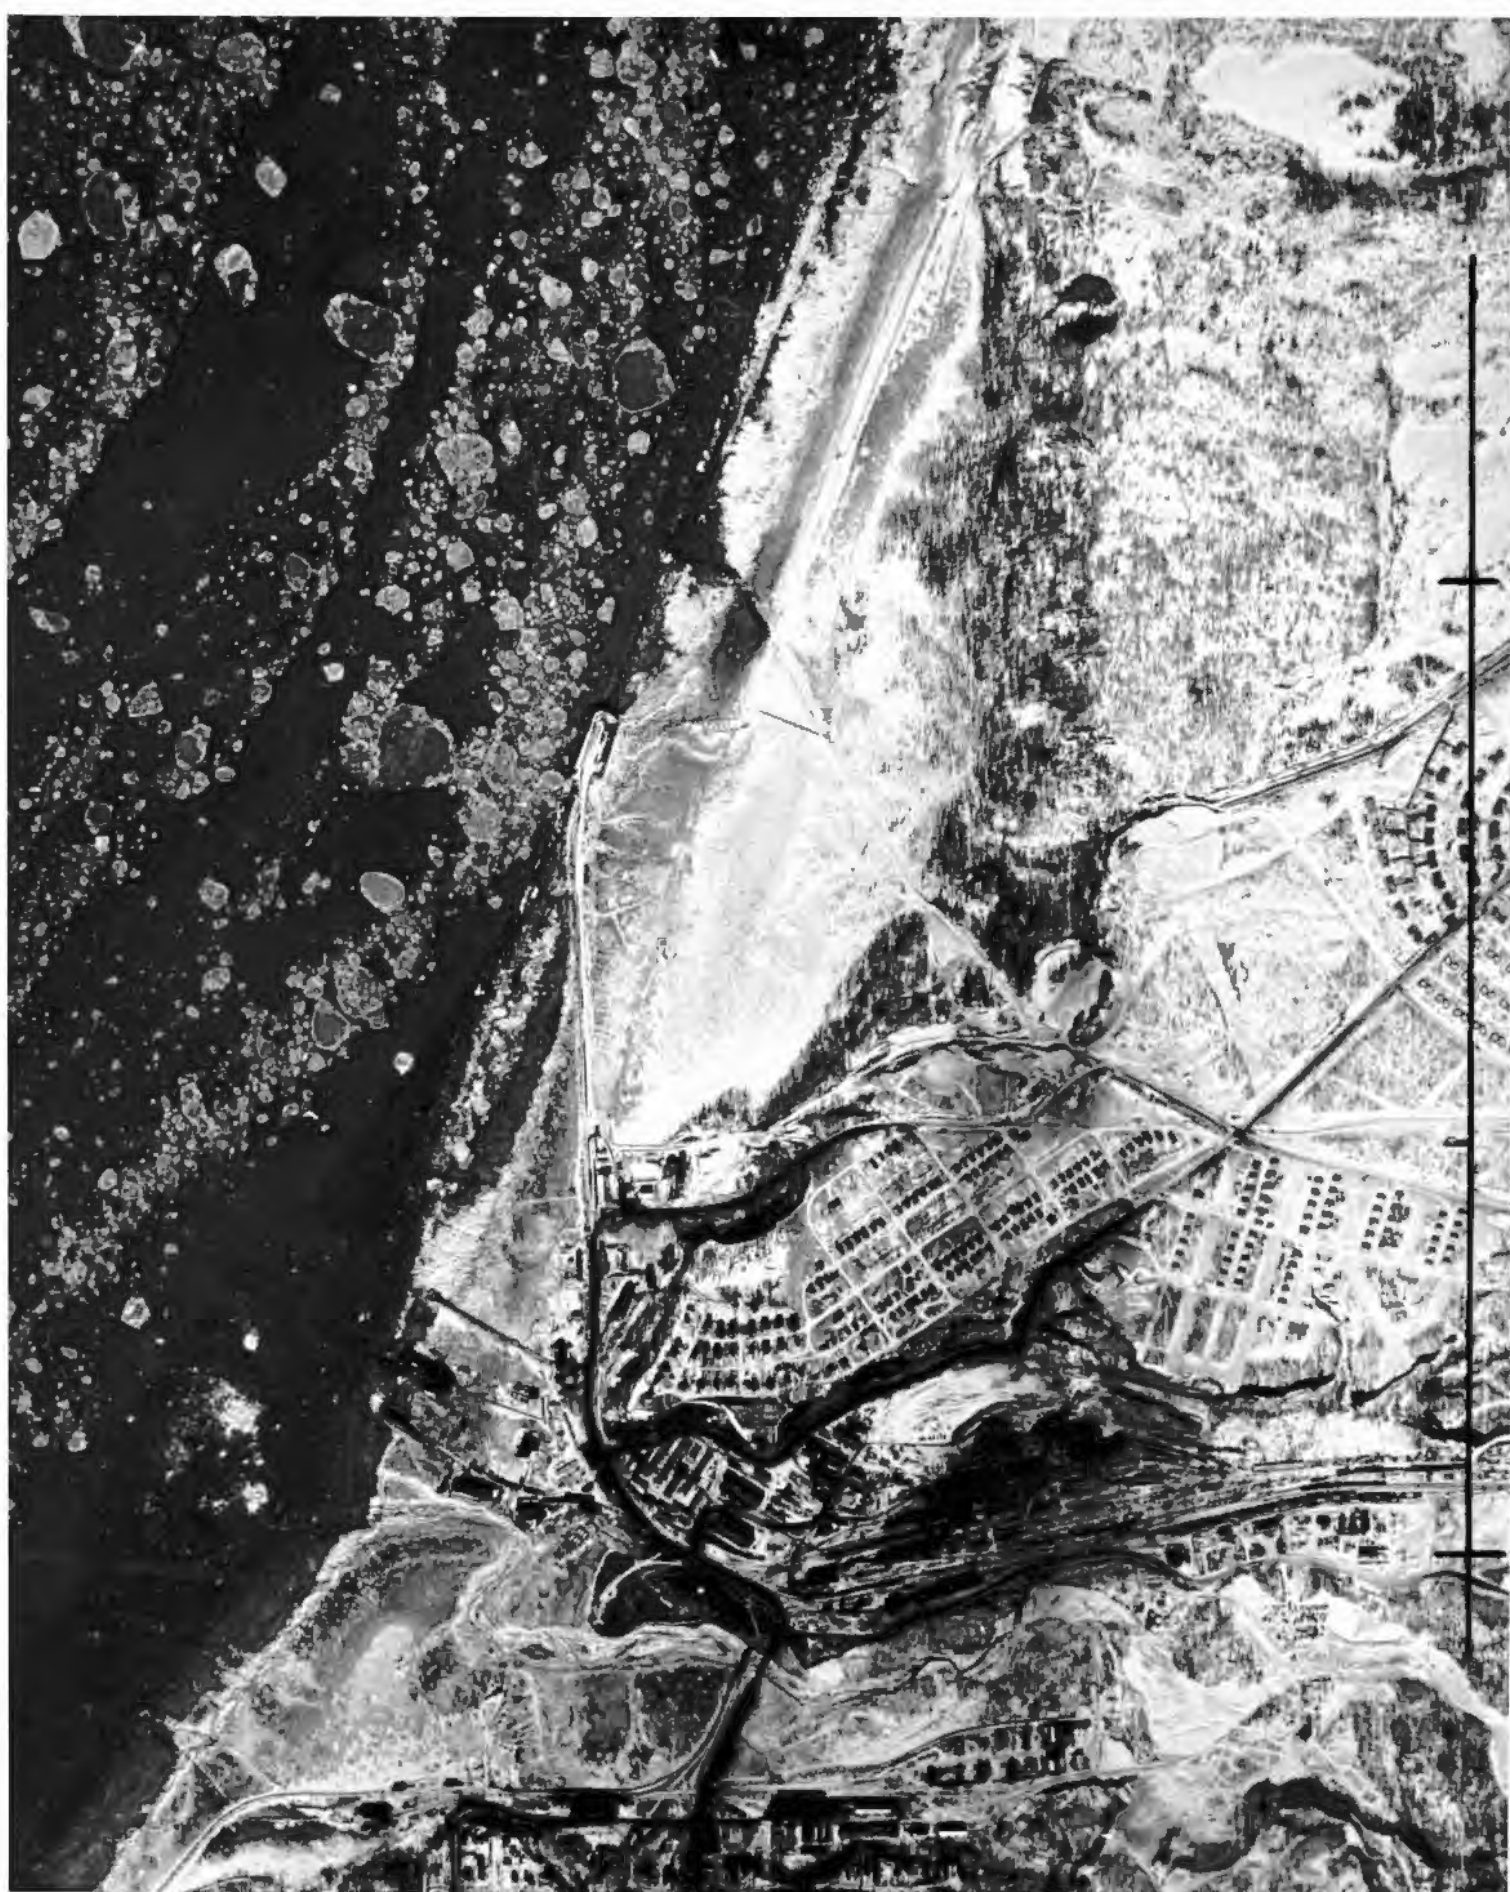
FIG. 12

Figure 12 shows development of the tank farm on the flow slide, Bluff Road crossing the slide, and some cuts being made in the slide blocks south of Bluff Road preparatory to placing the five Standard Oil asphalt tanks shown on figure 13. Figure 12 also shows cuts have been made into the slope east and southeast of the Independent Company Warehouse. Figures 13, 14, and 15 show that, as embankments were built on to the flat, particularly north of the Standard Oil development on the flow slide, drainage to the sea was impeded and ponds developed between the embankments or between embankments and the slope. At the same time, runoff from the expanded development at Elmendorf Air Base was apparently greatly increased, cutting a sharp-walled ravine as shown in the right central parts of figures 14 and 15, and no doubt contributing to the formation of ponds in the flat area.
