Alaska Railroad Terminal
Reserve, Anchorage
Soil stability study

Stability in the vicinity of
Boring Lines 1 and 2

David J. Varnes

Open-file report

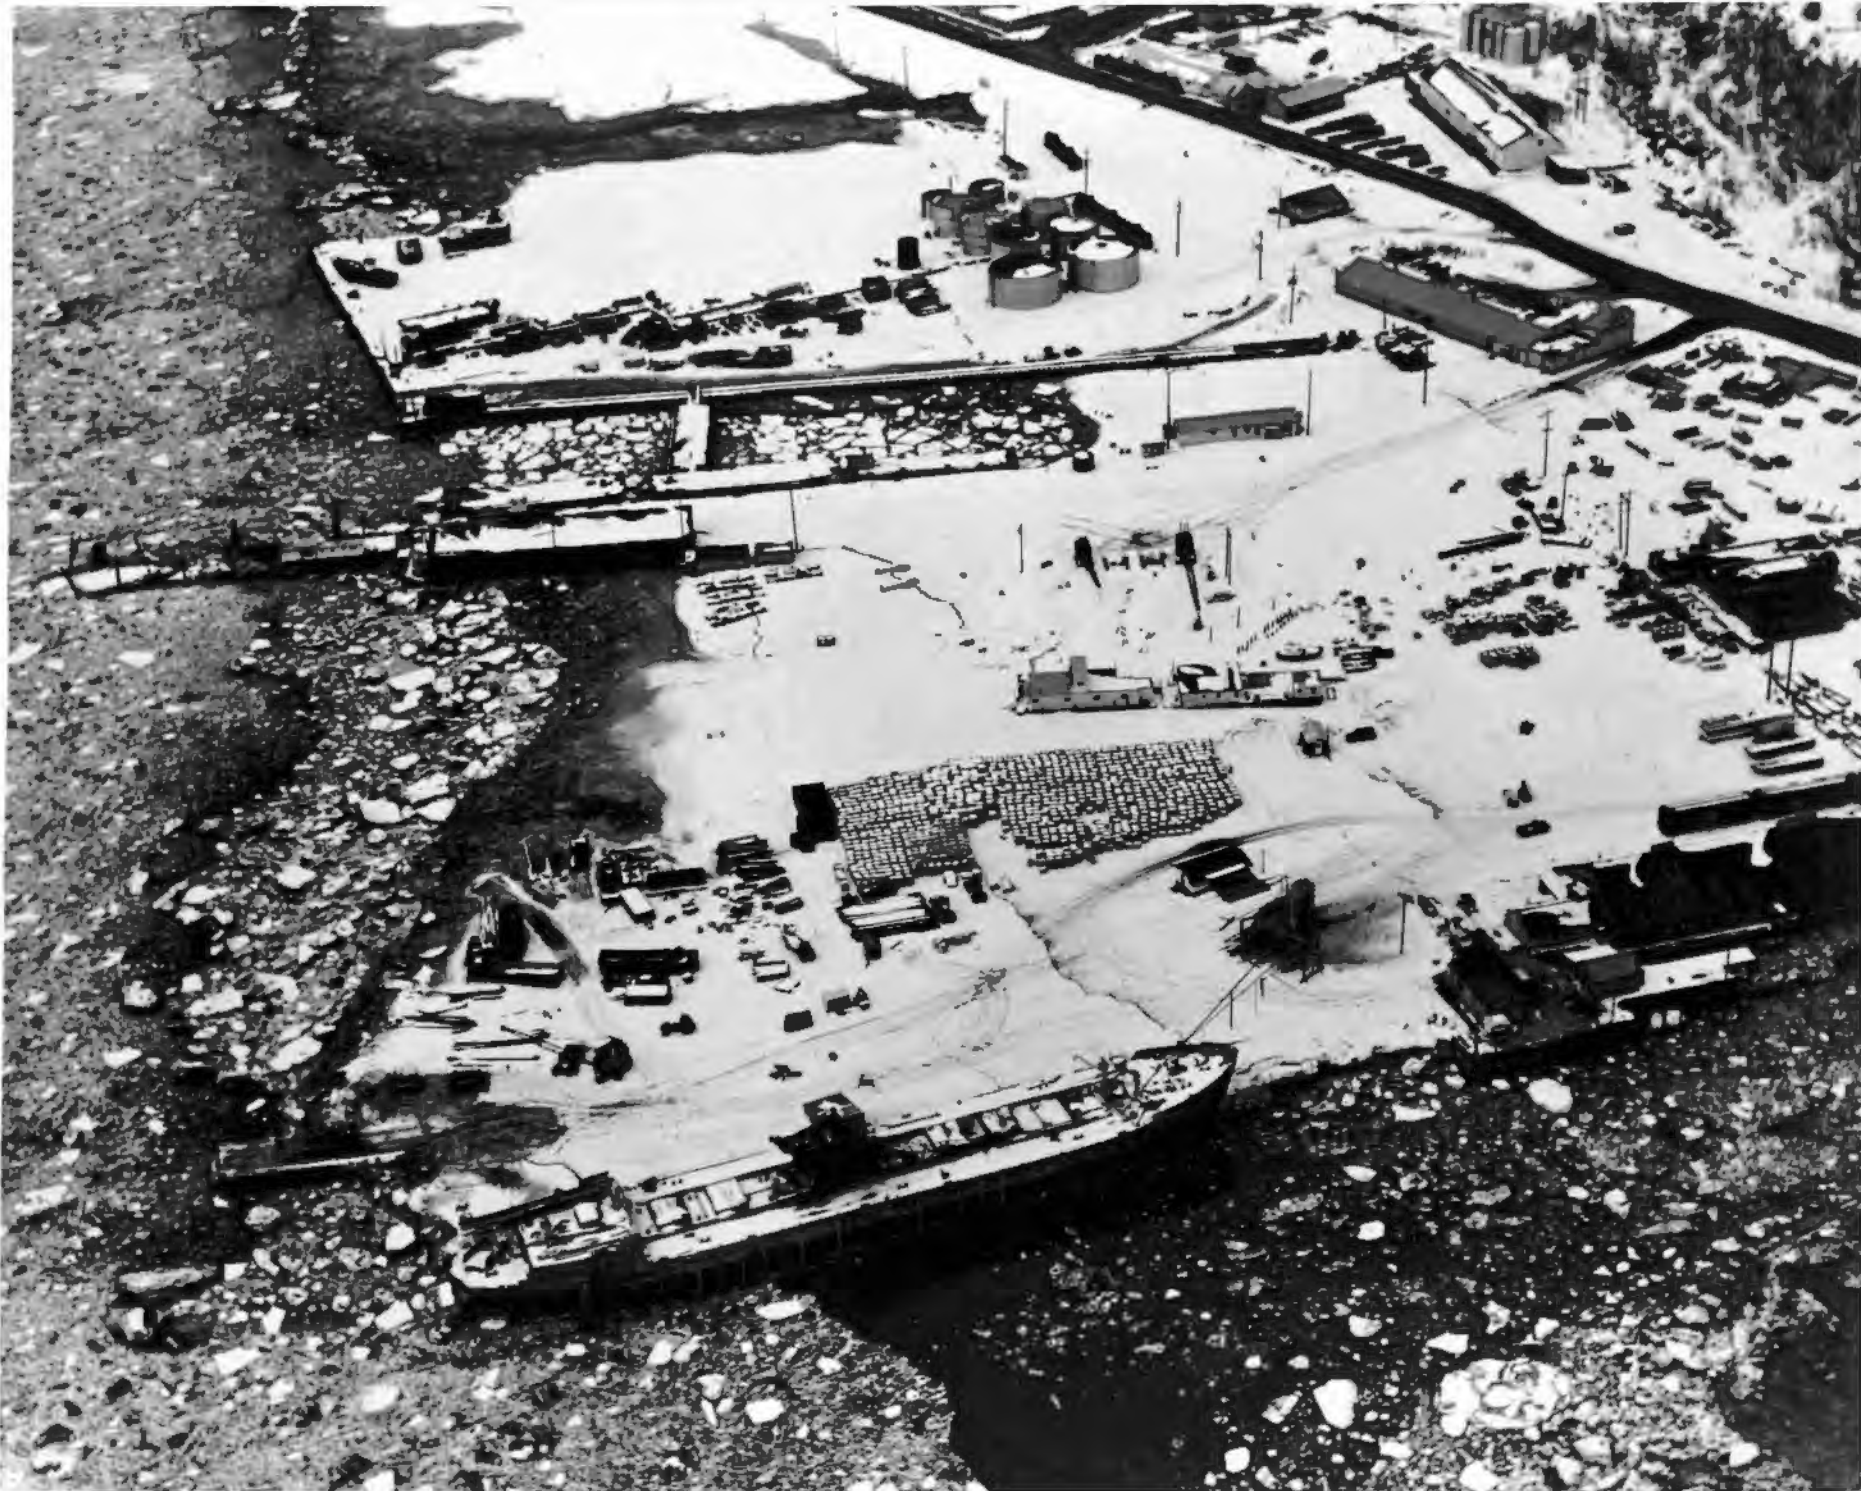
FIG. 22

Number 2 on figure 21 refers to a crack east of the Independent Lumber Company warehouse at the base of the slope. It may be seen in the upper right in figure 22, and is of interest because it crosses Boring Line 1, and gives some direct evidence for the potential instability under seismic shaking that is inferred in analyses to follow. The crack has since been obscured by regrading.

Figure 22.--Looking northeastward over the south end of the port area from above Ship Creek, after the earthquake of March 27, 1964. Cracks in the filled areas are mostly parallel with the shoreline as it was before filling. Note cracks at the base of slope, to the right of the power poles near the warehouse in the upper right corner of the photograph. Boring Line 1 passes down the slope and about midway through the warehouse. U.S. Army photograph.
