CHANNEL EROSION SURVEYS ALONG THE TAPS ROUTE, ALASKA, 1977

78-611

by
Robert M. Loeffler
and
Joseph M. Childers

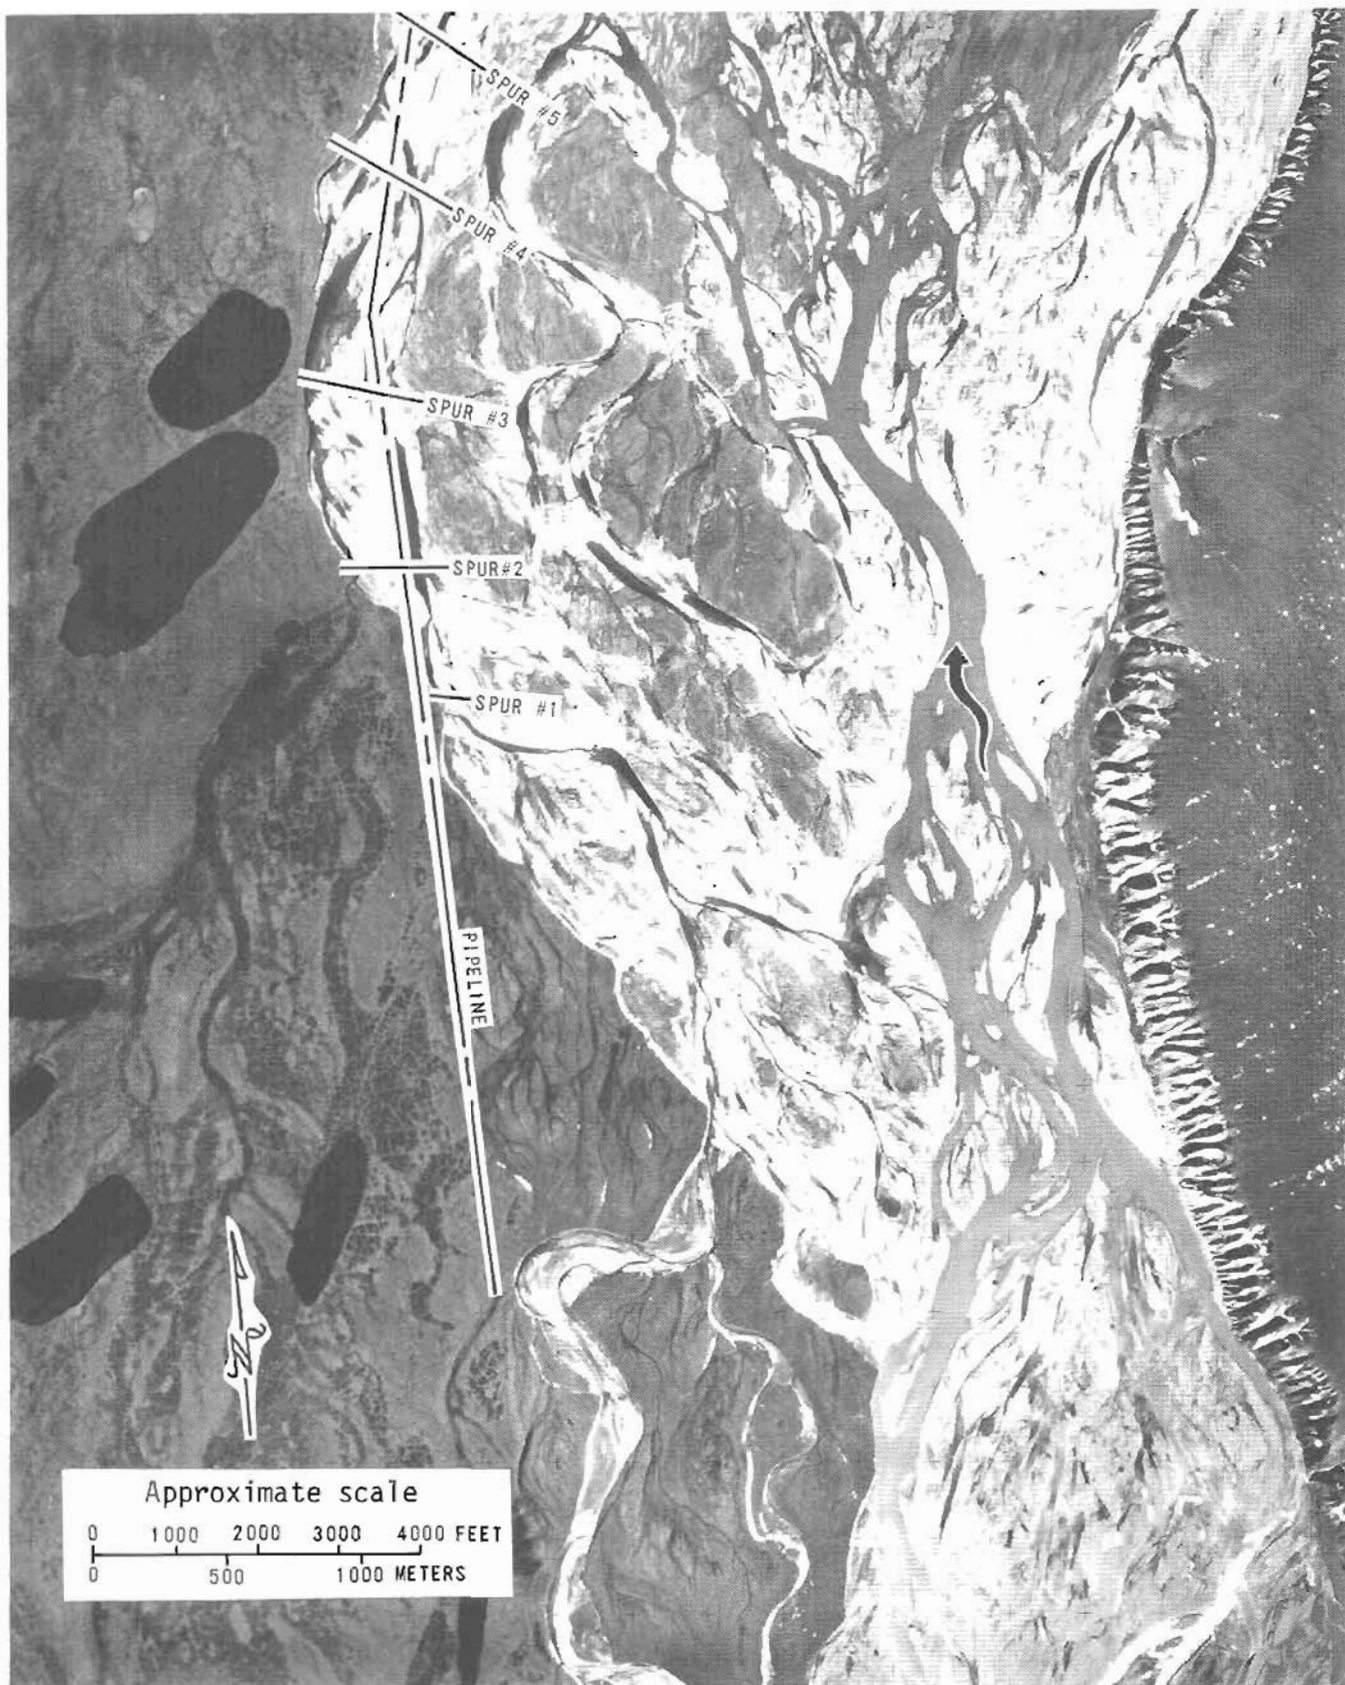
Figure 3 is a small-scale photograph of the pipeline right-of-way on June 10, 1977, following the June 5 peak of the spring breakup flood. The spur dikes and the approximate location of the material sites are shown in the figure. Spur dikes No. 2, No. 3, and No. 4 stretch from the left bank to a vegetated island, damming the subchannels. Note that only dikes No. 1 and No. 7 remain intact; the others have been breached:

Figure 2.--Sagavanirktok River at Alignment No. 134 near Deadhorse, August 31, 1969.
AIR PHOTO TECH

Spur No. 2	breached in 3 location
Spur No. 3	breached in 2 locations
Spur No. 4	breached in 3 locations
Spur No. 5	breached in 3 locations
Spur No. 6	intentionally breached

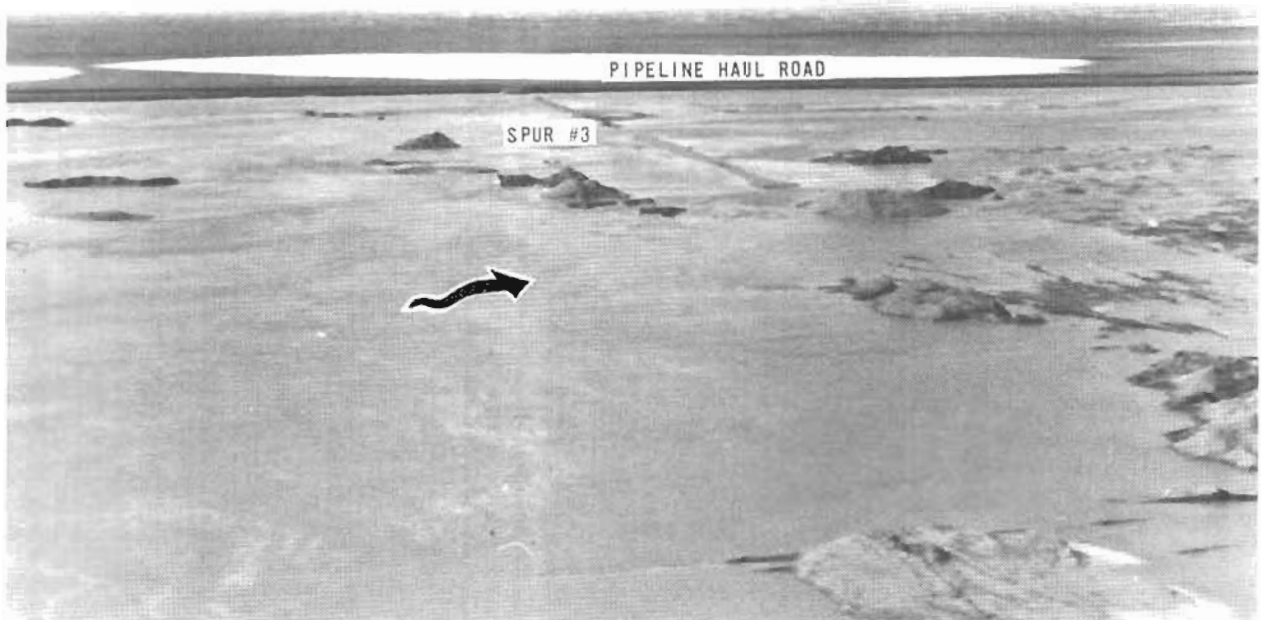
The breached spur dikes at least partially dammed off the subchannel and were overtopped and partially washed out. They failed to force the river to develop adequate flood conveyance elsewhere in the flood plain.

The spur dikes were designed to protect the pipeline from the pipeline design flood of 122,000 ft³/s. The peak discharge at the spur dike field is not known. Sixty miles upstream at the USGS gaging station, Sagavanirktok River near Sagwon, which is above the confluence of the Ivashak River and several smaller tributaries, the peak discharge was 29,500 ft³/s on June 5. This was the largest flood in the station's seven-year history. Even though the stage was higher than anticipated, it is highly unlikely that the discharge along alignment No. 134 approached that of the pipeline design flood.

Figure 4.--Spur dike no. 3 on Alignment No.134 of the Sagavanirktok River near Deadhorse, June 6, 1977.

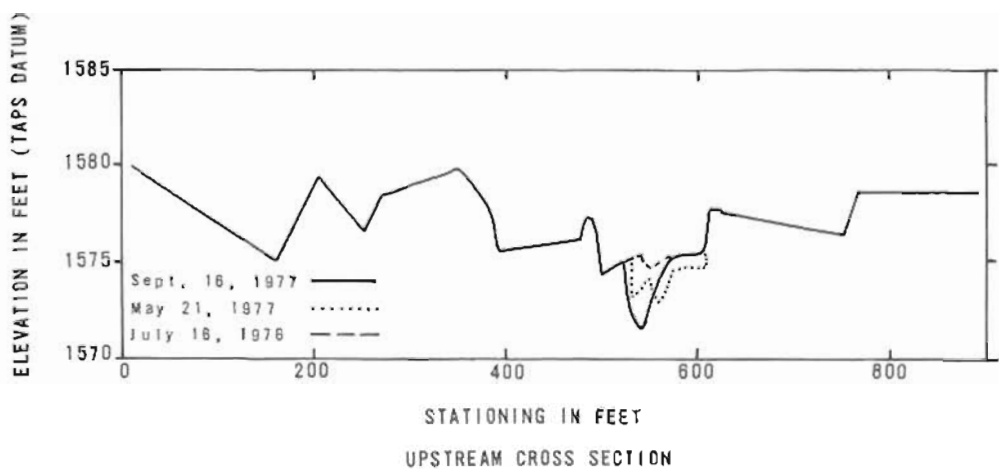
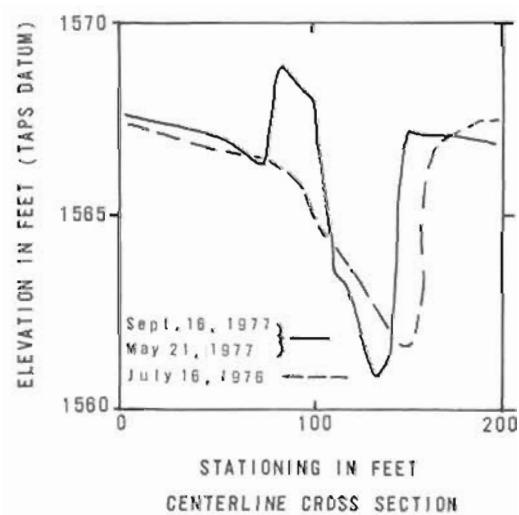
The crossing site was resurveyed on both May 21 and September 16, 1977. In May, changes were found in the upstream cross section and changes due to the completion of construction were found in the centerline section. In addition, the September survey showed that upstream thalweg had deepened since May (fig. 7). The peak discharge of July 31, 1976, was measured by indirect methods on May 21, 1977, at a site about 0.5 mi upstream from the pipeline. The peak discharge was 460 ft³/s or about 30 (ft³/s)/mi².

Figure 7. -- Cross sections of Snowden Creek near Dietrich Camp.

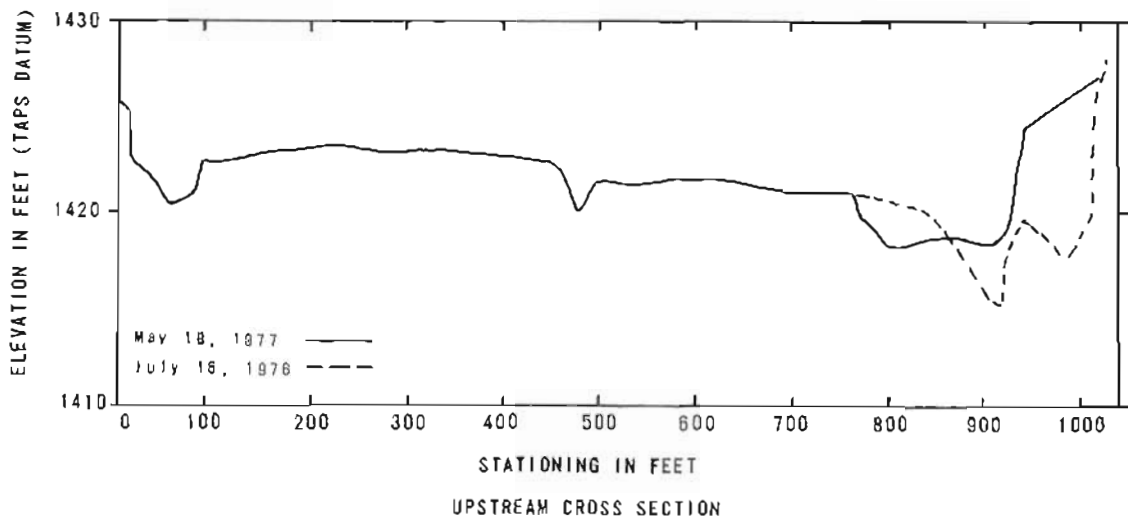
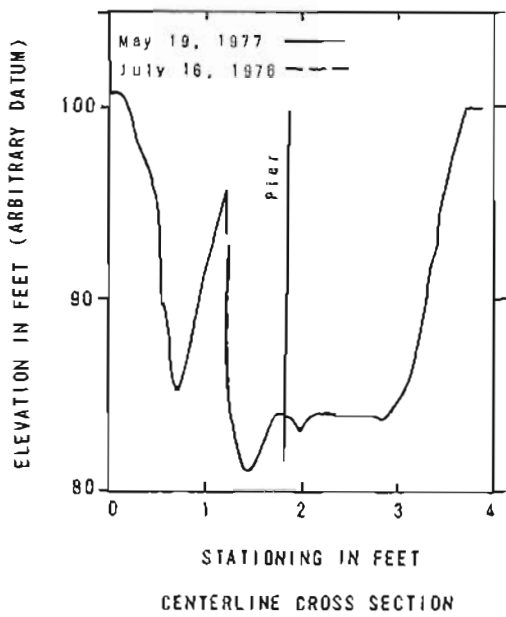
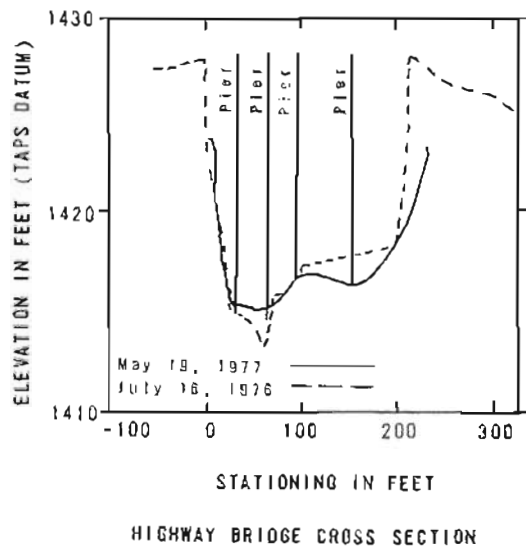
The site was resurveyed on May 19, 1977. No reliable datum was established for this year's centerline section; thus it cannot be rigorously compared to last year's. However, it is evident that the construction activities have changed the section's shape considerably. Both the upstream and the highway bridge section have also changed (fig. 9). No survey was taken on the downstream section.

Figure 9. -- Cross section of Dietrich River at Bettles River.

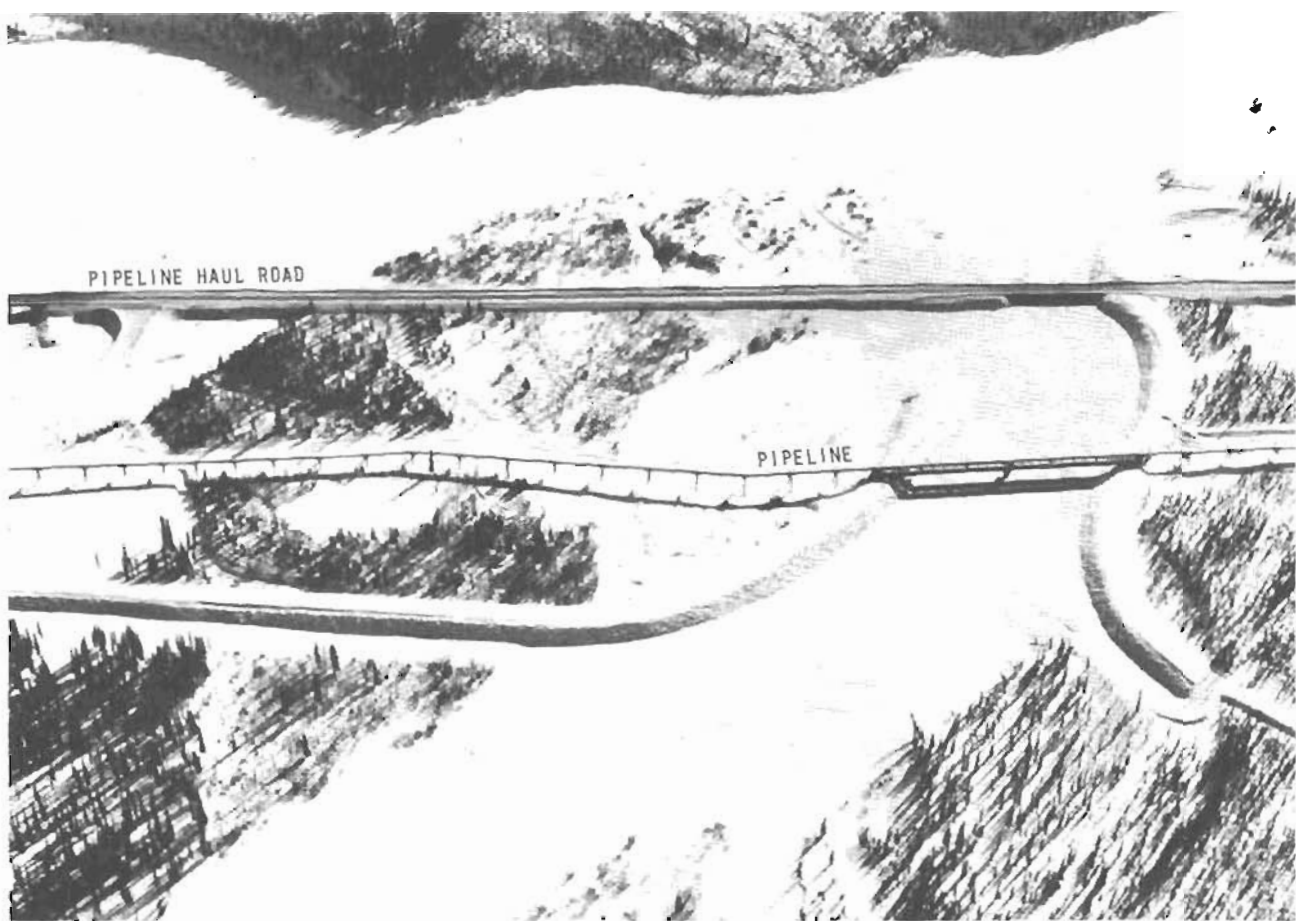
Figure 12 shows an active icing in progress on March 23, 1977. On-site observations indicated that the icing was caused by the highway bridge for the haul road. This year's survey indicated that the icing caused little or no erosion.

Figure 12.--Icing in progress on the Hammond River near Wiseman, March 23, 1977.

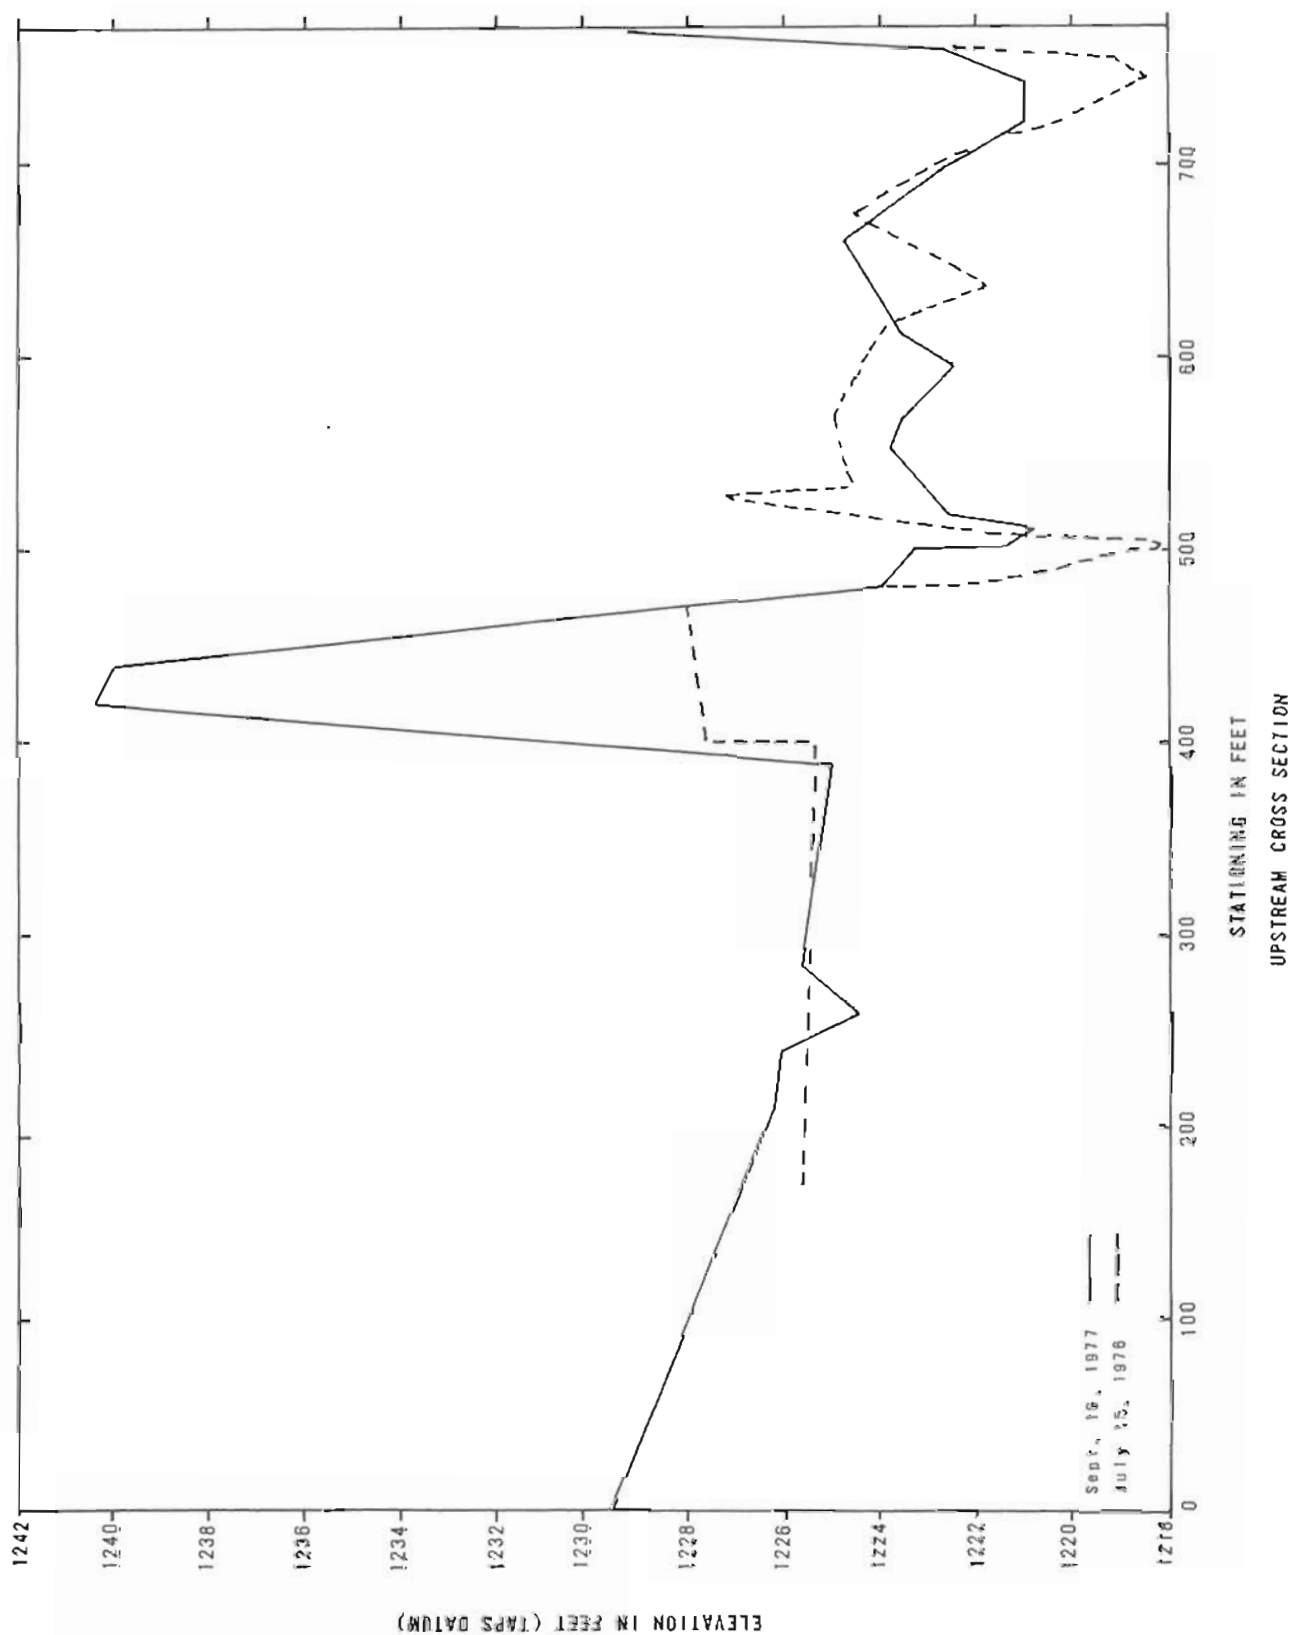
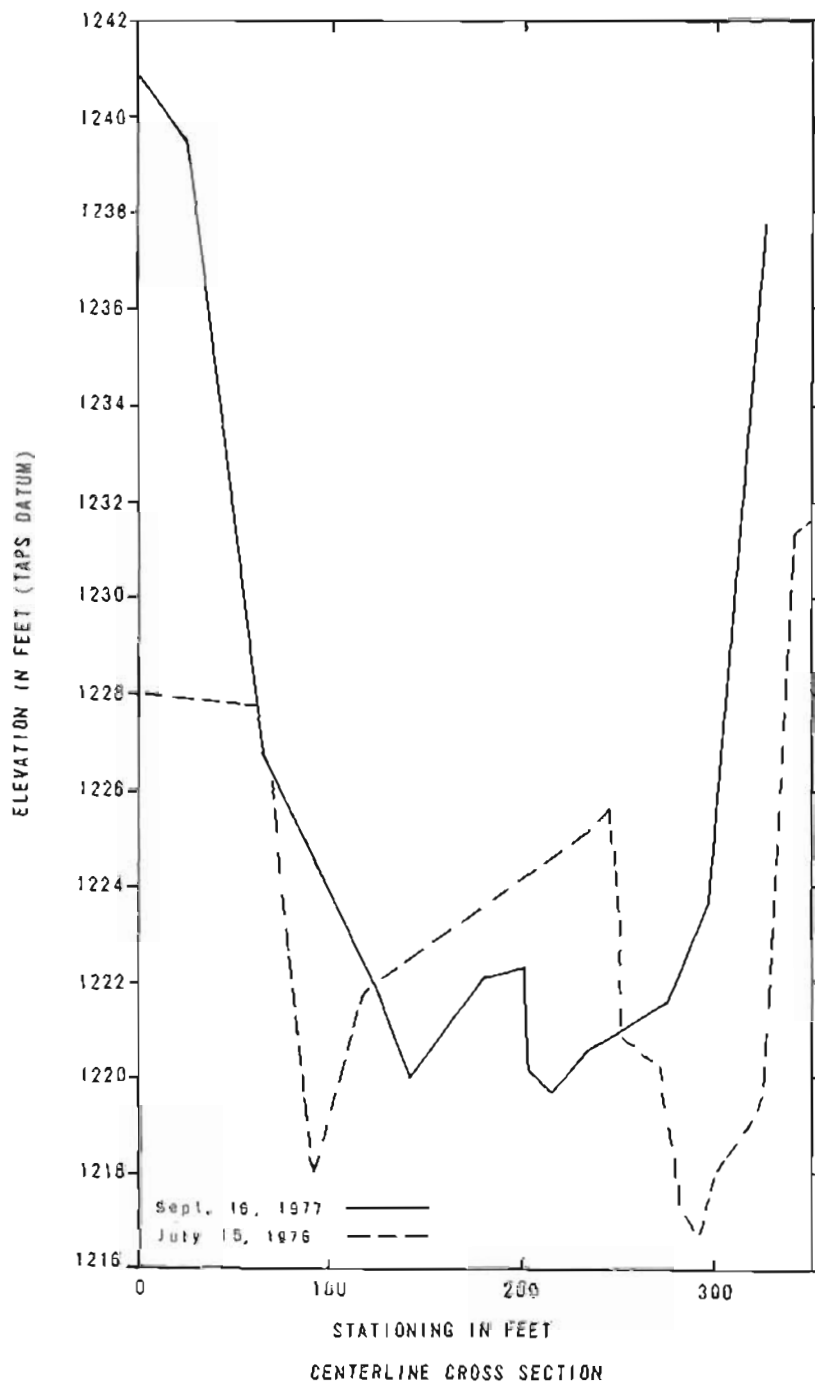
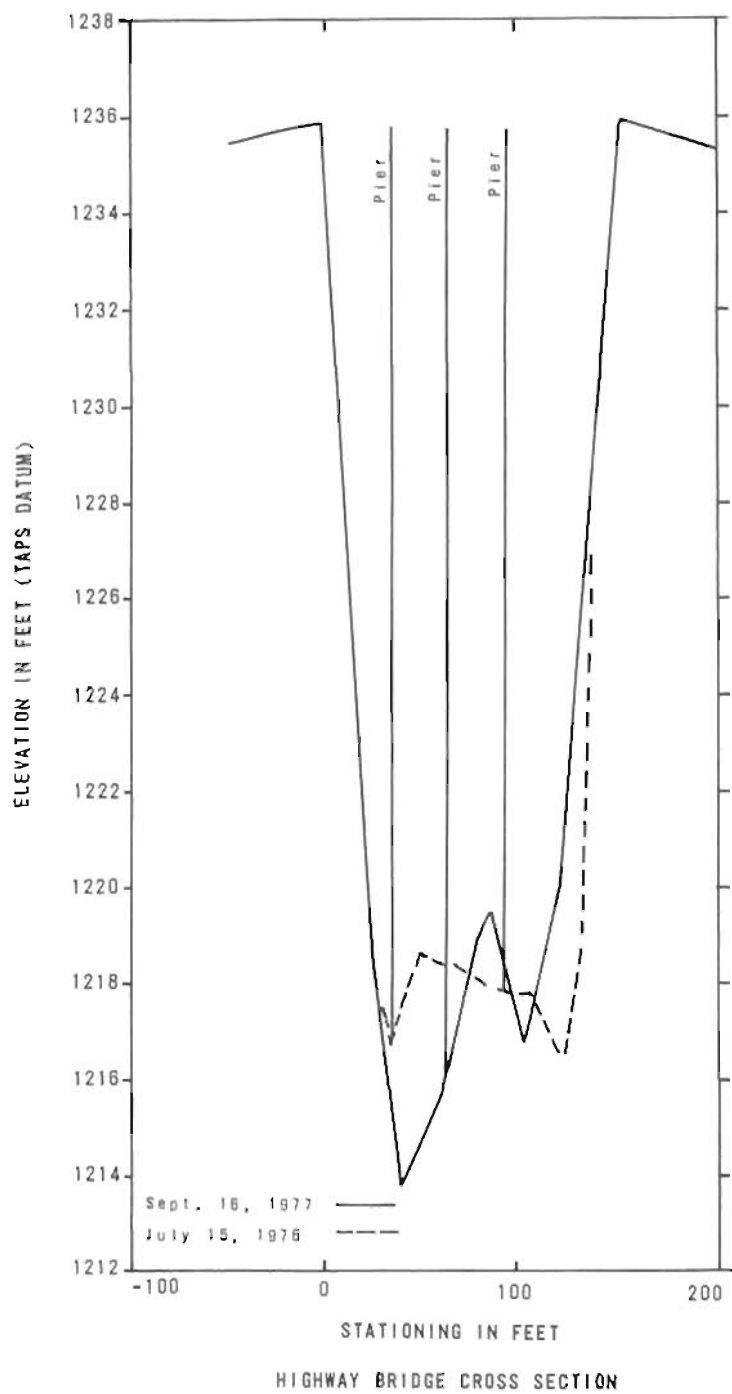
The crossing site was resurveyed on September 16, 1977. Figure 13 shows the changes in the three surveyed sections. The thalwegs of all three sections have become shallower by over 2.5 ft. No survey was made on the downstream section this year.

Figure 13. -- Cross sections of the Hammond River near Wiseman.

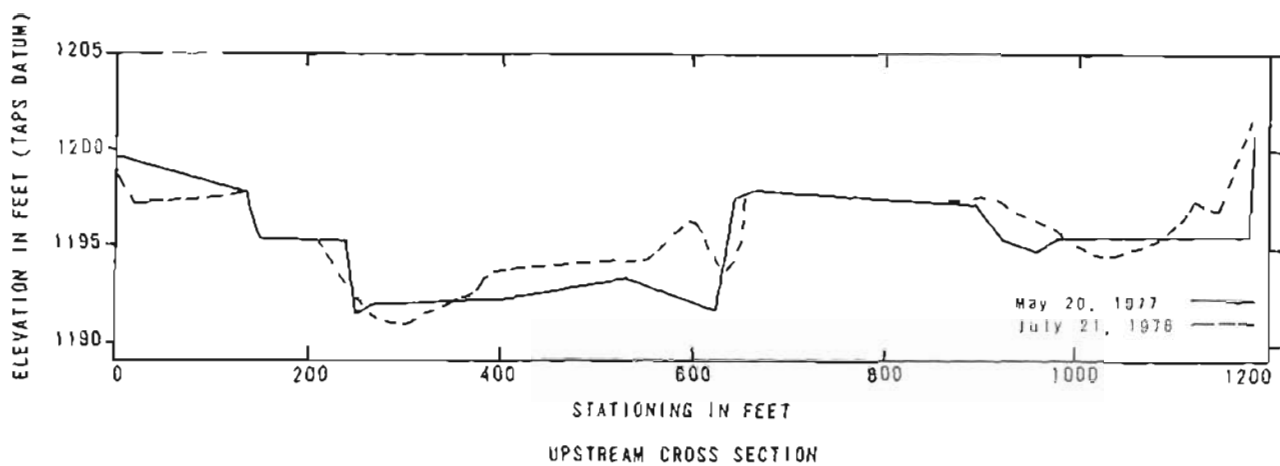
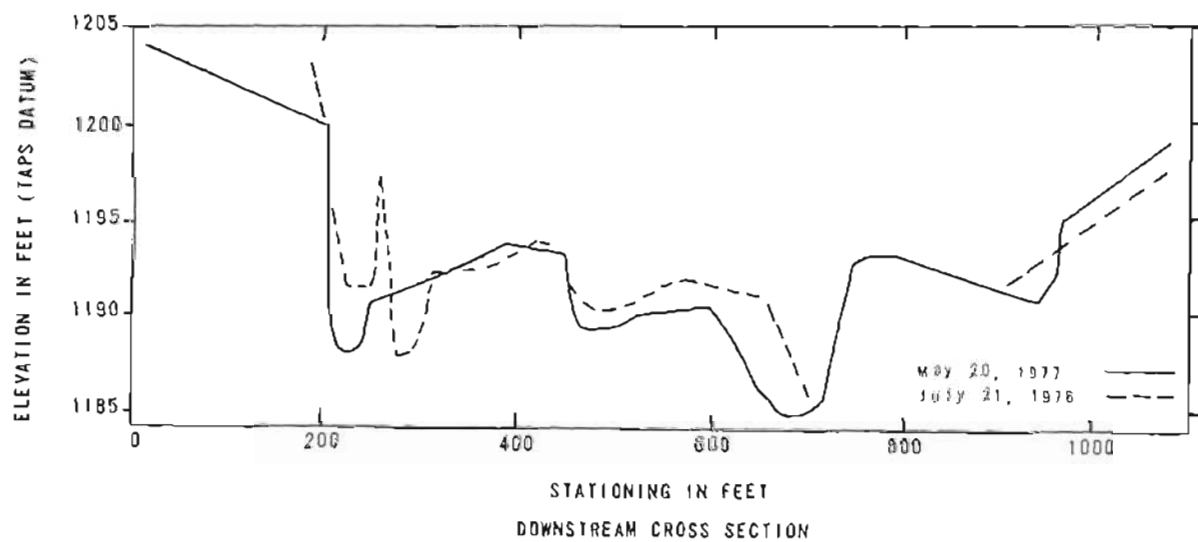
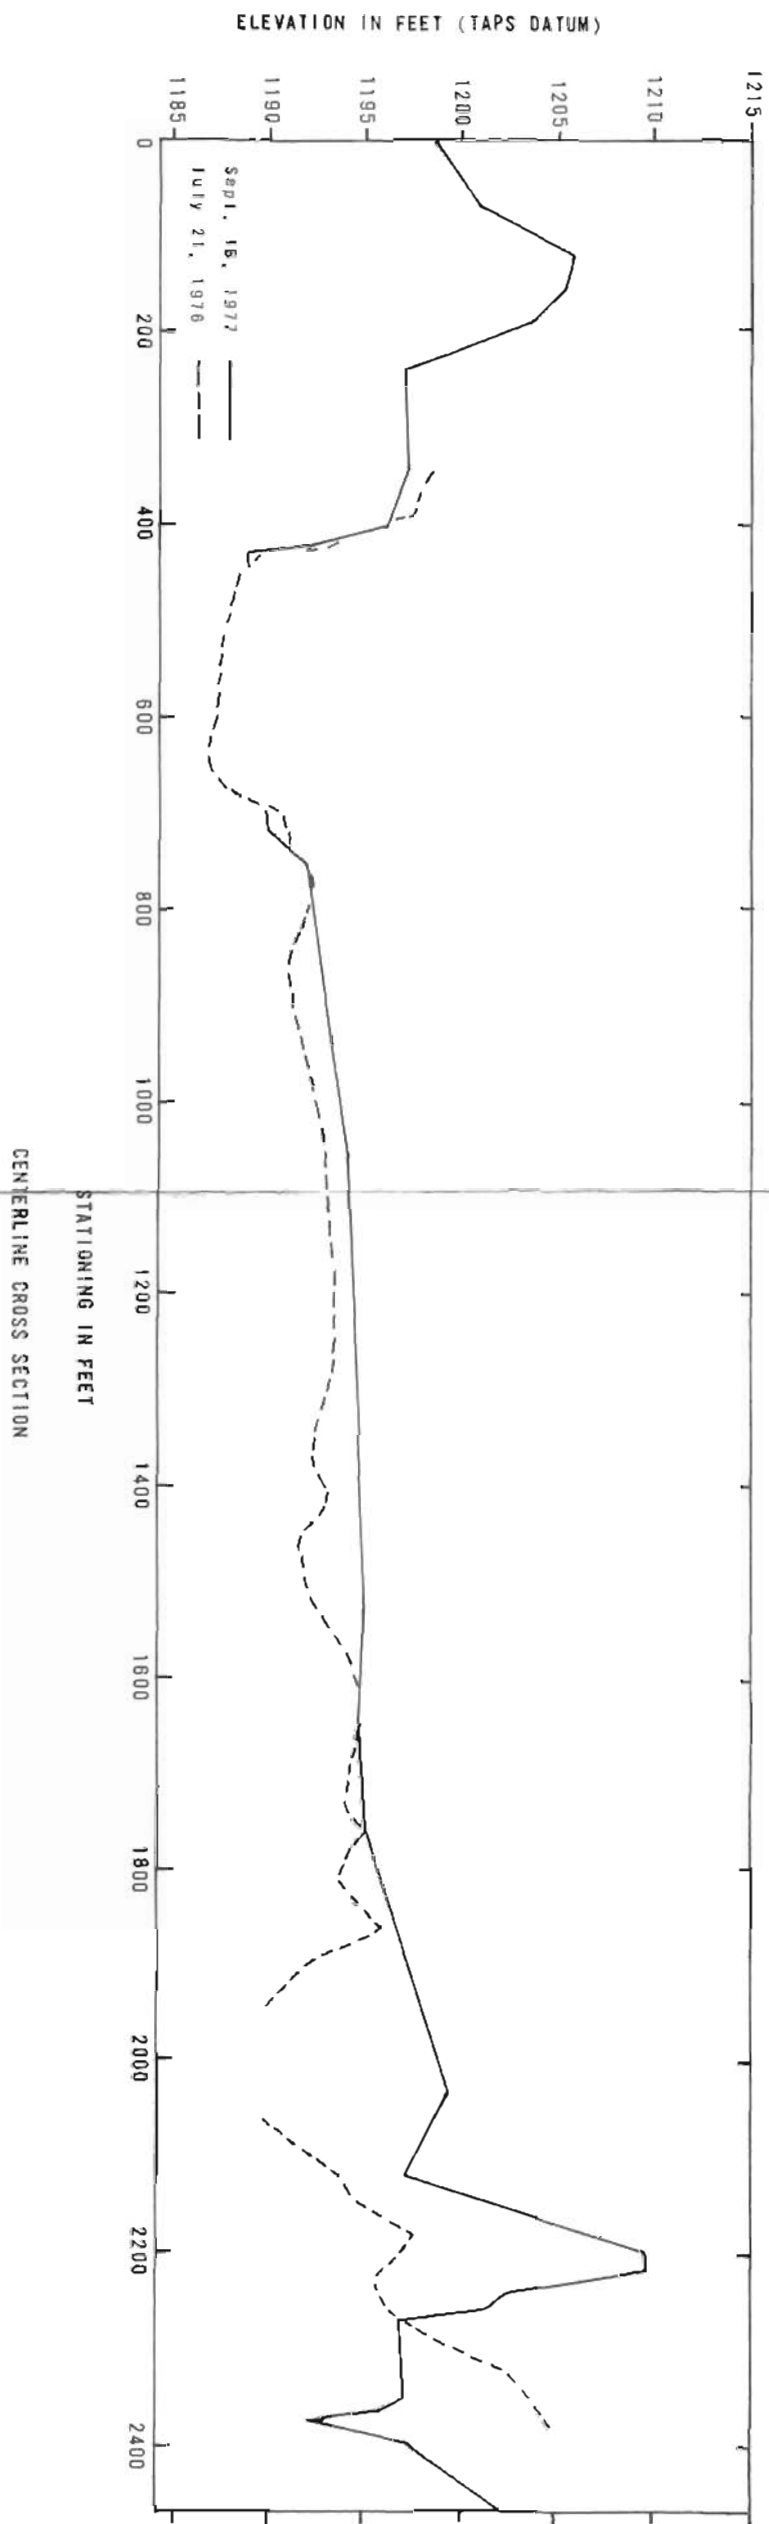
The upstream and downstream cross sections were resurveyed on May 20, 1977, and the centerline on September 16. Figure 15 shows the changes which occurred in all cross sections.

Figure 15. -- Cross sections of the Middle Fork Koyukuk River.

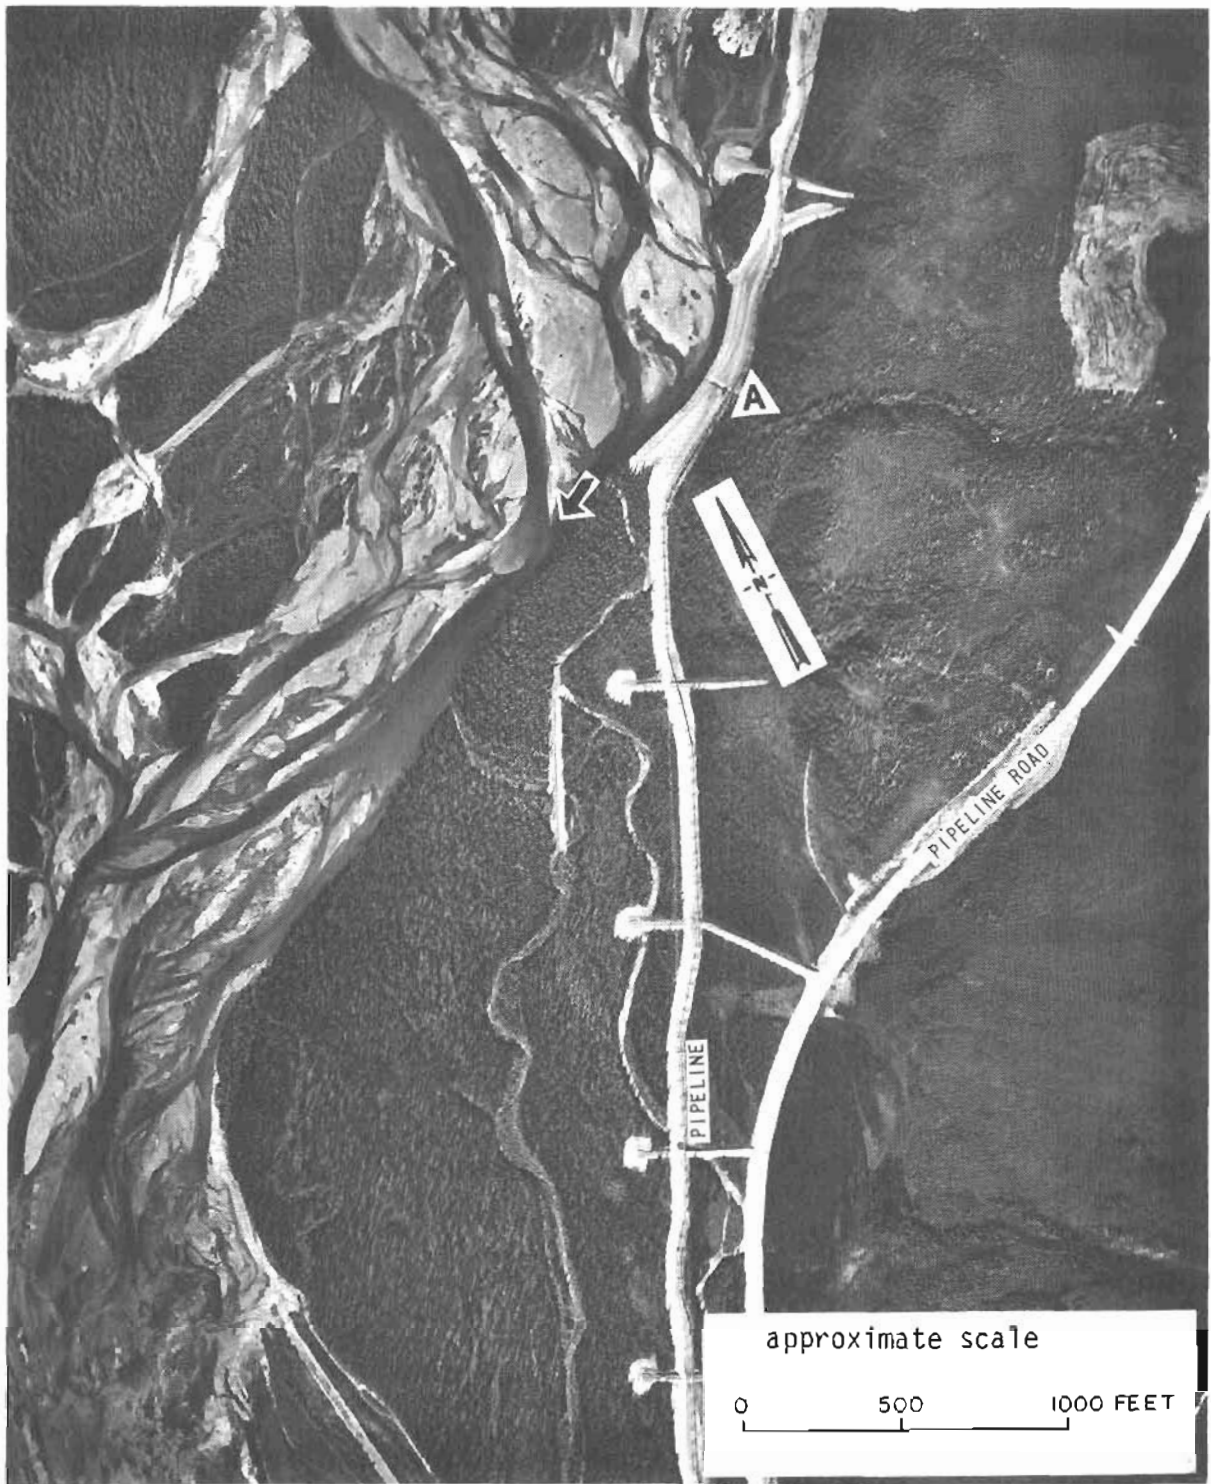
Comparison of the 1976 and 1977 air photos and a visual inspection of the site made in May 1977 indicate that no significant bank erosion has occurred. The photos show that the river's major conveyance has shifted toward the right bank at site A, continuing a trend noted in last year's report. Consequently, the zone of intense erosion on the left bank has moved approximately 1,400 ft downstream from the 1976 location at site A.

Figure 16. -- Middle Fork Koyukuk River near Coldfoot, July 12, 1977.
AIR PHOTO TECH

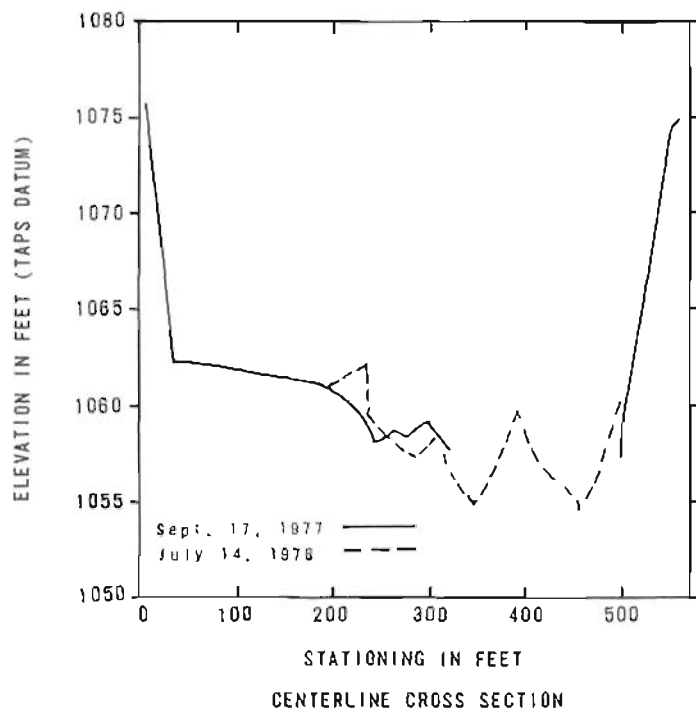
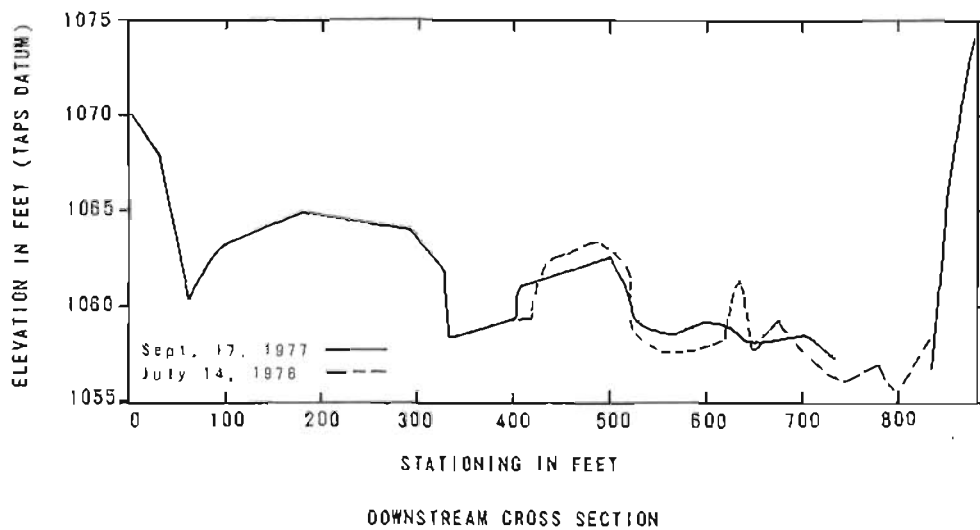
1977 Surveillance. --Figure 17 shows the South Fork Koyukuk site on July 12, 1977. The site was resurveyed on September 17, 1977. There has been no significant change in the upstream cross section since 1975, but minor changes were found in both the centerline and downstream cross sections (fig. 18).

Figure 18. -- Cross sections of the South Fork Koyukuk River near Wiseman.

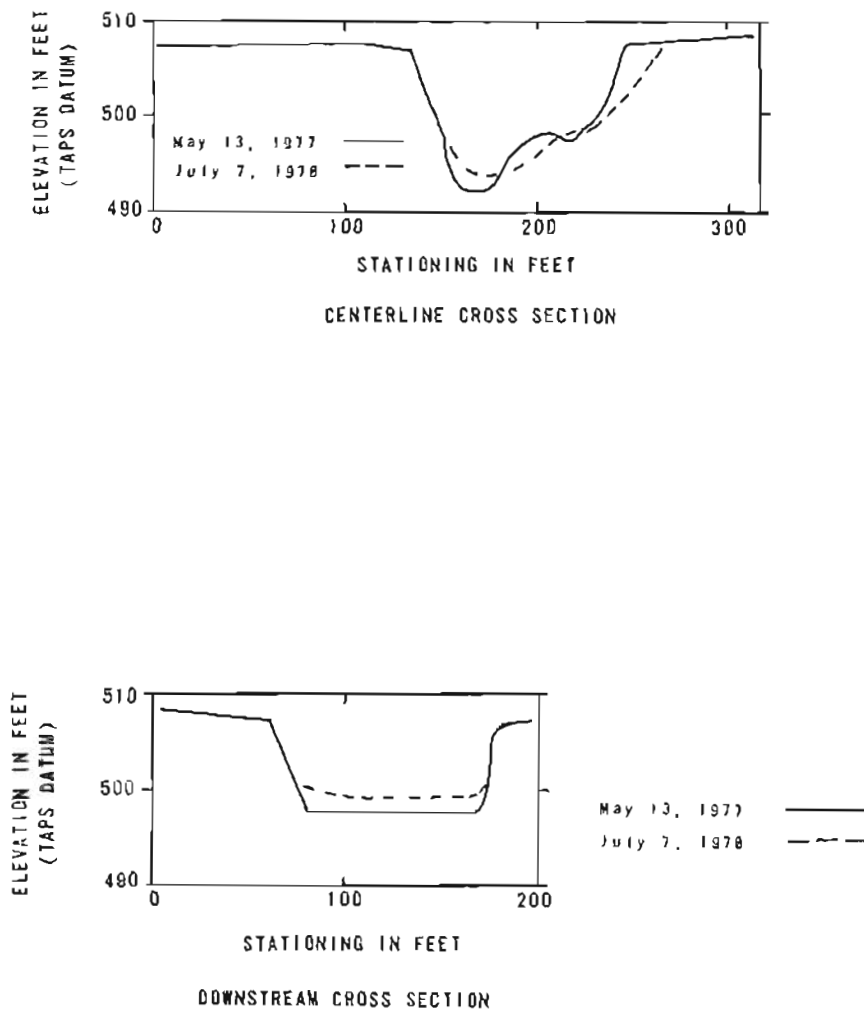
The site was resurveyed on May 13, 1977. No significant change was found at the upstream cross section, but the downstream and centerline sections both displayed marginal deepening of their thalwegs (fig. 26).

Figure 26. -- Cross sections of the Chatanika River near Olmes.

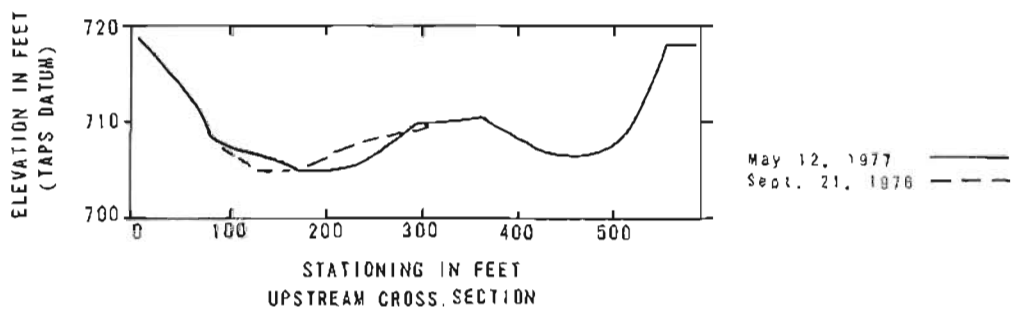
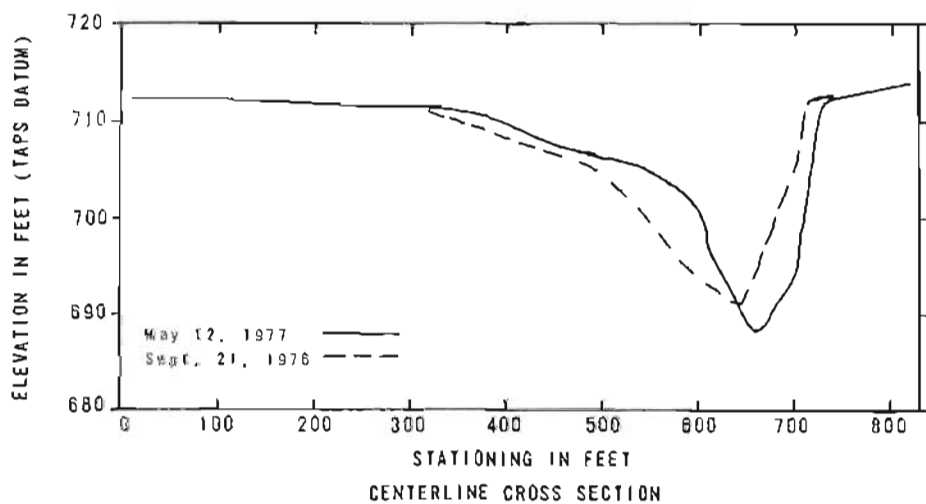
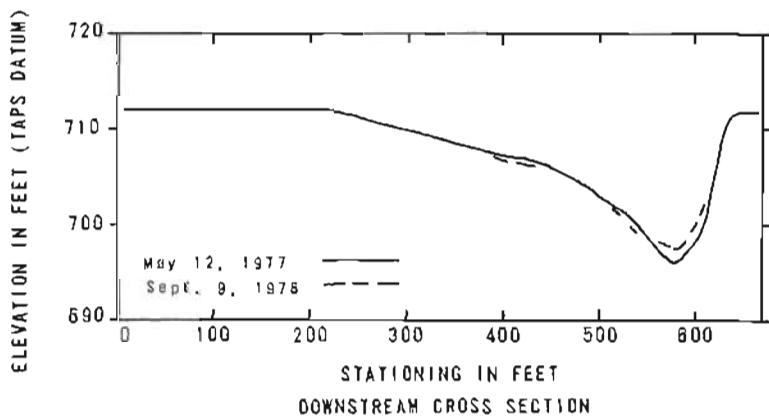
1977 Surveillance.--Figure 27 shows the Salcha River crossing on July 13, 1977. The site was resurveyed on May 12, 1977. The river at this site continues to be active; changes were found in all three cross sections. In each case the right bank has been eroded. The most dramatic effects occurred at the centerline where over 10 ft of lateral erosion and over 6.2 ft of vertical scour (fig. 28) were measured during the breakup flood. The peak of the flood occurred on May 19. It was measured as 11,500 ft³/s at the Salcha River gage near Salchaket, and is considered a moderate flood.

Taken together, the three cross sections indicate that the meander has widened during the last year, continuing a trend noted in 1974.

Figure 28. -- Cross sections of the Salcha River near Salchaket.

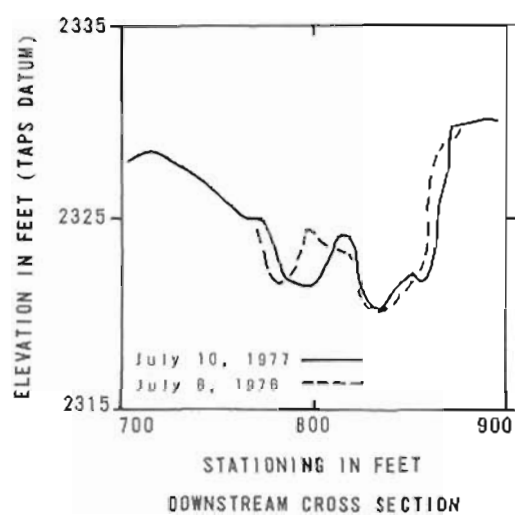
There were no significant changes in either the upstream or centerline cross sections except for a berm construction on the centerline 250 ft southeast of Flood Creek. The only noticeable difference in the downstream cross section is that the channel has moved approximately 8 ft northwest (fig. 30).

Figure 30. -- Cross section of Flood Creek near Rapids.
