CHANNEL EROSION SURVEYS ALONG THE TAPS ROUTE, ALASKA, 1977

78-611

by
Robert M. Loeffler
and
Joseph M. Childers

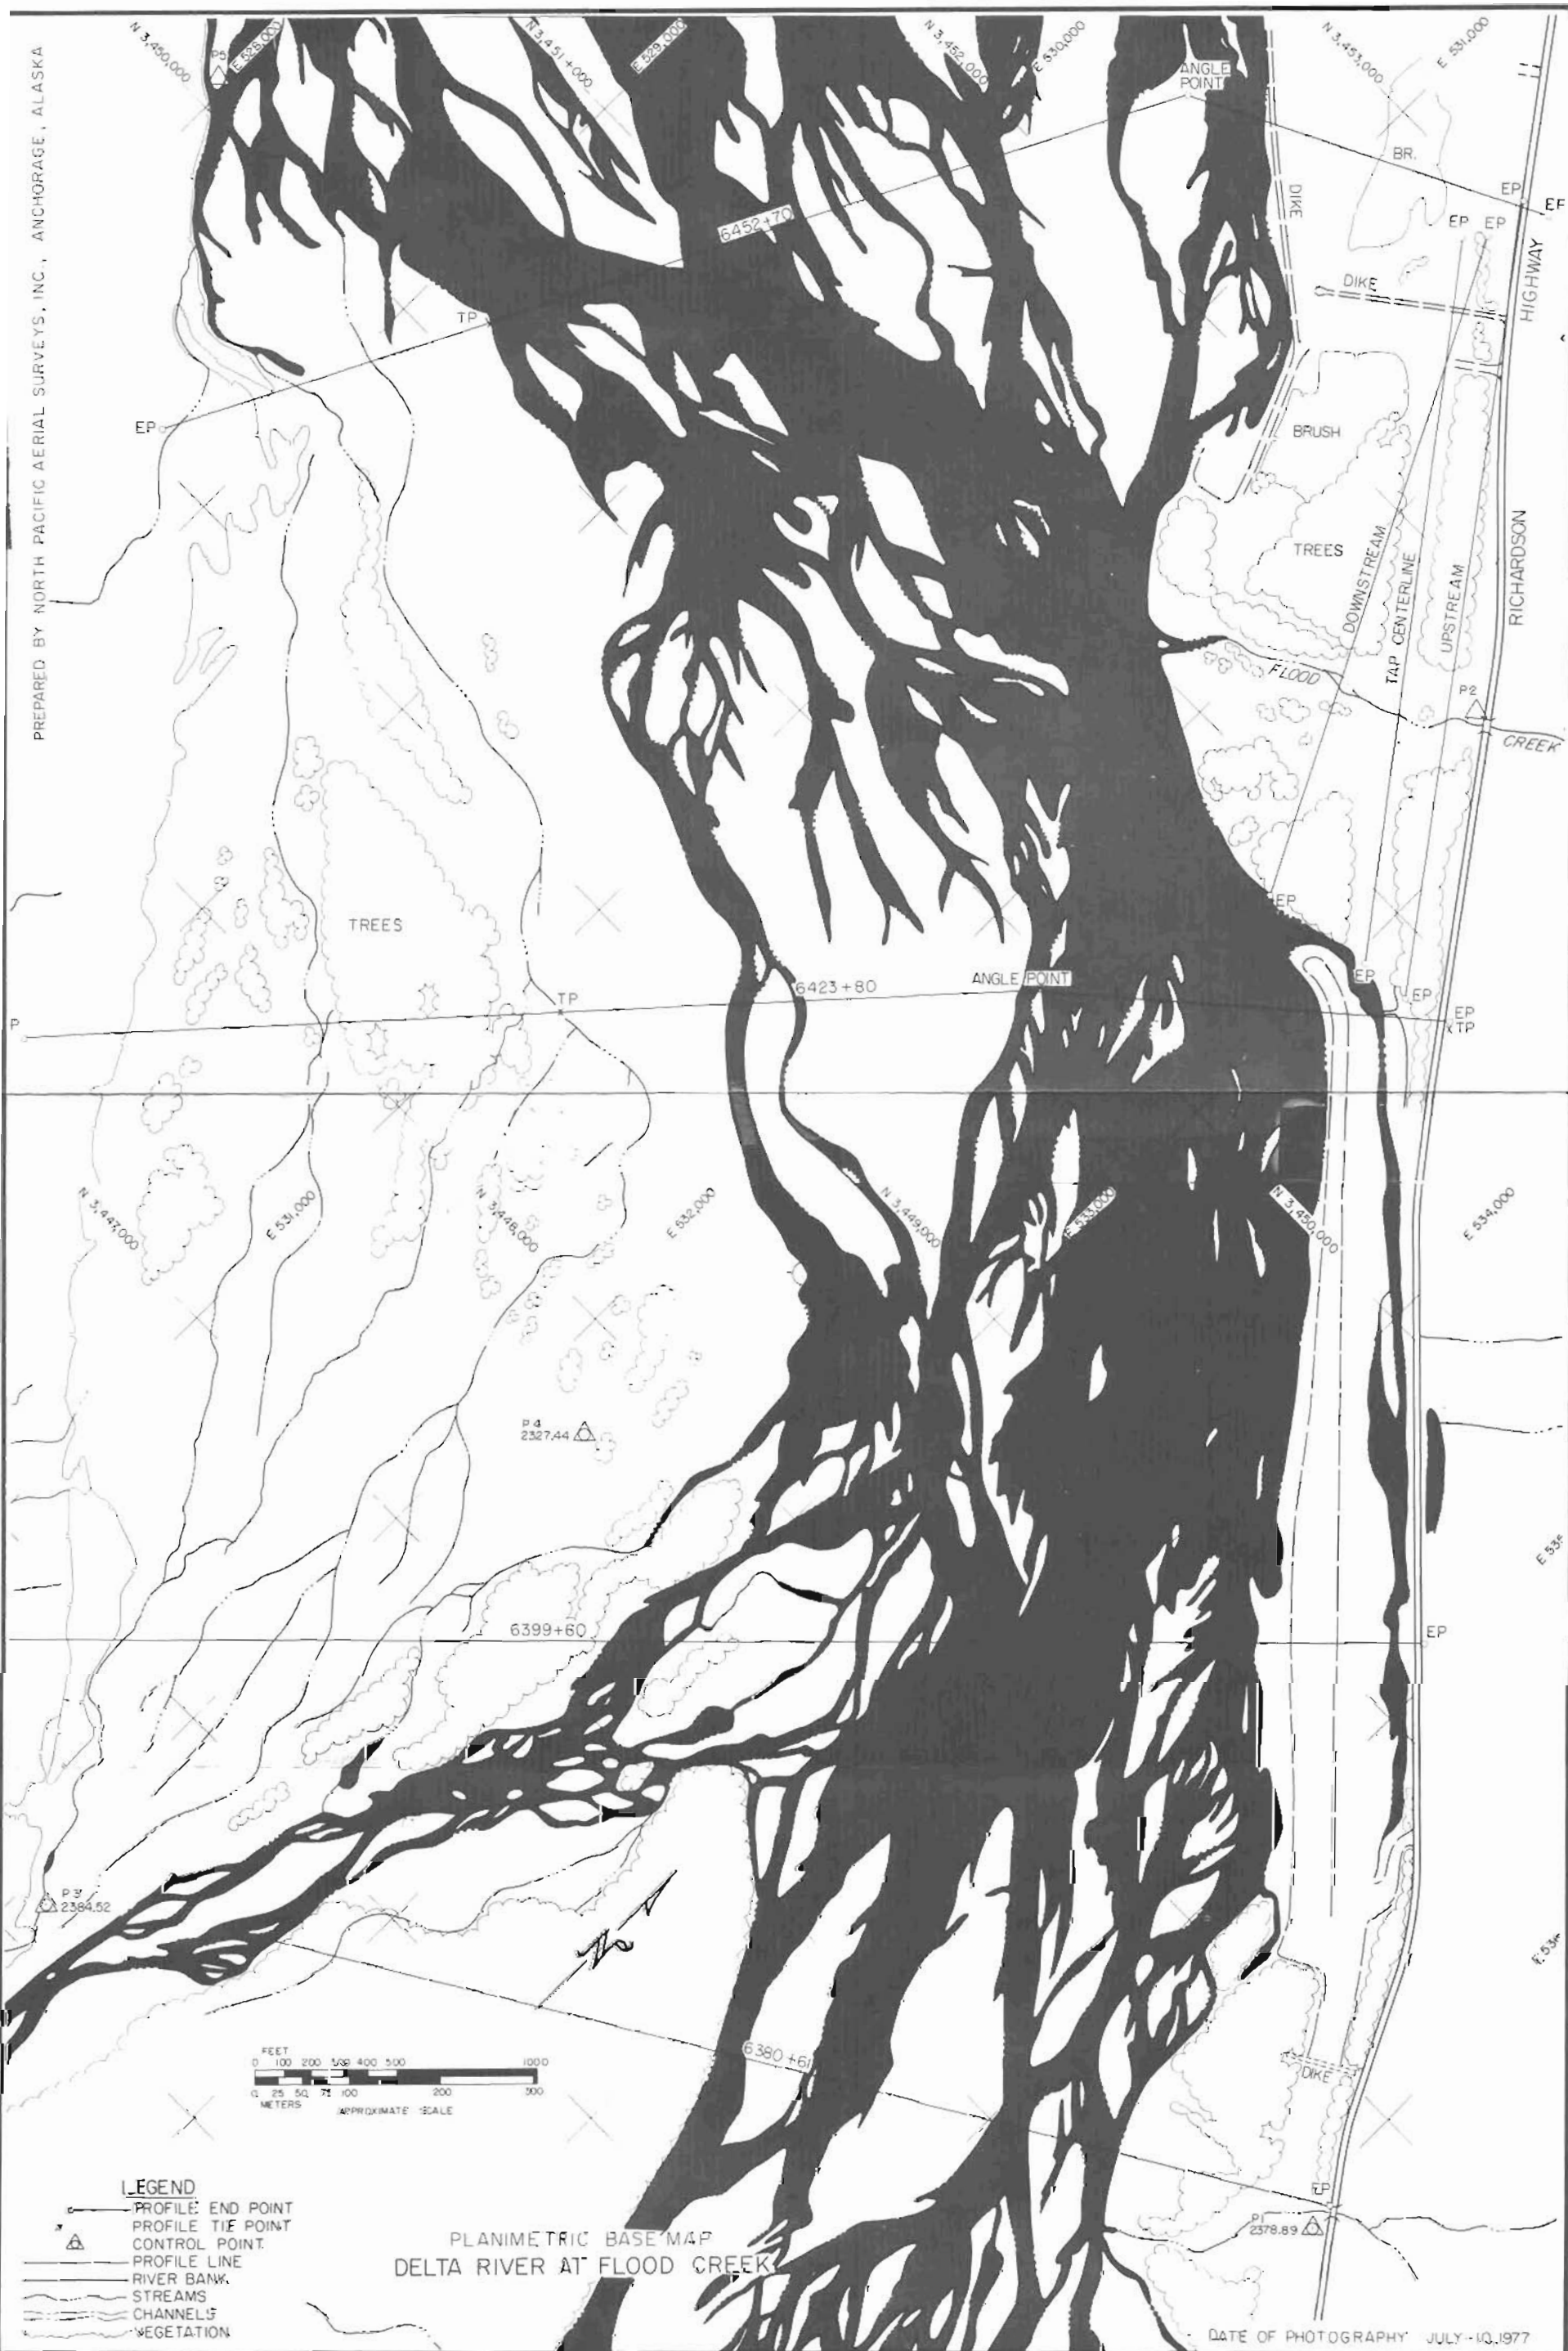
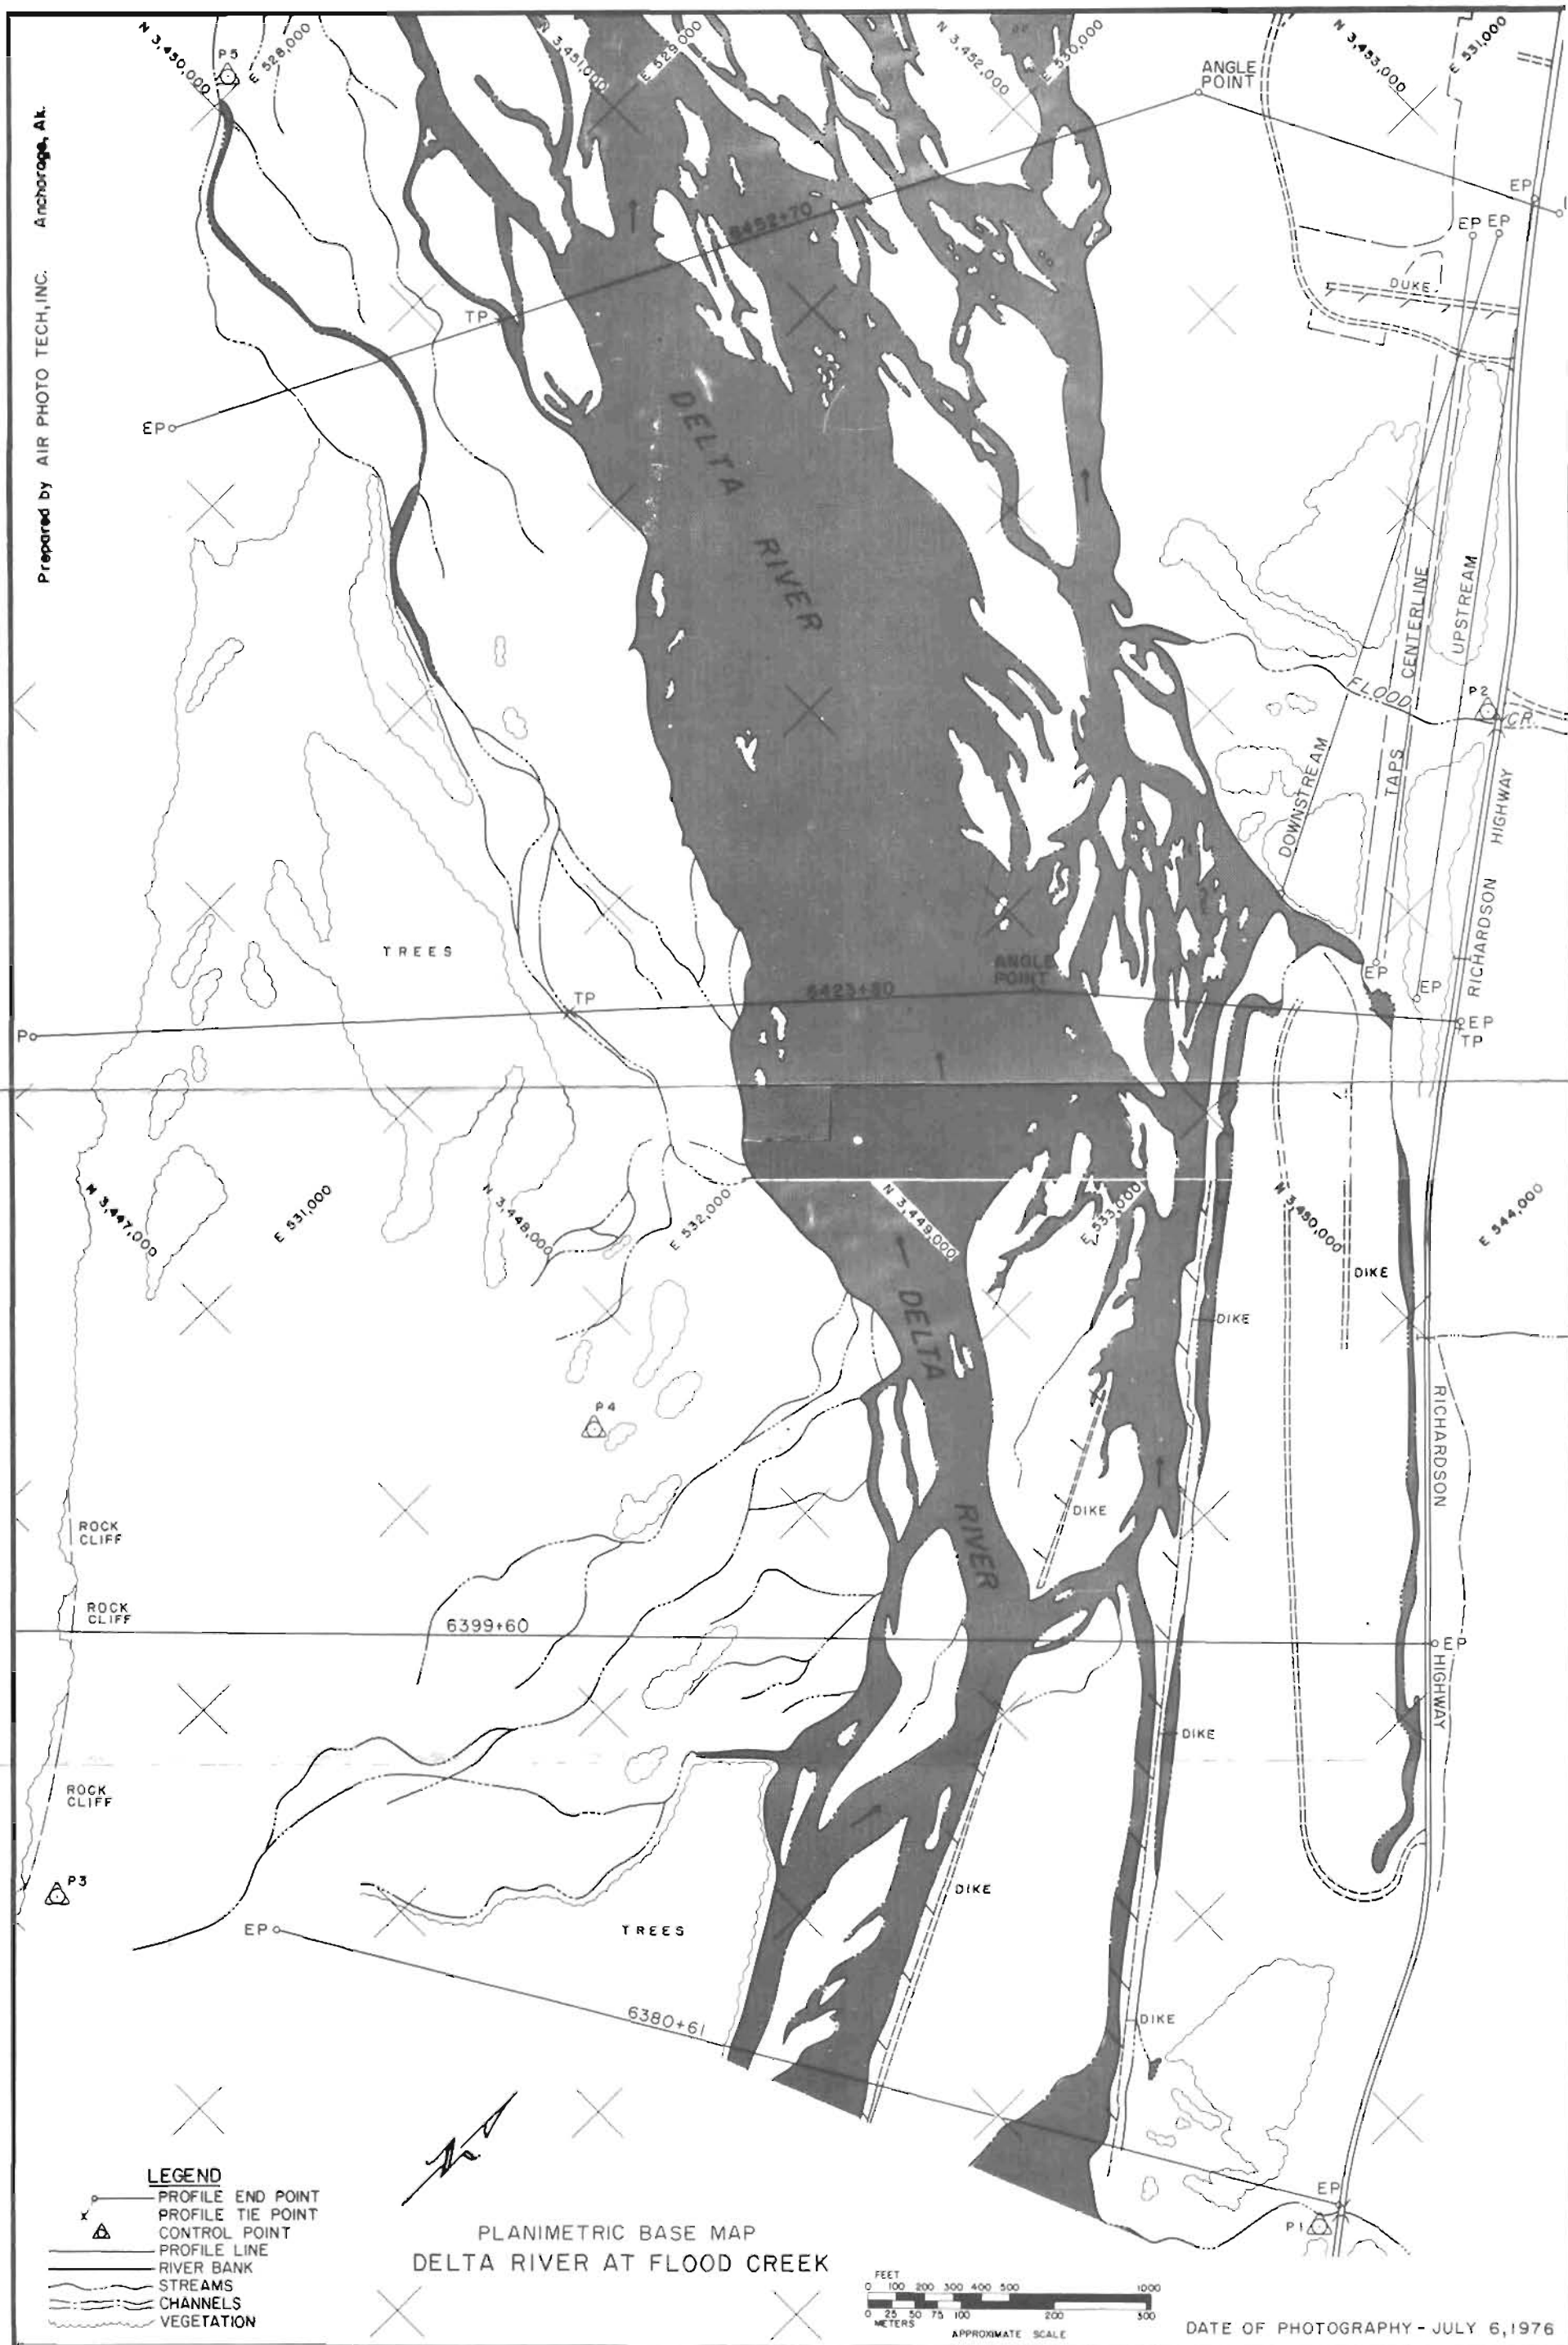
The July photograph shows the main channel on cross section 6423+80 attacking the longshore dike which protects the pipeline. In September, it was noted that the main channel had shifted back toward the center of the channel and a bar had formed along the longshore dike.

Figure 31a. -- Planimetric map of the Delta River at Flood Creek.

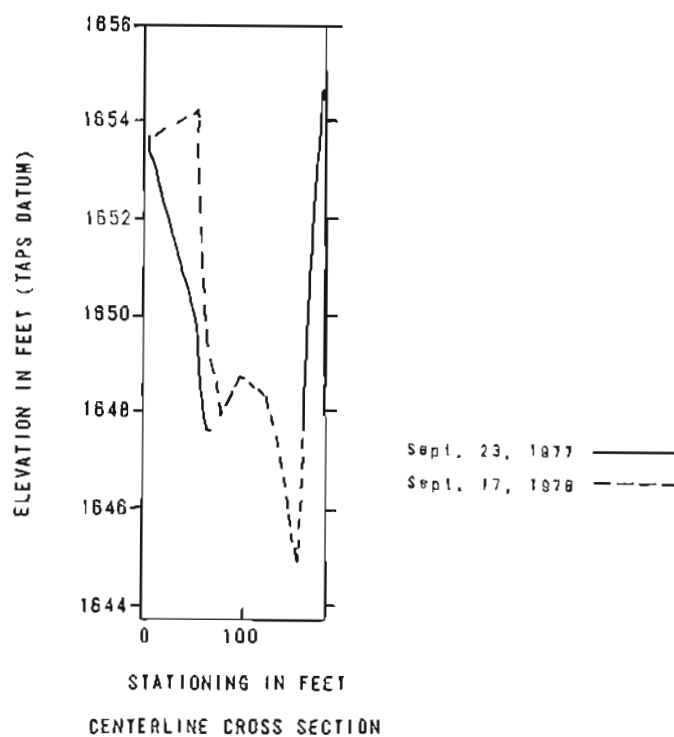
This site was resurveyed on September 23, 1977. No significant changes were found in either the upstream or downstream cross sections, but the centerline section was found to have widened slightly (fig. 39).

Figure 39. -- Cross section of the Tonsina River near Tonsina.

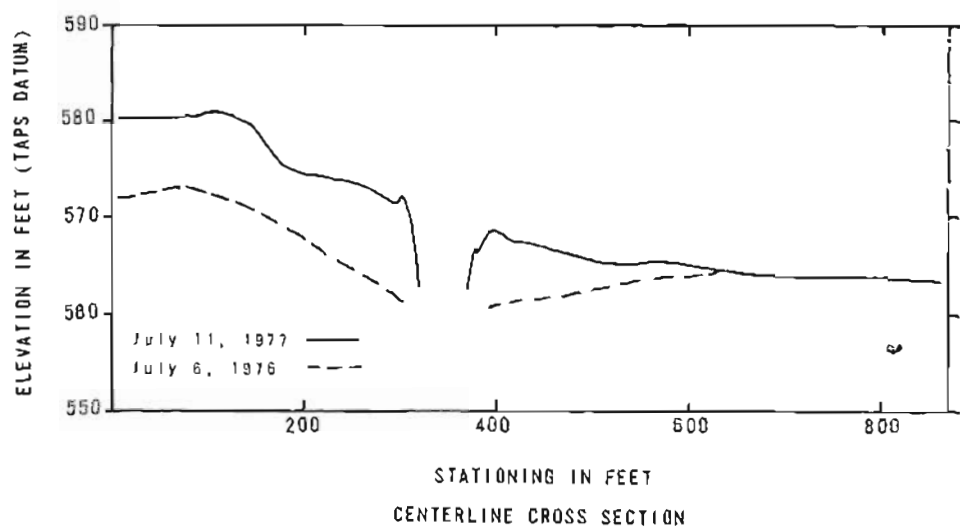
No significant changes were found in either the upstream or downstream cross sections. Figure 47 displays changes made by construction equipment on the centerline in the last year.

Figure 47. -- Cross section of Sheep Creek near Valdez.

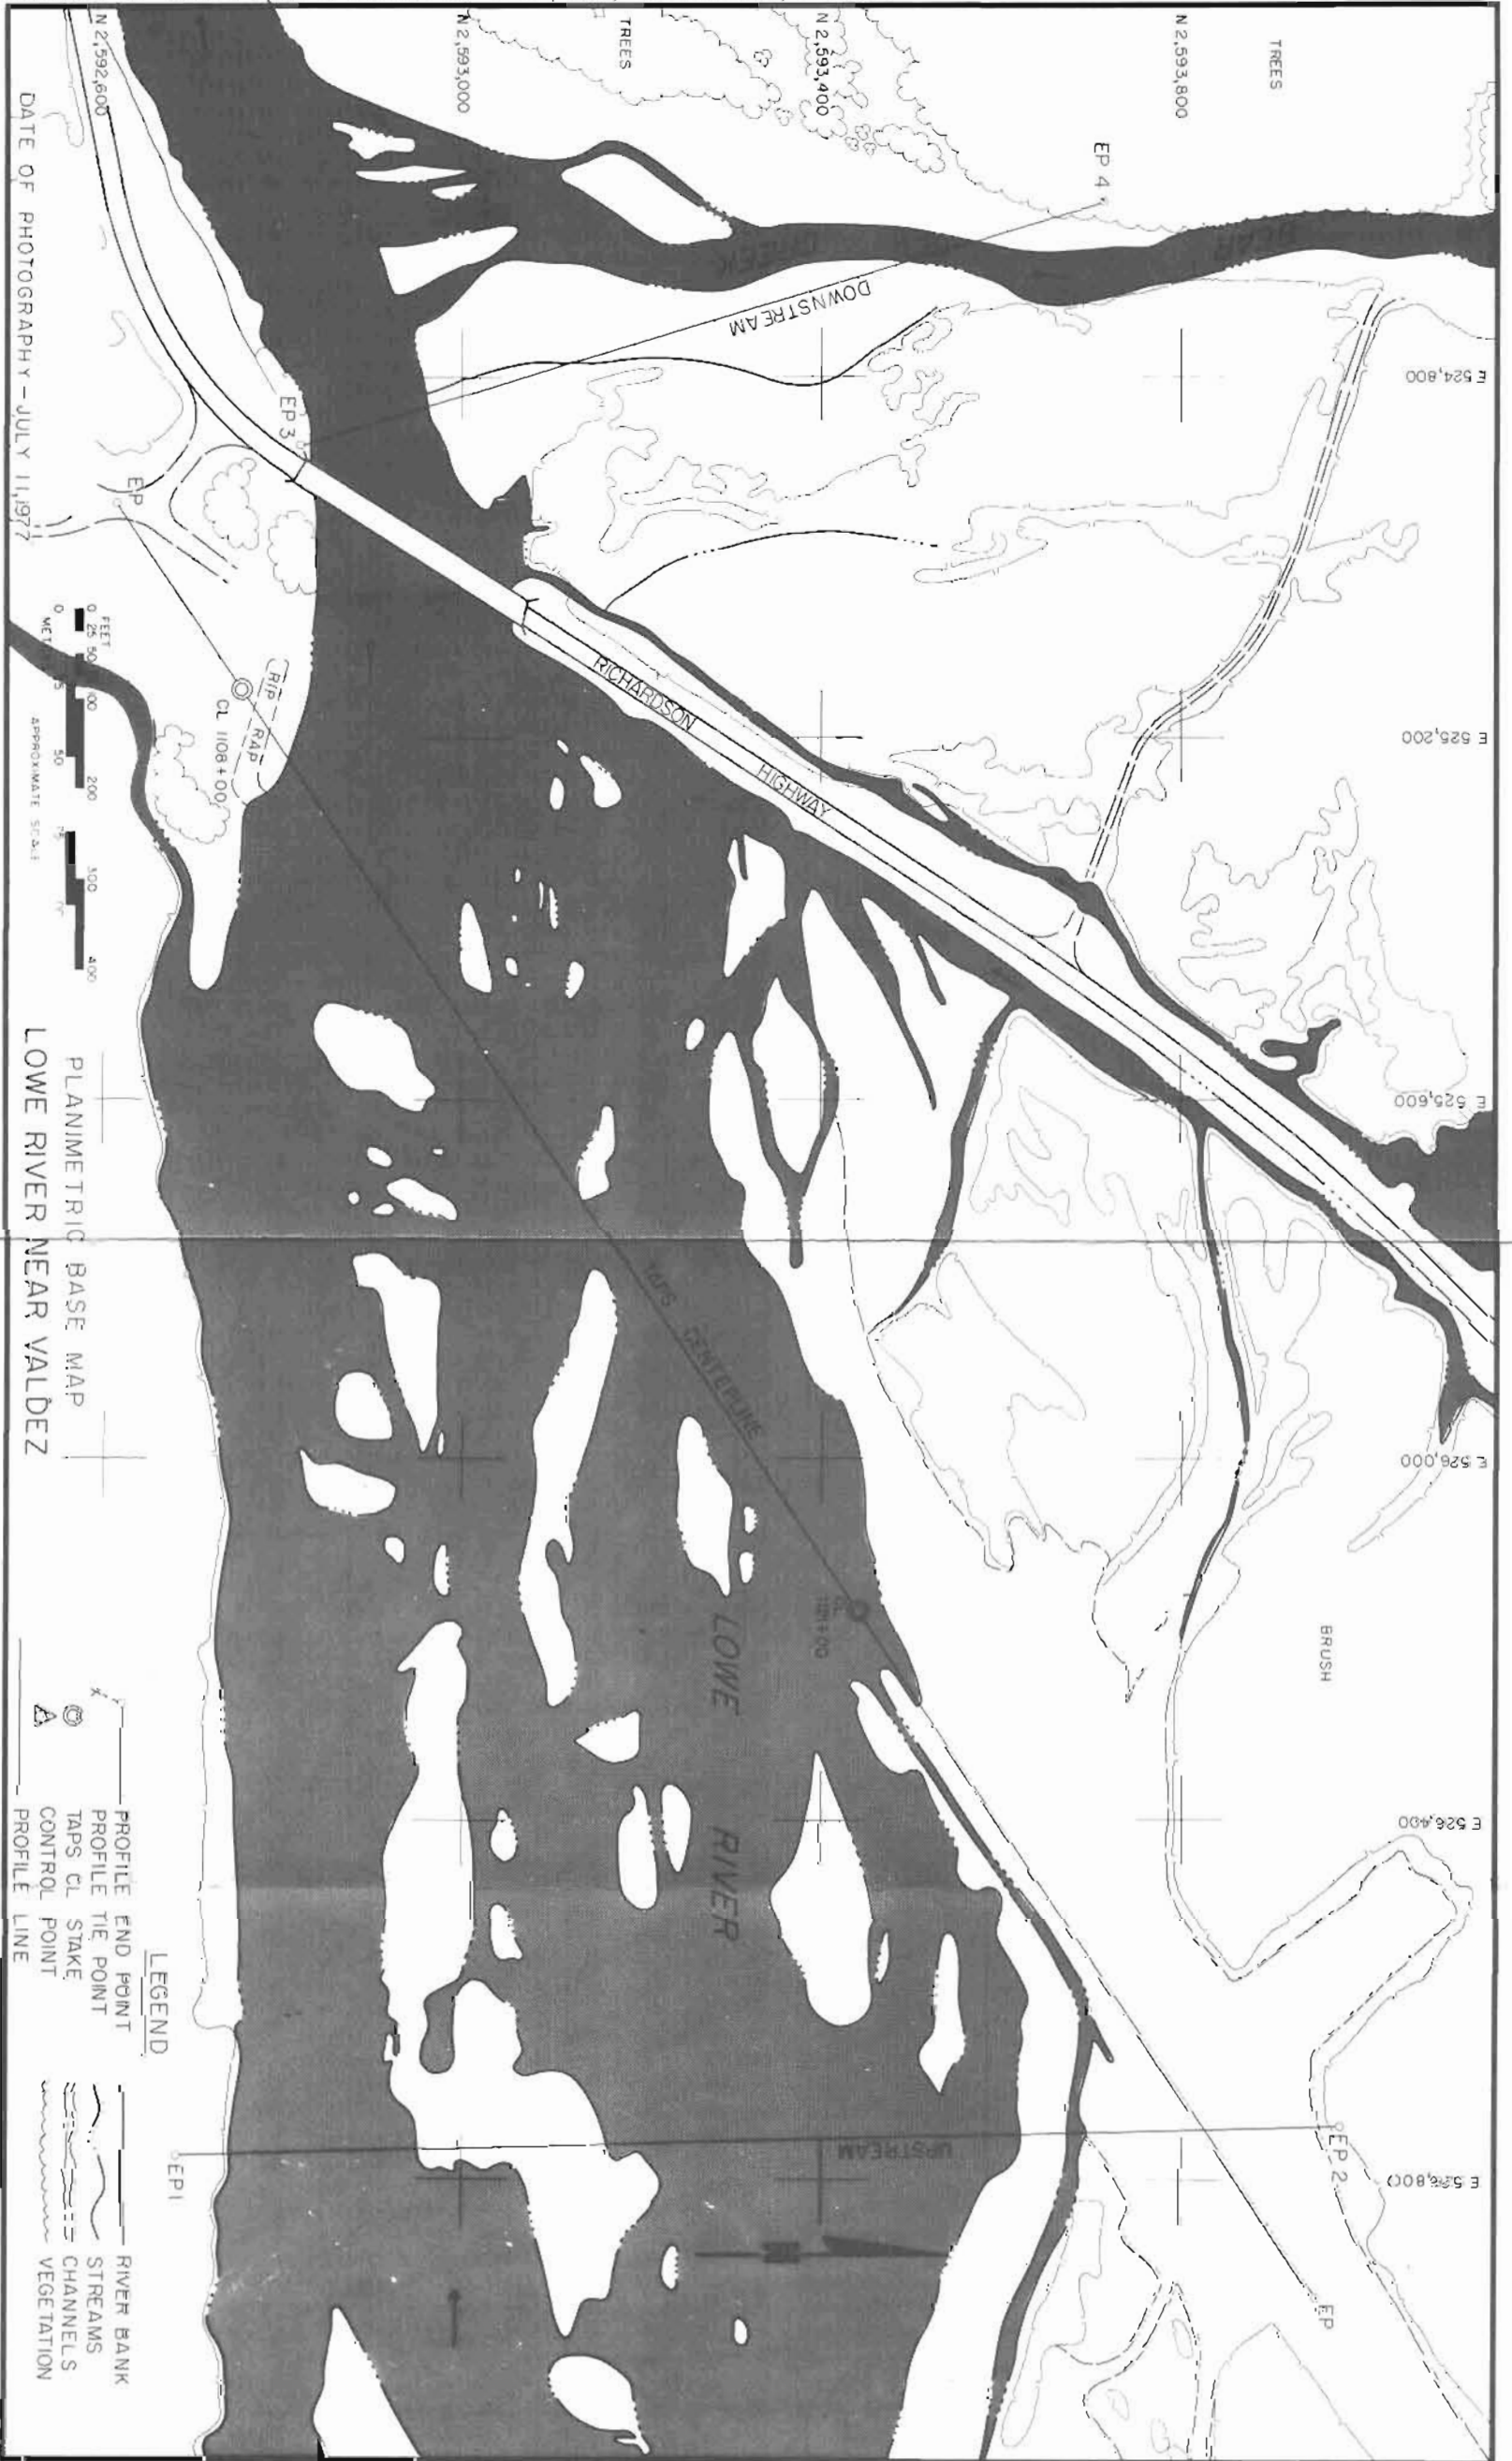
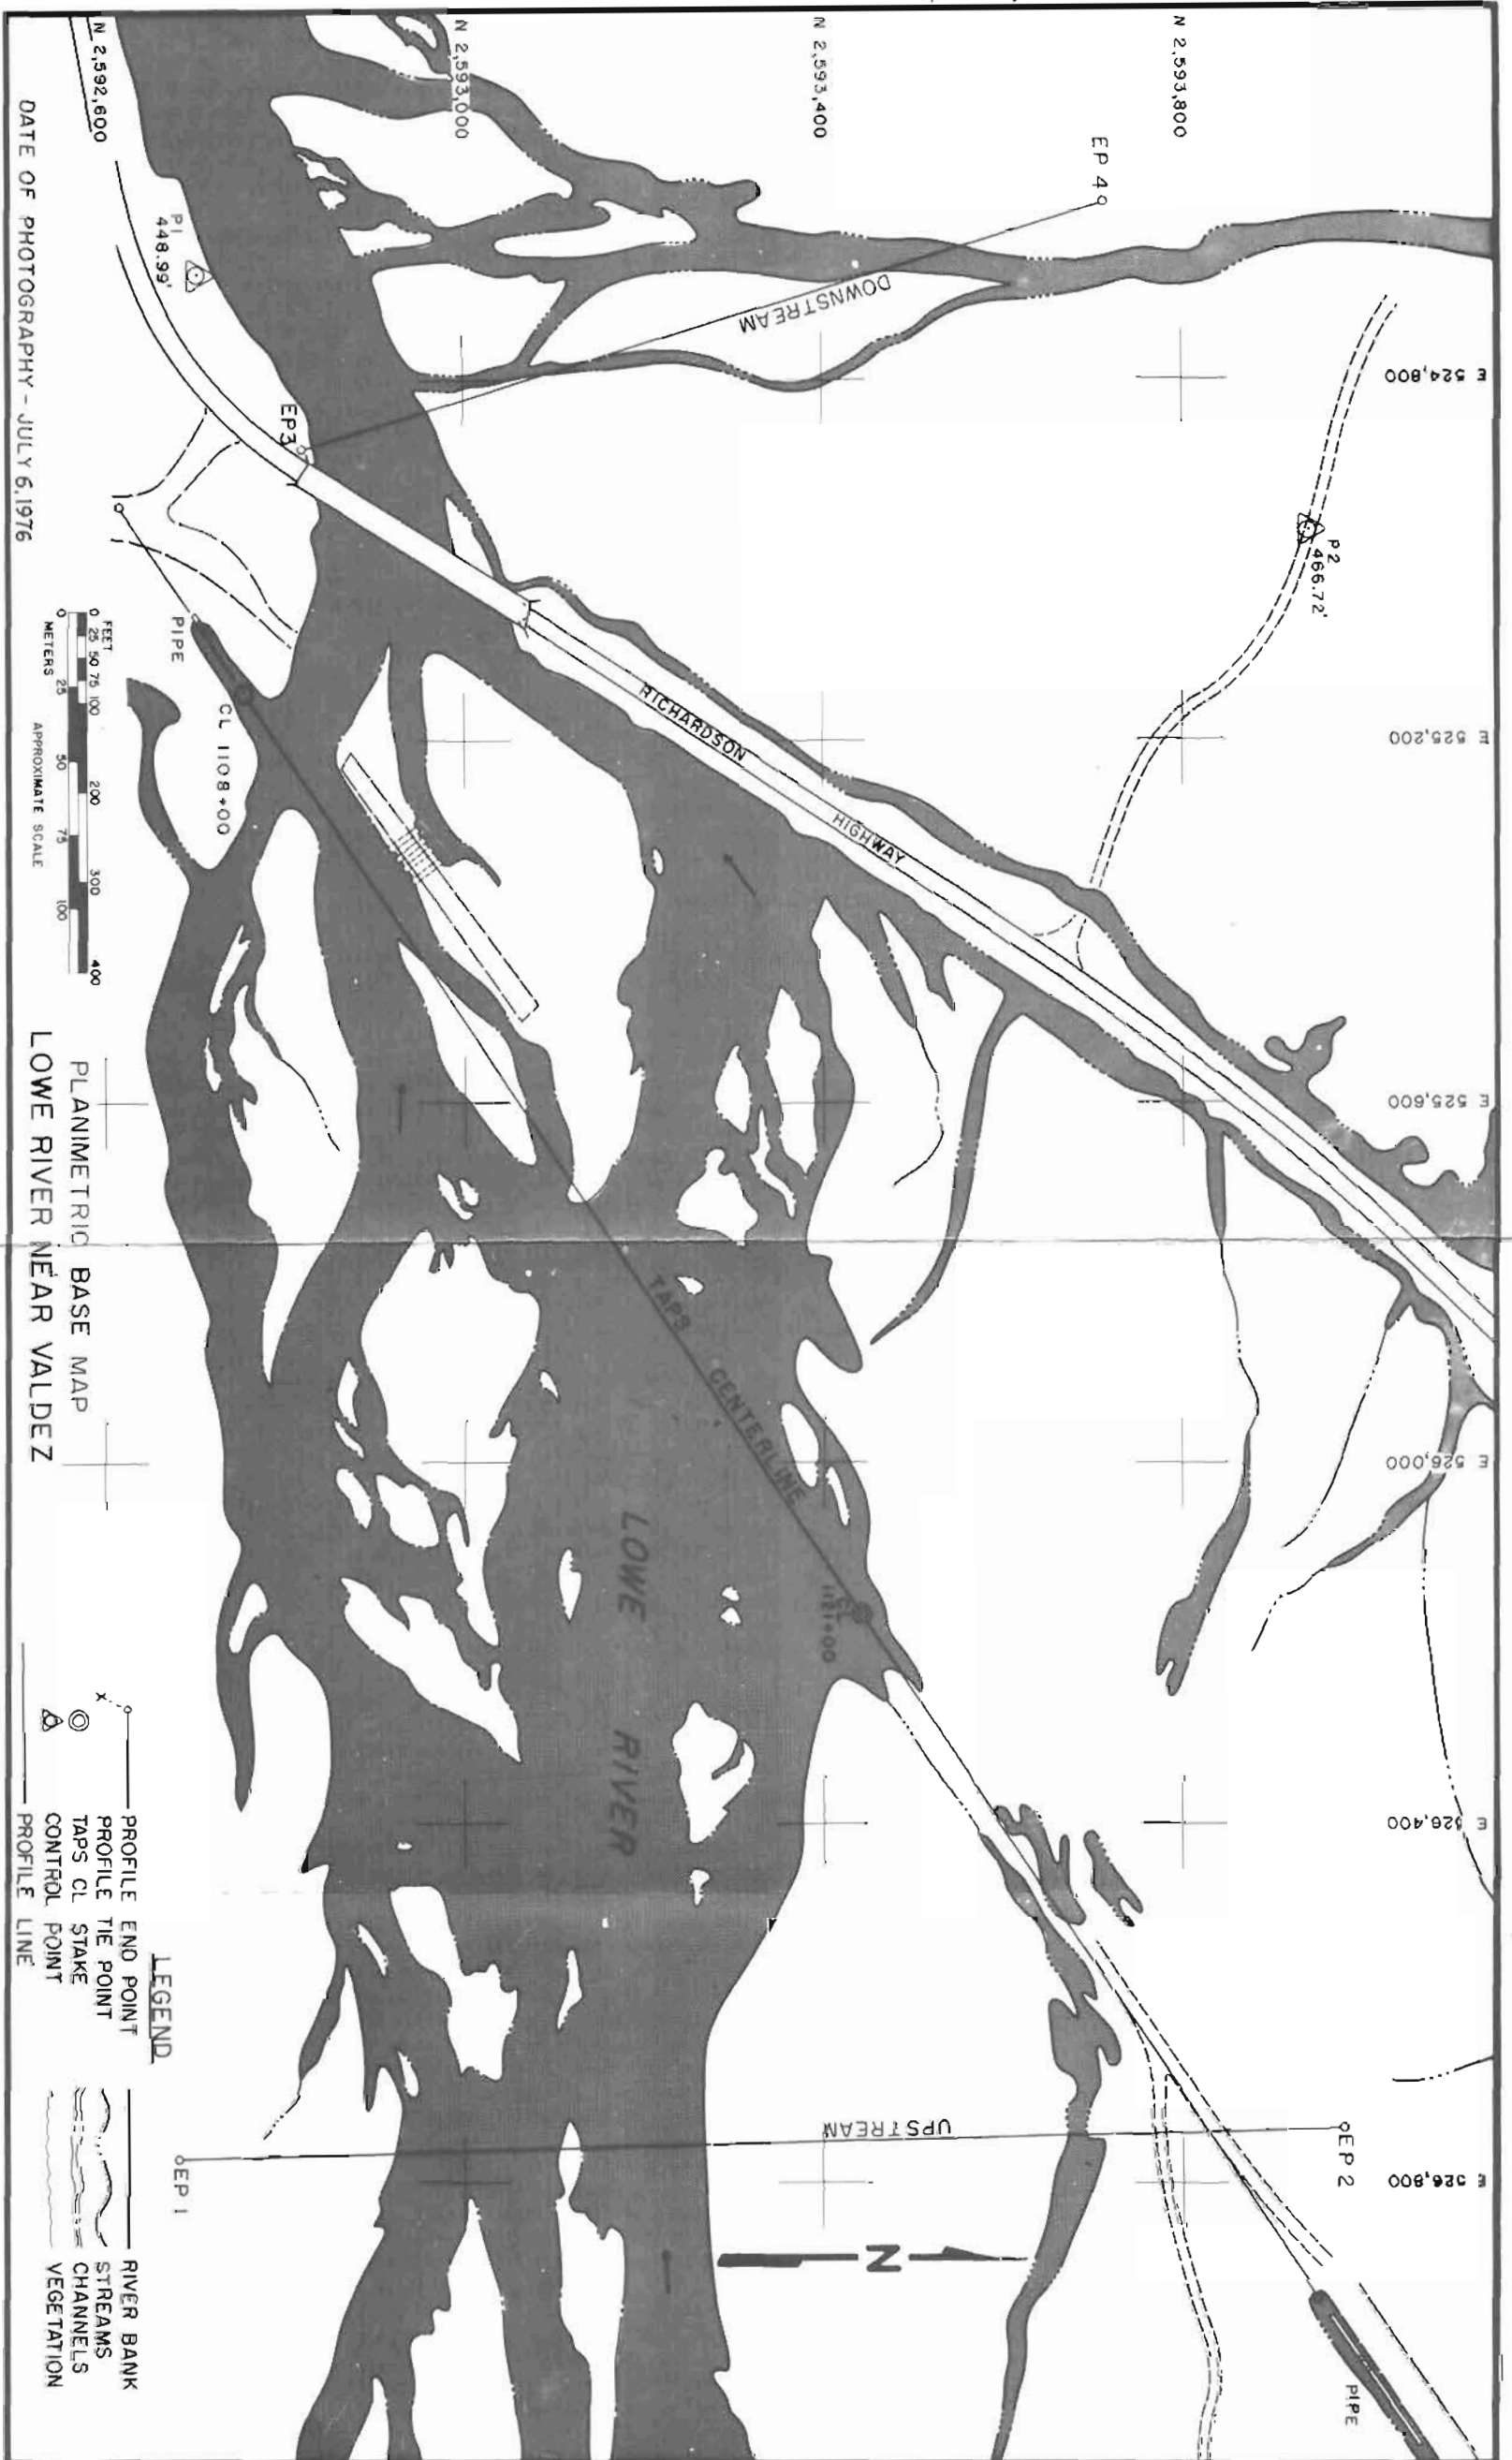
No significant change was found in the downstream cross section, but high water has covered the flood plain along the right bank at the upstream section. During the last year, the left bank of the centerline has been backfilled and a rip-rap dike has been constructed at the shore. This changed the profile of the left bank at the centerline, but the remainder of the cross section is identical to the last year's (fig. 49).

Figure 49a. -- Planimetric map of the Lowe River near Valdez.
