DEPARTMENT OF THE INTERIOR  
UNITED STATES GEOLOGICAL SURVEY

GEOLOGIC ROAD LOG  
ALYESKA HAUL ROAD, ALASKA  
JUNE-AUGUST, 1975

OPEN FILE REPORT  
79-227

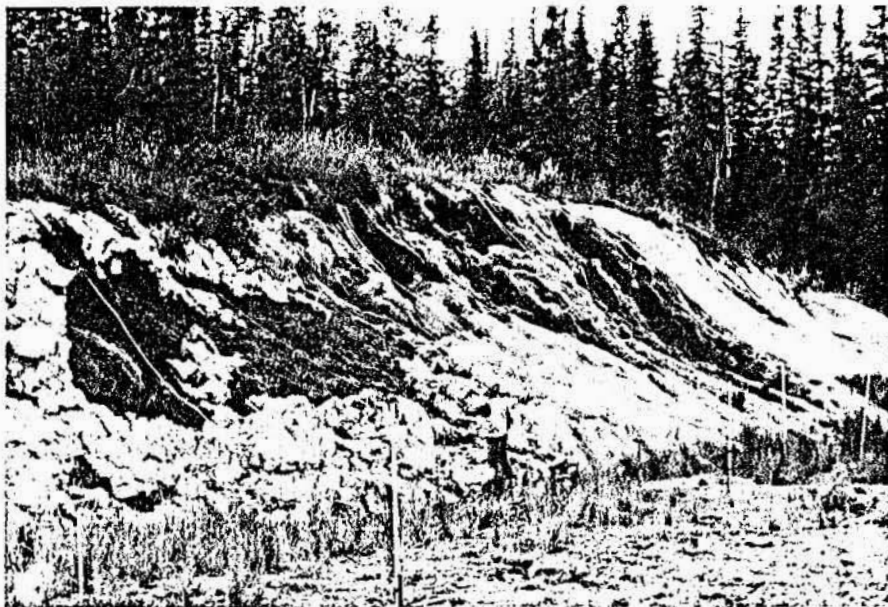
| Site No. | Mileage | Description |
|---|---|---|
| *9 | 94.7 | Cut 10 m deep in organic silt. Although sprayed with plastic foam and partly vegetated, cut still slumping and flowing on August 1 due to thaw of ice-rich permafrost (Fig. 1). |

Figure 1. Destruction of insulating plastic foam by slump and flowage into road cut, Mile 94.6 (Site 9), August 1, 1975.

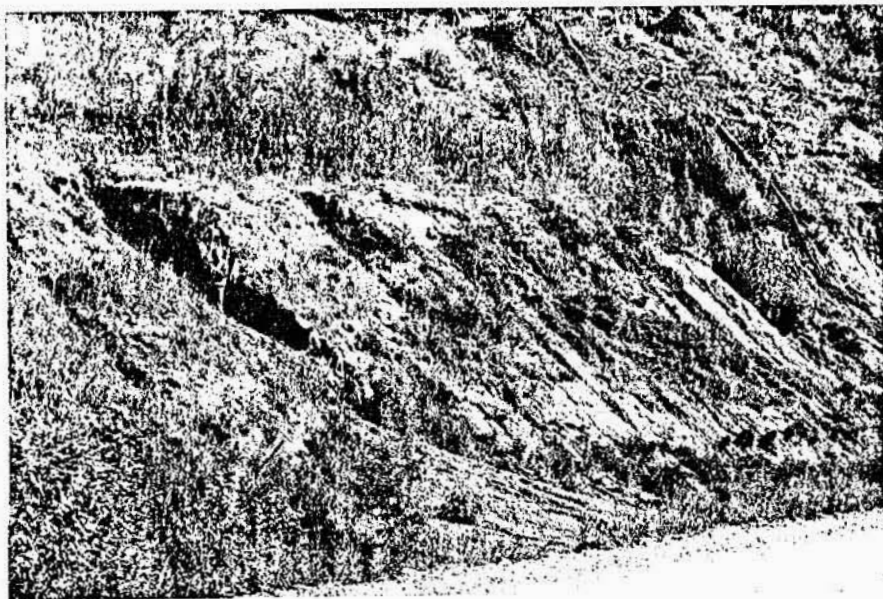
Figure 2. Gullies in cut at Mile 108.5 (Site 13). August 1, 1975.

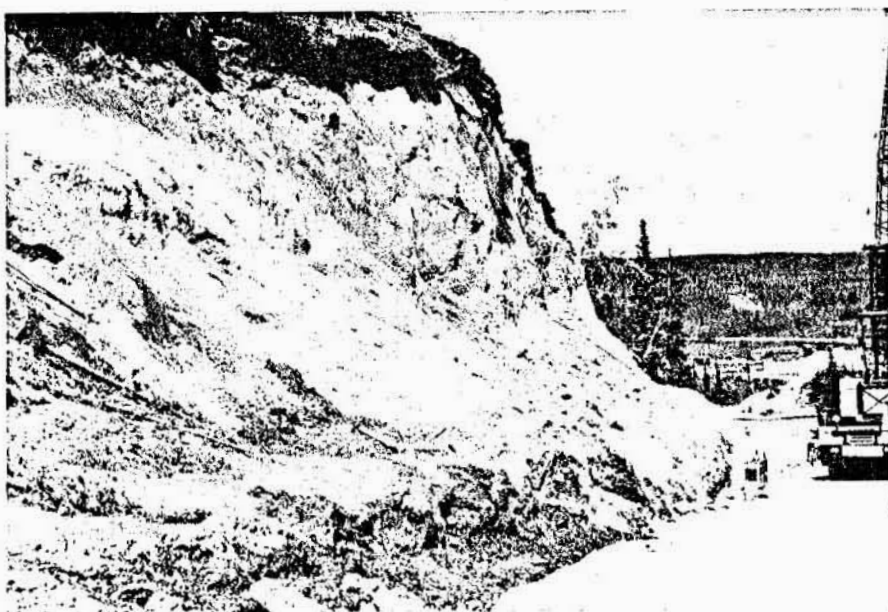
| Site No. | Mileage | Description |
|---|---|---|
| *20 | | On August 1, a side trip was taken to the south abutment of the Yukon River bridge (Site 20, Plate I) where a 20-m cut exposes silt above bedrock. Close to the bluff face, the silt is relatively coarse, well-drained, and ice-free (Fig. 3). Farther south it is oxidized to a depth of about 2 m, and grey, fetid-smelling, ice-rich, permanently frozen muck lies below this level (Fig. 4). Ice wedges begin at the base of the oxidized zone, and extend for an unknown distance down into the muck. The exposed permafrost is thawing and retreating, maintaining a vertical face above a sloping apron of flowing mud. |

Figure 3 (above). Cut into silt and bedrock at south abutment of Yukon River bridge (Site 20). August 1, 1975.

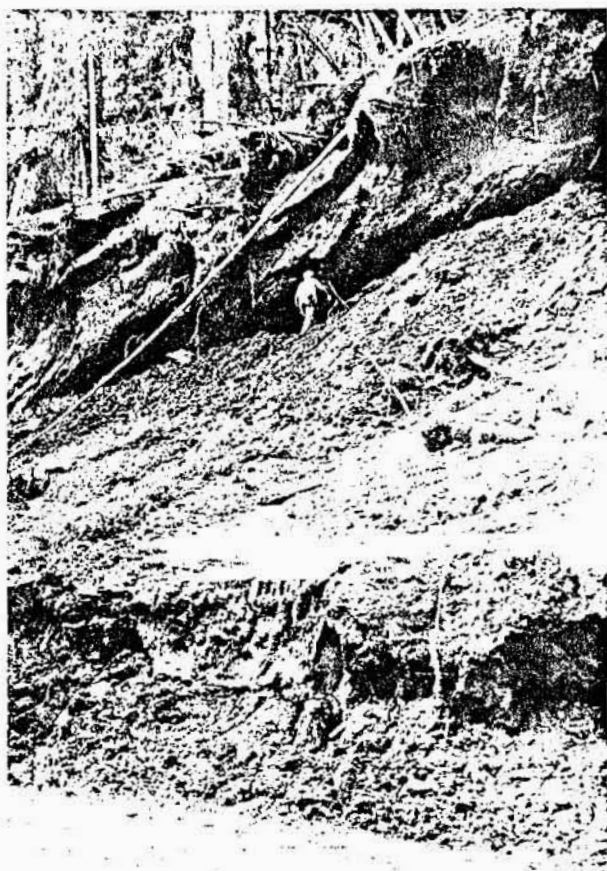
Figure 4 (left). Ice-rich silt immediately south of area shown in Figure 3. Permafrost is thawing rapidly, causing retreat of vertical face and accumulation of debris slope at its base. August 1, 1975.

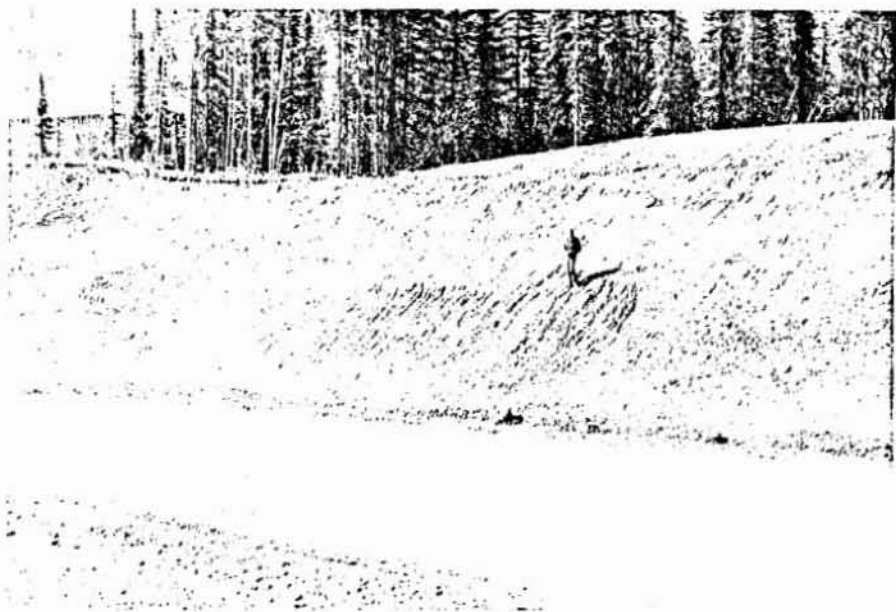
| Site No. | Mileage <sup>1/</sup> | Description |
|---|---|---|
| *27 | 11.3 | Cut across a minor ridge crest exposes about 2 m of gravel overlying up to 5 m of bedrock (Fig. 9). The gravel is virtually unweathered, but a thick, red, clayey weathering horizon lies along gravel/bedrock contact. North flank of ridge extends into nearly horizontal terrace surface. Minor shallow gullying and slumping in several places on August 1. |

Figure 9. Road cut through ridge crest at Mile 11.3 (Site 27). Man is standing on contact between gravel and highly weathered bedrock. June 24, 1975.

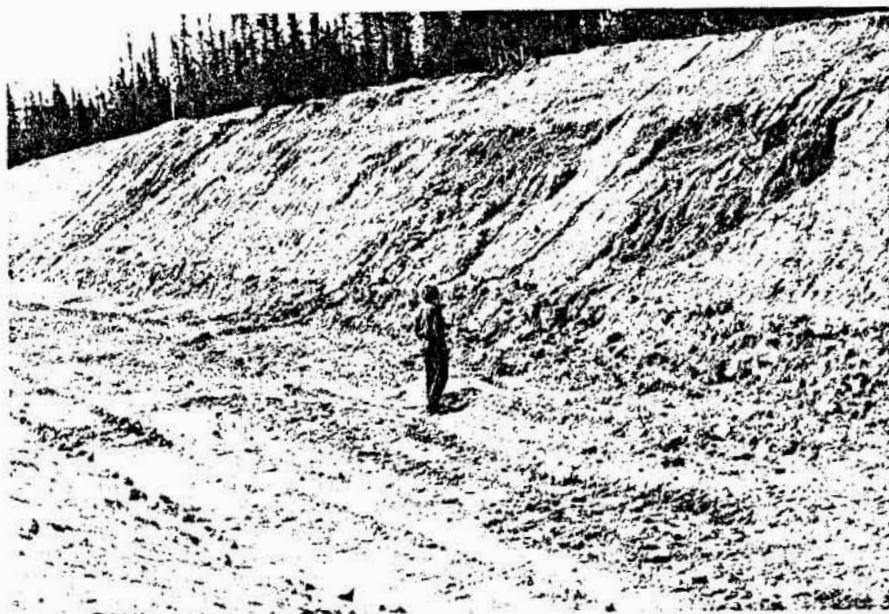
| Site No. | Mileage | Description |
|---|---|---|
| *36 | 21.0 | Cut into alluvial terrace exposes sand and granules above gravel. Some gullying evident on August 1, with sloughing into roadside ditch which contained standing water in places (Fig. 12). |

Figure 12 (below). Unstable road cut in alluvium at Mile 21.0 (Site 36). August 1, 1975.

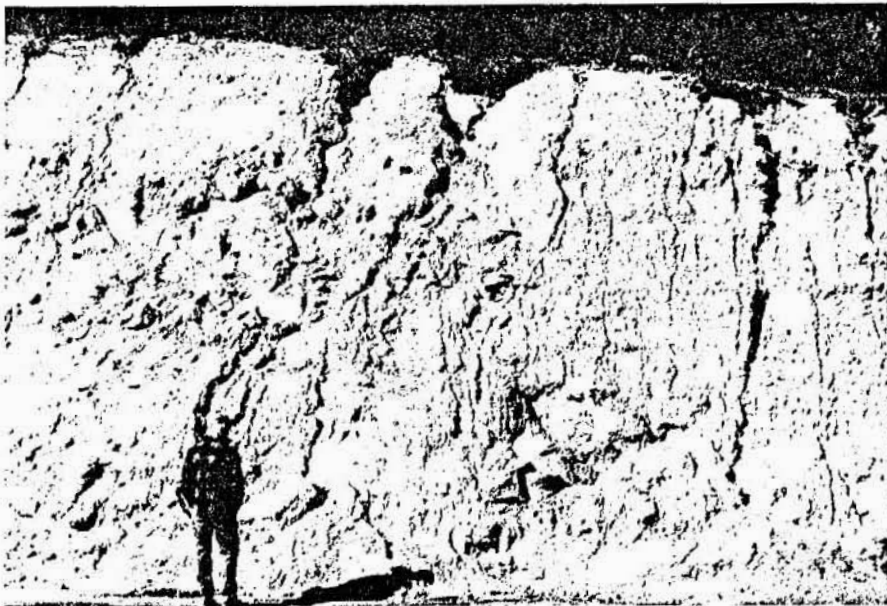
Figure 14. Gullies eroded into road cut near Old Man Camp (Site 46). August 1, 1975.

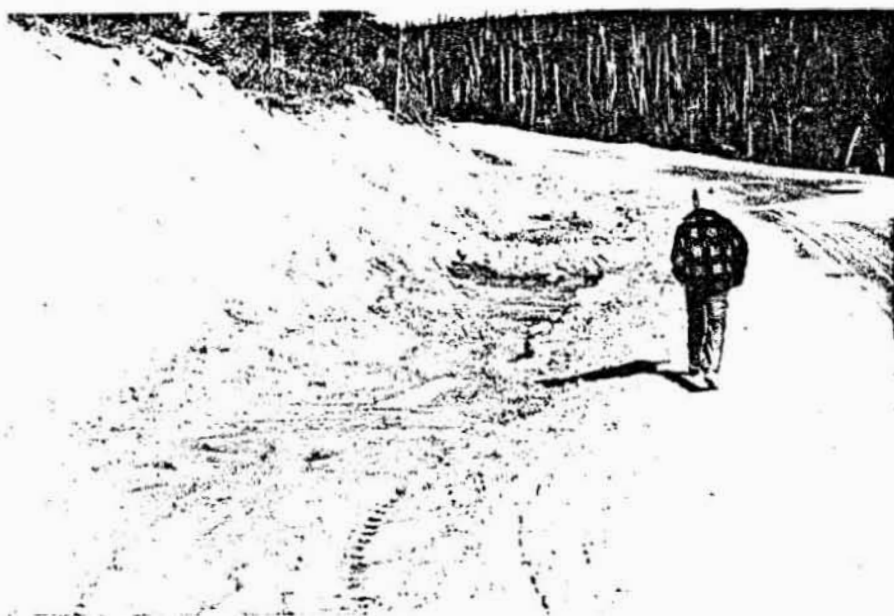
Figure 15. Wet, debris-filled ditch near Old Man Camp (Site 46). August 1, 1975.

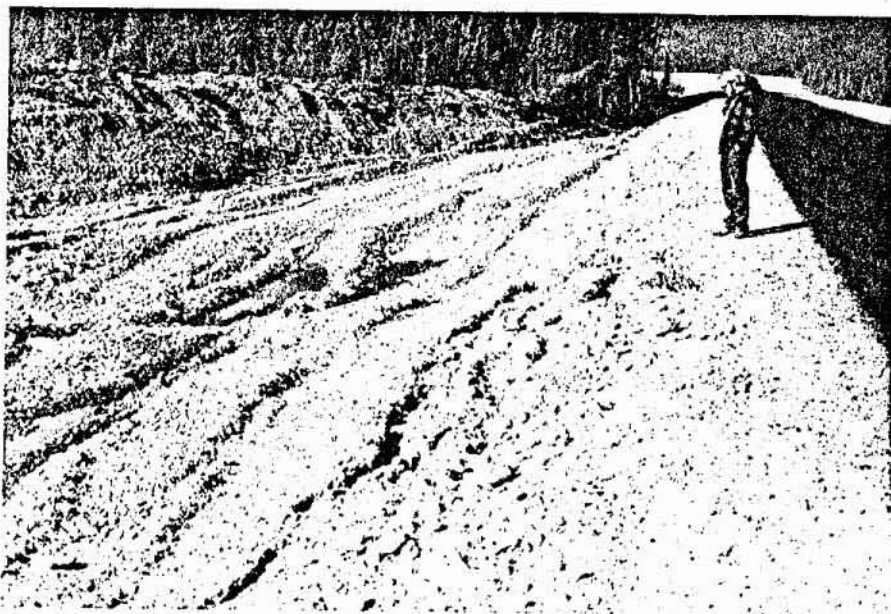
| Site No. | Mileage | Description |
|---|---|---|
| *58 | 87.0 | Cut 5 m deep into alluvial terrace exposes gravel with thin cap of sand and sod (Fig. 17). Floor of roadside ditch consists of moist sand, gravel, and grey clayey silt churned together by heavy construction machinery. The terrace gravel probably was deposited over Pleistocene lake beds. Ditch was still wet, soft, and muddy on August 1, and had been widened to about 15 m by removal of borrow material. Road shoulder was actively sloughing into ditch (Fig. 18). |

Figure 18. Sloughing of road edge into ditch at Site 58. August 1, 1975.

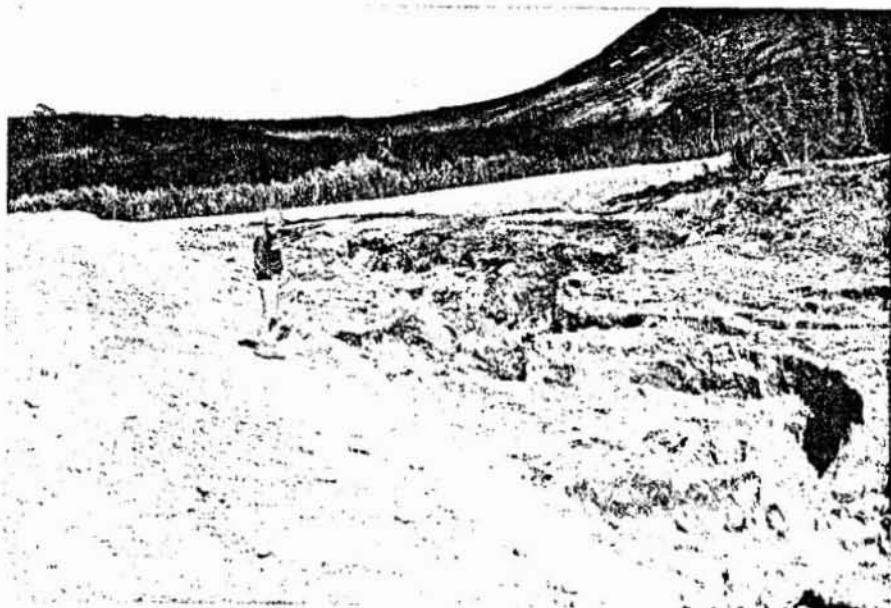
Figure 21. Gully erosion in roadside ditch at Site 71. June 24, 1975.

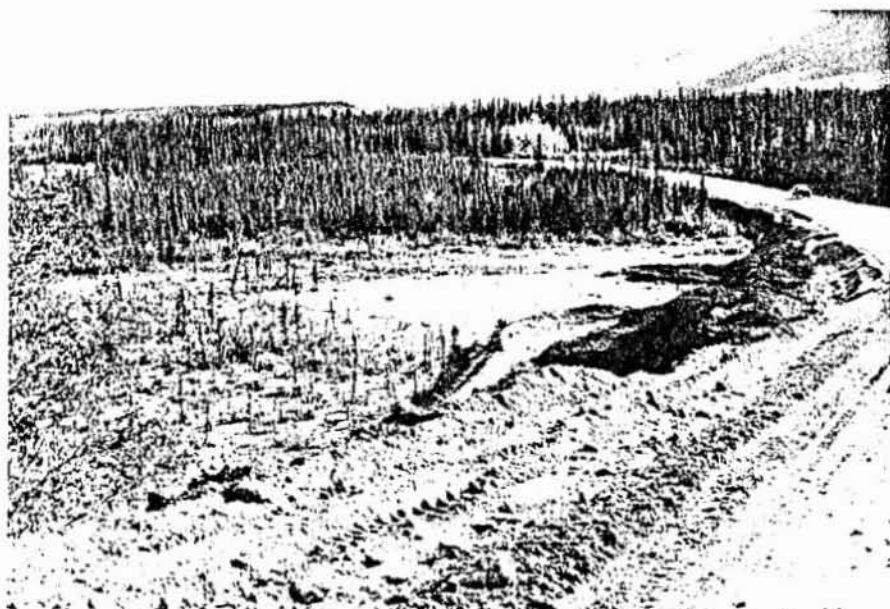
Figure 22. Siltation at base of road grade, Site 71. June 24, 1975.

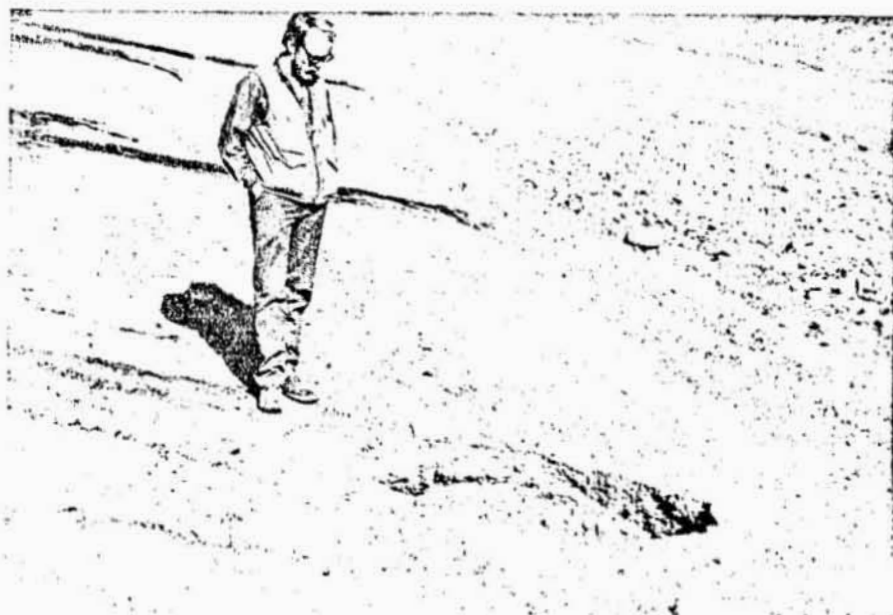
Figure 24. Piping in roadside ditch at Site 71. July 31, 1975.

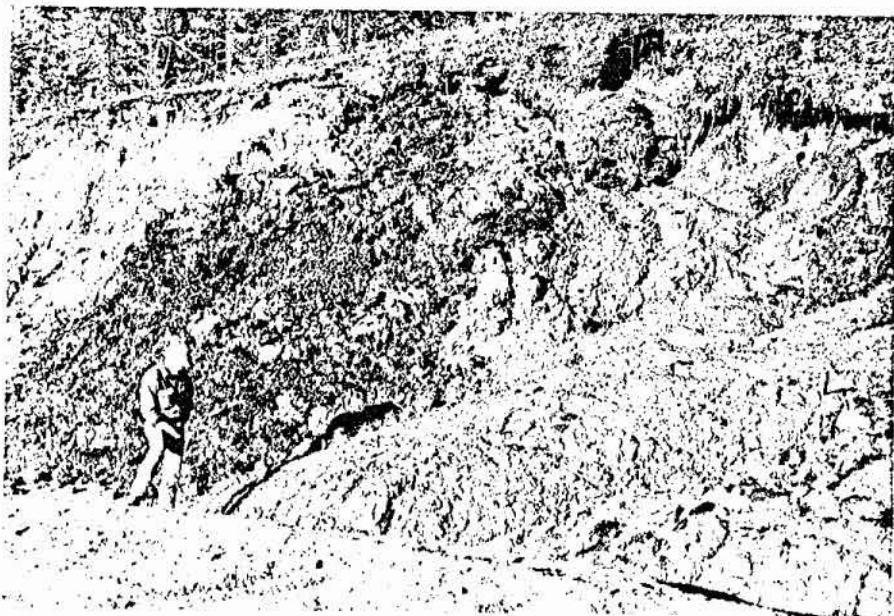
| Site No. | Mileage | Description |
|---|---|---|
| *75 | 119.7 | Cut along east side of road stands 6-7 m high. Muck and gravel alternately exposed, with ice-rich muck probably forming channel fills in gravel. Upon thawing, muck yields lobes of flowing mud which have nearly filled roadside ditch in places (Fig. 26). Two flow lobes still |

Figure 26. Mudflow at Site 75. June 24, 1975.

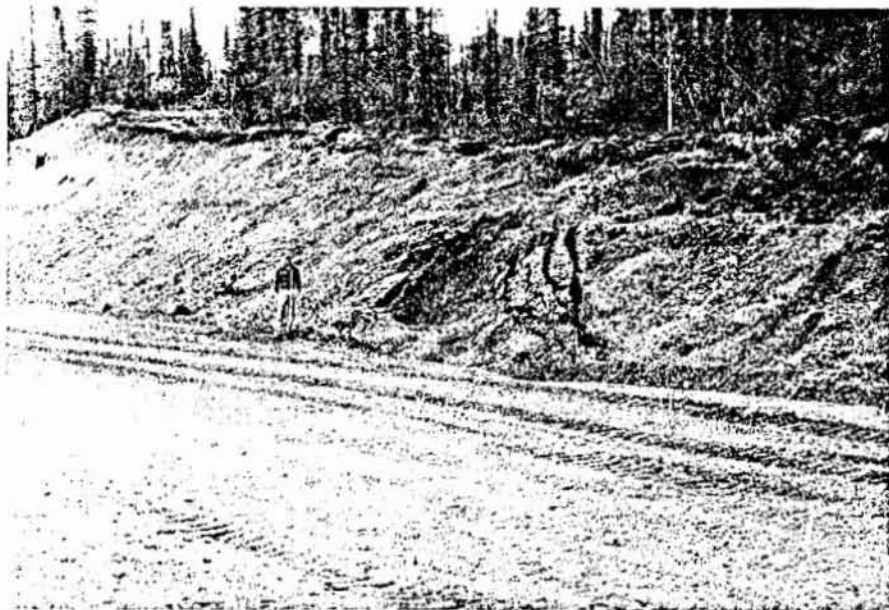
| Site No. | Mileage | Description |
|---|---|---|
| *83 | 137.0 | Cut 5-7 m deep along west side of road exposes till which contains deep kettle fill of silt and organic matter. Fill probably was permanently frozen and ice-rich prior to road construction because concentric tension fractures now surround an actively subsiding thermokarst depression at this site (Fig. 29). Area was still actively subsiding on July 31 (Fig. 30), and subsidence also was noted on pipeline work pad about 1 mile to the southwest. |

Figure 29. Thermokarst subsidence at Site 83. Subsidence is taking place beneath a berm of gravel which has been emplaced over face of road cut. June 25, 1975.

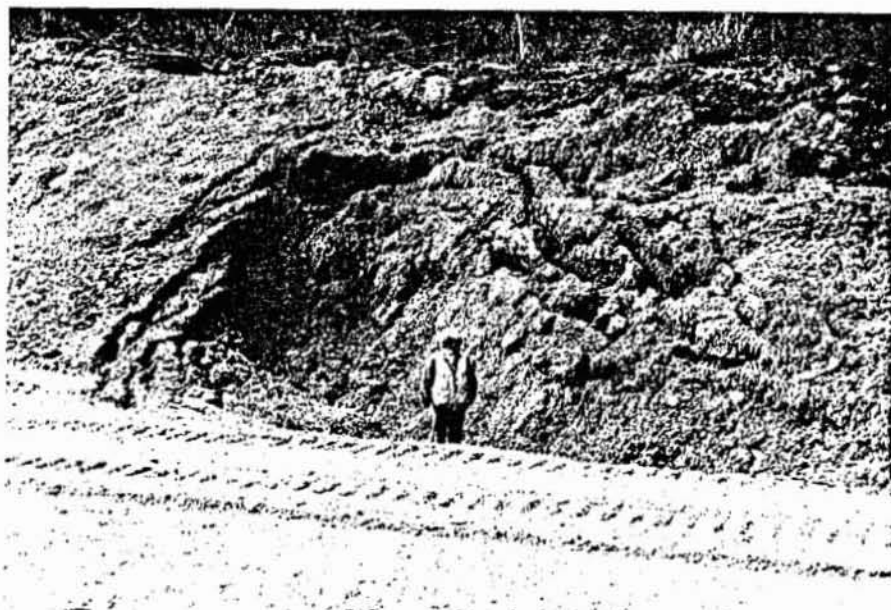
Figure 30. Continued thermokarst subsidence at Site 83. July 31, 1975.

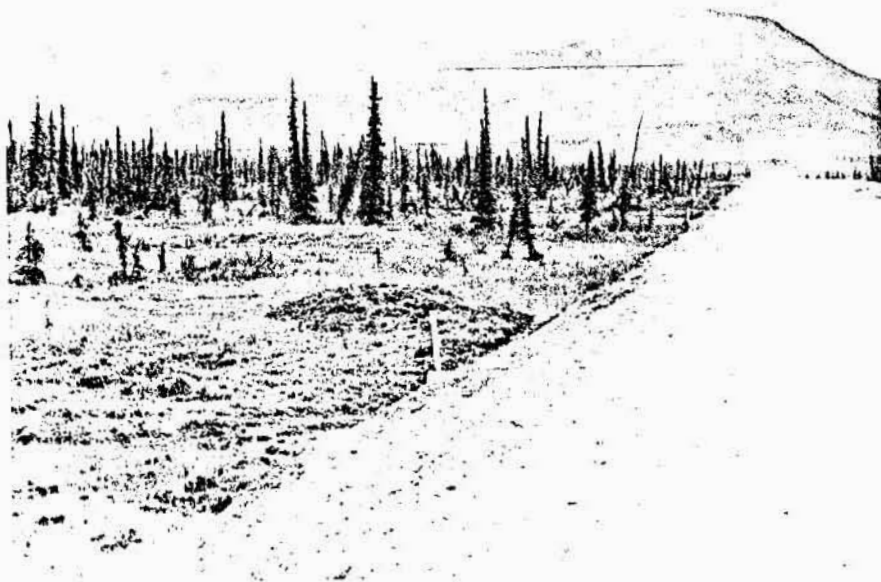
| Site No. | Mileage | Description |
|---|---|---|
| *94 | 154.6-<br>154.9 | Road crosses muskeg terrain which has poor surface drainage and many frost mounds (palsas) (Fig. 33). Mounds range in height up to 1.5 m, occur along both sides of road and are currently active, with open tension cracks 20-50 cm deep. They appear to be ice-cored because thaw leads to formation of nearly circular small ponds (Fig. 34).<br><br>This stretch of road (ca. Mile 154.4 to 154.9) was being rebuilt and regraded on July 31. Substantial quantities of gravel were being added, suggesting that thaw of permafrost and/or compression or soft bog sediments had caused appreciable subsidence. |

Figure 33 (above). Muskeg terrain and palsas at Site 94. June 25, 1975.

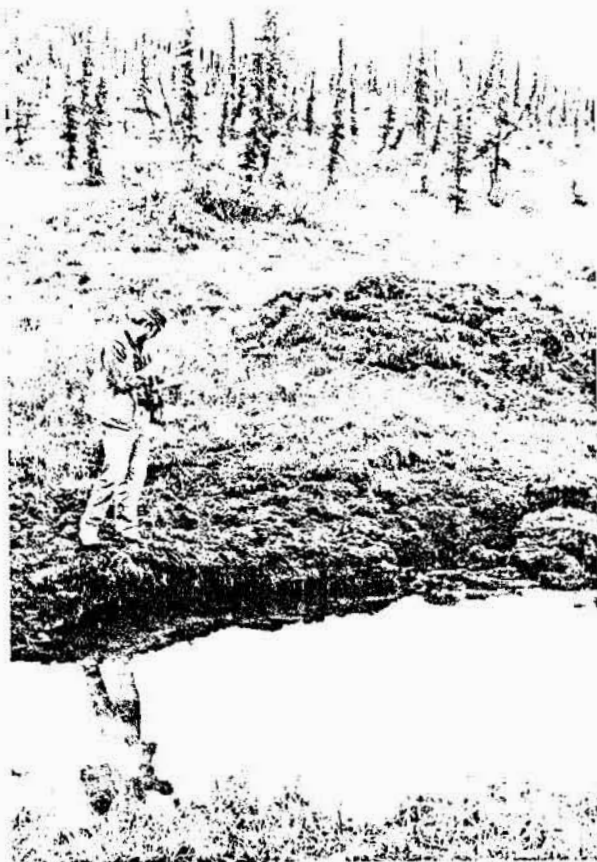
Figure 34 (left). Active palsa (note tension cracks) and thaw pond at Site 94. June 25, 1975.

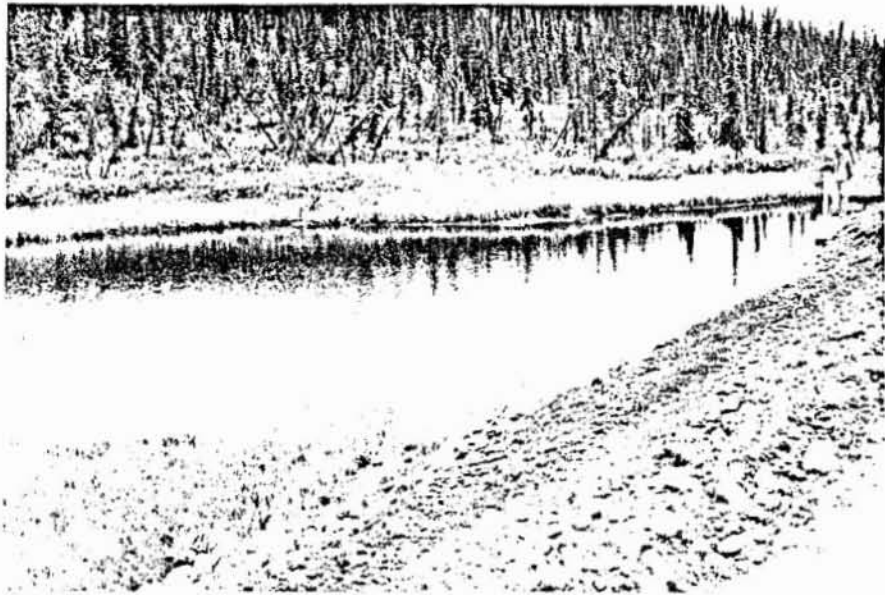
Figure 35. Pond formed since road construction (Site 100). June 25, 1975.

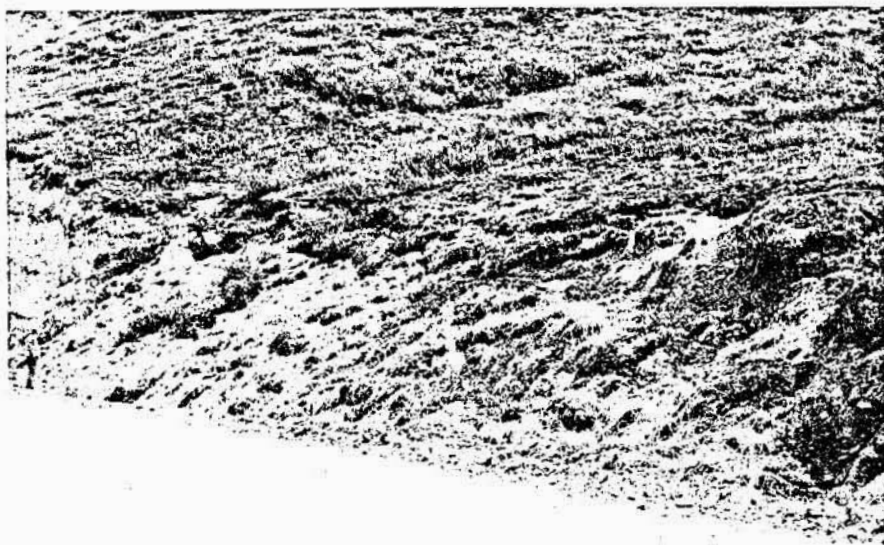
| Site No. | Mileage | Description |
|---|---|---|
| *119 | 189.6-190.6 | Nearly continuous cuts 10-20 m high border road to the east, exposing slate beneath colluvium which thickens across floors of swales. Minor raveling of exposed bedrock was noted on June 25, and debris cones were encroaching on road in a few places.<br><br>Slope activity was observed in 2 areas on July 31. A portion of the cut intersecting a silt-filled drainage swale at Mile 190.0 exhibited minor slumps and flows, which disrupted the blanket of straw insulation placed at this site (Fig. 37). A large elongate flow at Mile 190.1 extends from roadway down to the valley bottom (Fig. 38). It is fed by water and mud emerging from drainage swales along east side of the roadway (Fig. 39), at a place where road has been inadequately culverted. The flow was covered with a blanket of straw, which has been broken by continued flowage. |

Figure 37. Colluvium-filled swale reactivated by road cut at Mile 190.0 (Site 119). July 31, 1975.

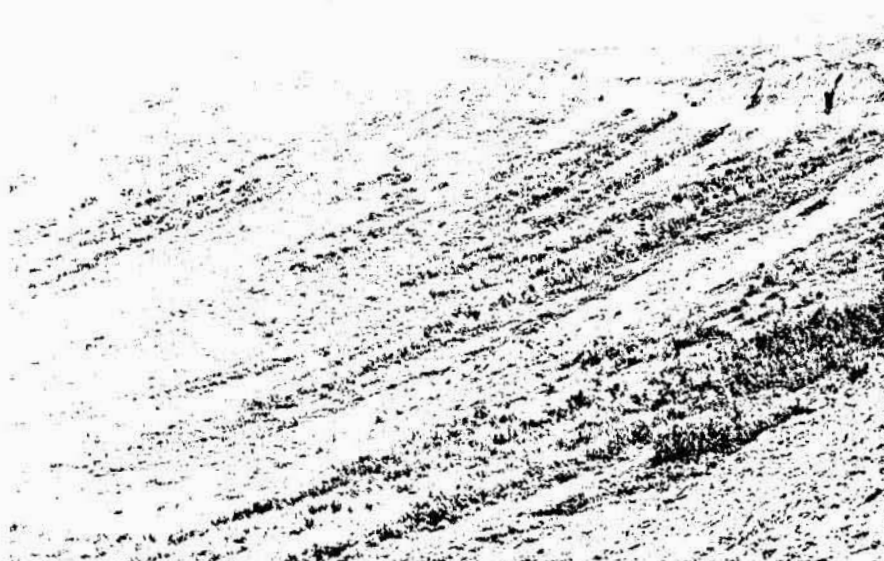
Figure 38. Large earthflow originating at Mile 190.1 (Site 119). July 31, 1975.

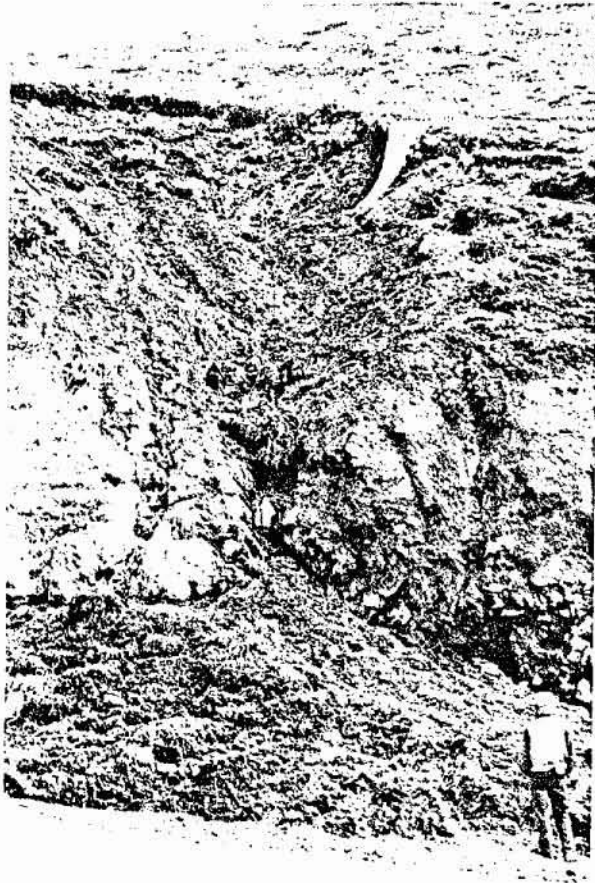
Figure 39 (left). Active flows and debris cone east of road at Mile 190.1 (Site 119). July 31, 1975.

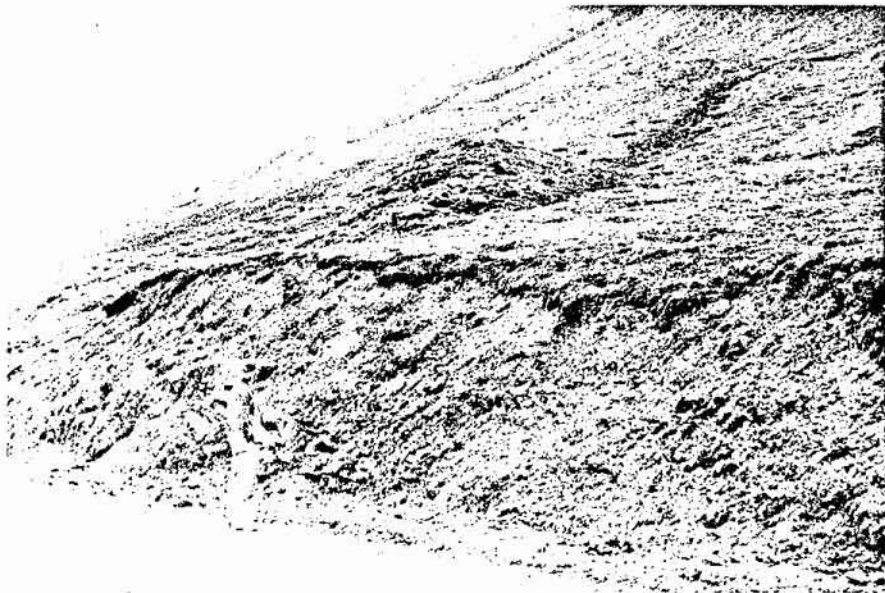
Figure 40 (below). Landslide rubble in road cut at Site 122. July 31, 1975.

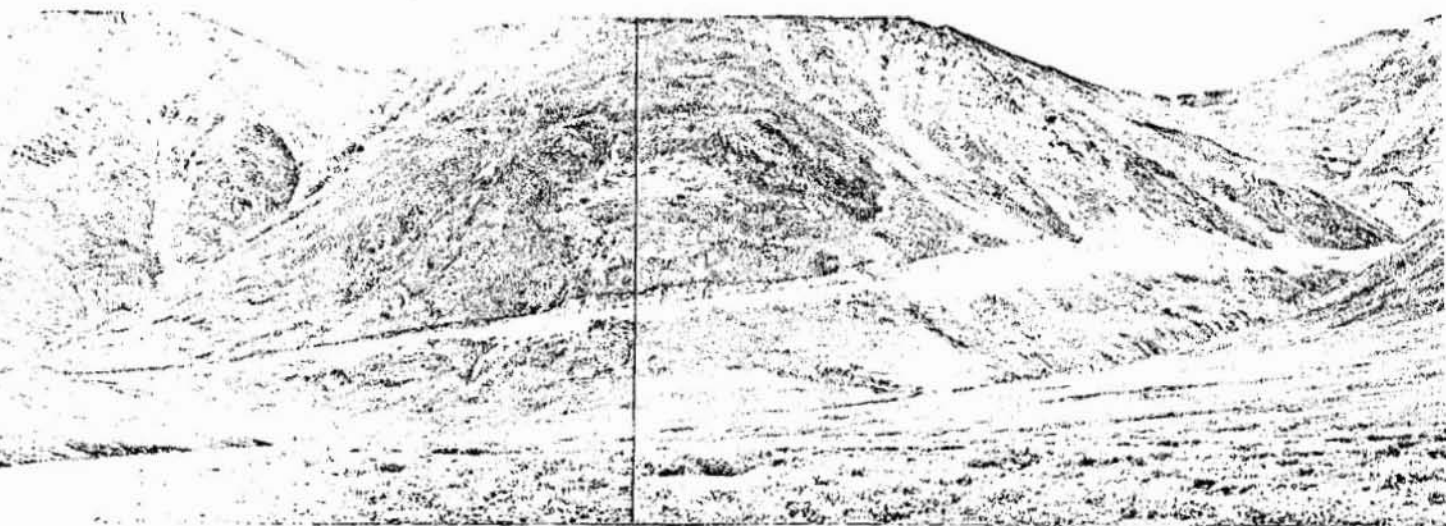
| Site No. | Mileage | Description |
|---|---|---|
| *123 | 196.2 | Road begins ascent toward Atigun Pass (Fig. 41). Several debris flows below the road appear to have originated from roadbed (Figs. 41 and 42). One of the flows appears generated by concentration of runoff water through a culvert (Fig. 42). |

Figure 41. Panoramic view of south flank of Atigun Pass from Site 123. June 25, 1975.

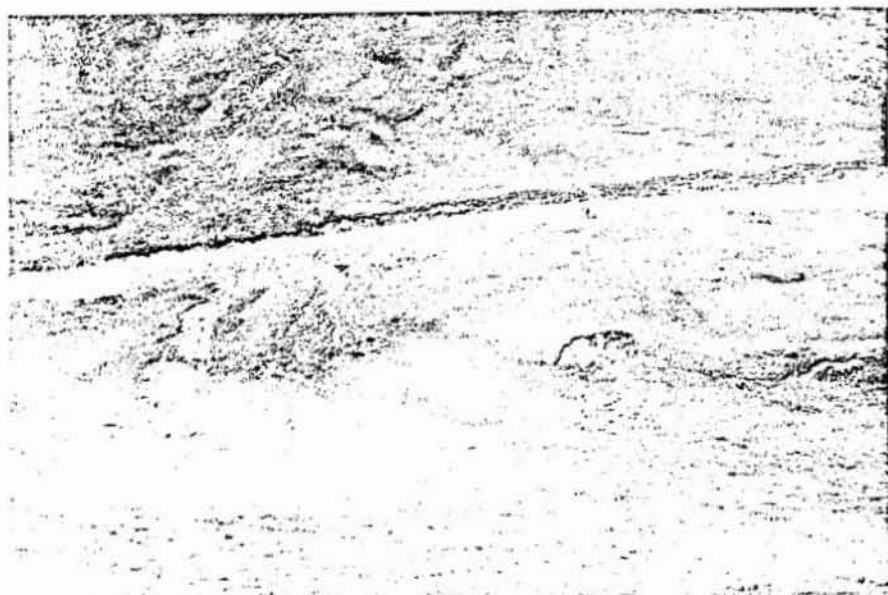
Figure 42. Closeup of debris tongues and earthflow which originate along road bed at ca. Mile 197.2 (Site 124). June 25, 1975.

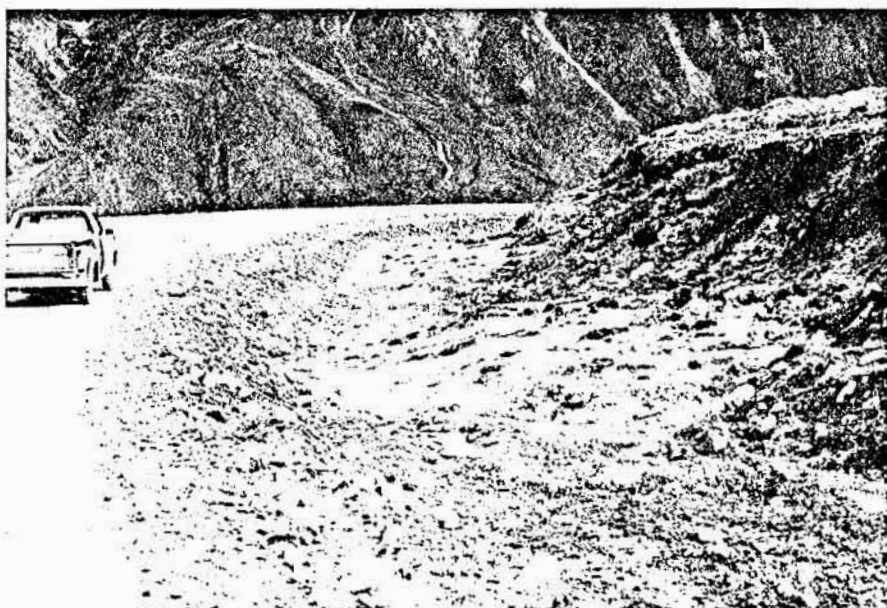
Figure 44.. Flows into roadside ditch along north flank of Atigun Pass (Site 128). June 25, 1975.

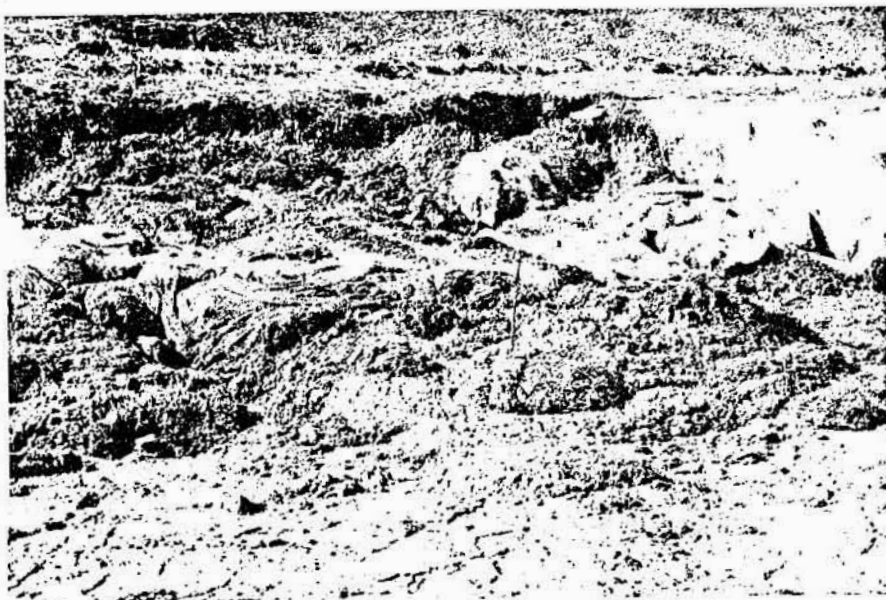
Figure 45. Continued flowage at Site 128. July 31, 1975.

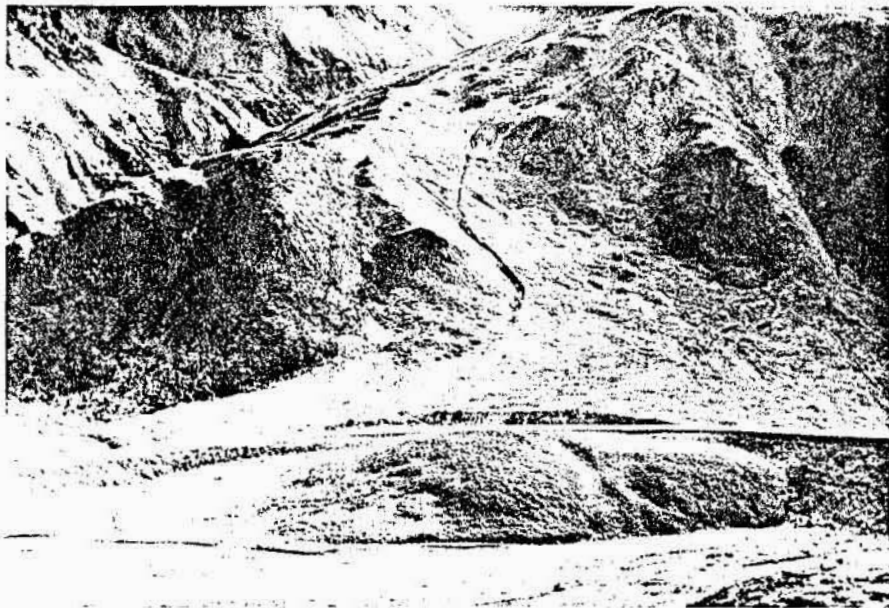
| Site No. | Mileage | Description |
|---|---|---|
| *130 | 200.4 | Road crosses very active debris slope (Fig. 47). Cuts 3-5 m deep expose rock rubble in ice-rich silty matrix. Cut west of road was highly unstable on June 25 owing to thaw of ice-rich permafrost. Mudflows, generated along face of cut, were filling roadside ditch (Fig. 48). Bank had been freshly covered with mat of insulating material when seen again on July 8, but by July 31 active flows had disrupted about 10% of the mat along both sides of road (Figs. 49 and 50). |

Figure 47. View east from Atigun Pass to Site 130. July 31, 1975.

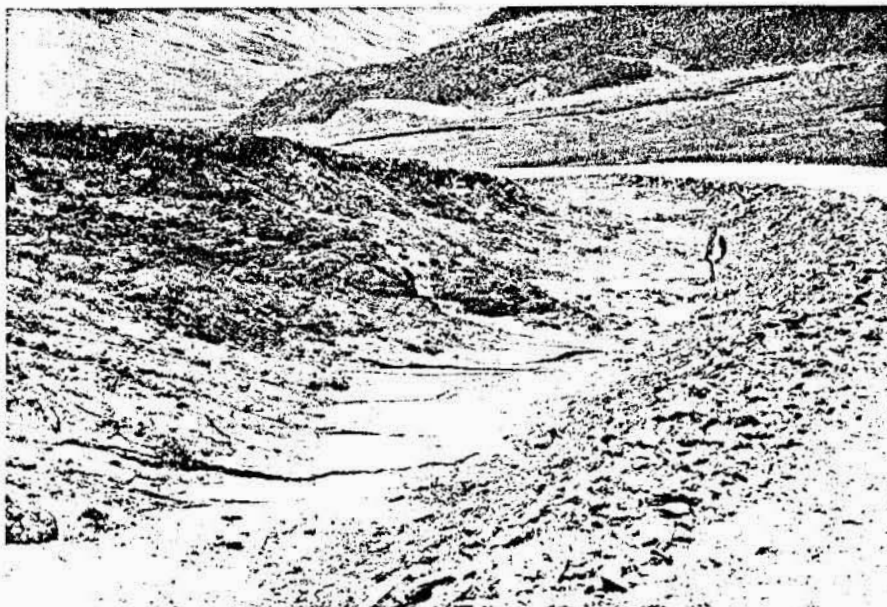
Figure 48. Flows into western roadside ditch at Site 130. June 25, 1975.

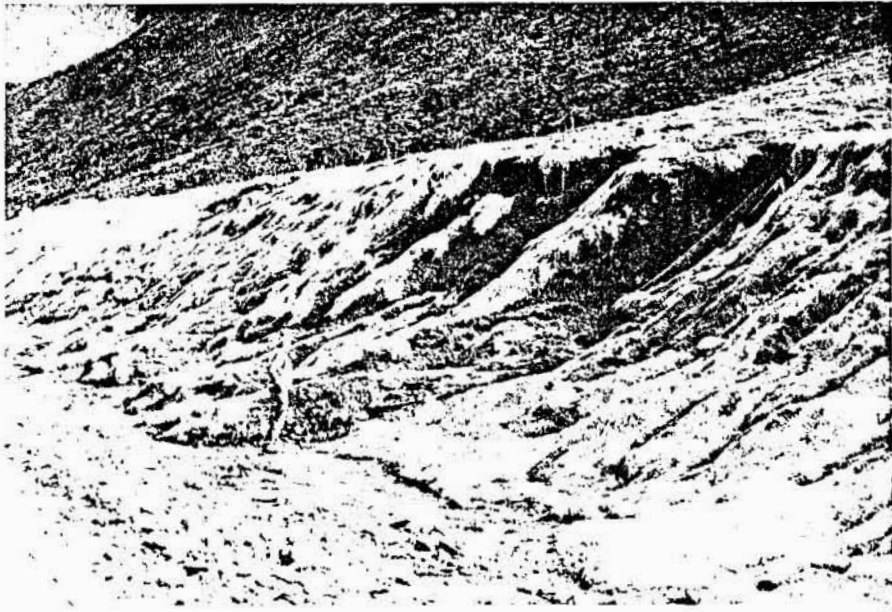
Figure 49. Active flows into eastern roadside ditch at Site 130. July 31, 1975.

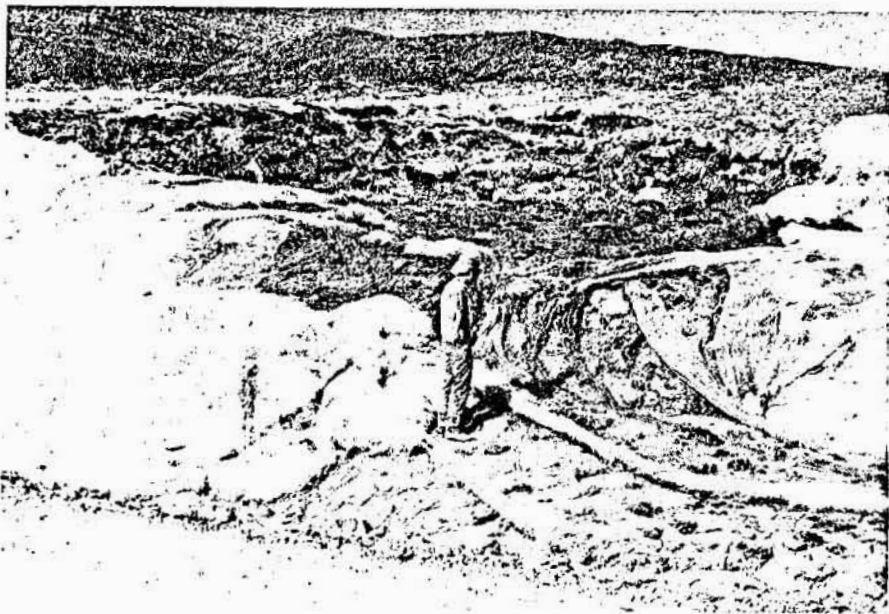
Figure 50. Active flows into western roadside ditch at Site 130. July 31, 1975.

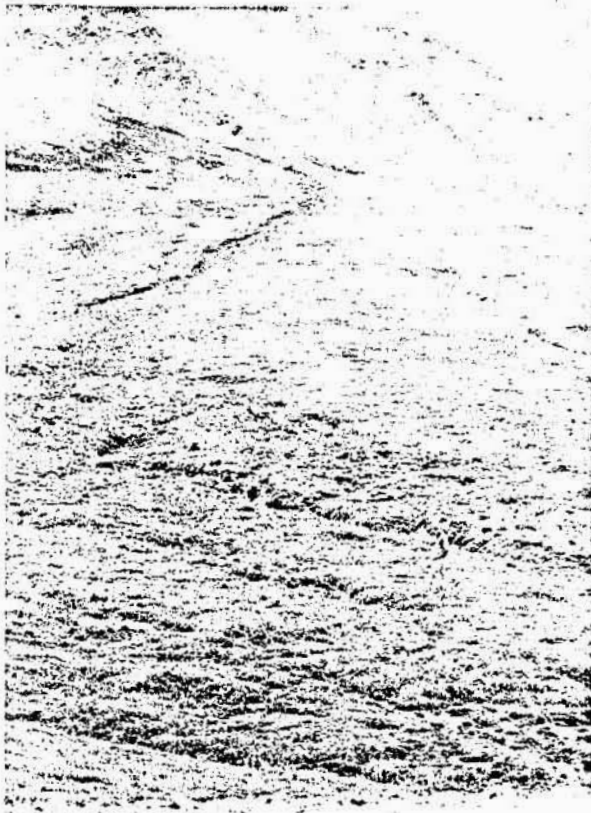
| Site No. | Mileage | Description |
|---|---|---|
| *131 | 201.1 | Road intersects a steep alpine fan which bears fresh-appearing levees and boulder litter indicative of repeated debris flows or slush flows (Fig. 51). Most boulders are weathered, but some lack weathering and lichen cover and may have been deposited recently (Fig. 52). |

Figure 51 (left). Steep alpine fan north of Atigun Pass (Site 131). Haul road visible at base of photograph. July 31, 1975.

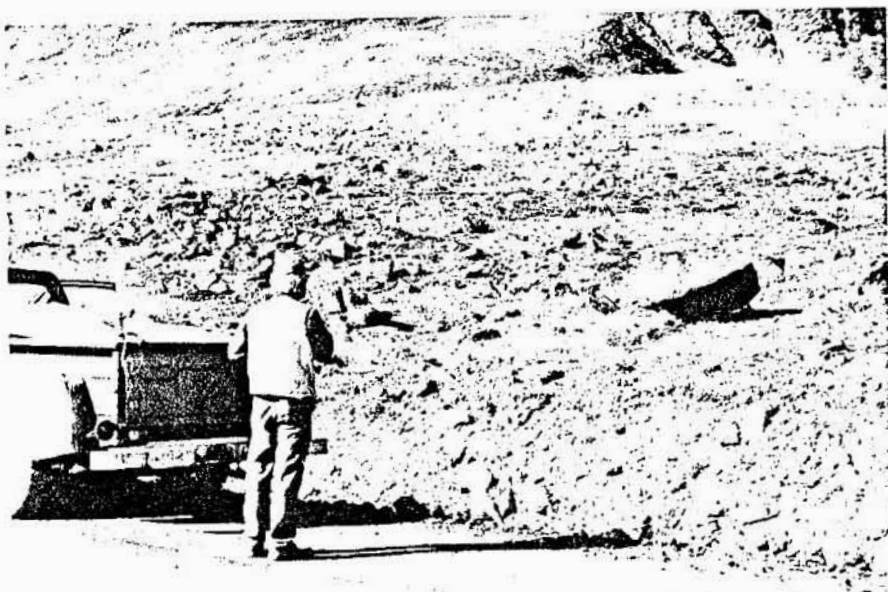
Figure 52 (below). Near view of Site 131. Heavy boulder litter on fan surface. July 31, 1975.

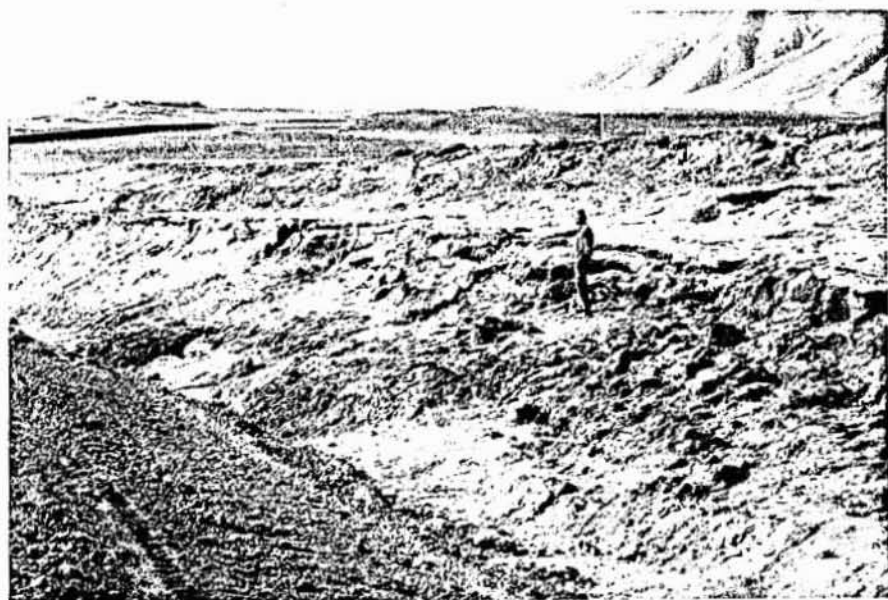
| Site No. | Mileage | Description |
|---|---|---|
| *144 | 224.9 | Cuts up to 9 m deep along both sides of road expose fluvial or glaciolacustrine sand and peat, with some overlying eolian sand. Cuts had been revegetated when revisited on July 31, but were still subject to continued minor slumping (Fig. 54). |

Figure 54. Slumping of eastern roadcut at north bank of Atigun River (Site 144). July 31, 1975.

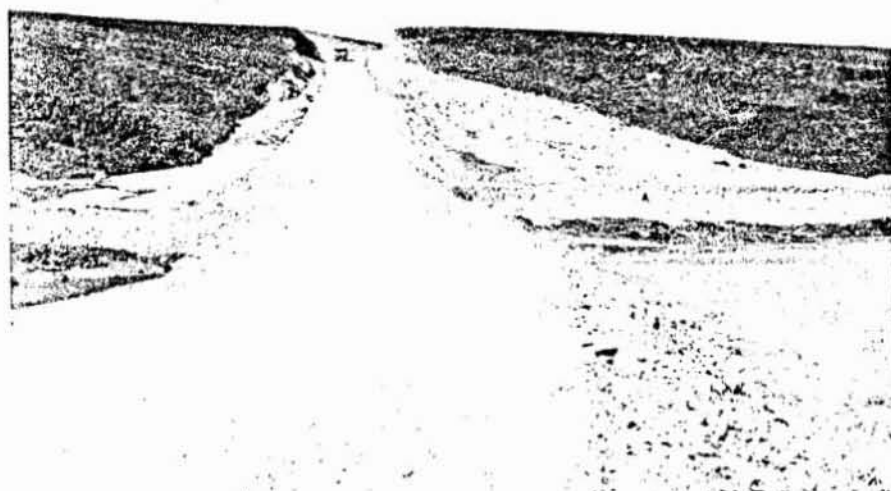
Figure 56. Road cuts into ice-rich muck above till and bedrock (Site 162). Disturbed areas on slope are mudflows and restraining structures. July 7, 1975.
