THE ALASKA EARTHQUAKE, MARCH 27, 1964—  
EFFECTS ON COMMUNITIES

# Effects of the Earthquake Of March 27, 1964 At Anchorage, Alaska

*A description and analysis of the damage resulting from seismic vibration, ground cracks, and especially landslides in Alaska's largest city*

GEOLOGICAL SURVEY PROFESSIONAL PAPER 542-A

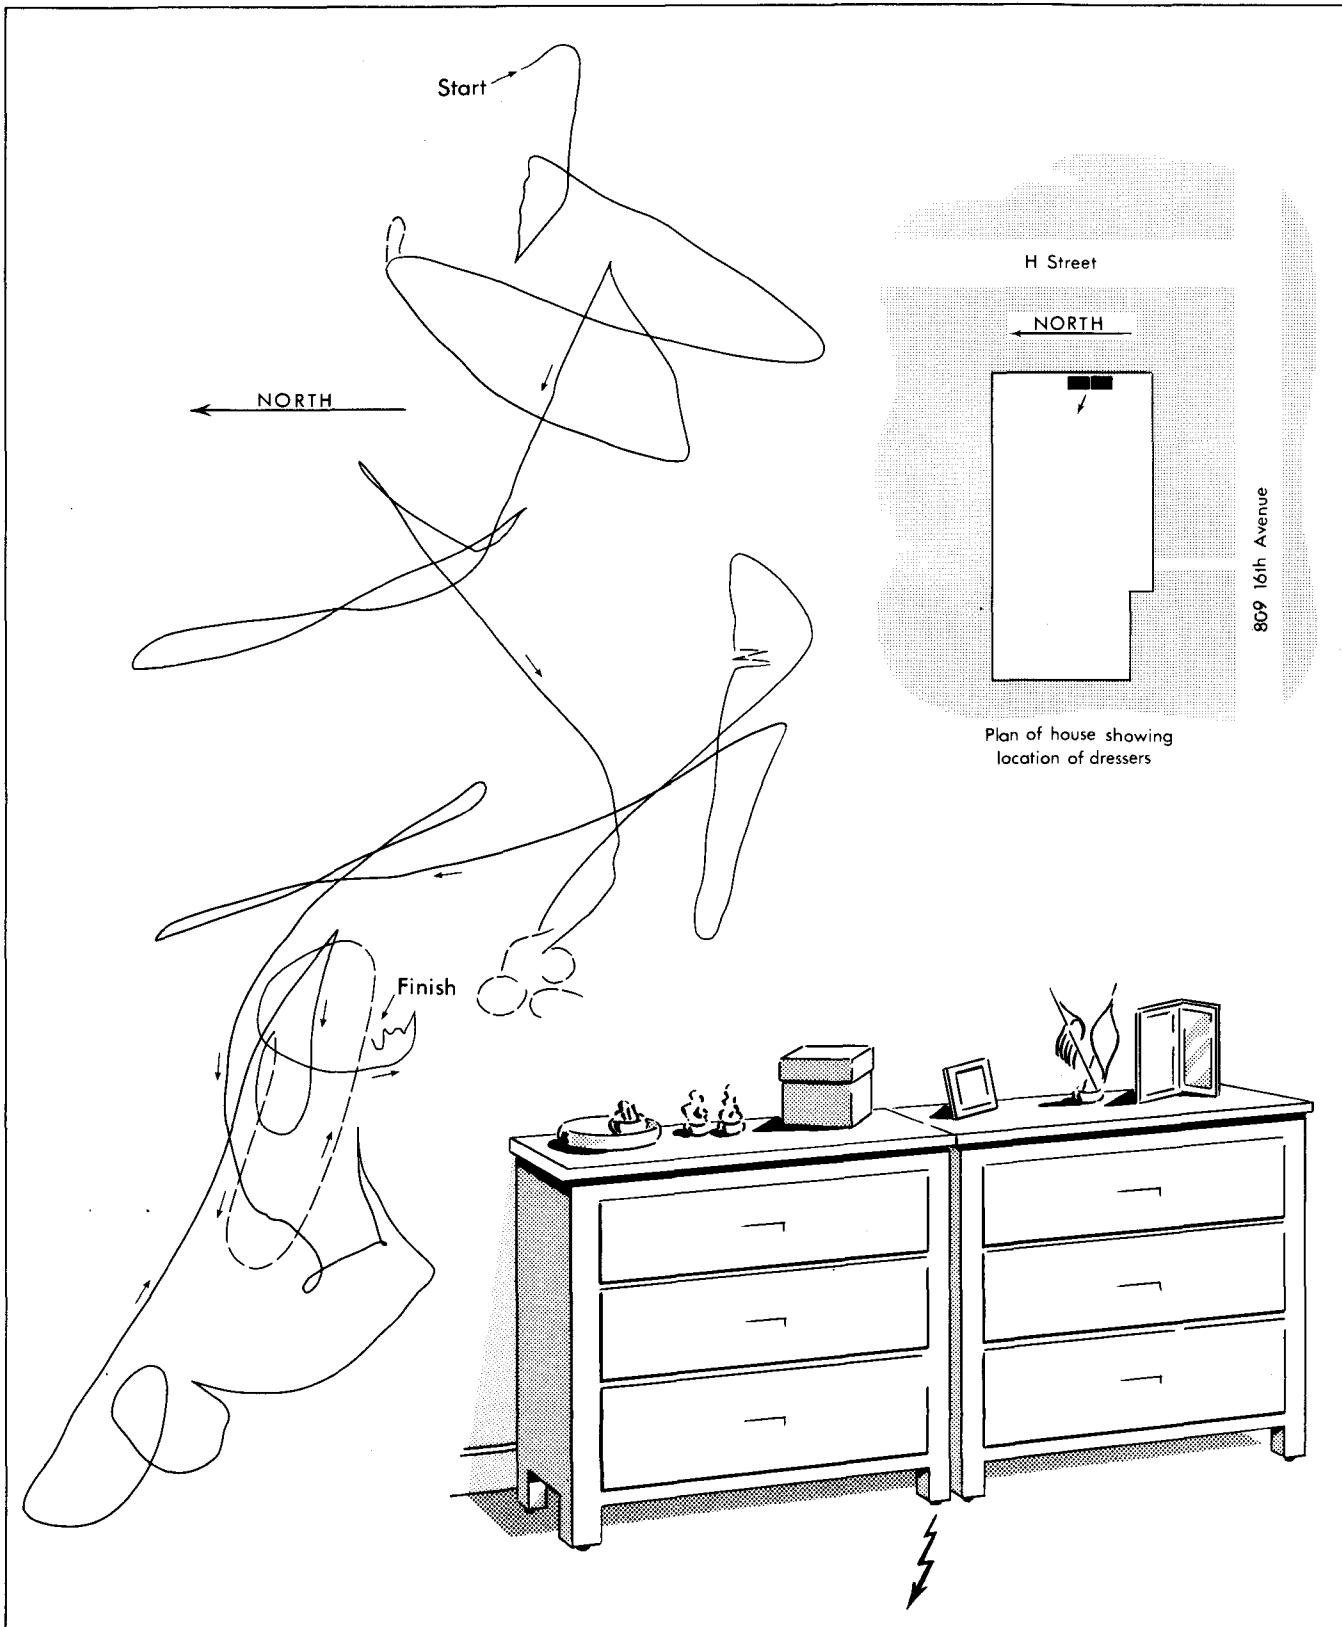
2.—Horizontal trace on asphalt tile flooring left by dresser leg during earthquake. Net movement of dresser was about N. 75° W. Other legs left nearly identical traces. Sundry items on dresser tops were little disturbed. Trace reproduced by Oliver V. Kola, published by permission of Dr. M. A. Sozen. Scale of trace,  $\times \frac{1}{2}$ .

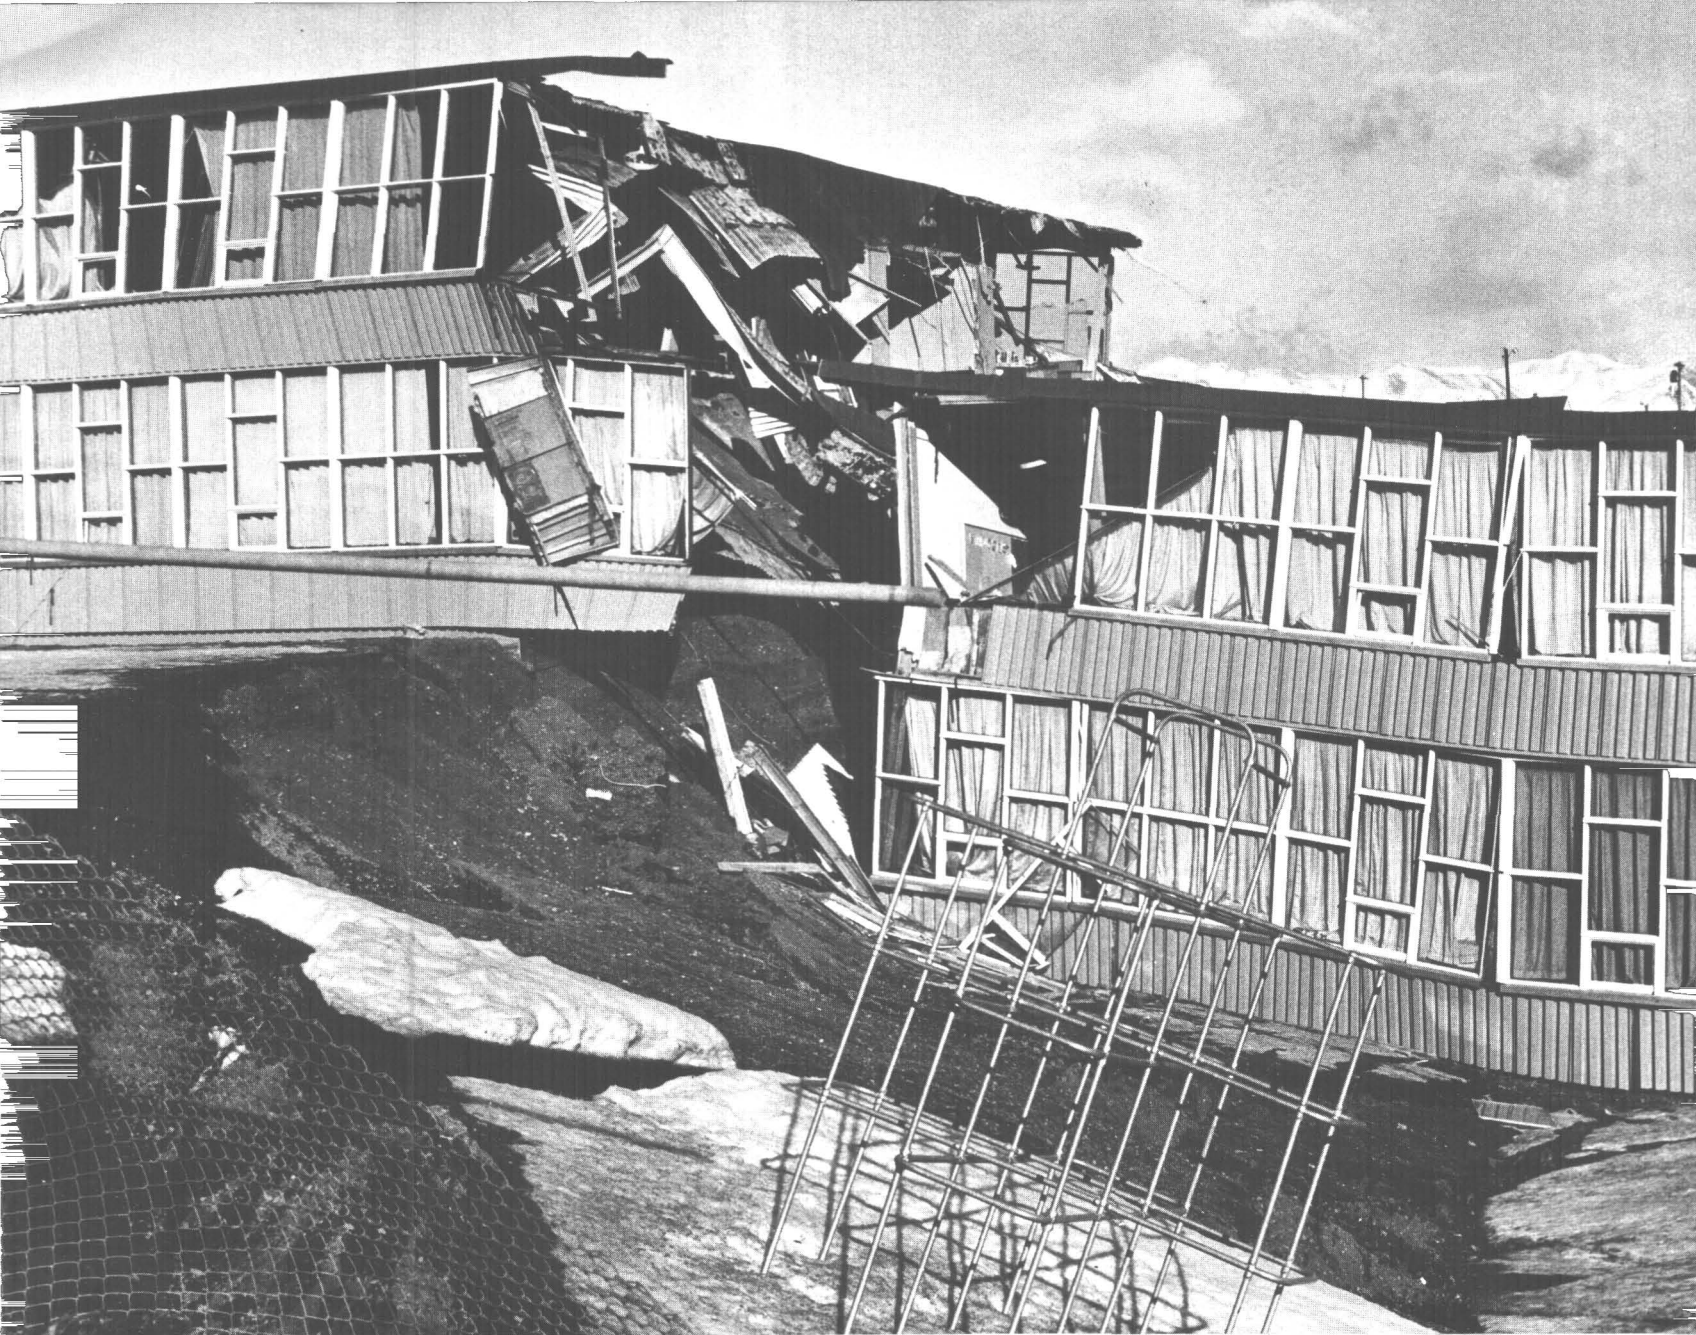
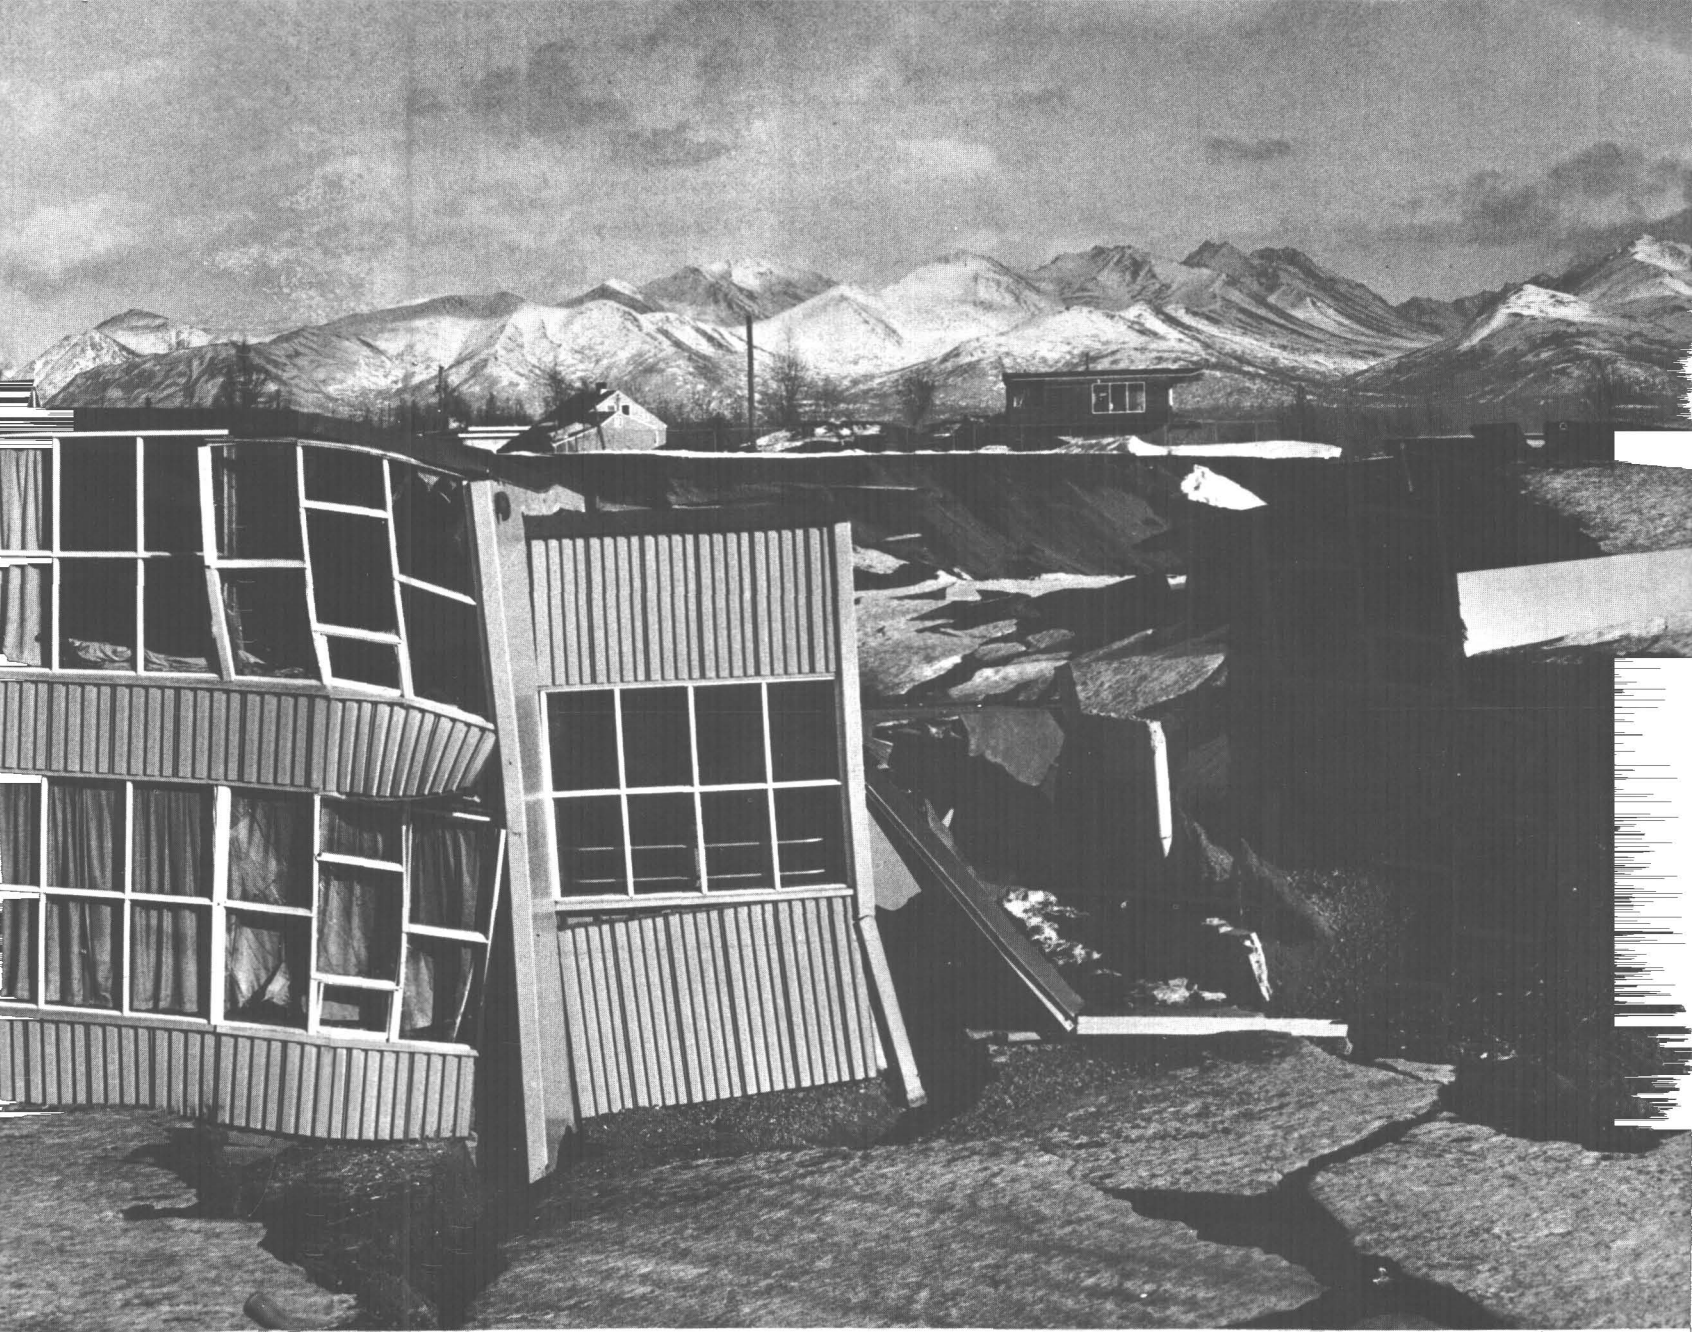
3.—Wreckage of Government Hill School. The south wing of the building, shown here, collapsed into a graben at the

head of the slide. Net slip of the graben block is shown by the displacement of the roofline. Photograph by M. G. Bonilla.

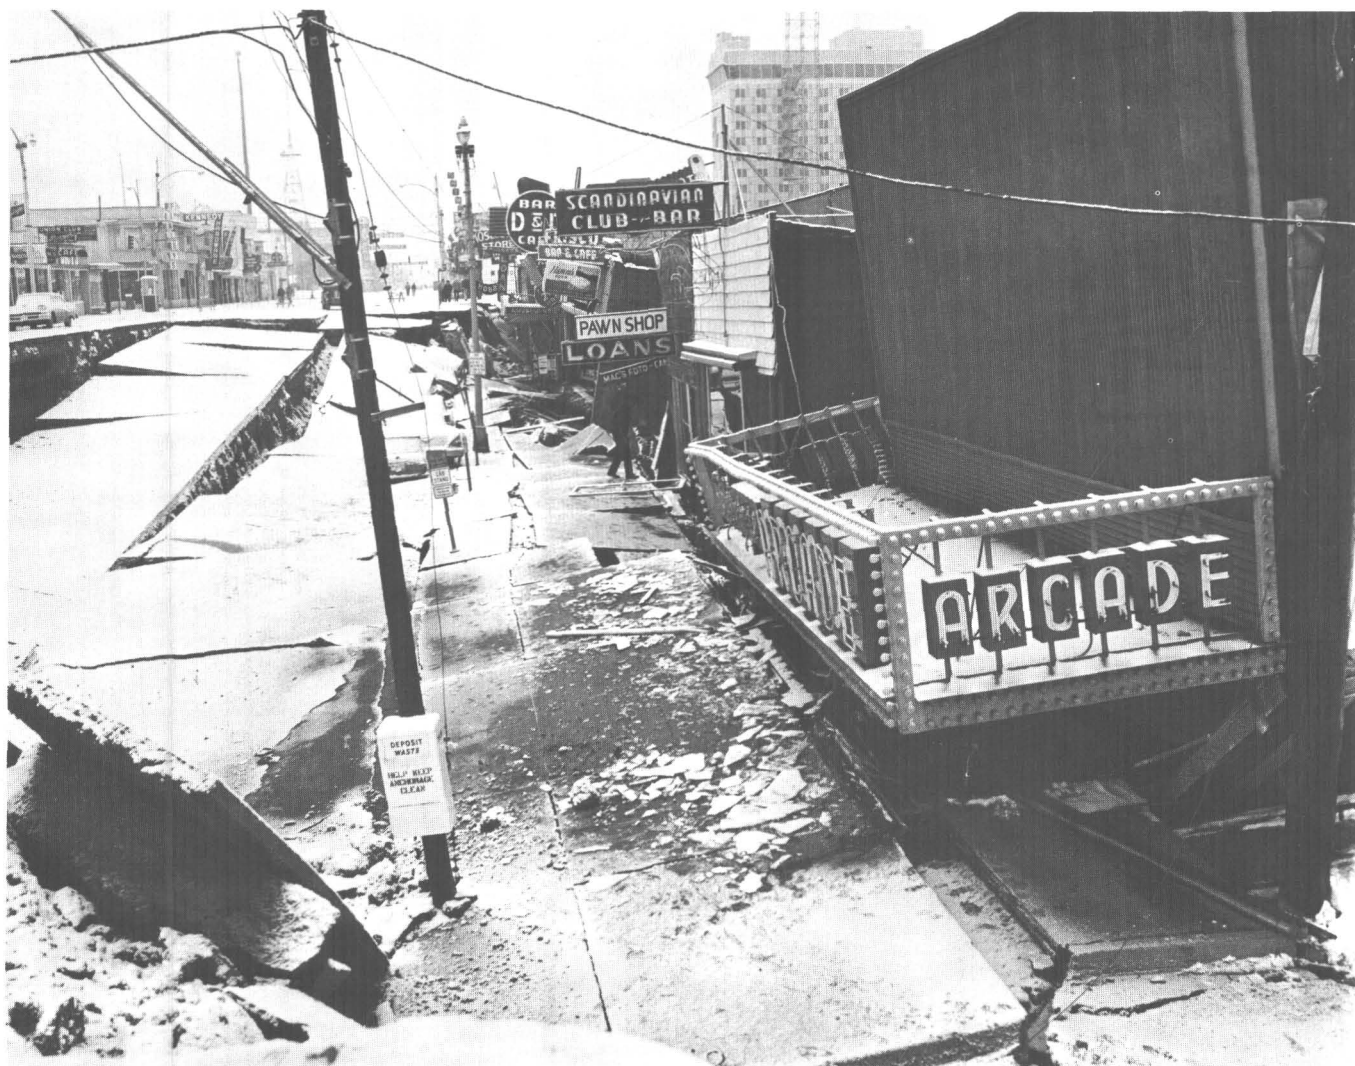
In downtown Anchorage (the L Street and Fourth Avenue landslide areas), about 30 blocks of dwellings and commercial buildings were destroyed or severely damaged (fig. 4). A new six-story apartment building, the Four Seasons, was razed. A new five-story department store (J. C. Penney Co.) was damaged beyond repair by seismic shaking and had to be torn down (fig. 5). Many automobiles in the downtown area were struck by falling debris. Twin 14-story apartment buildings, though a mile apart, sustained massive, nearly identical vibratory damage, much of it in response to vertical shearing forces caused by oscillation. Many other multistory or large-area buildings were severely damaged.

4.—View west along Fourth Avenue at head of landslide. North (right) side of street has collapsed into a graben. Vertical displacement is about 10 feet. Photograph by Mac's Foto, Anchorage, Alaska.

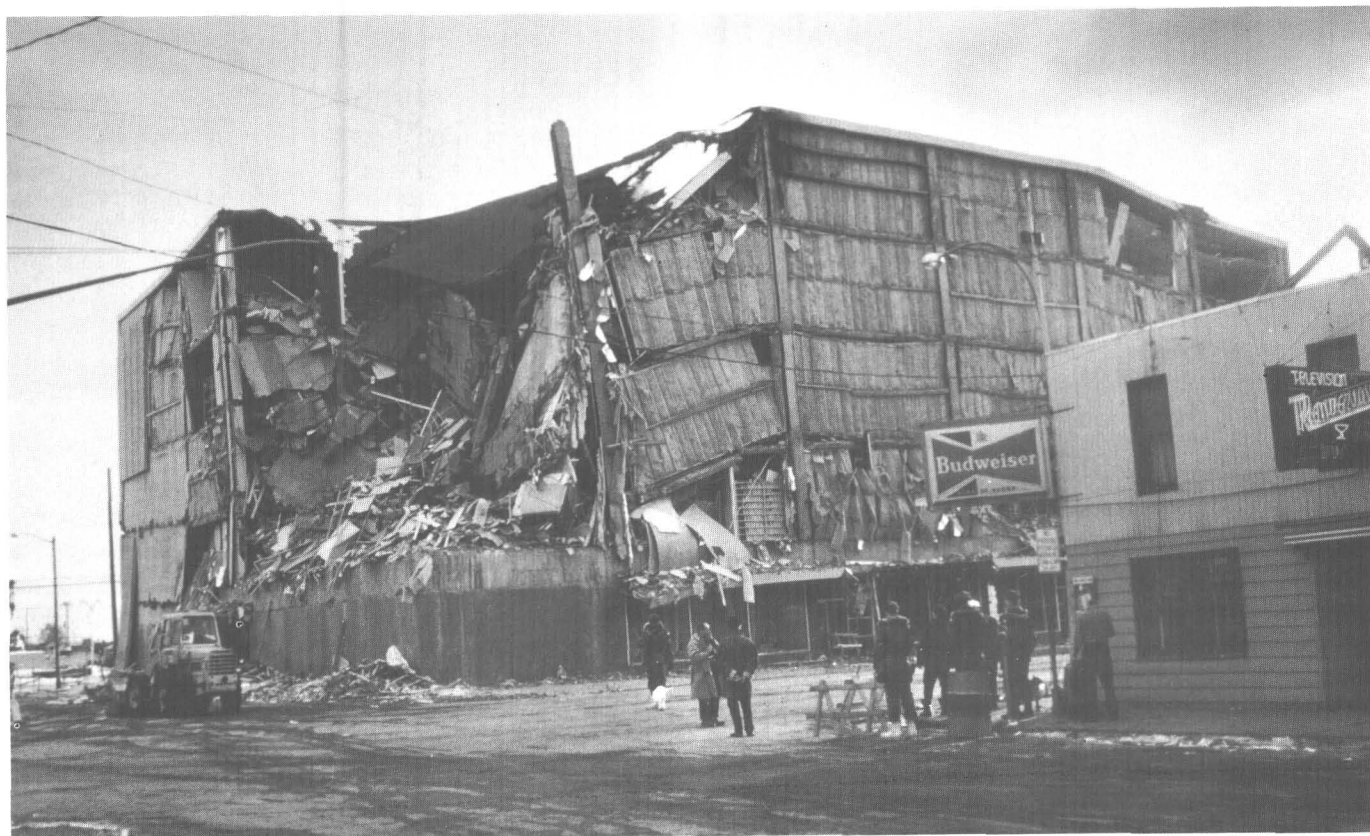
5.—Wreckage of Penney's department store, Fifth Avenue and D Street, Anchorage. Building failed after sustained seismic shaking. Most of rubble has been cleared from streets. Photograph by George Plafker.

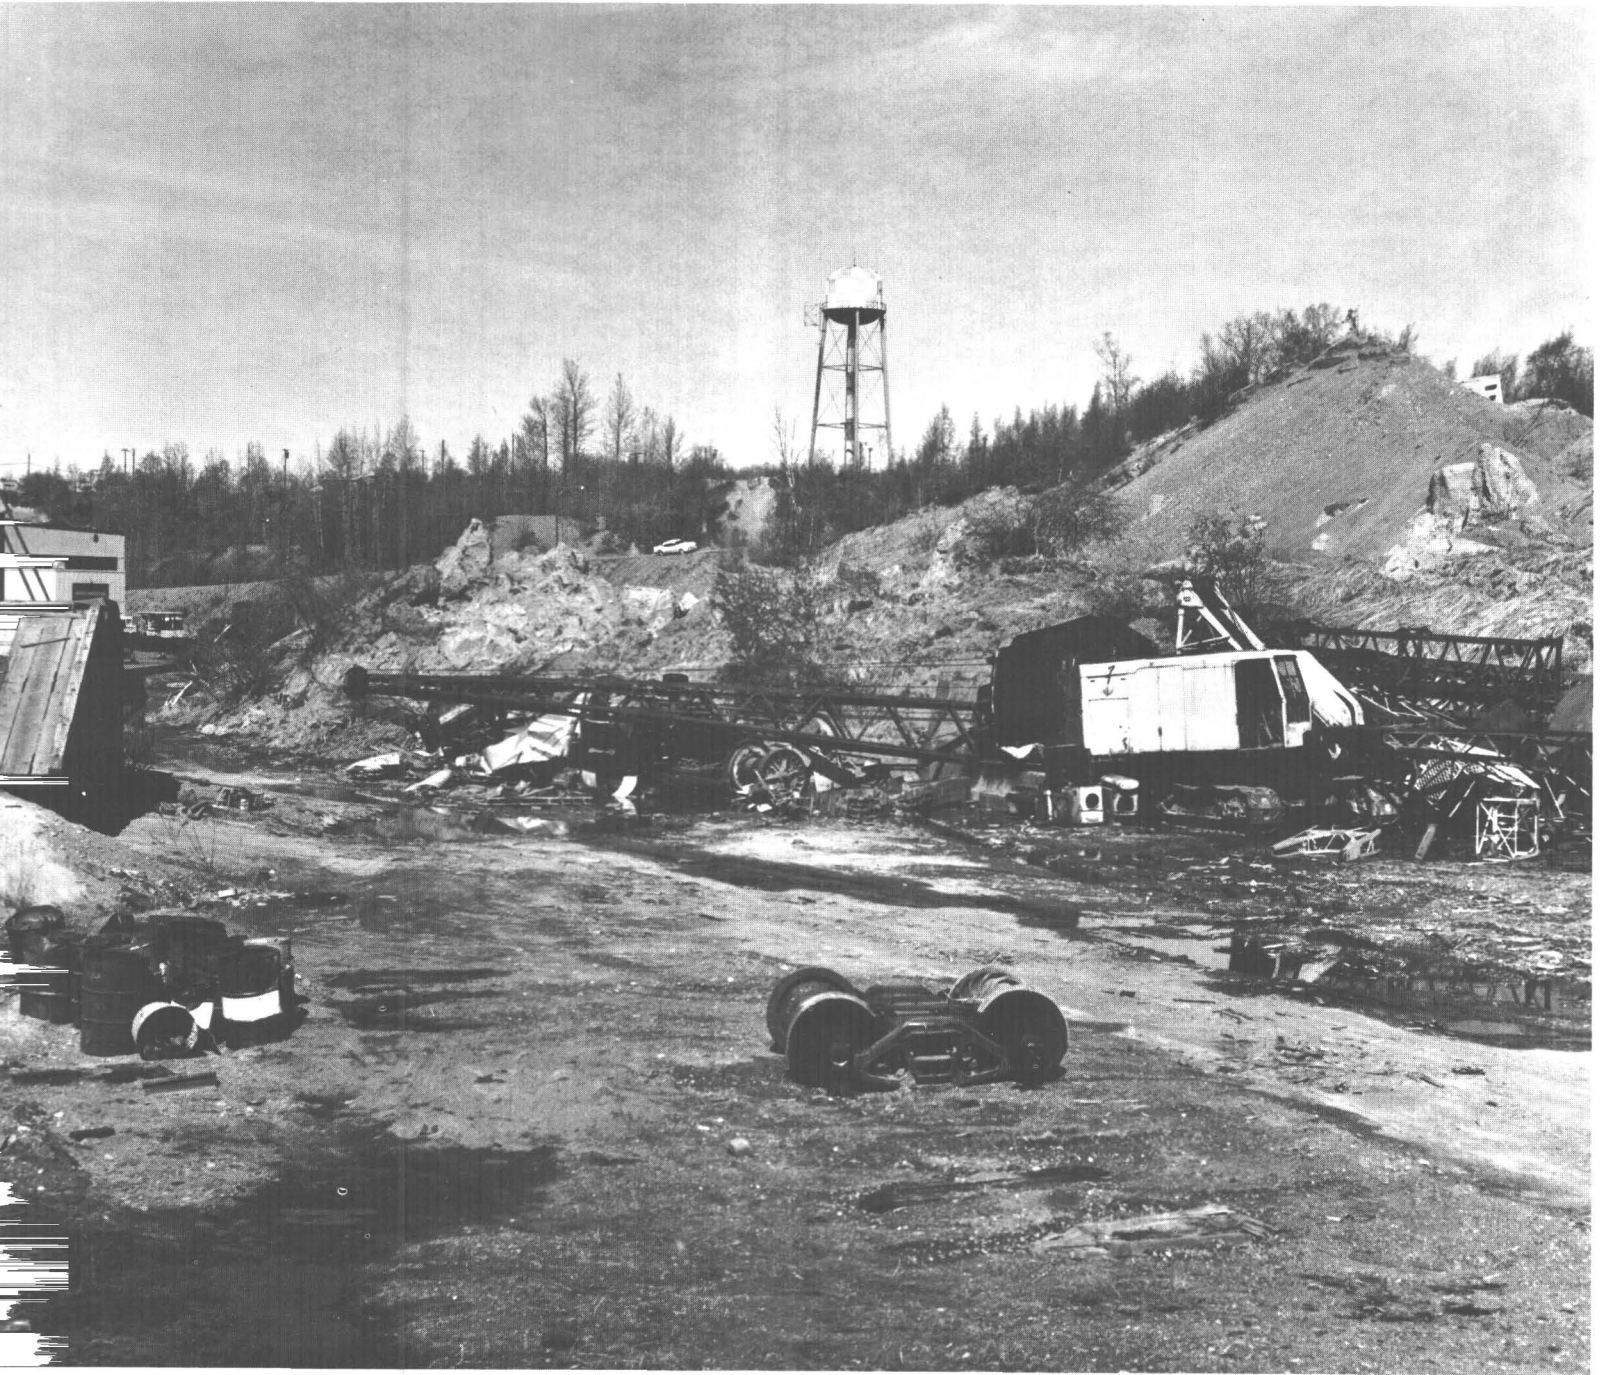
6.—Damage to yards of The Alaska Railroad, looking northwest, caused by earthflow at toe of Government Hill slide. Note undamaged water tank in background.

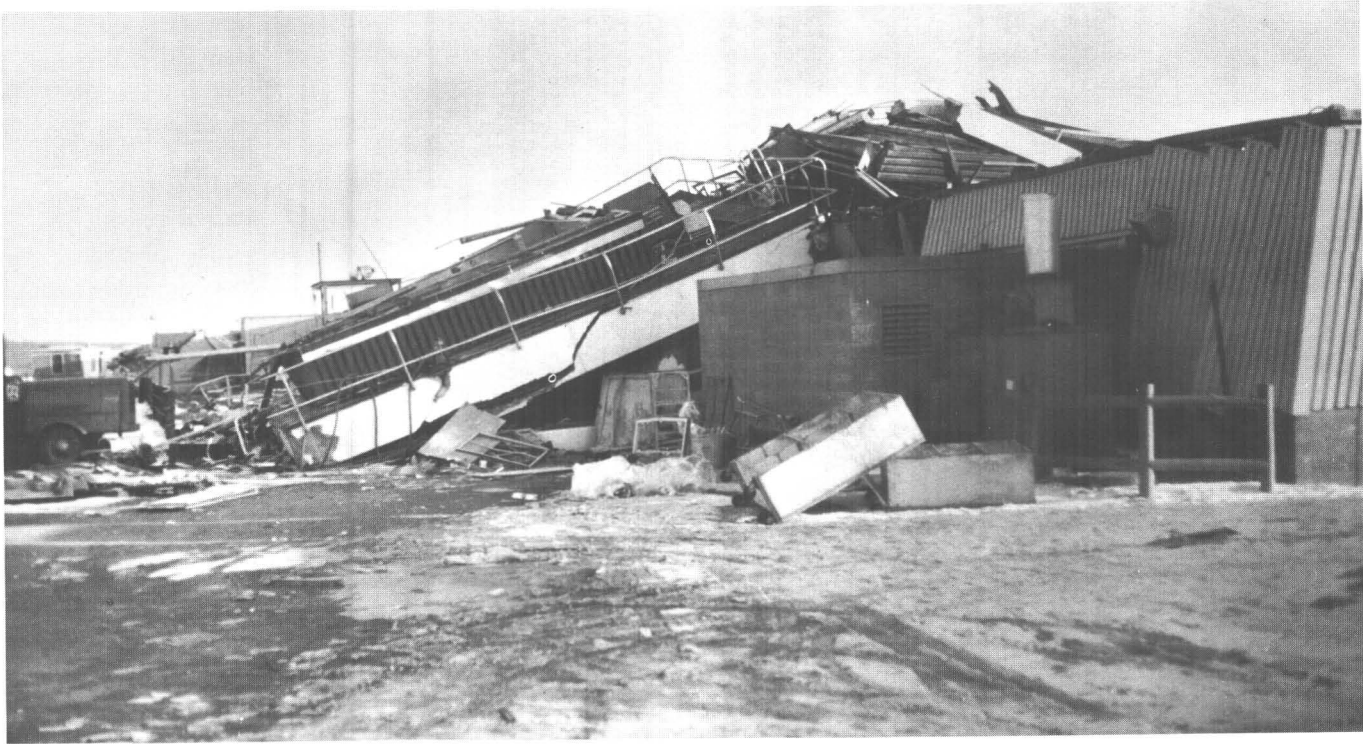
At the Anchorage International Airport, the control tower failed under seismic vibration and collapsed to the ground (fig. 7), killing one occupant and injuring another. The airport terminal building, although tied structurally to the tower, was only slightly

7.—Wreckage of control tower at Anchorage International Airport. Six-story tower failed under sustained seismic shaking. Photograph by George Plafker.

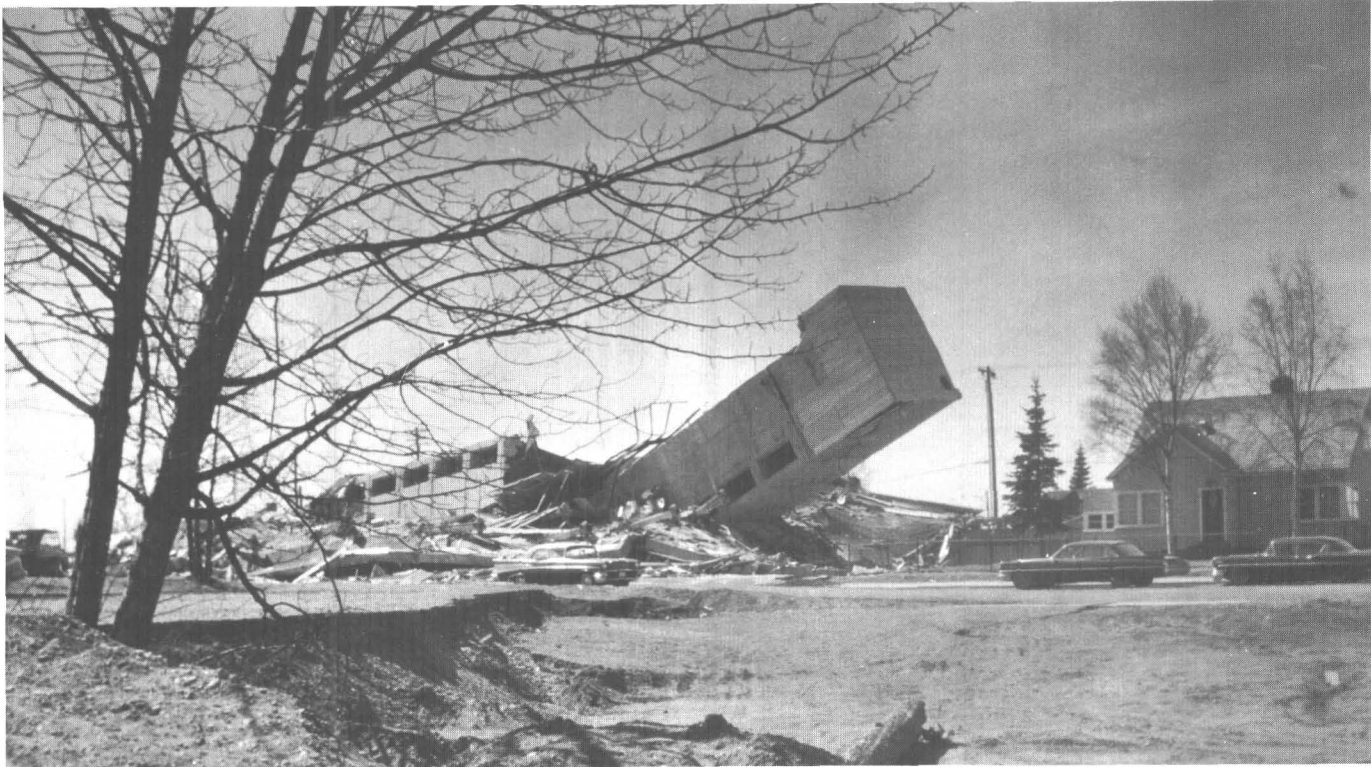
The effects of seismic vibration in areas of cracked ground cannot always be separated from the effects of ground displacement. The collapse of the Four Seasons Apartment Building (fig. 13), a case in point, has been attributed to seismic vibration. Perhaps vibration was the dominant factor in the building's failure. The building, however, was close to the L Street graben at West Ninth Avenue and M Street, and a large subsidiary fracture, trending about west-northwest, passed directly under the building. In the chaotic pile of rubble left after the

13.—Wreckage of six-story Four Seasons Apartment Building, Anchorage, Alaska. Canted elevator shaft at center. Large crack in foreground, filled in on M Street to restore traffic, passed beneath building.

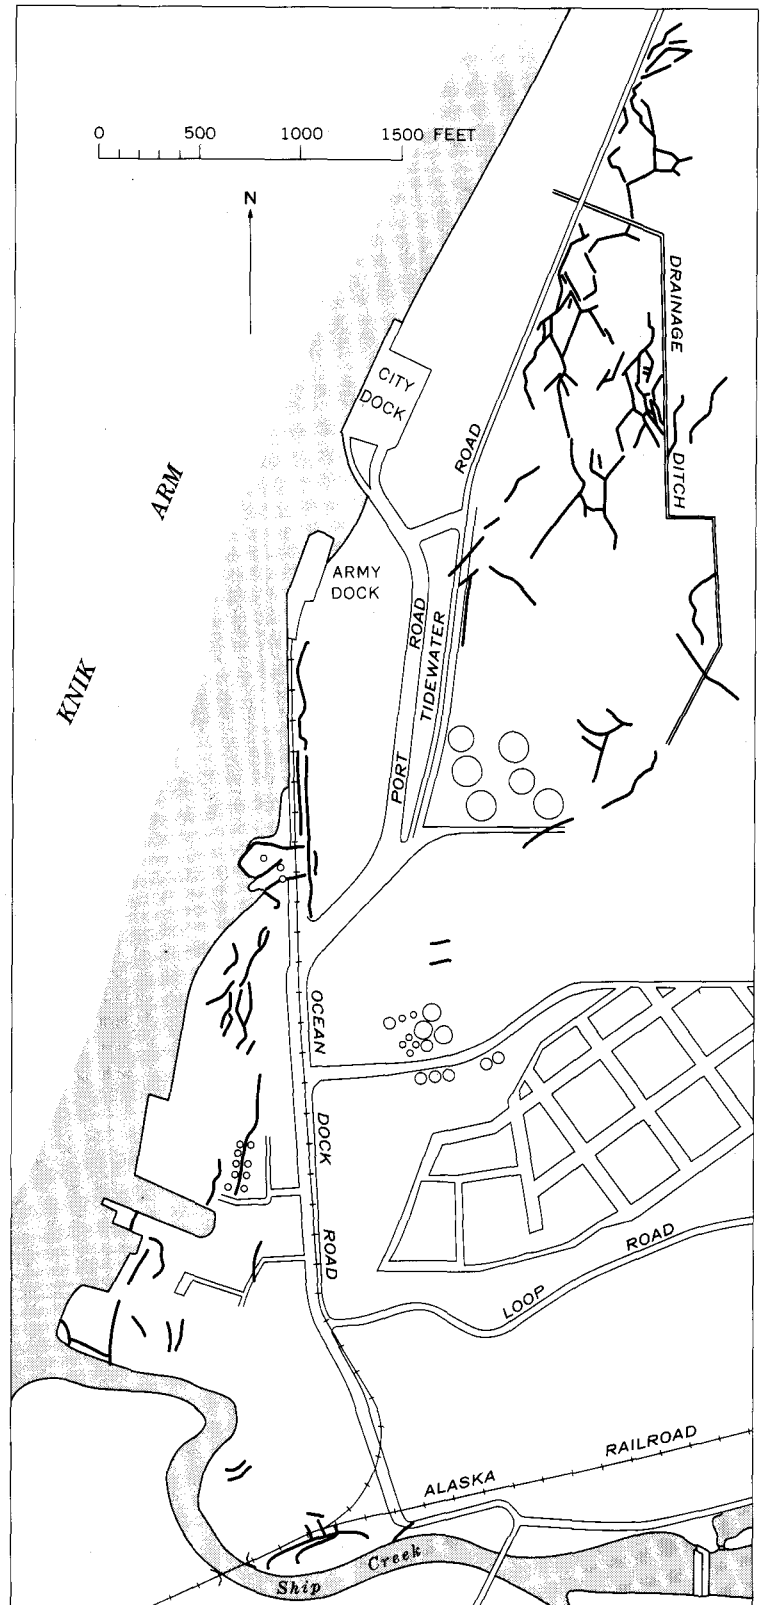
14.—Ground cracks, Port of Anchorage and vicinity. Anchorage, Alaska. Many of these cracks spouted mud, particularly those east of City Dock. Base by city of Anchorage, Office of City Engineer.

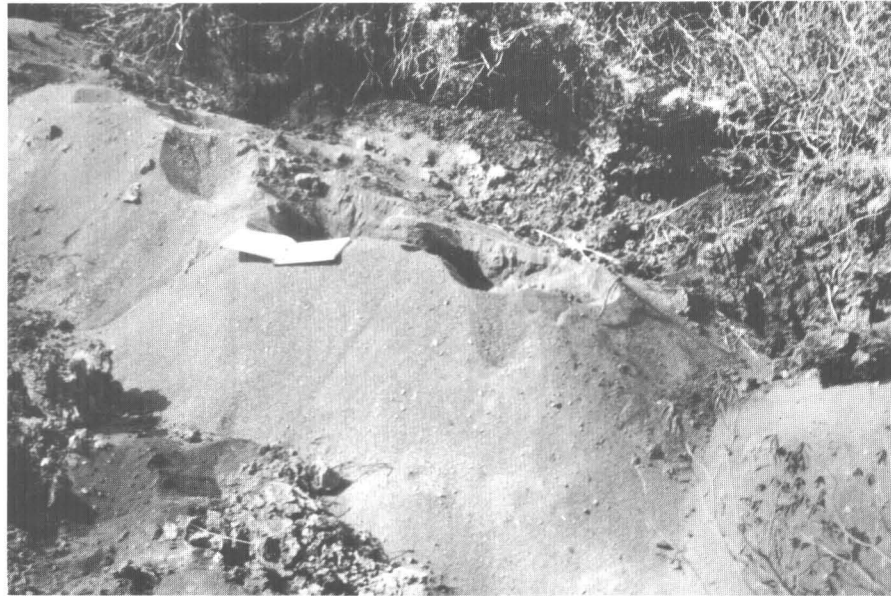
15.—Part of a sand boil, Turnagain Heights slide area. Ridges 2 to 3 feet high and 100 feet long or more were formed as fountains of water were ejected through frozen outwash.

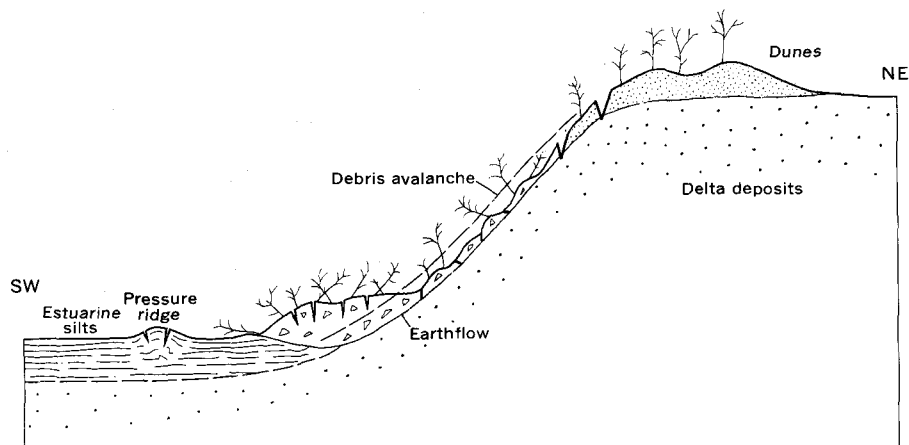
16.—Diagrammatic section near Point Campbell, showing mode of failure along bluff line overlooking Turnagain Arm.

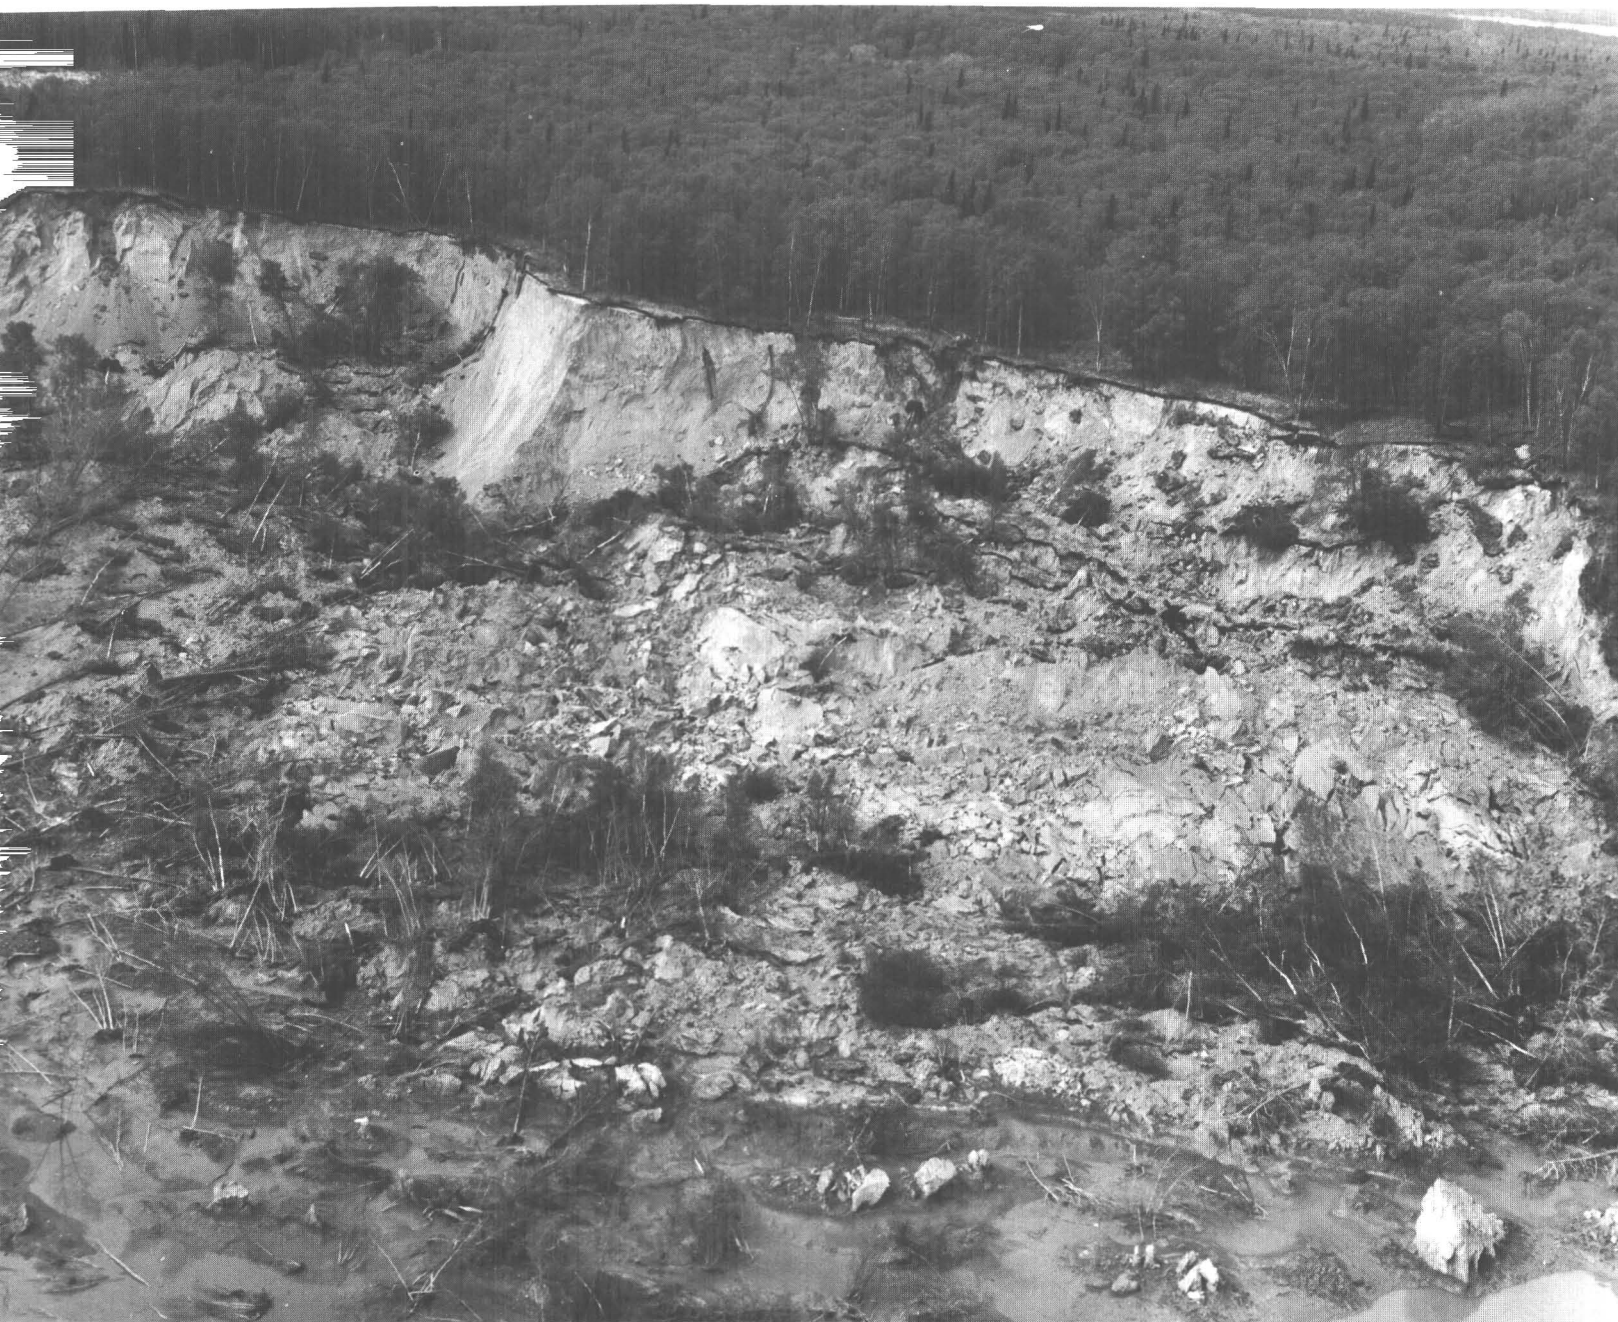
19.—Rotational slump near Sleeper landing strip, on the west side of Knik Arm opposite Cairn Point. At its foot, the slump passed into an earthflow. Tidewater in foreground. Scarp to left of upper center is about 80 feet high.

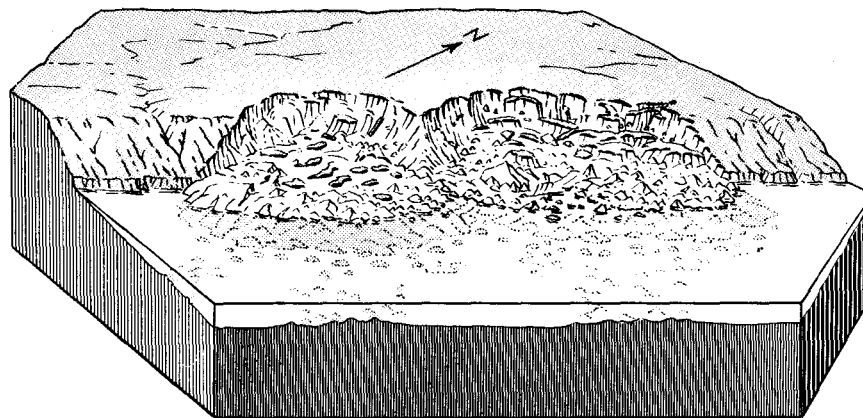
20.—Block diagram of compound slump near Sleeper landing strip. Two lobes of slide surged out onto mudflat below high tide.

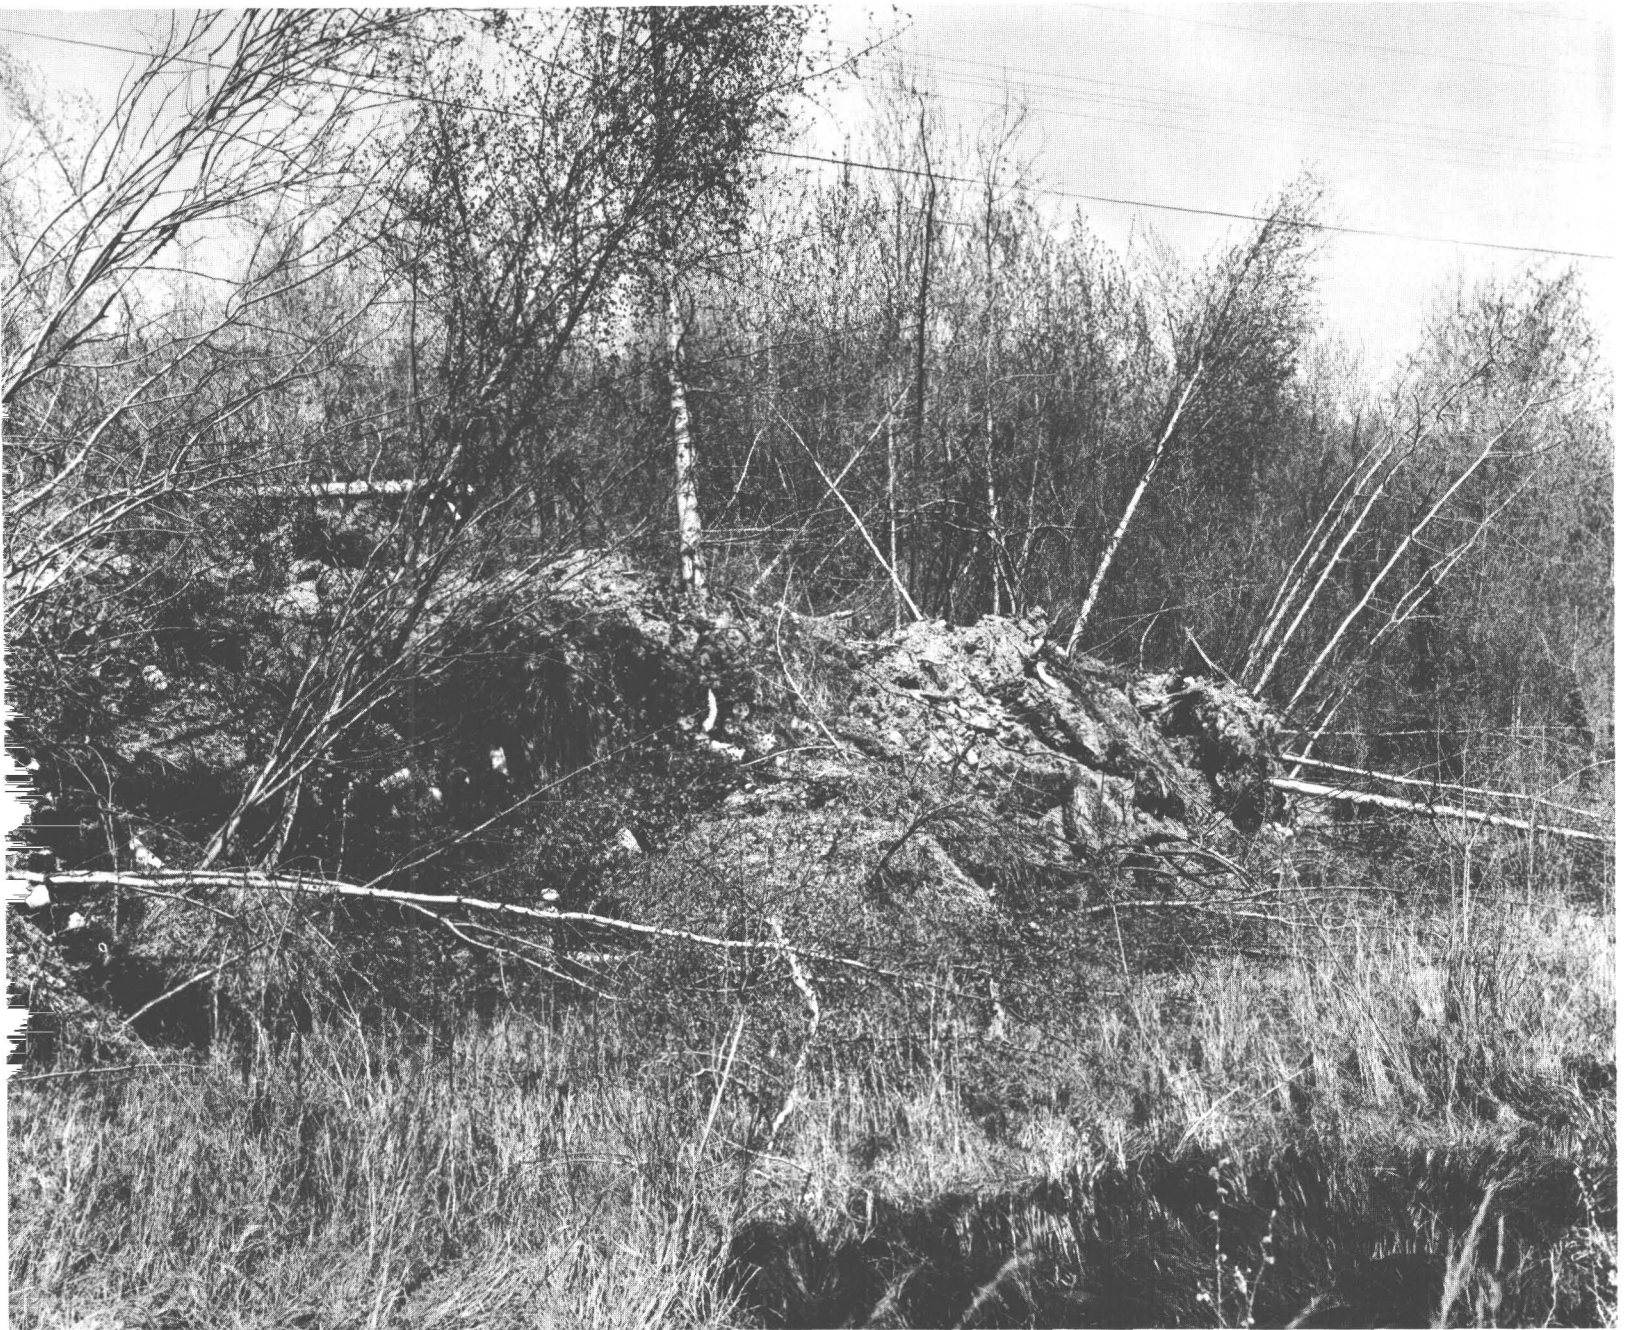
21.—Chaotic pressure ridge at toe of rotational slide, Bluff Road.. In part, toe surged forward as an earthflow. Compare with figure 22.

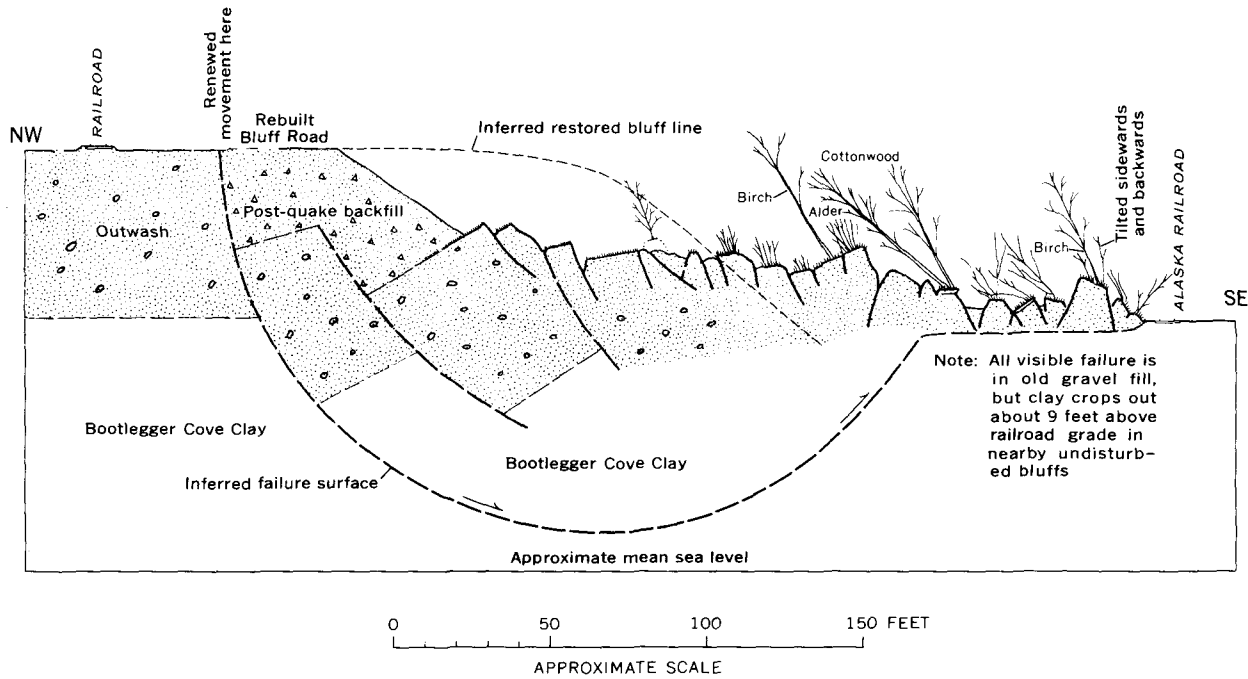
22.—Sketch section through rotational slide at Bluff Road.
