THE ALASKA EARTHQUAKE, MARCH 27, 1964—  
EFFECTS ON COMMUNITIES

# Effects of the Earthquake Of March 27, 1964 At Anchorage, Alaska

*A description and analysis of the damage resulting from seismic vibration, ground cracks, and especially landslides in Alaska's largest city*

GEOLOGICAL SURVEY PROFESSIONAL PAPER 542-A

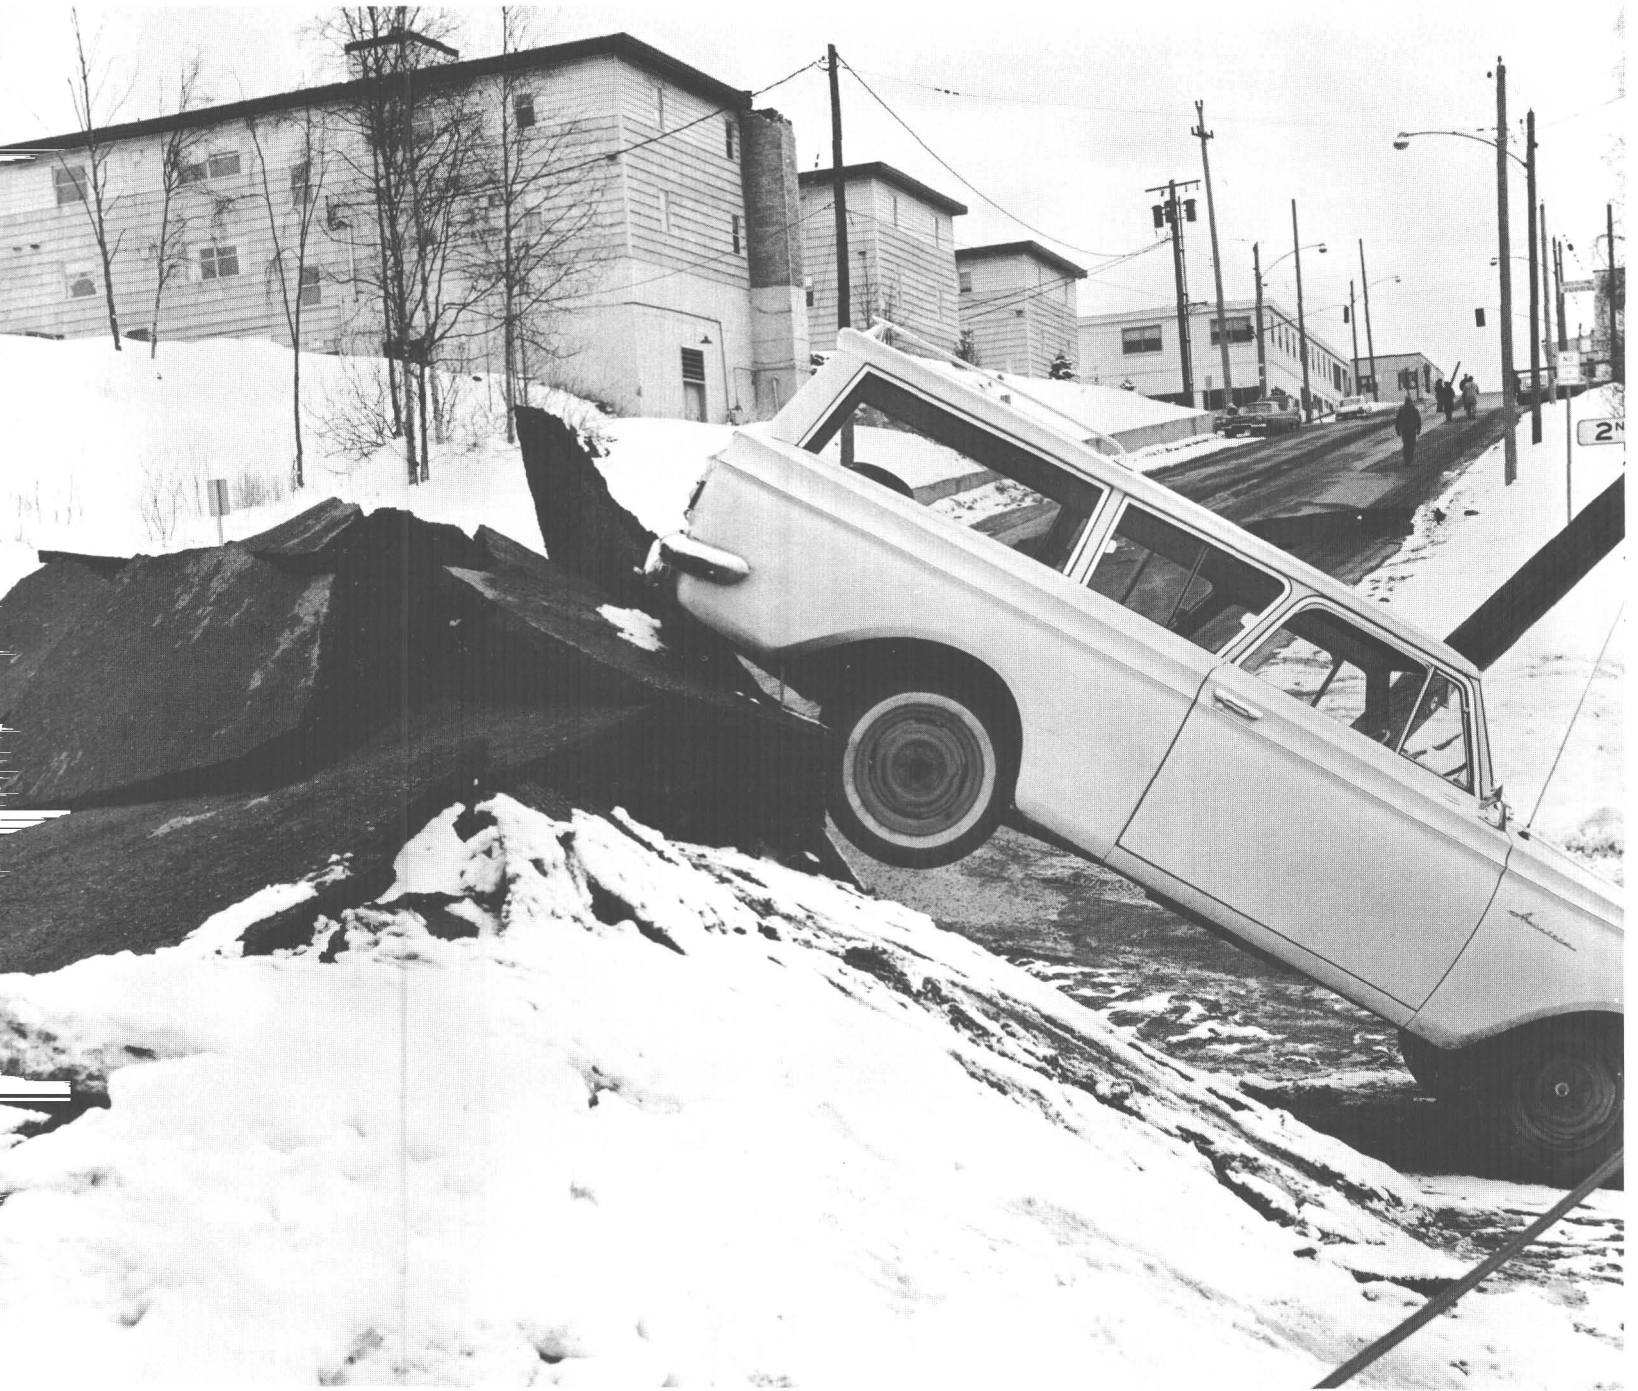
26.—Sharp-crested pressure ridge at Second Avenue and C Street, Anchorage. Probably caused by shallow translation of frozen surface layer. Note smaller pressure ridge in street part way up block and toppled chimney of building behind car. Photograph by Mac's Foto, Anchorage.

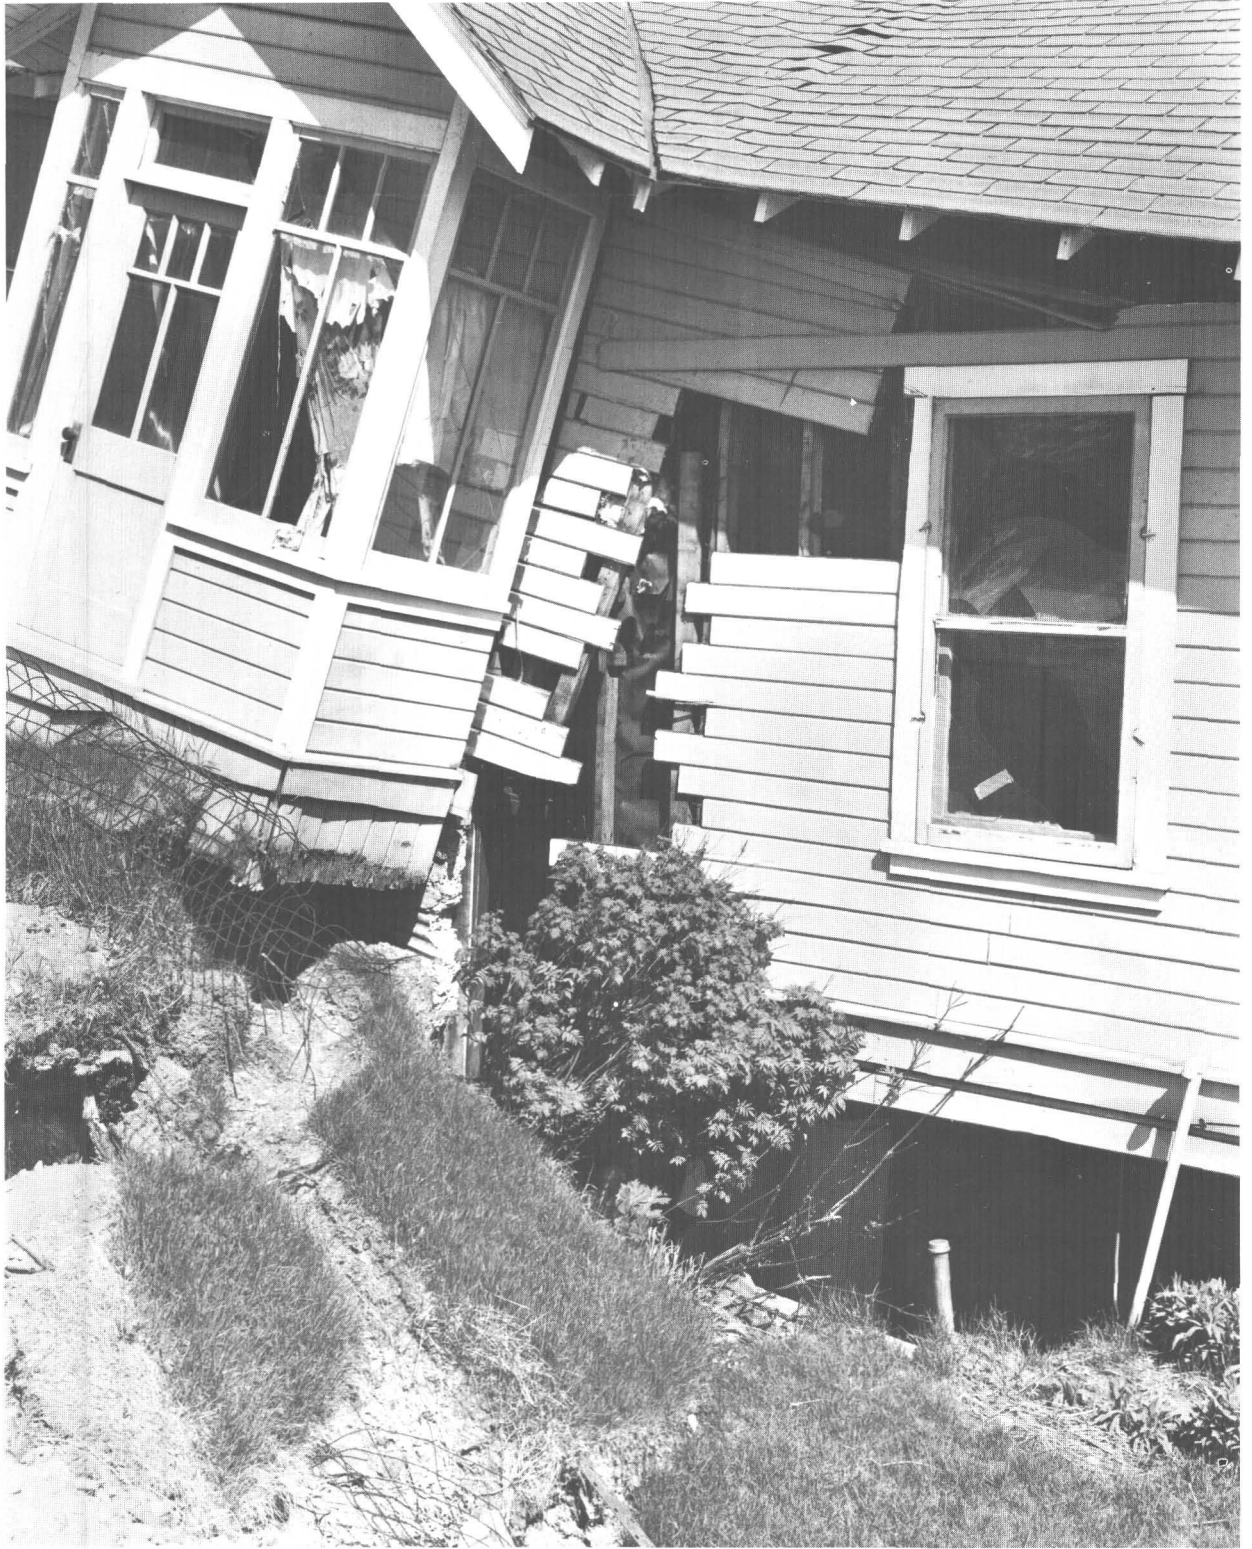
28.—Wrecked dwelling astride bounding fracture, L Street graben at Eighth Avenue and N Street. Damage caused entirely by ground displacement along fracture.

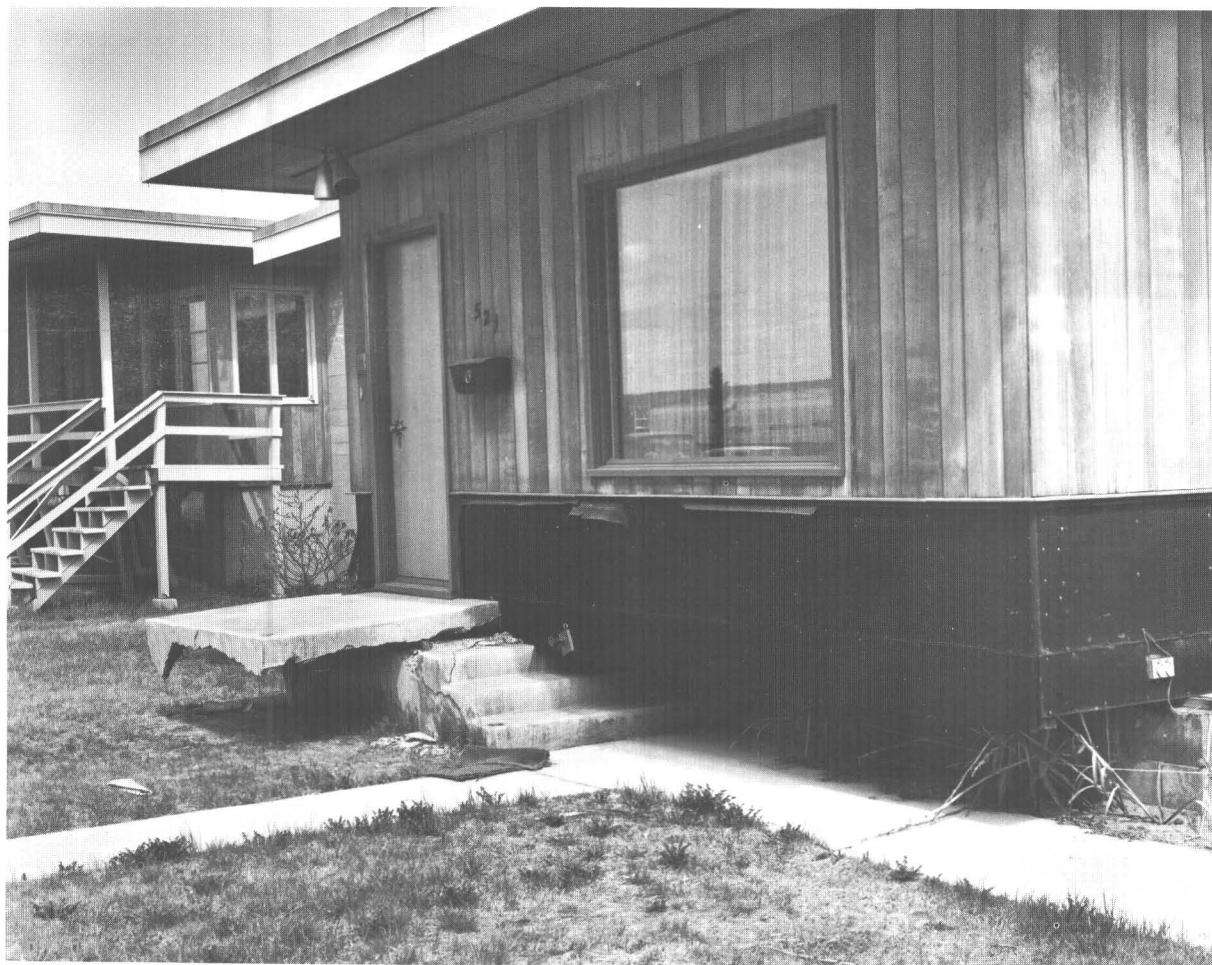
29.—House pushed off foundation by pressure ridge at toe of L Street slide. Well-framed house not otherwise visibly damaged. Push must have been shallow and nearly horizontal.

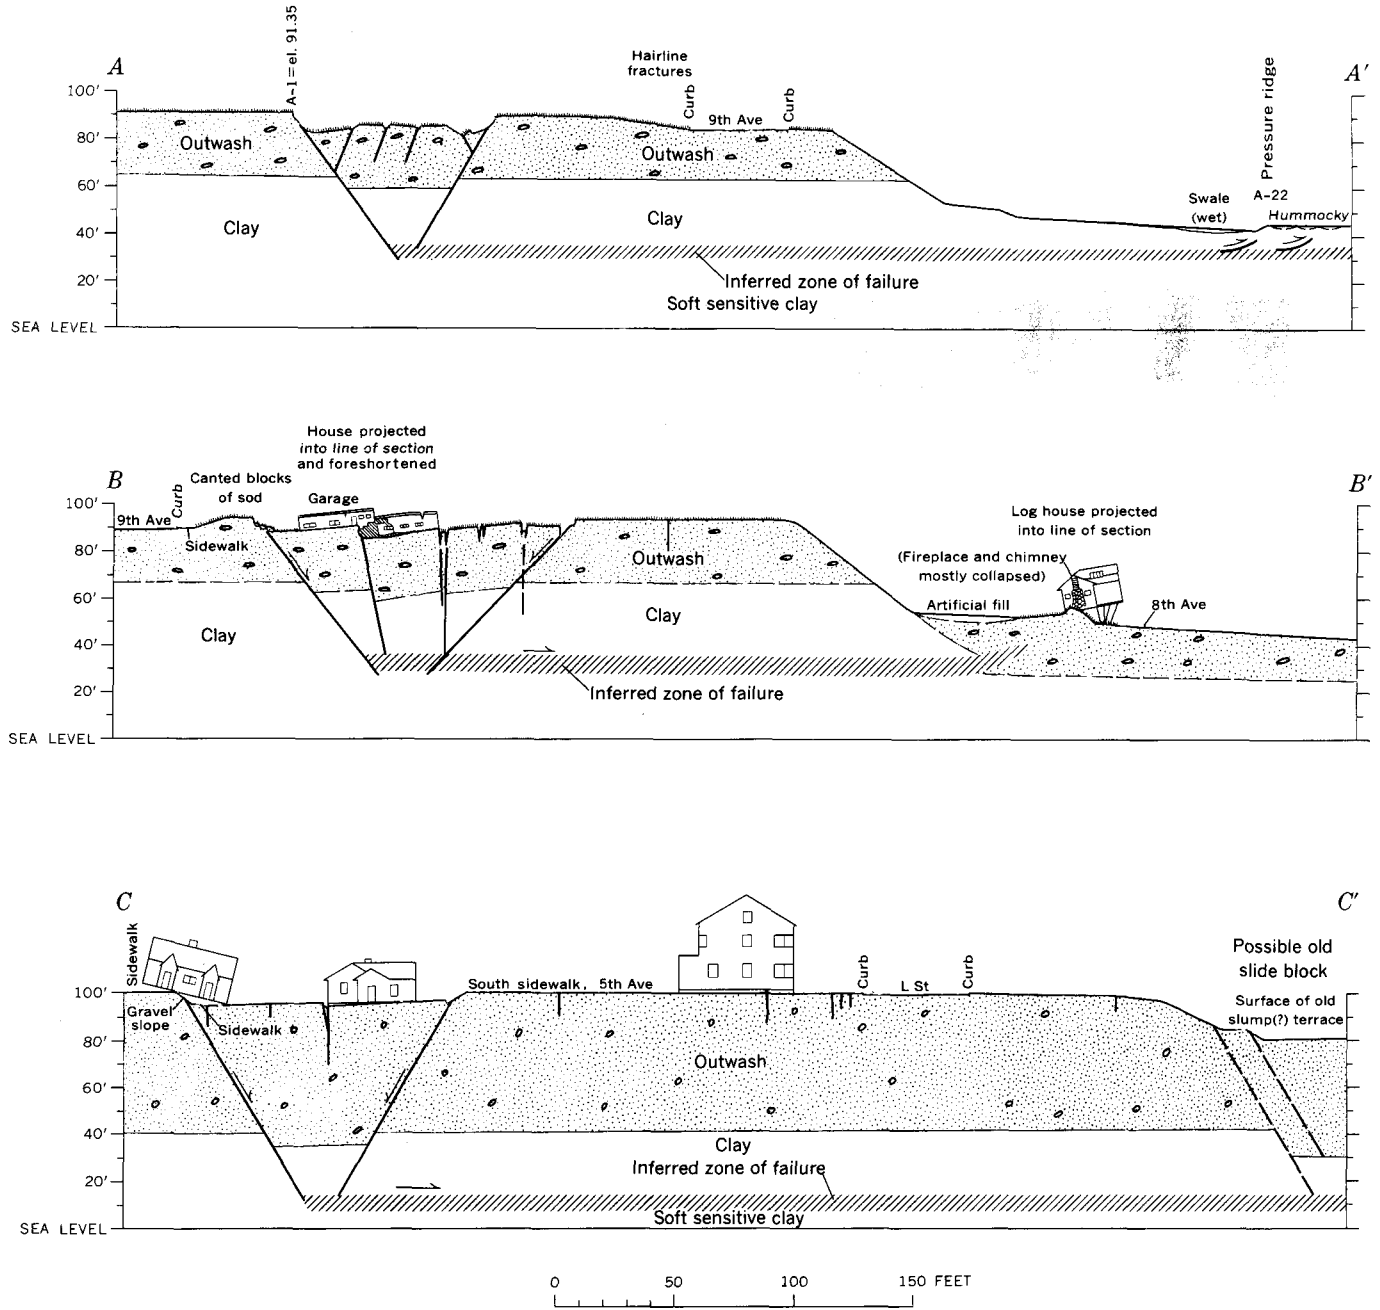
30.—Geologic section through the L Street slide. In section C-C' the toe of the slide is to the right of C'.

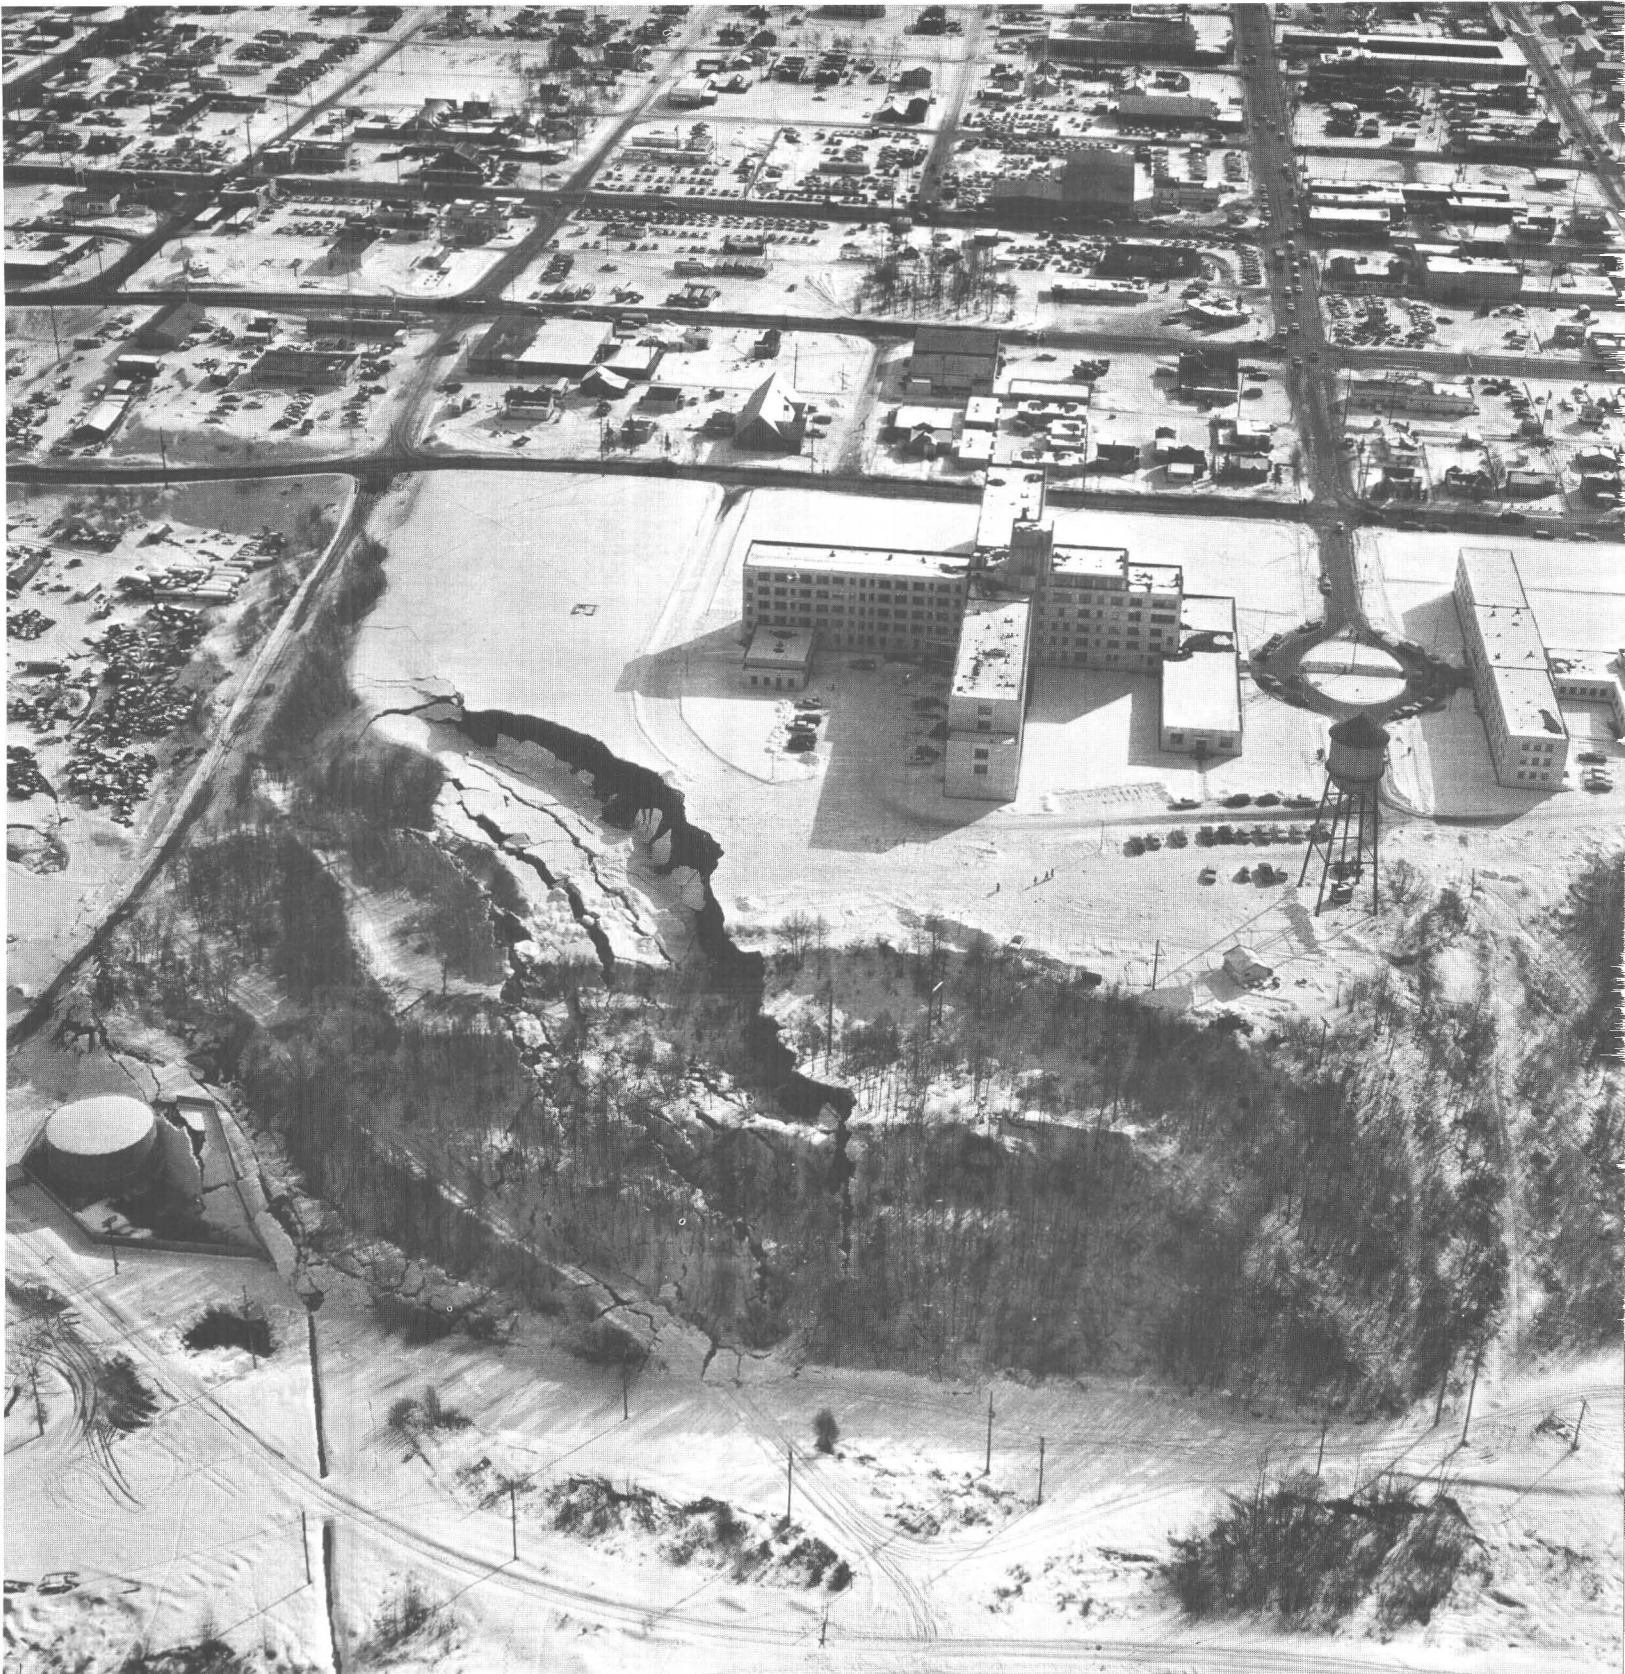
32.—Air view (looking south) of Native Hospital slide showing graben and pressure ridge. The scar of an older landslide is transected by the slide of March 27, 1964. Photograph by U.S. Army.

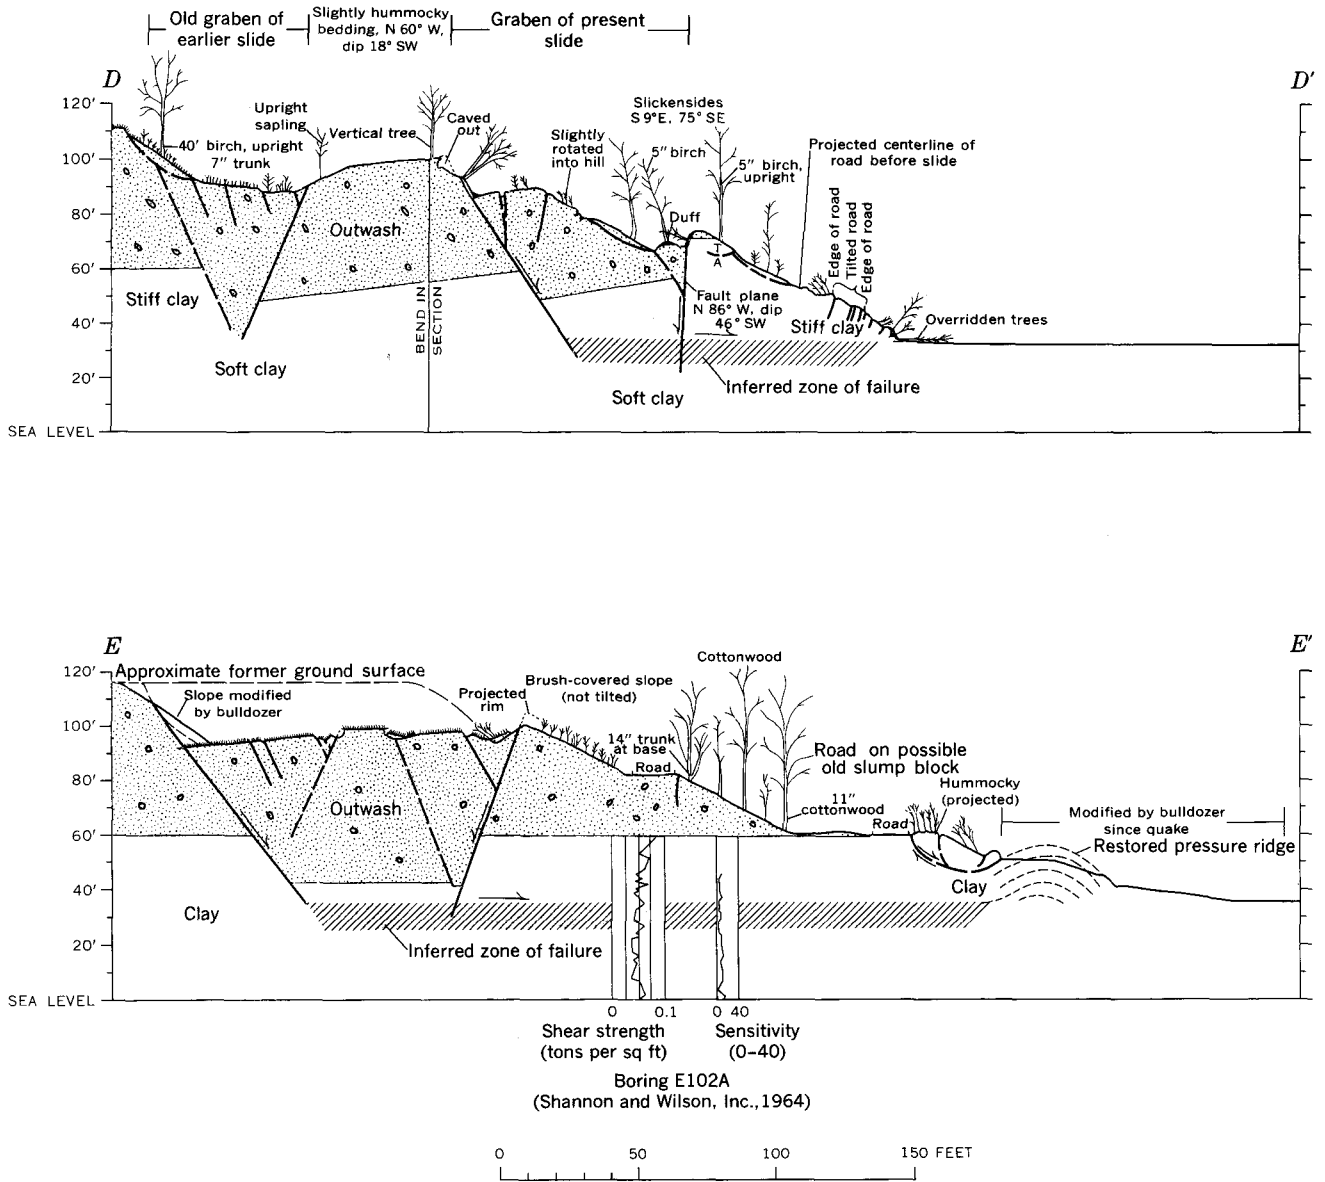
33.—Geologic sections through the Native Hospital slide, Anchorage, Alaska. Section D-D' transects the graben of an earlier landslide (upper left). Boring data from Shannon and Wilson, Inc. (1964).

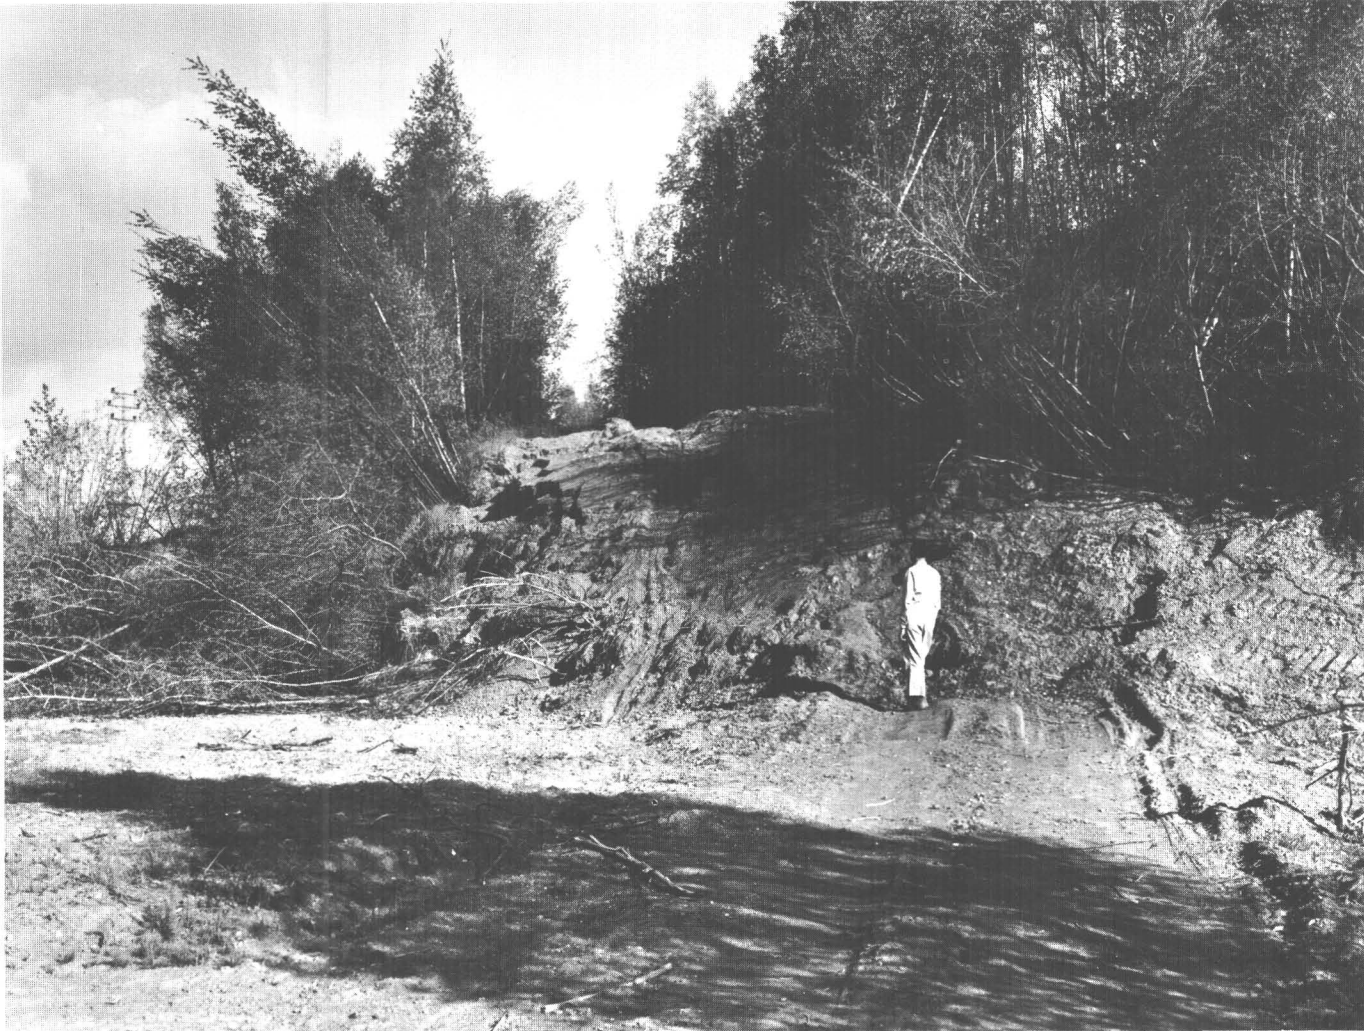
34.—Overthrust toe of Native Hospital slide. Road is bulged up and displaced about 12 feet laterally. Note overridden trees at left.

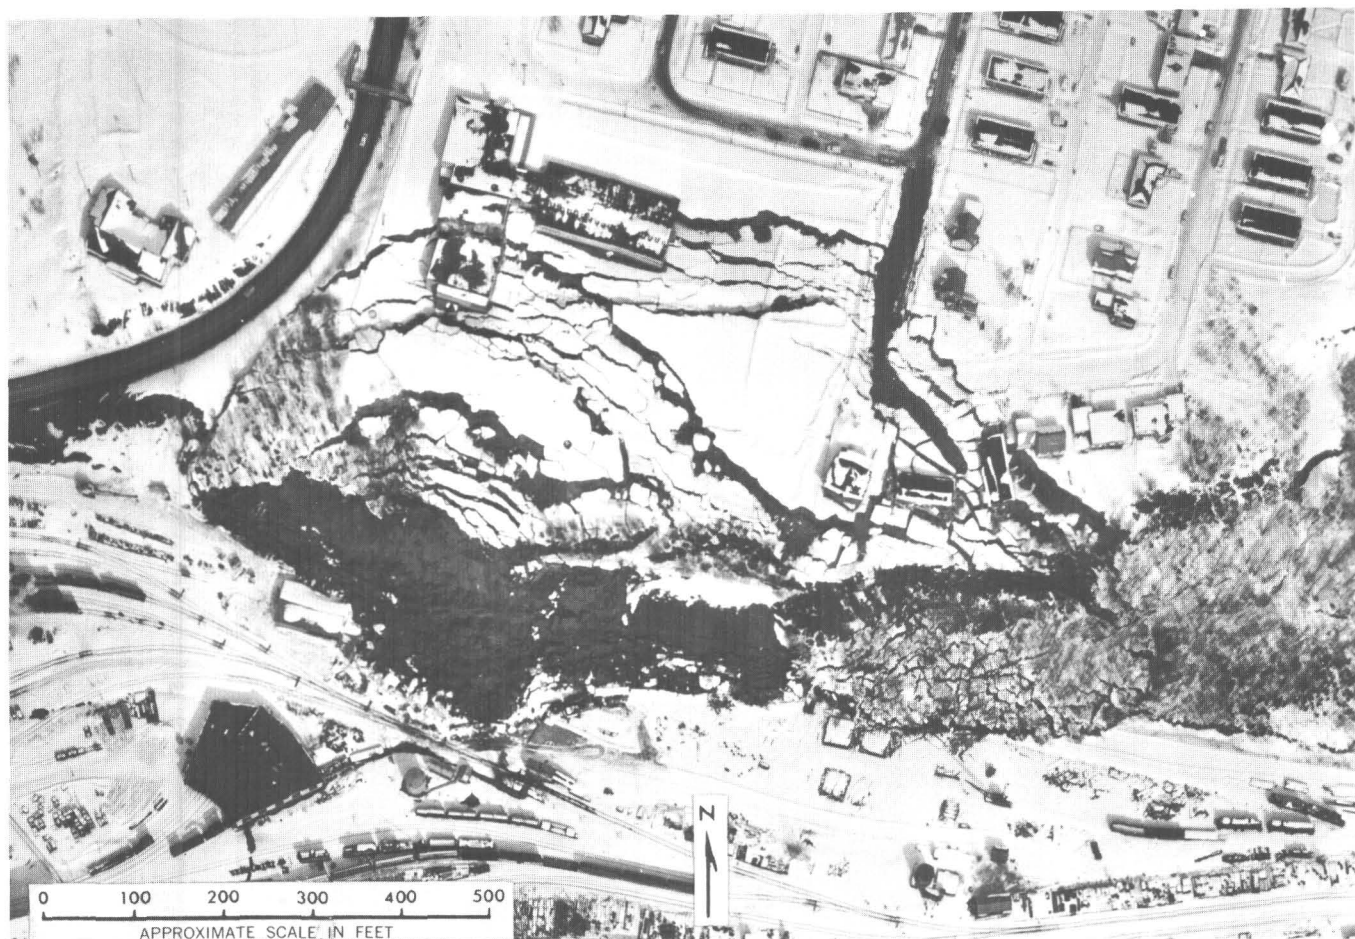
35.—Air view of Government Hill slide, Anchorage, Alaska. Graben plainly discernible. Compare with figure 38. Photograph by Air Photo Tech, Anchorage, Alaska.

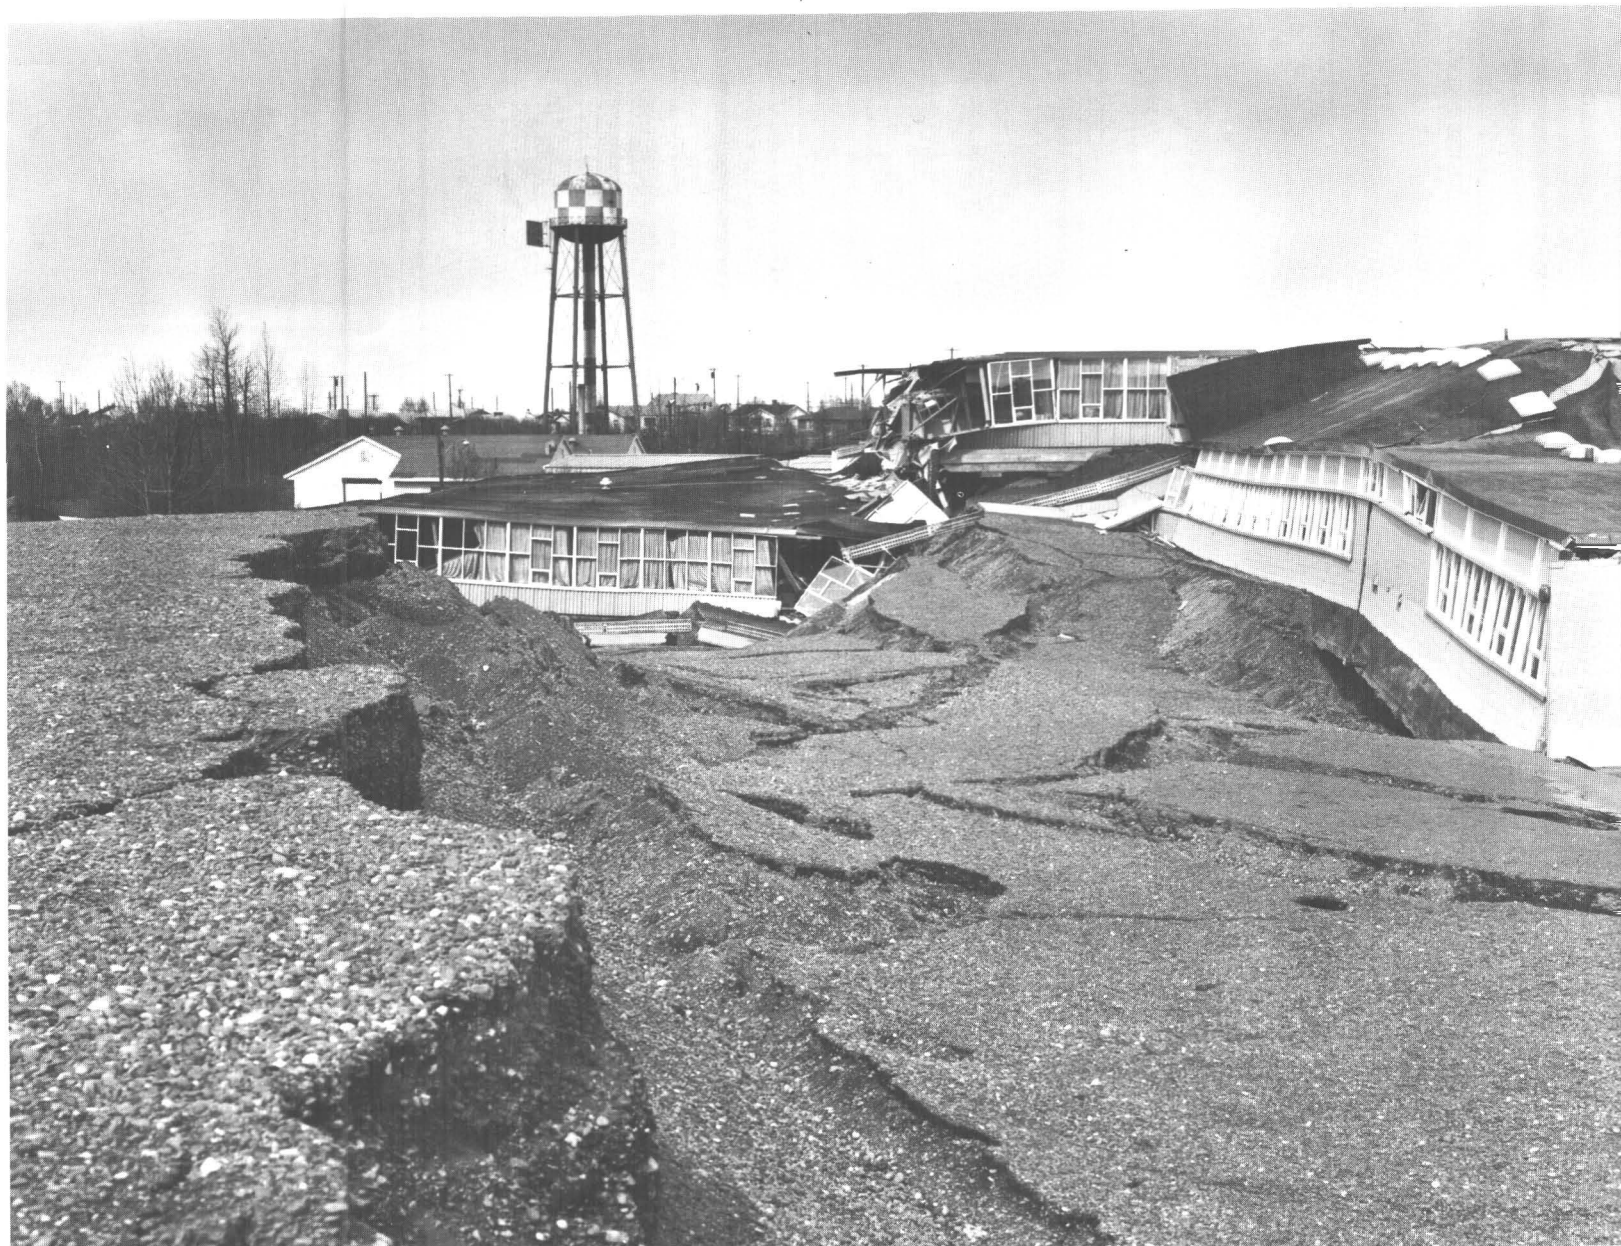
36.—Wreckage of Government Hill School as viewed from the playground, looking west. Graben in foreground is about 12 feet deep. Note undamaged water tower.

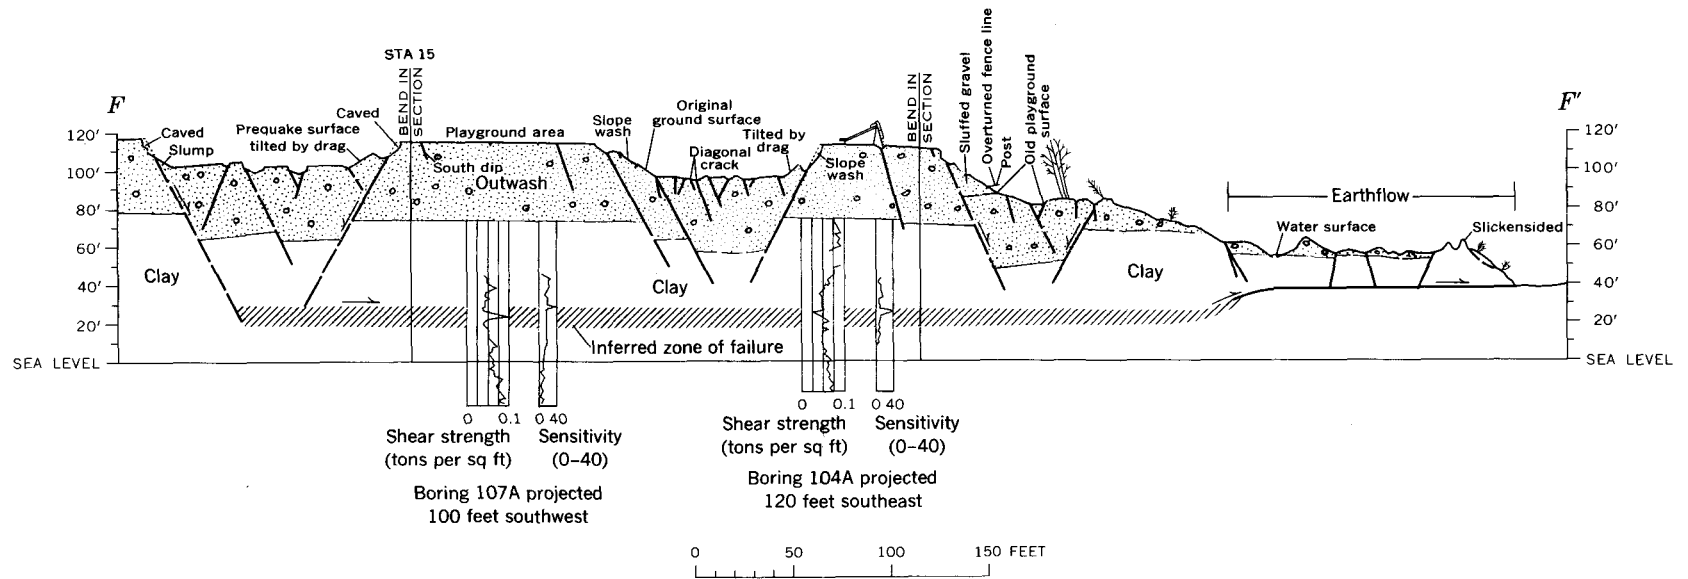
37.—Geologic section through Government Hill slide. Boring data from Shannon and Wilson, Inc. (1964).

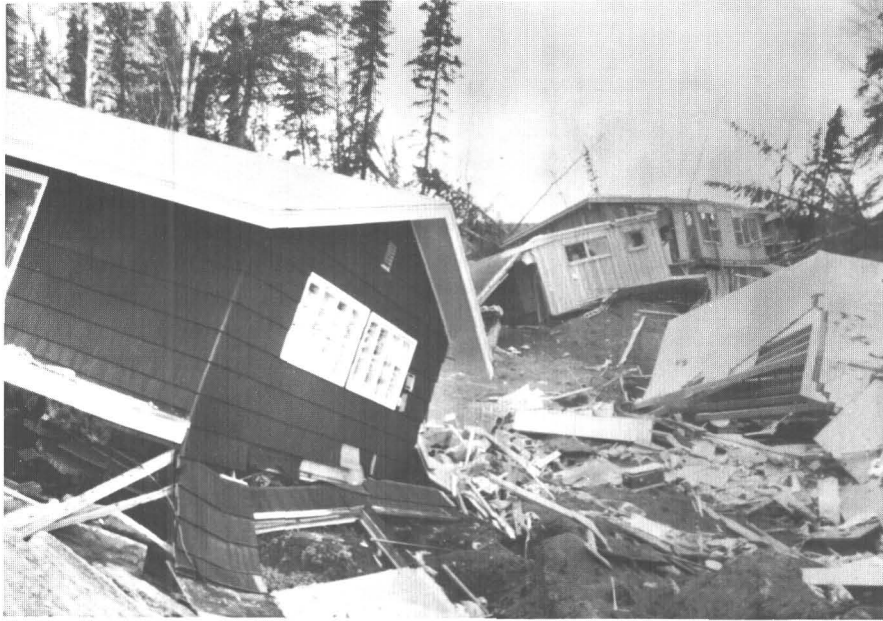
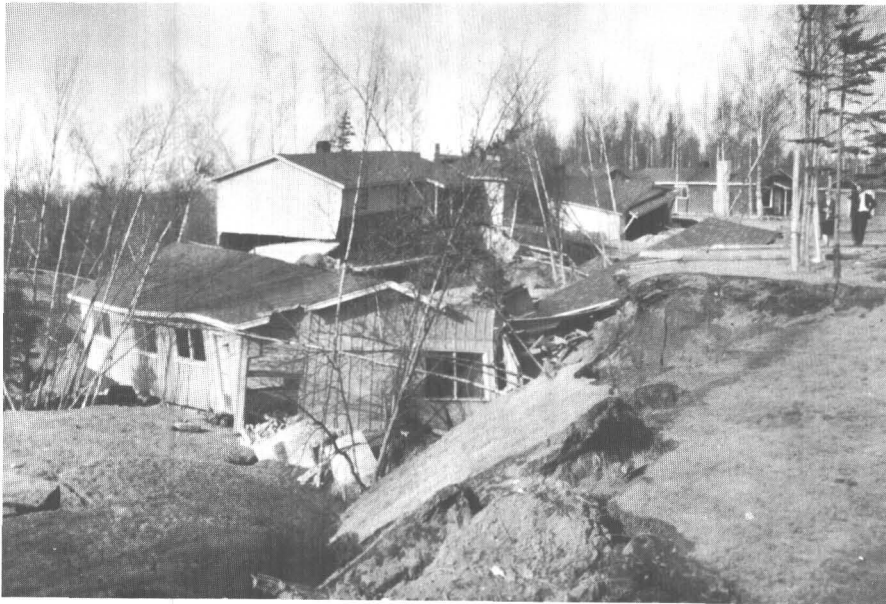
39.—Homes devastated by Turnagain Heights slide; deep within slide area, upper; at main scarp, lower. About 75 homes were destroyed.

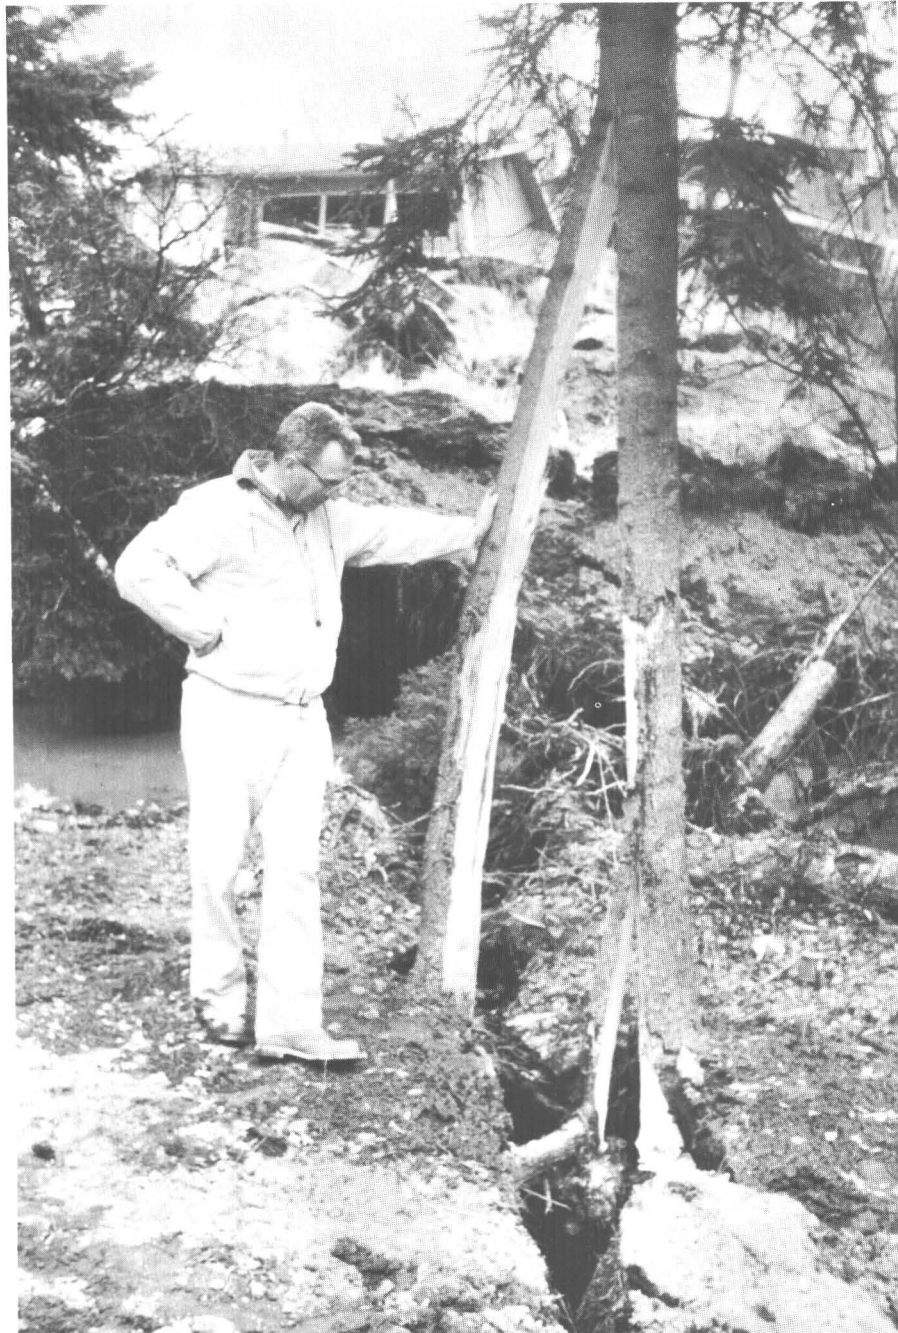
40.—Tree trunk split by tension fracture, Turnagain Heights slide. Many trees were similarly damaged because their roots were firmly embedded in the frozen ground.

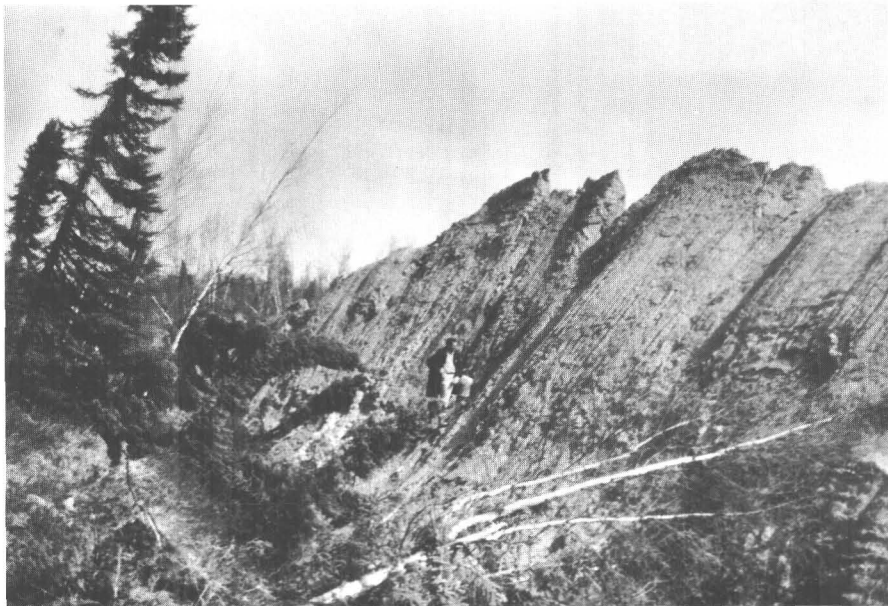
41.—Furrowed, slickensided clay ridge, Turnagain Heights slide. Ridge is about 20 feet high. Tilted collapsed block at left. Compare with figure 42.

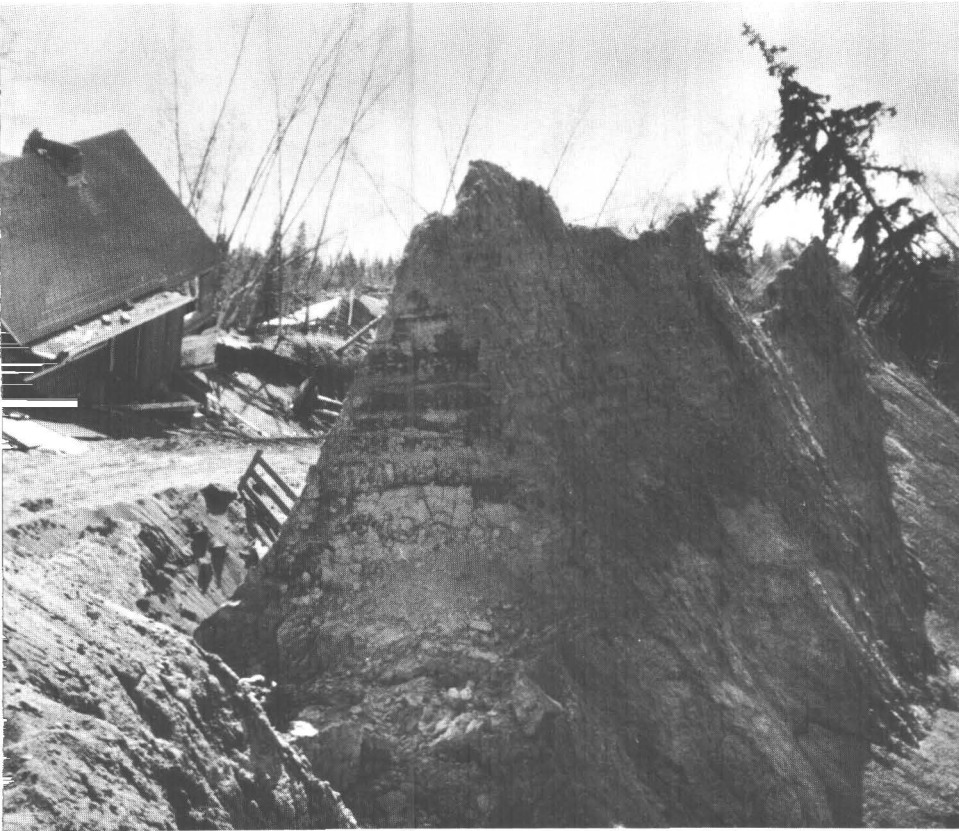
42.—Sharp-crested clay ridge, Turnagain Heights slide. Collapsed blocks tilted toward ridge on both flanks. Note horizontal stratification in ridge. Compare with figure 41.

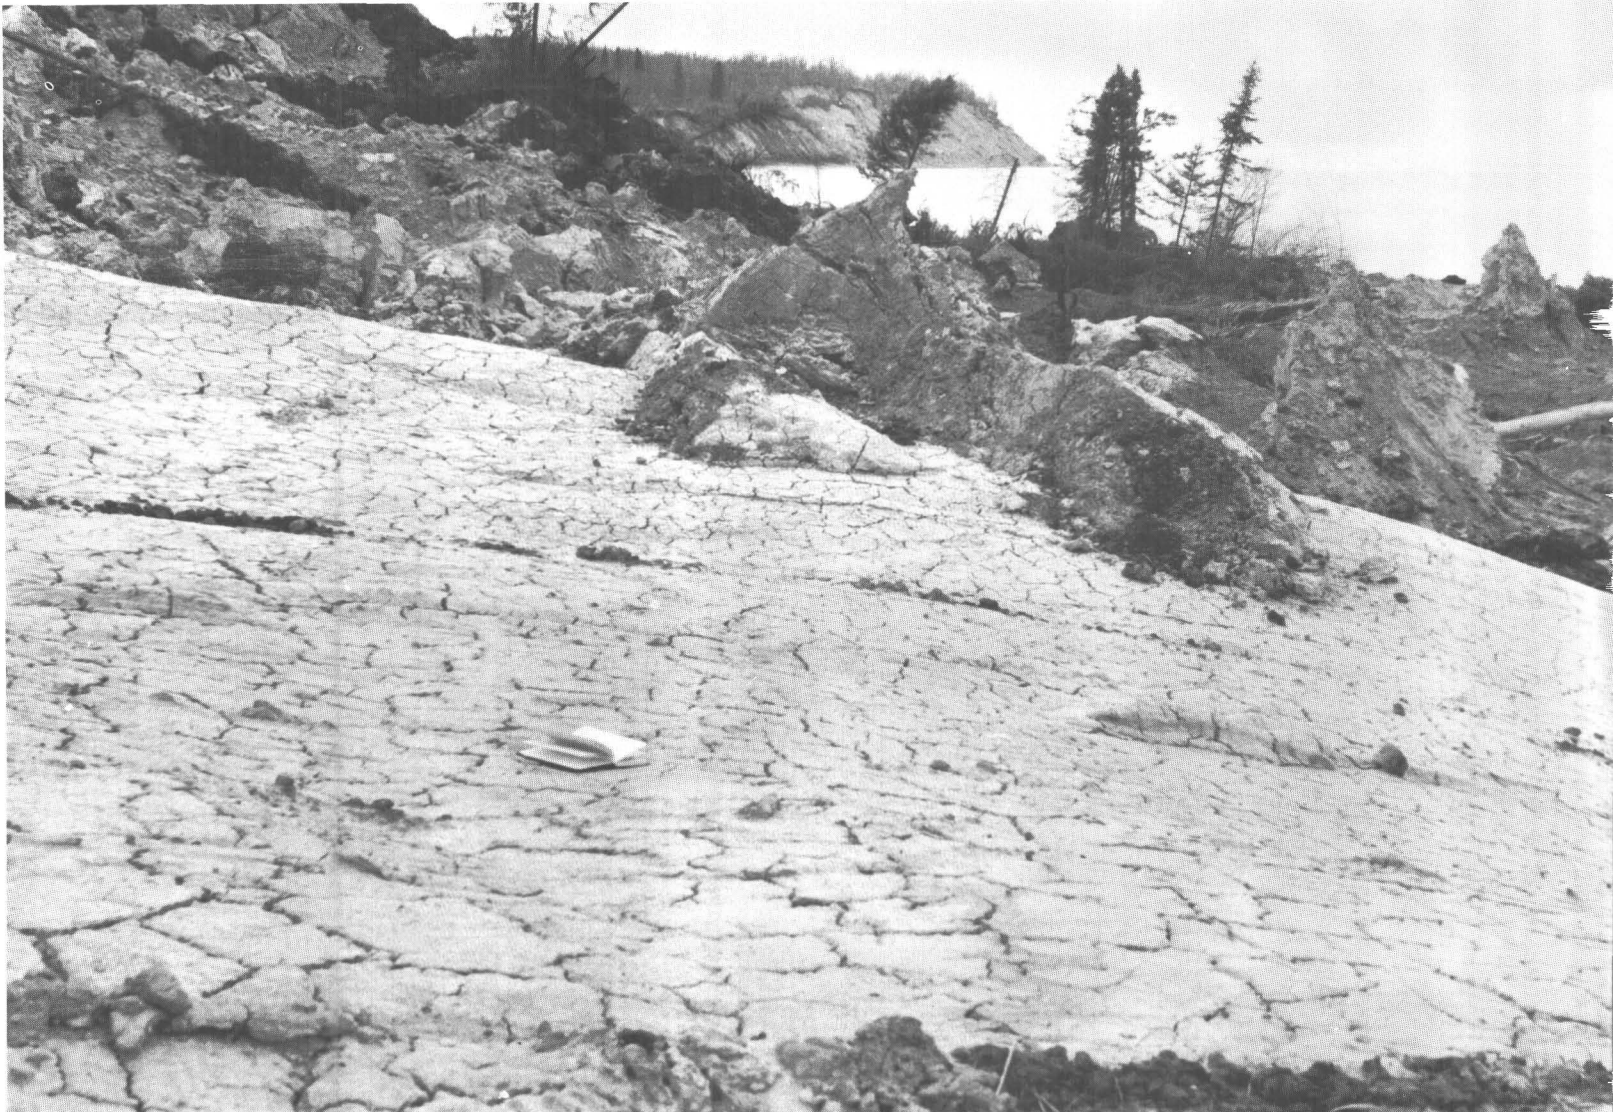
43.—Slip surface of Turnagain Heights slide exposed near west margin of slide. Furrows and welts still well preserved despite desiccation and weathering. Point Woronzof and Knik Arm in distance.
